Land at Green Rigg  
Medburn  
Northumberland

archaeological evaluation

report 4123  
March 2016

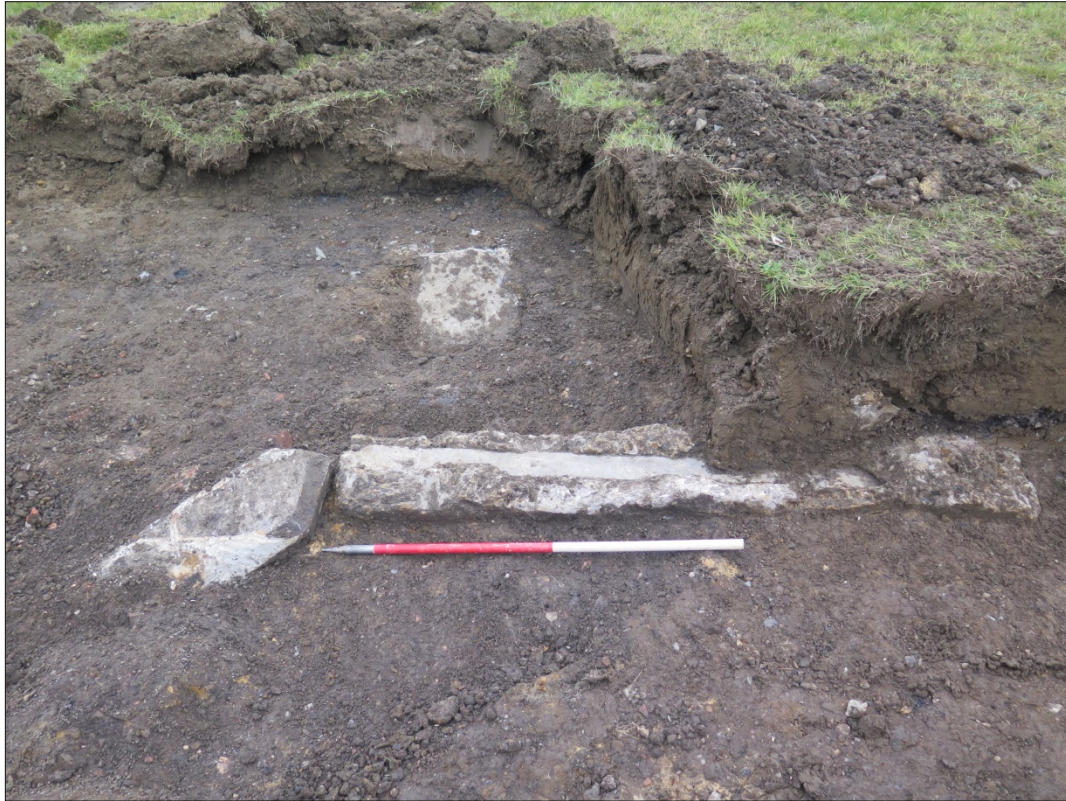
- 5.2 Trench 1 was 50m long and excavated on a north-west/south-east alignment in the western-most field in the development area. Natural subsoil, orange- brown clay and gravel [2], was identified at a depth of up to 0.4m, overlain by a deposit of brown clay-silt subsoil [3: 0.1m thick]. Toward the western end of the trench, a deposit of dark grey-brown clay-silt [7: 15m+ long, 0.5m+ thick] containing frequent rubble and modern glass fragments was identified, together with the remains of a concrete post [4: 2m long, 0.3m wide] (Figure 4).

Figure 4: Trench 1, modern deposit [7] and concrete post [4], looking north

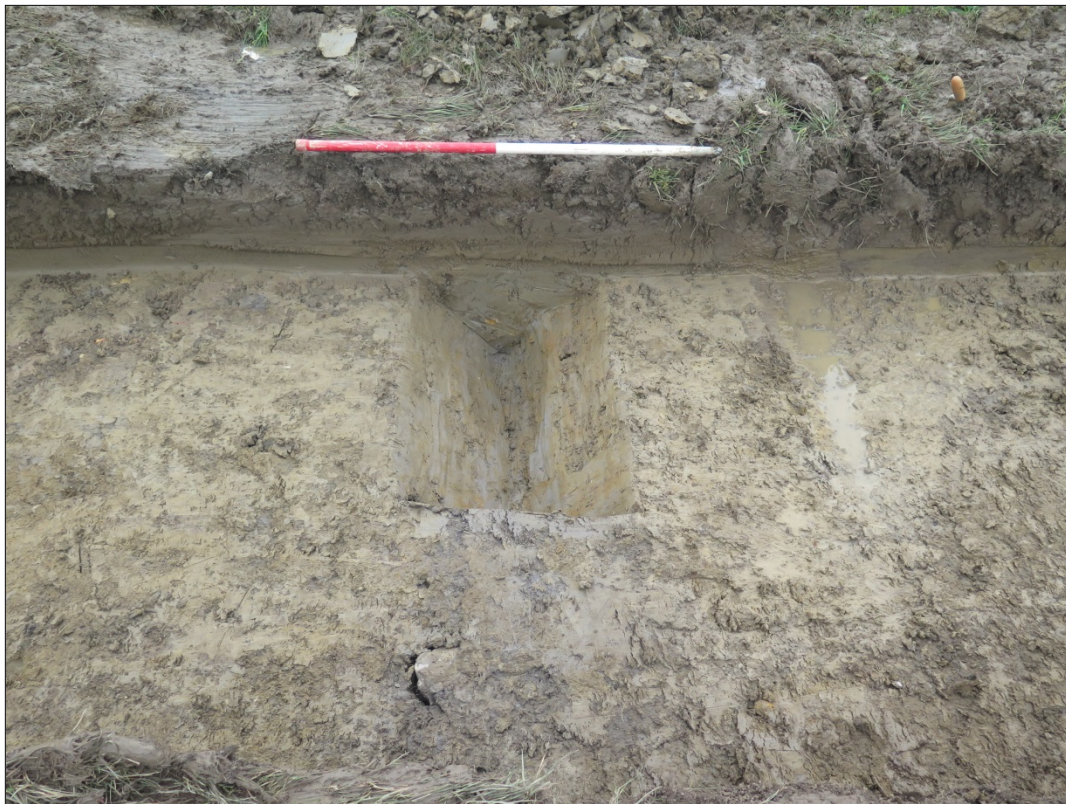
- 5.9 Trench 8 was 50m long and excavated on an east/west alignment in the western-most field in the development area. Natural subsoil, orange- yellow clay [2], was identified at a depth of up to 0.4m. A steep sided gully with a pronounced 'V' shaped profile indicative of a land drain cut the natural [F8: 0.6m wide, 0.35m deep]. This was filled by a grey clay-silt [9] (Figure 5). No archaeological features were identified and no artefacts were recovered.

Figure 5: Trench 8, land drain [F8] , looking west

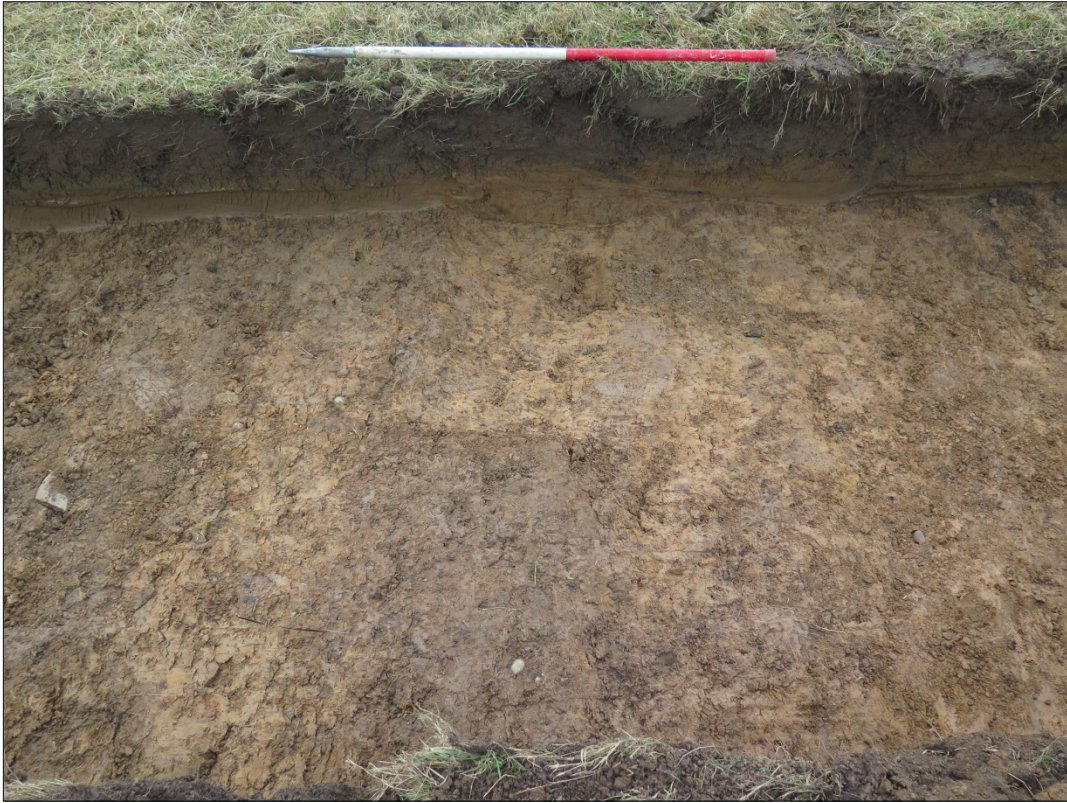
- 5.13 Trench 12 was 50m long and excavated on a north/south alignment in the eastern-most field in the development area. Natural subsoil, orange- yellow clay [2], was identified at a depth of up to 0.4m, and was cut by six plough furrows aligned approximately north-east/south-west. The furrows [F5] were spaced approximately 7m apart, were up to 5m wide and 0.2m deep and were filled by a deposit of brown clayey-silt [6]; the varying surviving width of the furrows is indicative of their truncation. A shallow truncated furrow [F10: 0.6m wide, 0.1m deep] was excavated, filled by a deposit of brown-grey clay-silt [11] (Figure 6). No artefacts were recovered.

Figure 6: Trench 12, truncated furrow [F10], looking west
