ARCHAEOLOGICAL  
SERVICES  
DURHAM UNIVERSITY

Wynyard Hall Cookery School  
Billingham  
Teesside

archaeological monitoring

report 4050  
July 2016

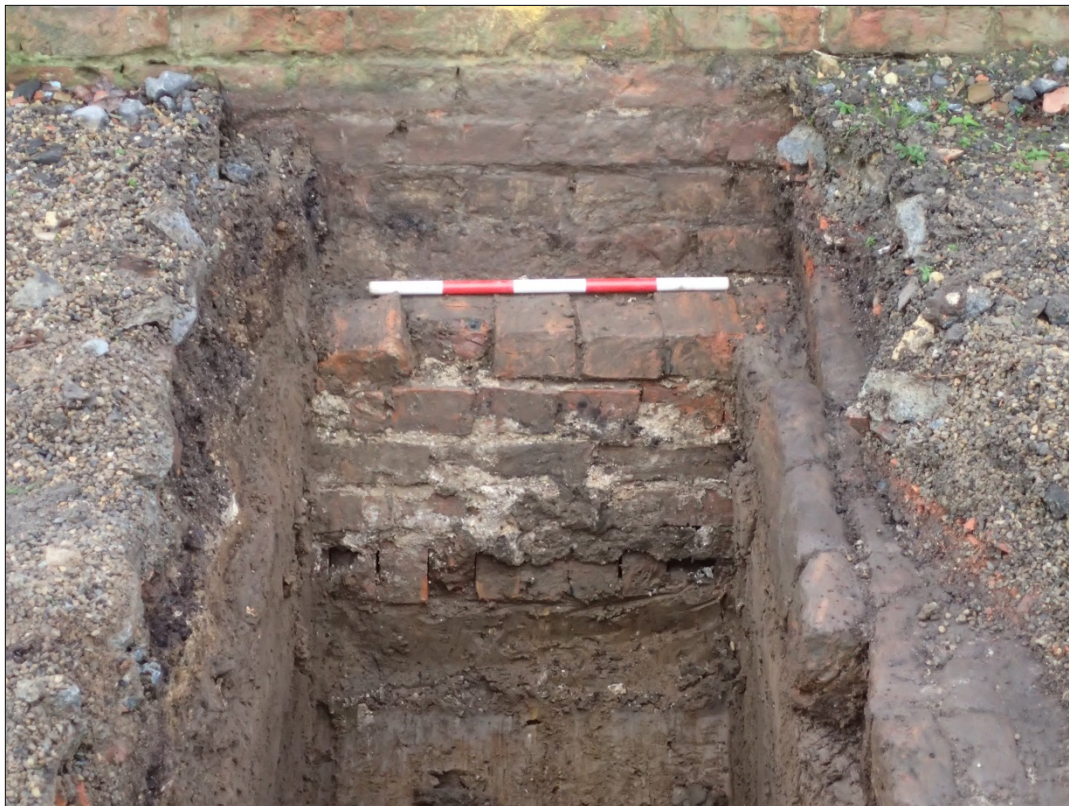
Figure 6: Wall foundation F308, looking south

- 5.3 Overlying both features was a buried subsoil layer, a sticky brown silty-clay [307: 3.4m+ by 0.6m, 0.22m thick]. Cutting this was an east-west trench [F314: 0.6m+ by 0.2m+, 0.49m deep] for the foundation of the garden wall [F308; Figure 6]. This comprised 5 courses of brickwork: the bottom course of bricks was laid on their

sides in header bond. Above these were two courses of stretcher bond, and then two regular courses of header bond. The foundation then stepped back (south) 0.2m and the remaining brickwork above was laid in English Garden Wall bond. The foundation trench was backfilled with a light yellowy-brown sticky clay [315].

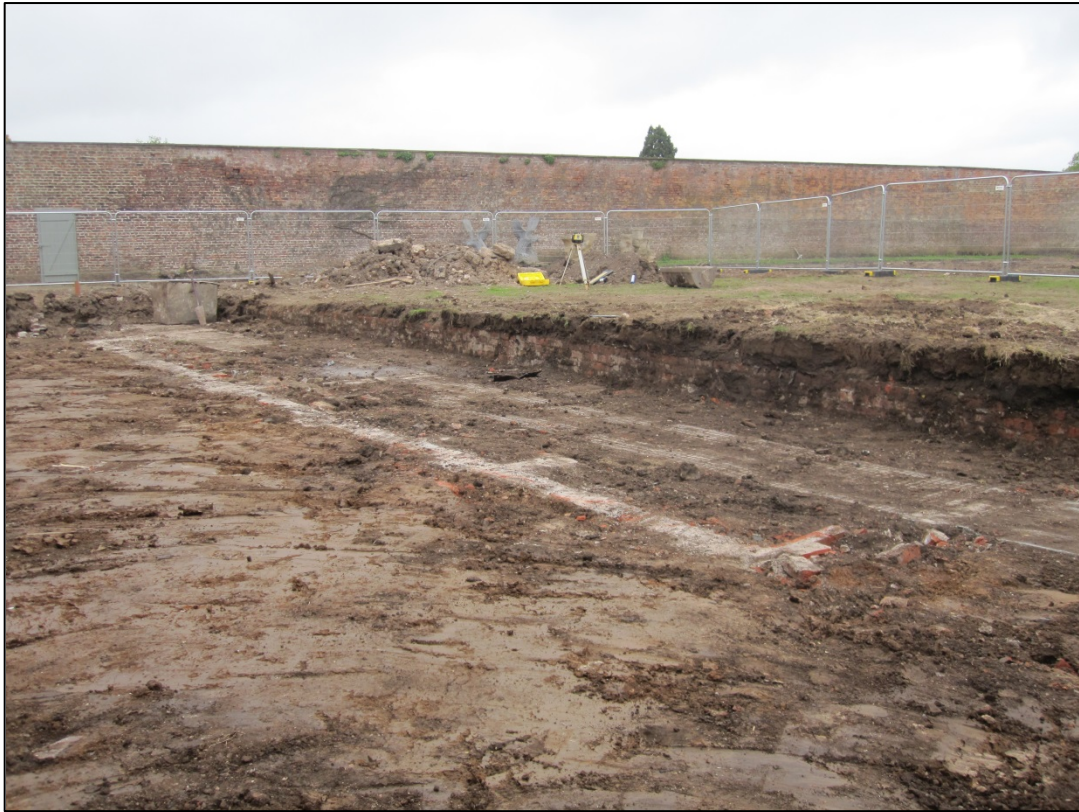
Figure 7: Eastern greenhouse, looking south-east

- 5.7 The eastern greenhouse was at least 16m long by 3m wide (Figure 7). Its external wall [F408] was two-bricks wide with a single brick reinforcing buttress every 2m along its outside edge and a one-brick wide internal division wall every 1m along its length (Figure 8). Space between these division walls was filled with rubble, including brick, mortar and silt. It was not removed as it lay below foundation level. The wall forming the southern baulk to the trench [F425] had no buttresses or

division walls along its visible length and therefore differed slightly from the northern wall.

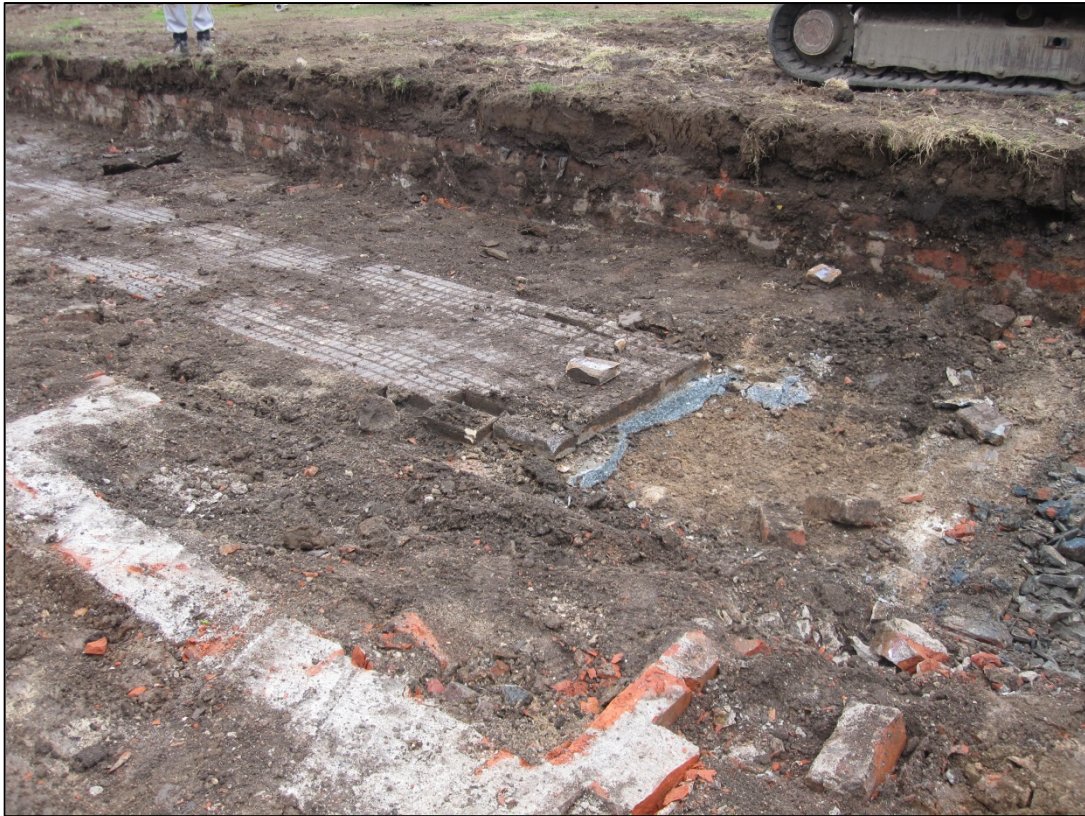
Figure 9: Tiled path 411 during removal, looking south

- 5.8 A path [411; 0.9m wide] ran lengthwise down the greenhouse, centrally between the north and south walls. Although at first glance this appeared to be composed of small tiles, excavation proved that these 'tiles' were actually a sculpted surface to conventional house bricks, the surface to each being moulded into two rows of five small 'tiles'. The bricks were set in a concrete foundation (Figure 9). The path extended over the western wall to the greenhouse and stopped at a large stone slab [424] immediately beyond. This is likely to have formed an entrance to the greenhouse although no evidence for any door jambs or other such features survived.

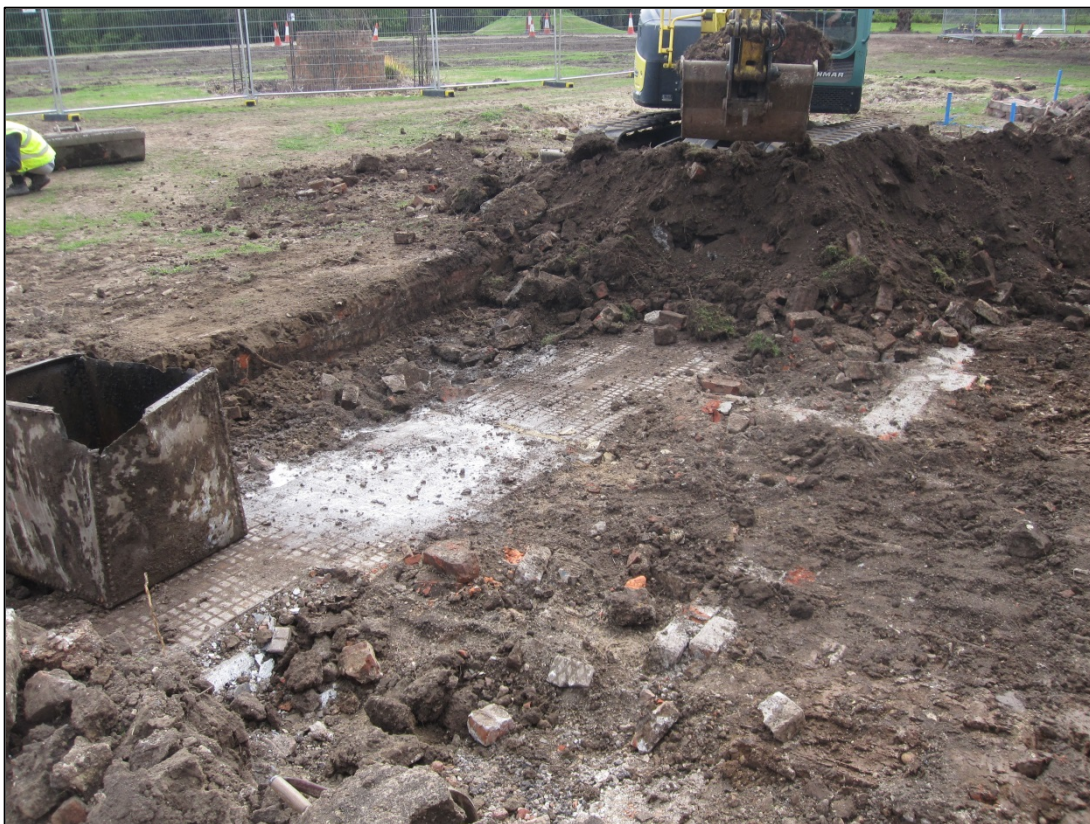
Figure 10: Water tank F414 after removal, looking south-west

- 5.9 To the south of the path was a deposit of dark grey-brown silt that contained a little rubble [413]. Two large metal water tanks [F414] were set into this deposit (Figure 10). Both measured 1m long by 0.6m wide by 0.8m deep. No evidence survived for any plumbing associated with these tanks.

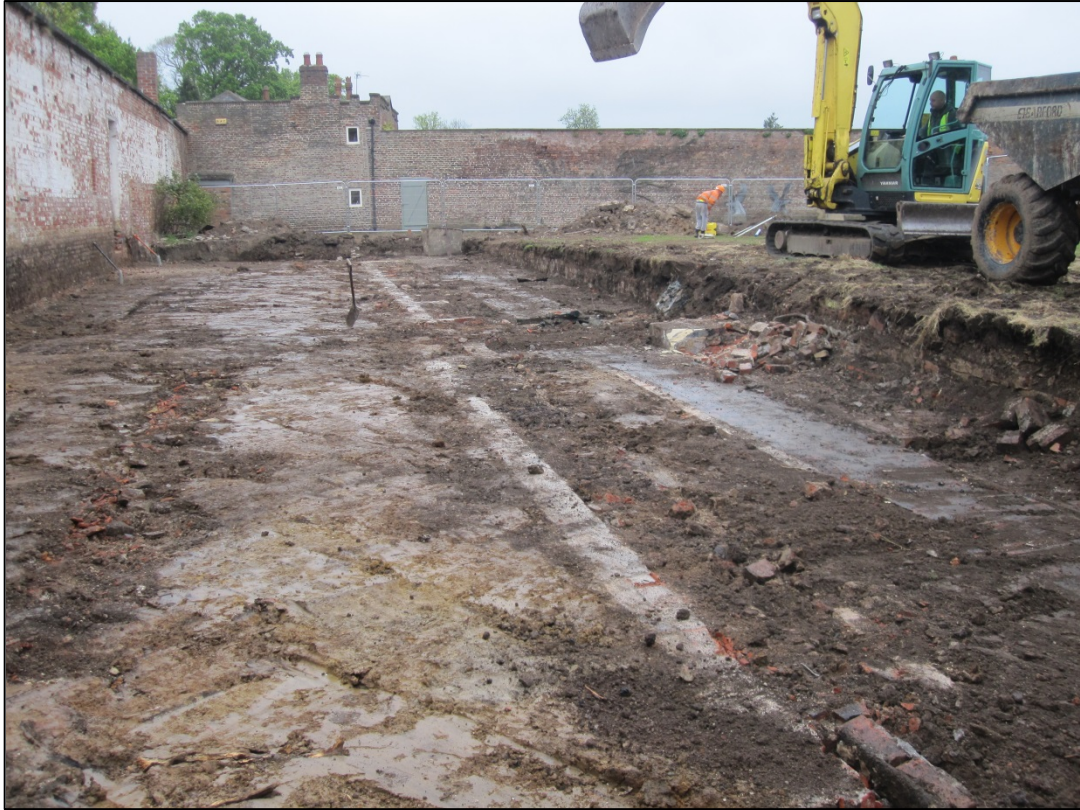
Figure 11: Western greenhouse with eastern one behind, looking east

- 5.10 A large pit [F410] full of rubble (including bricks from the path) cut through the centre of the path.
- 5.11 The western greenhouse was at least 13m long by 3.5m wide (Figure 11). As with the eastern greenhouse, its northern wall [F415] was two bricks wide, but unlike the eastern one, this wall had no external buttresses or internal divisions. As with the eastern greenhouse, another wall [F420] formed the southern baulk to the trench. This was partly removed (as it projected further north into the development area) exposing further brickwork immediately beyond. This could not be fully investigated as it lay outside the development area; it appeared to be a separate wall built onto the face of the first one.

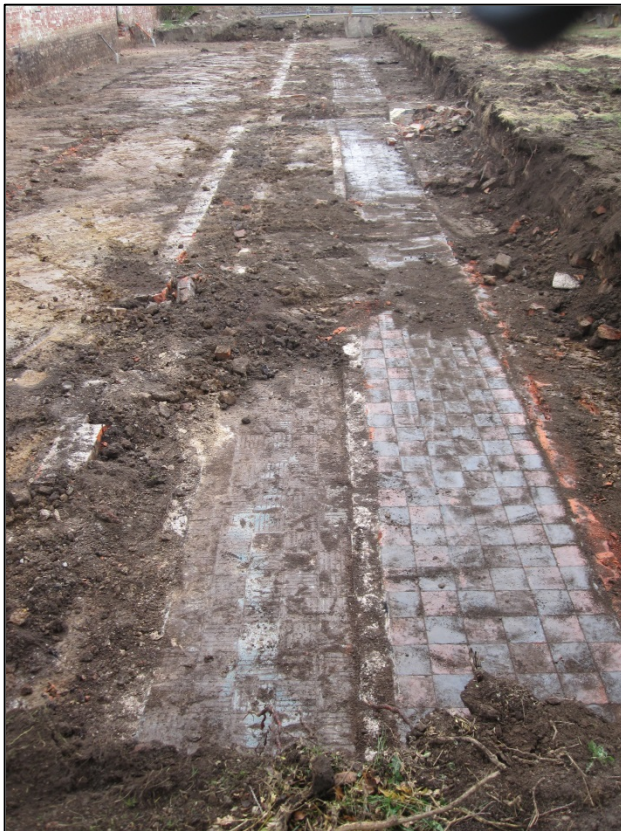
Figure 12: Tiled paths 416 and 417, looking east

- 5.12 Two parallel paths, separated by a single brick wide dividing wall, ran along the length of this greenhouse (Figure 12). These were made from tiles, although these differed slightly on each path. The northern path [416] had tiles scored with lengthwise grooves while the southern one [417] had flat tiles alternating between grey and brown in colour. The southern path was aligned exactly on the path through the eastern greenhouse, and like that one continued over the end wall of the greenhouse to finish immediately beyond it. The northern one finished within the end wall of the greenhouse and was at a slightly greater depth so that it was not originally exposed by machining. To the north of the northern path was a 0.3m wide strip of ground filled with rubble [419] and to the south of the southern path was a 0.8m wide strip of ground filled with grey-brown silt [418].

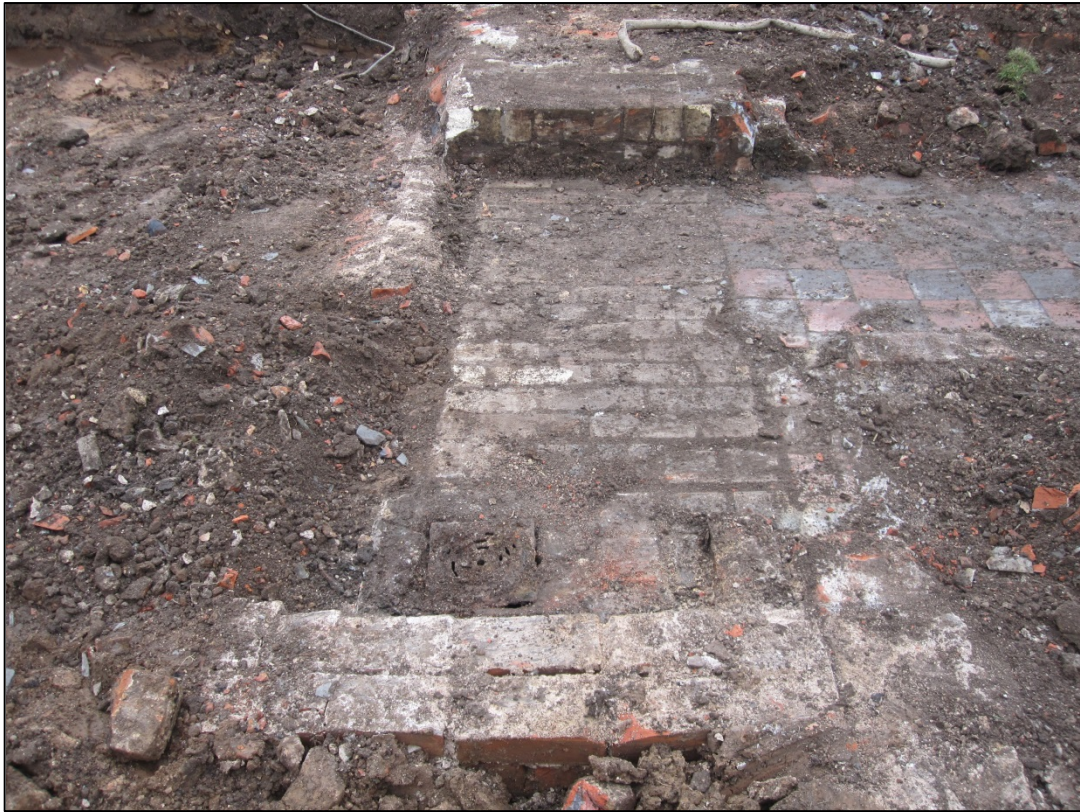
Figure 13: Brick extension at east end of west greenhouse, looking south

- 5.13 At the eastern end of the greenhouse was a small extension 2.5m long by 1m wide. This had a brick floor [422] with a metal drain cover in its north-east corner (Figure 13). Parts of a ceramic drain pipe [F423] heading in a south-west direction towards this were visible for a short distance outside the greenhouse. To the south of the brick floor, but still within the walls of this extension, was a raised platform composed of two layers of bricks set on their sides [F421]. No sockets, brackets or other fixtures were present to give any indication of what this raised platform may have been designed for.

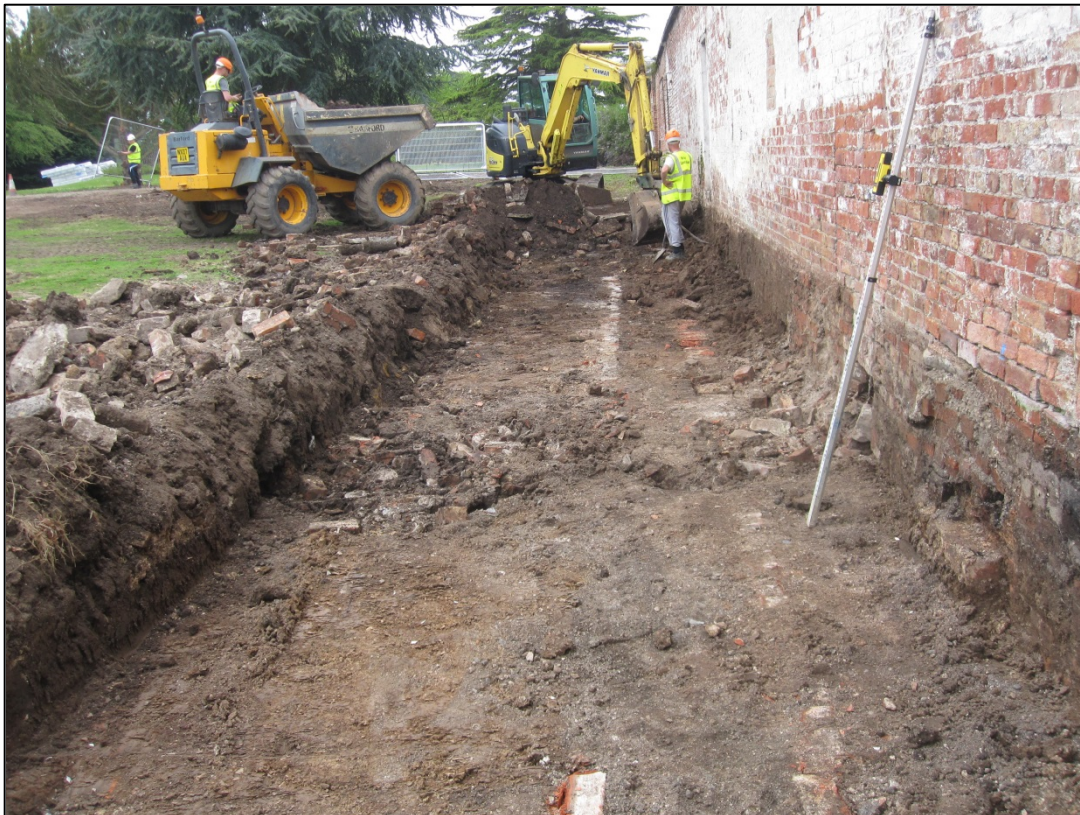
Figure 14: Parallel walls lining pipe duct 404, looking west

- 5.15 Two brick walls flanking a metal pipe [404] was present within 1m of the annex wall (Figure 14). The pipe was possibly for heating, and may have been associated with the boiler identified north of the wall (see below). The bricks differed between these walls; they were laid lengthwise and in a whitish mortar on the south wall and they were laid crosswise and in a reddish mortar on the north wall. Towards its centre, this pipe was below formation depth and was not disturbed. At either end it faded out and was lost. Towards the east at least this was due to modifications during the lifespan of the various greenhouses as its terminus was covered by a large concrete floor slab [401]. It could not be determined whether the western terminus was due to modifications of the greenhouses or due to disturbance during their demolition and conversion of the area to a rose garden. A large cut [F403] filled with rubble including much brick [402] was present in the north-centre of the trench, filling much of the ground north of the gap between the two greenhouse foundations.

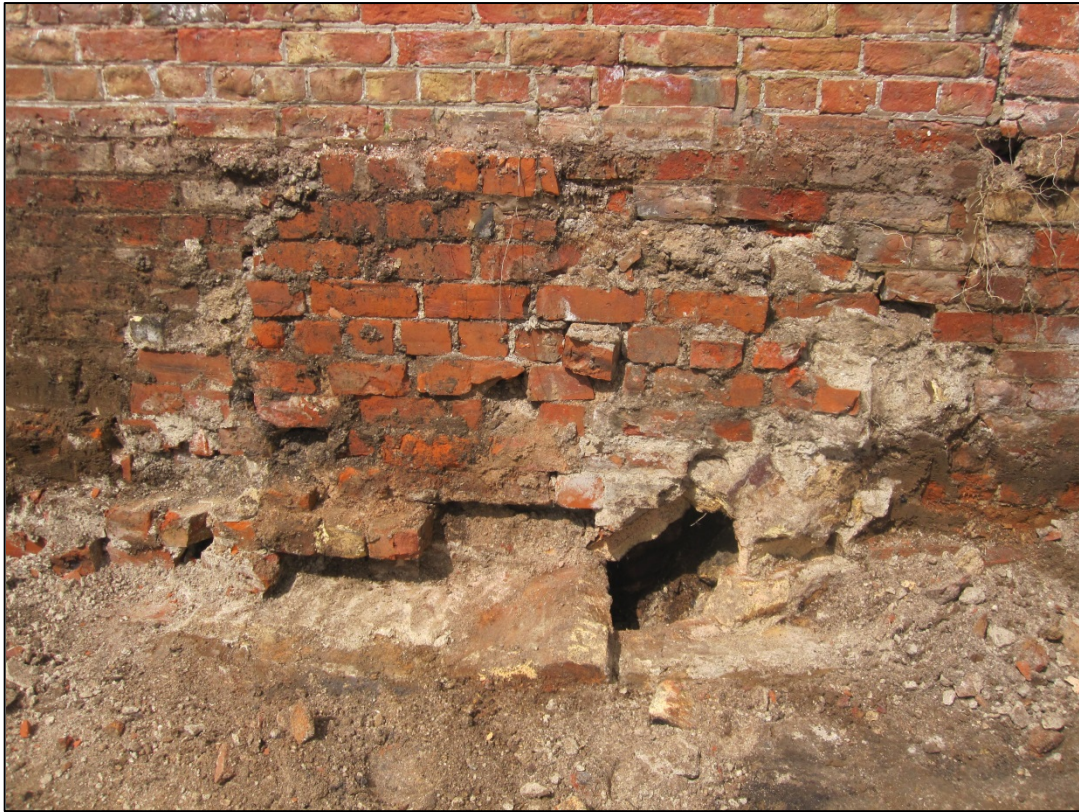
Figure 15: Heating flue F405 in annex wall, looking north

- 5.16 A brick duct [F405], probably for heating the wall, was present in the middle of the annex wall (Figure 15). This consisted of a brick-lined passage, stretching for around 1m along the bottom of the wall before turning upwards and heading into the interior of the wall. It is a later addition to the wall, as the brickwork surrounding it is a replacement of the original fabric. The duct is on the immediately opposite side of the wall to a rubble-filled cellar on the north side (see below) but even after this cellar was cleared out no evidence could be found for a connection through the wall. The duct could also not be traced along the length of the wall beyond its visible extent.

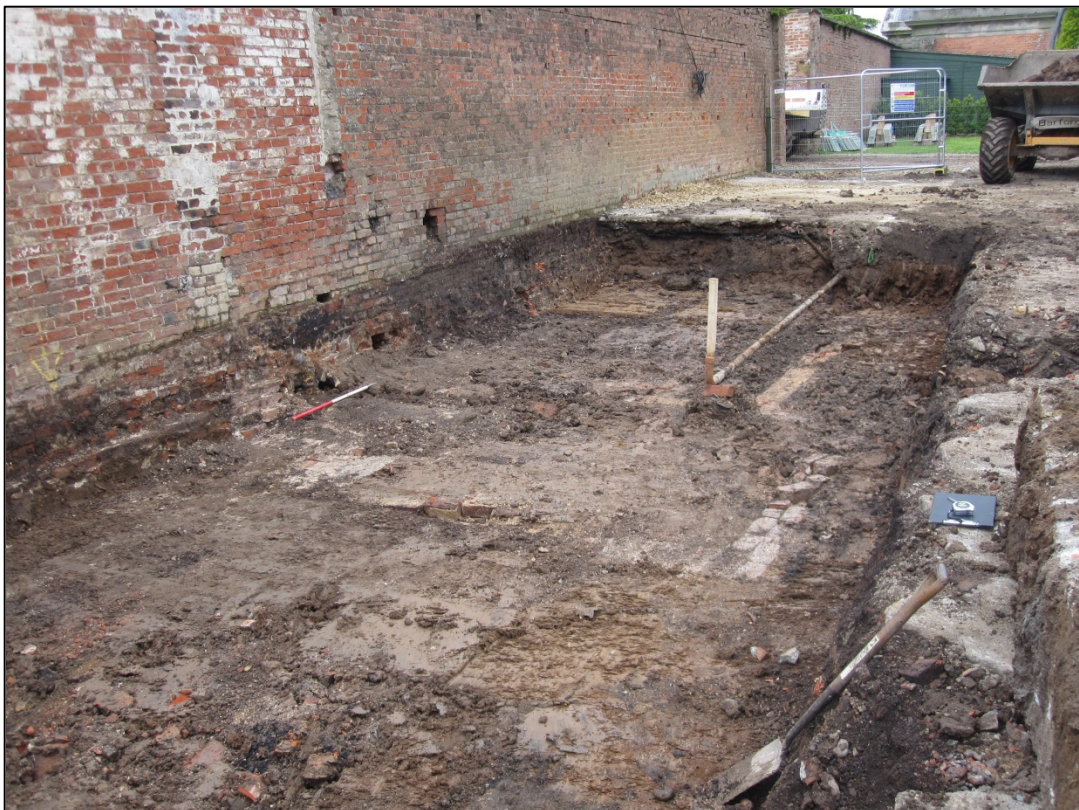
Figure 16: Cellar F512 for heating boiler, looking south-west

- 5.19 Towards the western end of the stripped area, orange clay natural subsoil [513] was present; this was cut by an infilled cellar that contained the remains of a boiler for heating the greenhouses to the south (Figure 16). It lay below foundation depth and was therefore left *in situ*. Only its upper surface was cleaned and recorded. The boiler [509] consisted of a metal cylinder, 0.5m in diameter and at least 1.5m long (Figure 17). It partly ran under the annex wall in an arched recess. Towards this wall there was a metal pipe rising out of its top and turning to disappear into the fabric of the wall. There was a flange in the centre of the boiler; this had possibly originally held a flue pipe. The northern end of the cylinder was open and filled with clay.

Originally there would have been a door here to allow stoking of the fire, although this was not visible within the limited area exposed.

- 5.21 To the west of the boiler and stoking chambers was a cellar with brick walls [F512]. It was infilled with a dark grey-brown silty clay containing brick and mortar fragments [511]. This was not excavated and its depth is unknown. It is not clear whether it was associated with the boiler house or not; assuming that it was associated then it may have been a fuel store. Two water pipes (one still live) and an electric cable (also still live) entered the north-west corner of the stoking chamber from the north and west.

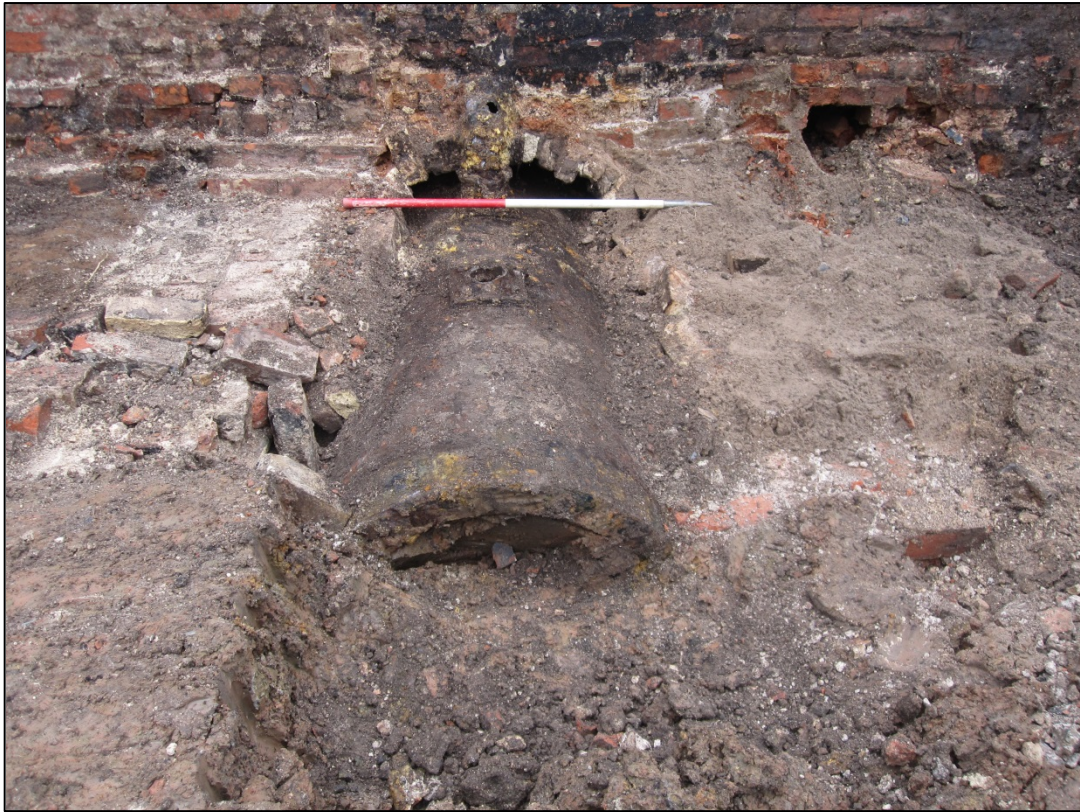
Figure 17: Heating boiler 509, looking south

- 5.20 The boiler was surrounded by brick walls [508] that originally supported an arch over it; the arch collapsed during machining of the structure. Towards the west the brickwork was partly overlain by a deposit of fine grey ash, presumably waste from the boiler fire. To the north of the boiler was a wider stoking chamber that was stepped out slightly eastwards from chamber that held the boiler. Again this had an arched roof that had collapsed during machining. The chamber was entirely filled with a thick brown clay (that also filled the interior of the boiler). This was a deliberate infill deposit.

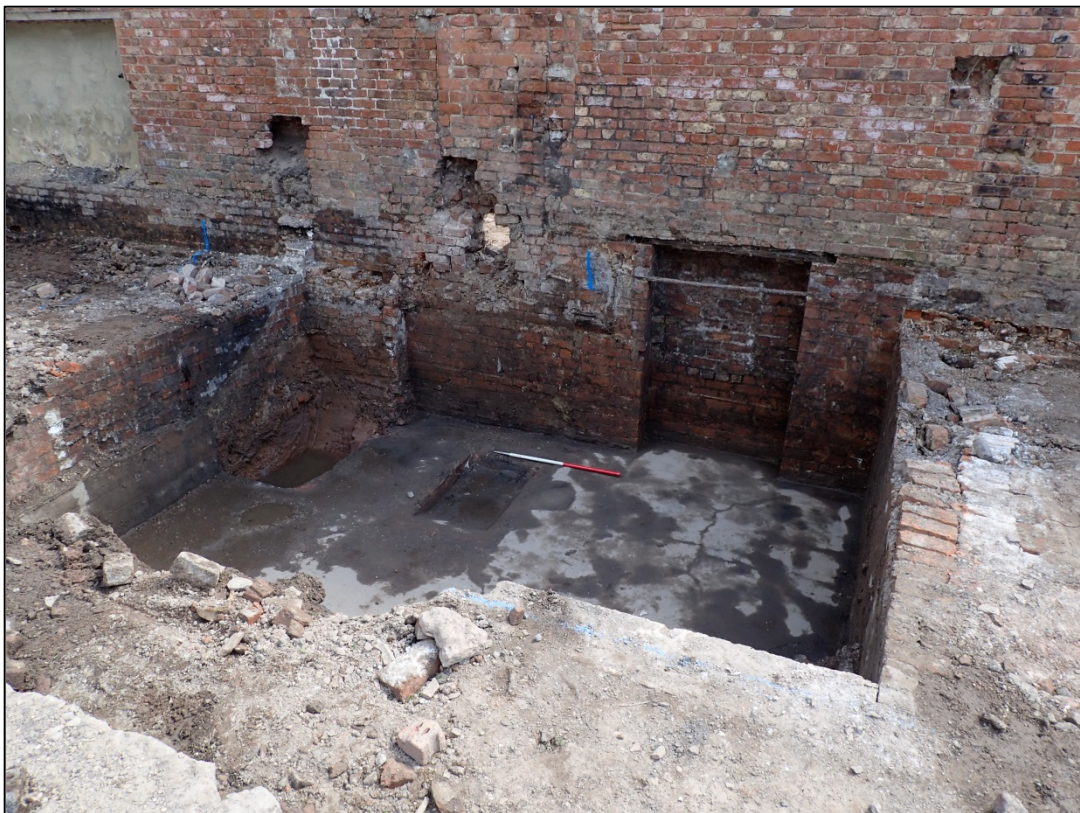
Figure 18: Cellar F504, looking south-east

- 5.25 A second cellar [F504] was present 12m east of the boiler house. Again this extended 3m out from the annex wall, but was deeper than the wall of the intervening area. The cellar was full of building rubble [503]. This was too loose to form a stable foundation and on the advice of the consulting engineer the cellar was emptied by machine. The cellar was 6m long and 3m wide, by 1.3m deep (Figure 18). It had brick walls and a concrete floor, although on the north and east sides this concrete extended 0.5m up the walls as well. There were brick platforms in both the north-east and north-west corners, although both were damaged during machining. There was a hole in the concrete in the south-east corner; natural clay was visible behind the cellar. A chamfered groove was present in the centre of the floor. There was a rectangular recess in the annex wall within the cellar. This had a wooden lintel and a metal grille across its face. It was on the directly opposite face to the heating

duct [405] seen in the area to the south of the wall. However there was no evidence for the duct passing through to this side of the wall.
