ARCHAEOLOGICAL
SERVICES
DURHAM UNIVERSITY

Proposed Business School
Elvet Waterside
Durham

archaeological
recording

report 5106
July 2019

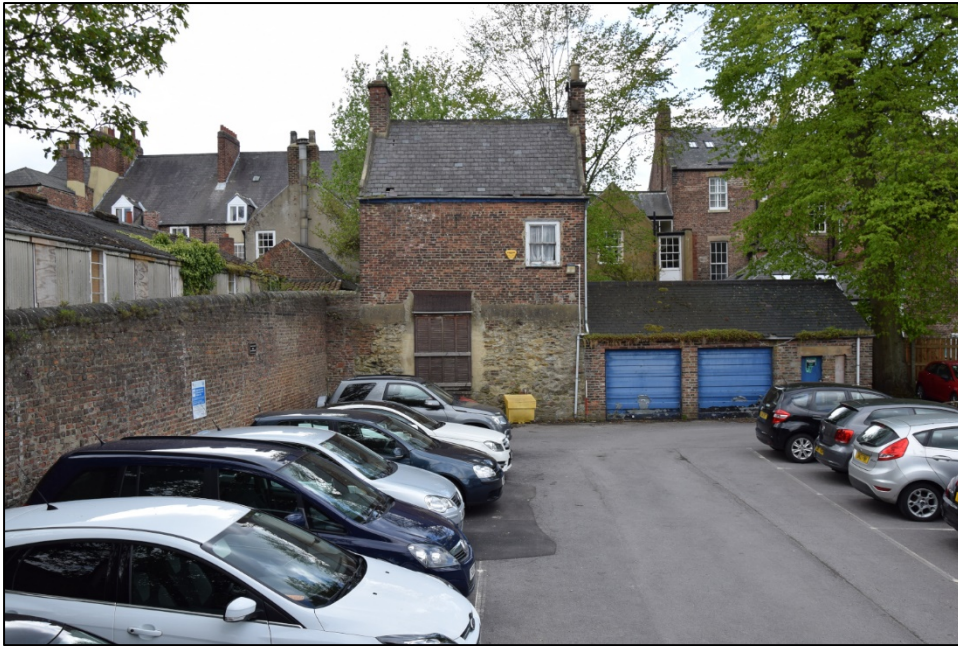
Photograph 1: Vennel Cottage and the garage block, seen from the Territorial Lane car park. The vennel runs at a higher level behind the brick wall at the left

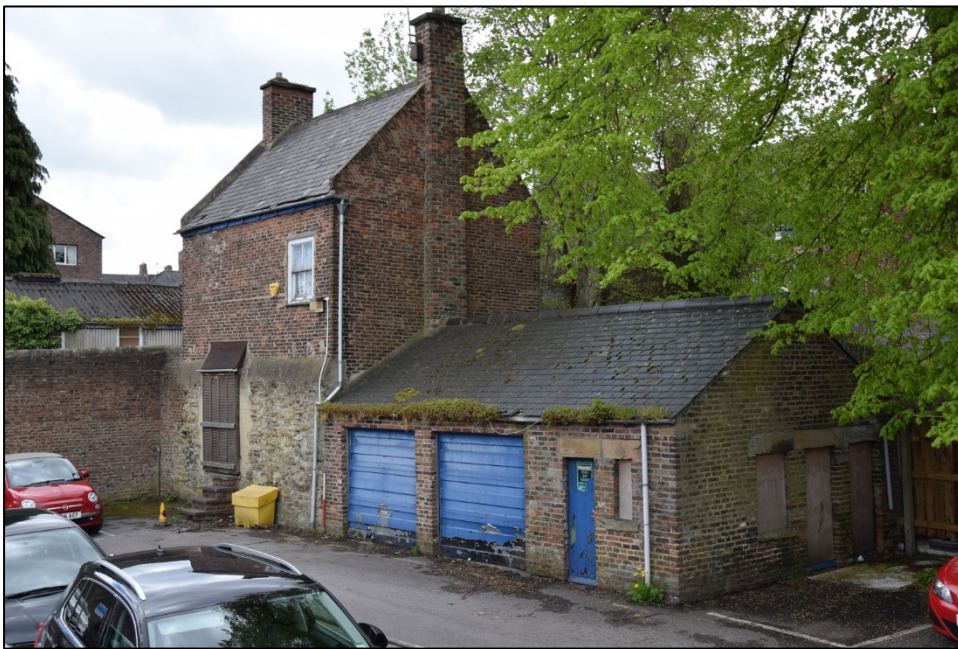
Photograph 2: Vennel Cottage seen from the north-west. Note the thick stone of the lower wall of the house

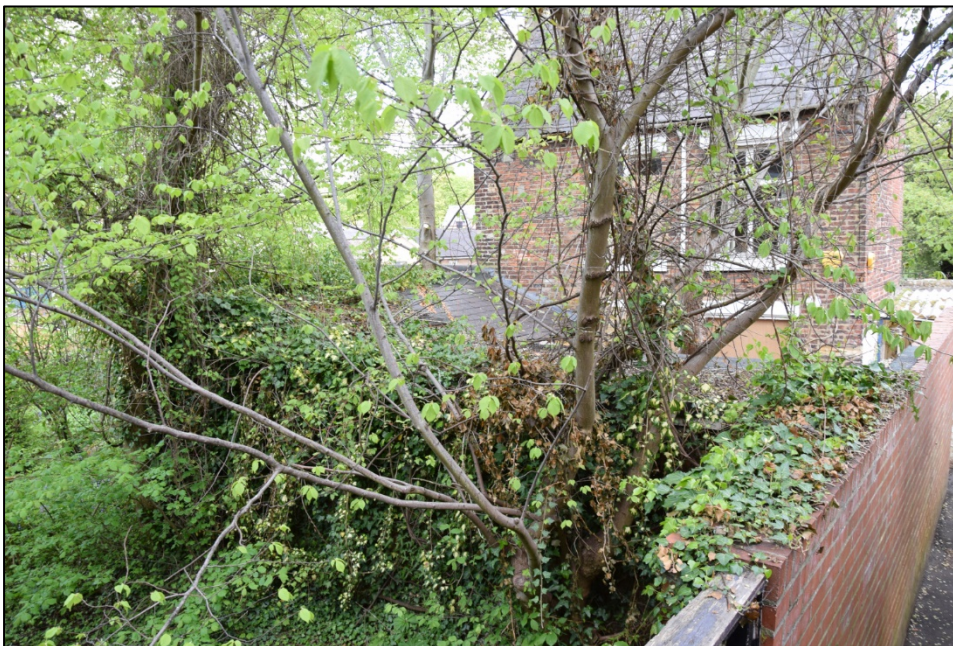
Photograph 3: The vennel and the east end of the Cottage. A view looking north-west

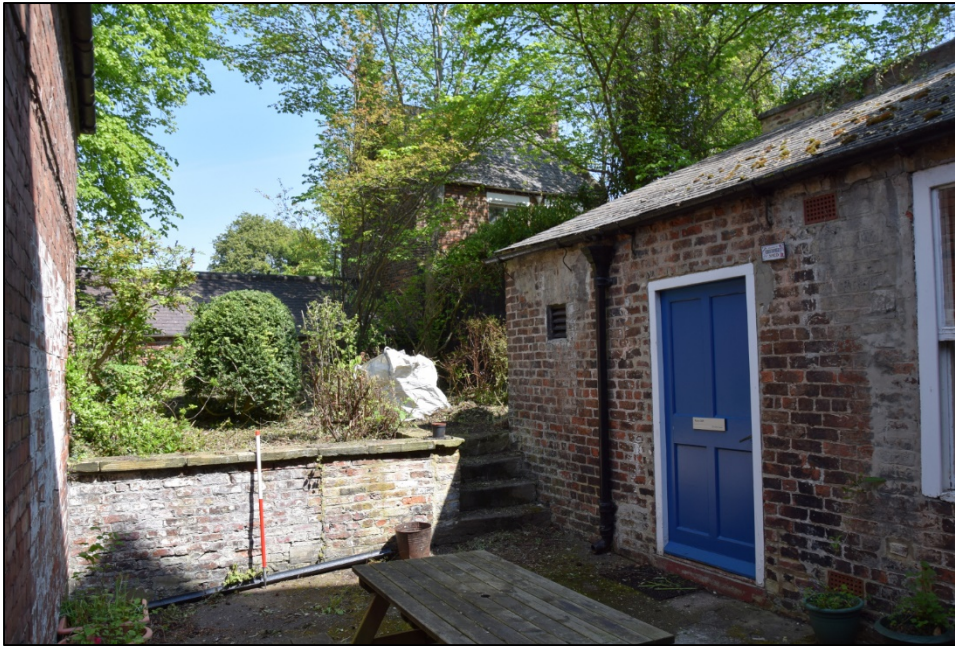
Photograph 5: A view looking towards Vennel Cottage from the rear of no. 51 Old Elvet. The 1861 map shows a path from the top of these steps to the door of the cottage, which was then a wash house

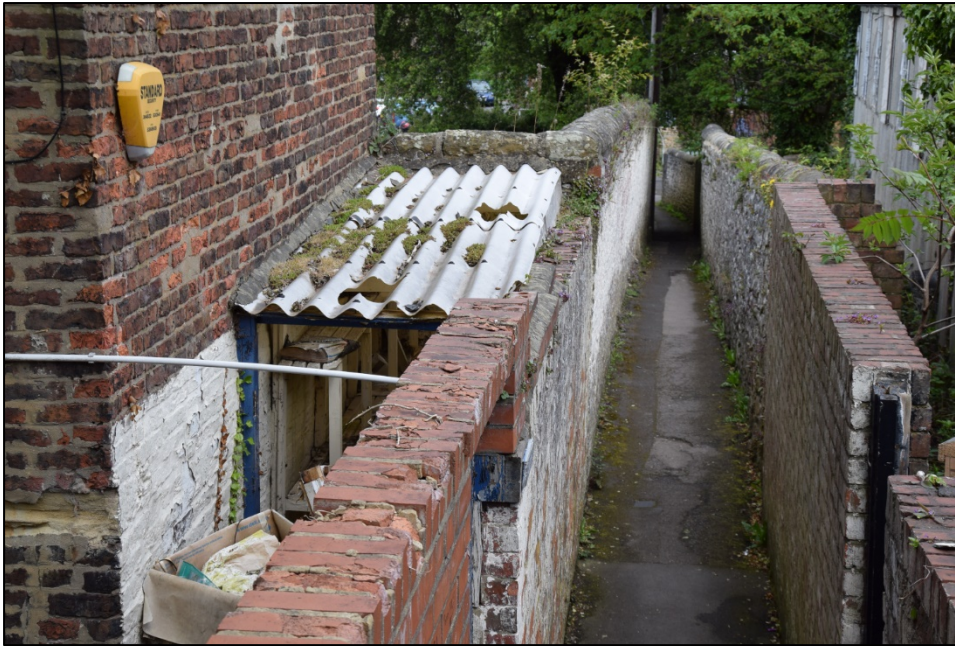
Photograph 7 (above): A view looking north along the vennel. The east end of the Cottage is about a metre west of the path. Note the distortion of the stone wall on the right side of the vennel, beyond the brick wall

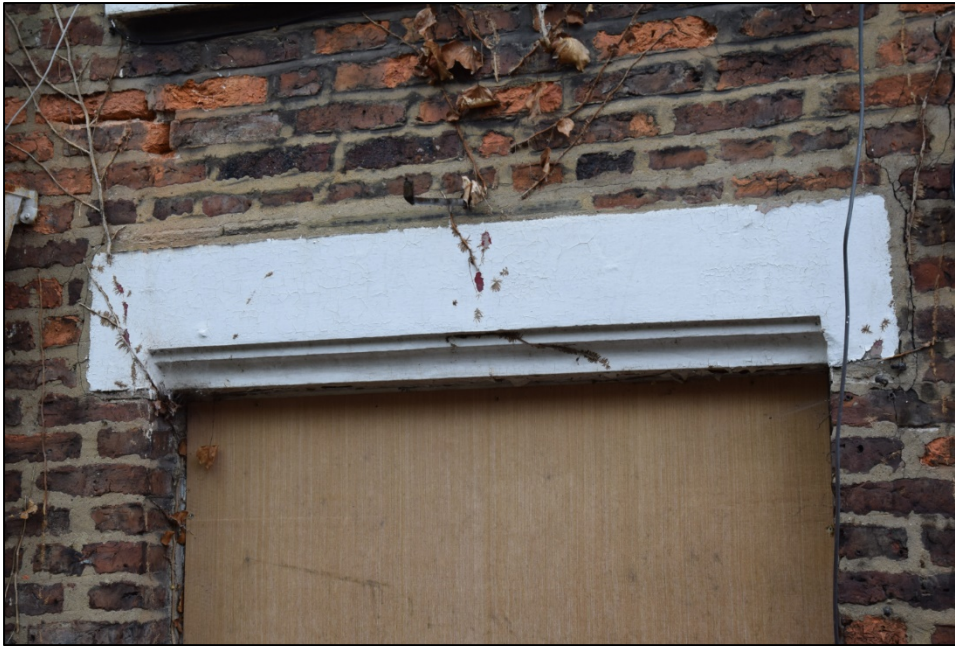
Photograph 8 (left): The south face of Vennel Cottage

- 5.2 The cottage is built of thin brick, randomly coursed, and has a steep slate roof and gable chimneys. There are four large windows in the south face, with projecting sills and moulded lintels (Photographs 8, 9). The north face is quite different; its lower section is a thicker stone wall, the junction between this and the brick of the first floor is roughly covered with cement mortar (Photograph 10). A large modern ground-floor window is covered with louvred panels. At first-floor level there is a

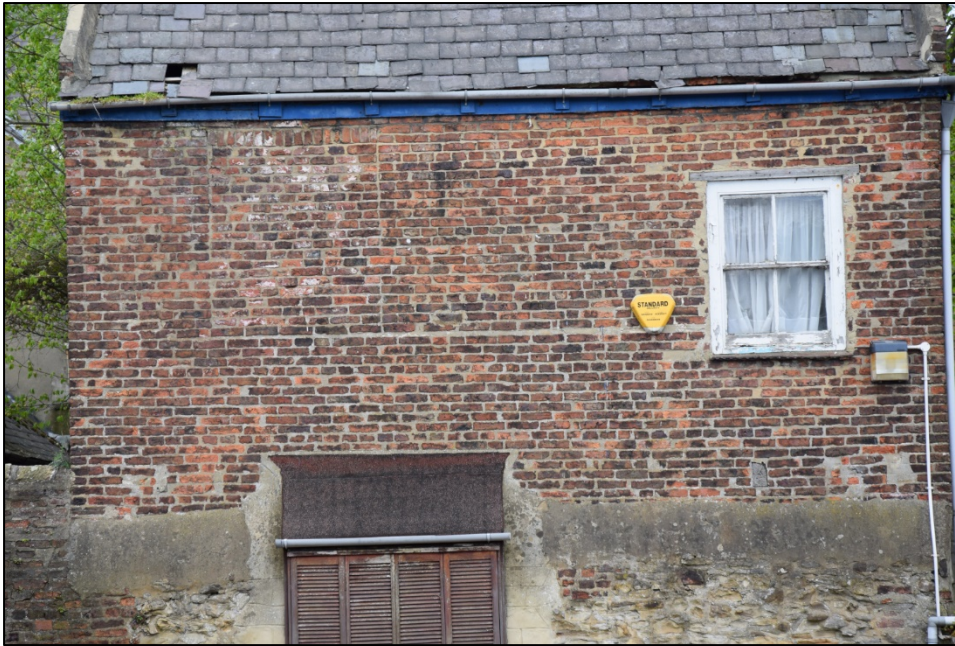
Photograph 10: The thick stone wall in the north face of Vennel Cottage does not extend as far as the wall of the vennel itself, and it does not run into the adjoining garage building at the right. A slope of cement mortar provides a crude cover for the join between the thick stone wall and the thinner brickwork above

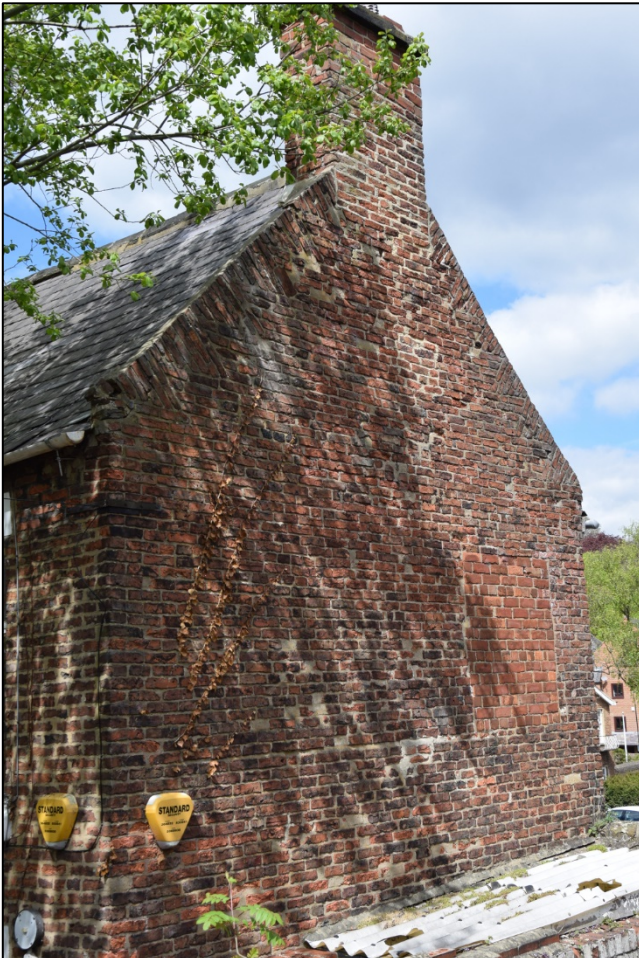
Photograph 11 (above):
The first floor wall on the north side of the cottage. The blocked opening at the left does not match the existing window. Note the row of joist holes for a vanished floor just above the mortar at the bottom of the brickwork

blocked window at the east end and an open one, of different proportions, at the west (Photograph 11). A row of joist-holes below these are almost certainly a trace of the building shown on John Wood's map, Figure 3. The east wall (Photograph 12) has tumbled-in brickwork in the gable and the chimney is inside the wall. There is a large window blocked with modern brick near the north-east corner. The west wall also has a tumbled-in gable but here the chimney projects from the face (Photograph 13).

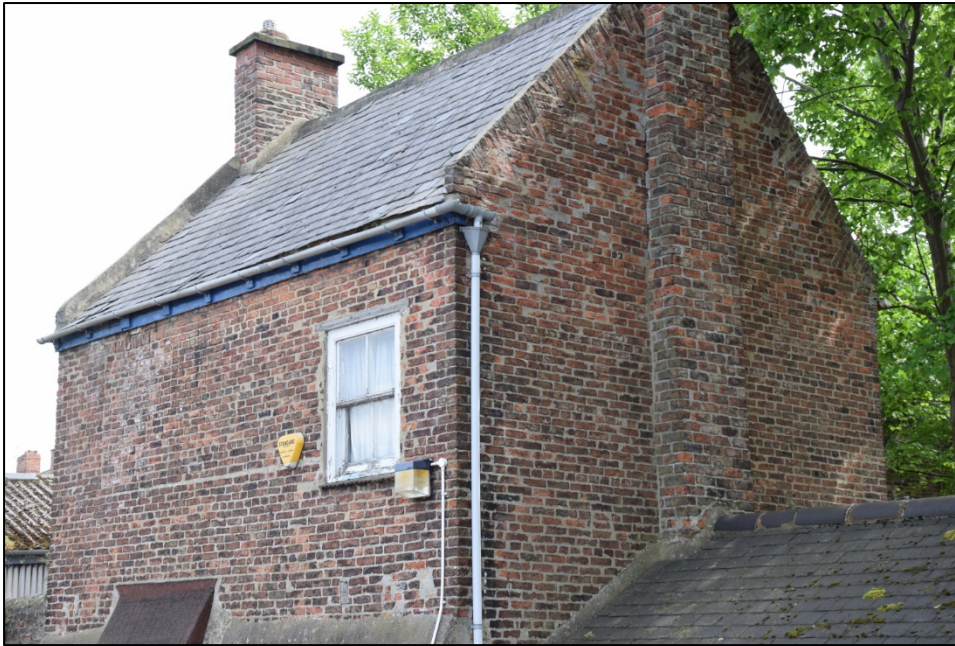
Photograph 12 (left):
Tumbled-in brickwork and another blocked window in the east gable. The chimney is inside the wall here

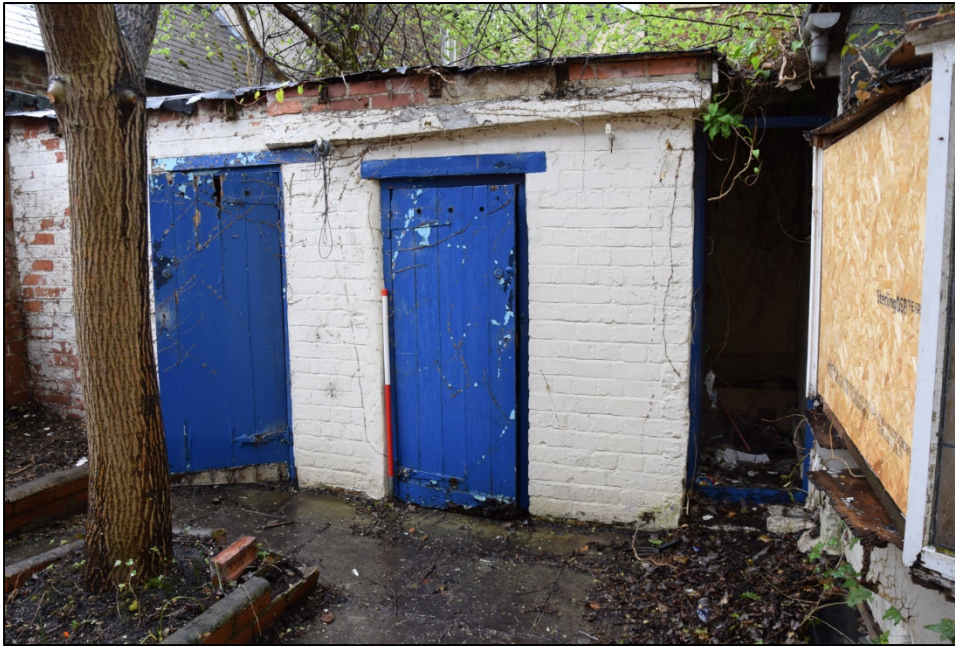
Photograph 14: The lean-to kitchen on the west side of the yard butts up against a smaller shed at the left, now the bathroom

- 5.3 In the yard, the west lean-to covers the original door and provides space for a kitchen and bathroom (Photograph 14). It is in two sections. The larger part, of modern brick with a low-pitched slate roof, is probably later than the small section at the south-west corner of the yard. The south range consists of a central brick shed with a concrete slab roof, adjoined on the east by a later addition (Photographs 15, 16). A single felt roof now covers both. The narrow space between the cottage and the vennel has been used for storage; at its north end, a ragged straight joint can be seen in the wall (Photograph 17).

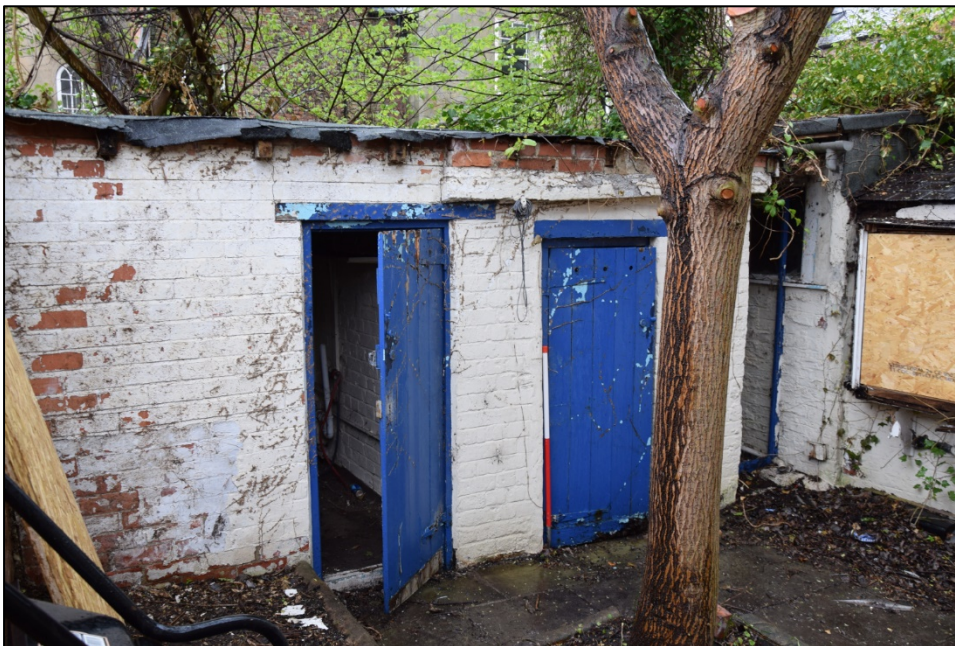
Photograph 15: The south side of the yard at Vennel Cottage. The central section was formerly a free-standing shed with a concrete slab roof. The gap at the right provides light to the bathroom window

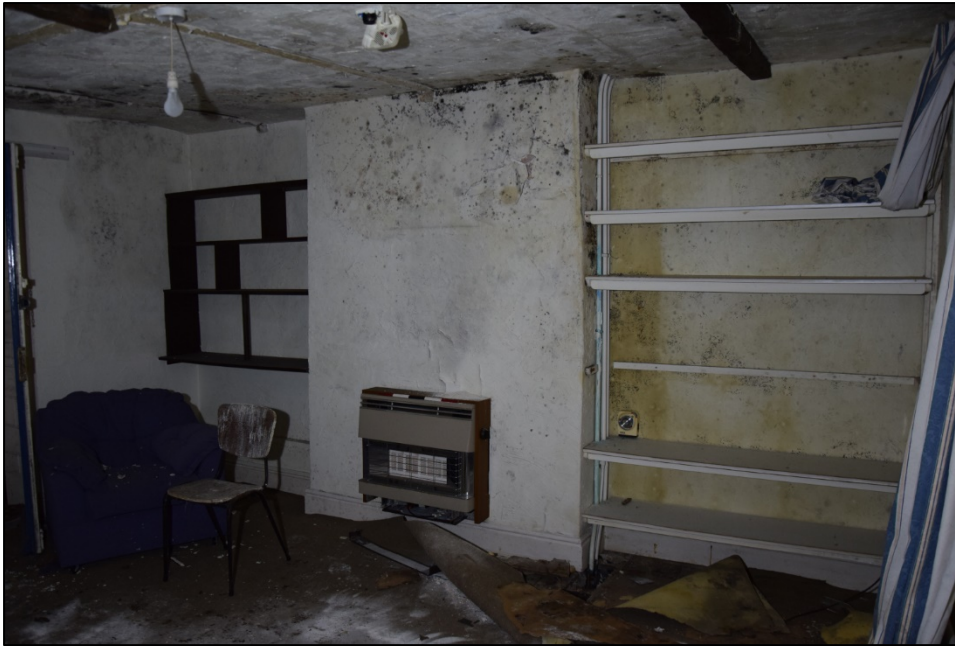
Photograph 18: A view looking south-west across the ground floor room 1 in Vennel Cottage. The partition at the right and the expanded polystyrene ceiling beams are modern additions

- 5.4 A thin modern partition with a large window divides the ground floor into a living room [1] and a staircase hall [2] (Photograph 18). The windows are modern, as are the false ceiling beams. Room [1] retains no original features apart from the blind chimney breast (Photograph 19). Glazed doors lead to the large north opening; above this, the ceiling has a marked slope at the east side (Photograph 20). The modern west wall has false half-timbering (Photograph 21). The hall [2] contains a simple staircase with a turned newel post and a small cupboard (Photographs 22, 23). The old entrance has been replaced with a folding door that opens into the lean-to kitchen [3] (Photograph 24). This narrow room is lined with matchboard and opens into the bathroom [4] at the south end (Photographs 25, 26). The bathroom is entirely plain and has a large window opening into the narrow space beside the south sheds (Photograph 27).

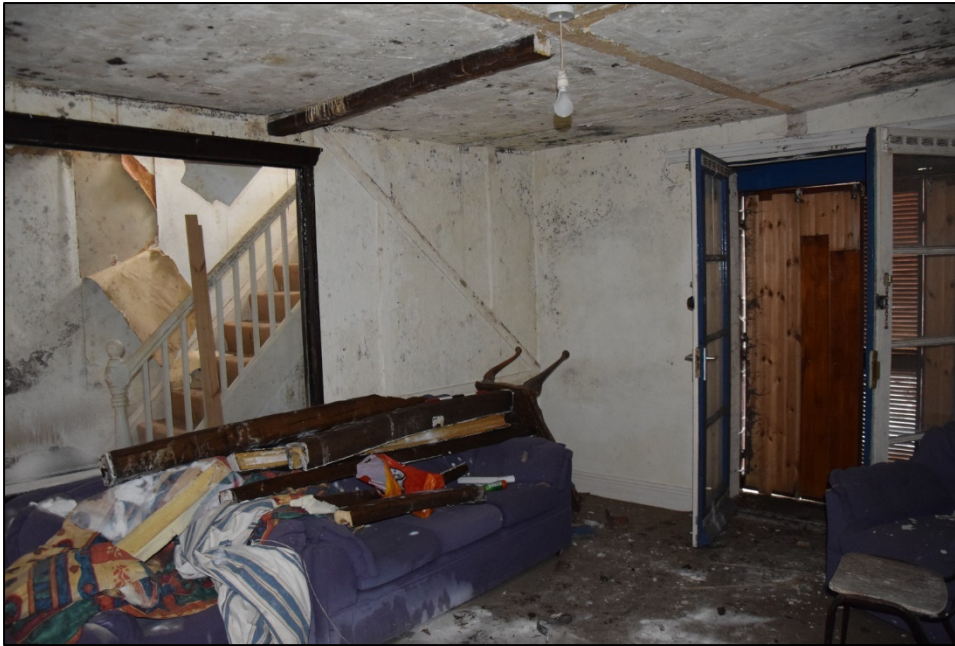
Photograph 20: Modern glazed doors in the north wall of the ground-floor room.
Note the slope in the right-hand half of the ceiling here

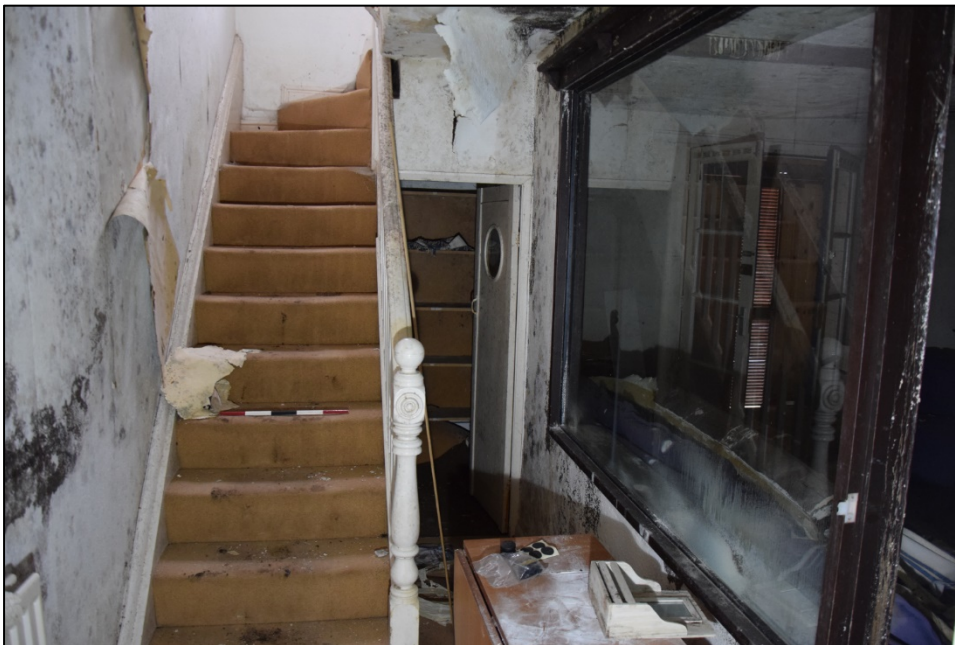
Photograph 21: The partition has a large window and 'half-timbered' features

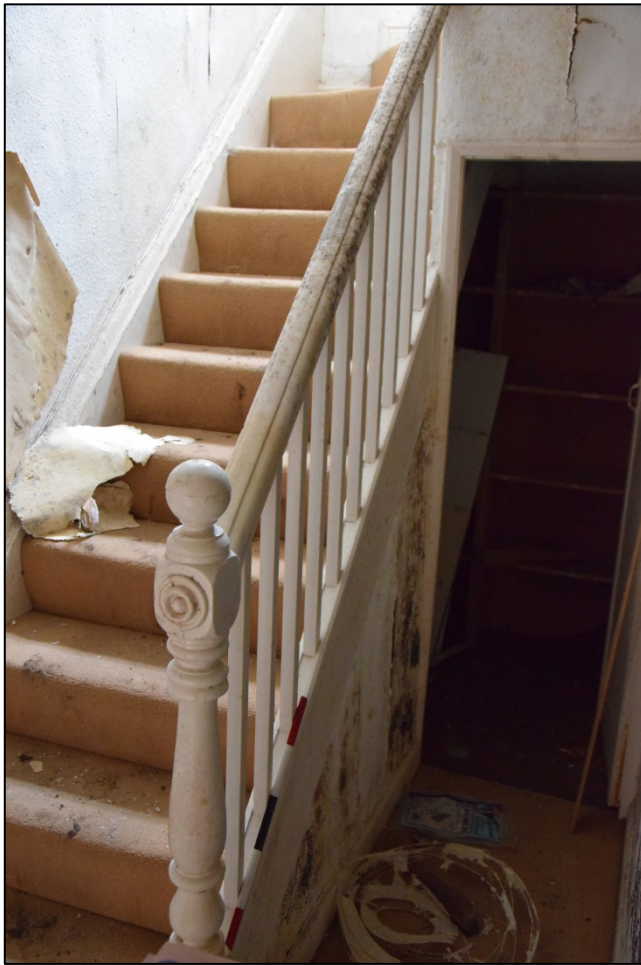
Photograph 22: The staircase hall 2, seen from the south. The thinness of the glazed partition can be seen here

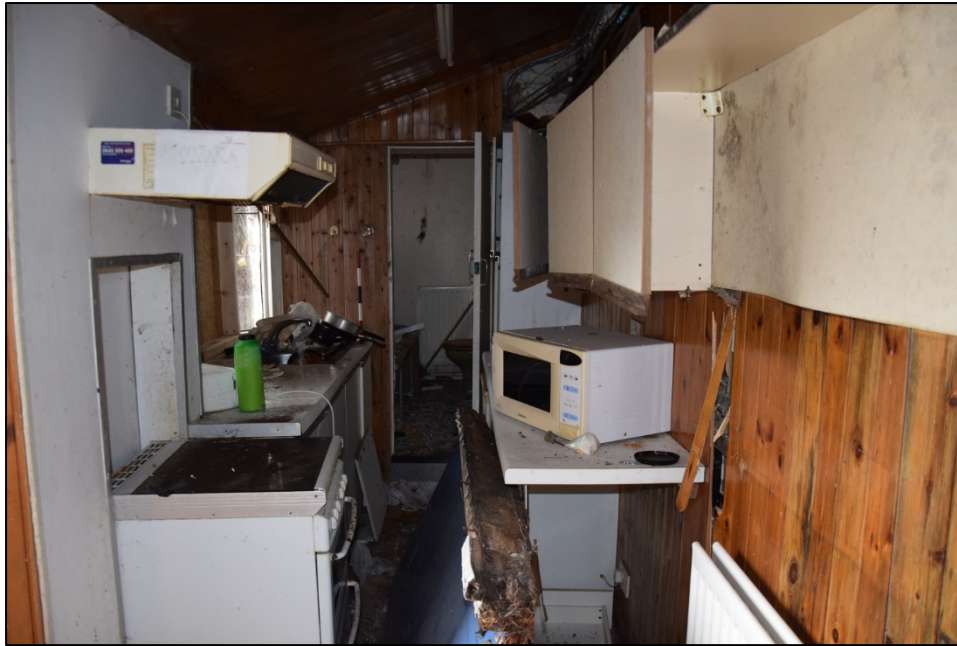
Photograph 24 (below): A view from the staircase into the kitchen [3]. The central opening, which was the original entrance to the building, has been fitted with a plastic concertina door

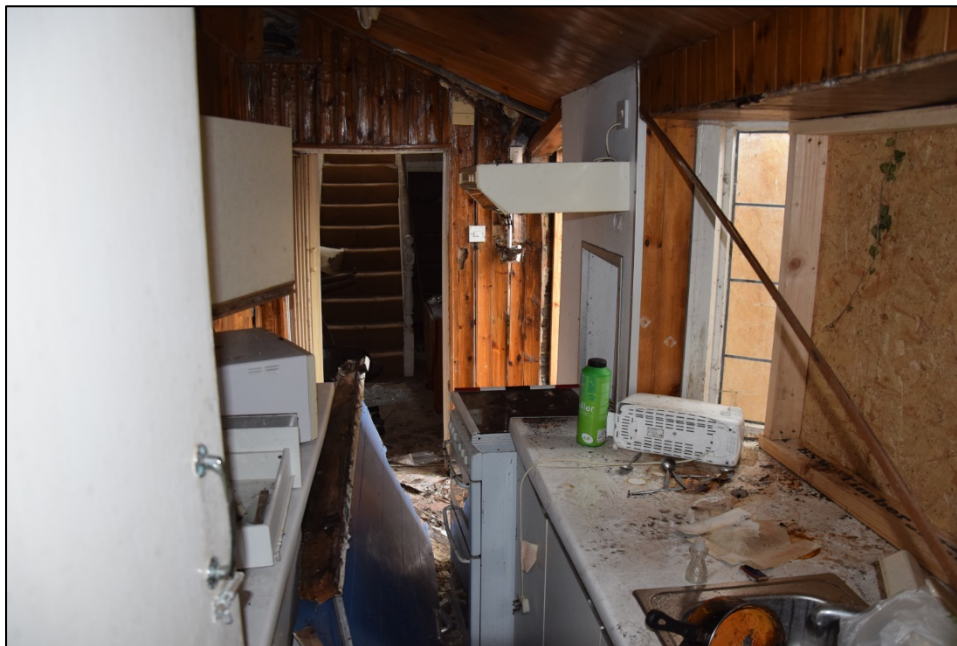
Photograph 25: The kitchen [3] seen from the north end. Because of the narrowness of the lean-to, the cooker is recessed into the wall and the sink extends into the projecting window. The far door leads up into the bathroom [4]

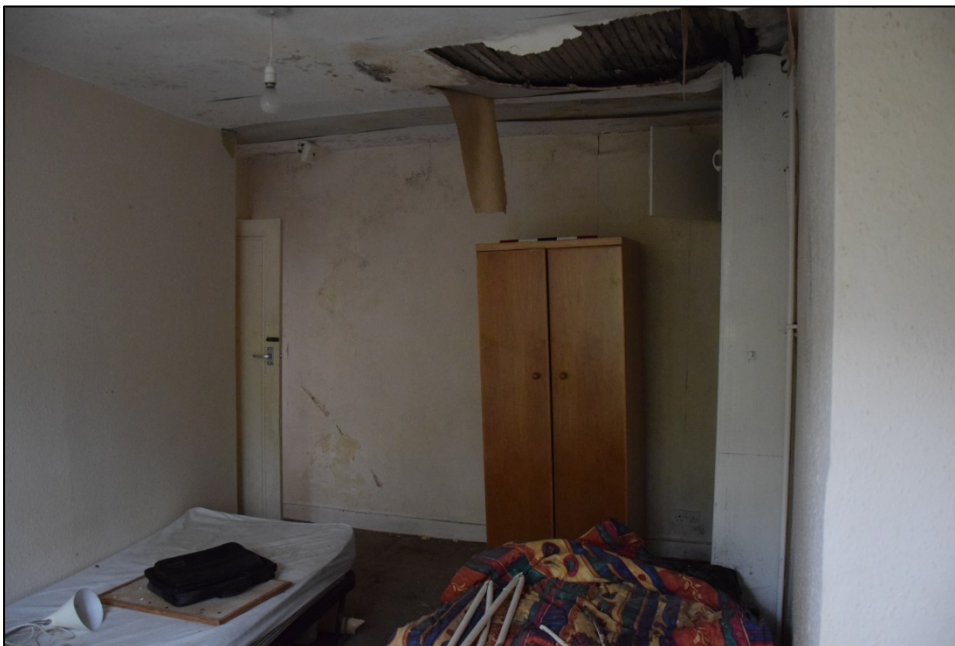
Photograph 31: The east bedroom [7], with its chimney breast. A view looking south-east

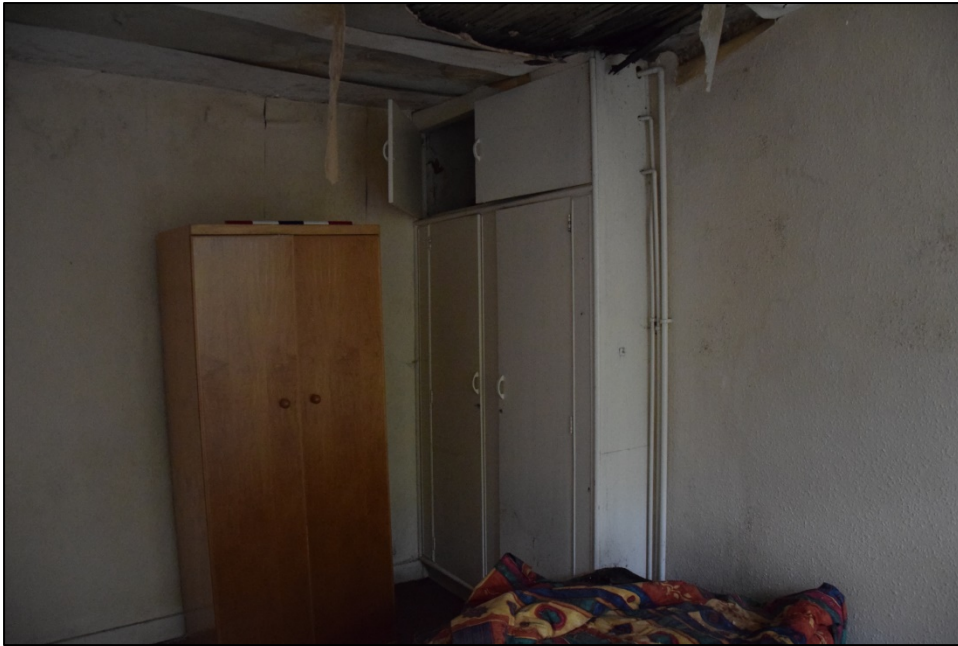
Photograph 32: The north end of bedroom [7], showing ceiling damage caused by a leaky roof. Plaster behind the wardrobe covers the site of the blocked window shown in Photo 11

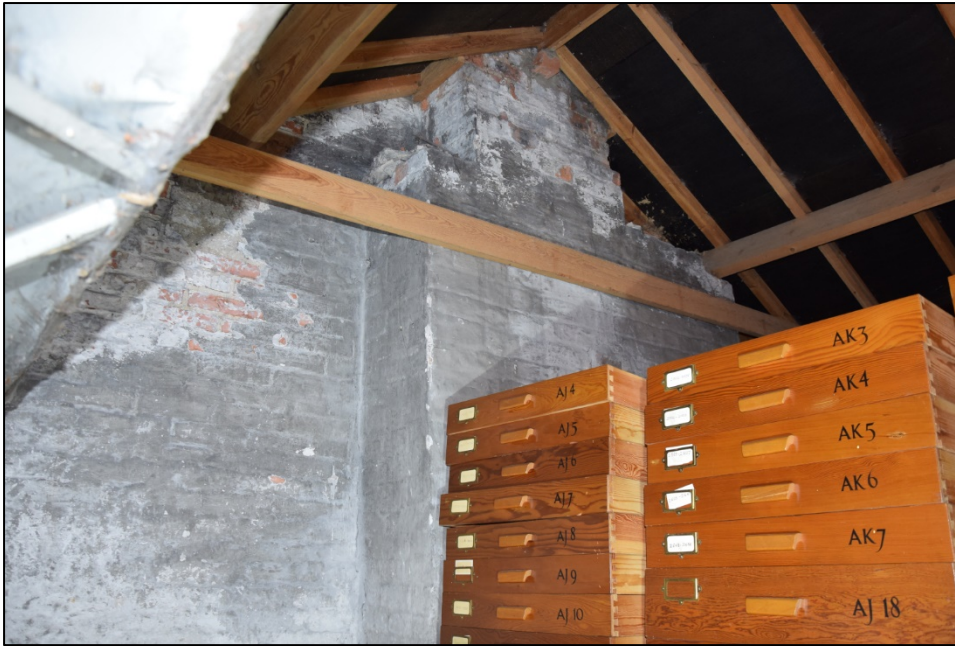
Photograph 34: The north face of the garage block. Modern brickwork can be seen above and between the steel doors

- 5.6 This low building abuts the west face of Vennel Cottage. It is built of similar brick and has a slate roof, but the openings have plain sandstone sills and lintels (Photograph 34). Later brickwork surrounds two modern garage doors. Inside, the projecting chimney on the west wall of the cottage is wider in its lower stage (Photograph 35). This could not be examined in detail because of a collection of geological samples stored in the garage. The former privy at the north-west corner retains fixtures for a cistern; the end room (Photograph 36) was inaccessible for this survey. To the south

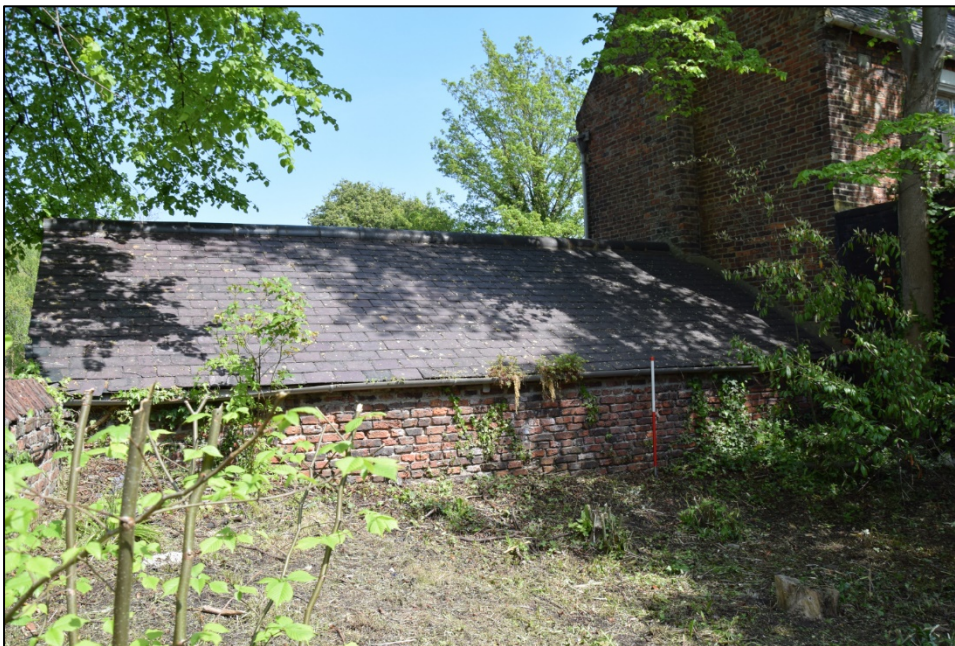
Photograph 37: A view of Vennel Cottage and the garages from the south end of Territorial Lane. The garden inside the boundary wall is about 1.4m above the ground level seen here

of the building are retaining walls for the garden behind no. 51 Old Elvet; the ground level here almost reaches the eaves (Photographs 37, 38).

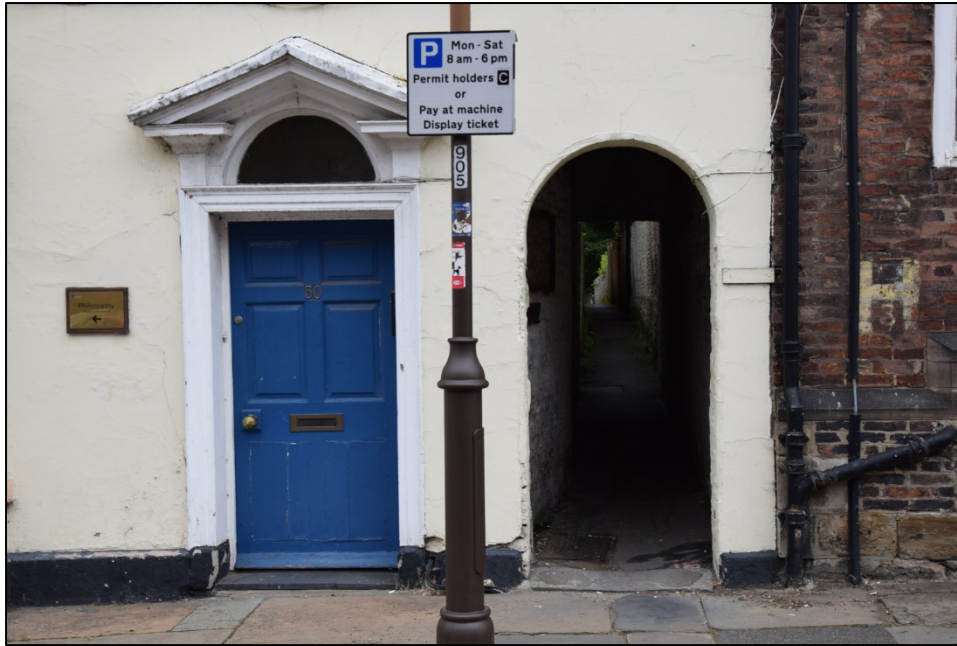
Photograph 40: The junction of Old Elvet and Territorial Lane. The south end of the vennel is the arched opening at the right-hand end of the white buildings

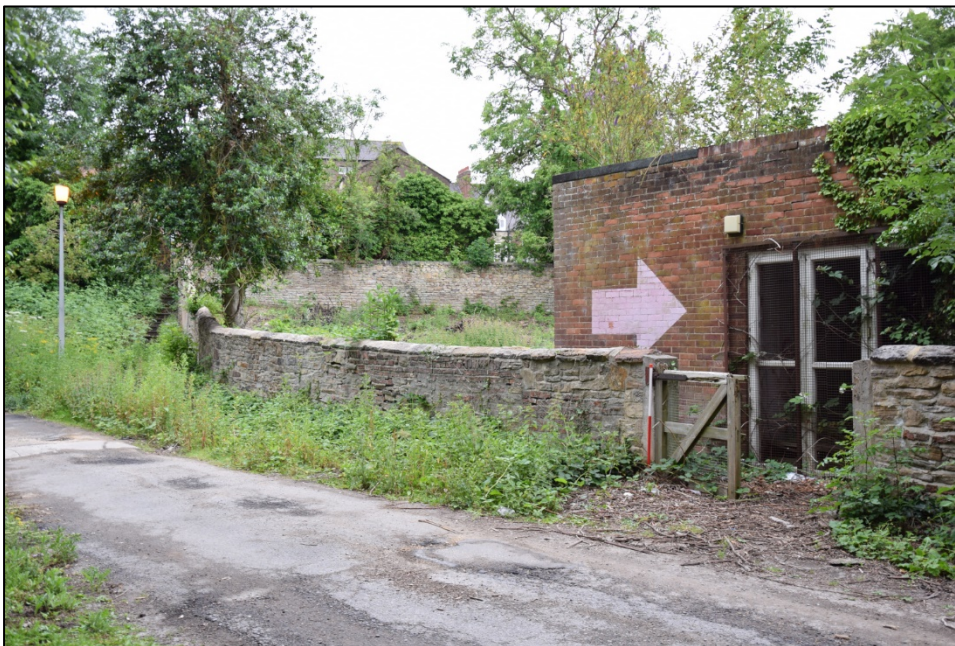
Photograph 43: A view looking north-east behind nos. 44-48 Old Elvet, showing the disused courtyard building with wall D to its left

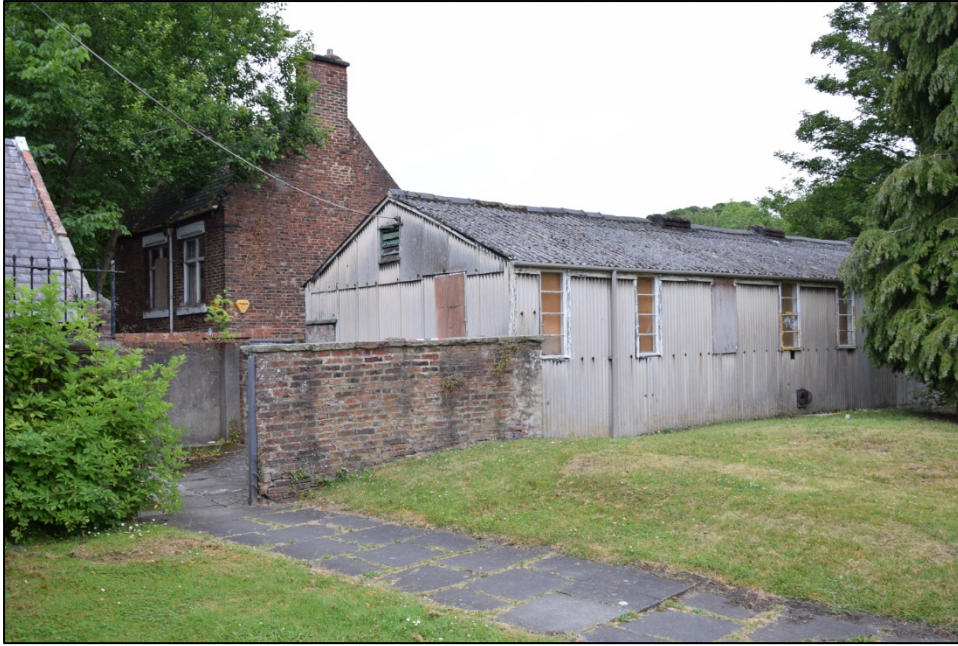
Photograph 44: The east end of the nursery building and walls D and E. A view looking south-west

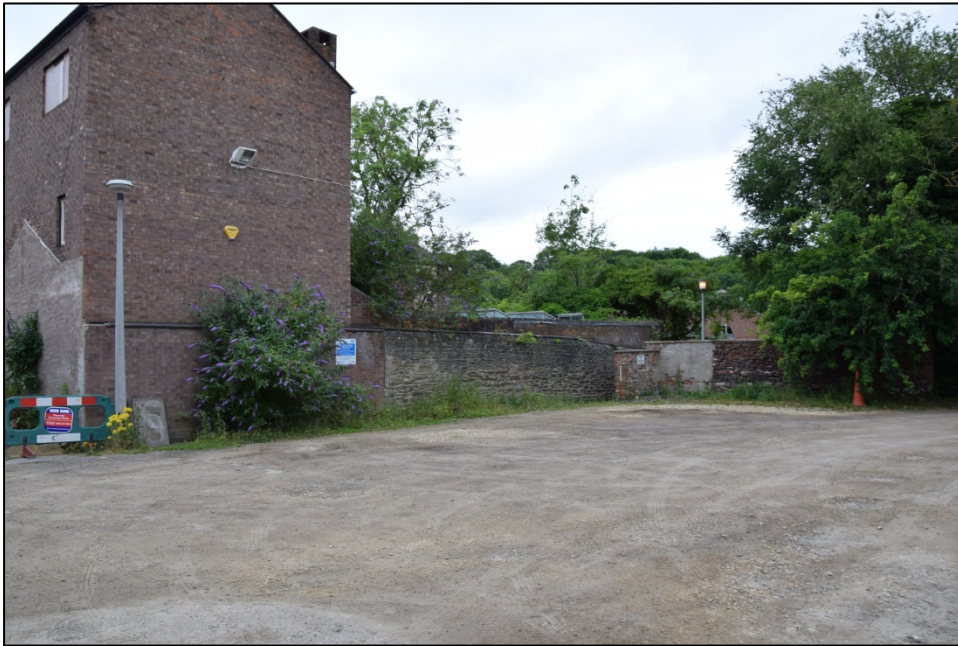
Photograph 45: The temporary building behind no. 49, with wall F in the foreground and Vennel cottage behind. A view looking north-west

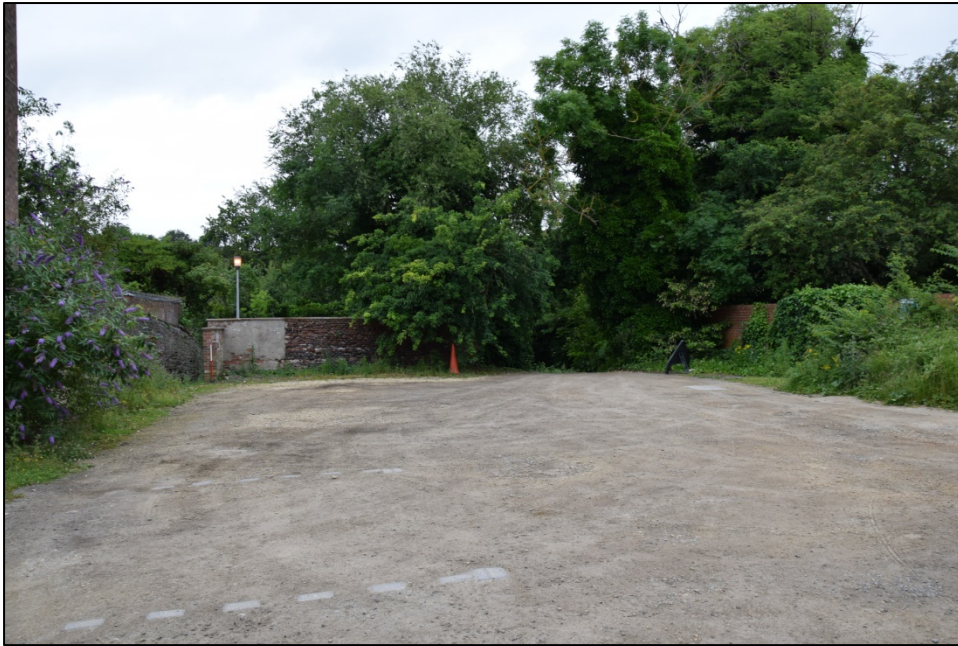
Photograph 46: Wall D extends into the east face of the courtyard building. Wall H is the detached section right of centre. A view looking north-west

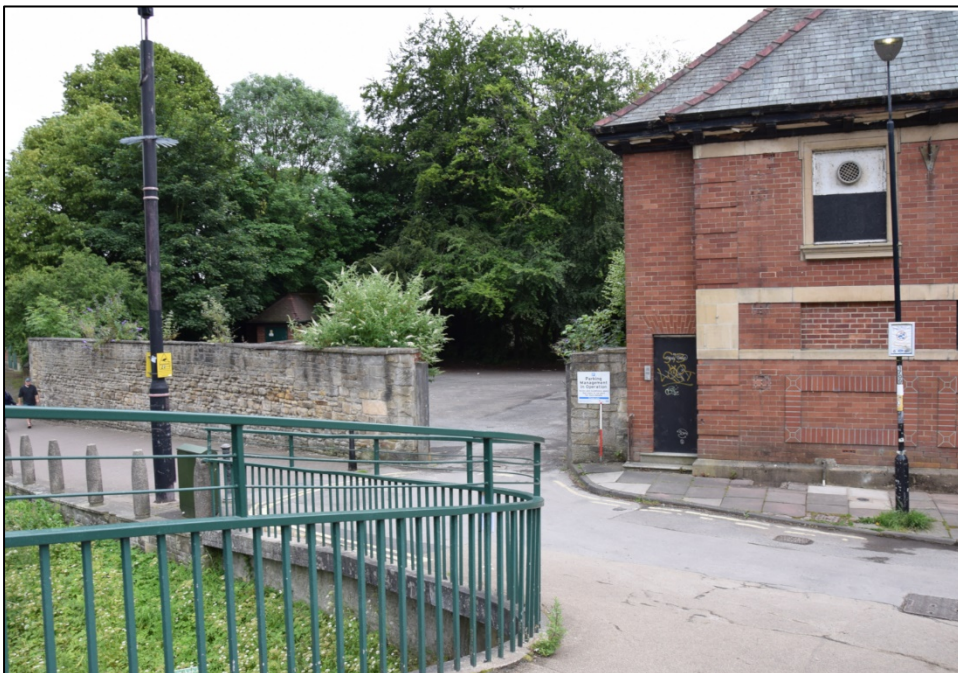
Photograph 47: A view looking north behind no. 43 Old Elvet. Wall H stands at the head of the slope, left of centre; to the right is a gap and the overgrown wall I

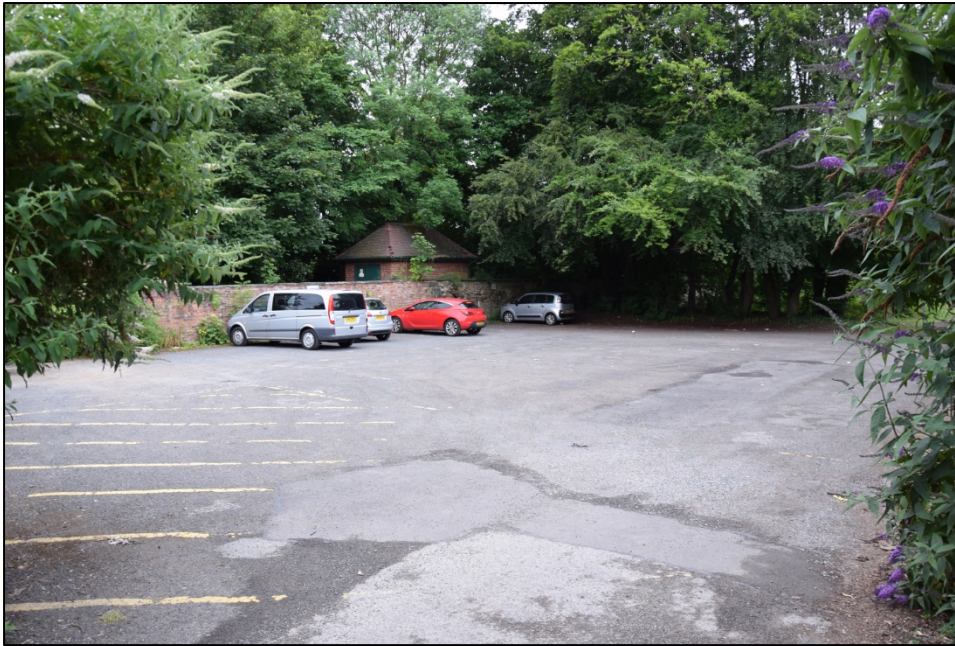
Photograph 48: The north end of the eastern car park, seen from Baths Bridge. This is wall J

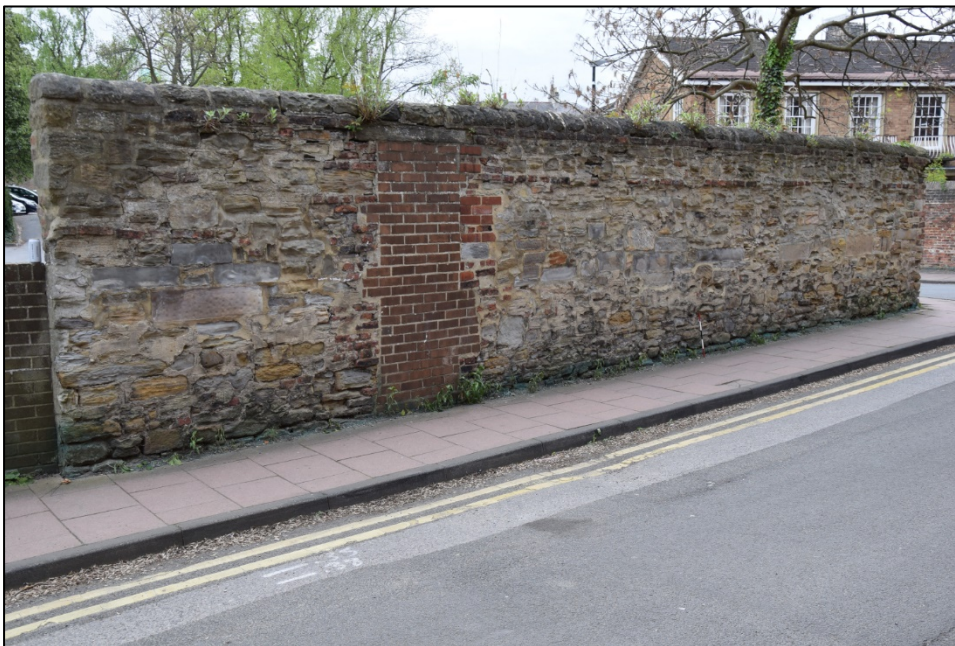
- 6.1 Eleven walls of various sizes were recorded for this project; these are shown as A-K in Figure 7. Wall A is an isolated section at the north end of the Territorial Lane car park (Photograph 39). The longest walls, B and C, run along the vennel. This begins as an arched opening between nos. 49 and 50 Old Elvet and the walls end near the former swimming baths building (Photographs 41, 42). Wall D runs between the open space behind nos. 44-48 Old Elvet and the sloping garden of the former nursery (Photograph 43). Wall E forms the east side of this garden and extends as far as the modern courtyard building (Photograph 44). Wall F is a short section at the west side of the garden south of Vennel Cottage (Photograph 37) and wall G is another isolated short section just east of the vennel (Photograph 45). Walls H and I are short sections at the top of the slope behind no. 43 (Photographs 46, 47). Wall J forms the north sides of the north-eastern car park (Photograph 48); the east side is wall K, which continues south into the wooded area below the slope (Photograph 49). The southern section is heavily overgrown and cannot be recorded.

Photograph 49: Wall K, on the east side of the car park, extends beyond the substation building into the wooded area to the south

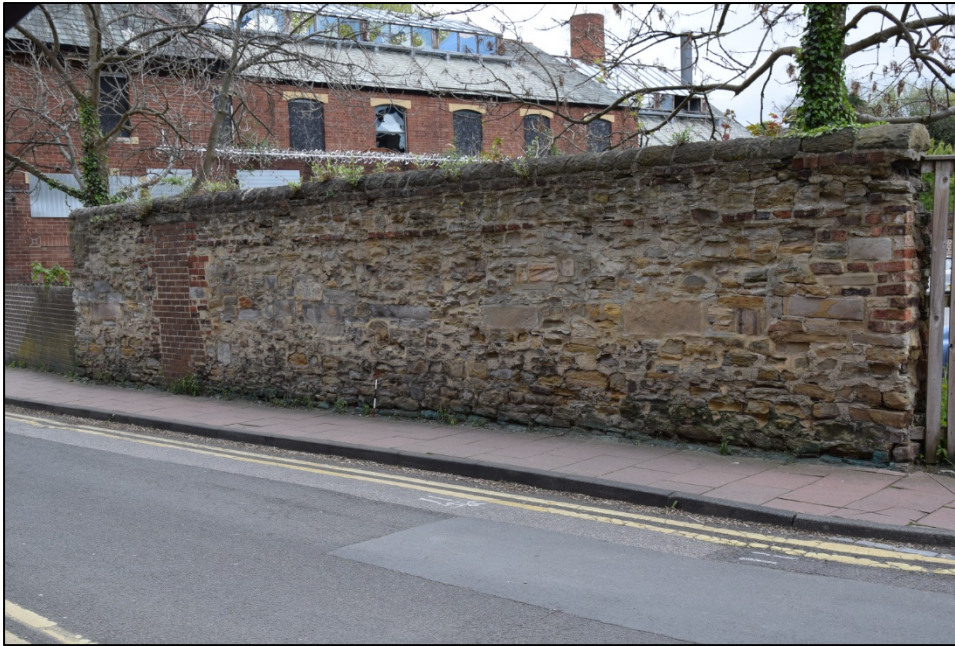
- 6.2 This free-standing section is about 12m long; its north face is made of random stone rubble with some old brick (Photographs 50, 51). There are rounded coping stones and a few large dressed blocks near middle height (Photograph 52). A largely continuous course of bricks near the top of the north face suggests that the wall might have been raised but there is no evidence of this in the south face, which is entirely brick in English Garden Wall bond, with four course of stretchers to one of headers (Photograph 53). A door near the east end, shown on the 1861 OS map, is close to the original north end of the vennel. It is blocked up with bricks like those in the low modern wall at the east end of the wall, on the site of a demolished house (Photograph 54).

Photograph 50: The north face of wall A. The bricked-up door is shown on the 1861 map

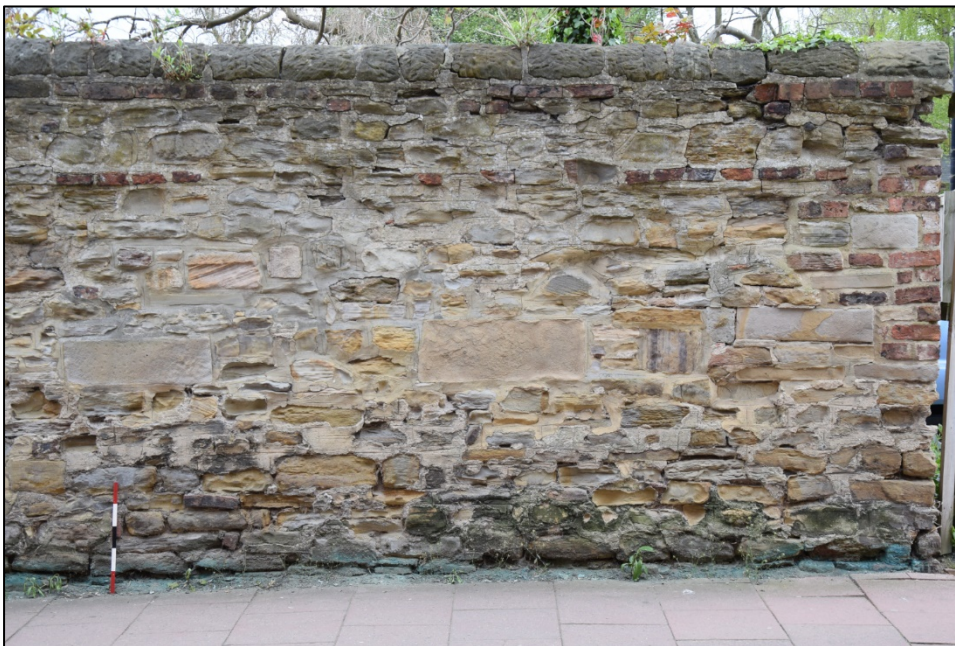
Photograph 51: Wall A from the north-west. Note the discontinuous line of bricks about 0.6m from the top of the face

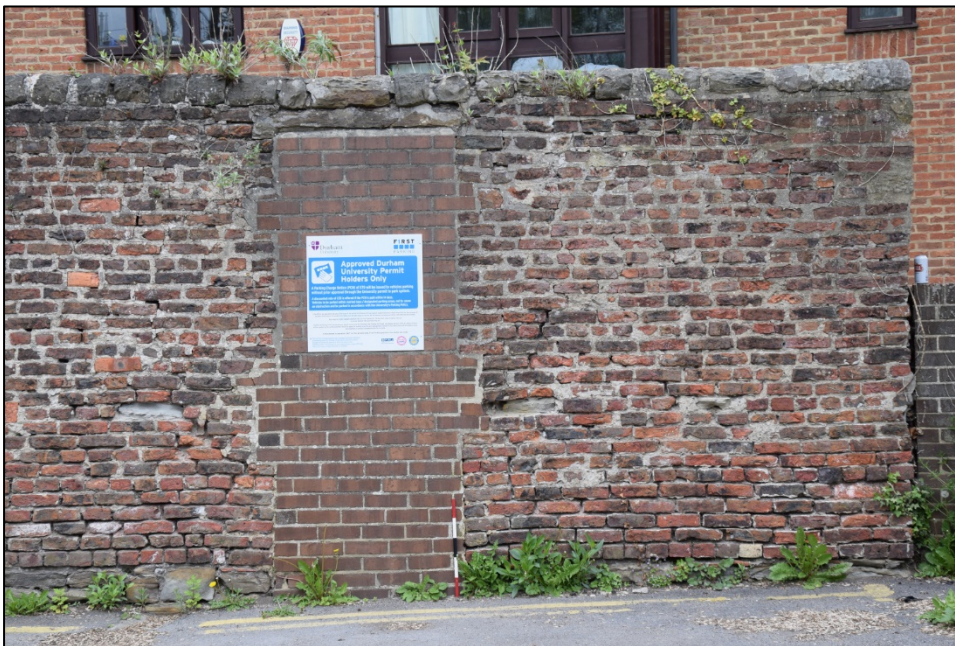
Photograph 53: The south face of wall A is all brick and formerly faced onto a large garden
