ARCHAEOLOGICAL
SERVICES
DURHAM UNIVERSITY

Proposed Business School
Elvet Waterside
Durham

archaeological
recording

report 5106
July 2019

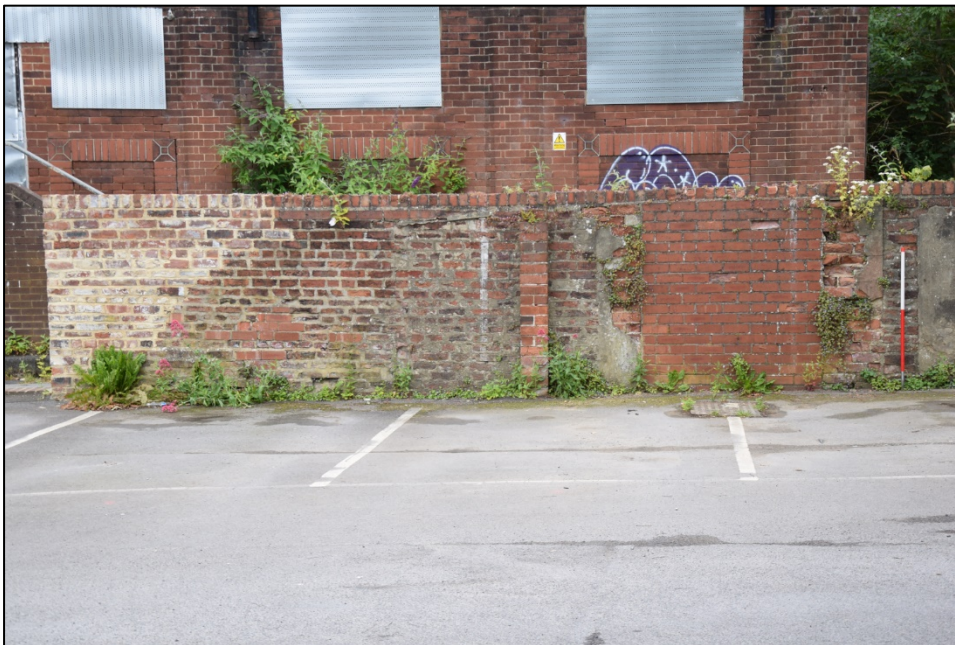
Photograph 55: The west face of the north end of wall B, on the vennel

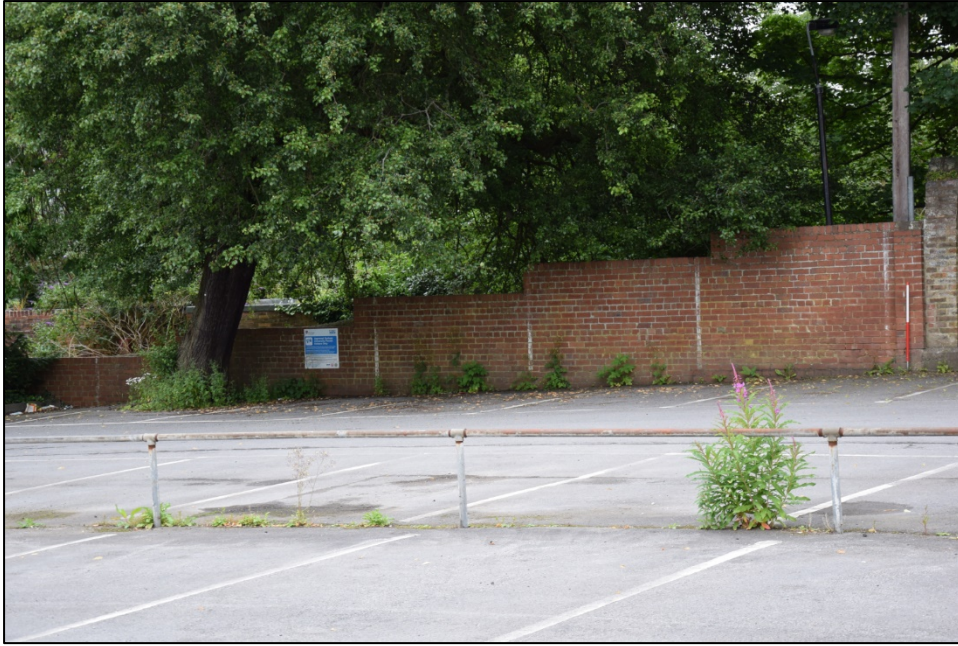
Photograph 56: Wall B, west face. Recent repairs and a blocked gate at the north end

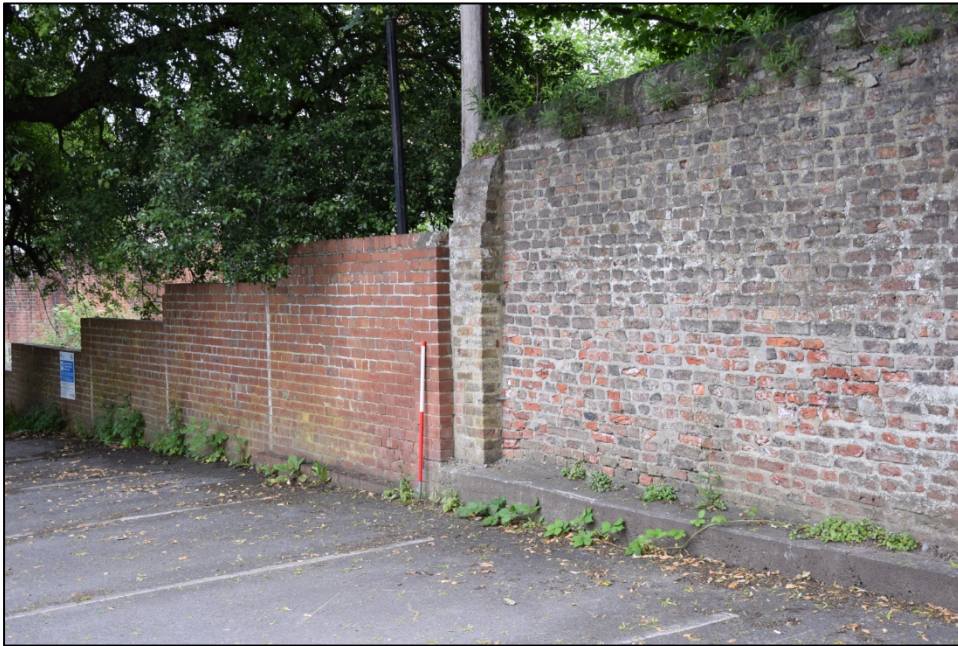
Photograph 57: Wall B, west face. Modern brickwork runs up the slope and onto the upper part of the car park

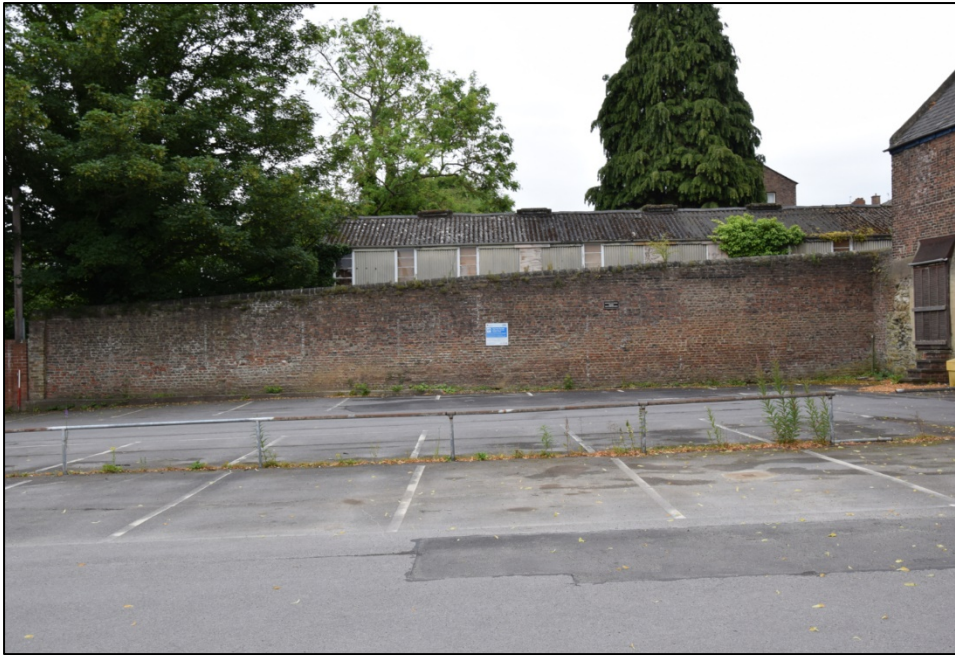
Photograph 58: Wall B, west face. A step and the stub of a wall separate modern fabric from the older brickwork of the building shown on the 1861 map. The concrete plinth course is at about the same level as the visible stone foundation on the opposite face (Photo 67, below)

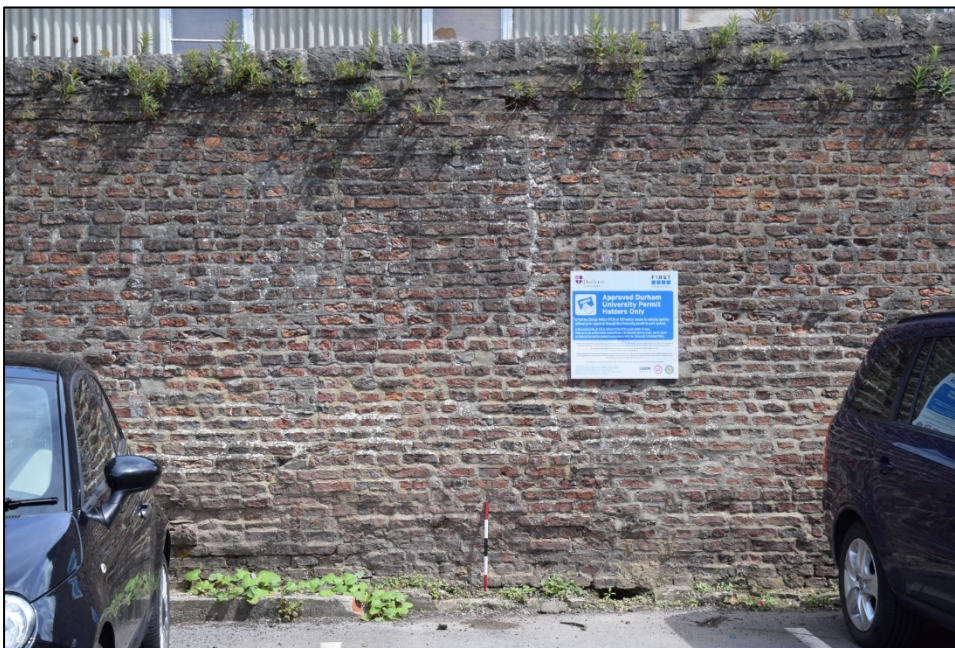
Photograph 59: Wall B, west face. This is what remains of the east face of the early 19th-century building

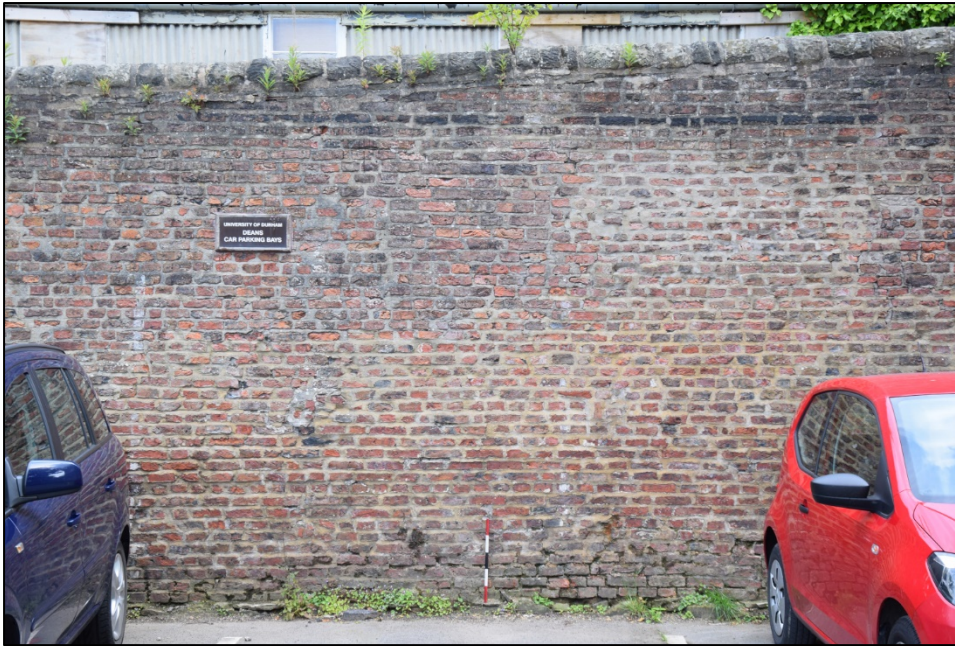
- 6.3 This, the longest of the walls covered in this report, runs along the west side of the vennel. The whole of the west face is brick. A stretch of about 10.5m at the north end shows evidence of several episodes of repair or rebuilding; there is a blocked gate near the south end of the baths building (Photographs 55, 56). From the bottom of the slope in the car park there is a section of modern brickwork about 25m long (Photograph 57). At its south end there is a step between this section and an older brick wall to the south, with the stub of a wall running west (Photograph 58). The old wall, built of randomly bonded thin dark red bricks, runs south for about 23m to meet the north wall of Vennel Cottage (Photograph 59). This is the east wall of the large building shown on John Wood's 1820 map. Traces of three blocked windows are visible here (Photographs 60, 61).

Photograph 60: Wall B, west face. A blocked opening can be seen to the left of the notice

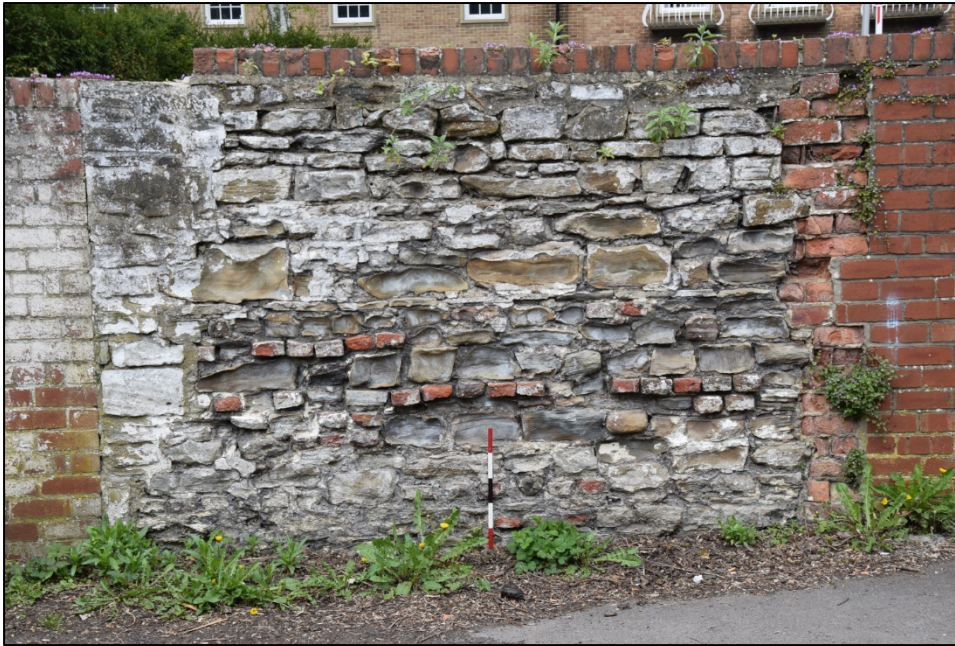
- 6.4 At the north end, the east side of the wall is faced with roughly-coursed rubble (Photograph 62). There is some brick in places; the former gate is blocked with modern masonry (Photograph 63). The modern brick of the central section (Photographs 64, 65) ends at the step seen on the west side (Photograph 66). A stone foundation projects from the face for a short distance from this point (Photograph 67). The blocked windows are more clearly visible on this side of the

Photograph 62: Wall B, east face. This short section of the old garden wall has an outer face of roughly-coursed stone

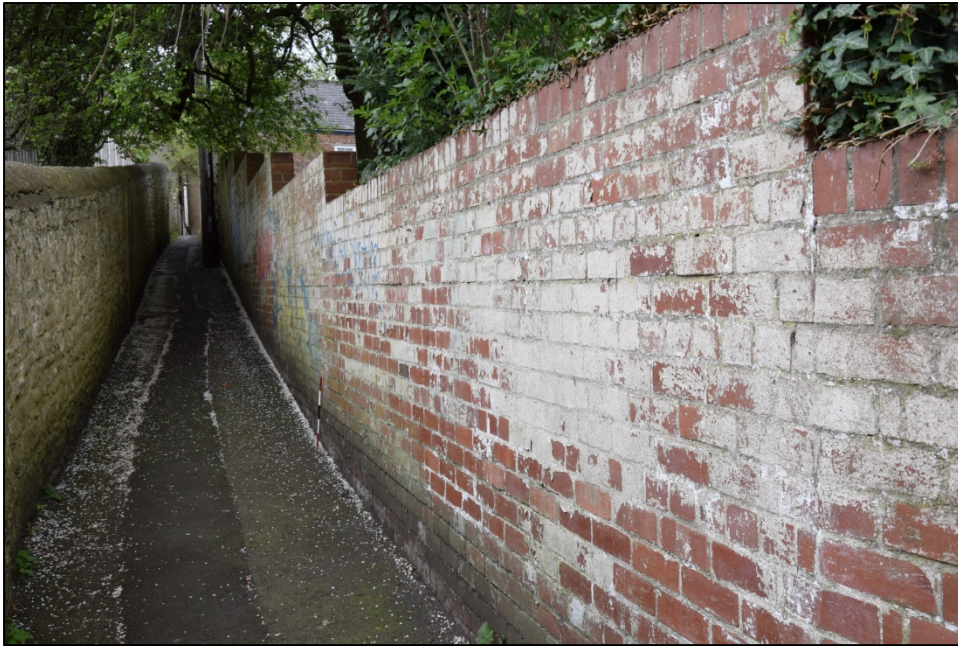
Photograph 64: Wall B, east face. Modern brickwork below and on the slope

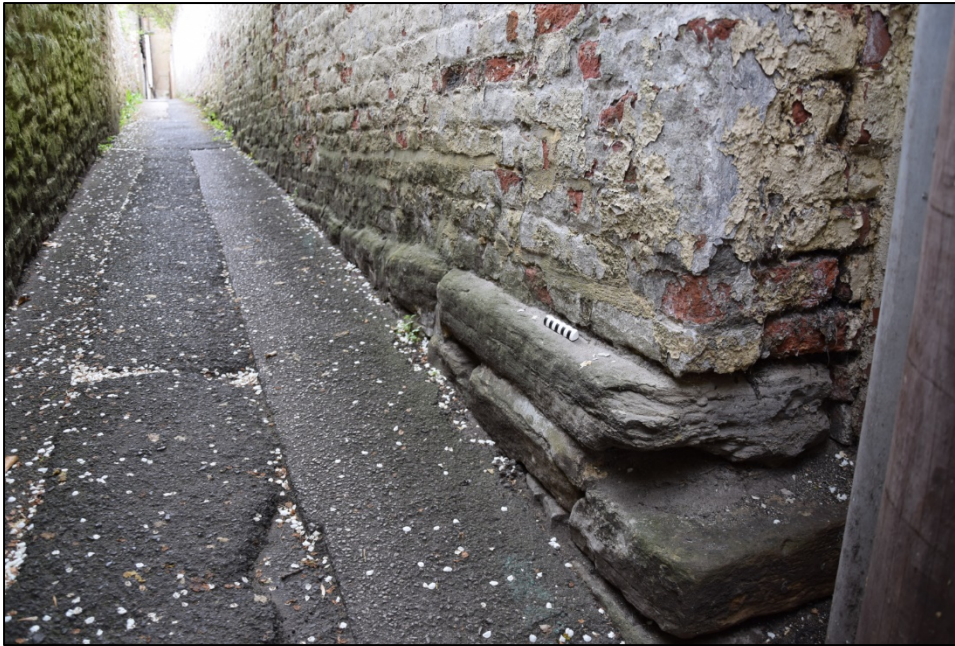
Photograph 66 (left): Wall
B, east face. This step in
the wall marks the north-
east corner of the
demolished building
behind no. 50

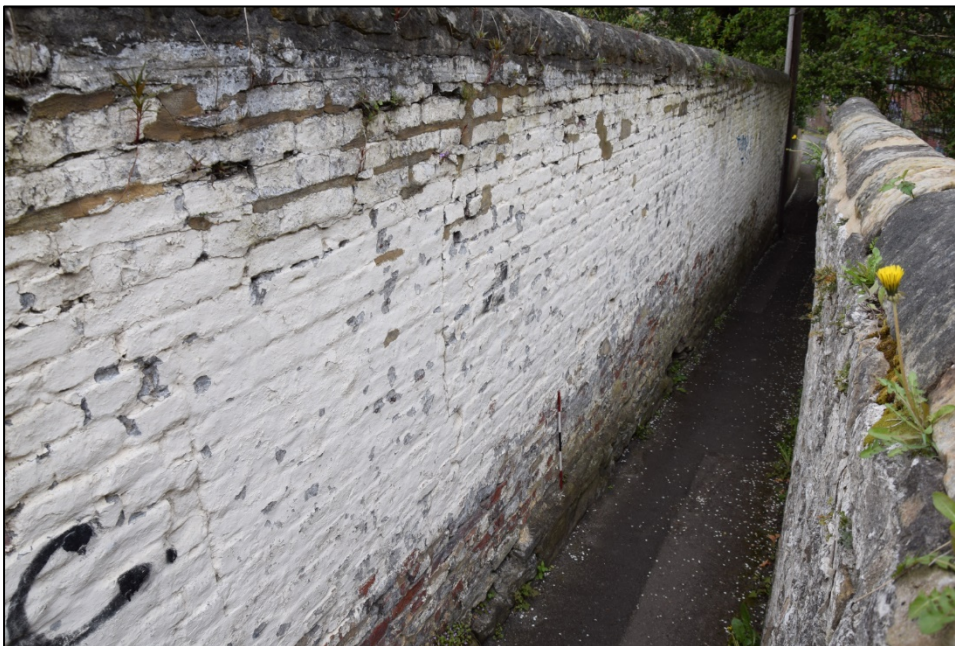
Photograph 67: Wall B, east face. This stone foundation is visible for about 13m from the north-east corner of the old building

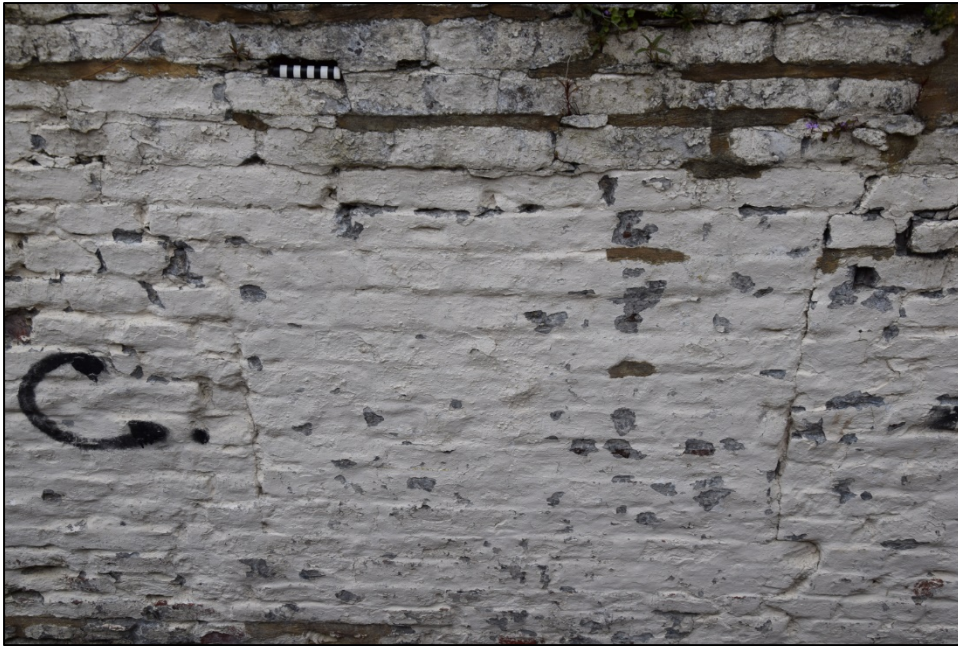
Photograph 68: Wall B, east face. The centre and north of the old building. A blocked window shows as two straight joints, left of centre

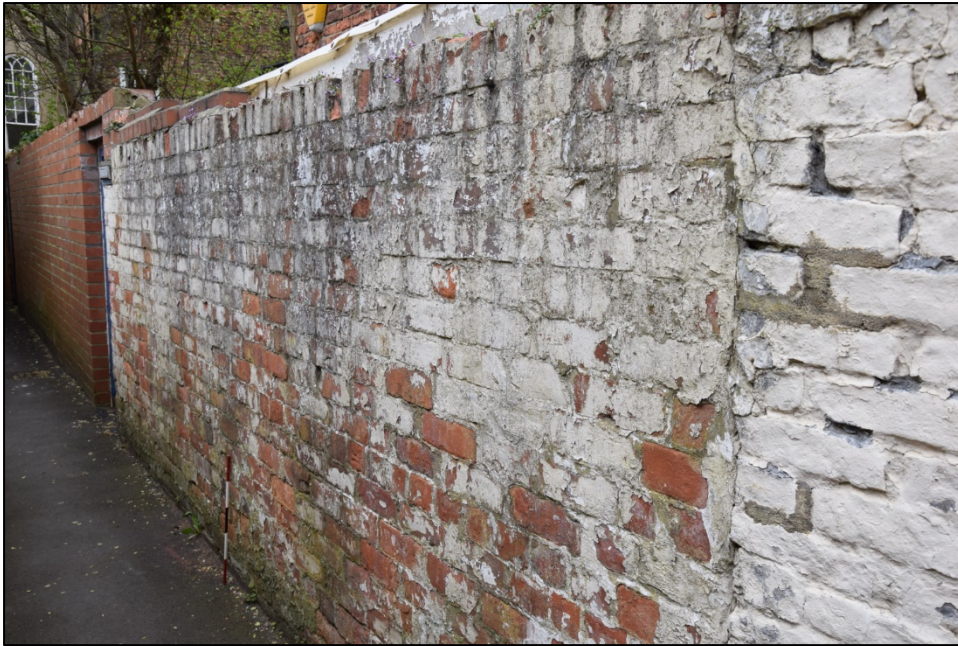
wall, which has a return at the north-east corner of Vennel Cottage (Figure 8; Photographs 68-70). The wall of the cottage yard is later brick and this extends as far as the garden door south of the house (Photographs 71, 72).

Photograph 70: Wall B, east face. The centre and south end of the old building, with Vennel Cottage behind

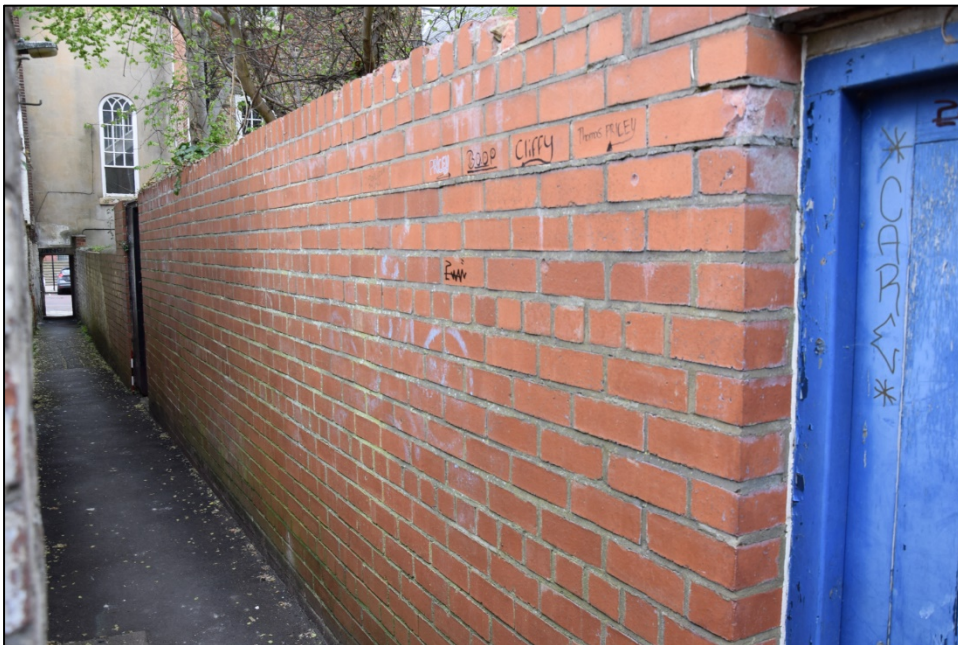
Photograph 71: Wall B, east face. The painted brick wall beside Vennel Cottage

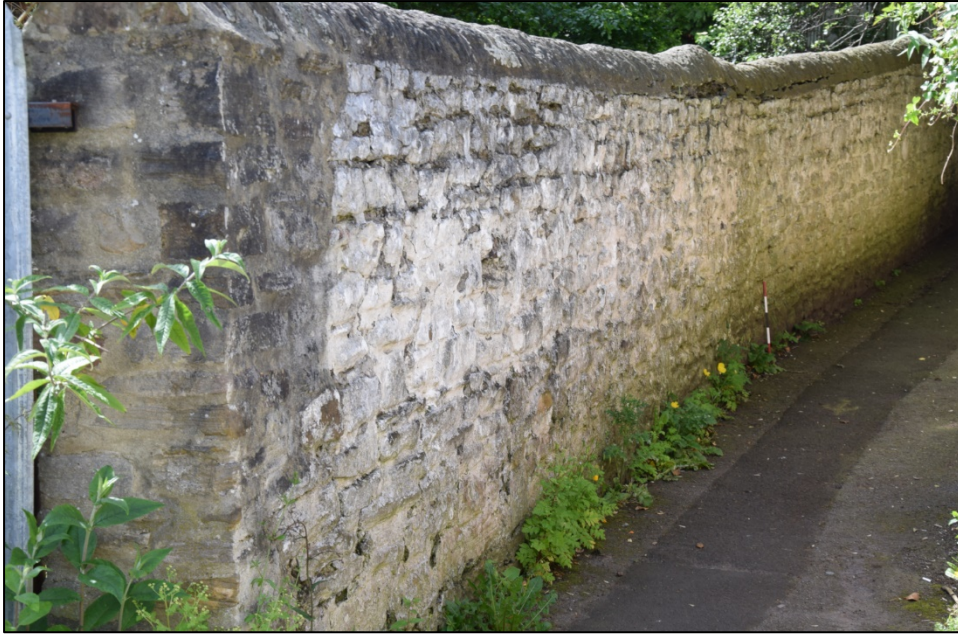
Photograph 72: Wall B, east face. Recent brickwork south of the gate to the Cottage

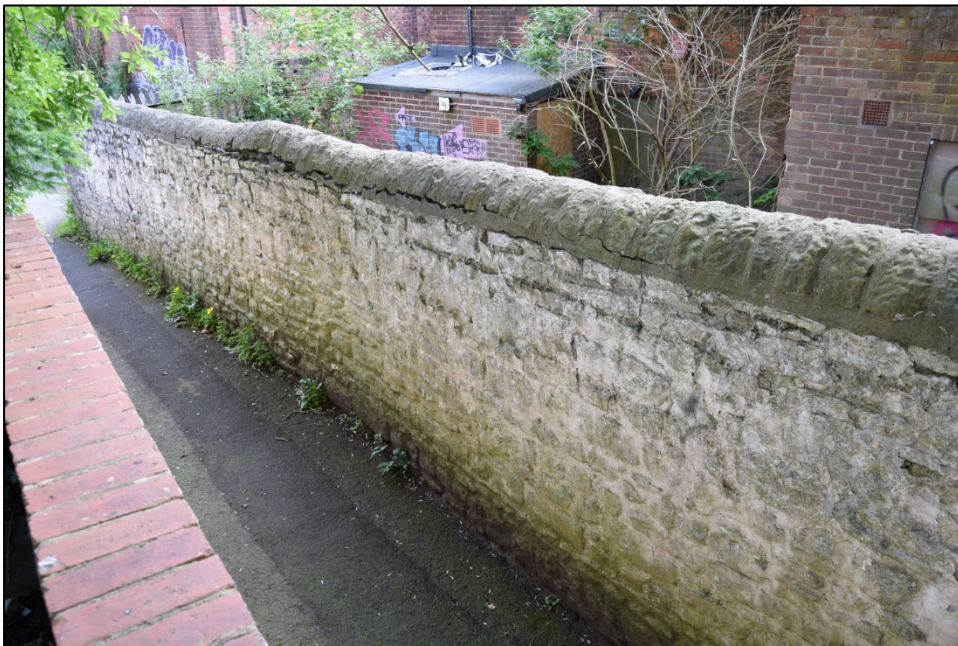
Photograph 73: Wall C, west face. This is the north end, near the old nursery building

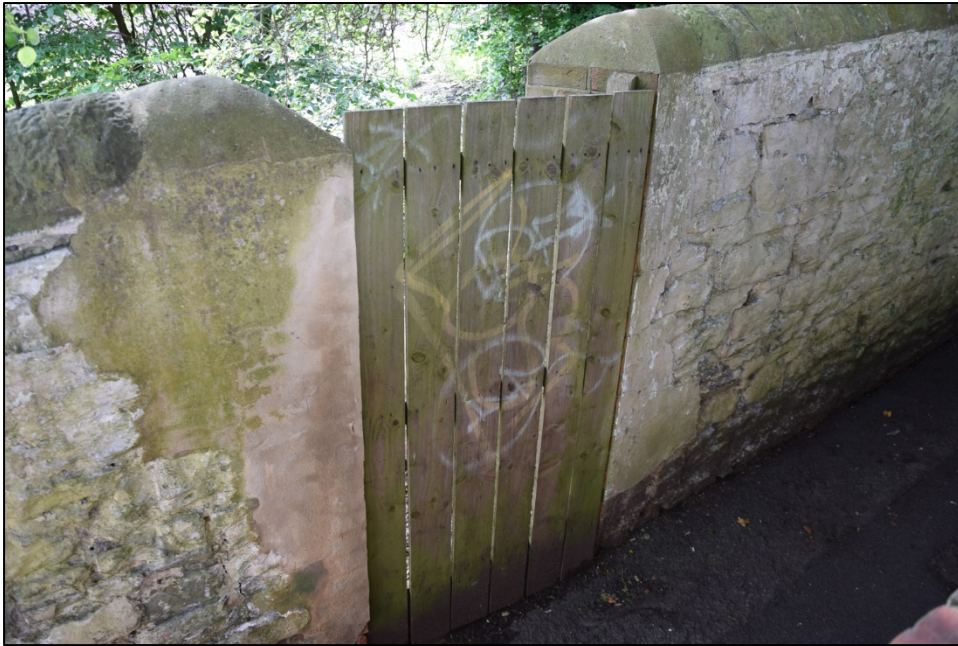
Photograph 74: Wall C, west face. This painted rubble masonry with rounded copings runs almost as far south as Vennel Cottage

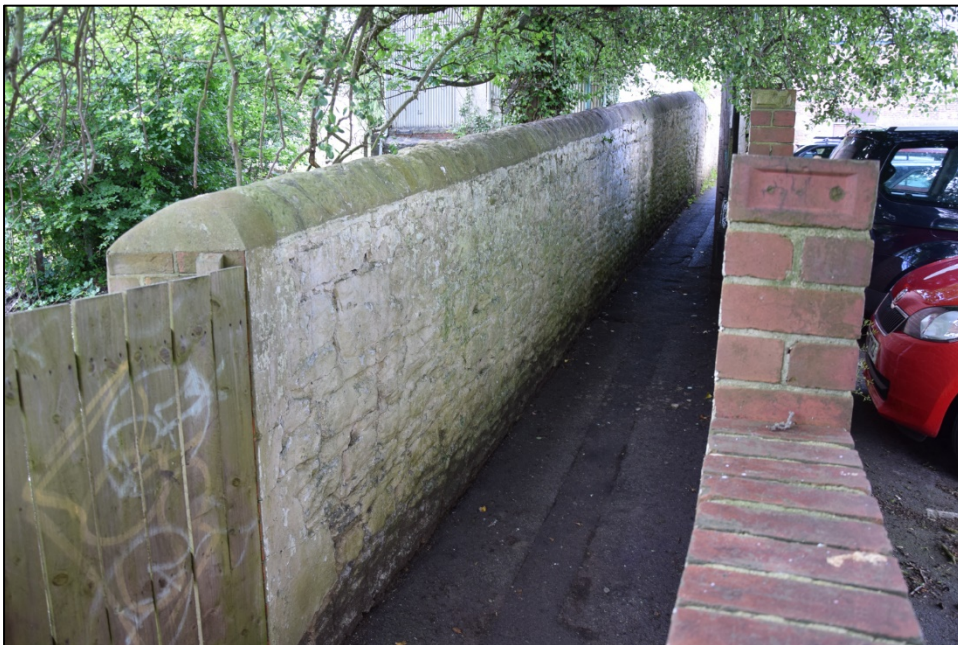
Photograph 75: Wall C, west face. The modern gate to the nursery

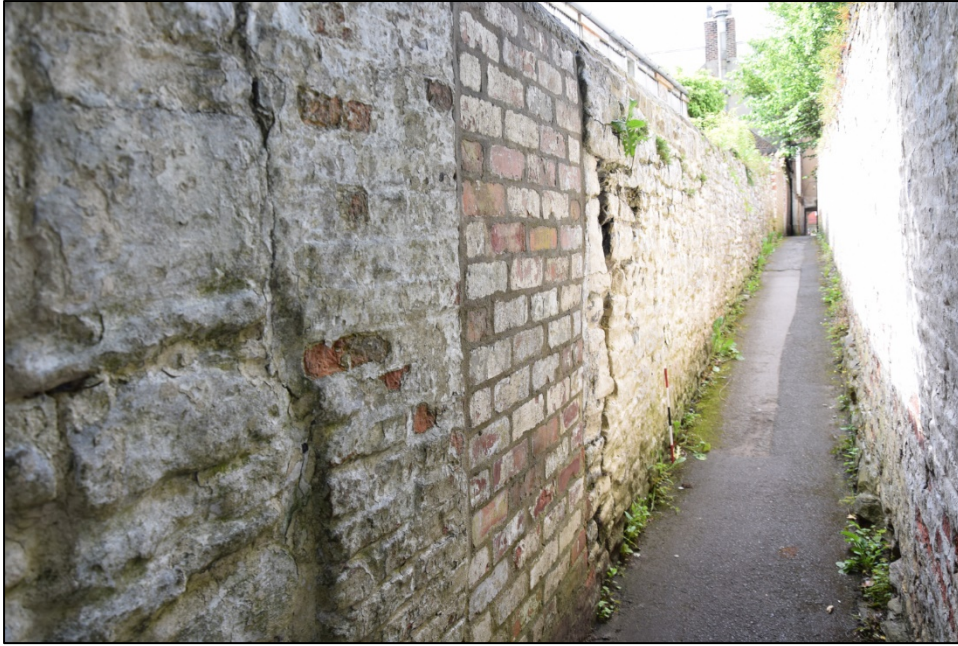
Photograph 76: Wall C, west face. From the nursery gate to the north end of the temporary building

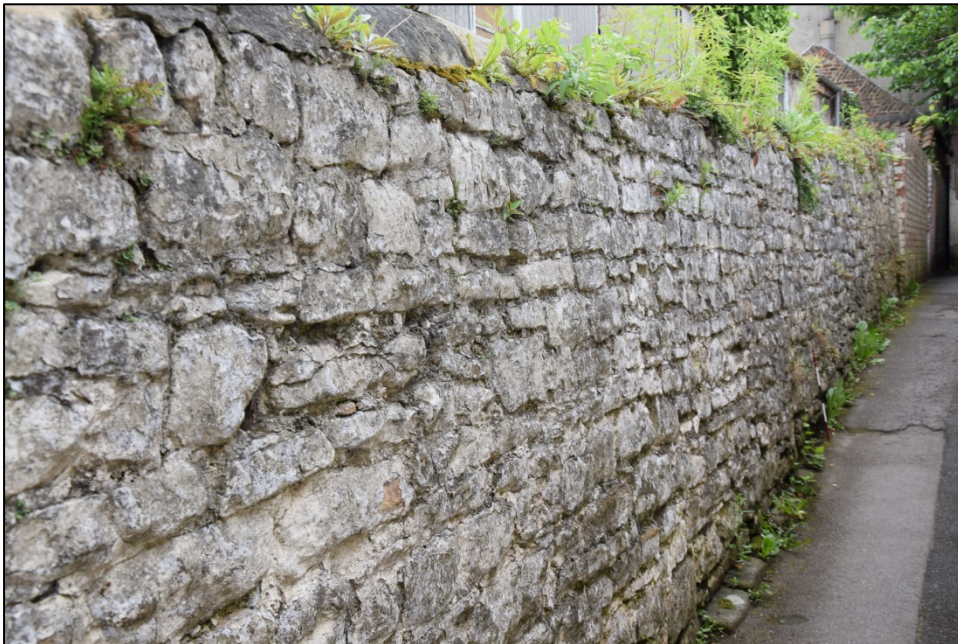
Photograph 77: Wall C, west face. The older middle gate near the north end of the temporary building. The masonry beyond the gate is the same as that seen in Photos 73-76

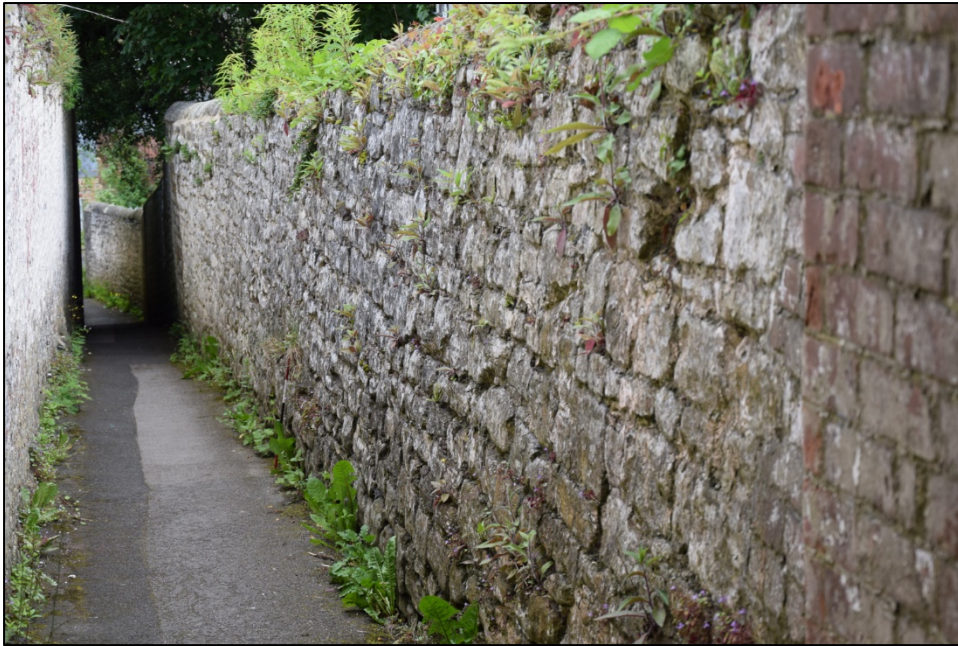
Photograph 78: Wall C, west face. The south end of the wall has a pronounced lean to the east

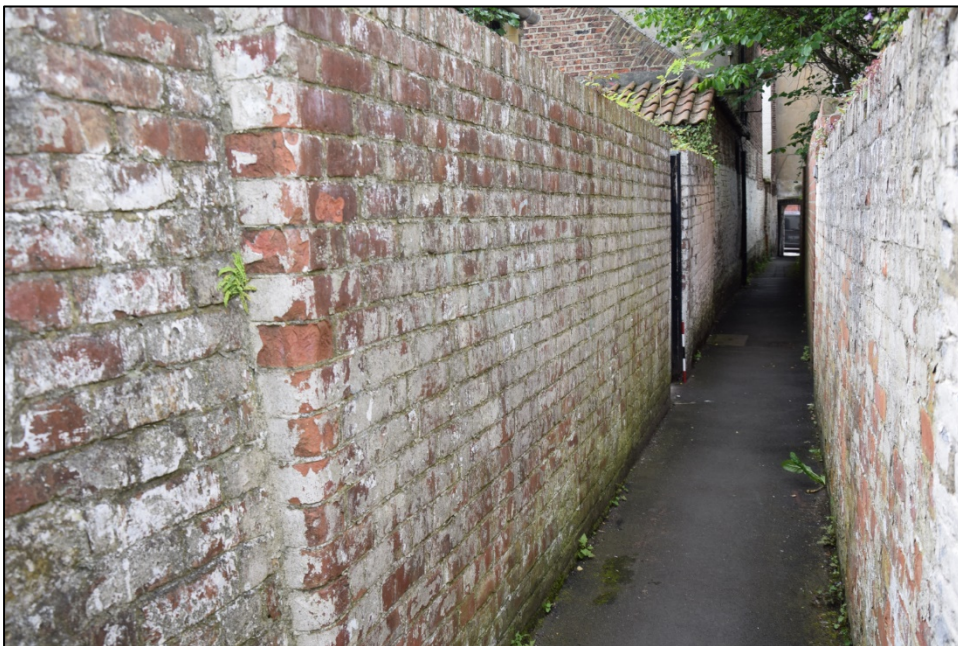
Photograph 79: Wall C, west face. The junction of the leaning stone wall and later brick

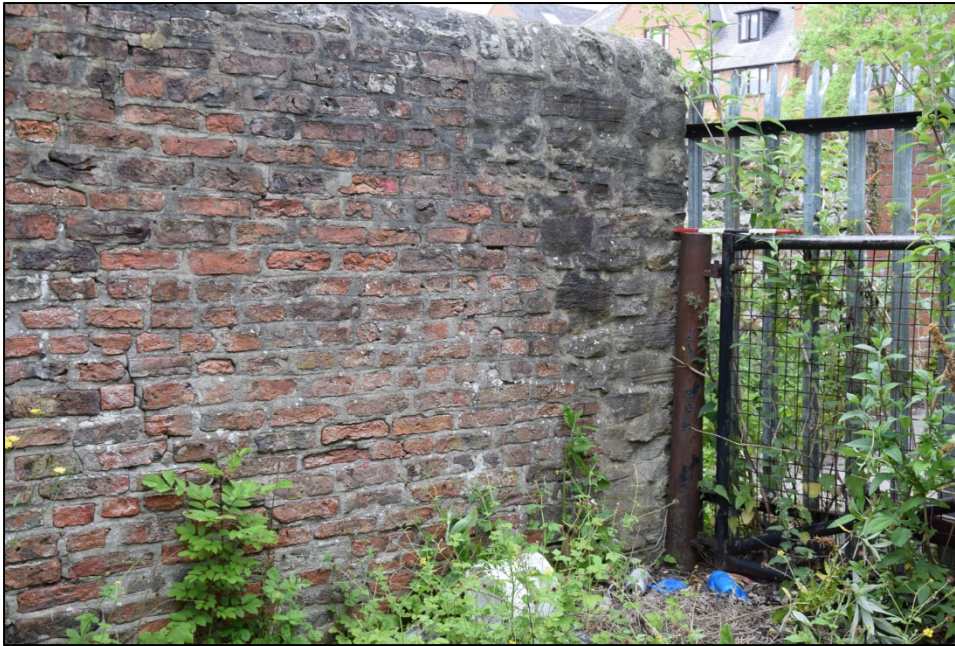
Photograph 80: Wall C, west face. The vertical brickwork is part of a small building shown on the 1919 map; the opening is the south gate

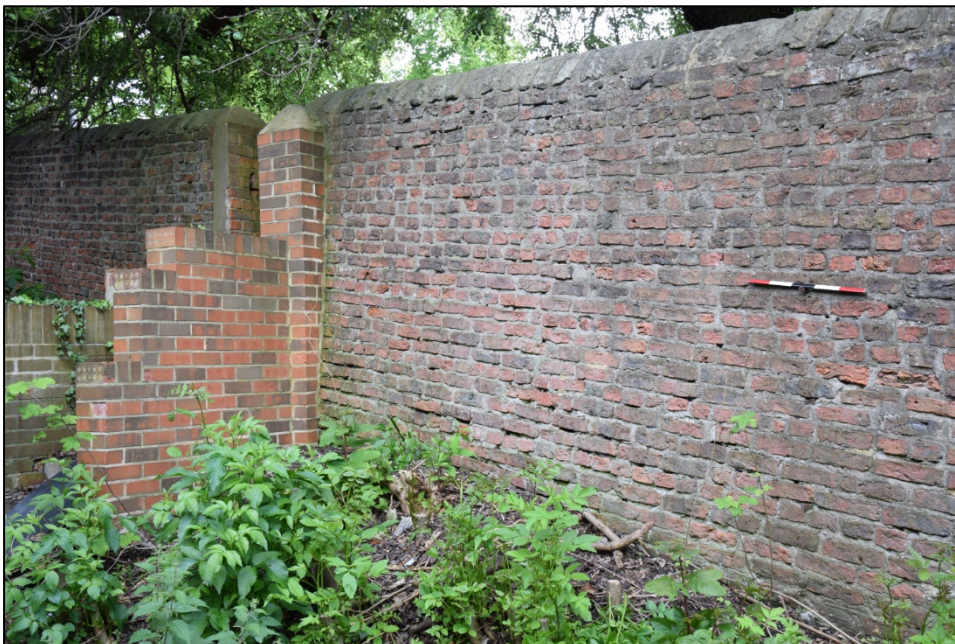
Photograph 81: Wall C, east face. This wall, like others, has brick throughout its inner face. This is the north end, rebuilt after a small building south-west of the baths was demolished

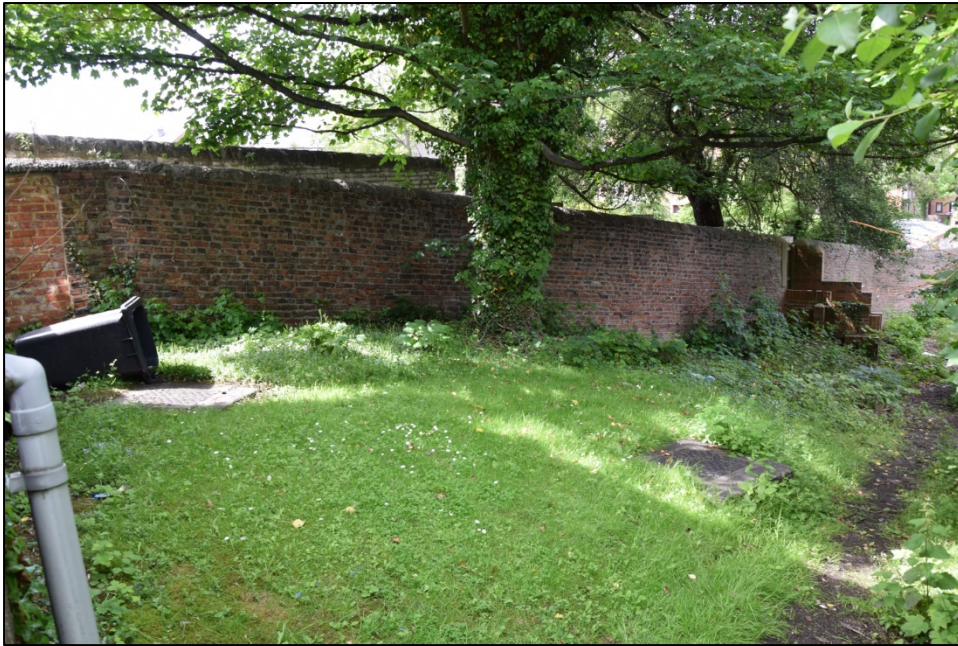
Photograph 82: Wall C, east face. The modern nursery gate and steps

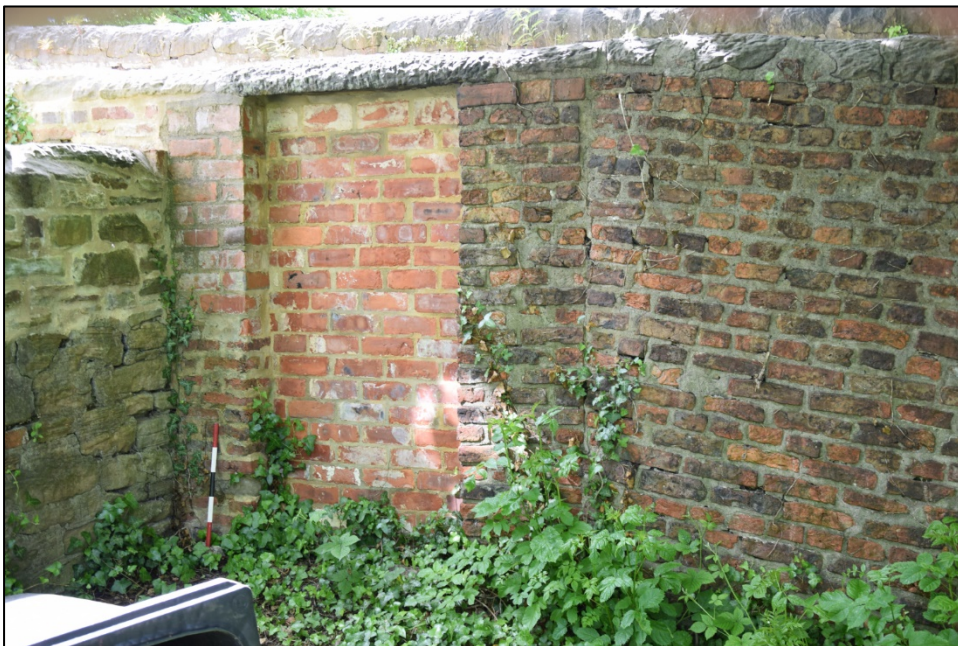
Photograph 83: Wall C, east face. The brick face on the slope, rising to the middle gate, extreme left

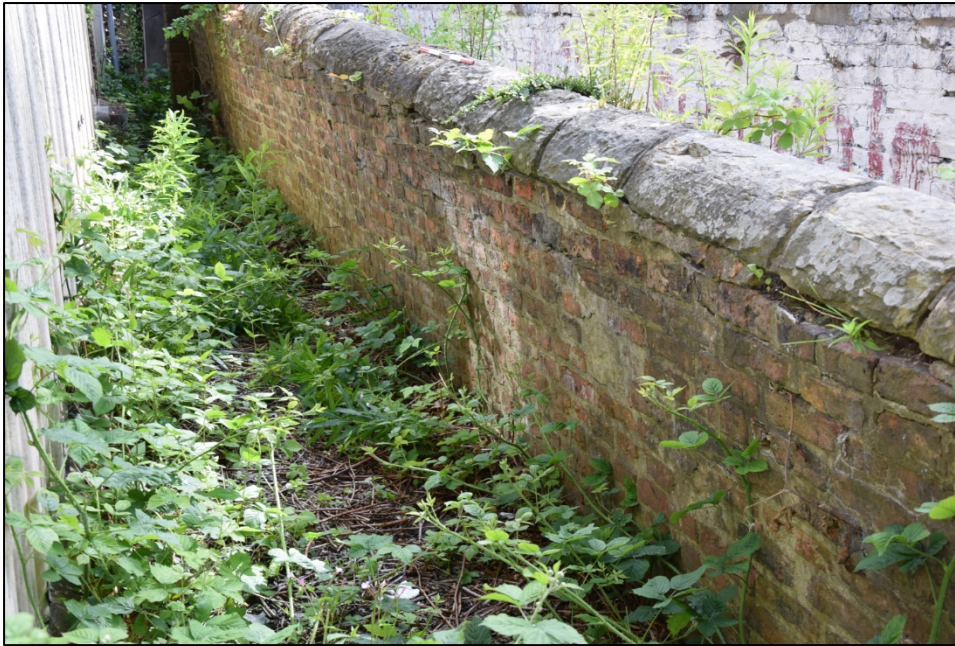
Photograph 84: Wall C, east face. The middle gate and the east end of wall D

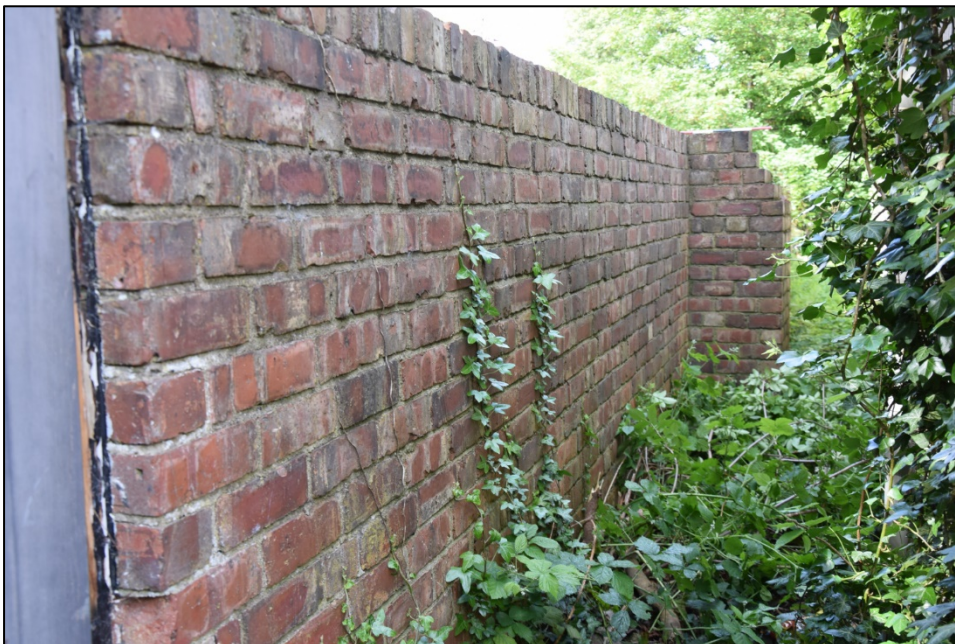
Photograph 85: Wall C, east face. Looking south-west along a narrow gap between the vennel and the temporary building. The ground level south of wall D is higher than that to the north and in the vennel

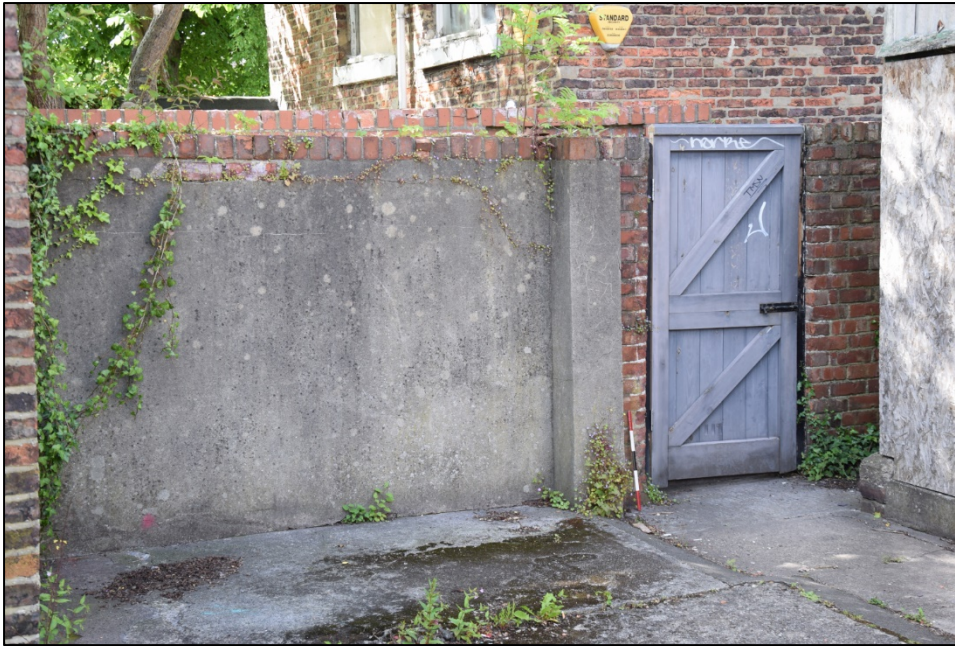
Photograph 86: Wall C, east face. Brickwork immediately north of the south gate

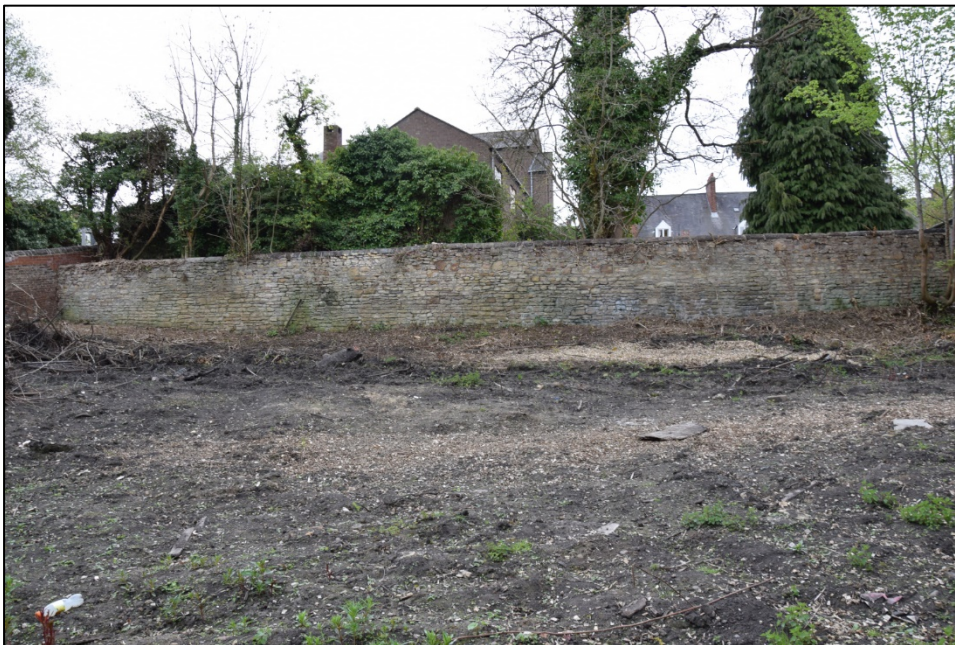
- 6.5 As with walls A and B, this has a stone outer face and brick within. The coursed rubble of the west face extends for about 47m from the north end, at the north-west corner of the former nursery building. There are two later gates, both closed up, in the section north of the temporary building behind no. 49 (Photographs 73-78). A third gate near the south end gives access to the garden behind No. 49 Old Elvet. The north end of the stone wall leans to the east; to its south is a section of later brickwork with a gate to the open space behind nos. 43-49 (Photographs 79, 80). The east face is entirely irregularly-bonded brick, apart from the coping and a small rebuilt section at the north end (Photographs 81-83). The north gate is a modern feature made for access to the nursery; the middle gate is a little older (Photograph 84). South of this, the ground level is higher under the temporary building (Photograph 85). The modern brick in the south end of the wall (Photograph 86) is what remains of a building shown on the 1919 OS map; this had been demolished by the time of the 1939 edition. A rendered section of wall just south of the south gate marks the position of a coal bunker that appears on the 1861 Town Plan (Photograph 87).

Photograph 87: Wall C, east face. The south gate and render of a former coal shed

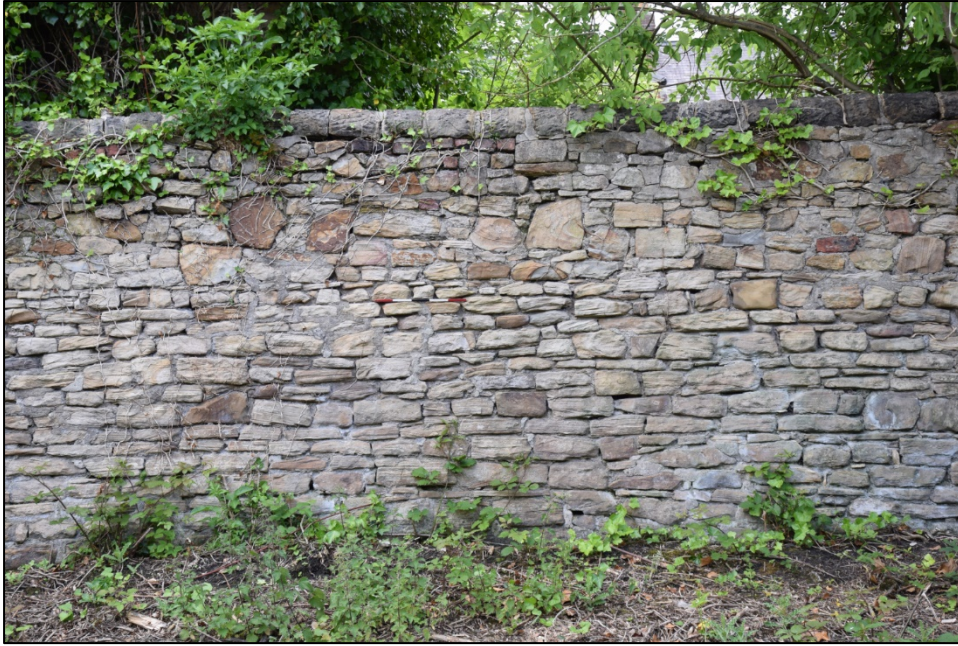
Photograph 88: Wall D, north face. A view looking south from the nursery building

- 6.6 This wall retains the level ground between the courtyard building and the temporary classroom near the vennel. Its north face is stone, similar in character to that seen elsewhere (Photograph 88). The lower courses are a little more evenly-coursed than the upper, marking a rebuild (Photograph 89). A modern gate and the north end of the temporary building have damaged the east end of the wall. As in other places, the south or inner face of the wall is brick. Over most of its length, the lower part of the visible face is older brick and the rebuilt upper stage is modern; both are built in 1+3 English Garden Wall bond (Photographs 90, 91). At the east end, the whole face is older brickwork (Photograph 92).

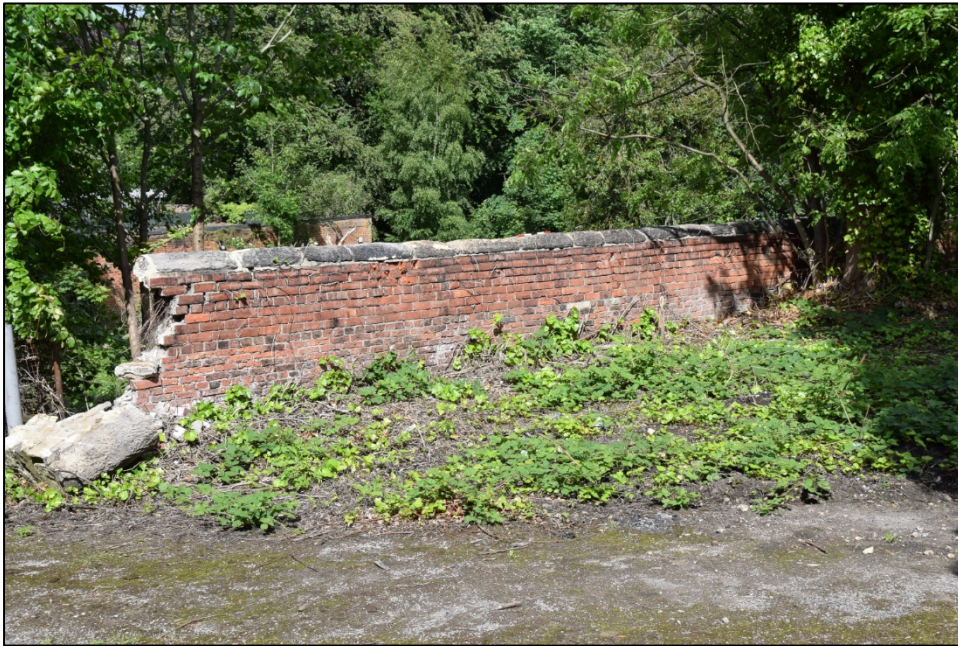
Photograph 89: Wall D, north face. Detail of the masonry, which is more irregular in the upper part of the face

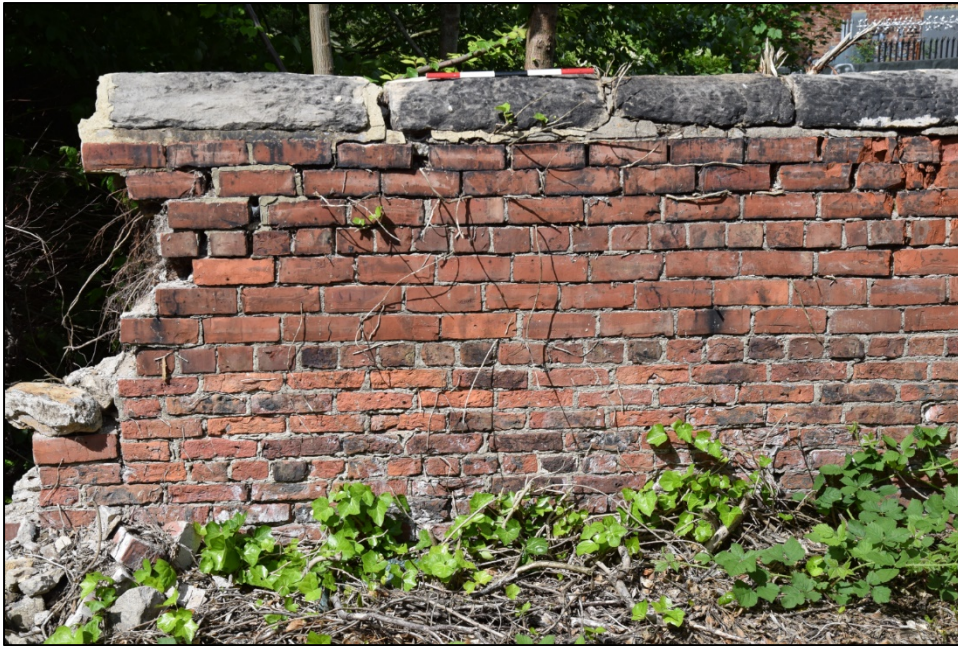
Photograph 90: Wall D, south face. As elsewhere, the inner face is brick. The damaged west end adjoins a later gateway cut through the wall at the north-east corner of the temporary building

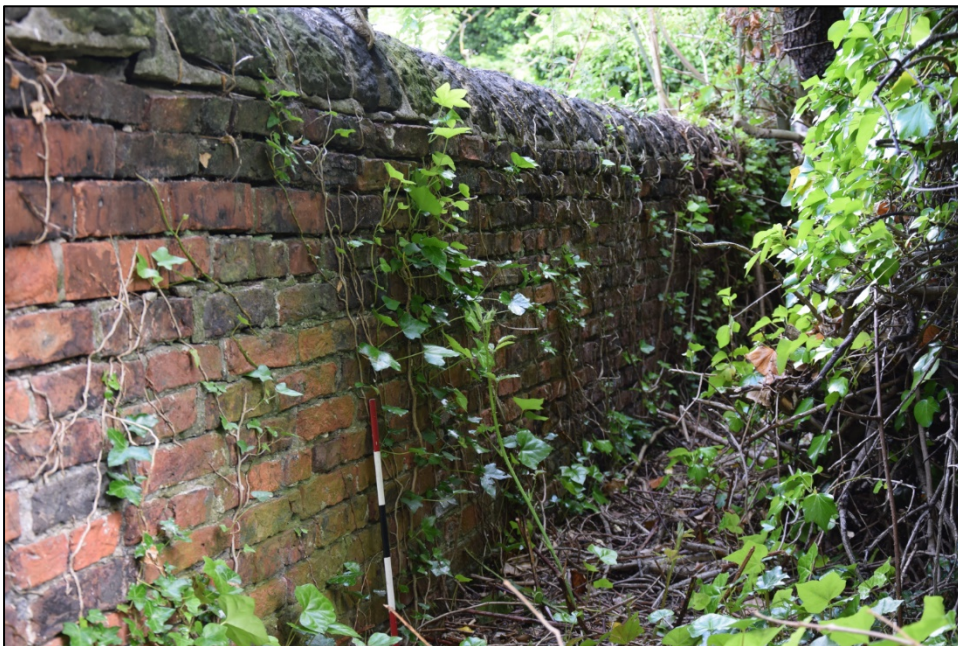
Photograph 91: Wall D, north face. Detail showing the two different types of brickwork. Both use common or English Garden Wall bond, with three courses of stretchers to one of headers
