ARCHAEOLOGICAL
SERVICES
DURHAM UNIVERSITY

Proposed Business School
Elvet Waterside
Durham

archaeological
recording

report 5106
July 2019

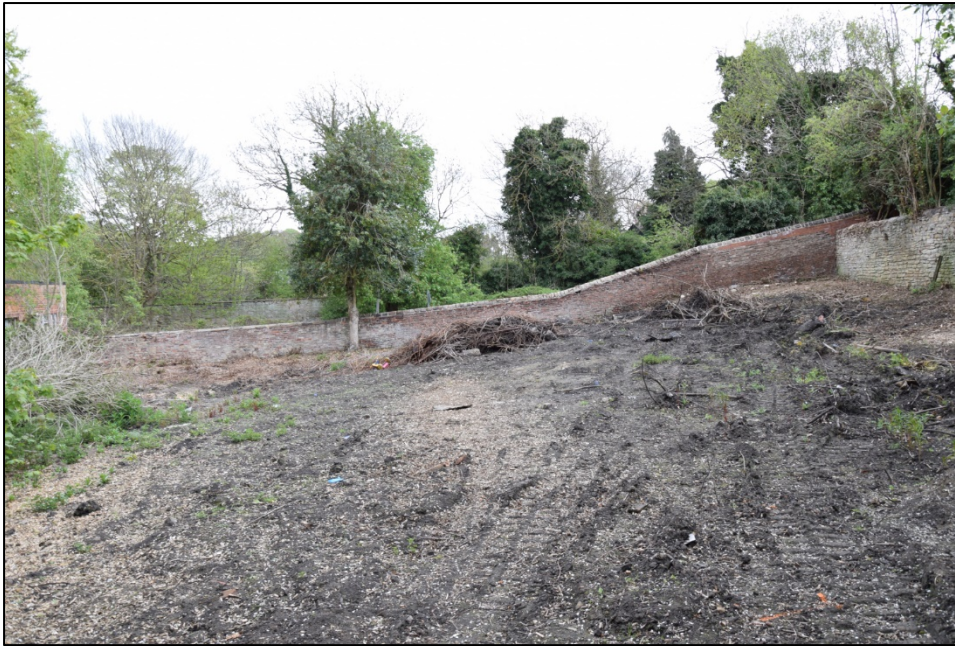
- 6.6 This wall retains the level ground between the courtyard building and the temporary classroom near the vennel. Its north face is stone, similar in character to that seen elsewhere (Photograph 88). The lower courses are a little more evenly-coursed than the upper, marking a rebuild (Photograph 89). A modern gate and the north end of the temporary building have damaged the east end of the wall. As in other places, the south or inner face of the wall is brick. Over most of its length, the lower part of the visible face is older brick and the rebuilt upper stage is modern; both are built in 1+3 English Garden Wall bond (Photographs 90, 91). At the east end, the whole face is older brickwork (Photograph 92).

Photograph 92: Wall D, north face. The east end of the wall is entirely faced with the older bricks

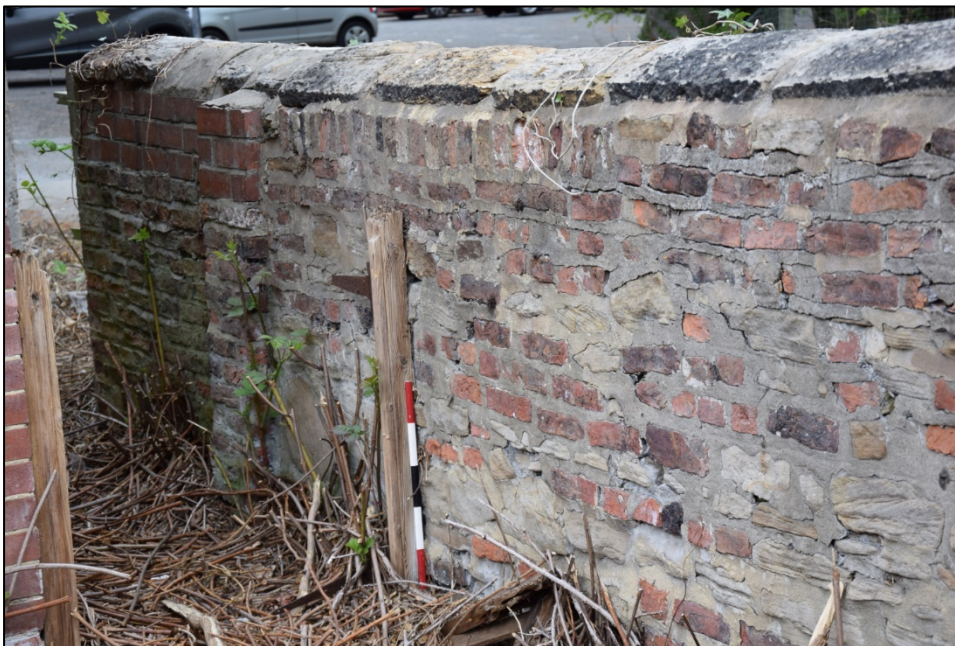
- 6.7 This runs from the south-east corner of the baths building across the east side of the nursery site and up the slope to the courtyard building (Photograph 93). Most of the west face is brick. There are modern alterations at the nursery gate (Photograph 94) and north of this the masonry is rough, with a mixture of brick and uncoursed stone (Photographs 95, 96). This poor-quality face is near the site of a small shed that appears on the 1816 Ordnance Survey map. On the lower part of the slope, more consistent masonry has later brickwork above it; this extends beyond wall D to the face of the courtyard building (Photographs 97, 98).

Photograph 93: Wall E, west face. This is largely brick but there are areas of rough stone in the lower section

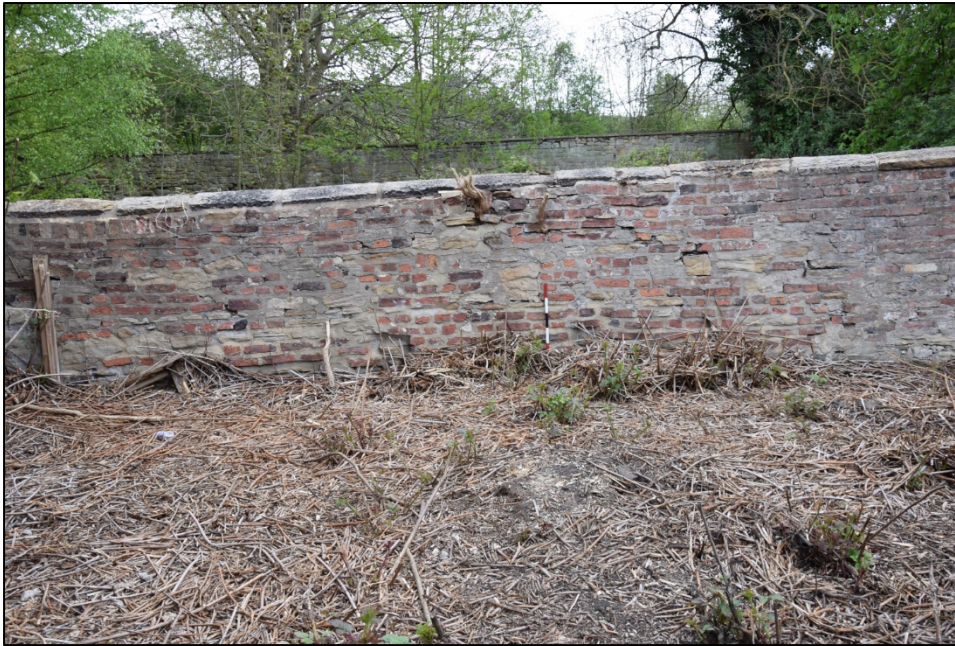
Photograph 94: Wall E, west face. The north end and the gate to the former nursery. A view looking north-east

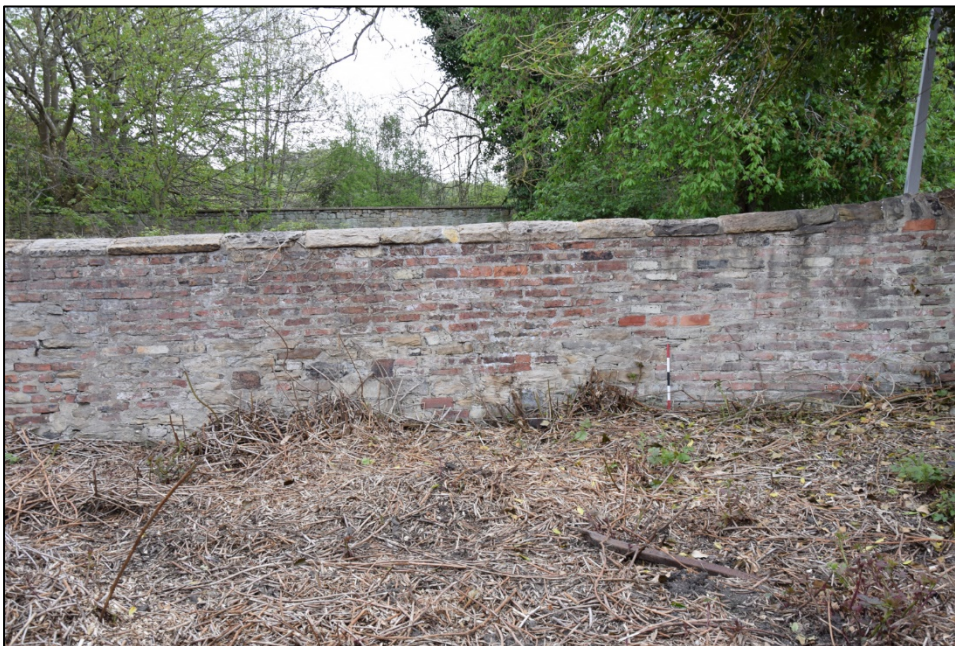
Photograph 95: Wall E, west face. This area of irregular masonry is close to the site of a small building shown in the 1816 OS map

Photograph 102: Wall E, east face. This irregular masonry matches that on the west face; compare with Photo 95, above

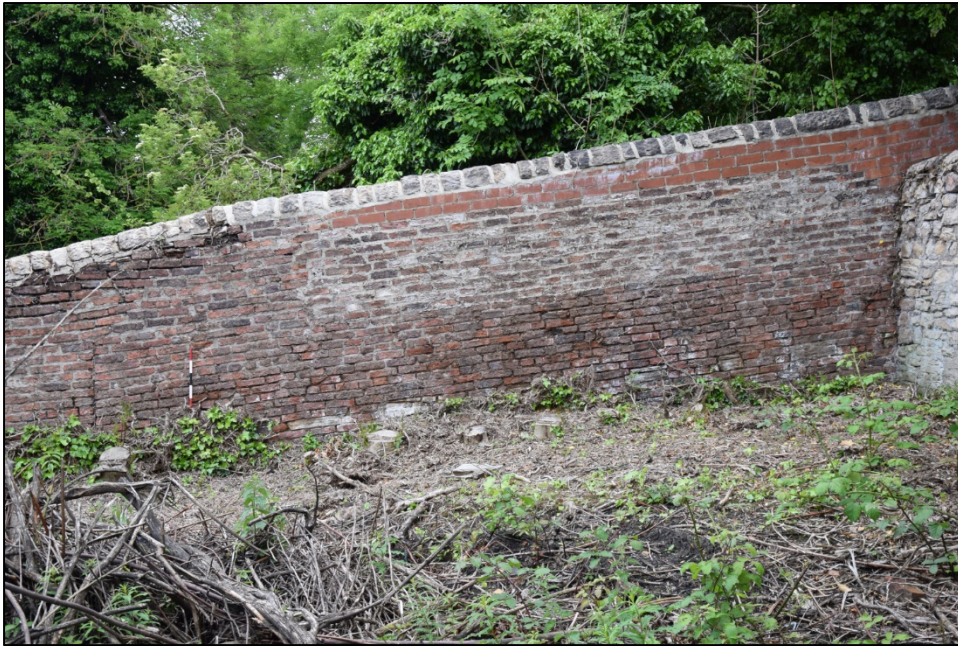
Photograph 96: Wall E, west face. Mixed sandstone and brick near the foot of the slope

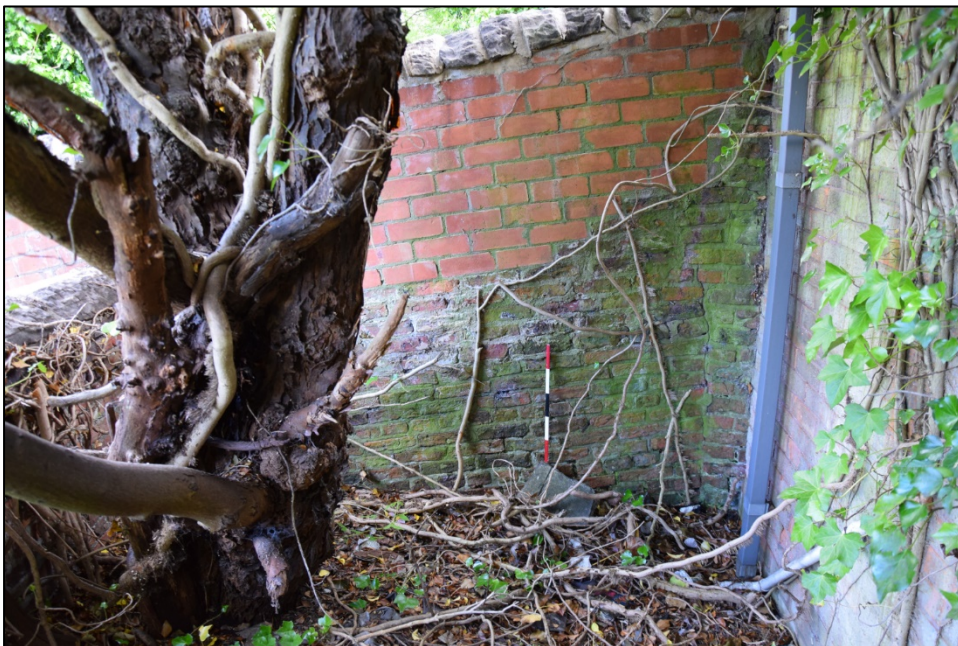
Photograph 97: Wall E, west face. Old and modern brick near the junction with wall D

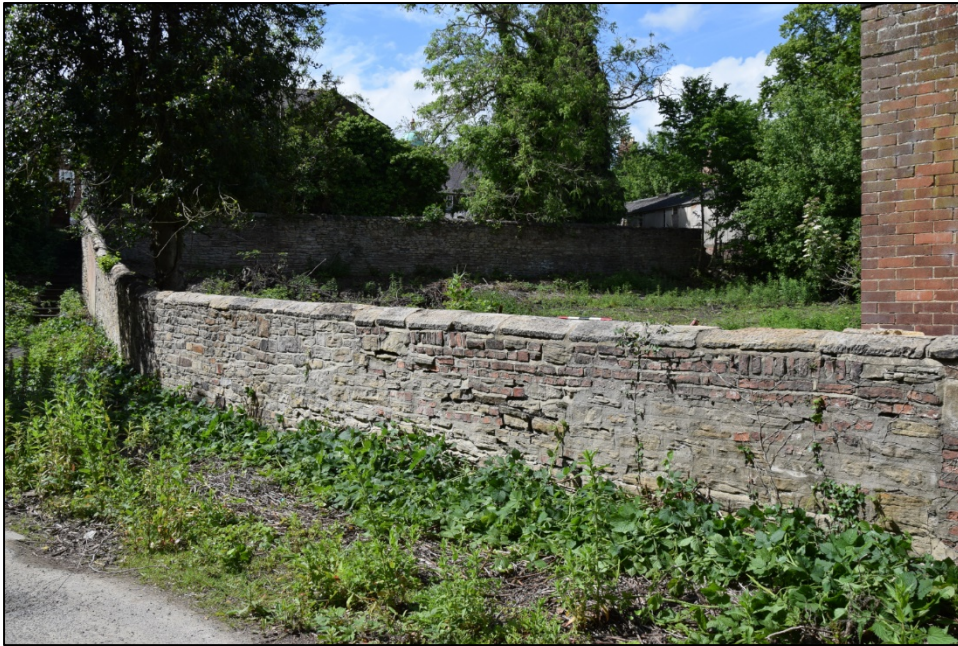
Photograph 98: Wall E, west face. The same pattern of old and modern brick between wall D and the north side of the courtyard building

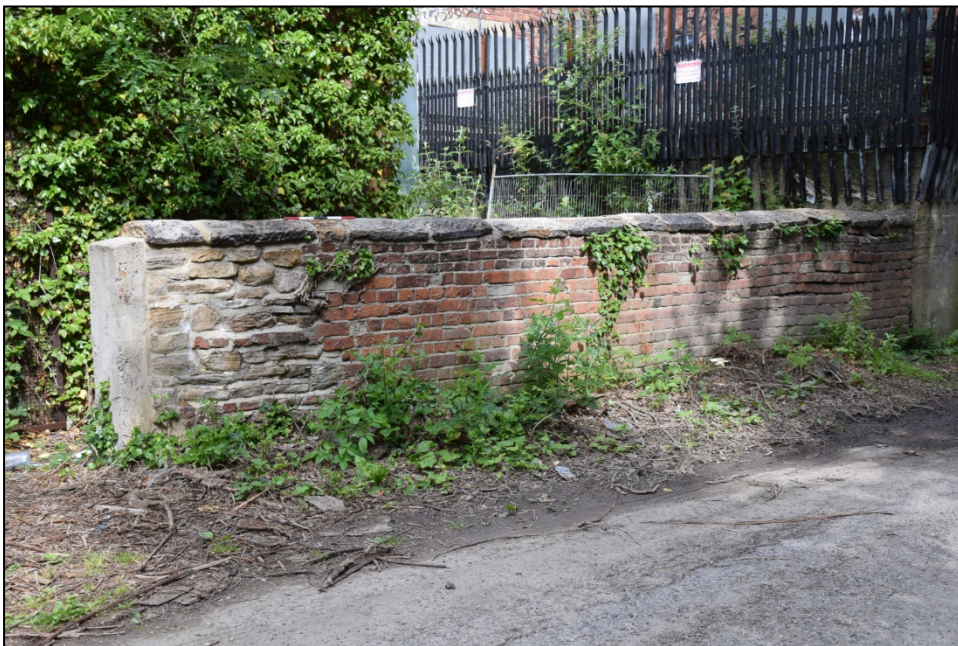
Photograph 99: Wall E, east face. This general view looking south-west shows the change in alignment near the bottom of the slope

- 6.8 As elsewhere, the outer face of the wall is stone (Photograph 99). A small section has been rebuilt in brick at the north end, between the nursery gate and the batch building (Photograph 100). The wall around the gate shows patches and repairs and the masonry is rather poor immediately south of this (Photographs 101, 102). There is slightly better quality rubble masonry on the slope. A patch of render here shows the position of a shed that appears on the 1898 map (Photographs 103, 104). South of this, the wall is in better repair (Photographs 105, 106).

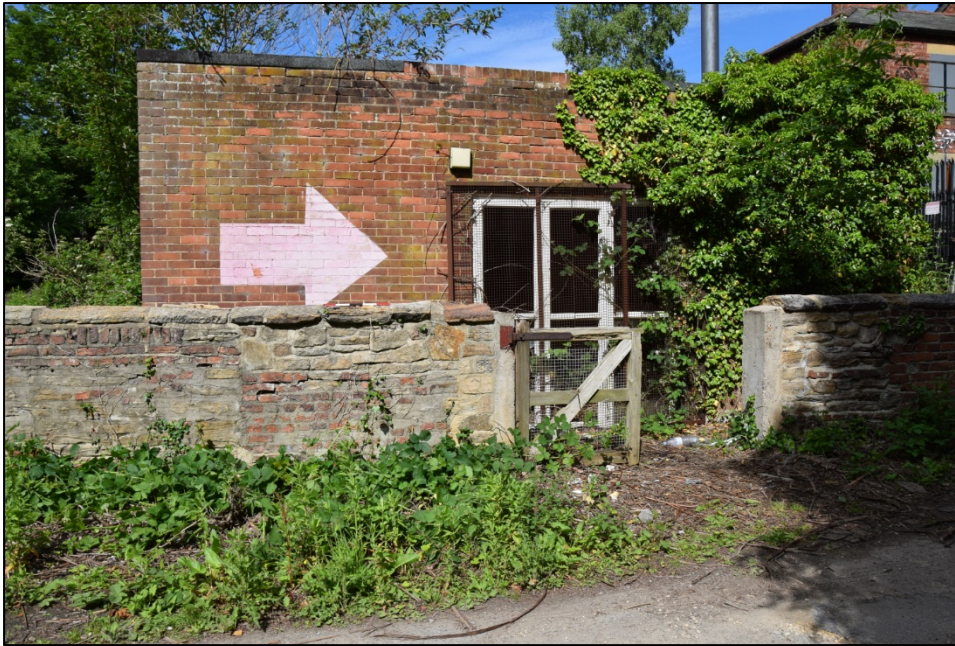
Photograph 100: Wall E, east face. A short section between the gate to the former nursery and the corner of the baths

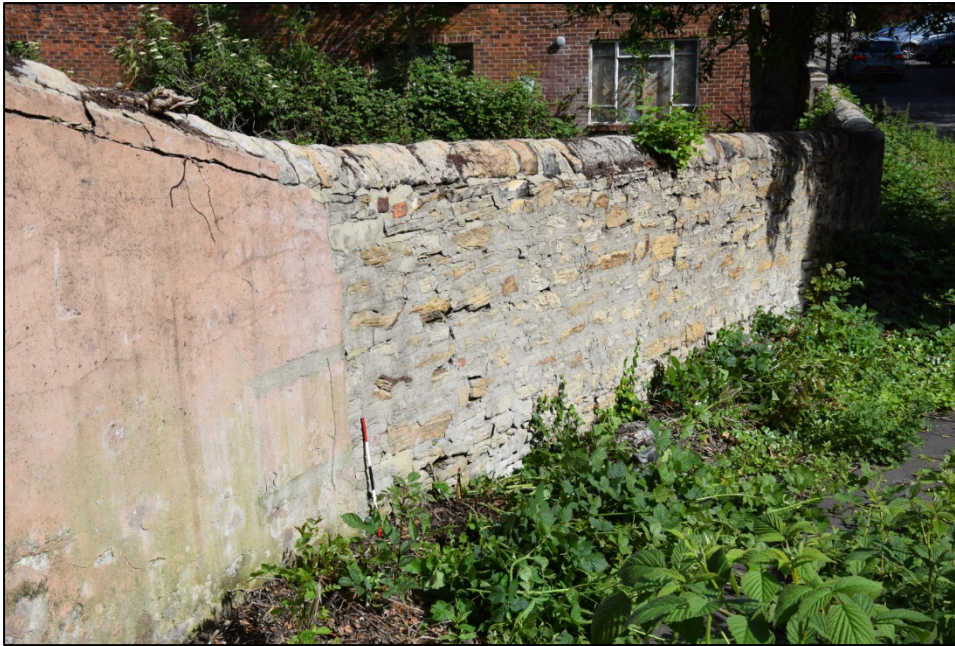
Photograph 103: Wall E, east face. The wall on the slope has an area of pink plaster

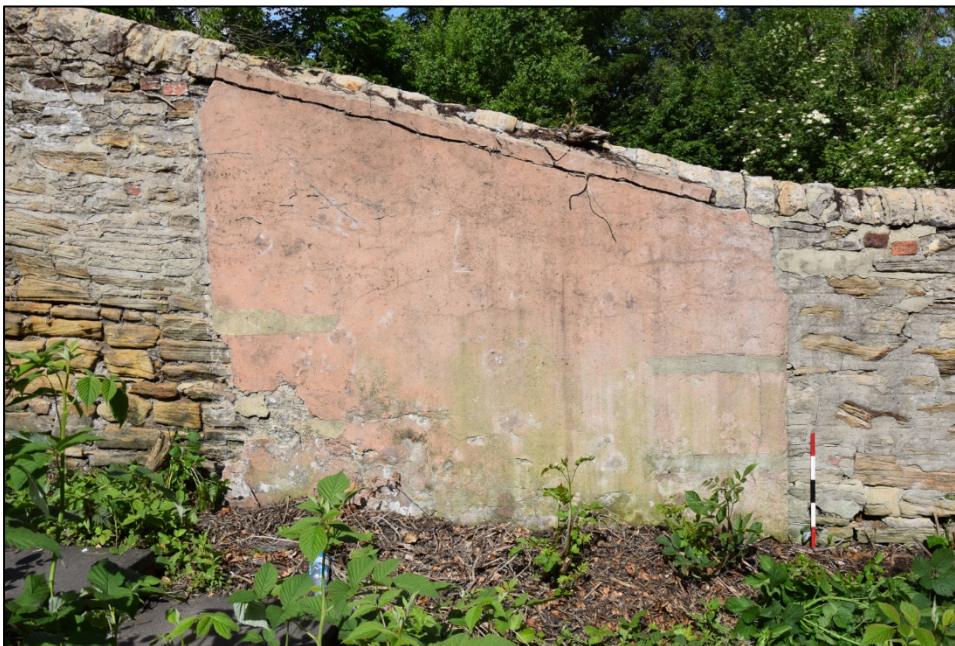
Photograph 104: Wall E, east face. The plaster marks the site of a shed shown on the 1896 OS map

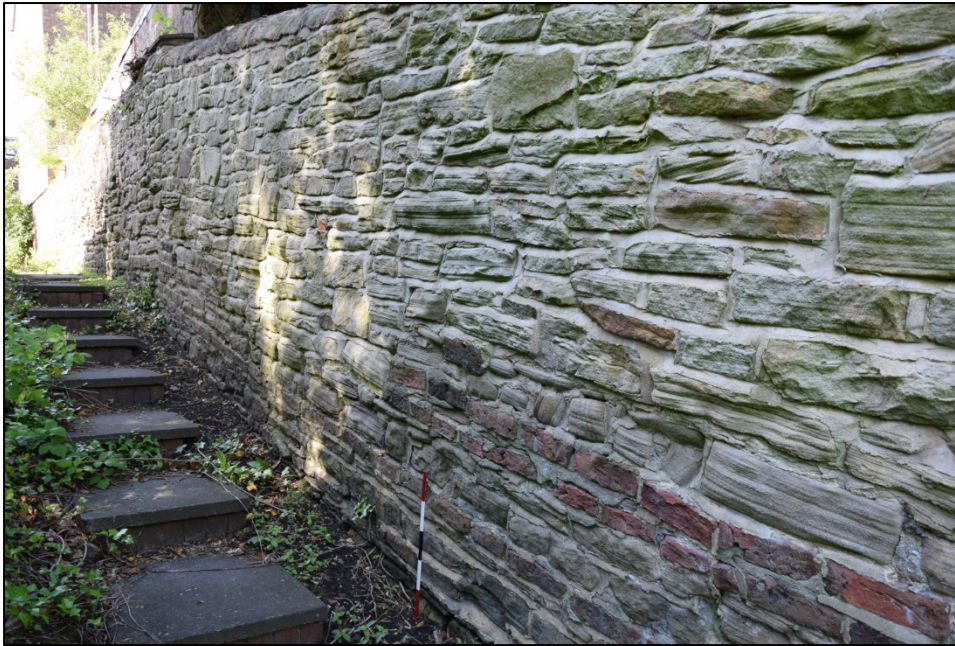
Photograph 105: Wall E, east face. The upper section of the wall has been repointed in recent years

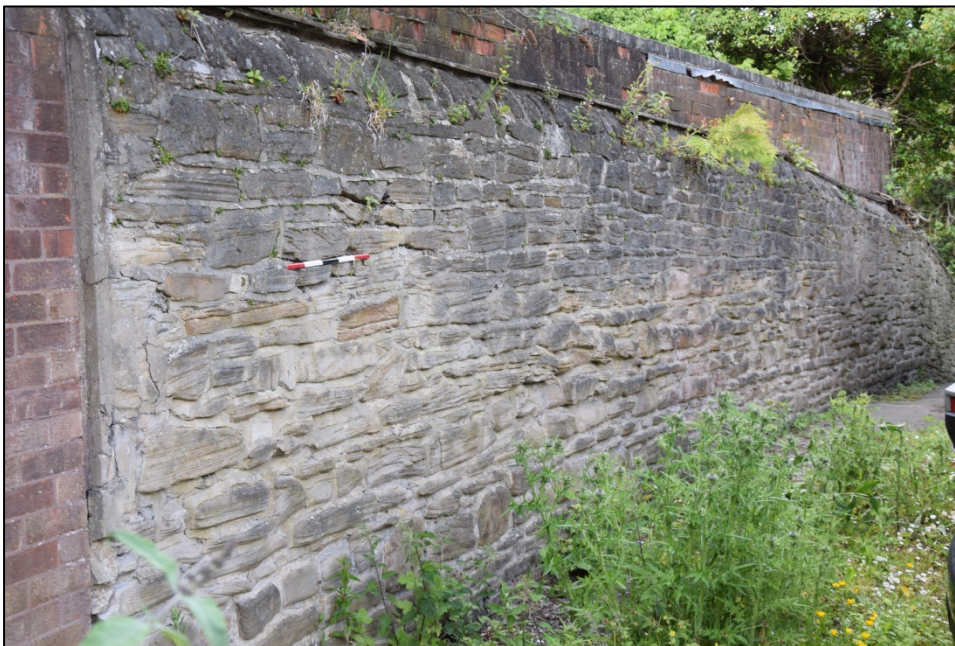
Photograph 106: Wall E, east face. The south end, built into the modern courtyard building

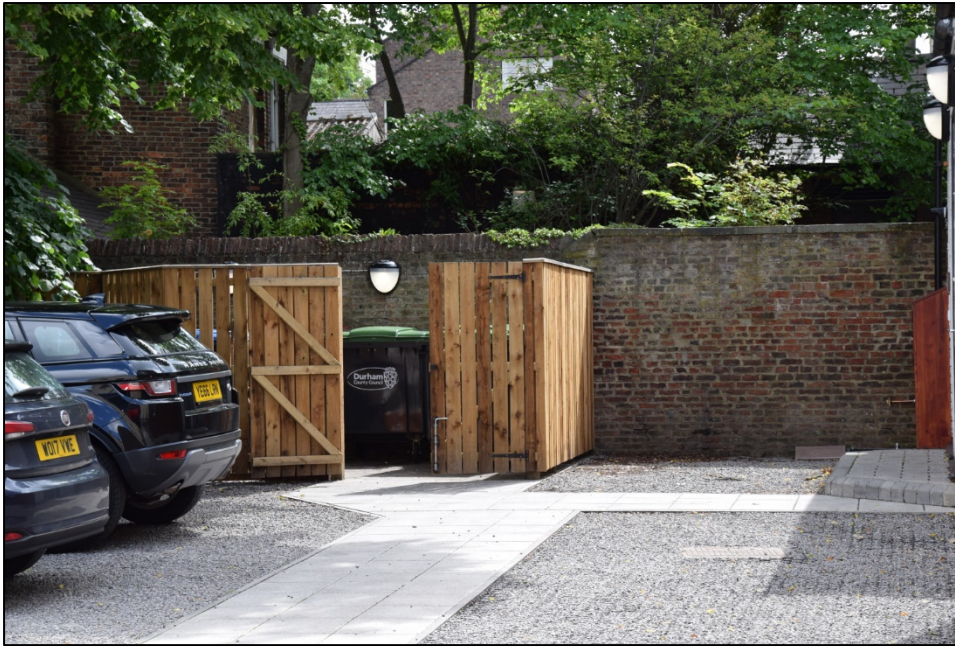
Photograph 107: Wall F, west face. This is the retaining wall for the garden outside Vennel Cottage

- 6.9 The retaining wall for the garden behind 50/51 Old Elvet is partly covered by a fenced yard. It is made of plain brickwork in English Garden Wall bond, 1+5, with a stone slab coping (Photographs 107, 108). The east face is almost completely covered by the higher ground of the garden.

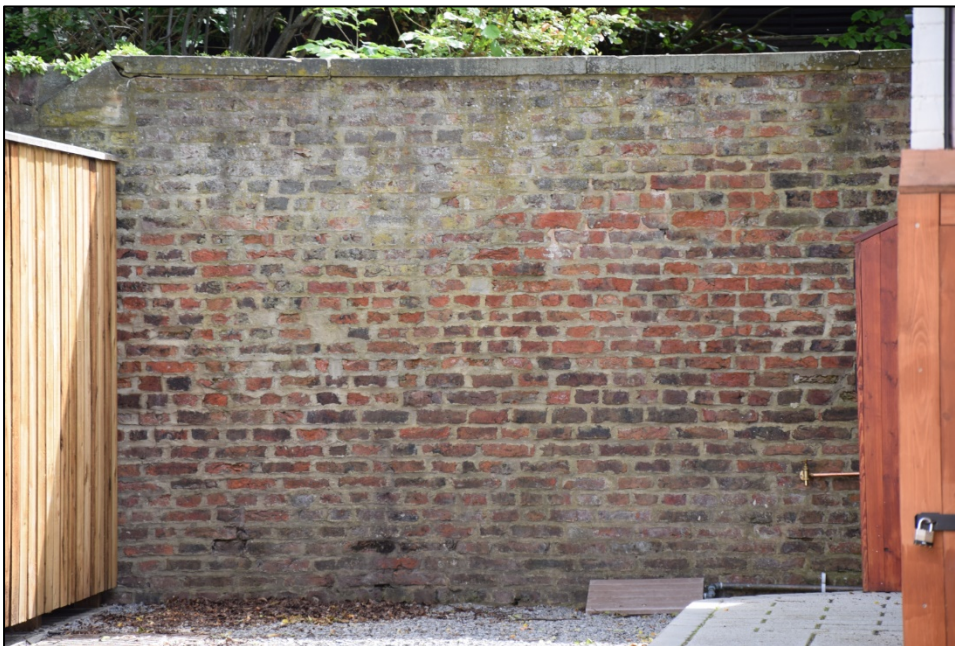
Photograph 108: Wall F, west face. Detail of the brickwork

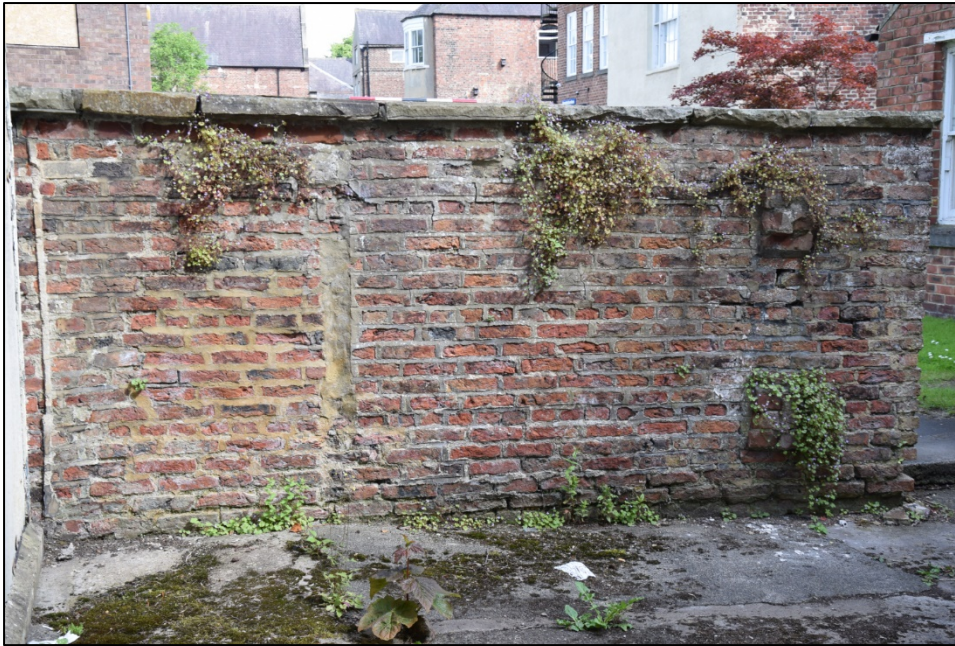
Photograph 109: Wall G, west face. Note the projecting brickwork near the south (left-hand) end

- 6.10 This short isolated fragment runs north-south near the temporary building. Both faces are English Garden Wall bond 1+5, under plain stone coping slabs (Photographs 109, 110). There are projecting sections of brick on the west face; these cannot be identified with any building shown on old maps of the site.

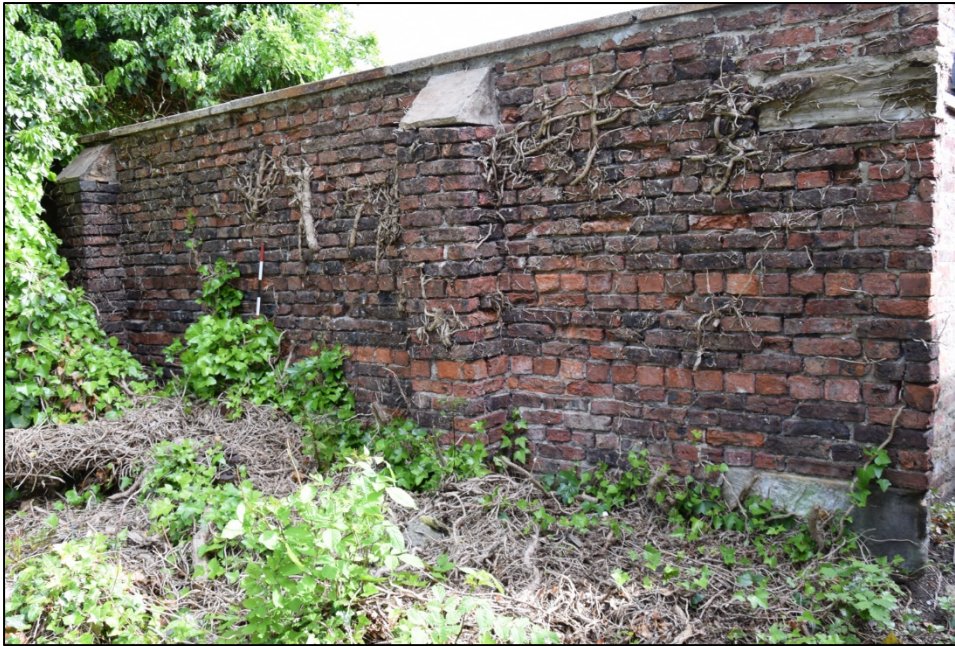
Photograph 111: Wall H, north face. These buttresses are shown on the 1816 map

- 6.11 This is another isolated fragment of old wall with a later addition that gives it an L-shaped plan. The north face is brick with buttresses and slab copings (Photographs 111, 112). The south side is slightly irregular English Garden Wall bond with a patch of render at the west end; this is part of a summer house that is shown on the 1861 map, but that had been removed by 1939 (Photographs 113, 114).

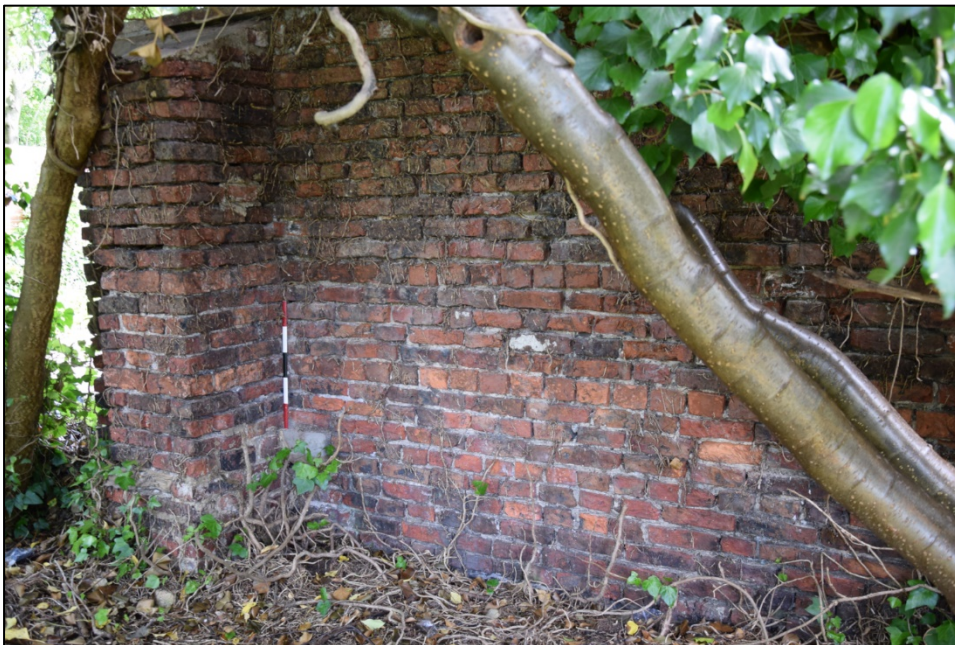
Photograph 112: Wall H, north face. The slightly larger buttress at the east end was originally beside a gate to the lower garden

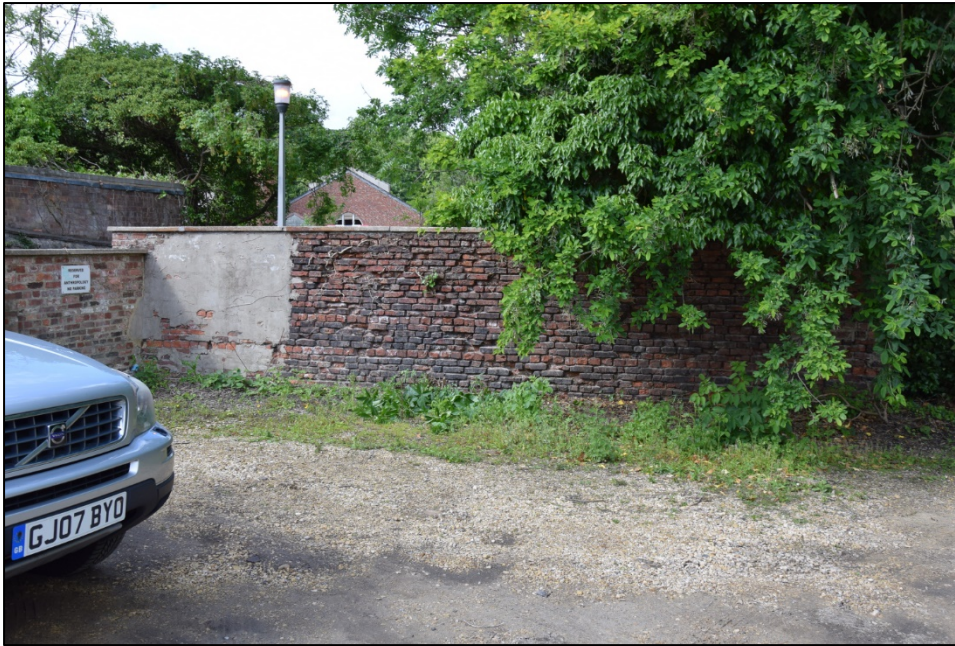
Photograph 113: Wall H, south face. The 1816 map shows a structure at the left-hand end, but no sign of it can be seen

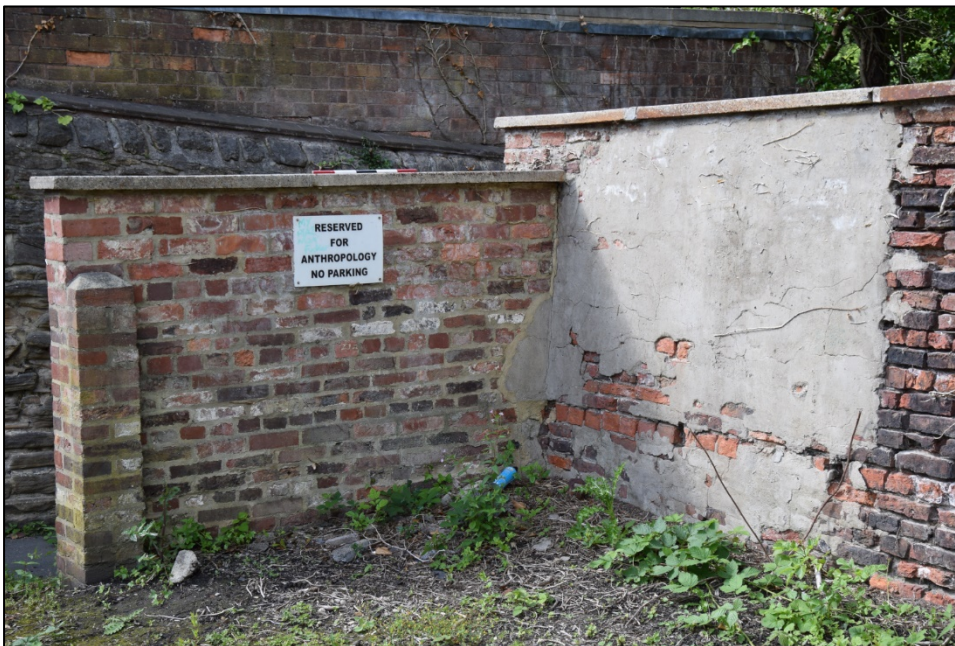
Photograph 114: Wall H, south face. A modern wall runs south beside an area of render. There was a summer house in this corner in 1816

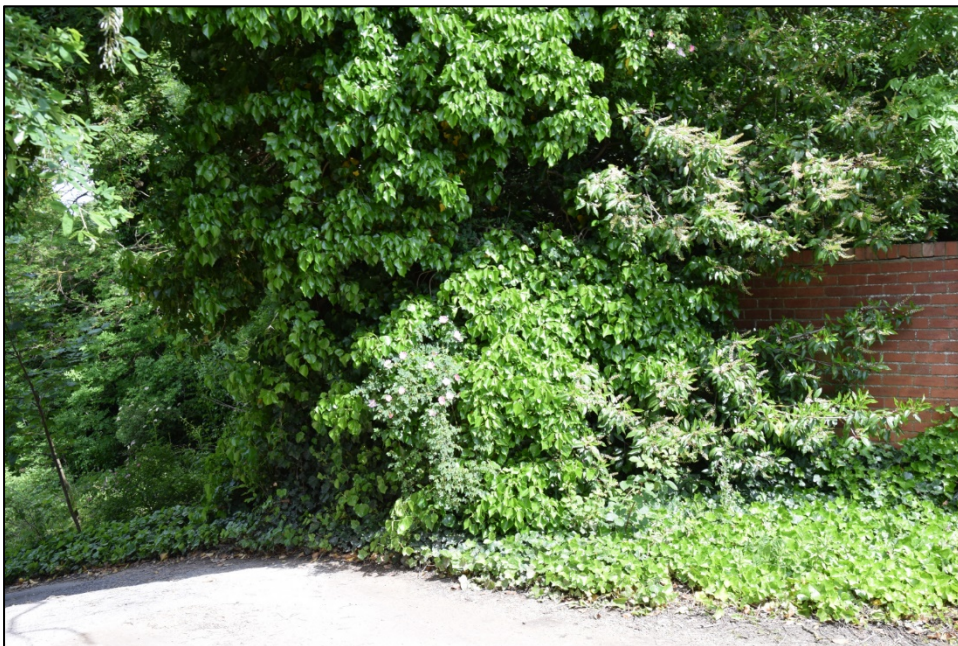
Photograph 115: Wall I, north face. This buttress is different from those on the other side of the old gate. The outer face of brickwork beside it is in a dangerous state

- 6.12 This is a short section of a wall that runs east beyond the study area. The north face is buttressed brick of different construction from wall H (Photograph 115). The masonry is in poor condition and only a small area could be seen. The south face is entirely covered by vegetation. The adjoining wall of the garden behind no. 42 is all modern brick (Photograph 116).

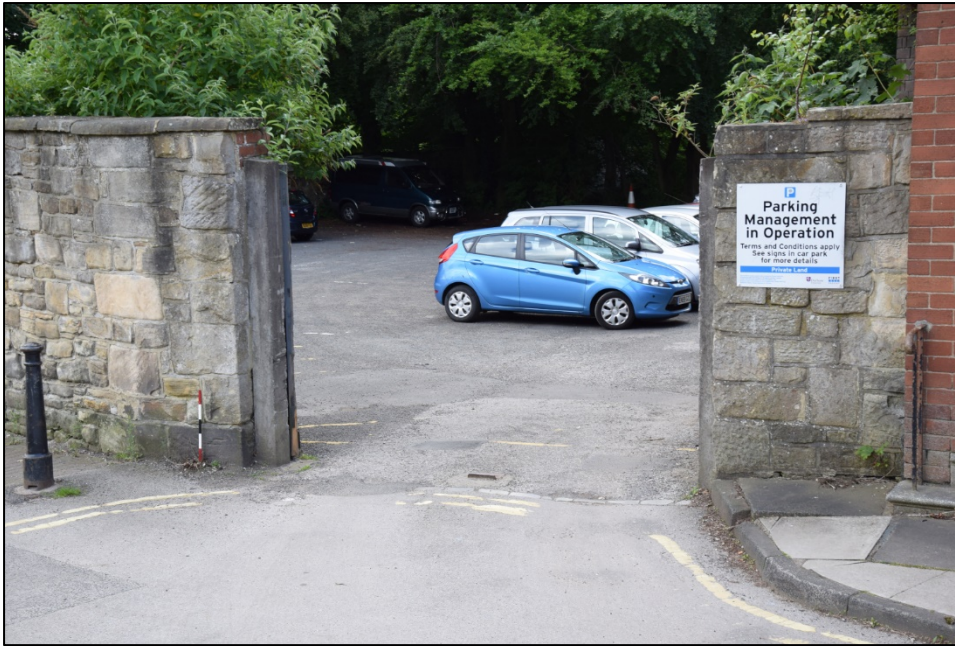
Photograph 117: The modern gate at the west end of wall J

- 6.13 This high wall at the north end of the eastern car park has a large modern gate at its west end (Photograph 117). The north face is coursed squared sandstone; it appears to have been raised by about 0.6m (Photographs 118, 119). The inner face is English Garden Wall brickwork (Photographs 120, 121); there was a glasshouse here in the early 20th century but no clear evidence of it can be seen in the wall today.

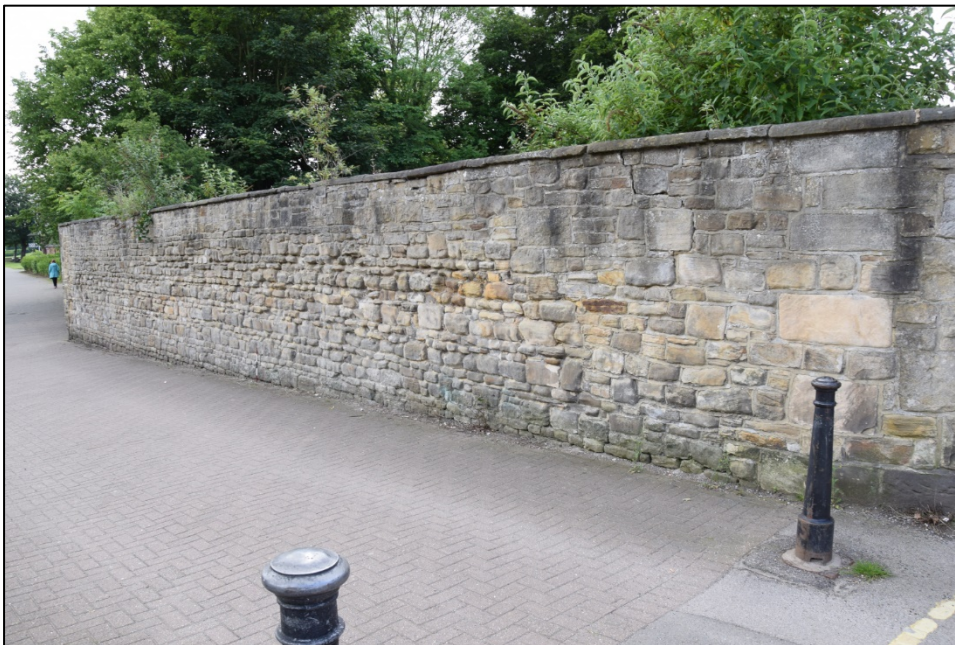
Photograph 118: Wall J, north face. Note the difference between the upper courses and the rest of the face

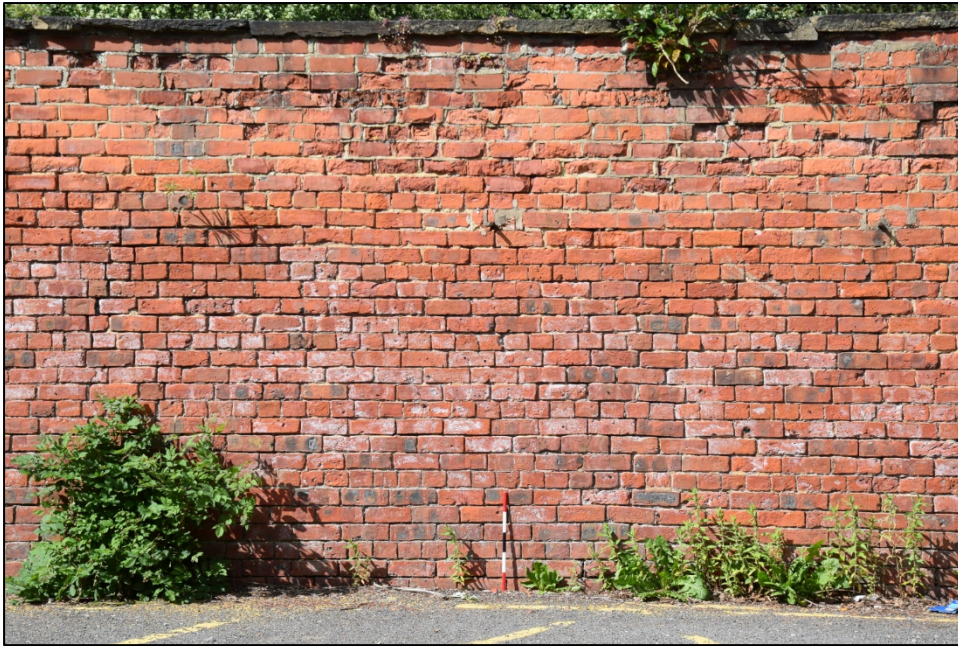
Photograph 121: Wall J, south face. Detail of the brickwork. Two small iron pegs, a little over halfway up, are the only trace of a glasshouse that stood here in the early 20th century

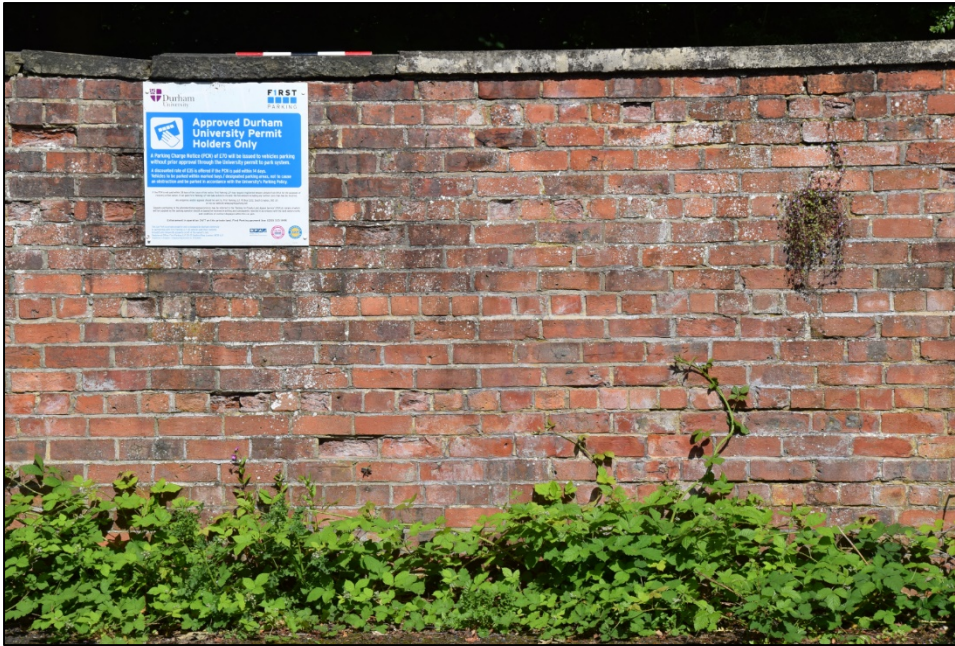
Photograph 123: Wall K, west face. Detail of the masonry

- 6.14 This wall is the east side of the car park. The north end has modern brick in its west face (Photographs 122, 123) but this gives way to stone near the electricity substation that stands just outside. A buttress of dressed stone contrasts with the rather poor rubble of the wall itself (Photograph 124, 125). Better masonry further south incorporates sizeable sections of cast concrete (Photographs 126-128). The east face is entirely stone (Photographs 129-133).

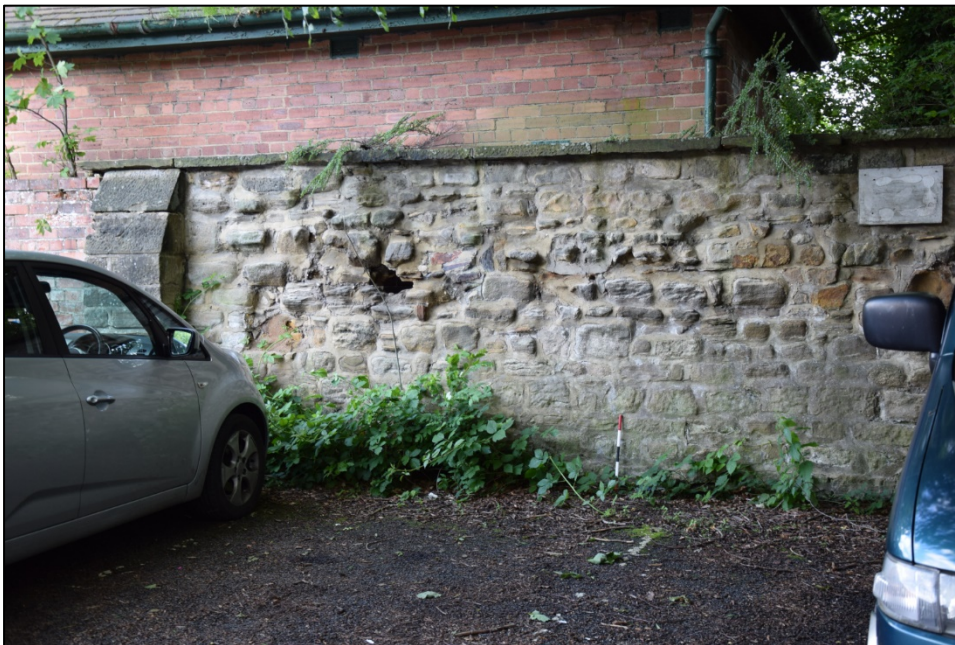
Photograph 124: Wall K, west face. The stone wall with the electricity substation behind it. The stone has decayed to the point that there is a hole through the wall, just right of the grey car

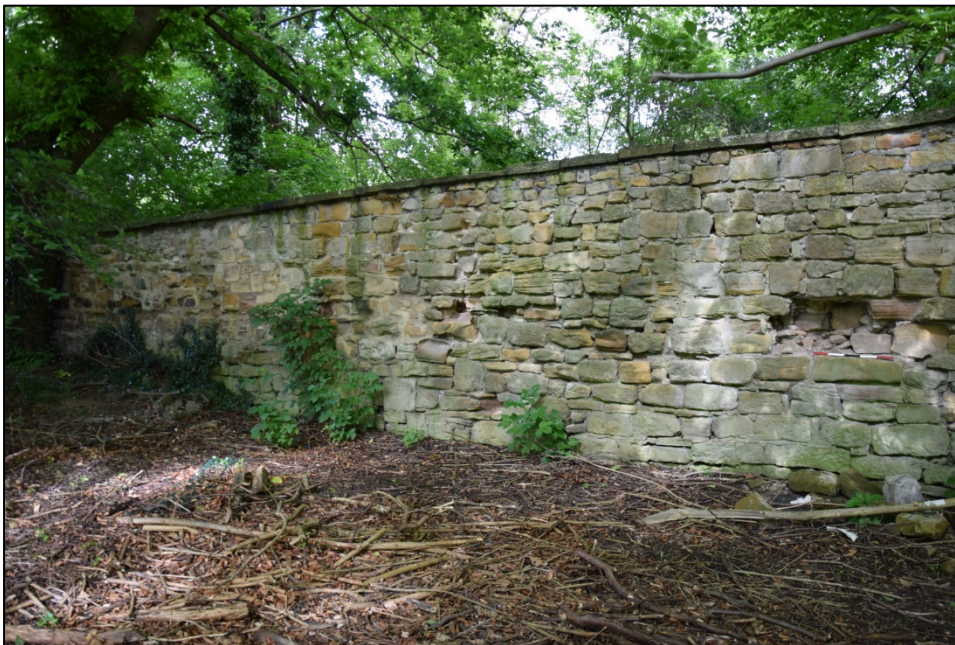
Photograph 126: Wall K, west face. The masonry here, near the middle of the wooded area, is better than that in the wall further north

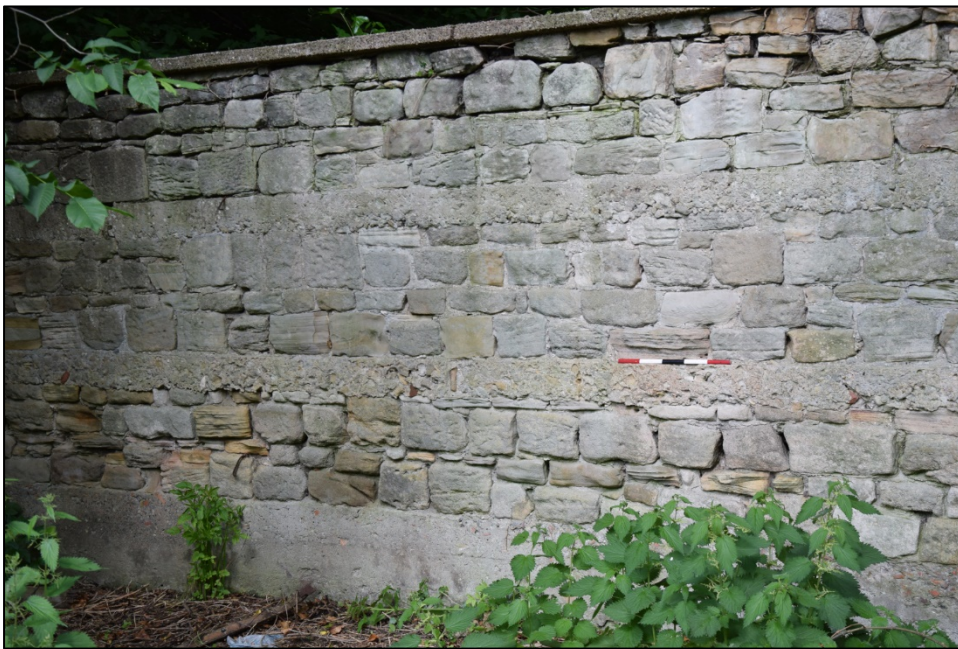
Photograph 128: Wall K, west face. This section has a deep concrete footing course and bands of concrete higher up; these are also visible in the opposite face

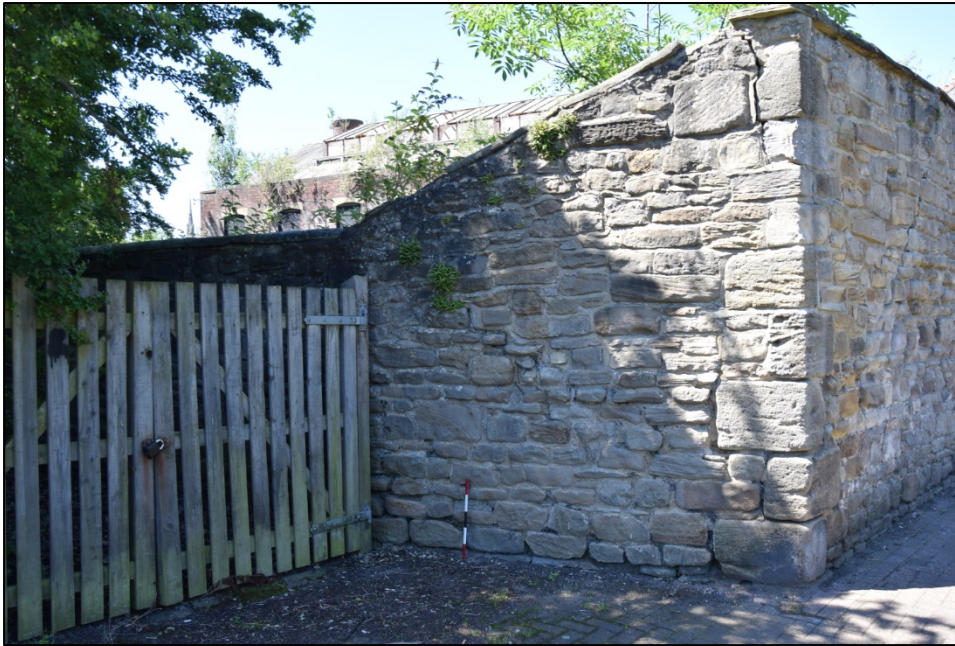
Photograph 129: Wall K, east face. The fence is the compound for the electricity substation

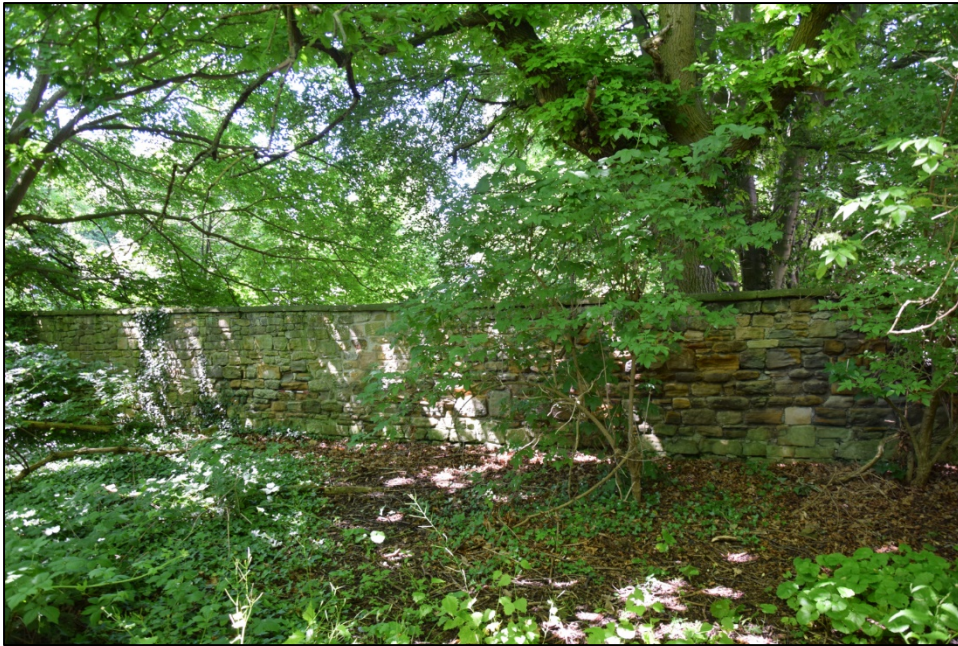
Photograph 130: Wall K, east face. Once again, there is a stone face on the outside of a wall seen as brick from inside the former garden

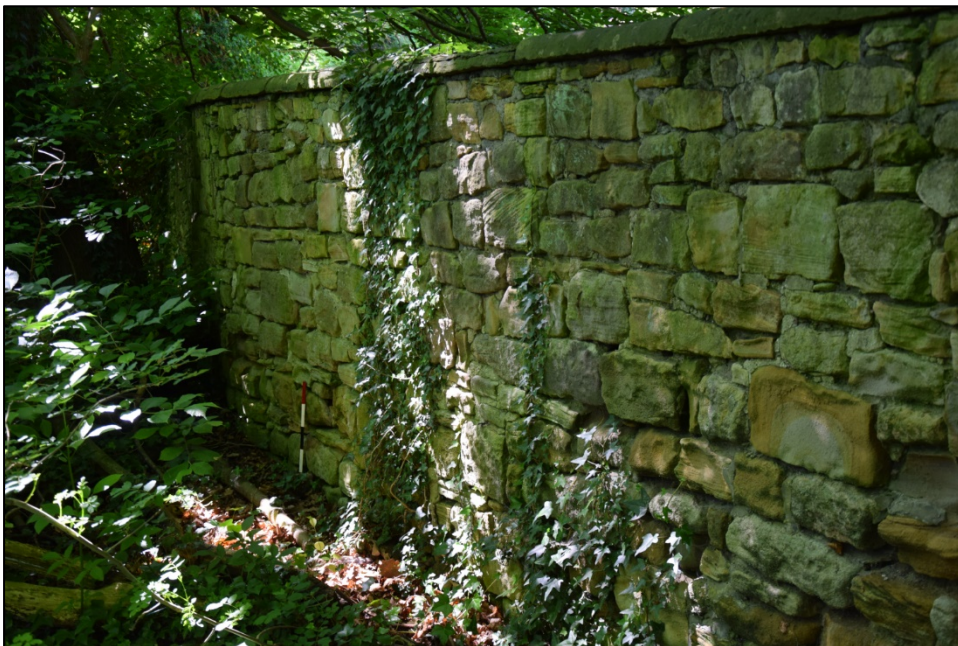
Photograph 131: Wall K, east face. The masonry near the centre of the wooded area at the foot of the slope is similar to that on the opposite face, seen in Photo 126

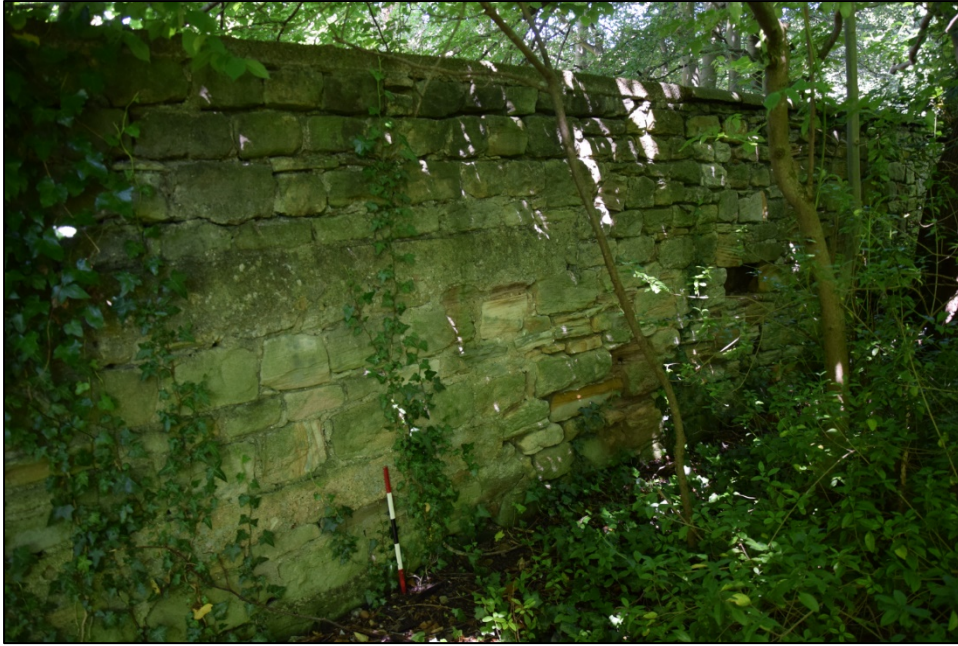
Photograph 133: Wall K, east face. Substantial concrete slabs in the wall match those on the other side (Photo 128)
