Blanchland Abbey Church Blanchland Northumberland

geophysical survey

report 5237 February 2020

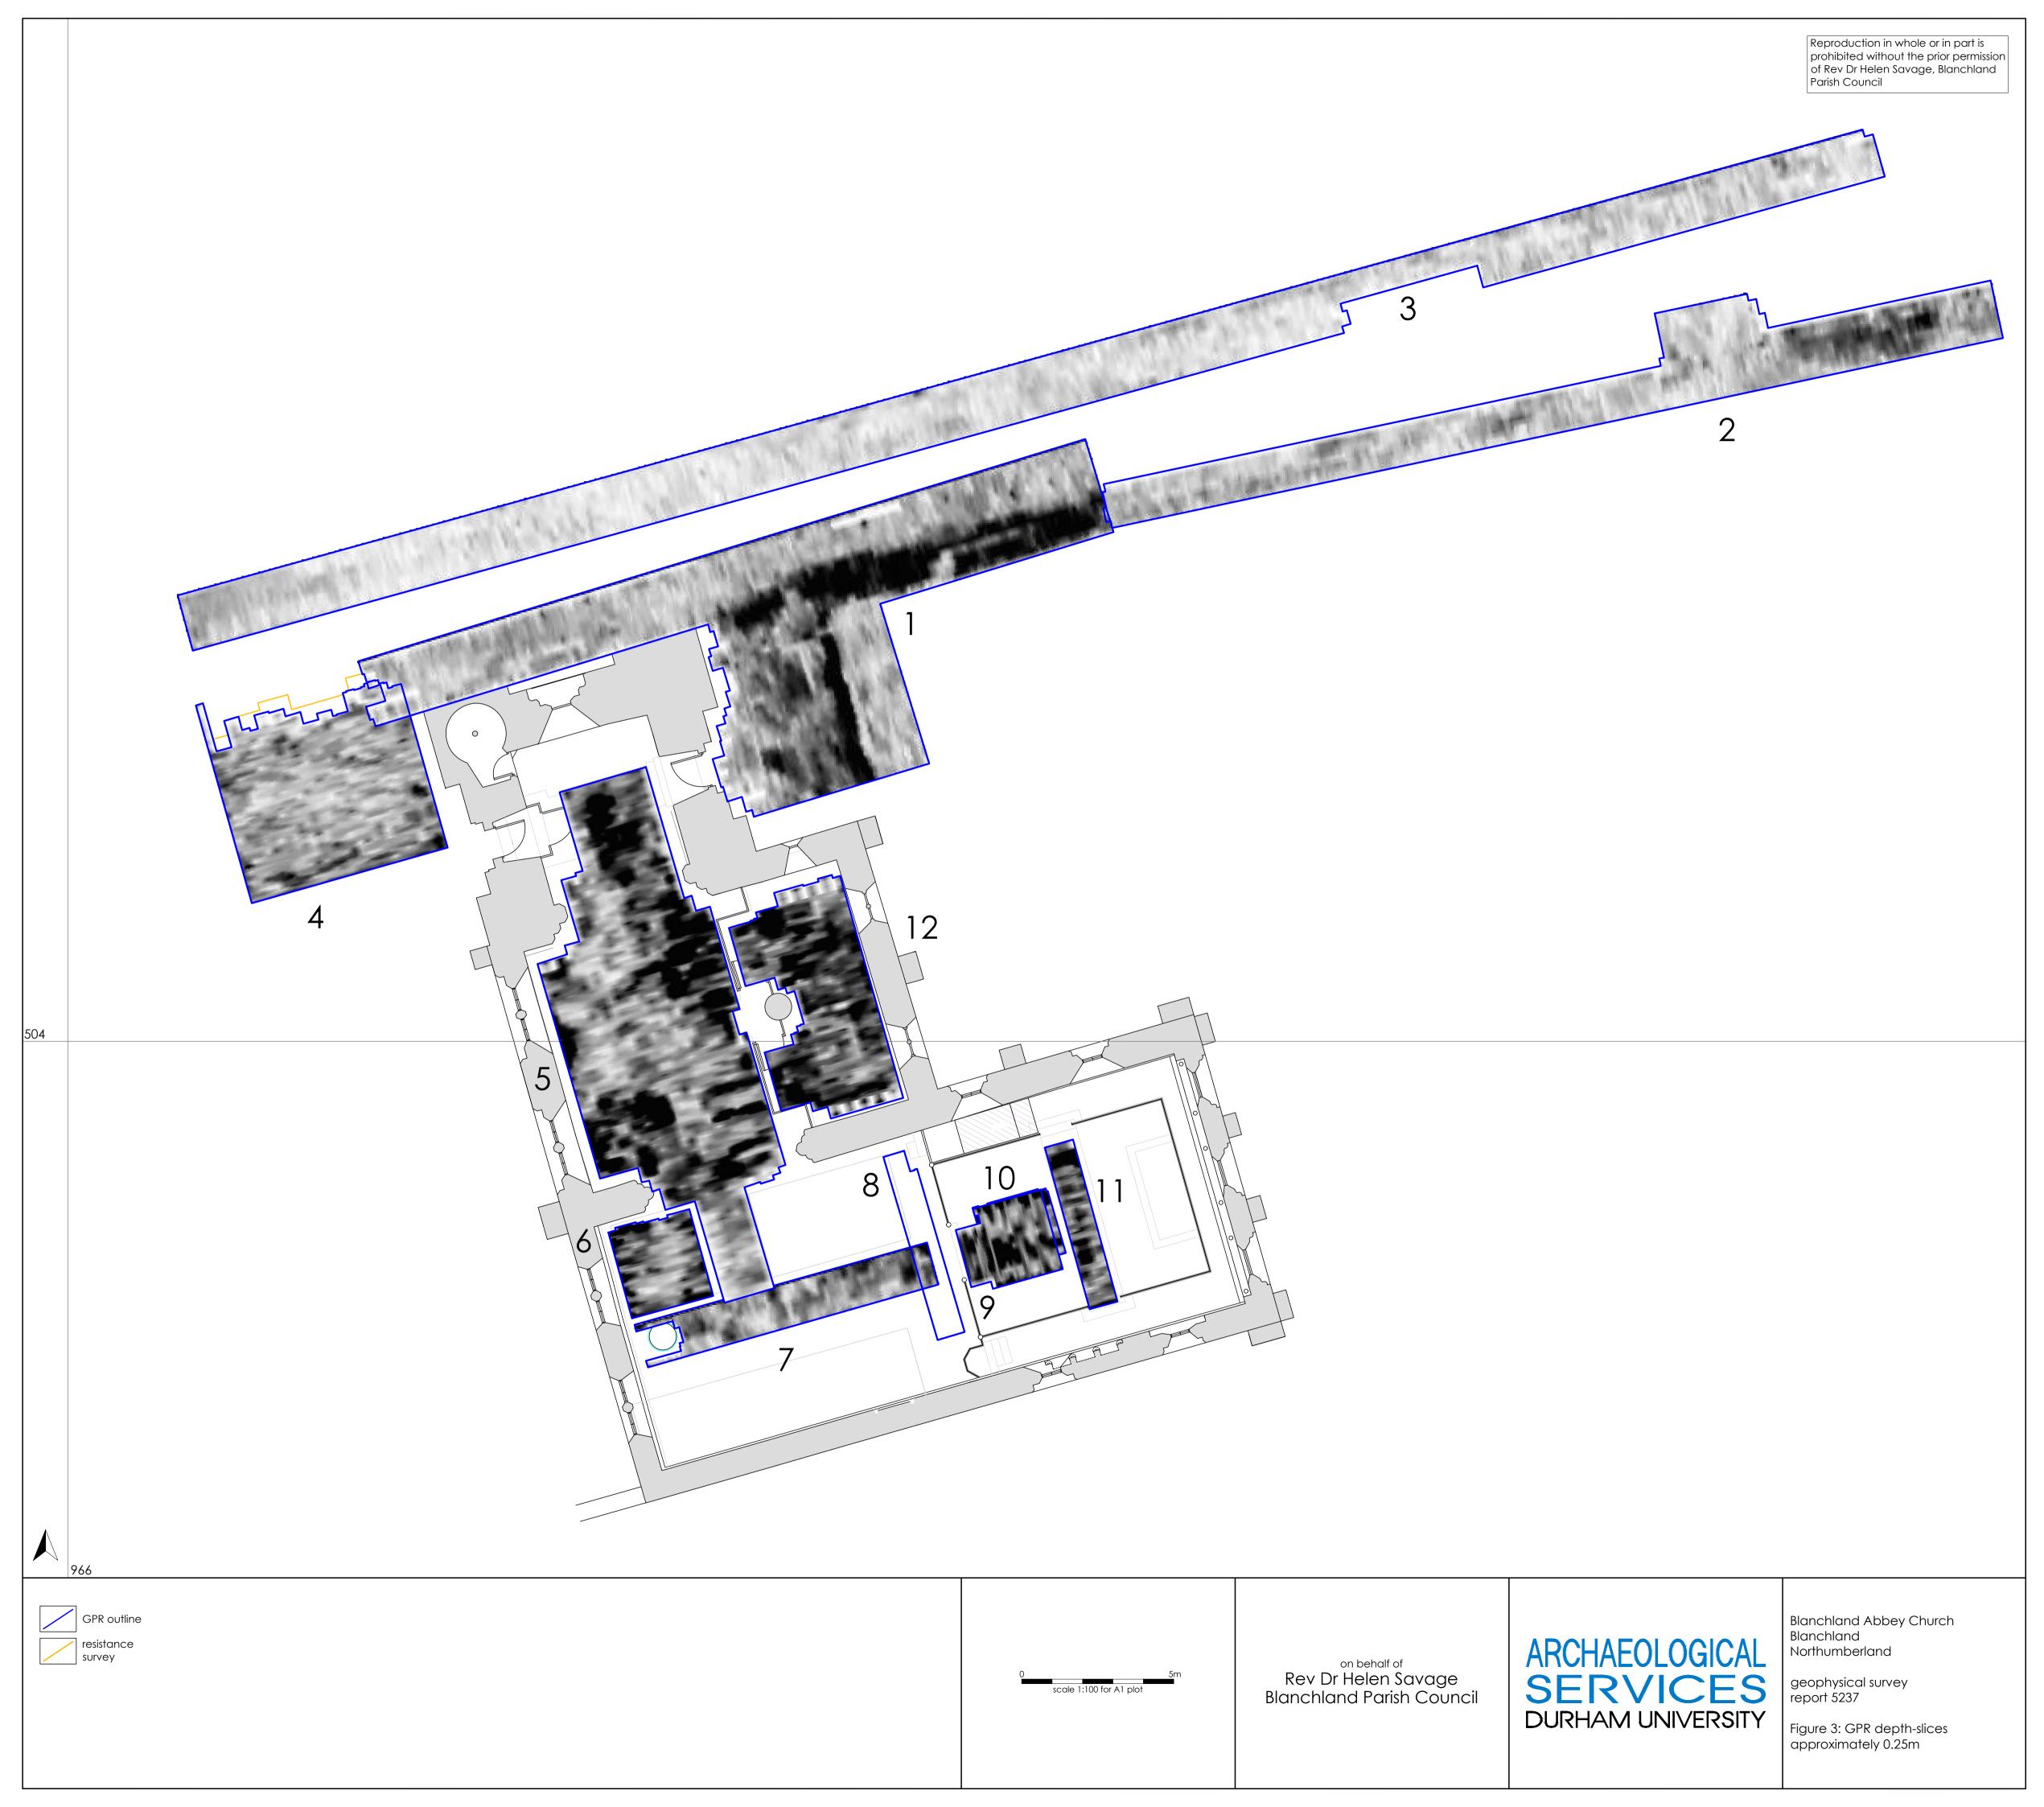
5.17 GPR profiles and time-slices have been examined; representative profiles, time-slices and interpretations are presented in Figures 3-6. In this instance, the time-depth conversion is based on a soil velocities of between 0.05 – 0.1m/ns; the velocity is only an estimate based on a hyperbola fitting technique and therefore any depths below ground level (BGL) mentioned in the text below are only approximate.

- 5.24 The clearest reflections recorded in the GPR data for this area occur in the very surface to approximately 0.3m BGL. These correspond to the path through the churchyard and the small area of gravel outside the eastern door of the tower. The eastern and northern edges of the gravel area are particularly well defined. The clear reflections detected here could represent the remains of wall footings associated with the former chantry chapel. The baptistery, to the immediate south of the area, was built in 1854 on the foundations of the former chantry chapel, which may have extended northwards alongside the south-eastern side of the tower.

- 5.33 At depths of between 0.25 0.5m the clearest anomalies visible in the data appear to represent the moved grave stones on the eastern side of the transept. Several other high amplitude anomalies are also present across this area, the vast majority of which probably reflect areas of rubble or other material used to level the area prior to laying the 19th century flagstones. The majority of high amplitude reflections have been detected in close proximity to the exiting church walls and almost certainly reflect foundations and rubble associated with the church walls.

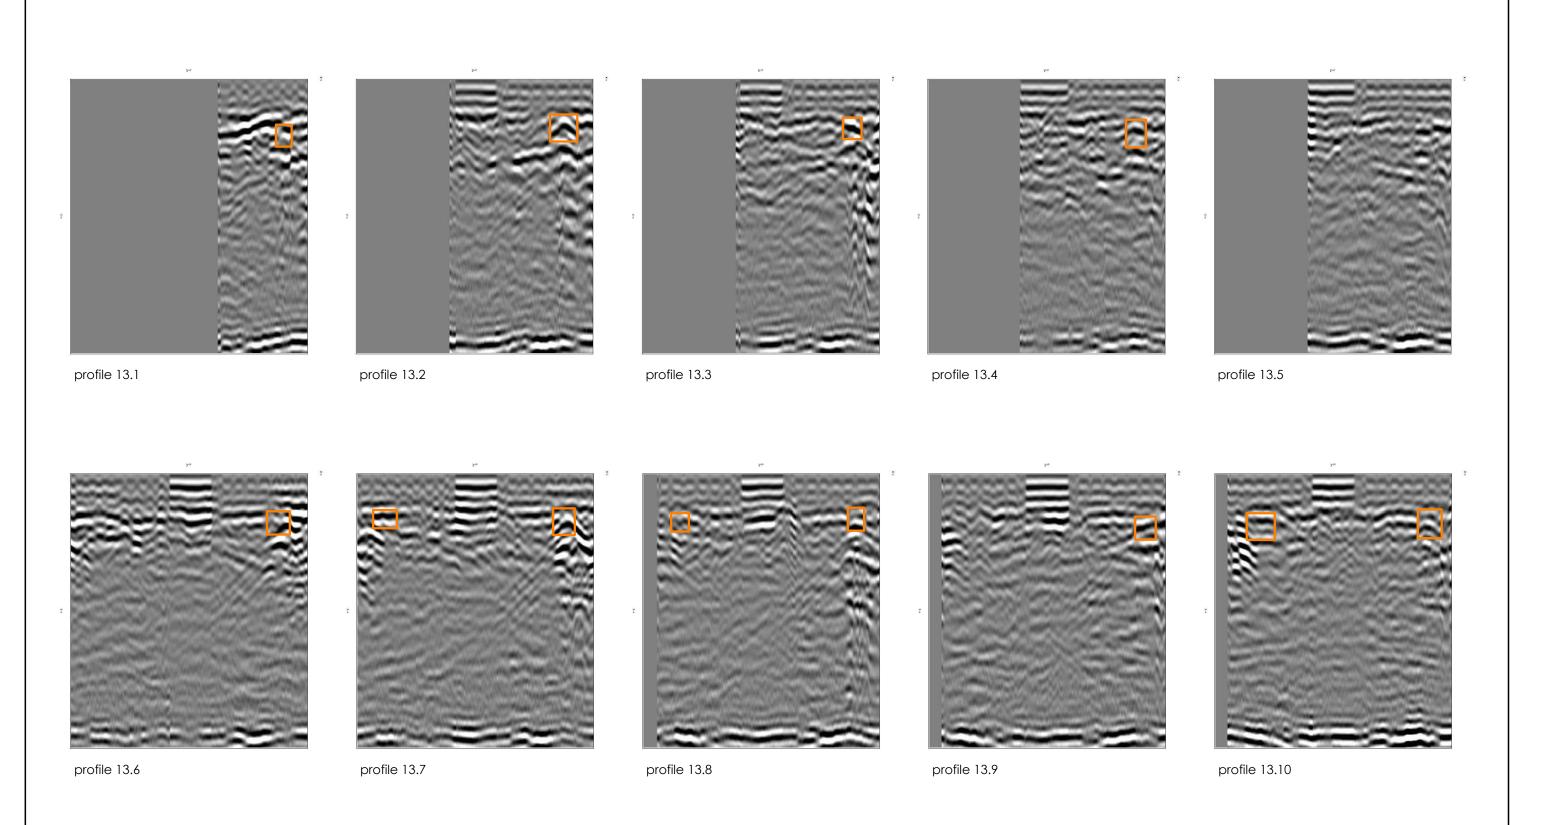
Figure 6: GPR profiles, Area 13

- 5.41 The clearest features on these profiles correspond to the change in signal attenuation between the wooden boards on which the pews sit and the carpeted aisle in the centre.

- 5.42 GPR reflections recorded across several profiles in this area may indicate a possible feature, consistent with the putative acoustic pit, along the southern side of the choir, approximately 1m north of the southern choir wall. This feature would appear to measure somewhere between 0.5m to 1m wide. There is also some evidence of a similar feature on the northern side of the choir, as would be expected from the evidence at Whalley Abbey (above, para. 3.11). These possible features have been indicated on profiles 13.1-13.10 (Figure 6) and the expected line has also been indicated on the archaeological interpretation plan. It should be noted that the evidence of these possible pits has not been detected in all of the profiles, nor has it

been identified in the GPR data for Areas 5, 6 or 8. It is probable that these possible features survive in varying states of repair after so much later work in the church.

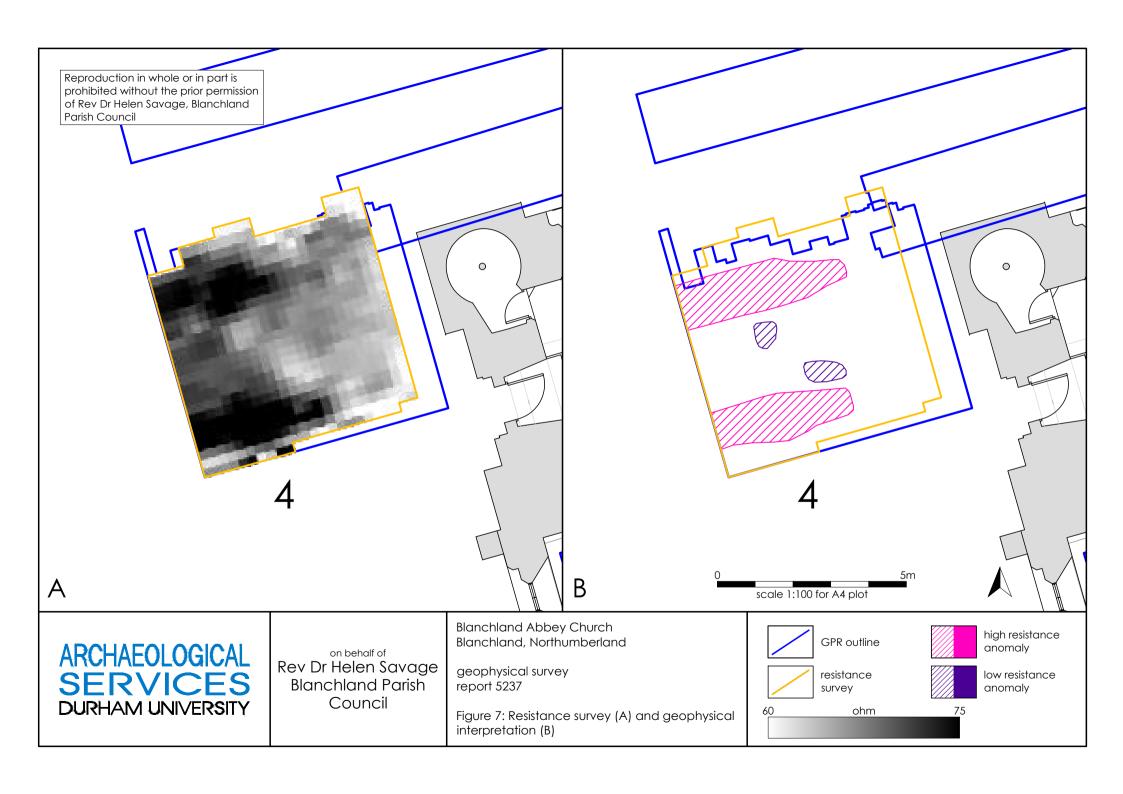
- 5.20 A colour-coded geophysical interpretation plan is provided.
- 5.21 Two types of resistance anomaly have been distinguished in the data:

high resistance regions of anomalously high resistance, which may reflect

foundations, tracks, paths and other concentrations of stone

low resistance regions of anomalously low resistance, which may be

associated with soil-filled features such as pits and ditches

- 5.31 Two parallel, high resistance anomalies have been detected in this area, broadly aligned east/west from the church's main entrance. These types of anomaly often reflect features such as wall footings and could represent the remains of walls or foundations associated with the former chapel or school room. High amplitude anomalies have been detected in the GPR data in this area which broadly correspond to these features, with reflections at depths from the very near surface to approximately 0.5m BGL. This would be consistent with stone wall footings.

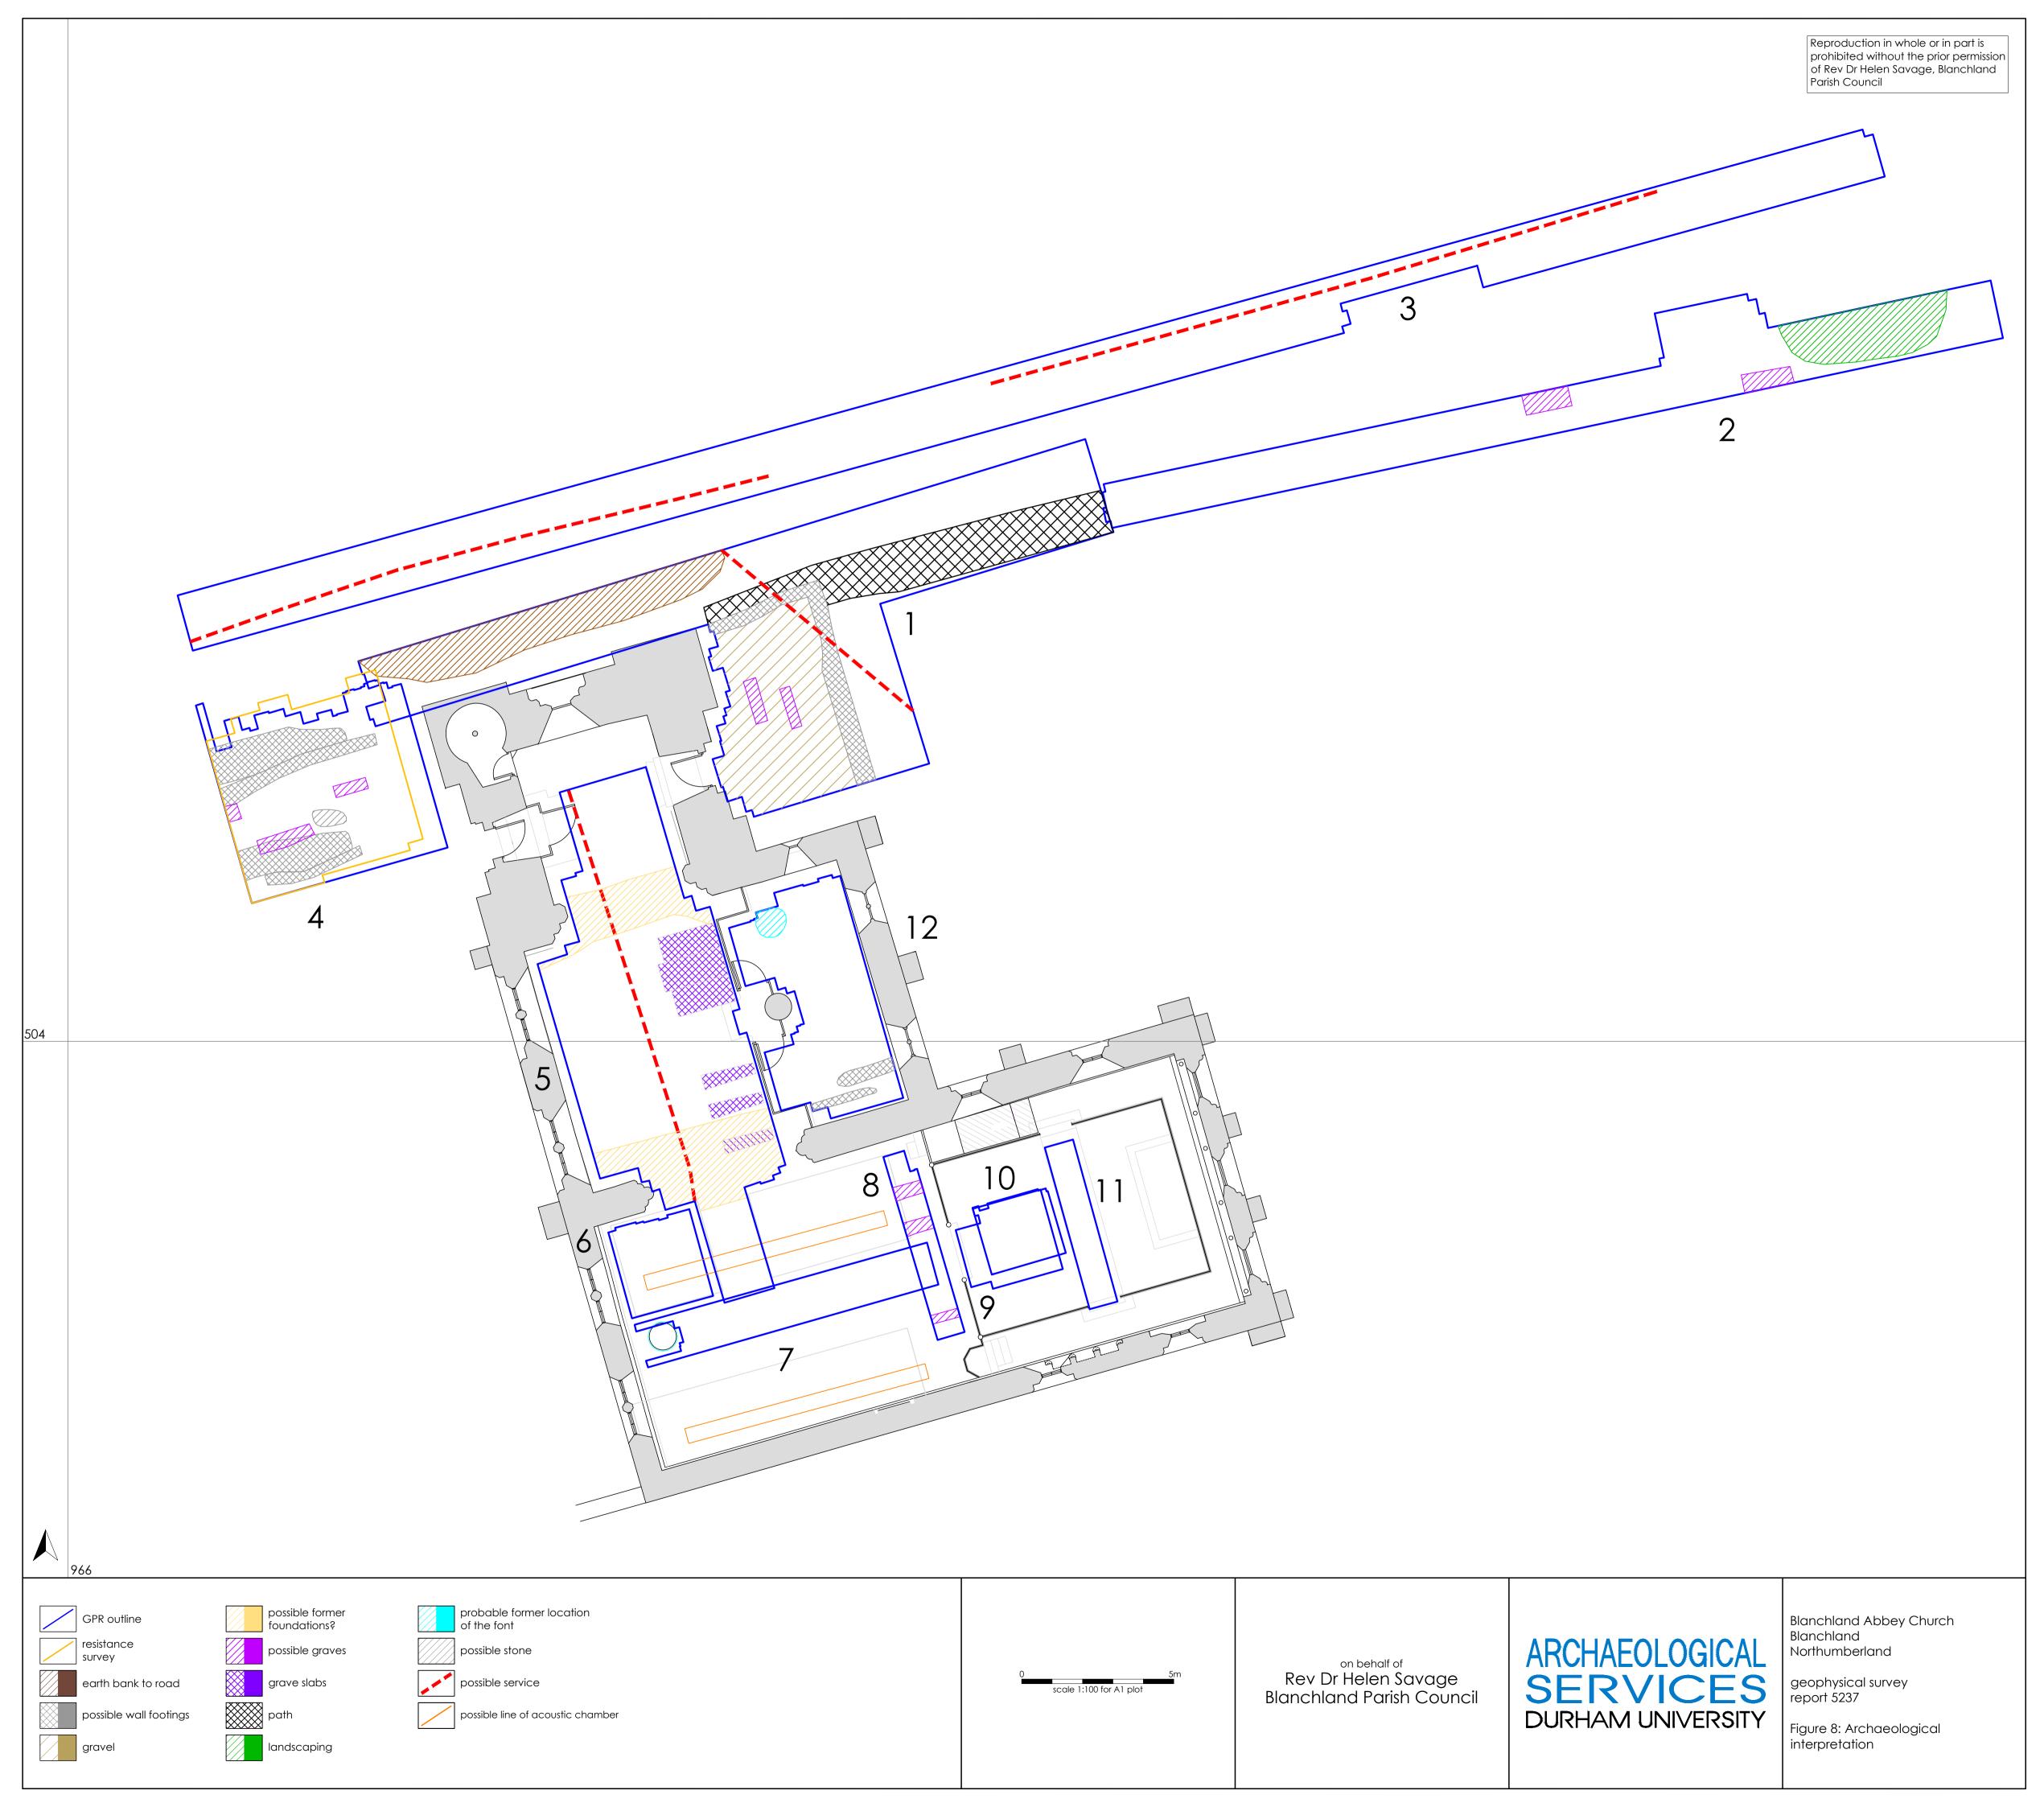
- 5.22 A colour-coded archaeological interpretation plan is provided (Figure 8), which can be used in conjunction with the depth-slice images and profiles (Figures 3-6), and the relevant digital video file for each area supplied with this report.
- 5.23 Across every area small, high frequency point reflections have been detected in the GPR data. Typically these reflect small stones, tree roots and other natural components in the soil and are not considered to be of archaeological significance.
