ARCHAEOLOGICAL  
SERVICES  
DURHAM UNIVERSITY

Finchale Priory  
Framwellgate Moor  
Durham

archaeological works

report 5272  
February 2020

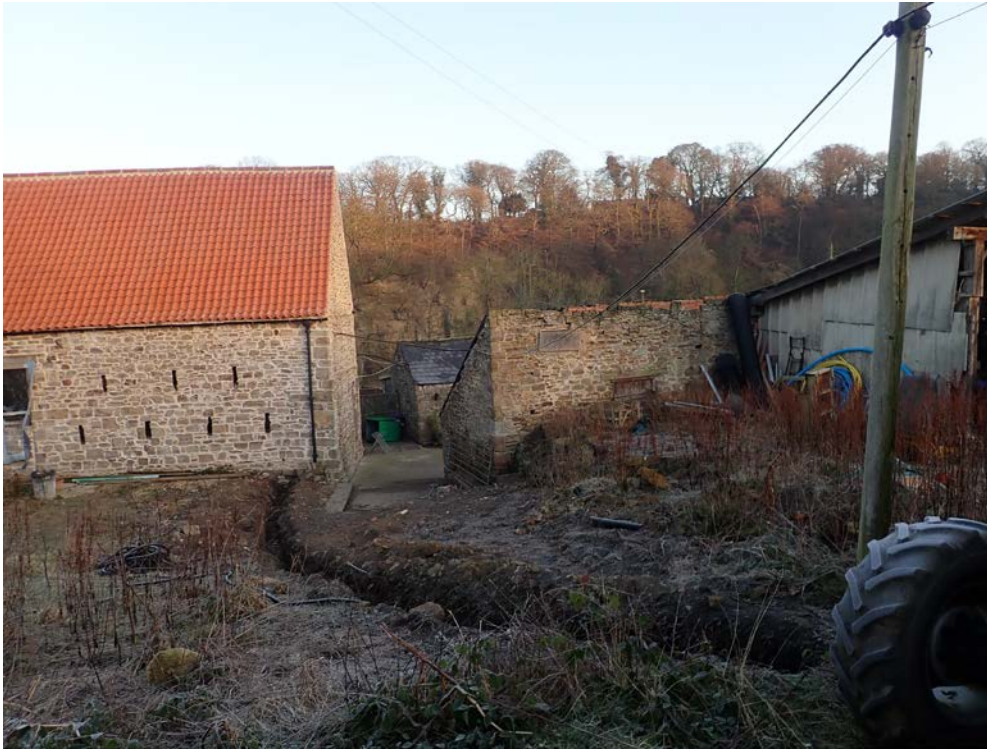
- 3.1 At the time of this investigation, the trench was in a disused area to the rear of a Grade II listed barn (Photo 1).
- 3.2 The area gently sloped upwards from the rear of the barn (c.25m OD) towards a gravel farm track to the south (c.27.2m OD).
- 3.3 The underlying bedrock geology of the area comprises Pennine Middle Coal Measures Formation sandstone, overlain by Devensian Diamicton Superficial Deposits (The British Geological Society).

Photograph 1: Location of trench, looking north

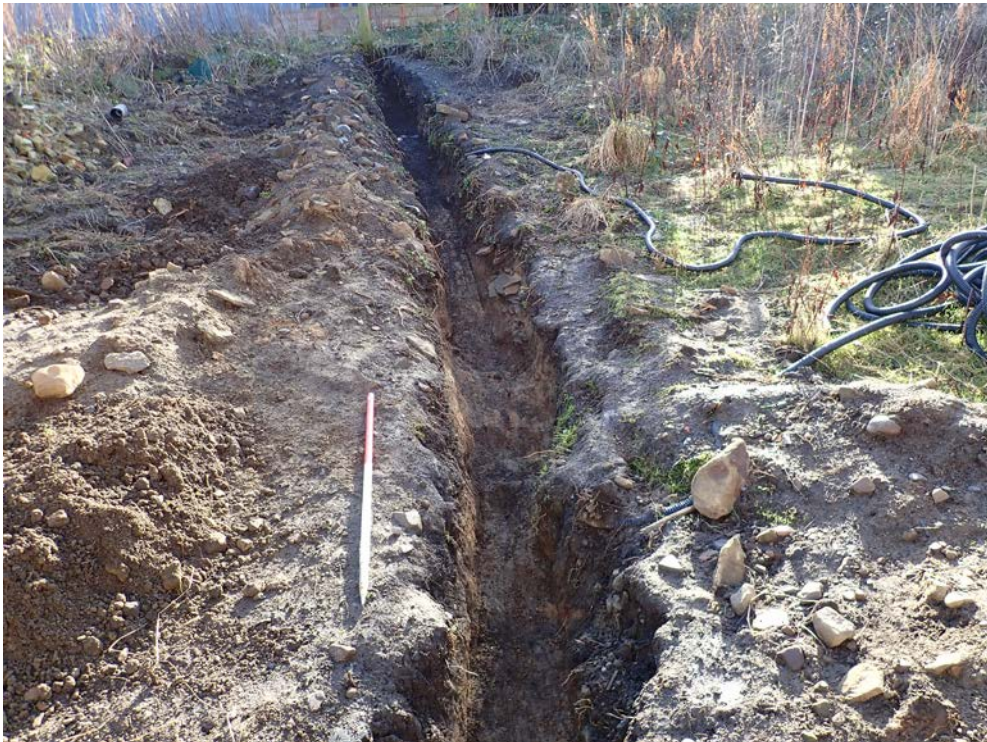
- 5.2 The trench was 17m long, between 0.4 and 0.6m wide and 0.5-0.6m deep. It was aligned north/south, starting from the south-east corner of the barn and curving uphill to the south-east (photos 1 & 2). Natural subsoil, a yellow-brown sand with stone inclusions [3], was identified at a depth of 0.1m below ground level (24.57m OD) in the central and northern sections of the trench (Photo 3). Some redeposited natural with rubble was present in the centre of the trench beneath the topsoil [2: up to 0.3m deep]. Natural subsoil was not identified at the south end of the trench as a modern cut for a north/south plastic sewer pipe was present to a depth of below 0.6m below ground level (Photo 4). Immediately above this and extending across the whole trench was a dark grey sandy-silt topsoil mixed with rubble and

Photograph 2: Trench, looking south-east

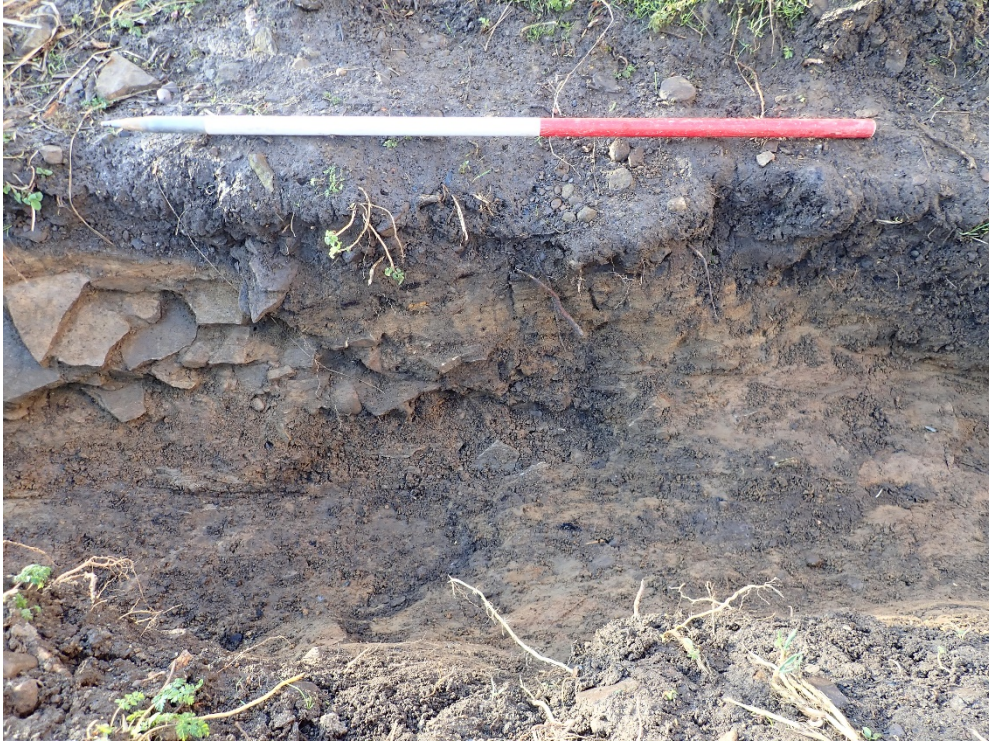
stone [1: 0.1m to over 0.6m deep]. No archaeological features or deposits were identified in the trench.

Photograph 3: Trench section, centre, looking west

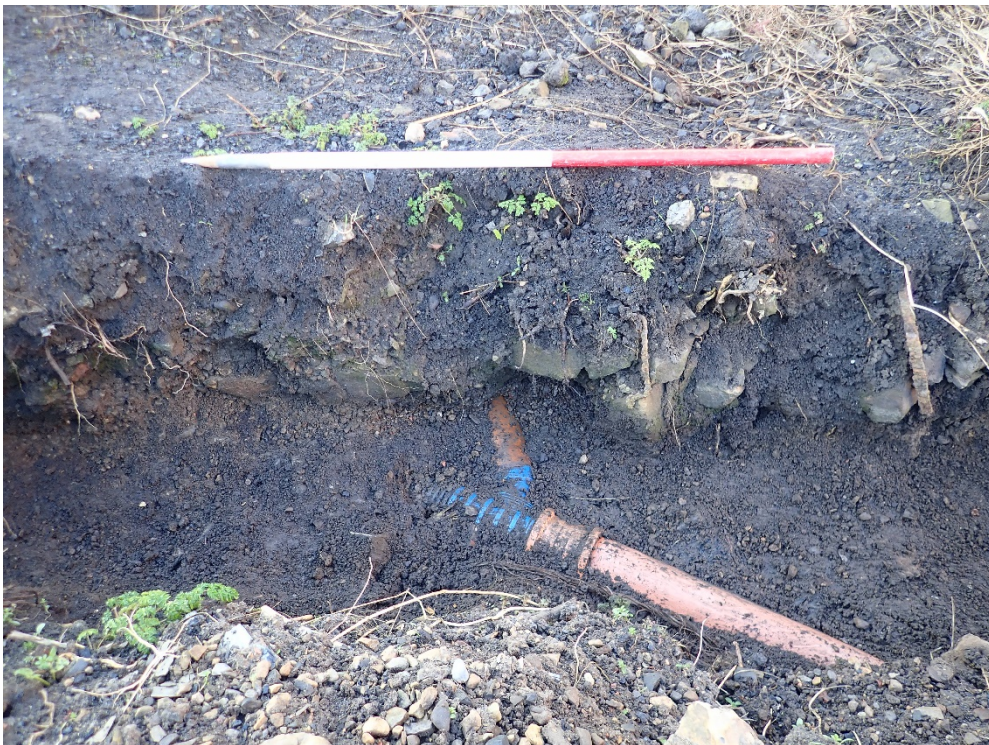
Photograph 4: Trench section, south end, looking west

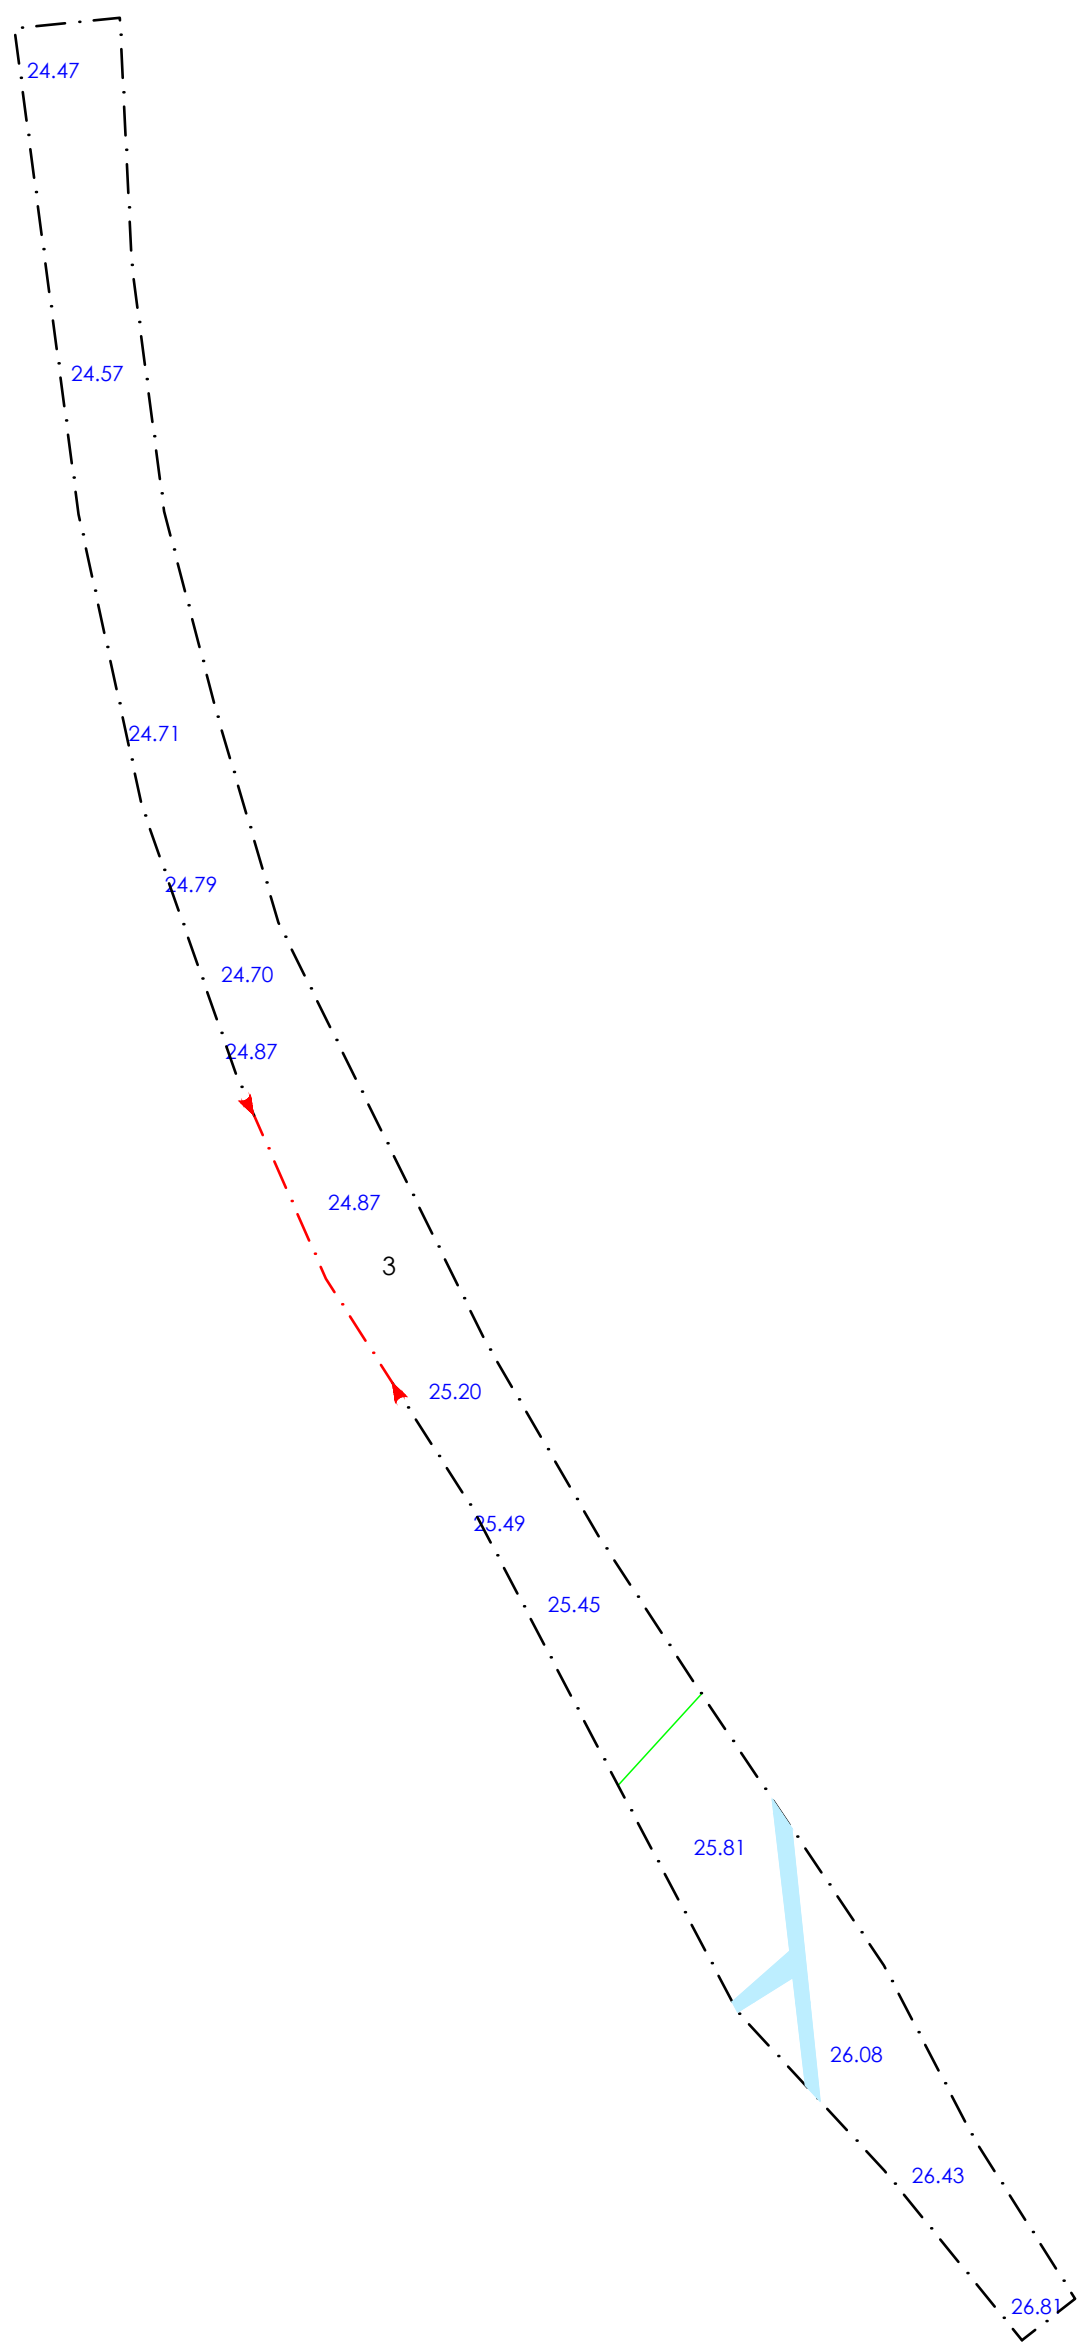
Figure 3: Trench plan and section

- 5.1 The works comprised the cleaning back and recording of a trench which had been excavated for an electric cable. The excavation had been conducted using a machine fitted with a small toothed bucket and without the presence of an archaeologist. The trench plan and sample section are shown in Figure 3. Context data is summarised in Table 1.1.
