16-18 The Front
Middleton One Row
Darlington

archaeological watching brief

report 5610
September 2021

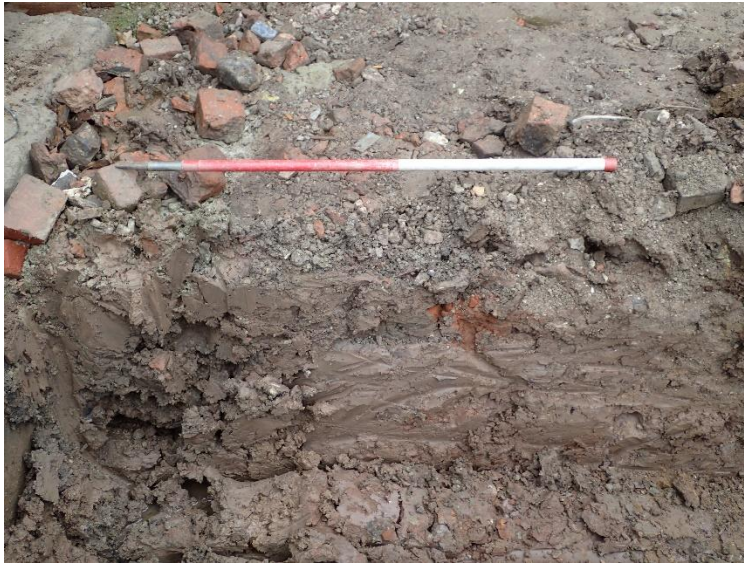
Photograph 1: Trench 1
section, looking east

- 5.2 This trench was 10.4m long (east-west) and extended 3m from the north face of the building. The trench was 0.85m wide, and was excavated to a maximum depth of 0.7m. Natural subsoil, a pinkish boulder clay [2] was encountered at a depth of 0.1m. It was overlain by a deposit of dark grey silty-clay with inclusions of modern building detritus [1: 0.1m thick]. No features of archaeological significance were identified and no artefacts recovered.

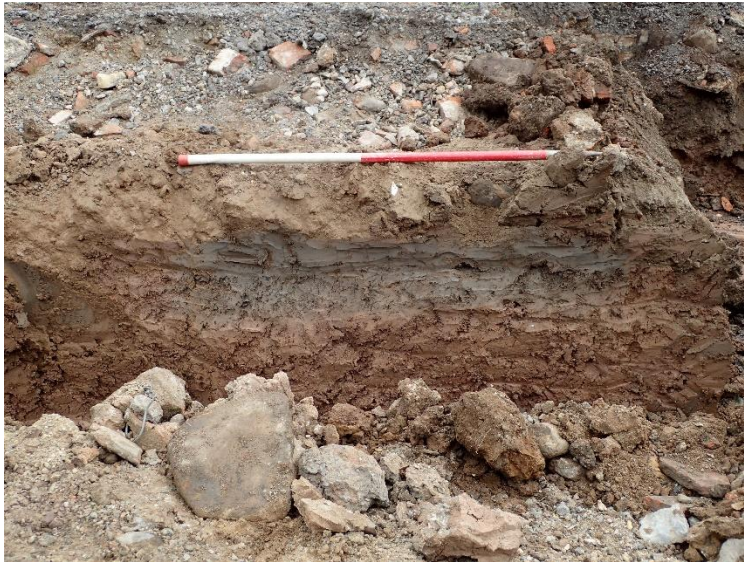
Photograph 2: Trench 2
section, looking north

- 5.3 This trench was 10.4m long (east-west) and extended 5m from the north face of the boundary wall. The trench was 0.85m wide, and was excavated to a maximum depth of 0.9m. Natural subsoil, a pinkish boulder clay [2], was encountered at a depth of 0.4m. To the west the natural subsoil was overlain by an intermittent layer of grey silty-clay [4: 0.2m thick], possibly a buried soil horizon. To the east the natural subsoil was overlain by a deposit of dark grey silty-clay with inclusions of modern building detritus [3: 0.4m thick]. Both deposits were overlain by a sand aggregate [5: 0.2m thick] which formed part of the car park to the rear of the property. No features of archaeological significance were identified and no artefacts recovered.
