ARCHAEOLOGICAL
SERVICES
DURHAM UNIVERSITY

Town Farm Cottage
Corbridge
Northumberland

archaeological watching brief

report 5926
March 2023

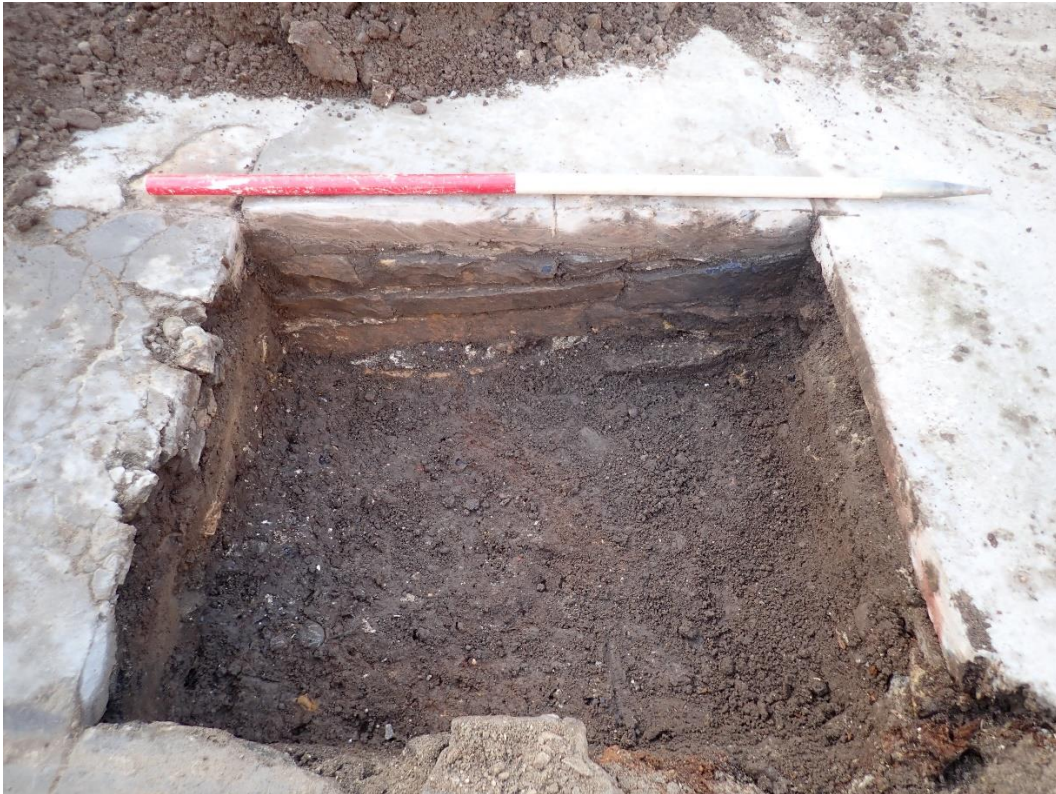
- 5.3 This test pit was located at the intersection of the wall of the existing building and an internal dividing wall (Photo 1). It was excavated to investigate the need to underpin the wall of the building and measured up to 0.64m long by 0.52m wide, and between 0.36m and 0.64m deep.

- 5.4 Along the south edge of the test pit was a sandstone foundation [F5: over 0.64m deep] constructed from roughly hewn regular coursed sandstone blocks measuring up to 0.24m long by 0.17m wide and 0.13m thick. It was directly below the internal division wall and is therefore probably a foundation for this wall. It was keyed into the east wall of the building indicating that they are contemporary.

Photo 1: Test pit 1, F5, looking south

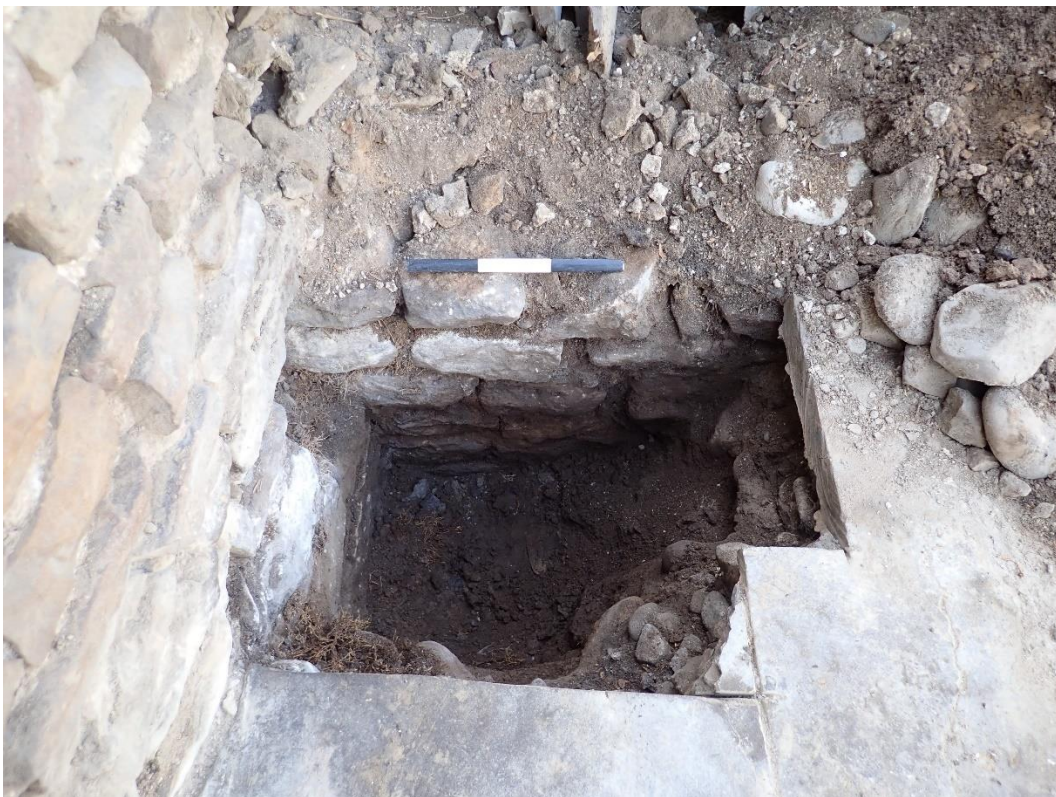
- 5.6 This test pit was located 2.5m west of Test pit 1 and was excavated to assess the suitability of the ground for a raft foundation. It was 0.79m long by 0.66m wide, and up to 0.3m deep (Photo 2).
- 5.7 A sandstone foundation [F5: over 0.23m thick] was identified along the south edge of this test pit constructed from uneven coursed sandstone blocks measuring up to 0.48m long and 0.07m thick.
- 5.8 Build up against this and across the base of the test pit was a firm dark brown sandy clay [4: over 0.07m deep] containing occasional small, rounded stones, under a dark yellow-brown sand [3: 0.14m deep]. Capping the trench was the concrete floor of the outbuilding [F1: 0.06m thick]. No artefacts were recovered.

Photo 2: Test pit 2, F5, looking south

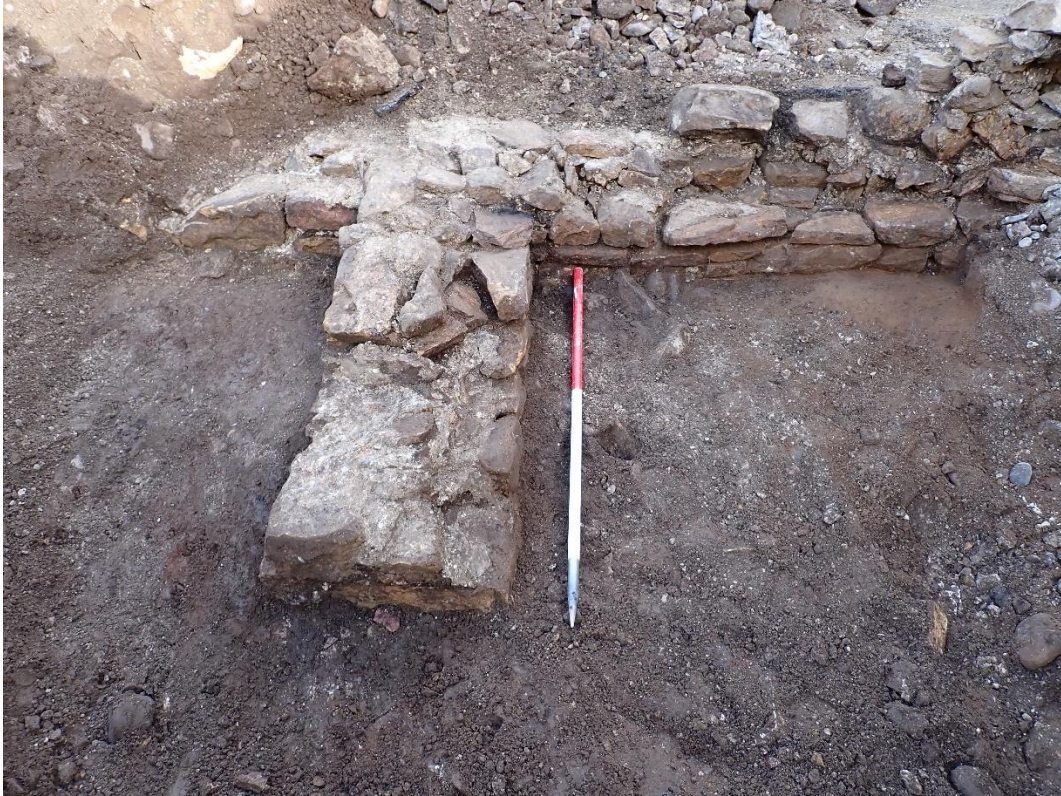
- 5.12 The sandstone wall along the north edge of the trench, aligned east/west, had been partially demolished [F27: 3.7m long, 0.48m wide, 2.5m high]. Aligned north/south and butting this wall was the remains of a sandstone foundation [F28: 1.15m long, 0.5m wide, 0.26m high, Photo 3].

Photo 3: Wall F28, looking north

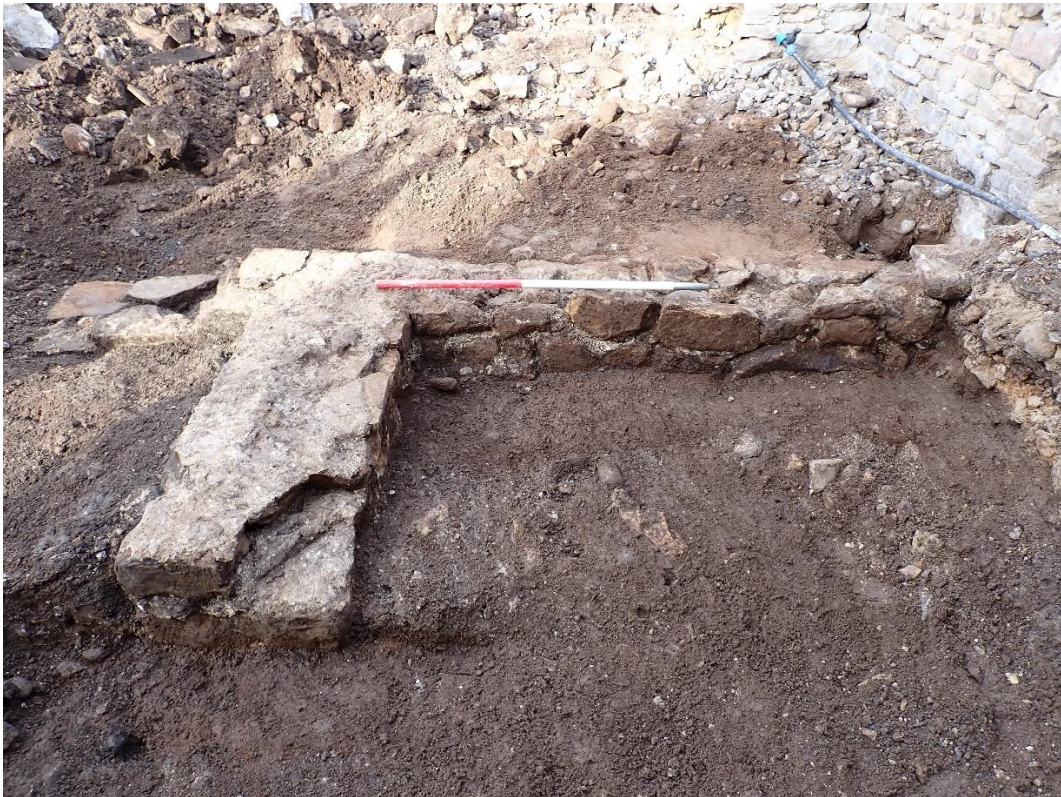
- 5.13 To the south another sandstone foundation [F5: 3.7m long, 0.45m wide, 0.6m high] was recorded aligned east/west and keyed into the extant building wall to the east, this was the foundation identified in the test pits (Photo 4). A second wall foundation extended south from and was tied into F5 [F20: 1.05m long, 0.5m wide, 0.25m high]. Both walls were sat within a vertical sided construction cut [F24] that cut the earlier deposits. The area between the cut and the wall had been backfilled with a red-brown gritty sandy clay [23].

Photo 4: Walls F5 and F20, looking north

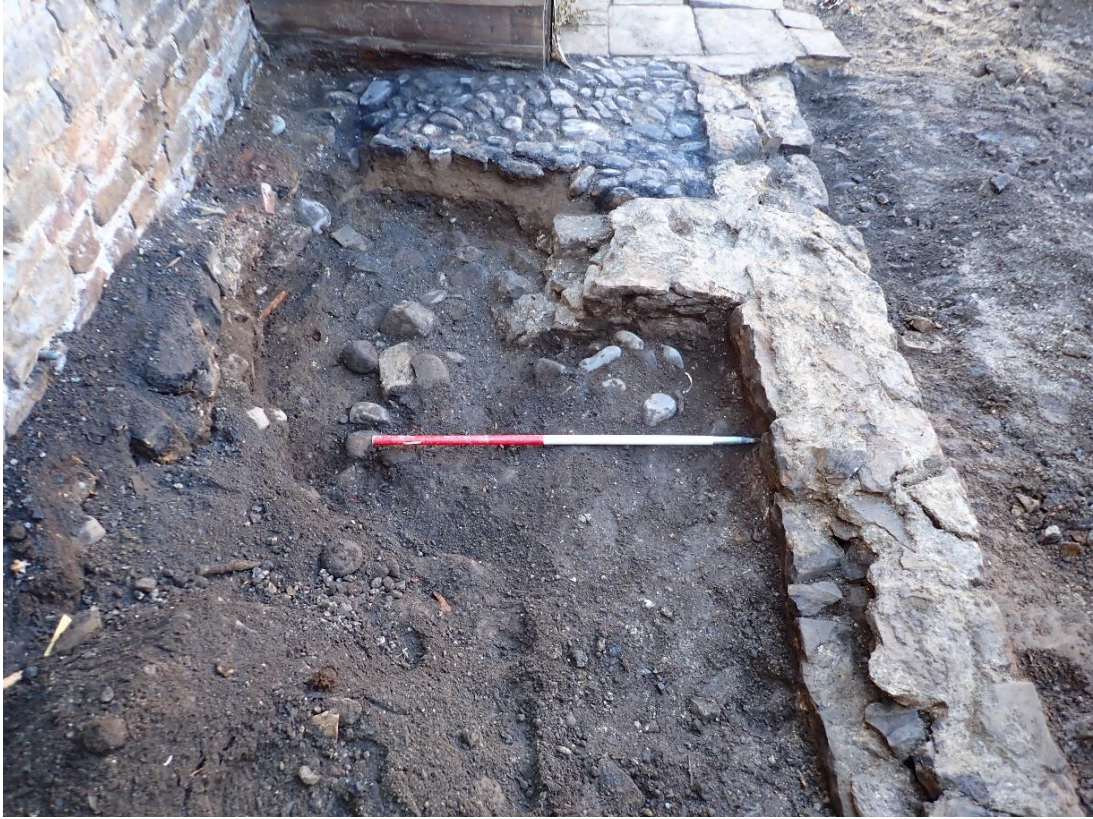
- 5.14 Further south the same alignment of walls was repeated forming a third cell. Wall F6 [3.7m long, 0.45m wide, 0.18m high] extended east/west from the extant building, with wall F7 [0.8m long, 0.5m wide, 0.2m high] extending south from F6 (Photo 5). These walls were also sat within a vertical sided construction cut [F22] that had been backfilled with a dark yellow-brown gritty sand [21].

Photo 5: Wall F6 and F7, cobbles F8 and paving F9, looking west

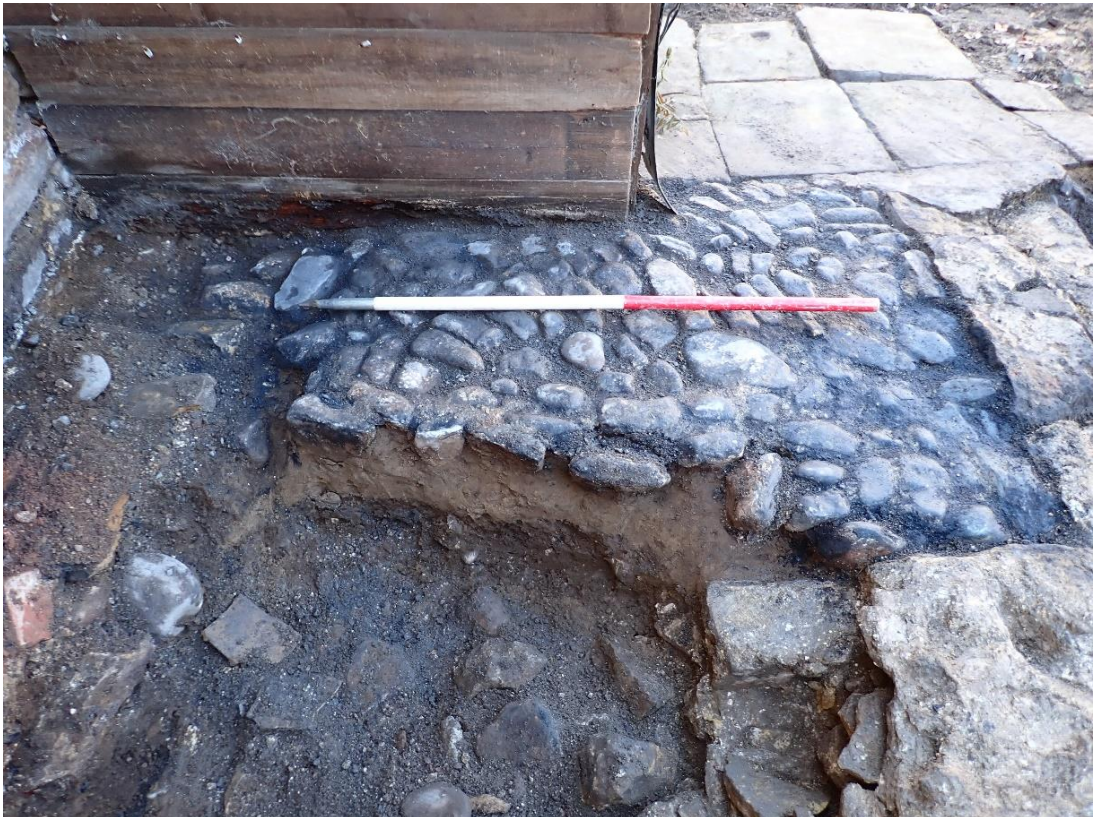
- 5.15 South of wall F6 overlying layer [29] was layer of yellow-brown sand [16] deposited as a ground levelling deposit.
- 5.16 Overlying layer 26 and butting up against walls F6 and F7 was the remains of a cobble surface [F8: 1.4m long, 1.3m wide, 0.07m deep, Photo 6] set into a layer of yellow-brown sandy clay [16: 0.11m deep].

Photo 6: Cobble floor F8, looking west

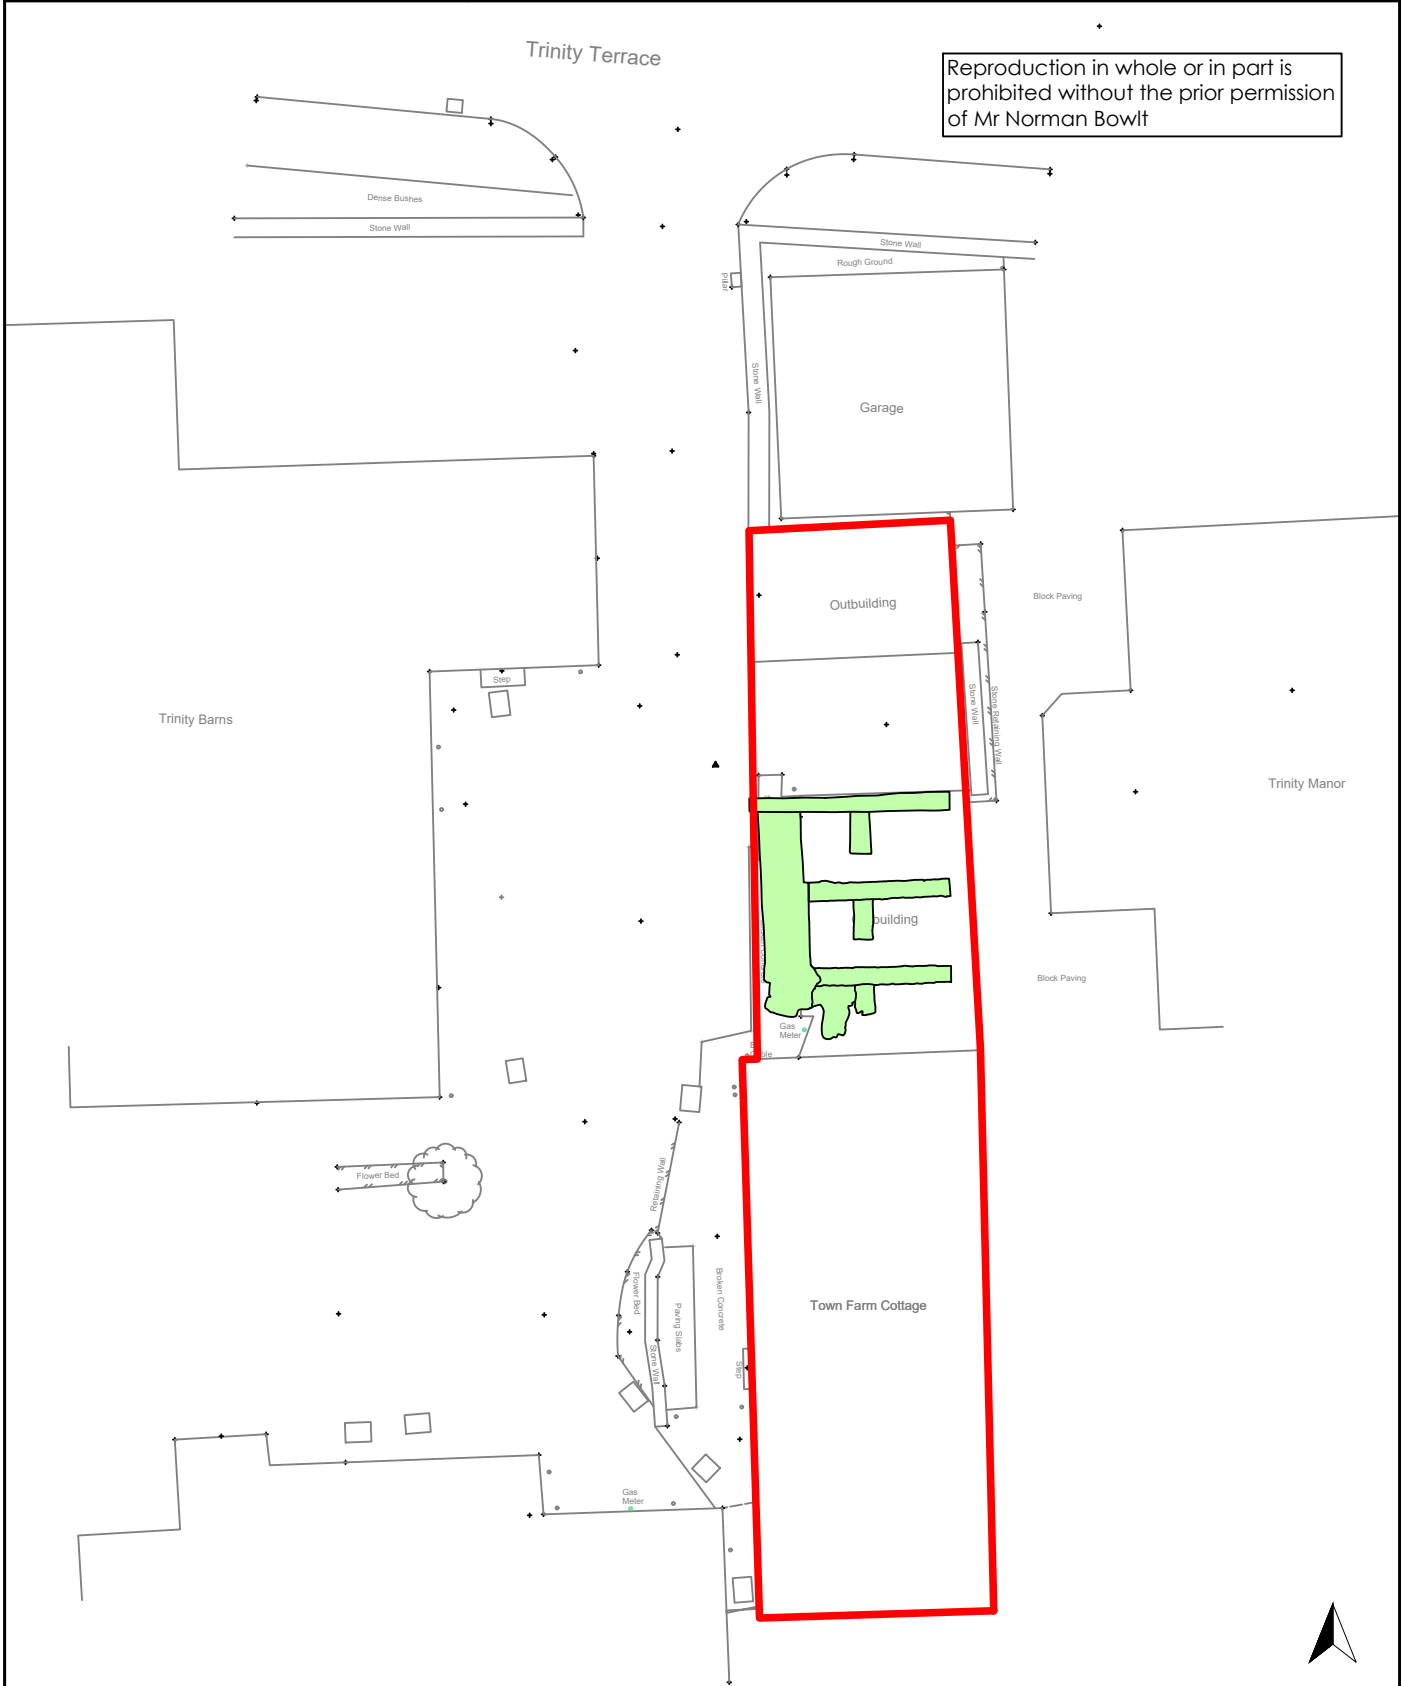
Figure 2: Location of watching brief

- 5.11 The north and east sides of the trench were bounded by existing sandstone walls from an outbuilding that had recently been partly demolished. The south side of the trench was bounded by the north wall of Town Farm Cottage. Within the trench a series of sandstone wall foundations were recorded (Figure 2) that divided the area up into three small cells aligned east/west measuring 3.7m long by 1.8m wide. The cells were further partially subdivided by short walls aligned north/south measuring up to 1.5m long. This cell arrangement is too small for horse stables and is more likely to reflect the remains of pigsties or other animal housing.

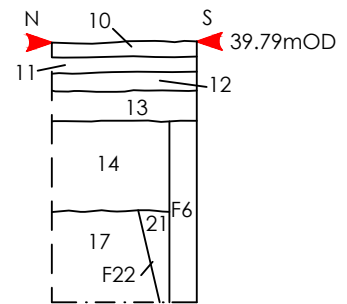
Figure 3: Photogrammetric plans and section

- 5.1 Demolition of the existing building had taken place prior to the watching brief. In line with the WSI, stone from the building was examined to check for evidence of reused Roman material; no reused material was identified.
- 5.2 Two test pits were excavated, followed by an area of ground reduction (Figures 2 and 3). The test pits were excavated by hand, and the ground reduction was conducted using a machine equipped with a toothless ditching bucket. All excavations were carried out under constant archaeological supervision. Trench plans and section are shown on Figure 3. Context data is summarised in Table 1.1.
