Berrymead Farm air raid shelter
Harrowgate Hill
Darlington

archaeological building recording

report 6003
October 2023

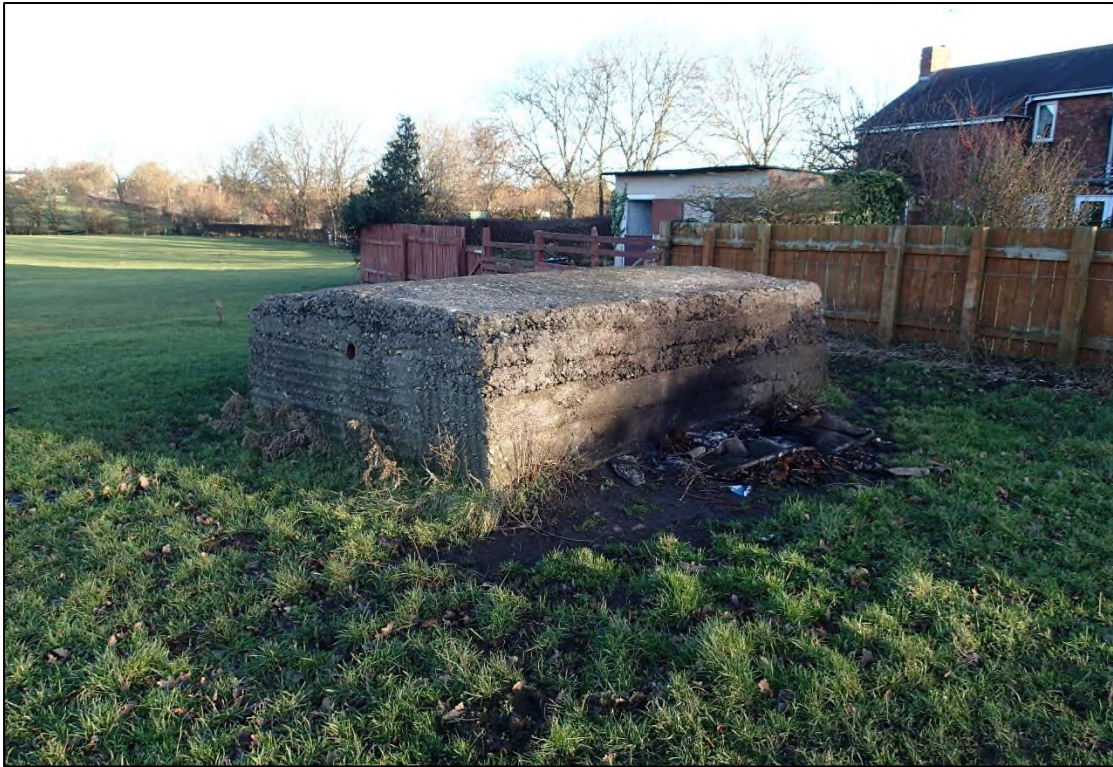
Photograph 1: The air raid shelter before the start of development work, with one of the two smallholding houses in the background. Photo taken by Catrin Jenkins in 2015

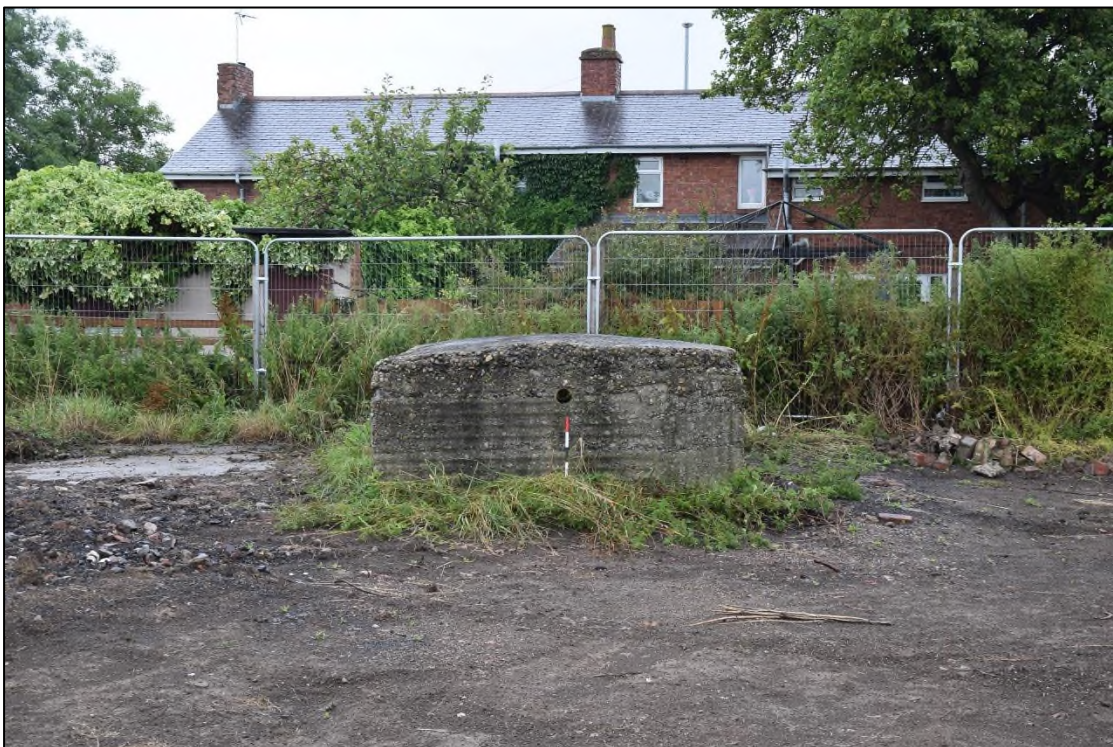
Photograph 2: The shelter and the houses, seen from the west. Note the ventilation pipe and the marks of corrugated iron shuttering in the concrete. The scale is 0.5m long

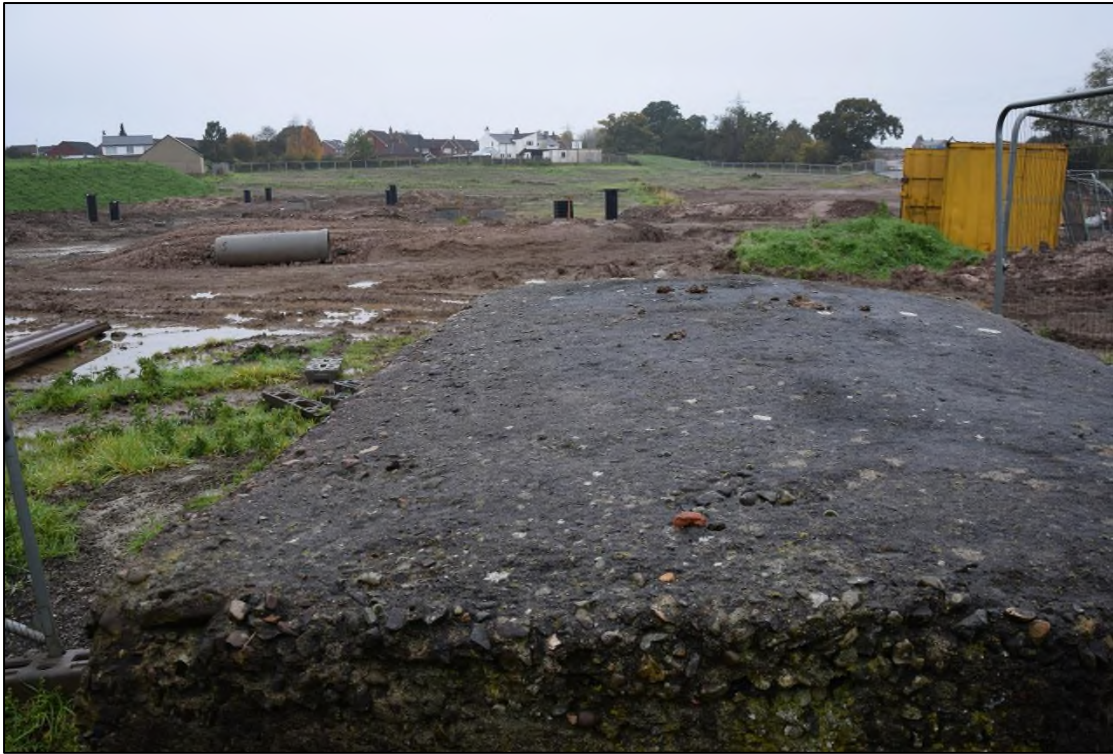
Photograph 3: A view looking west across the roof of the shelter. The white building in the distance is another pair of semi-detached smallholding houses

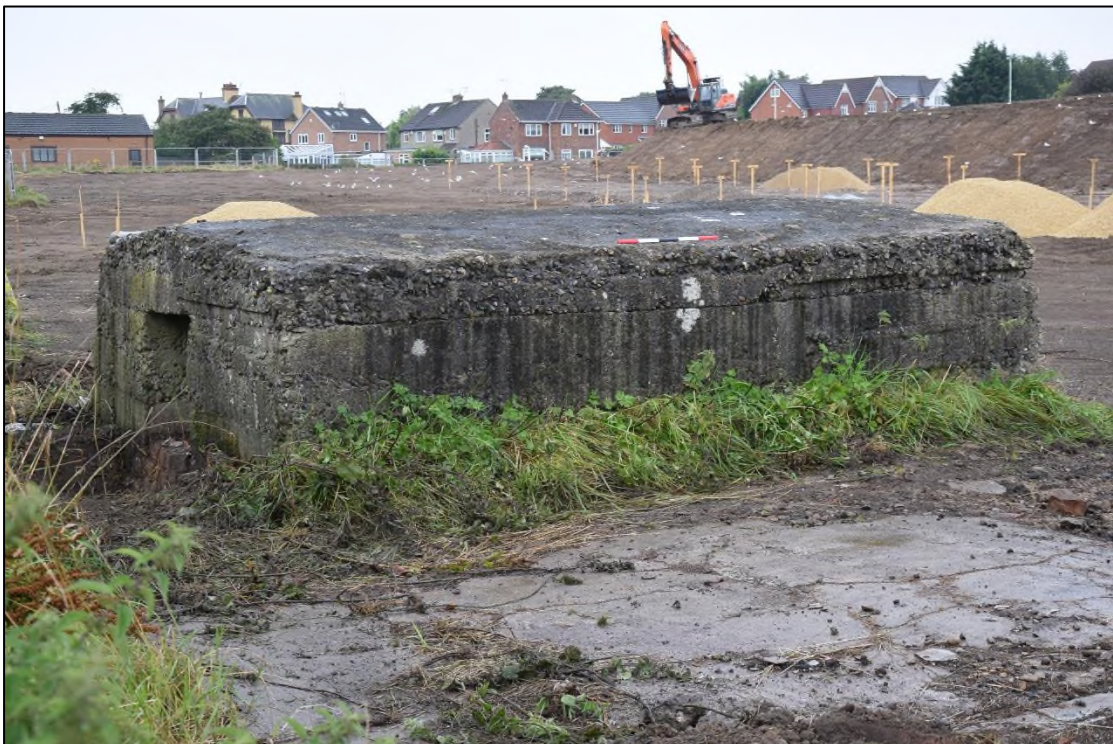
Photograph 4: The north and east faces of the structure, with the door at the left. The concrete in the foreground is the floor of a demolished shed

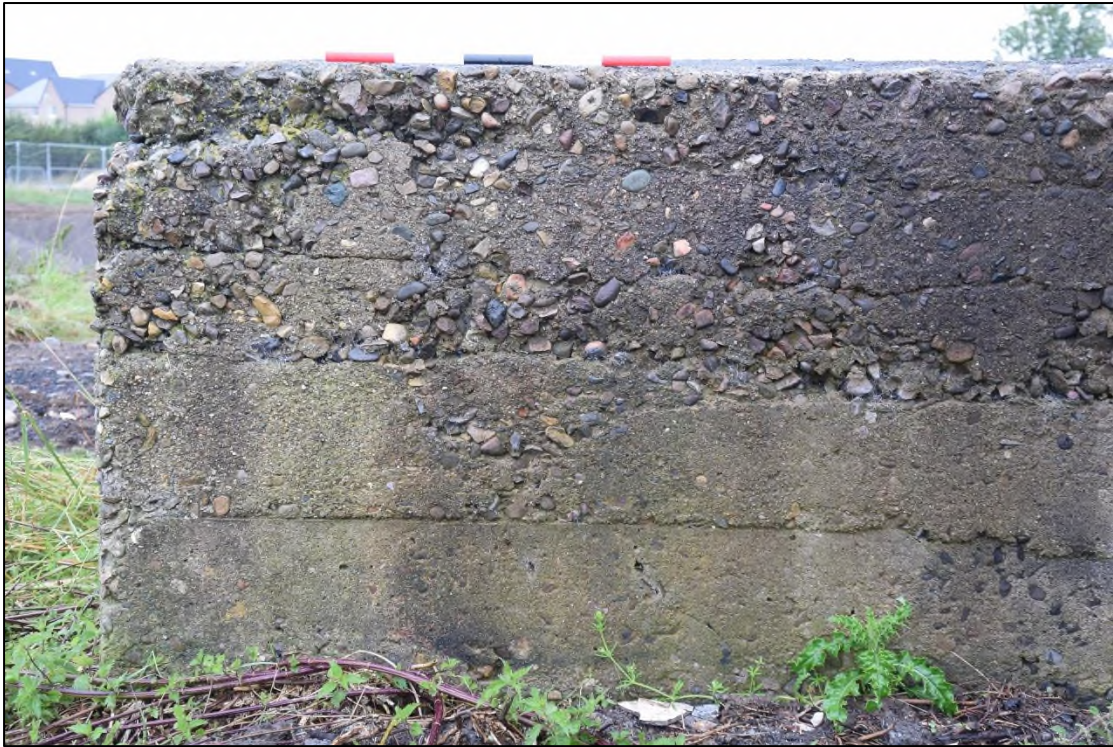
- 5.3 The walls and roof are made of mass concrete without any sign of reinforcement. The material contains a good deal of large aggregate, and the marks of the shuttering that was used to form the walls when the concrete was poured in can be seen on all sides (Photograph 5). In places this was timber, but on the west and south sides, and inside the door, it was corrugated iron sheets (Photograph 6). These materials were often used for this sort of wartime structure: very similar marks can be seen on the wall around a Home Guard spigot mortar post recorded recently at Wolsingham, Co Durham (Photograph 7: Archaeological Services 2021).

Photograph 5: Detail of the south-west corner, showing irregular shuttering marks and the coarse, poorly-sorted aggregate in the concrete

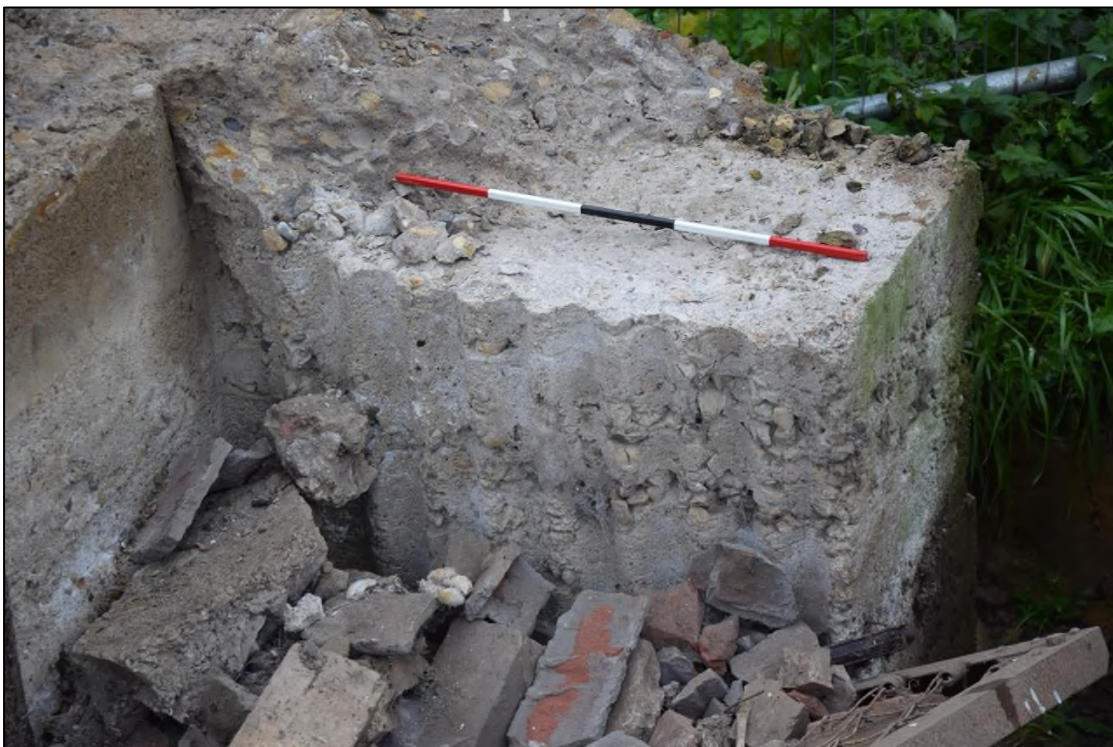
Photograph 6: The marks of corrugated iron sheet shuttering just inside the door of the shelter

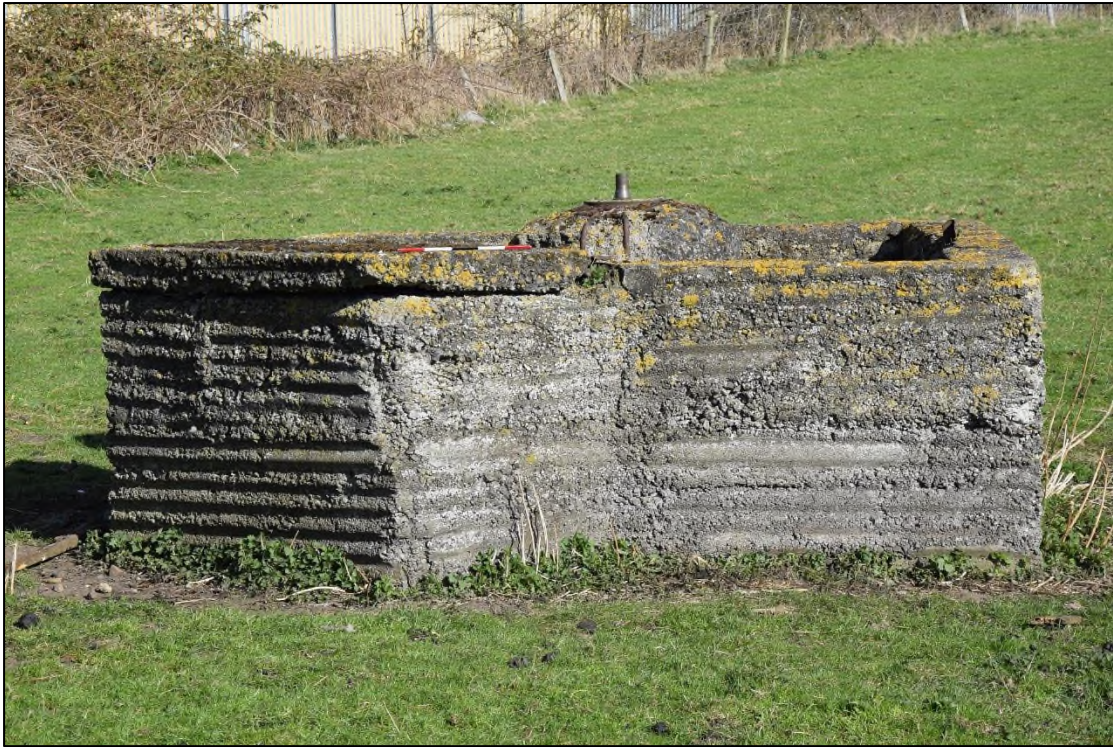
Photograph 7: Similar construction evidence can be seen in this contemporary structure, a Home Guard spigot mortar emplacement at Wolsingham, Co Durham

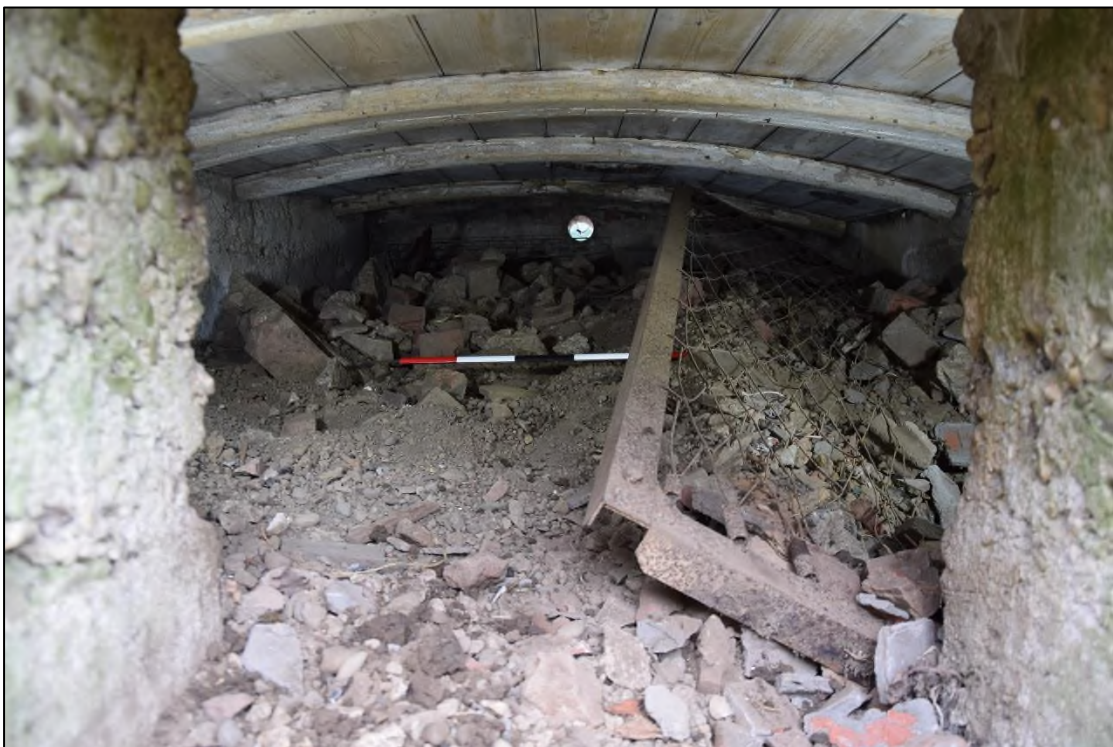
- 5.4 The shelter's door is 1.22m (four feet) high and 0.58m wide; the walls are 0.42m thick. The roof, which is slightly curved, is 0.25m thick. It is in this shape because the concrete was poured onto a timber roof taken from a railway wagon (Photograph 8). This wooden structure has transverse ribs, two of them sandwiching vertical boards from a partition. Three holes in the plank roof would have accommodated vents or flues (Photograph 9); these, together with the evidence of an internal wall, show that the roof was originally part of a brake or guard's van. The roof was cut down to fit the shelter and the ribs all stop short of the walls. The inner faces on all sides show the marks of shuttering; when the roof was removed, no trace of reinforcement was seen in the concrete (Photographs 10, 11). The timber of the roof was surrounded by a course of unfrogged bricks. The vents in the guard's van roof had been covered with wood and sealed with putty before the whole roof was covered with roofing felt or some other waterproof membrane (Photographs 12, 13). In the shelter's entrance, traces of a wooden door frame were seen when the door was unblocked (Photographs 14-16). There was no sign of fixings in the

Photograph 8: A view looking into the shelter after the upper part of the door was cleared. The wooden railway van roof that supports the concrete is set slightly askew

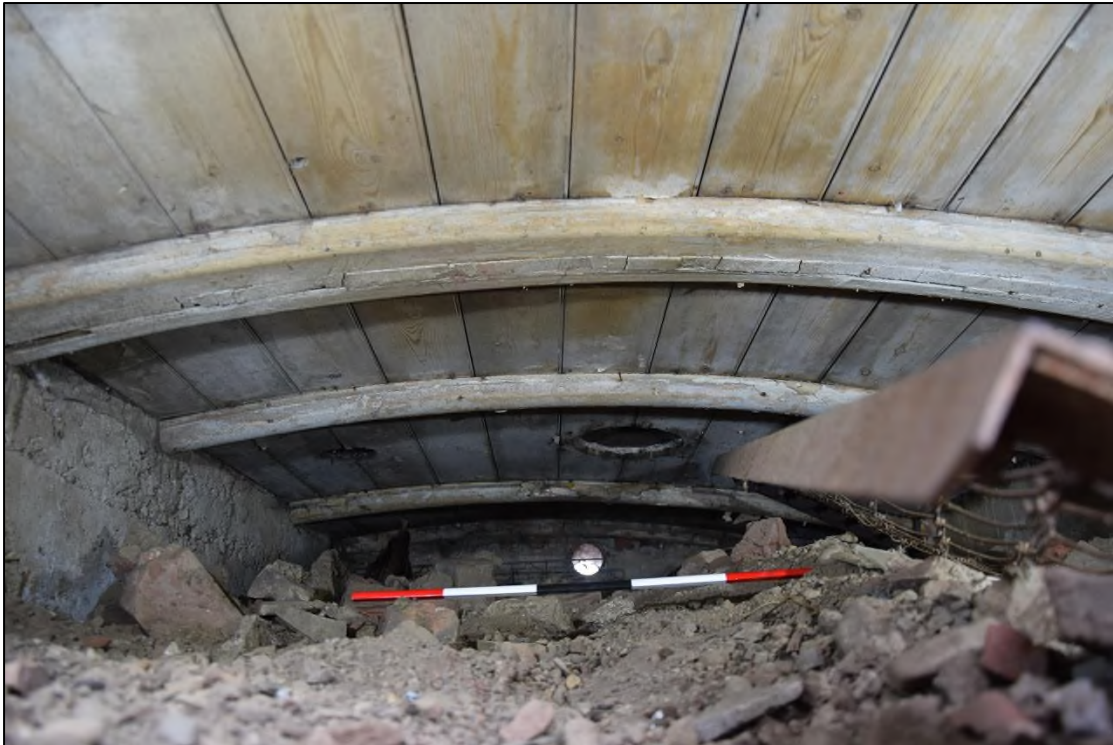
Photograph 9: Detail of the ribs and planking of the roof. Note the vertical boards sandwiched between two ribs, and two of the three flue holes in the timber further back

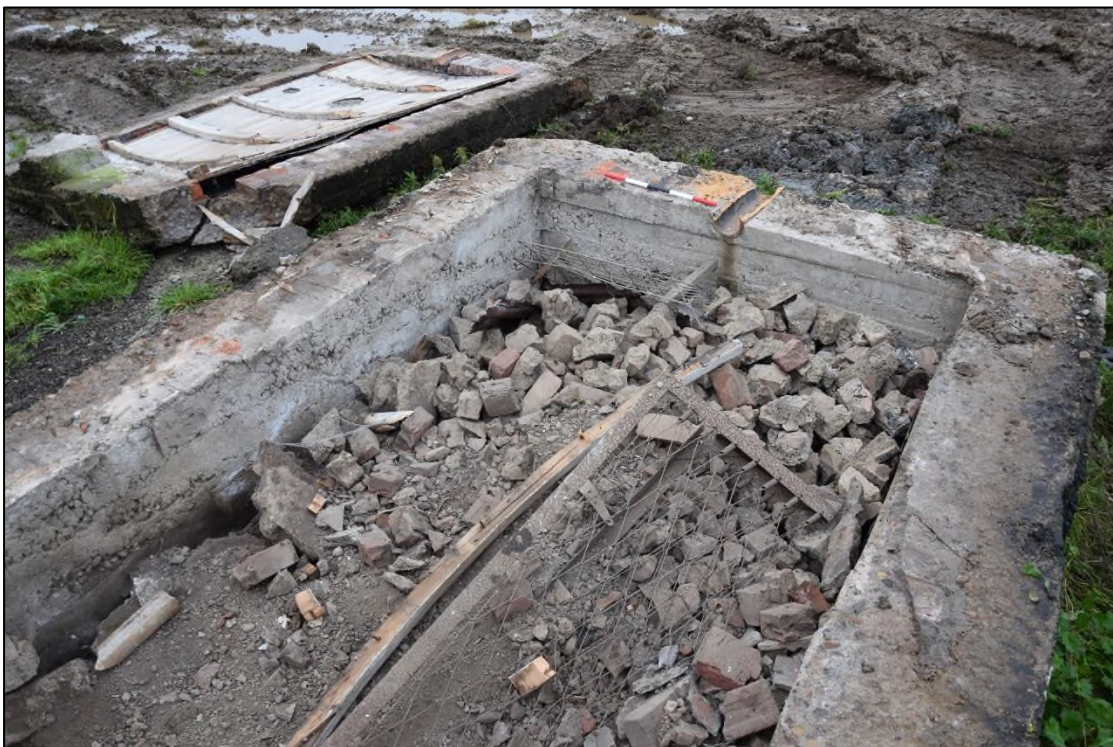
Photograph 10: The interior of the shelter, with the roof lying on the ground beyond it. Timber shuttering marks and coarse, unsorted aggregate can be seen on the inside faces of the walls

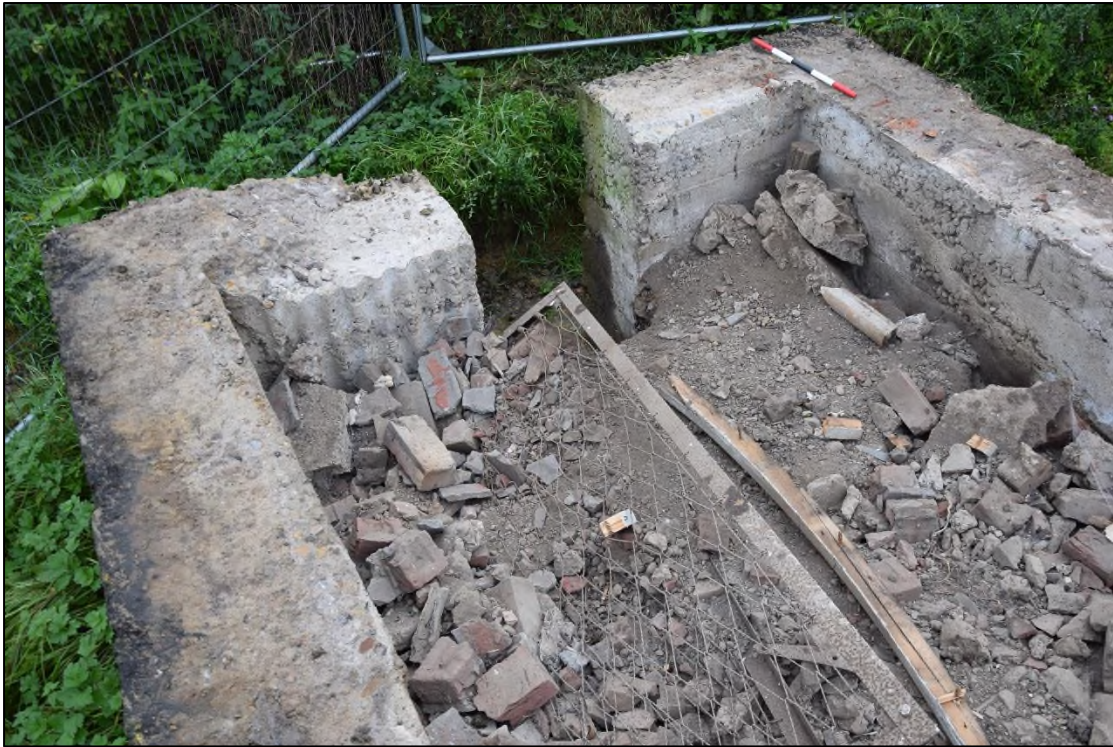
Photograph 11: The east end and the door after removal of the roof. The absence of any reinforcement is obvious here and in the previous picture

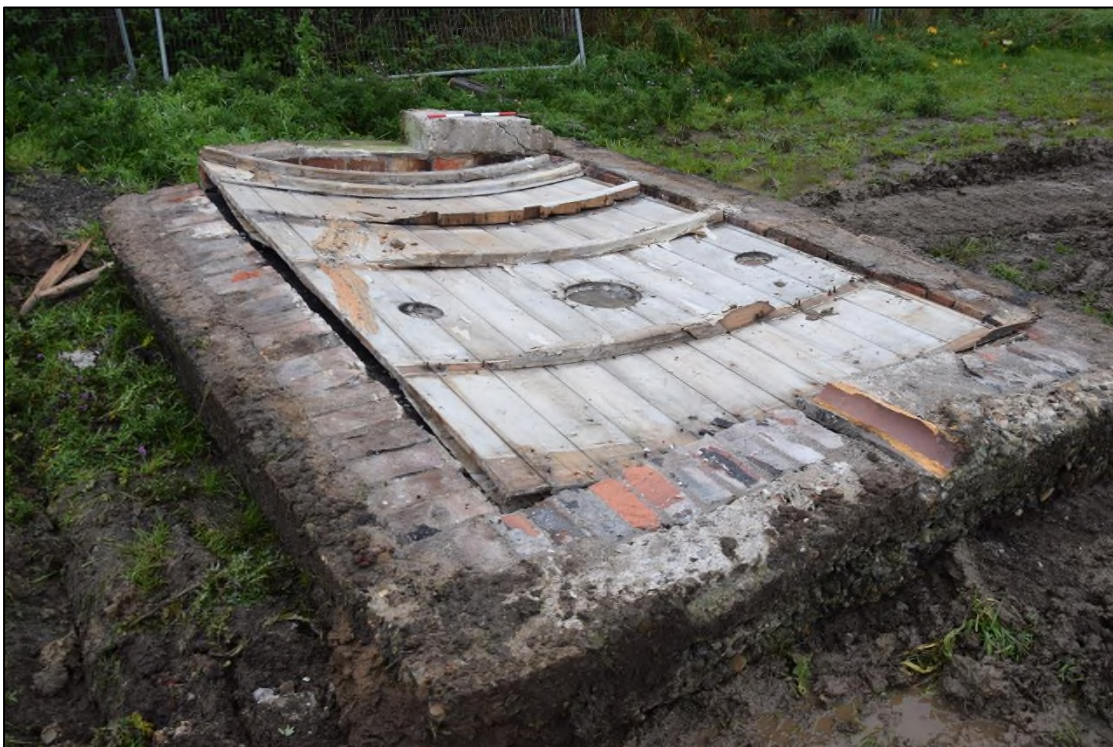
Photograph 12: The upturned roof of the shelter. A row of bricks runs around the inside of the concrete slab, which has broken away from the curved timber base along the left-hand side

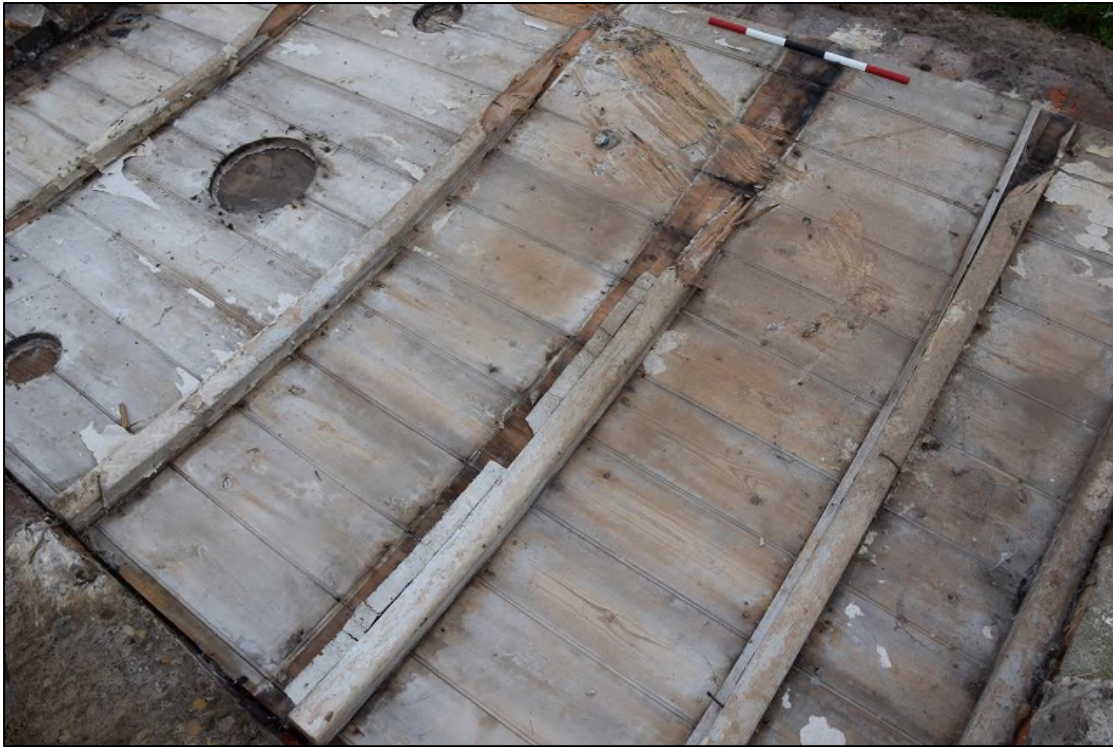
Photograph 13: Detail of the ribs and chimney or vent holes in the former guard's van roof. The thick rib at the centre incorporates the thick boards of the former partition

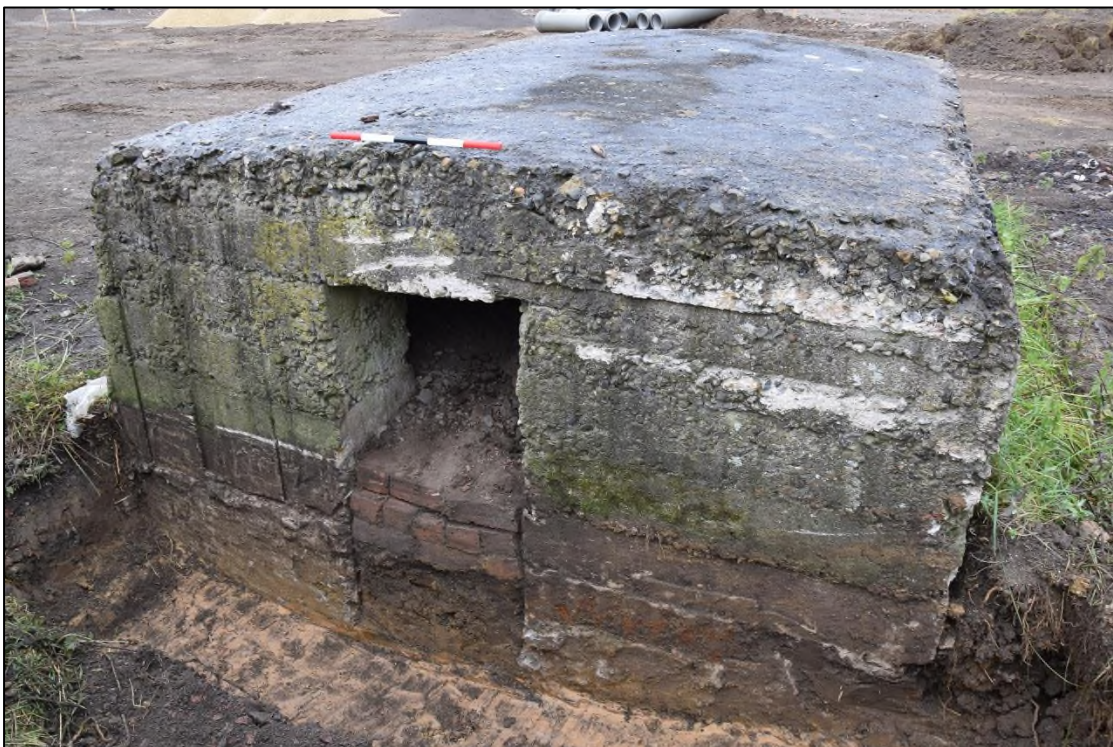
Photograph 14: Clay and bricks have been used to close up the lower half of the door. The walls rest directly on the natural yellow clay subsoil

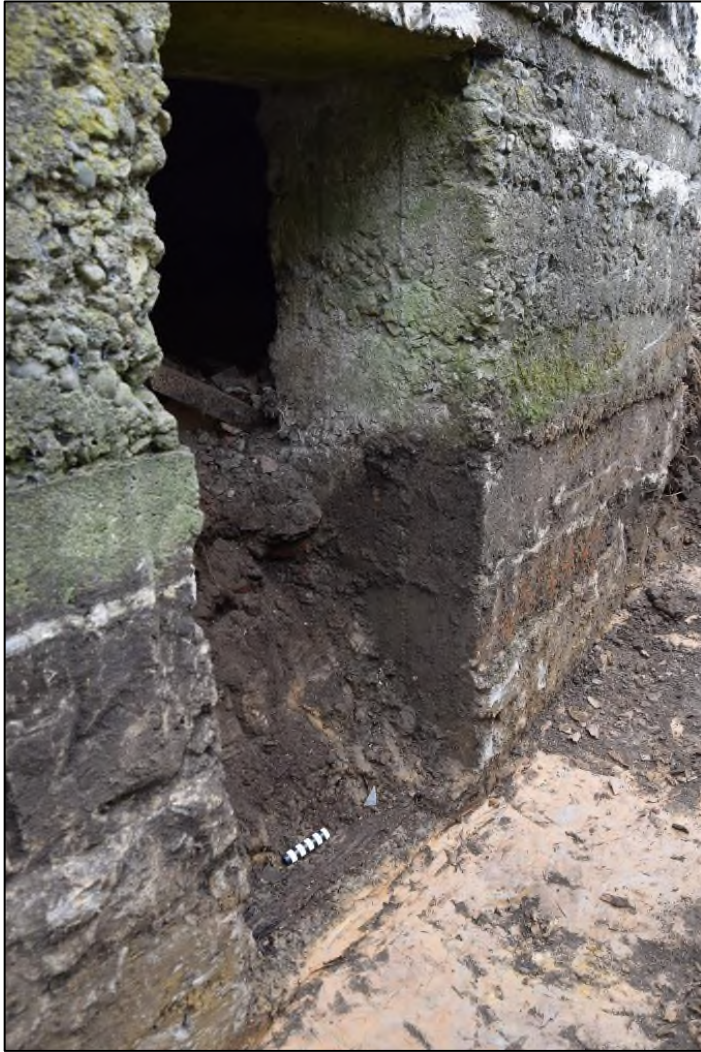
Photograph 15 (left): An oblique view of the door during excavation. Scraps of decayed wood from a door frame are just visible beside the scale. Note the rough construction of the walls and the absence of fixings for the door or its frame

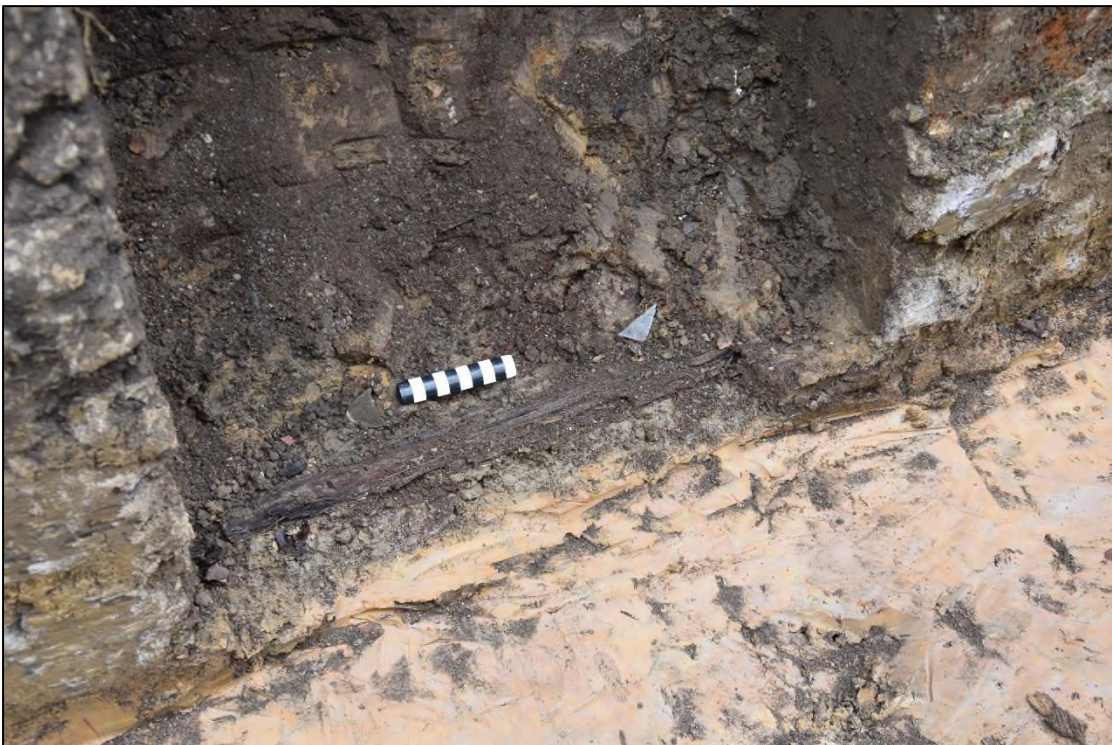
Photograph 16 (below): Detail of the wooden door sill, which lies on a scatter of grey unconsolidated mortar. The scale is 100mm long

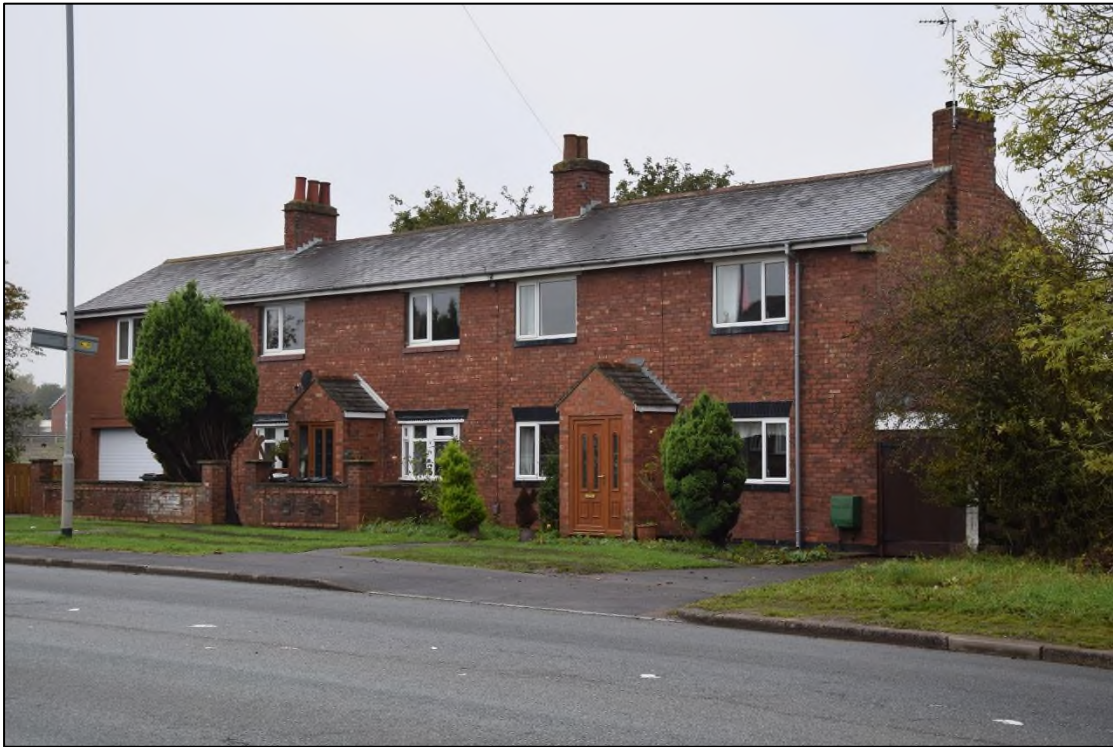
Photograph 17: The two former smallholding houses at the front of the air raid shelter site. The porches and the bay beyond the left-hand chimney are later additions

- 5.6 It is not known when the smallholdings went out of use. The pair of houses at the front of the site, like the others on Burtree lane, have been altered but are still recognisably of the same design (Photographs 17, 18). After the war, the old shelter seems to have been incorporated into the structures at the rear of the houses. The 1945 air photograph mentioned above appears to show it as part of a larger shed, the concrete floor of which can be seen on the north side. Later, it seems to have been deliberately part-filled with soil; a layer of clay up to 0.43m deep was recorded when the blocking of the door was removed. In more recent times, bricks and asbestos cement roofing sheets from an adjoining hen house were thrown into the shelter. A resident of one of the old smallholding houses says that her father did this to prevent children from playing in the structure.

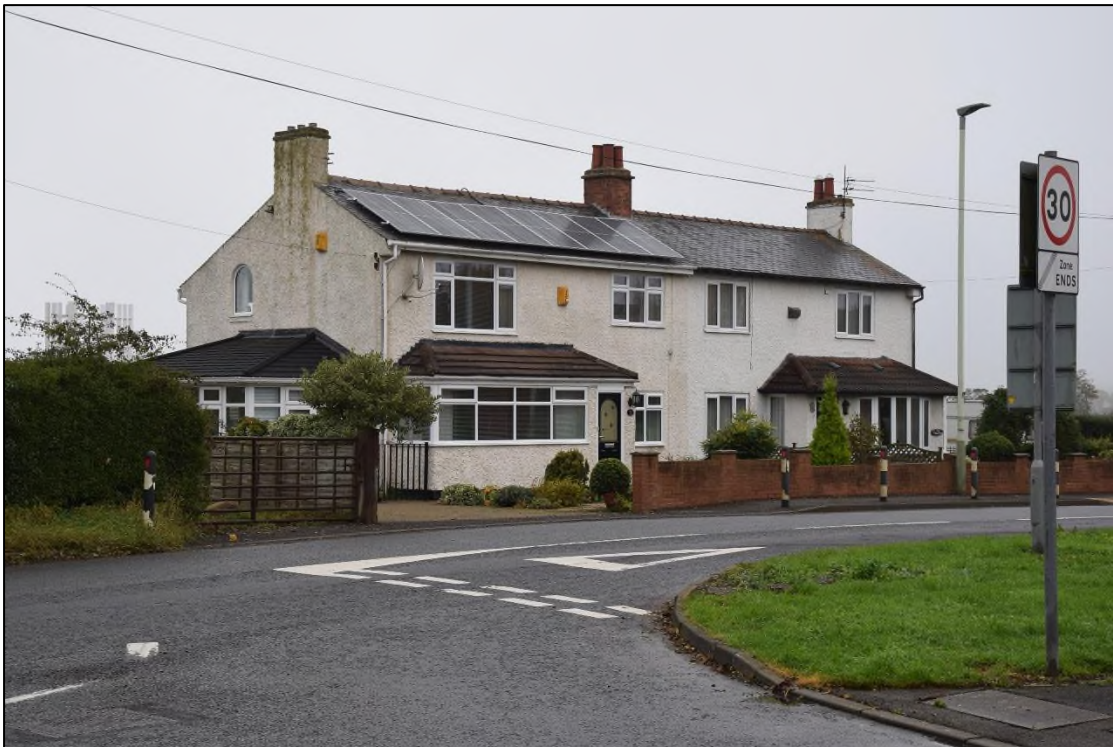
Photograph 18: Another pair of smallholding houses, on Burtree Lane. Despite modern alterations, the similarity between these and the houses in Photo 17 is obvious

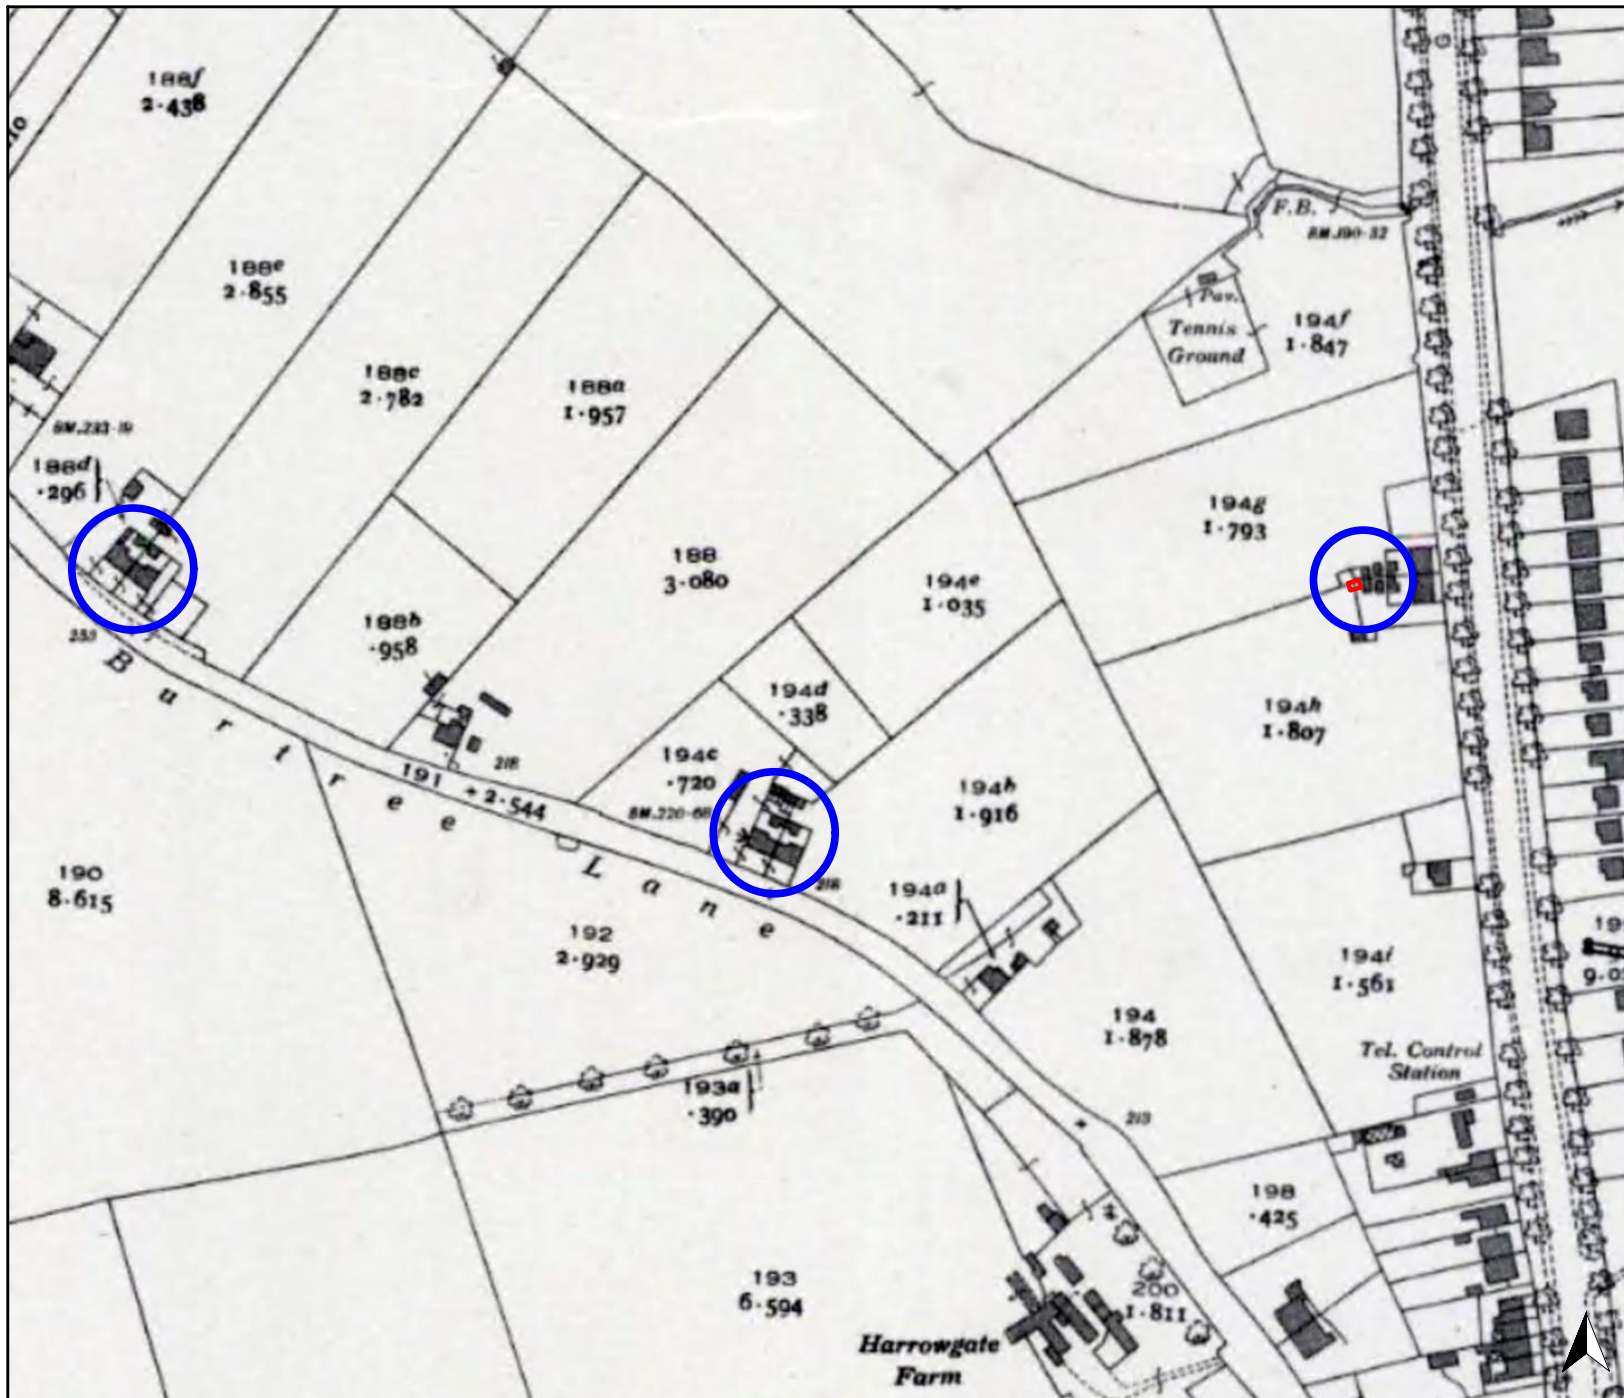
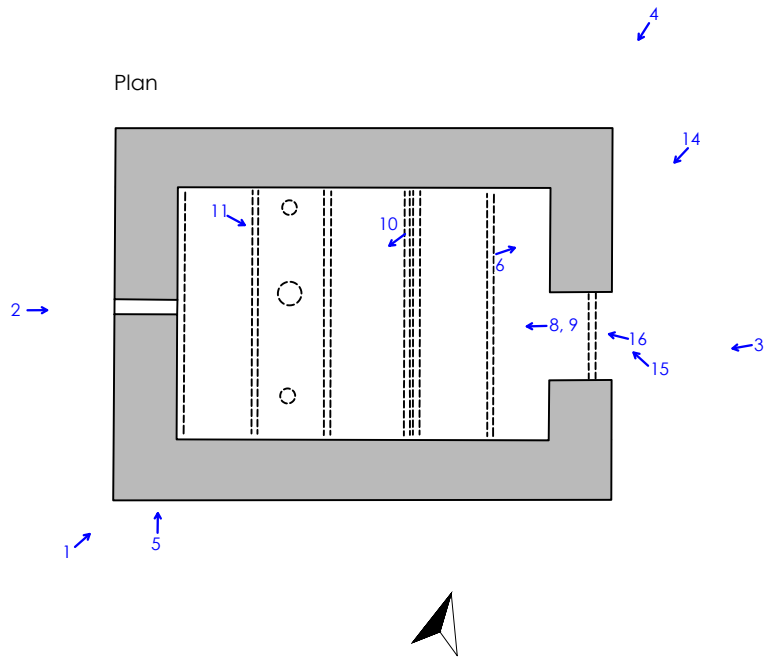
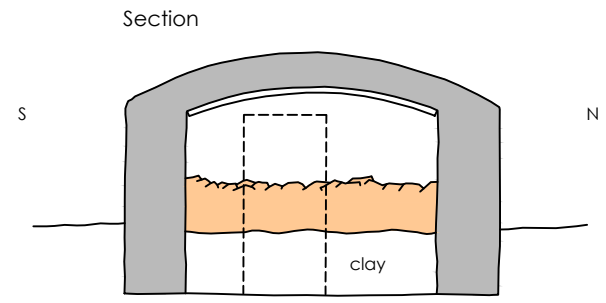
Figure 4: Plan and section

- 5.2 The air raid shelter is a rectangular concrete structure measuring 3.3m east-west, 2.7m north-south and up to 1.6m high, and with a slightly curved roof (Figure 4: Photographs 1-4). It is partly sunk into the ground and has a single door off-centre in its east side. The only other opening is a ventilator made from a piece of four-inch ceramic drainpipe, set high up in the middle of the west face.
