# Land to the north of Whittlesey Railway Station, Cambridgeshire

# archaeological desk-based assessment

Report 2129 December 2008

## Report 2129

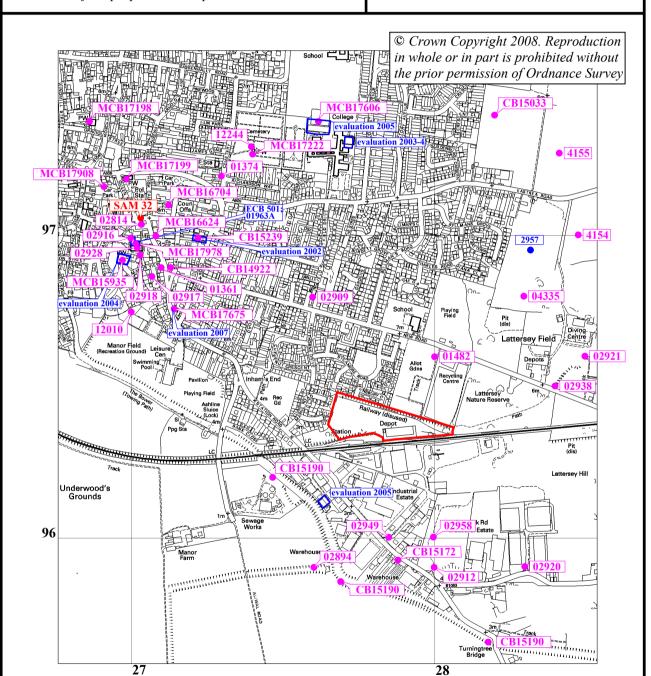
Figure 1

Location of the proposed development area and HER sites

2.1 The site is located on land to the north of the Railway Station, Whittlesey, Cambridgeshire (grid reference TL 2759 9643). It covers an area of 3.67 ha, and is bound by the railway to the south, houses and gardens to the west and north-west, and allotment gardens and a recycling centre to the north.

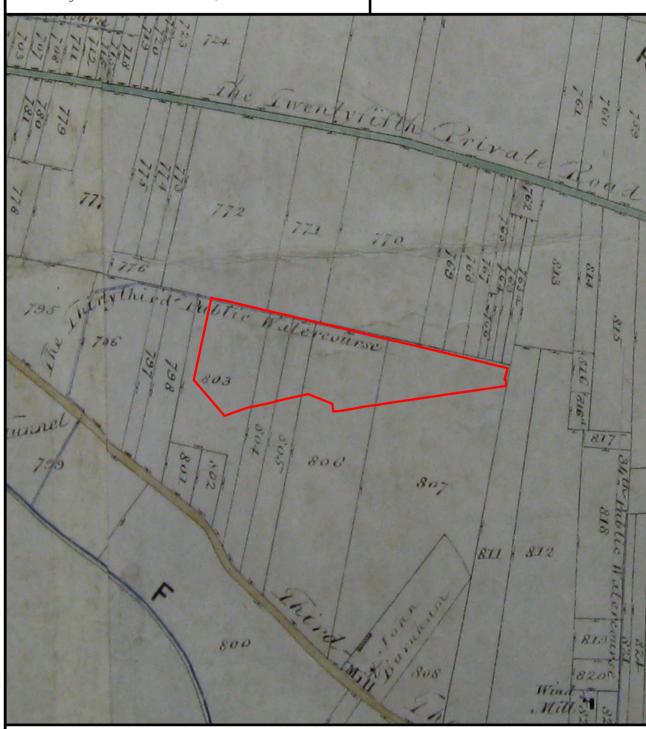
Figure 2

Extract from the Inclosure Award, 1844

- 4.16 The Inclosure Award for Whittlesey is dated 1844 (Figure 2) and at this time the development site was agricultural land, crossed by north to south running field boundaries, to the south of the Thirtythird Public Watercourse.

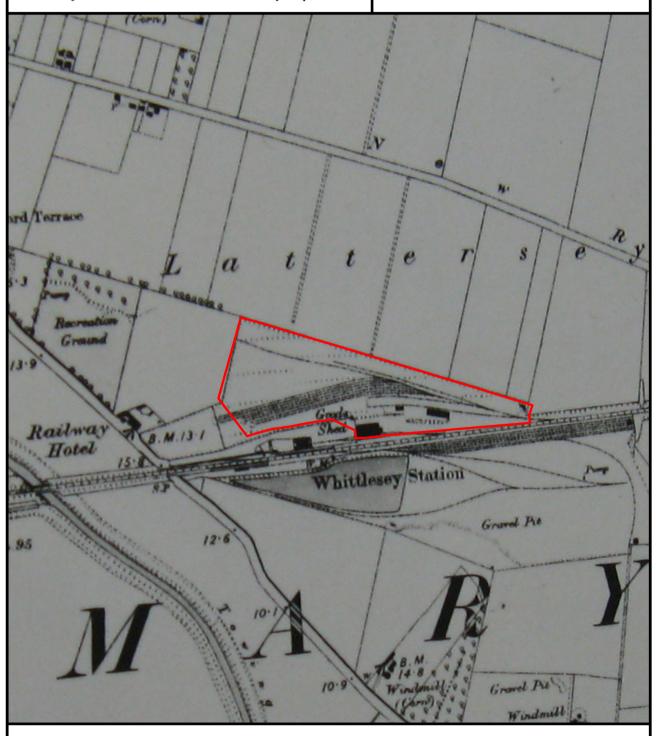
Figure 3

Extract from the 1st edition Ordnance Survey map, 1844

- 4.18 The 1st Edition Ordnance Survey map, dated 1888 (Figure 3), shows the development site north of the railway line with goods sheds and sidings. The development site is lower than the surrounding area but it is not clear whether this is the result of ground reduction work or embankment of the railway line and surrounding area. The western part of the site is shown as rough scrubland.

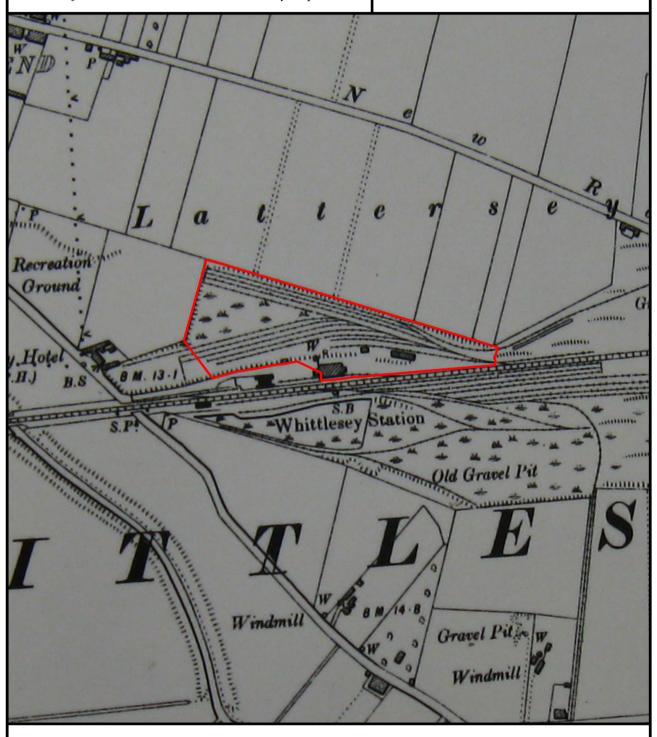
Figure 4

Extract from the 2nd edition Ordnance Survey map, 1903

- 4.19 The 2nd Edition Ordnance Survey Map, dated 1903 (Figure 4), shows a similar layout for the development site as do the 1927 and 1950 Ordnance Survey maps (Figures 5 and 6).
- 4.20 The area around the development site was exploited from the second half of the 19<sup>th</sup> century by gravel quarrying and for tile and brick manufacture. In the early 20<sup>th</sup> century over 12% of the population worked in the brick industry and over 40% worked in agriculture. In the second half of the 20<sup>th</sup> century the town expanded along Station Road and New Road.
- 4.21 During the Second World War a series of pillboxes (HER CB15190) were constructed along the southern bank of the Whittlesey Dyke.

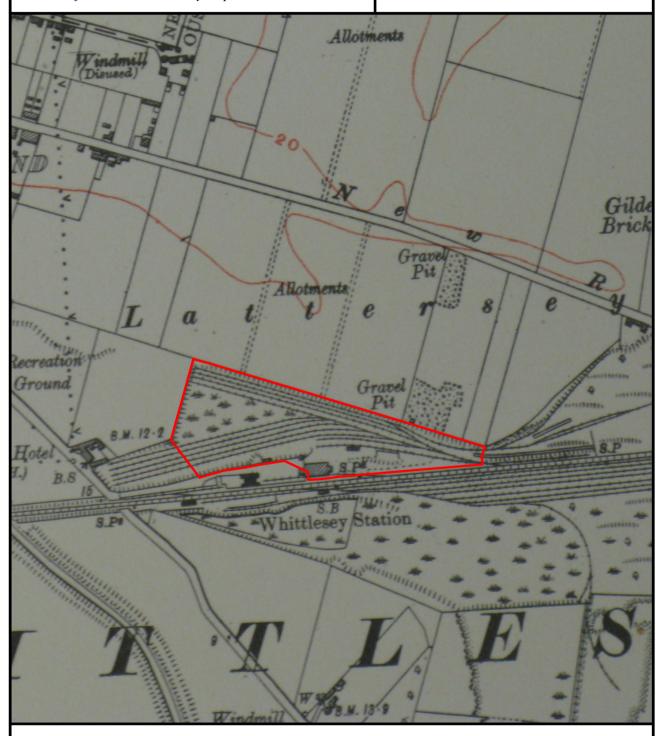
Figure 5

Extract from Ordnance Survey map, 1927

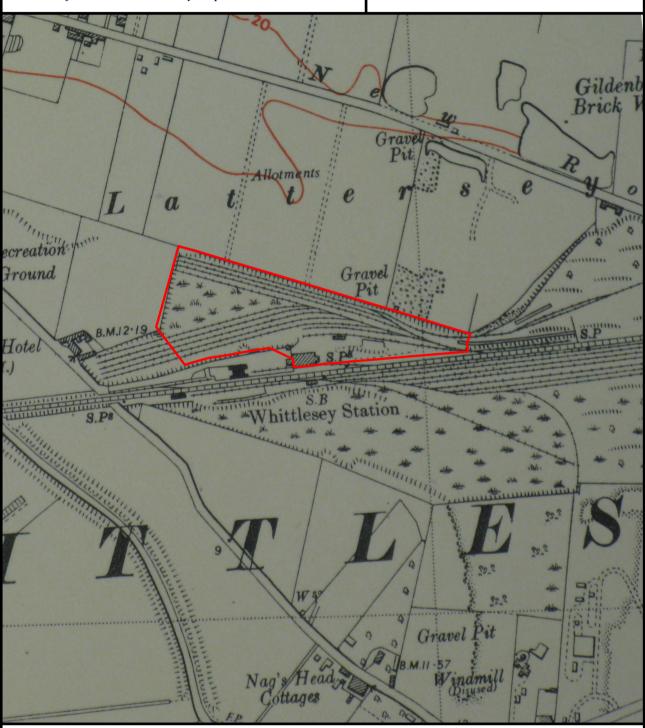
Figure 6

Extract from Ordnance Survey map, 1950

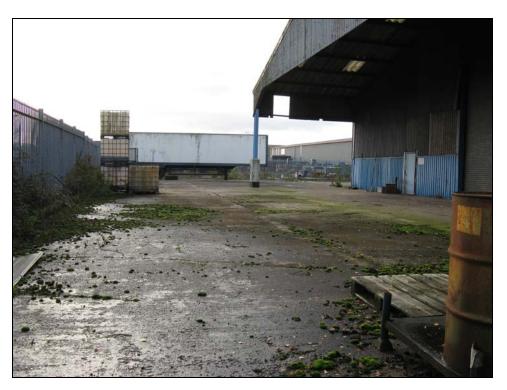
- 5.2 Much of the southern part of the site is covered with a fenced compound with hard standing and a large metal warehouse (Figure 7). To the rear of the depot are several manholes and a considerable amount of modern rubbish.

**Figure 7**View to south showing warehouse and hard standing

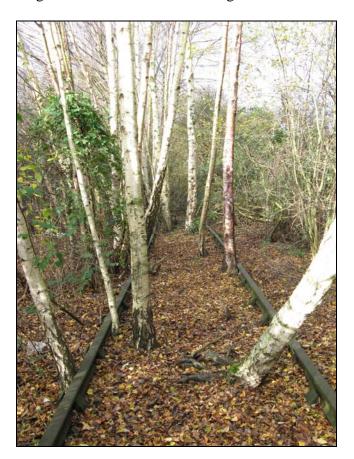
- Along the north-eastern part of the site the land rises. At the base of the slope are tracks of the disused railway with mature trees growing through them (Figure 8). The tracks are in relatively good condition with stone chippings between. There is no visible evidence for the railway goods shed shown on the historic Ordnance Survey mapping.

**Figure 8**View to west showing disused railway line

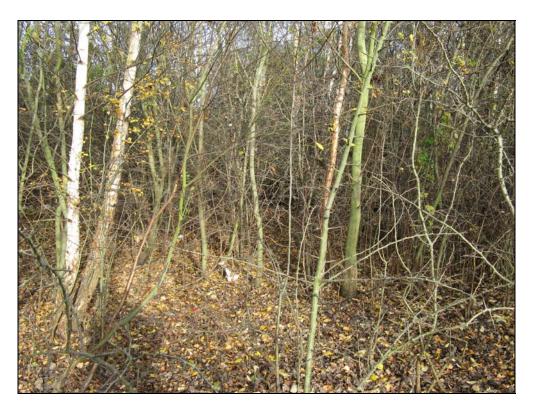
- 5.4 The central and western part of the development site is overgrown with trees and shrubby undergrowth (Figure 9).
- A large part of this area was flooded at the time of the site visit (Figure 10). This is the area shown on all detailed maps as scrubland or marsh.

Figure 9
View to north through undergrowth

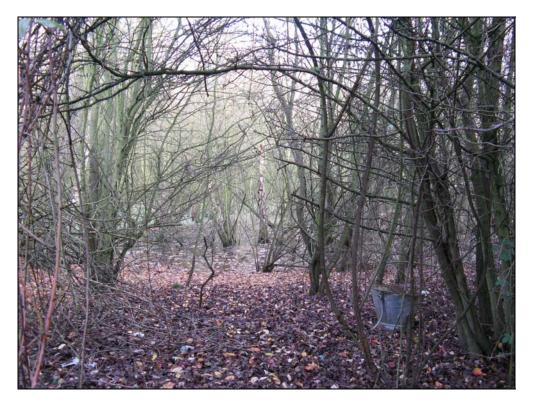
- 6.3 The western part of the site does not appear to have been occupied during the historic period, and the waterlogged nature of the ground indicates that the potential for preservation of any archaeological remains that survive on the site is high. The railway sidings and modern depot are unlikely to have deep foundations, so apart from truncation by drains and deep service trenches, any archaeological resource is likely to have been preserved.

Figure 10 Flooded area in western part of the site
