### archaeological desk-based assessment

on behalf of Lidl UK GmbH

**Report 2234**July 2009

Moordale Rd
Off Millennium Way
Aycliffe Business Park
Newton Aycliffe
Co. Durham
DL5 6BA

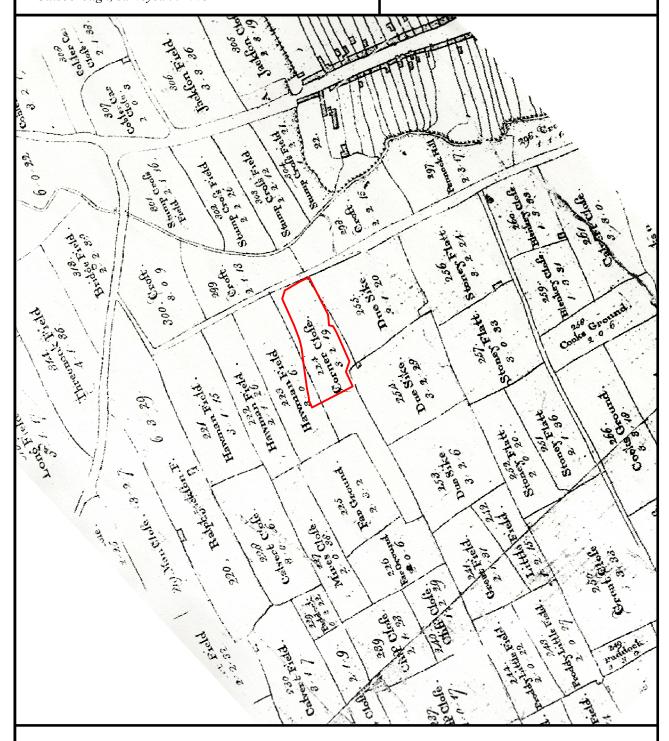
Figure 3 Extract from A Rough Map of the Manor of Guisborough, surveyed in 1773

- 4.11 In 1773 (Figure 3) the development site was known as Corner Close (field 224, just over three acres). The boundaries of the field appear largely unchanged since this period.

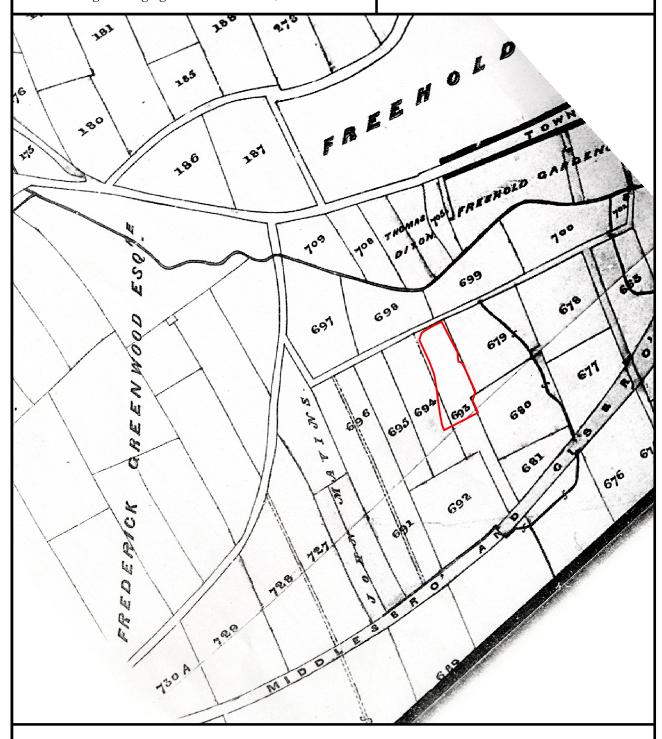
Figure 4 Extract from a Plan of an Estate in the Parish of Guisborough belonging to Robert Chaloner, 1854

- 4.13 By 1854 the Middlesborough and Guisbrough (sic) Railway (HER 3887) ran just south of the field containing the proposed development area (Figure 4) towards the station in Guisborough (Figure 5). In 1866 the Parsonage (built 1859) was re-named the Rectory and South Back Lane became Rectory Lane (Dixon 1992).

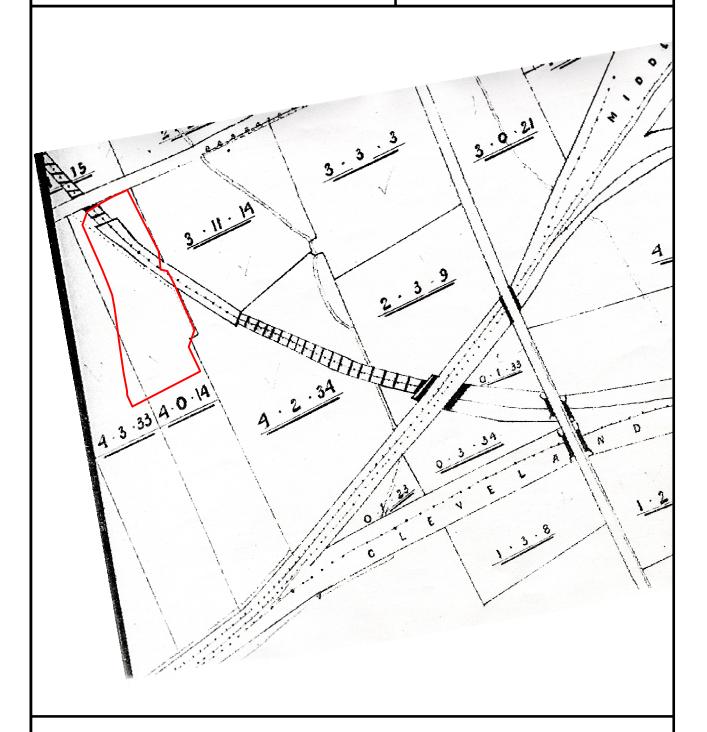
Figure 6 Extract from a Plan of Chaloner Estates at Guisborough, 1867

- 4.14 In 1867 a branch line (HER 5755) from the Chaloner pit (to the north-west of the town) crossed the site and joined the Cleveland Railway at Hutton Junction (HER 5769), to the south of the development site (Figure 6). This line crosses the Middlesborough and Guisborough railway and the north-eastern part of the site before crossing Rectory Lane.

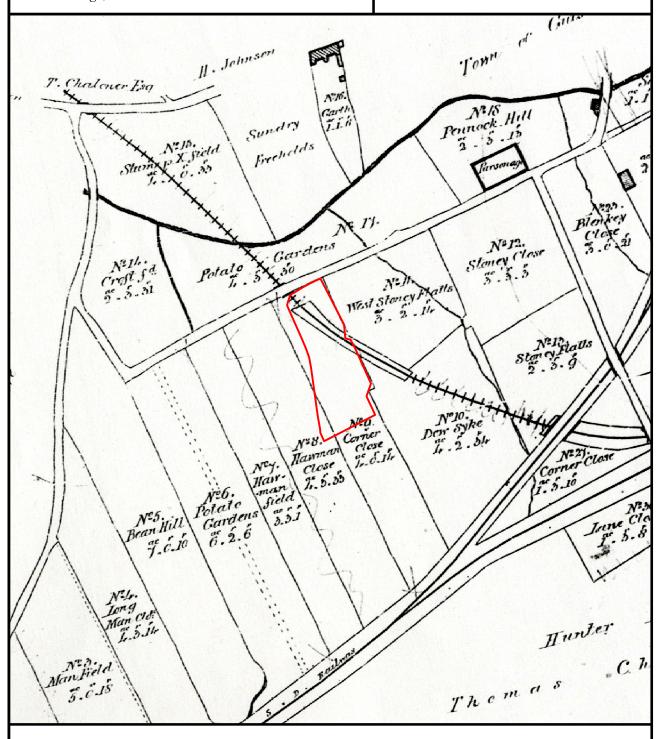
Figure 7 Extract from a Plan of Chaloner Estates at Guisborough, 1869

- 4.15 The branch line can also be seen in a map of Chaloner Estate lands made in 1869 (Figure 7): both these maps show an earthwork associated with the railway where it crosses the proposed development area. This map shows the Middlesborough to Guisborough railway was now part of the Stockton to Darlington Railway system with the Cleveland Railway branching off to the south of the town.

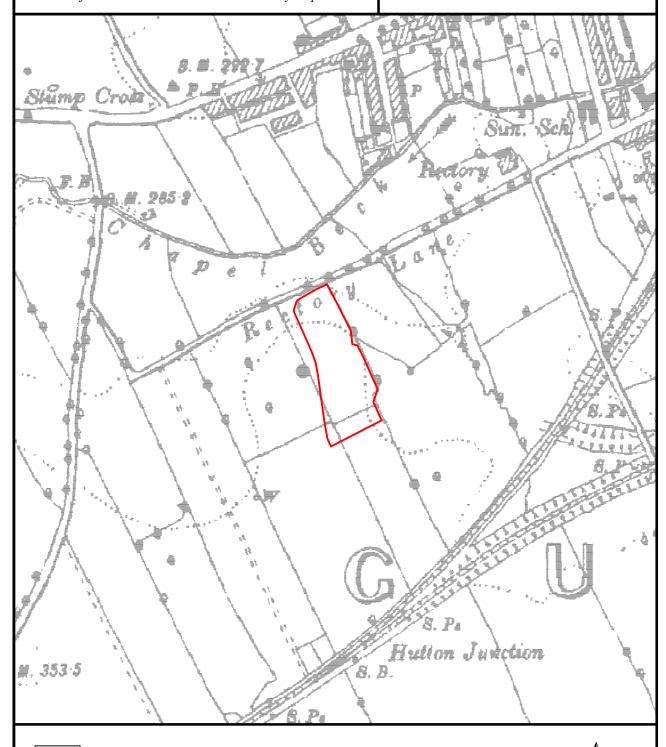
Figure 8

- 4.16 The 1894-5 and subsequent Ordnance Survey maps show the branch line that crossed the northern part of the site to have been dismantled, although it remained visible as an earthwork across the proposed development area (Figures 8-12).

Extract from the 2nd edition Ordnance Survey map

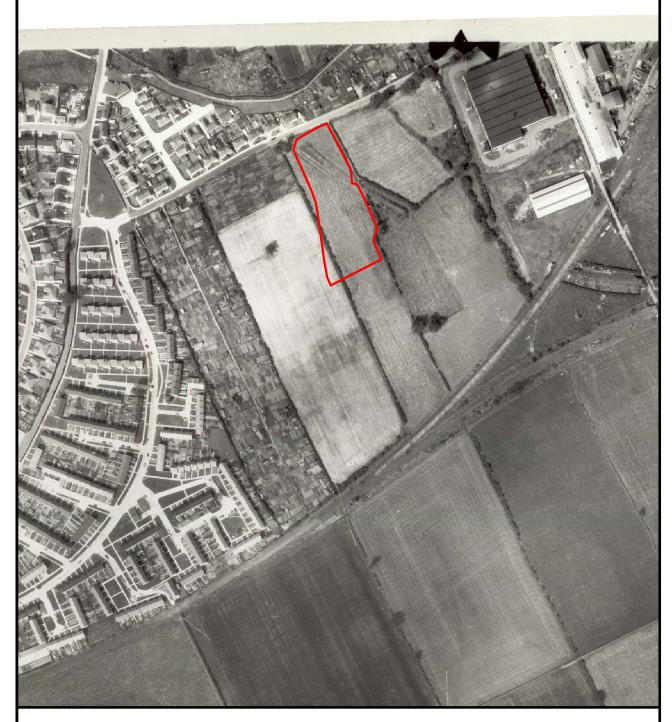
Figure 14 Aerial photograph of the site, 1965

- 4.7 The remains of medieval agricultural activity can be seen in extensive areas of ridge and furrow earthworks to the south of the town (HER 1568) and to the east of Belmangate. Possible ridge and furrow earthworks are visible in modern aerial views of the area (Figure 14). South Back Lane, later re-named Rectory Lane, ran to the rear of medieval properties fronting on to Westgate and to the south of Chapel Beck. The proposed development site appears to lie beyond the edge of the medieval settlement.

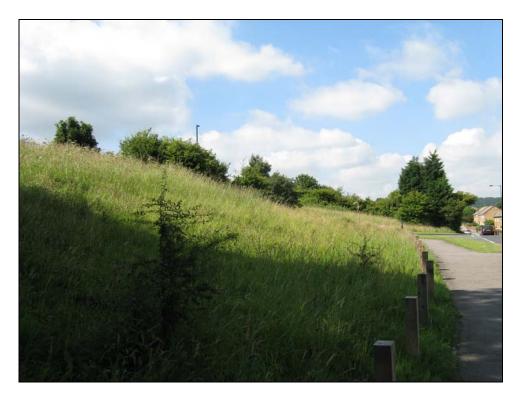
- 5.2 The site is relatively level but the land drops away by over 3 metres on three sides to Rectory Lane (Figure 15), Enfield Chase (Figure 16) and the Morgan Drive Industrial Estate (Figure 17). On the north part of the site the natural slope has been cut into to create a level surface for the construction or widening of Rectory Lane. On the east the steep downward slope along the edge of the site appears to reflect levelling work in conjunction with the establishment off the industrial estate that is cut into the natural slope on this side. On the west side, Enfield Chase has been cut through the northern slope of the spur to create a regular graded incline for this road as it climbs from Rectory Lane to the housing estates to the south of the former railway line. The development land slopes gradually up to the south. A hedge marks the eastern boundary of the site with remains of a barbed wire fence visible in places. The southern boundary of the site is marked by modern grid pegs but is otherwise indistinguishable from the remainder of the plot, to the south (Figure 18).

Figure 15 View west along Rectory Lane

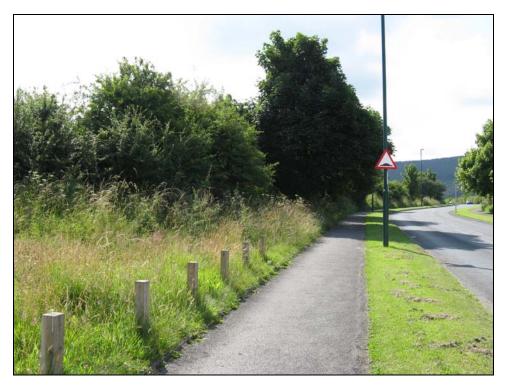
Figure 16 View south along Enfield Chase

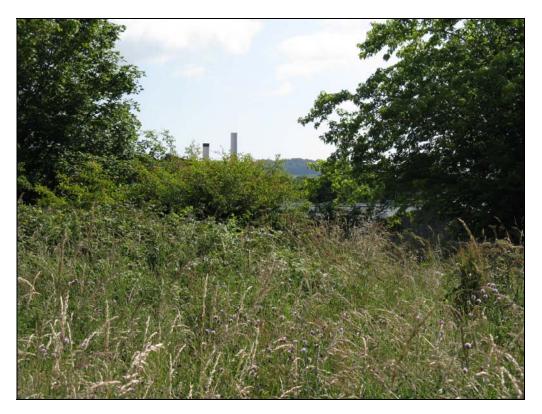
**Figure 17** View to the north-east showing Morgan Drive Industrial Estate

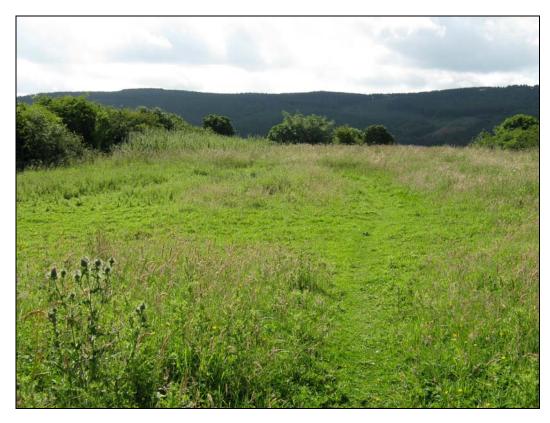
Figure 18 View towards the southern boundary
