St. Mary Magdalene Church Eardisley

Archaeological Watching Brief

December 2006
SMR 44133

**St. Mary Magdalene Church
Eardisley
(NGR SO 3103 4901)**

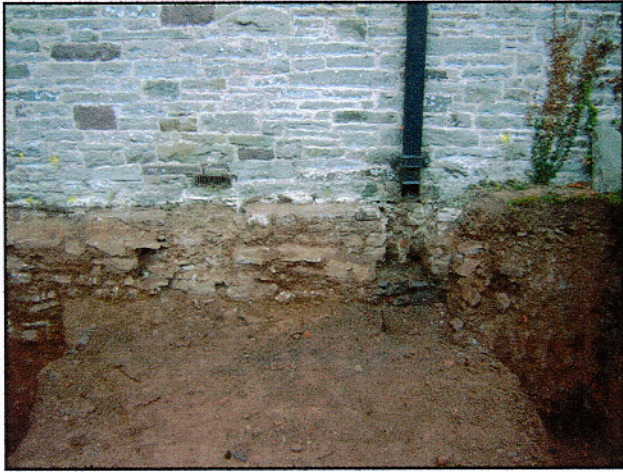
No significant archaeology was revealed during excavation. The foundation plinth for the existing northern aisle was encountered during excavation and shown to extend at least 1.40m below the current ground level (Plate 1).

Plate 1 - Foundation levels of north aisle. Camera direction south.

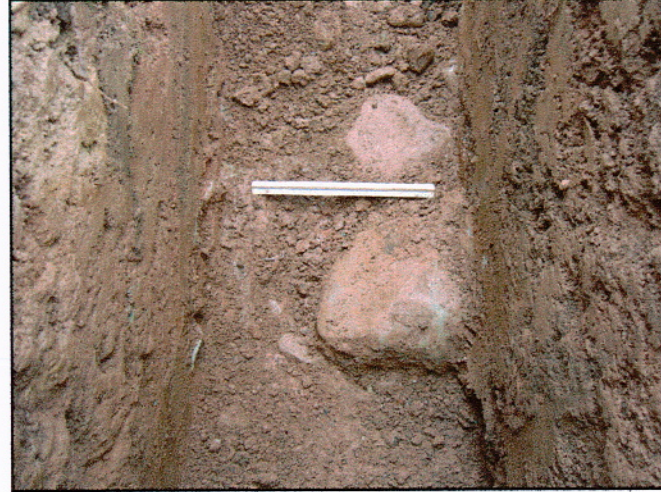
A linear arrangement of large cobbled stones (108) was found in the north of the service trench contained within and above the natural soil horizon (Plate 2). Although there is a possibility that these formed the base of a very crude wall it is more likely that these were naturally occurring erratics within the natural. No evidence for bonding material was found.

Plate 2 - Possible wall feature (108). Camera direction north.

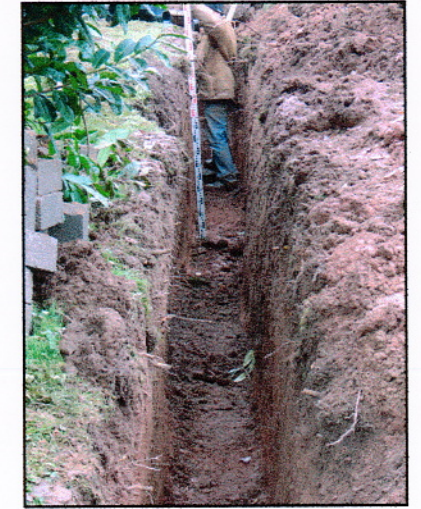
Excavation of the east-west service trench revealed that service trenches [102] had disturbed any human remains that may have been buried in this area. As the trench turned in a NNW direction across the churchyard however, human remains were encountered (Plate 4). The most significant burial in this trench was SK 105 (Plate 5). The 0.65m wide trench revealed a pair of lower leg bones (Tibia and Fibula) that appeared to belong to the same skeleton. In very close proximity were further sets of lower leg bones representing three legs in total. The close proximity of these bones (representing at least three individuals) would suggest either a multiple grave, or graves being dug extremely close together. It seems likely that further burials were concentrated in this area however a later grave cut (106) had removed the evidence for this. This concentration of remains shared similarities with a further two burials encountered in this trench. SK 103 and SK 104 (Plate 6) were found on a similar NEE-SWW alignment and were buried in relatively shallow graves (between 0.35m and 0.74m). The poor preservation of the bone in these burials would suggest that they are earlier than the remains discovered in phase one, although a lack of dating evidence recovered from the graves makes any attempt at dating the burials pure speculation.

Plate 4 - General shot of service trench. Camera direction NNW.

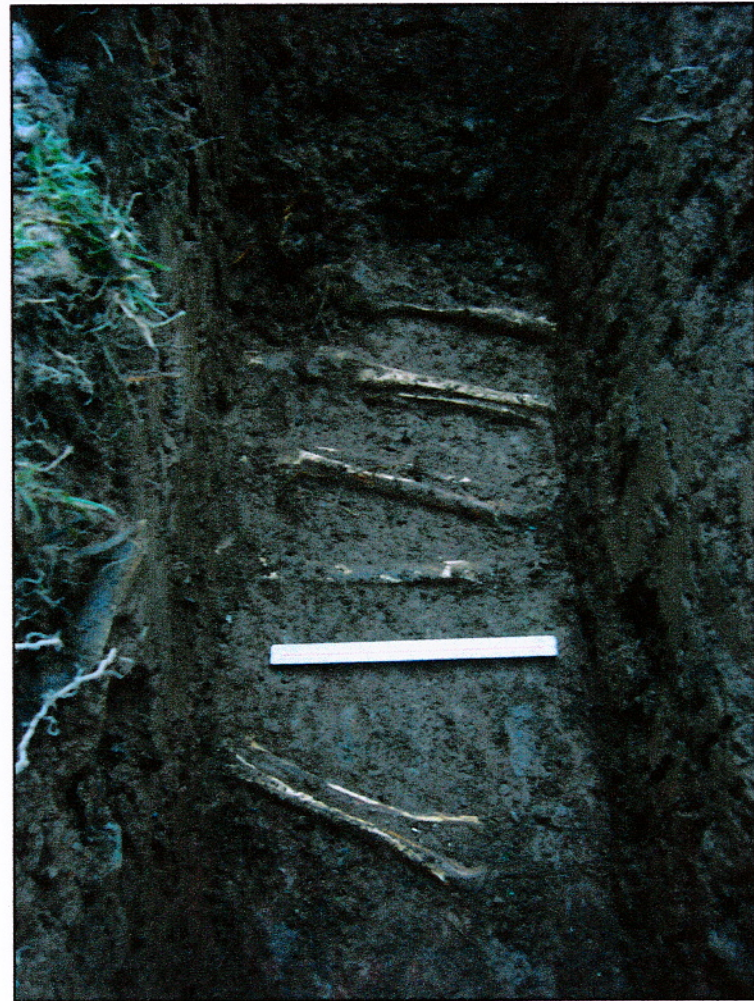
Plate 5 - Skeleton (SK 105) and associated lower leg bones. Camera direction north.

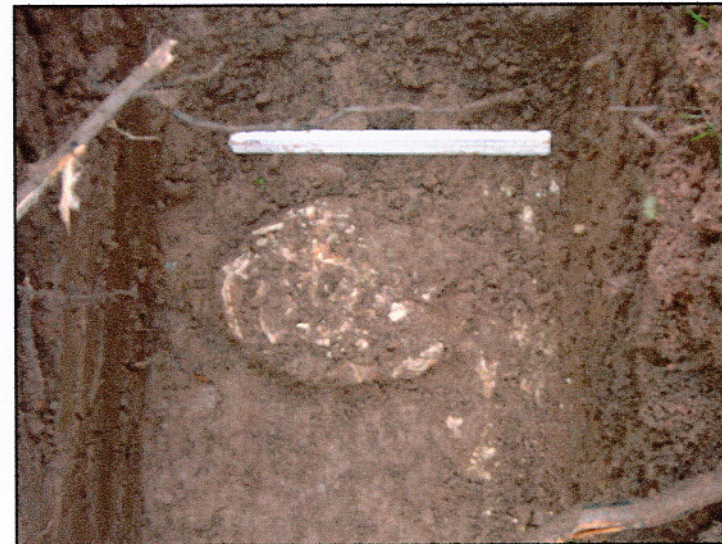
Plate 6 - Skeleton (SK 104). Camera direction north.

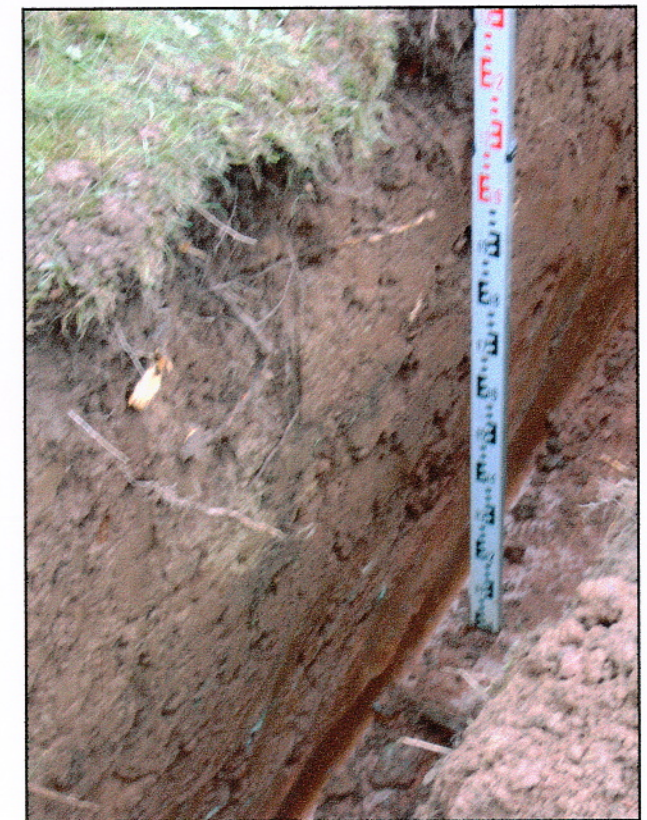
Plate 7 - Service trench section. Camera direction NW.
