New Toilet Block Gaul Street Hereford

Archaeological Watching Brief

Hereford Archaeology Series 749

**New Toilet Block,
Gaol Street,
HEREFORD**
Archaeological Watching Brief
NGR SO 5130039935
SMR No. 44167

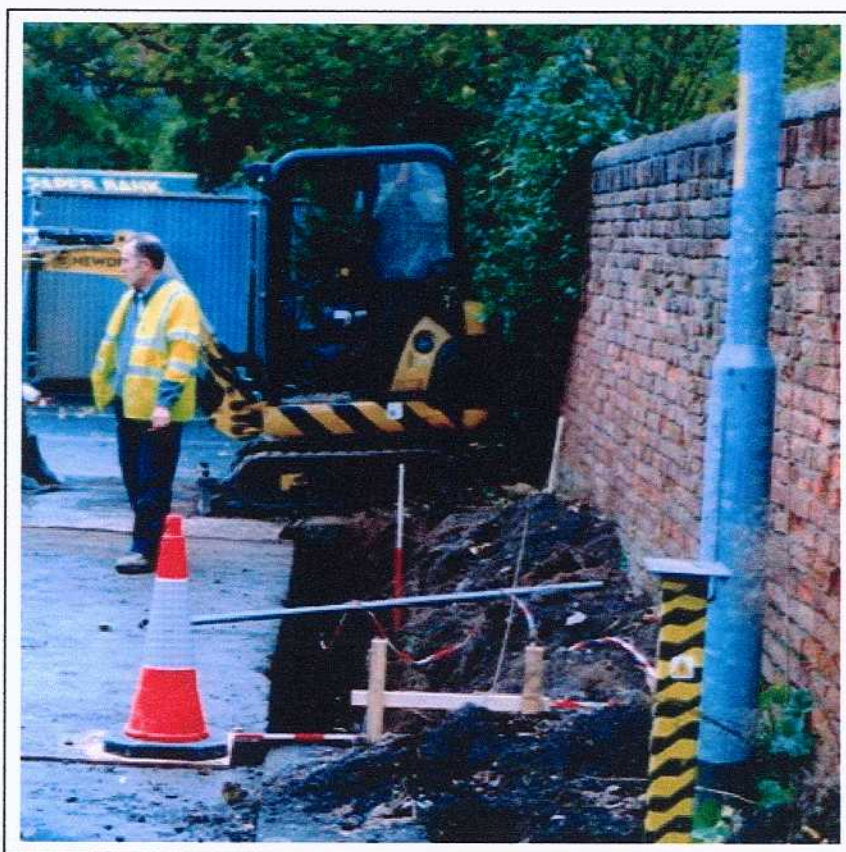
Cover picture: Trench 4 under excavation, facing west

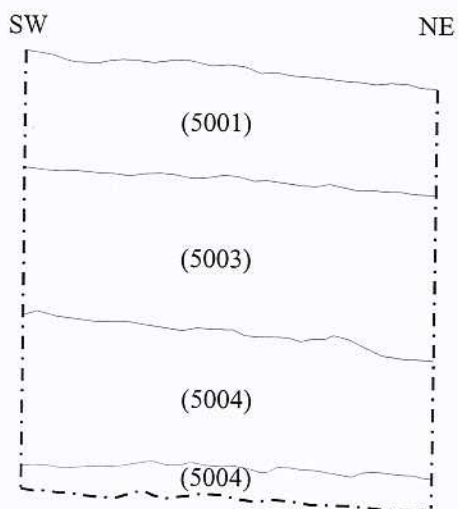
Fig. 4c

An area of disturbance was then present, with no discrete archaeological layers visible (Fig. 4c). Clay pipe was recovered from this area demonstrating a post-medieval date for these deposits.
