St Martins Allotments Hereford

Archaeological watching brief.

H.A.S 719
SMR 43216
August 2006

AMEC wished to carry out excavations required to replace the existing sewer and storm drains along the south-west side of the Greyfriars Bridge adjacent to the Saint Martins Allotments (Fig 1).

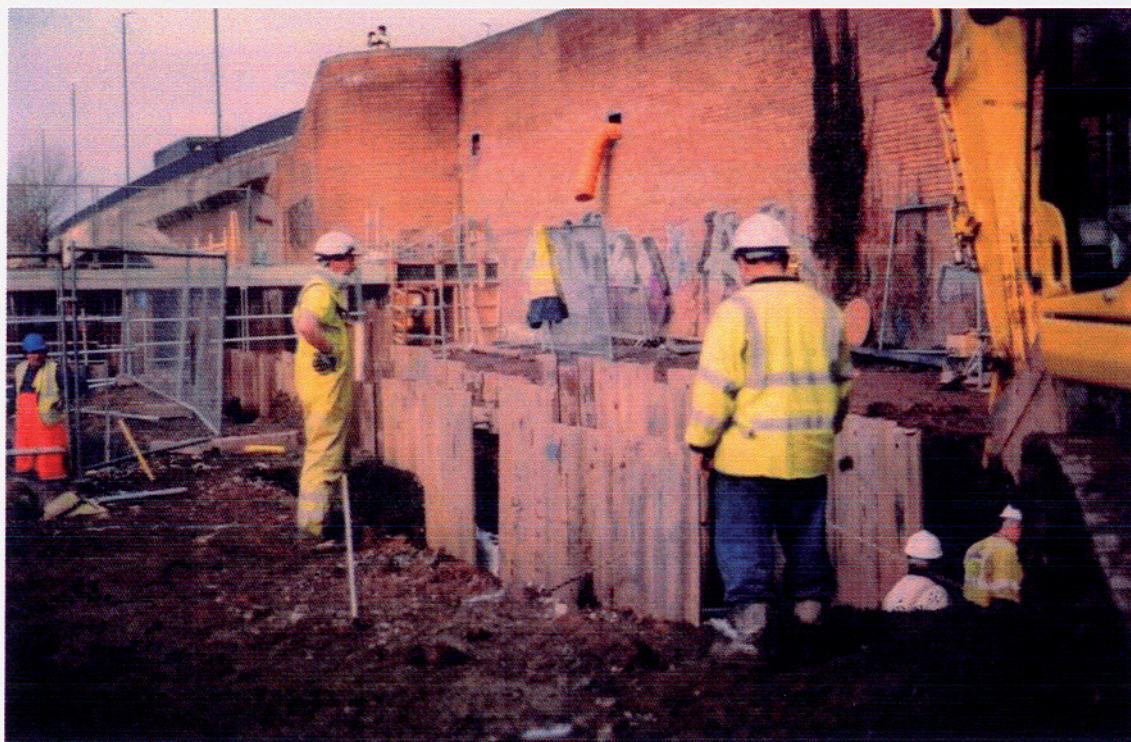
Cover picture

Excavation underway on the weir chamber during works on the site at Saint Martins Allotments, Hereford.

More excavation was carried out, connecting the excavation on the eastern side of the wet well to the existing sewer line. Some of the old sewer was to be disconnected as part of it was being diverted from its original line. The excavation was carried out for construction of a weir chamber, this time under archaeological supervision.

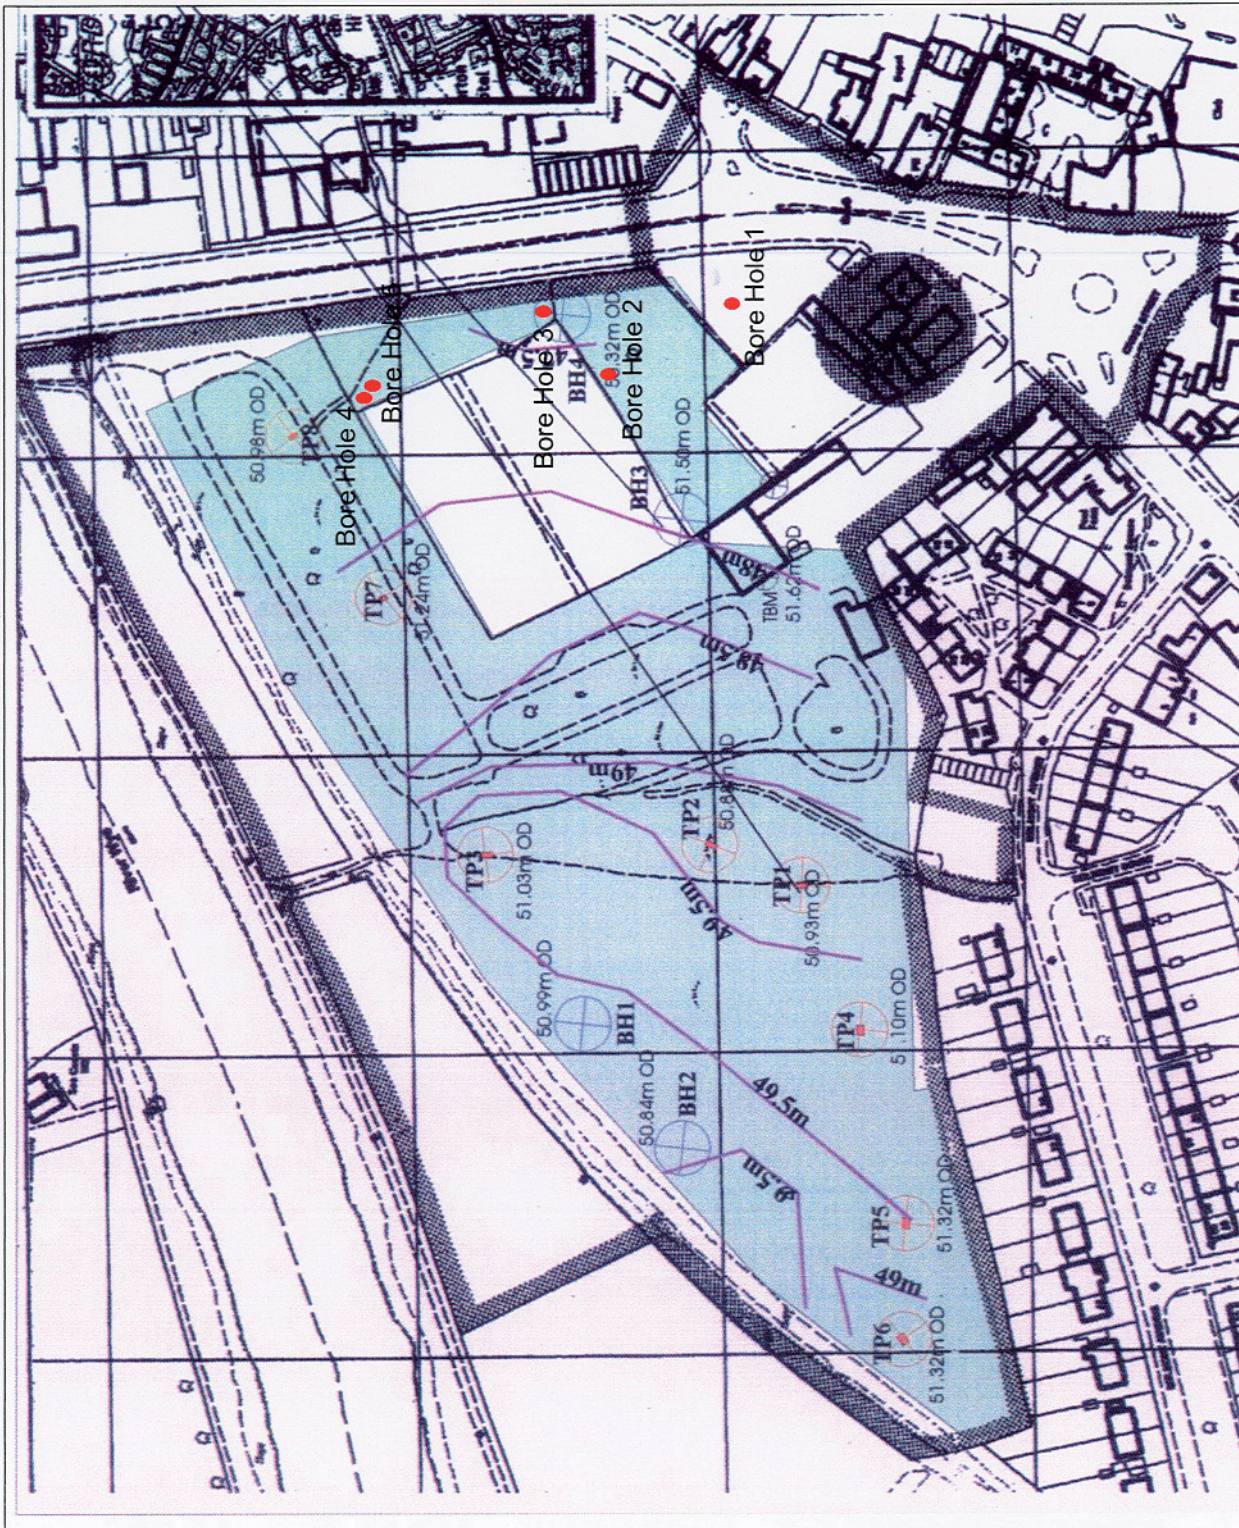
Fig. 10 Positions of Bore Holes

As mentioned in the method section this was not possible but five holes were augured on the site (figures 10 & 11).

Bore Hole 1

Bore hole 1 was positioned to the far southwest of the site. In this area the topsoil had been removed and the upper deposit in the bore hole was layer of mid brown silt (001) which was present to a depth of 0.66m. Underlying this was a mid brown layer of silty clay (002) 0.29m thick. This in turn is underlain by a yellow brown fine grain clay deposit (003) 0.2m thick. Beneath this was a darker deposit of red brown fine grained clay (004) 0.67m thick. Underlying this was a slightly paler red brown clay deposit with dark brown mud fleck inclusions (005) 0.78m thick. This overlay a thin band of black sand (006) approximately 0.01m in thickness. This lay above the natural gravels (007) which were reached at a depth of 2.61m.

Bore hole 2 was positioned near the southern end of the western allotment fence. This area was covered with dark brown silty clay topsoil (008) which was present to a depth of 0.30m. This topsoil is broadly similar to that observed in bore holes 3-5. Beneath this was a mid red brown silty clay deposit with rare stone inclusions (009). This deposit was 0.38m thick. Underlying this was paler red brown fine grained silty clay (010), 0.22m thick. This was underlain by a darker deposit (011) with inclusions of tiny rounded stone and flecks of dark brown mud similar to those present in deposit 005. Deposit 011 was 0.18m thick. Beneath this was slightly paler red brown silty clay with pale clay spots and rare mudstone flecks (012) 0.11m thick. These inclusions were the only factor distinguishing deposit 012 from the underlying deposit (013). In this instance the inclusions were red sandstone flecks. Beneath this was a red clay deposit with low silt content (014). Deposit 013 was 0.54m thick and 014

Bore hole 3 was positioned near the south-western corner of the allotment fence. As in trenches 2-5 the upper deposit was a layer of loose brown silty clay topsoil. In this instance it was 0.32m thick. Beneath this was a subsoil deposit (018), similar in character but with a higher clay proportion. This was underlain by a red brown silt layer (019) with inclusions of white crushed stone and occasional flecks of topsoil. This deposit was 0.77m thick. Underlying this deposit was a red brown clay layer with dark brown mud fleck inclusions (020) identical to 005. In this instance the deposit was 1.65m thick. This overlay the gravel natural which was reached at a depth of 3m.

Bore hole 4 was located near the south-eastern corner of the allotment fence. The topsoil (022) in this bore hole was thinner than in the other holes and in this case was only 0.1m thick. Underlying this was a light brown silty clay deposit (023) which was 0.6m thick. Beneath deposit 023 was a layer of red brown clay (024) which was augured for 0.2m. At a depth of 0.9m the bore hole was abandoned as the ground became too hard to dig into. It is presumed that there was a context change at this depth although it was not possible to test this hypothesis as no soil sample could be recovered. It is unlikely that the gravel was reached however as in nearby bore hole 5 the gravel was not reached until a depth of 2.08m.

Bore hole 5 was located near bore hole 4 in the south eastern side of the site. The topsoil (025) in this bore hole was present to a depth of 0.21m. Underlying this was a light brown silty clay deposit (026) which was 0.44m thick. Beneath deposit 026 was a layer of red brown silty clay 1.3m in thick. This was underlain by a similar layer of red brown silty clay with frequent inclusions of angular and sub-angular grey gravel fragments. This overlay the natural gravel (029) which was reached at a depth of 2.08m.

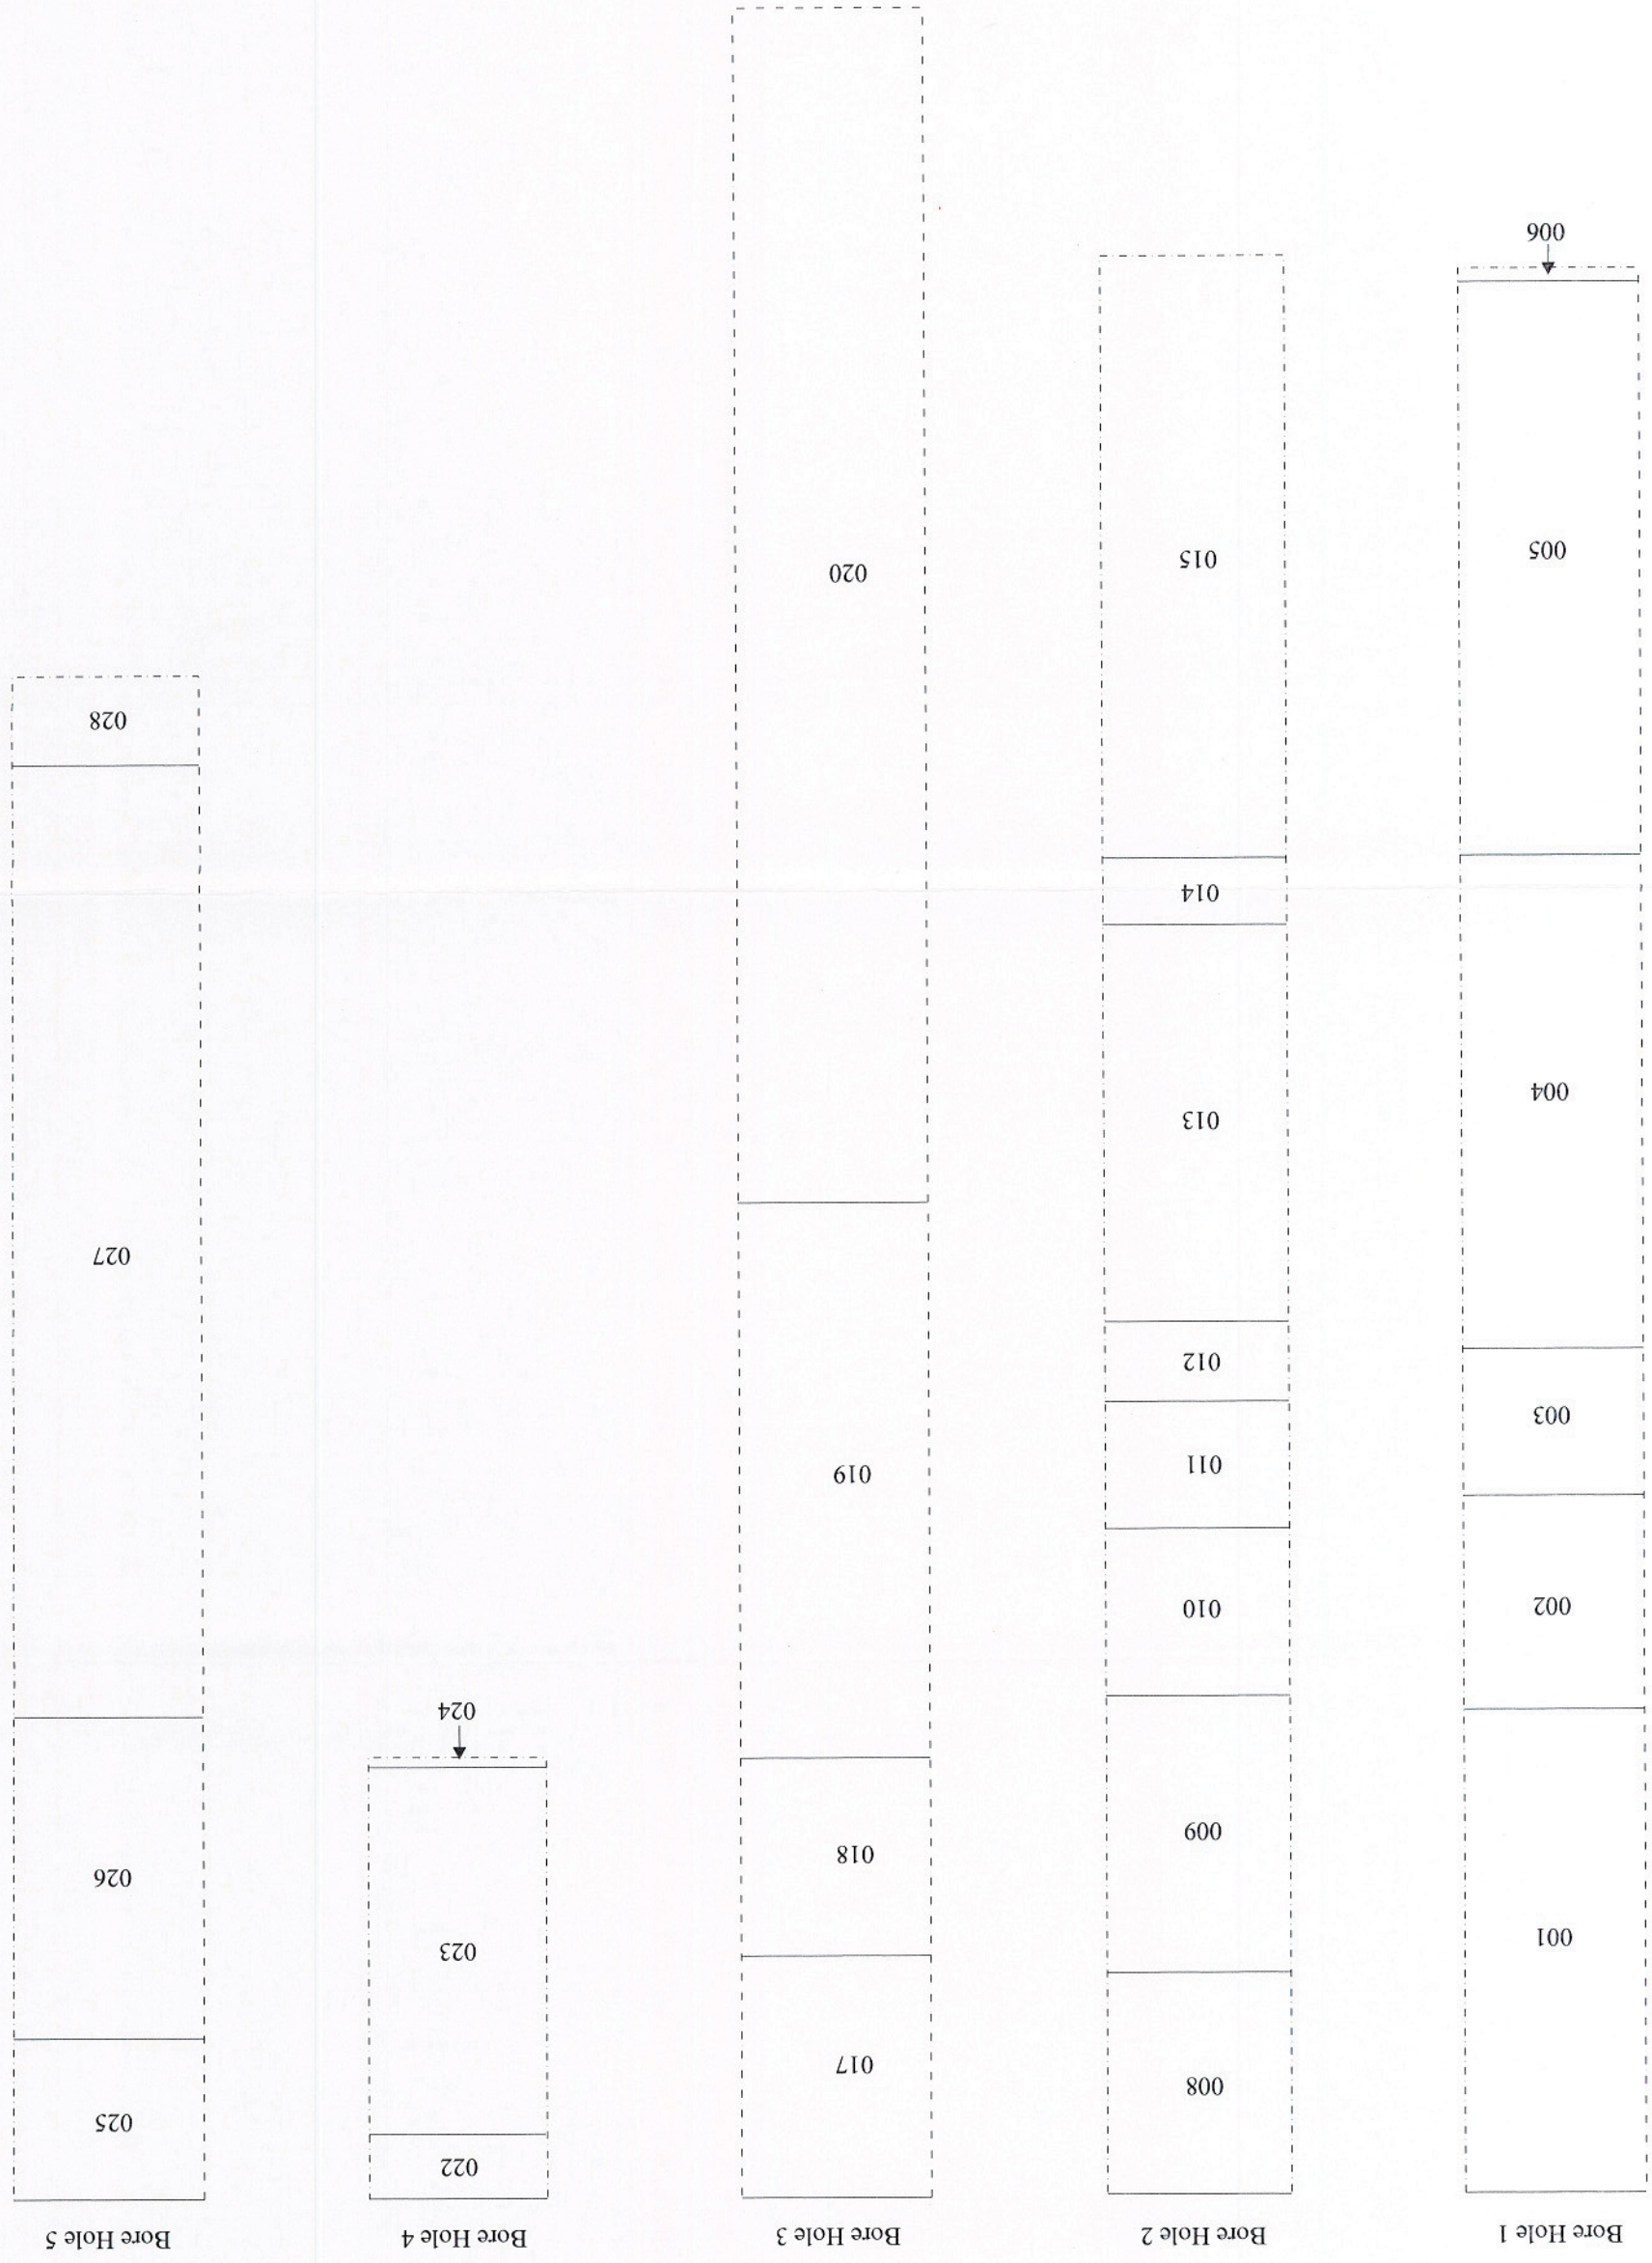
Fig. 11 Bore Hole Sections Scale 1:10

The stratigraphy observed in the 5 bore holes was broadly similar in nature with a layer of dark brown silty clay topsoil overlying various layers of red brown silty clay and clay. Gravel is the underlying material in all cases where the base of the bore hole was reached. This is also generally in-keeping with the results of previous bore hole and trial trench survey in the area (Boucher & Eisel 2000) although the sandy silt layer observed overlying the gravels in Boucher's survey was not observed.

The increased depth of the gravels at bore hole 3 and also the greater depth of the same in bore holes 1 & 2 compared to 5 appear to support the possibility of an earlier channel cutting through the east end of the site at this point. The depth of the gravel in this area is in keeping with the earlier survey results.

Context number	Depth to surface	Deposit thickness	Deposit Description
001	0	0.66m	Mid brown silt
002	0.66m	0.29m	Silty clay similar in appearance to 001
003	0.95m	0.20m	Paler fine grained yellow brown clay
004	1.15m	0.67m	Red brown fine grained clay
005	1.82m	0.78m	Paler red brown clay with dark brown mud flecking
006	2.60m	0.01m	Black course sand
007	2.61m	-	Gravel

Context number	Depth to surface	Deposit thickness	Deposit Description
008	0	0.30m	Dark brown silty clay topsoil
009	0.30m	0.38m	Mid red brown silty clay with rare stone inclusions
010	0.68m	0.22m	Pale red brown silty clay
011	0.90m	0.18m	Darker red brown silty clay. Inclusions – tiny rounded pebbles and flecks of dark brown mud
012	1.08m	0.11m	Slightly paler red brown silty clay with pale clay spots and rare crumbling mudstone flecks
013	1.19m	0.54m	Pale red brown silty clay with red sandy flecks
014	1.73m	0.09m	Red clay – low silt content. No visible inclusions
015	1.82m	0.82	Slightly paler red clay – low silt content. No visible inclusions
016	2.64m	-	Gravel

Context number	Depth to surface	Deposit thickness	Deposit Description
017	0	0.32m	Dark brown loose silty clay topsoil
018	0.32m	0.26m	Subsoil – as above but with higher clay content

019	0.58m	0.77m	Red brown silt with crushed white stone and dark mud fleck inclusions
020	1.35m	1.65m	Red brown clay, dark brown flecks
021	3.00m	-	Gravel

Context number	Depth to surface	Deposit thickness	Deposit Description
022	0	0.10m	Mid brown silty clay topsoil
023	0.10m	0.60m	Light brown silty clay
024	0.70m	0.20 m	Red brown clay

Context number	Depth to surface	Deposit thickness	Deposit Description
025	0	0.21m	Dark brown silty clay topsoil
026	0.21m	0.44m	Light brown silty clay
027	0.65m	1.30m	Red brown silty clay
028	1.95m	0.13m	Red brown silty clay with frequent inclusions of angular and sub-angular grey gravel fragments
029	2.08m	-	Gravel
