7-11 Brookend Street Ross on Wye HEREFORDSHIRE

*Archaeological Trial Trenching
and Building Appraisal*

**May 2007
SMR 44555**

Hereford Archaeology Series 752

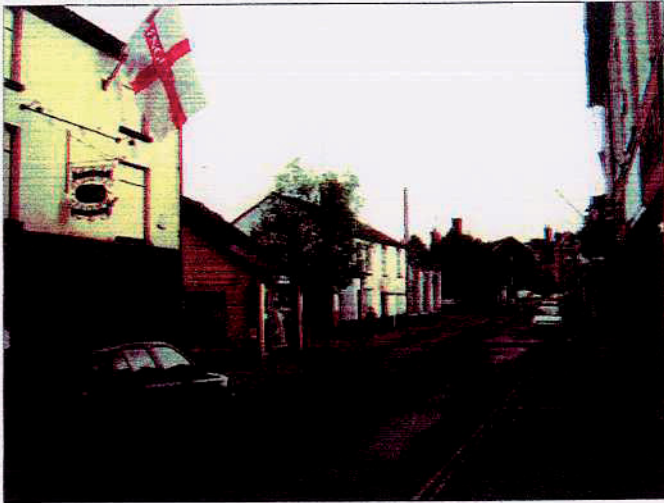
Figure 8. Brookend Street (facing north)

The original building consisted of a terrace of three buildings with a through passage to the rear of the properties. The main fabric of the row of “two up two down cottages” remains virtually intact despite the many alterations and additions. Constructed in red brick with stone

lintels and steps the building retains many original features within the external fabric (figs. 8 and 9).

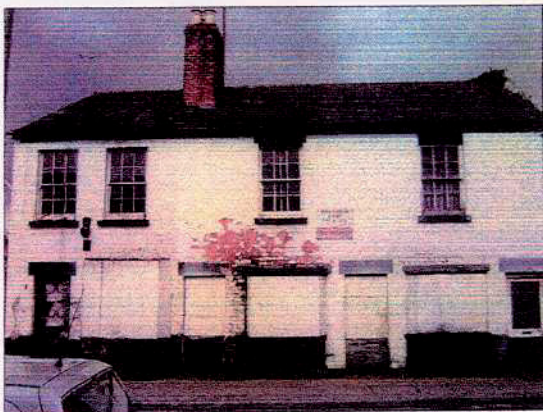
Figure 10. Numbers 9-11 front elevation

The first floor elevation retains four original 12 pane sliding sash windows; whereas the ground floor windows have been removed through the addition of flat roofed, three sided bay windows, projecting into the street (fig. 10).

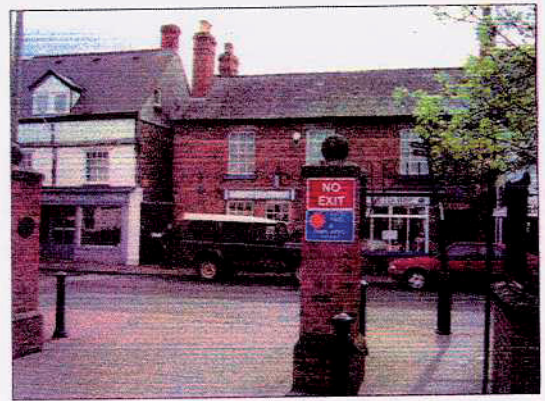
Figure 11. 'The Tea Cosy' on opposite side of Brookend Street

The original form of the building was best gained through examination and comparison with the building across the road, "The Tea Cosy" (fig. 11) where details such as windows, lintels, steps, doorframes and the decorative coursing below the eaves are repeated and retained, suggesting similar build dates.

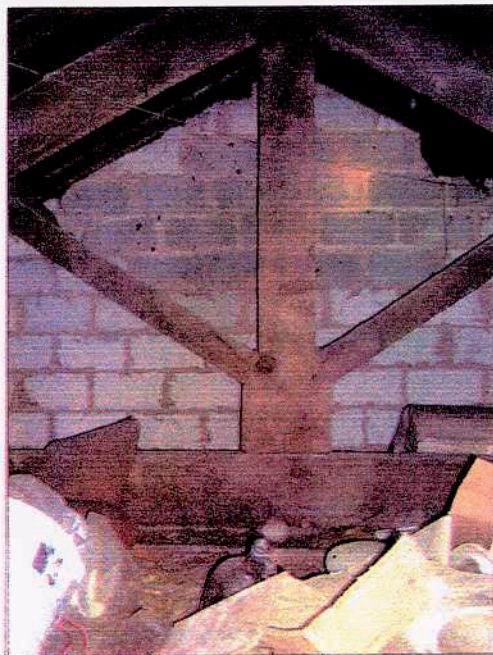
Figure 12. Internal roof structure

All bar one of the internal chimney arrangements have been blocked and removed, possibly as part of a later re-roofing phase of the buildings. Internal examination of the roof structure (fig. 12) showed a late constructed king post roof truss (surprisingly containing single pegged joints, and butted purlins). The trusses and the main tie beam were in remarkably good condition, the manufacture of the trusses being from machine cut timber on the basis of the straightness of the timbers.

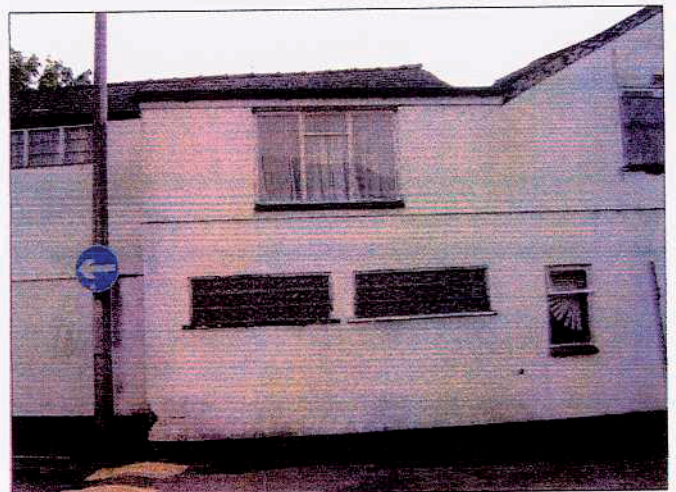
Figure 13. South facing elevation

The re-roofing of the building probably occurred when it was extended into the yard behind the property, resulting in a wider ground plan from the original terraced plan, this was also evident in the internal roof and the difference in pitch between front and rear of the property when viewed from the side (fig. 13).
