# Rooms 1-4 of the West Wing Witley Court Worcester

*Archaeological monitoring of excavations and building recording.*

Hereford Archaeology Series 745

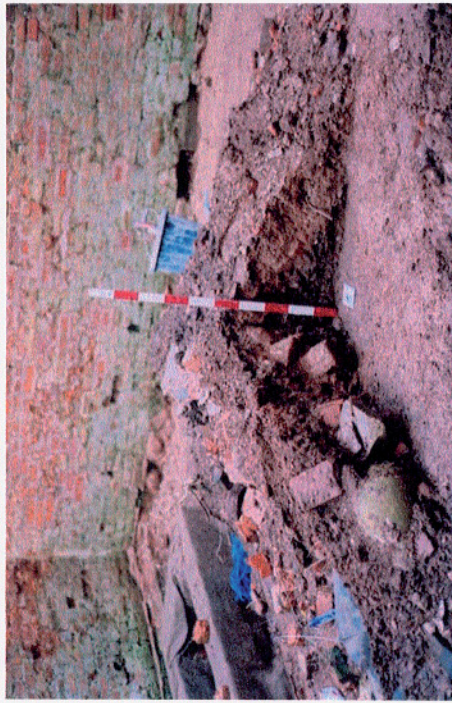
Plate 1, Spoil heap from the stone chamber in Room 2 during excavation.

The spoil heap was divided into quarters then two opposing quarters (SE and NW) were excavated (Plate 1). The excavation revealed that three layers relating to distinct fills could be identified. The uppermost layer on the spoil heap, which had presumably been the primary layer (102) was a red-brown mixed deposit consisting of sand, mortar and silt. Brick, mortar fragments and stone were included in the fill as well as a plastic soft drink bottle and an aluminium lager can.

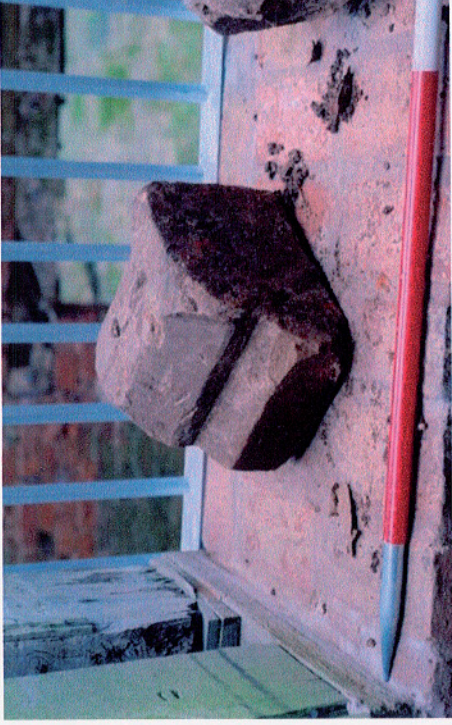
Plate 3, Broken 17th c. lintel from below the earth floor in Room 1 (Small Find 1).

The excavated stones were examined. The two largest pieces (SF 1 and SF 2, Fig 3) were moulded red sandstone, and appeared to be broken window sills or more likely, lintels (Plates 3 and 4). The mouldings were identical on both pieces. The stones measured 0.28m wide by 0.20m high. One was 0.285m long to its broken end, the other was 0.40m long. The top face of the stones measured 0.12m wide with chamfered edges to angled stops. On the top face was a central glazing slot and a 1" (2.5cm) V shaped socket, for either a glazing rod or a bar.

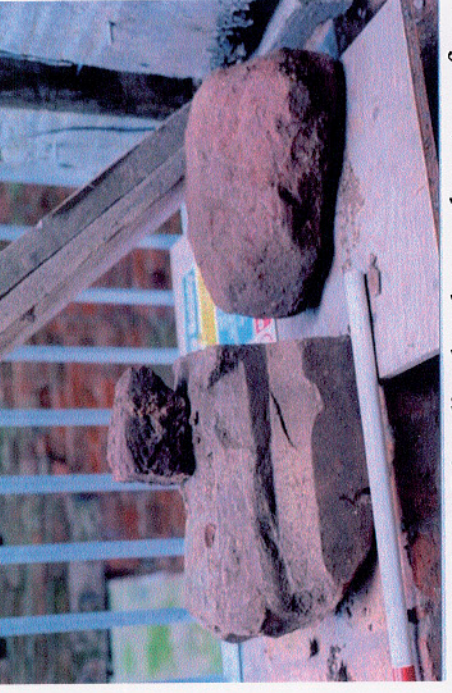
Plate 4, Broken 17th c. lintel and two other stones from below the earth floor in Room 1 (Small Finds 2, 8 and 9).

The other two stones (SF 8 and 9) removed from 1002 were also red sandstone (see Plate 4). Neither were dressed or obviously tool marked, both were very worn and had no diagnostic features.

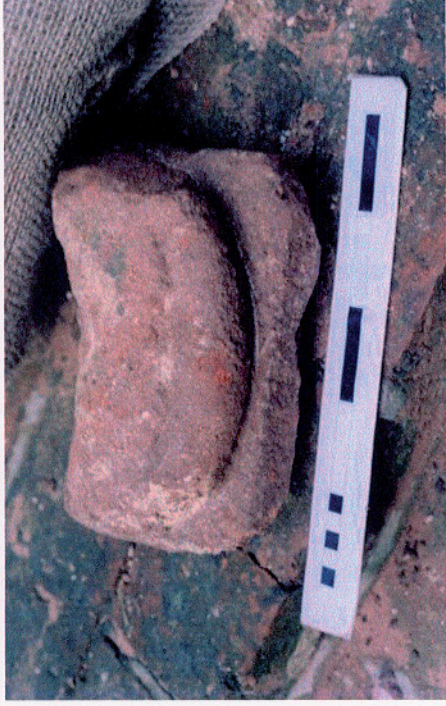
Plate 6, Broken 18th/19th c. baluster base from the floor of Room 3 (Small Find 7).

Finds from the layers mostly dated to the 19<sup>th</sup> century, or were modern (as in rooms 1 and 2). A piece of moulded stone baluster (SF 7), probably dating from the late 18<sup>th</sup> century or early 19<sup>th</sup> century was found within layer 3001 (Plate 6). The stone was creamy coloured Oolitic limestone (Bath stone) with mouldings consisting of a 3.25cm deep, square shaped base with a collared roll on top. The details above the collar were lost as the stone was broken off at an angle at this point. Under the square base was a roughly cut, rounded plug, the face of which was 2.5cm deep and appeared to have been roughly cut back to a curve. On the underside and central to the base was a recessed lozenge, about 7cm long x 3mm deep (Plate7).

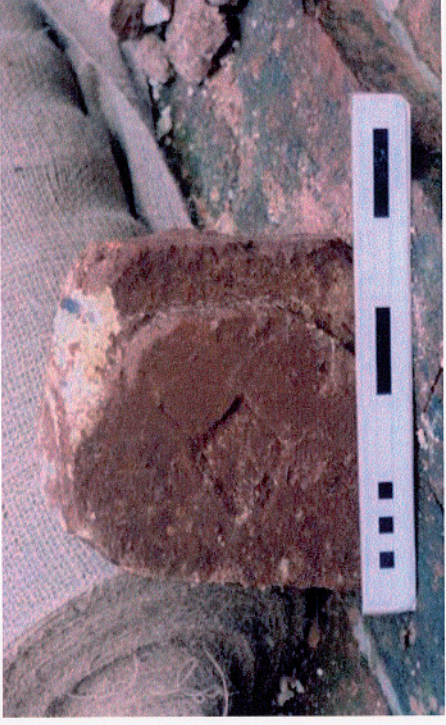
Plate 7, Broken baluster base (Small Find 7) viewed from below, shows lozenge cut into the base and cut back edge.

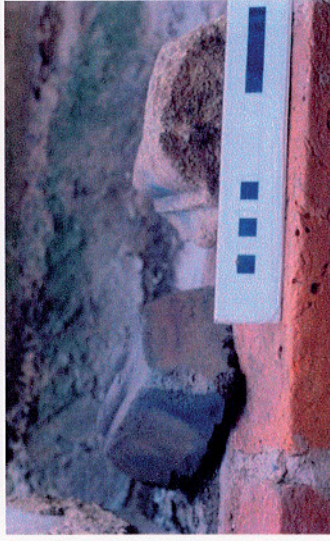
Plate 10, Broken 18th or 19th c. Bath stone moulding, and 19th c. broken fire brick (Small Finds 5 and 6) from Room 4.

A fragment of battered moulded Bath stone (SF 5) which probably dated to the later 18<sup>th</sup> or 19<sup>th</sup> centuries was also found in layer 4001. The moulding appears to include a roll to a fillet with the start of possibly another roll (Plate 10).

Also coming from 4001 was a broken piece of red-brown ceramic brick/tile (SF 6) measuring 15cm long by 10 cm wide by 5cm deep with 2 raised rounded bars, both 1cm wide by 1cm high (see Plate 10). The piece had an angled corner with two faces sloping at approximately 45°. The piece appears to be a fragment from a fireplace.

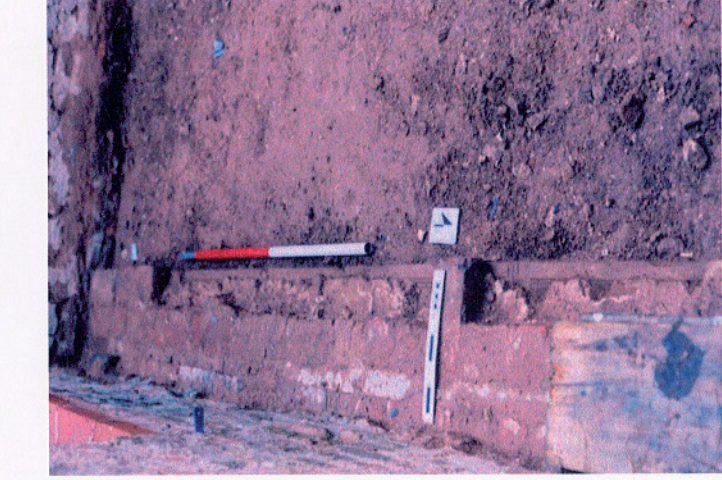
Plate 12, Room 4, ledge along the west wall re-using 17th c. transom/mullions.

As the excavation of Room 4 progressed, rows of bricks butting the east and west walls were left proud exposing an underlying line of cut and dressed stones. On closer inspection the stones were identified as being more of the same red sandstone mullions and transoms already excavated from within the room (see small finds 3 and 4) and dating to the 17<sup>th</sup> century. At least twelve pieces had been re-set and re-used along the walls to level the brickwork that was used to carry the timber floor in Room 4. Many of the pieces appeared to be complete, if a little damaged in some cases with spalled mouldings (Plates 11, 12).

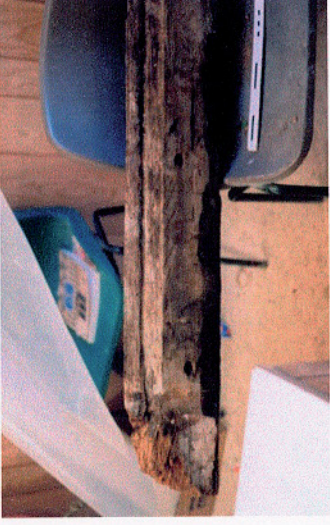
Plate 13, Moulded timber re-used as a lintel from the doorway between Rooms 1 and 2 (showing the good side).

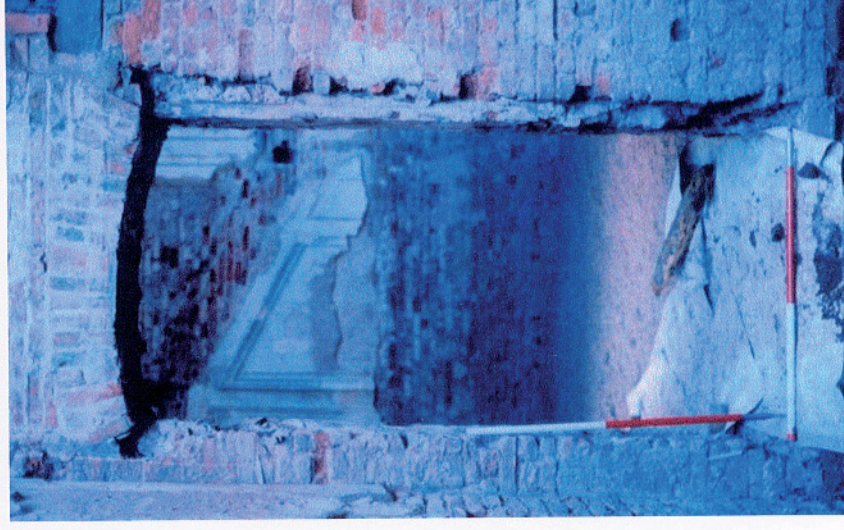
Plate 15, Doorway between Room 1 and the stair tower, unblocked.
