Bartestree Convent **HEREFORDSHIRE**

Archaeological watching brief and photographic survey

Hereford Archaeology Series 803

Monitoring of ground works and photographic survey

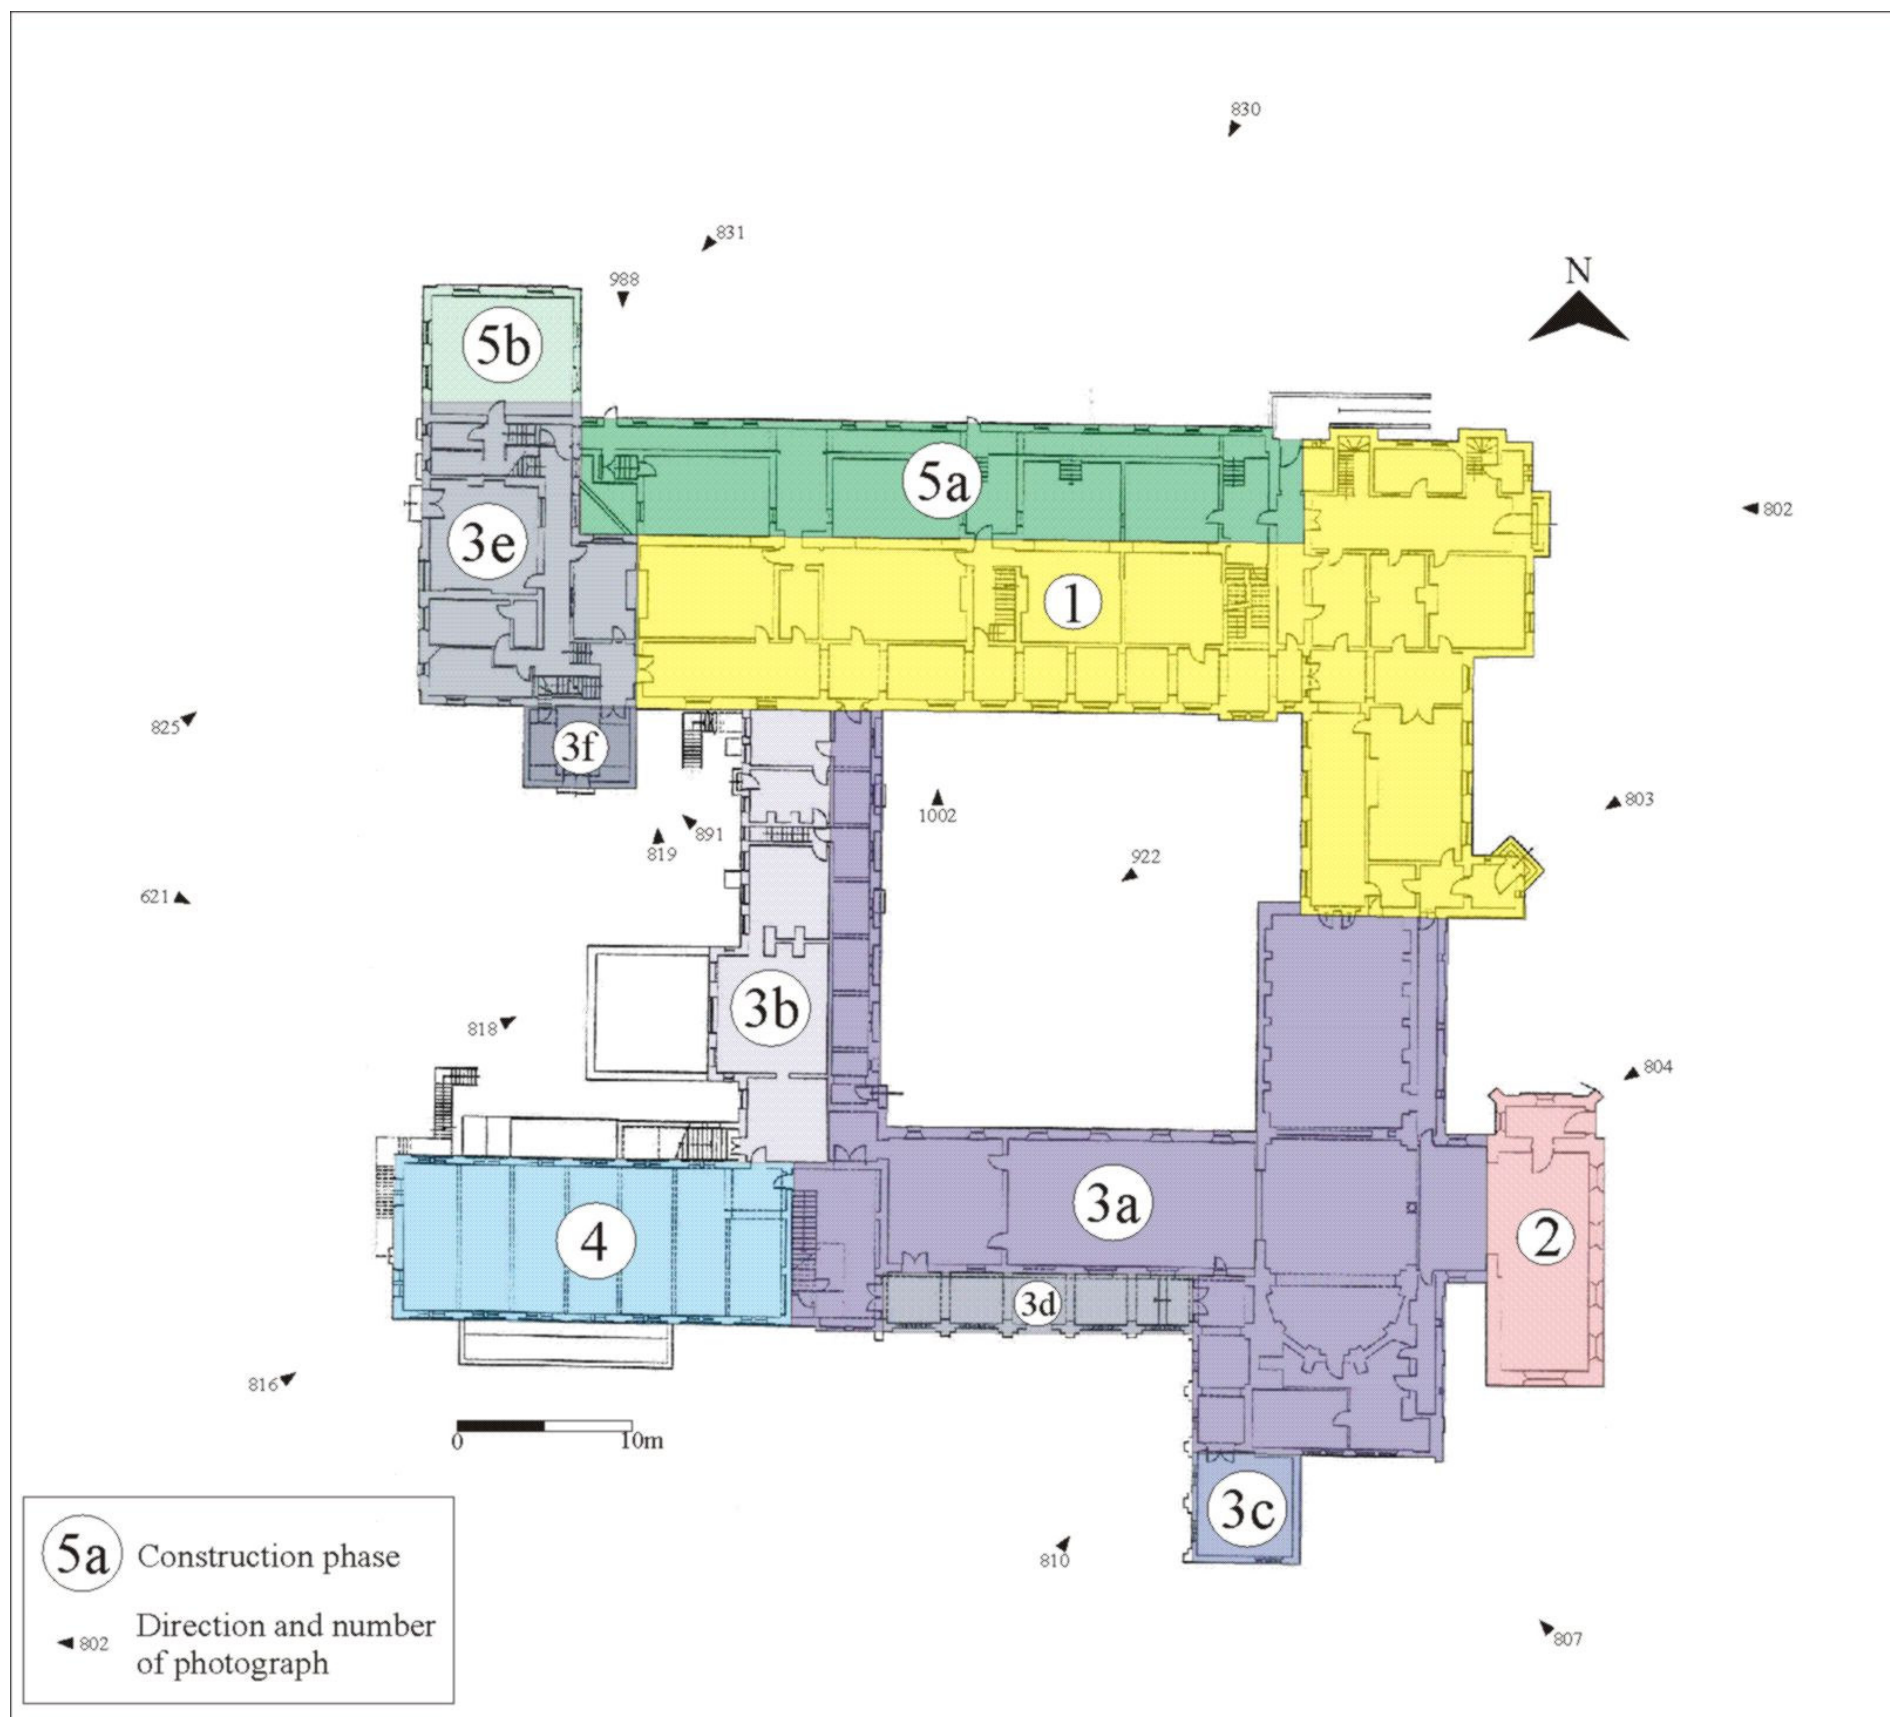
Figure 4b

Construction phases of Convent and photograph location

Used in conjunction with historic maps and research alongside a site visit, the photographic survey has helped to establish the different phases of construction of the Convent.

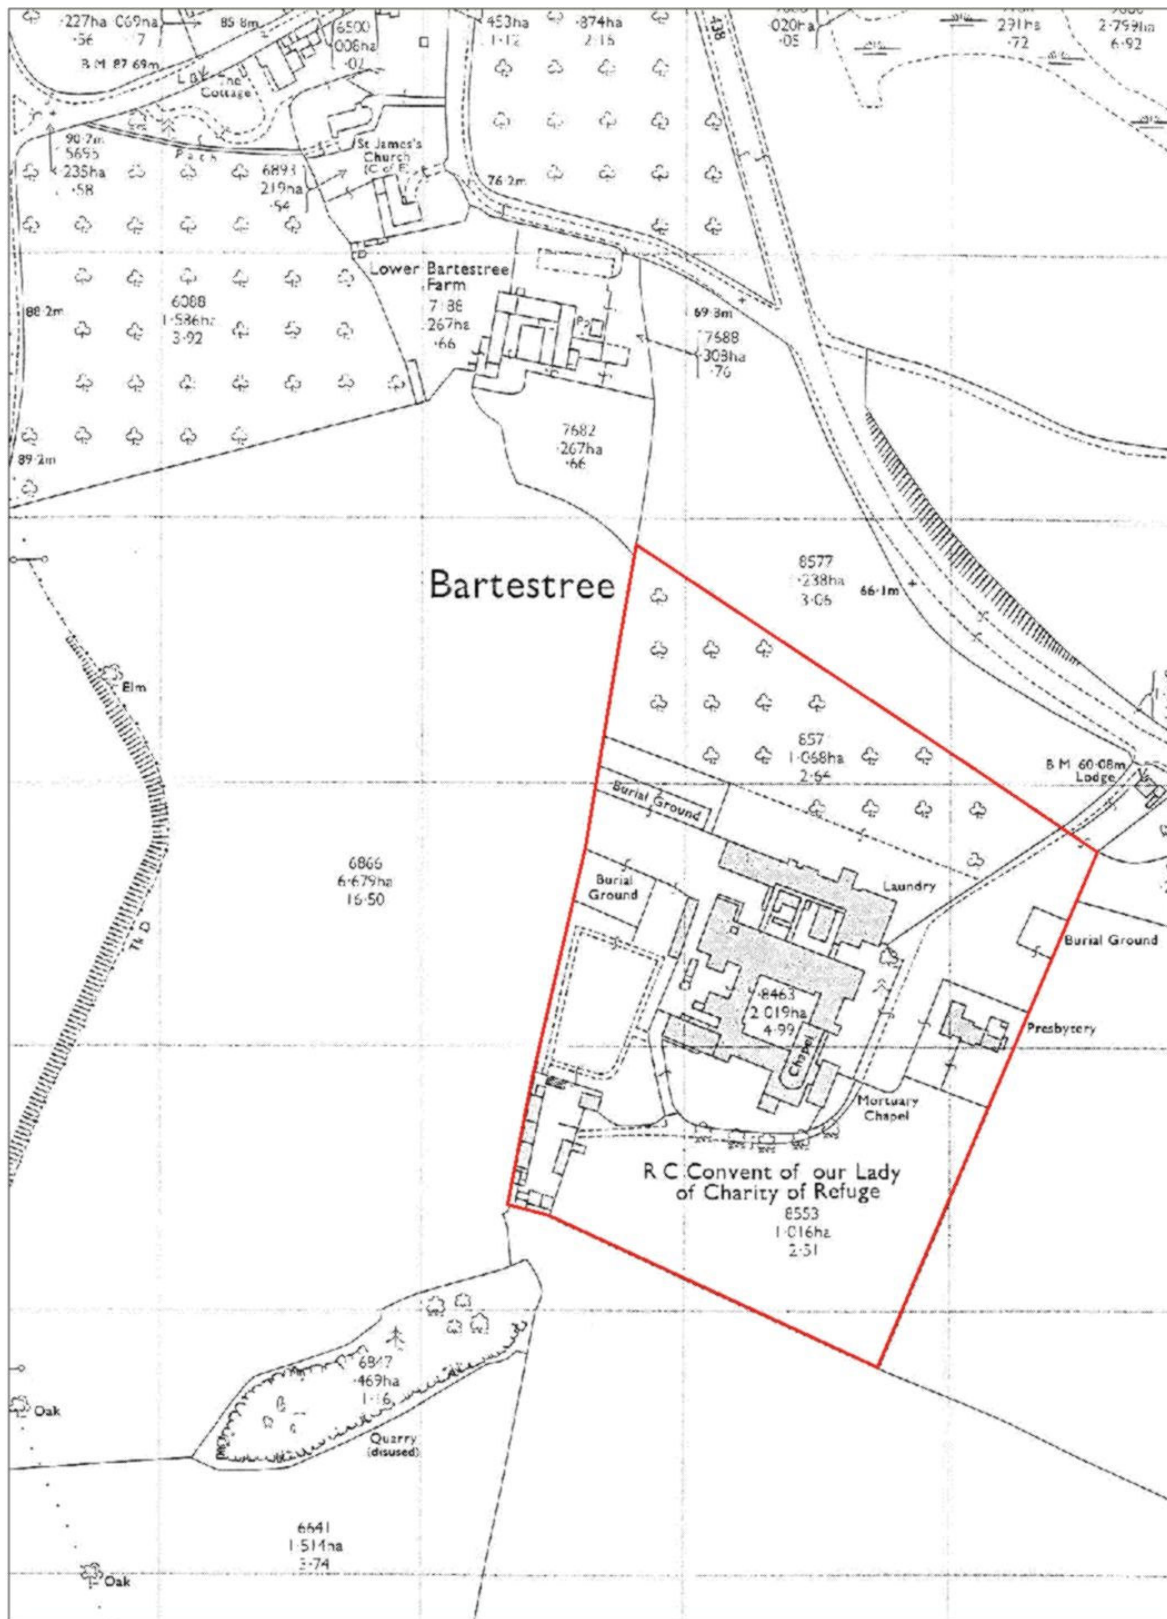
1971 Ordnance Survey map

A single storey room at the southernmost point of the convent does not appear on any historic maps of the site until 1971 (Fig. 9). No construction break could be found between this structure and the Phase 3a structure, however, and it is the authors belief that this structure belongs to Phase 3 (Plate 1; 810).

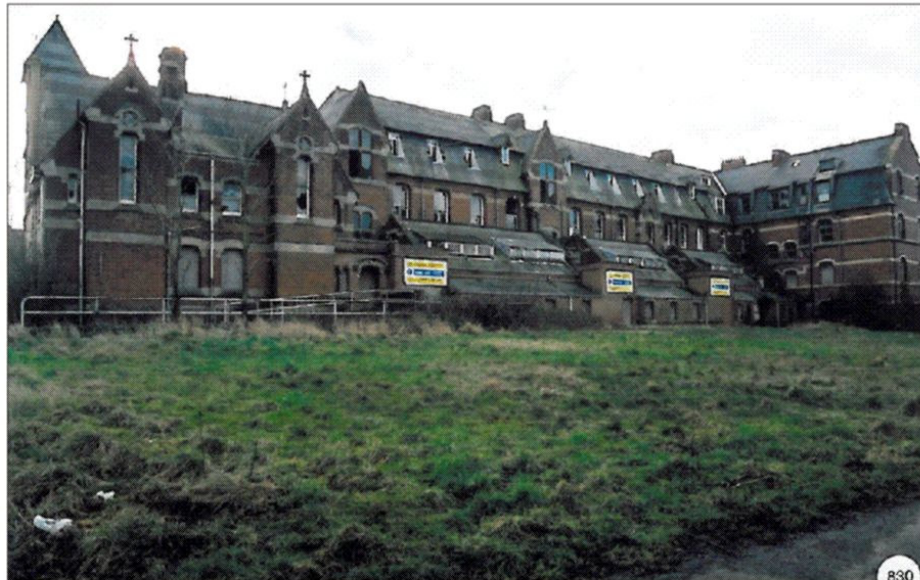
830

A single storey building was constructed adjacent to the northern elevation of the Phase 1 structure (Plate 2; 830). As a result of this, modification of the Phase 1 northern elevation has taken place with the insertion of large, arched openings to provide a thoroughfare between the Phase 1 building and the Phase 5a extension.

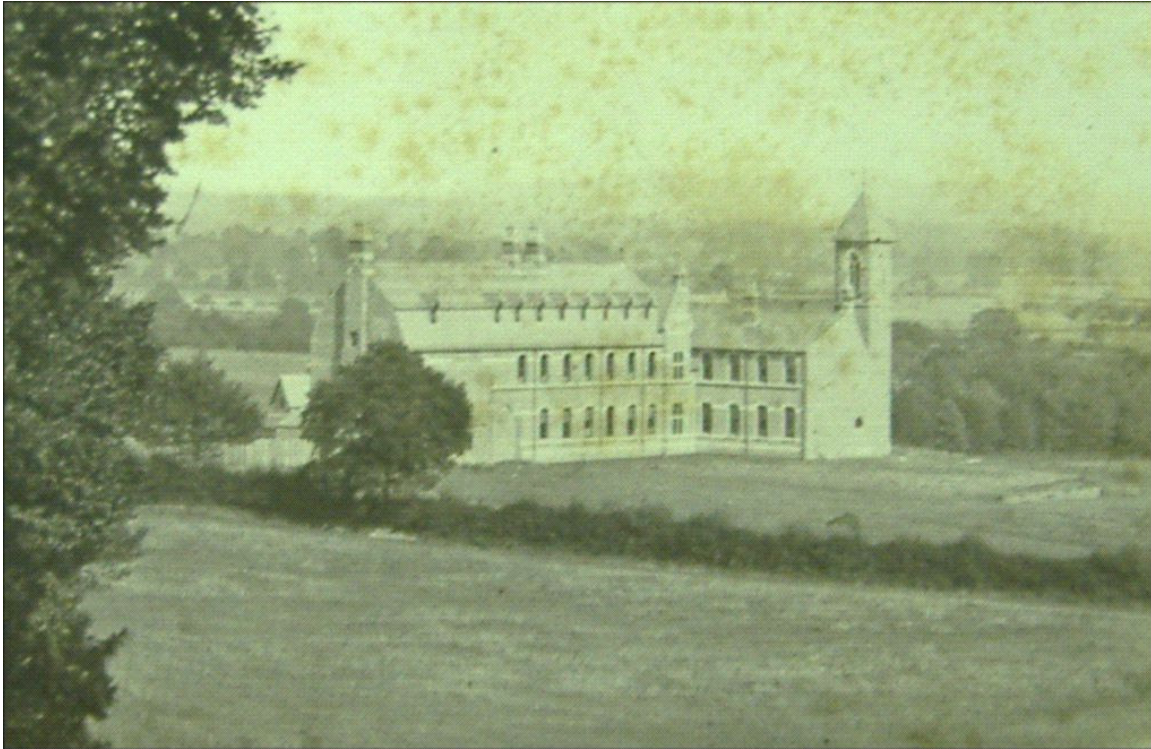
Plate 4

Phase 1 convent c.1863. View looking northwest. Reproduced courtesy of Herefordshire records office. BE/14/27/1-14

The north range and east range were constructed by Pugin in a Gothic style (Plates 4 & 5). An Italianesque tower stands at the southwest corner of the structure with an entrance porch below. The porch and tower are set at a 45° angle to the rest of the building and face northeast. The buildings were constructed from red brick. The window lintels are stone and a continuous stone band links the lintels.

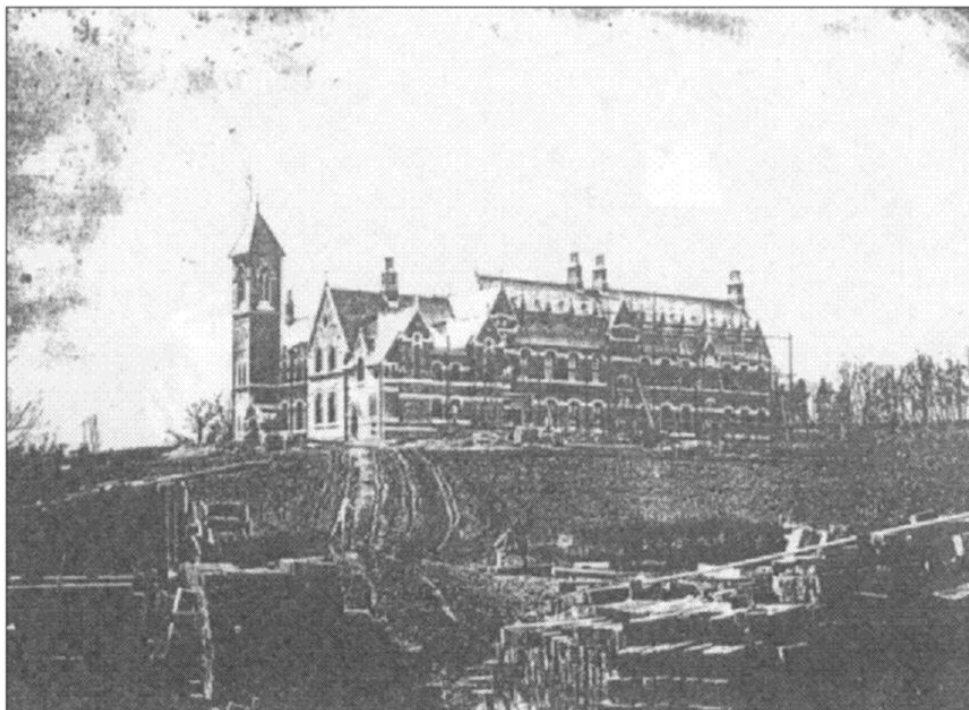
Plate 5

Convent under construction, March 1863. View looking southwest. Reproduced courtesy of Herefordshire Records Office. BE14/27/12

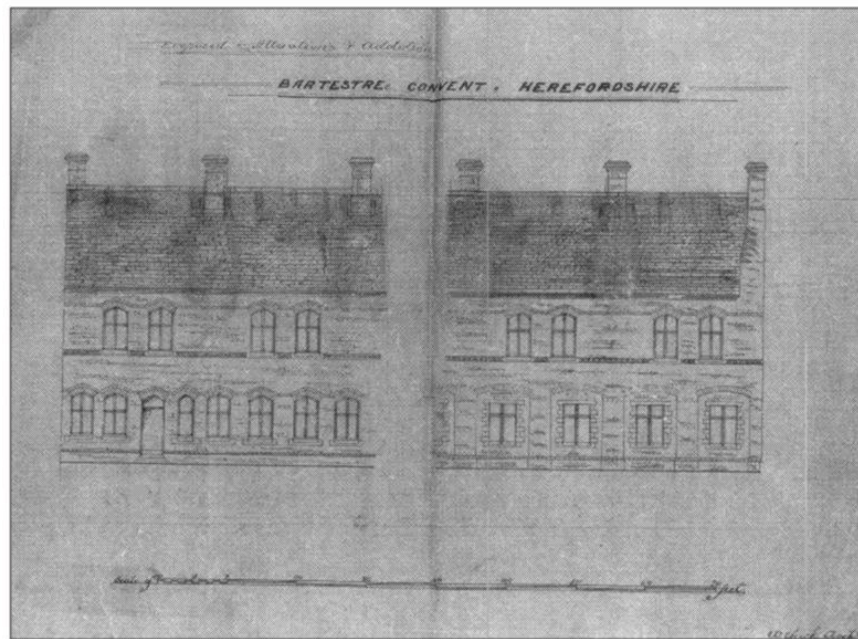
Proposed alterations and additions to kitchen and butlery by William Chick. Courtesy of Herefordshire Records Office, BE14/29
