# THE DUNGEON, GOODRICH CASTLE HEREFORDSHIRE

*Excavation and building recording*

**November 2008**

Hereford Archaeology Series 807  
SMR 48682

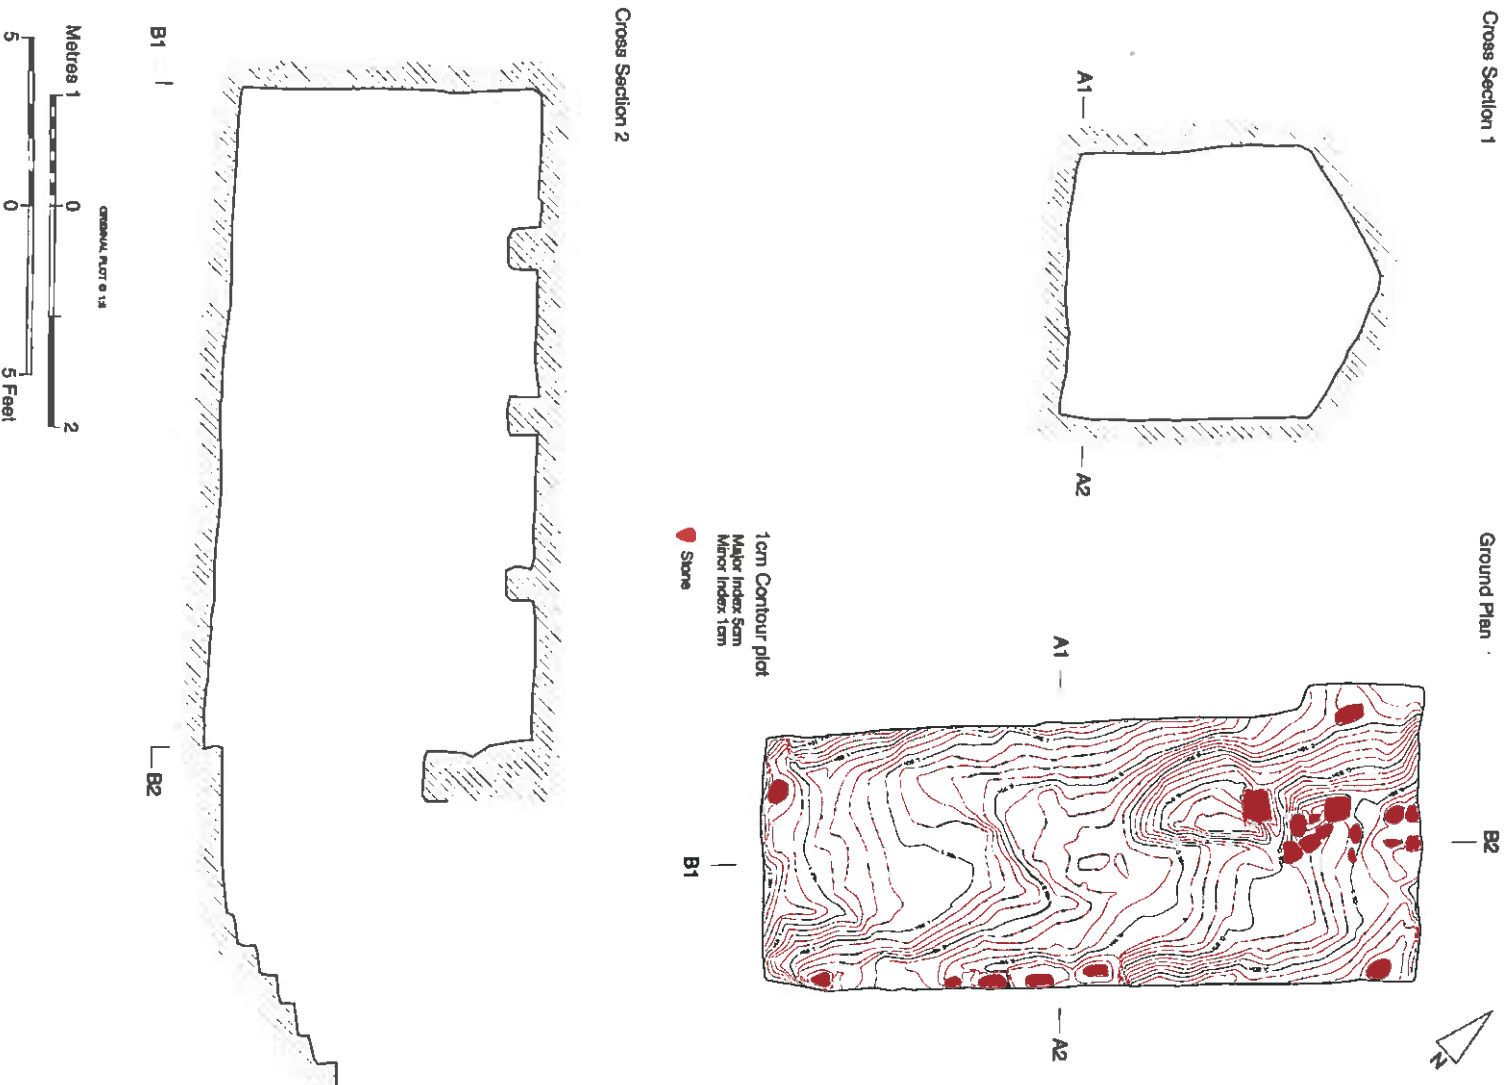
A contour plan of the floor was created showing the irregular surface and an interior survey of the building was created (Figure 3). Along with the photometric survey of the floor (Appendix 1.Black and white photos archive, shots 1-24), a photographic survey of the walls was compiled (Colour photos archive, Shots 2-36). A large hole at the top of

The contour survey results show that the interior dimensions of the dungeon are not symmetrical, with the width varying from 2.75m at the entrance, to approximately 2.35m at the rear. The internal height is 2.85m and the length is 6.05m. The surface rises by 35cm from the entrance to the rear wall which explains why the water pools at the front of the dungeon.

Figure 3. Contour plan and cross sections of Goodrich Castle Dungeon

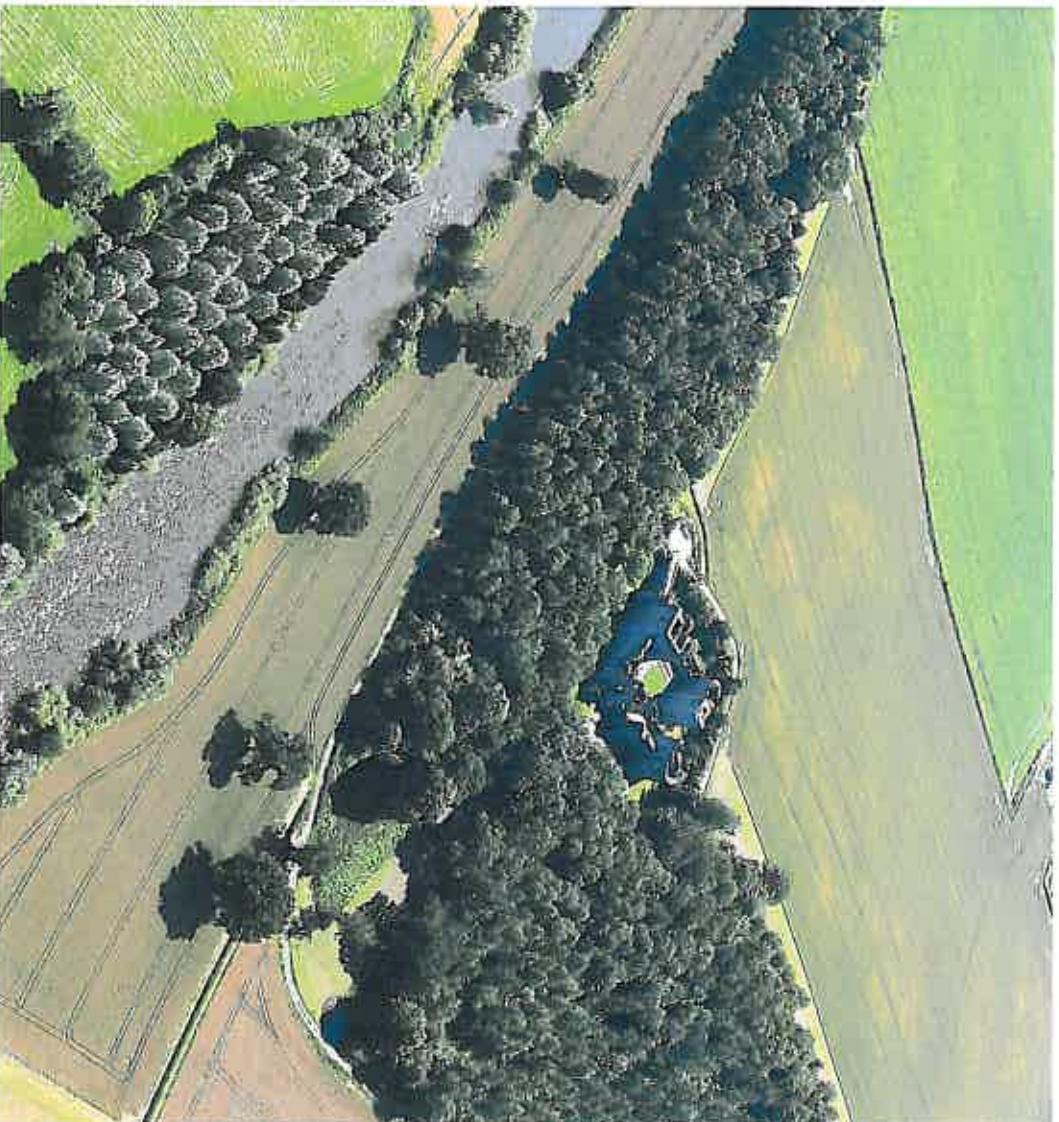
**Plate 1. Goodrich Castle. Situated in a prime location overlooking the river Wye**

Goodrich castle is situated on top of a wooded hill and occupies a key position overlooking the Wye Valley to the south of Ross-on-Wye (Figure 1, Plate 1). The geology of the area is Old Red Sandstone.

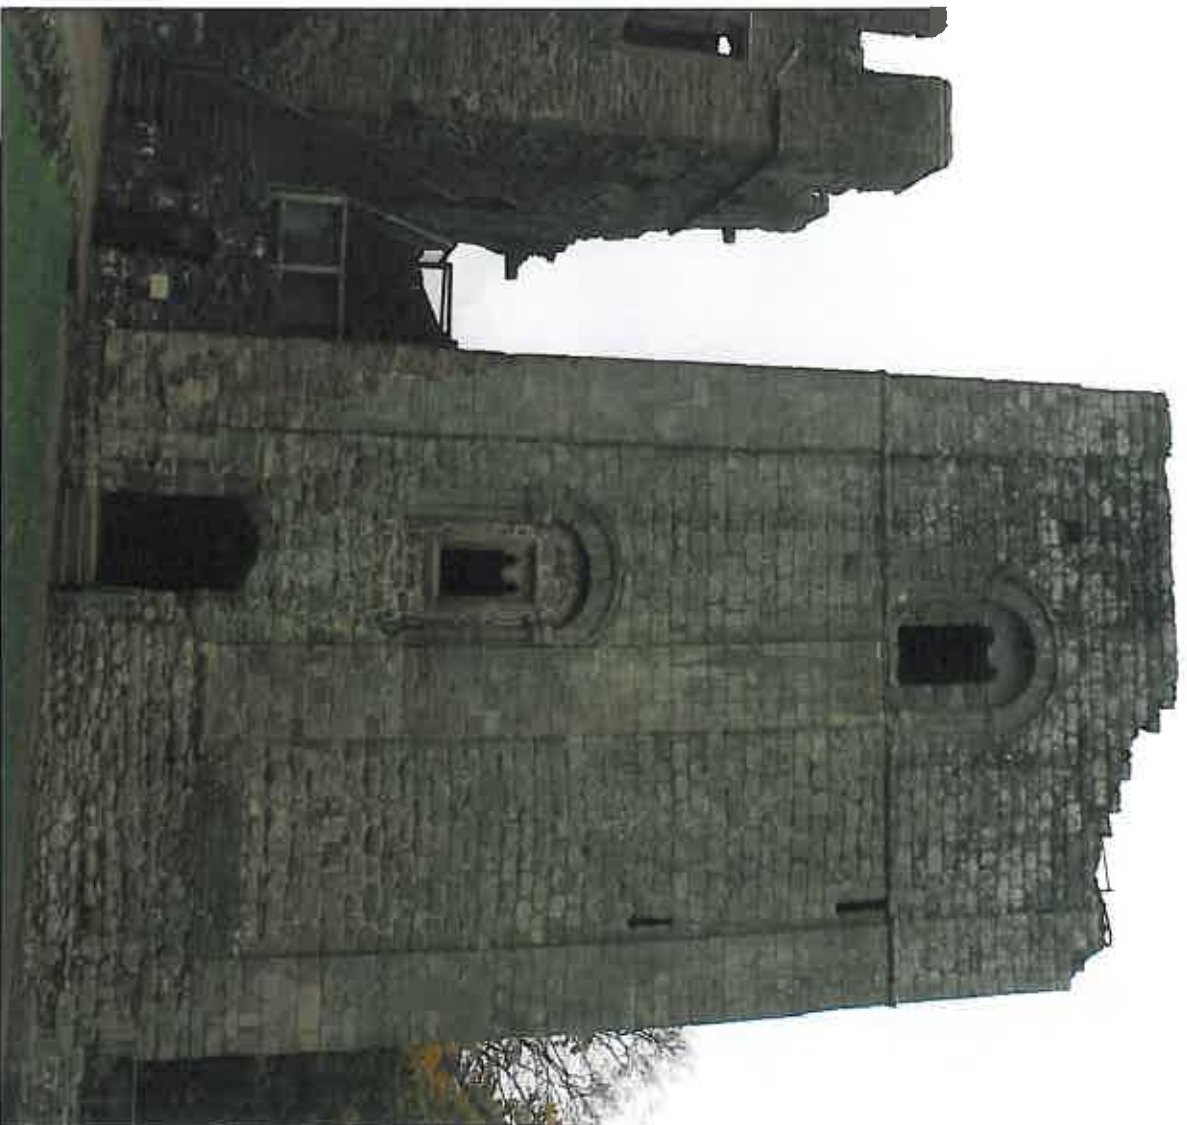
The dungeon is four bays deep with a vaulted ceiling and constructed from coursed ashlar of a grey, conglomerate sandstone on a bedrock surface. Its northwest wall, of poorly-coursed rubble, is more or less underneath the southeast wall of the keep (Figure 1, Plate 2). The surface of the dungeon covers an area of approximately 6m by 2m. The dungeon lies beneath the rubble and deteriorated stonework of the platform and steps that were once above it. In the 19<sup>th</sup> century it was described as:

Plate 2. The dungeon adjoining the southeast wall of the keep

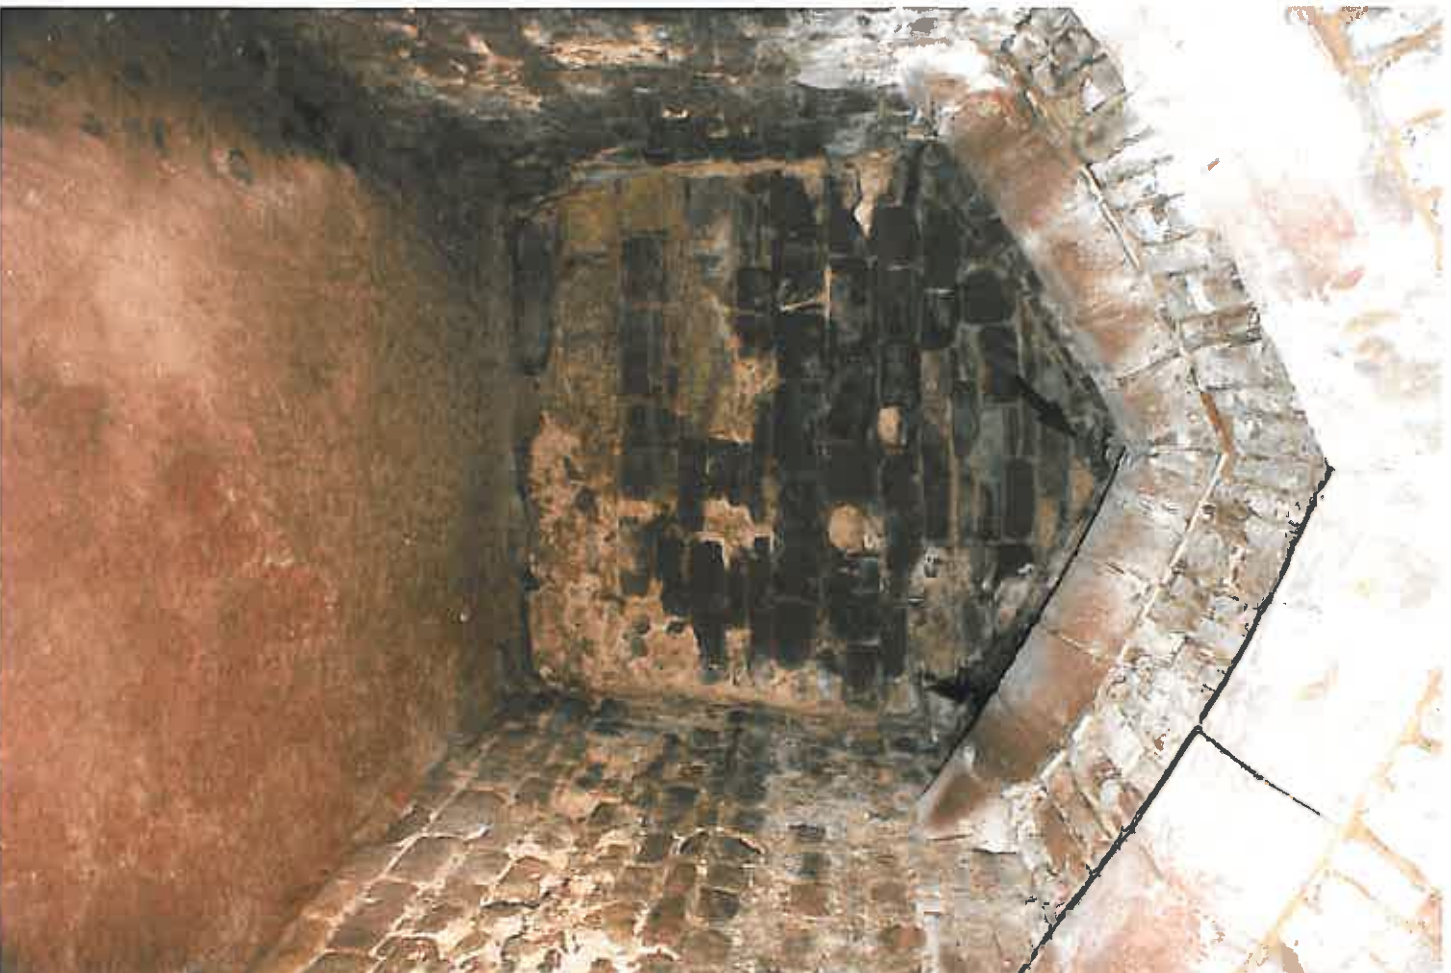
the rear wall is visible (Plate 3). The function of this is unclear and it may be the result of damage or deterioration of materials. A large recess is also apparent on the northwest wall (Plate 4) and again its function is unclear. The resealed passage to the keep, noted in HAS 73, on the NW wall is clearly visible (Plate 5). A few stones were uncovered near the entrance (Plate 6) and within the gully which runs down the southeast wall (Plate 7).

The rear wall appears to have been heavily reconstructed, possibly during restoration, as the blocks are larger than those in the other walls and there is evidence of scotch mortar and fragments of glass in other mortars (Plate 9). The large hole at the top of this wall may be the result of damage or deterioration of materials.

Plate 3. Hole at the top of rear dungeon wall and red sandstone bedrock surface

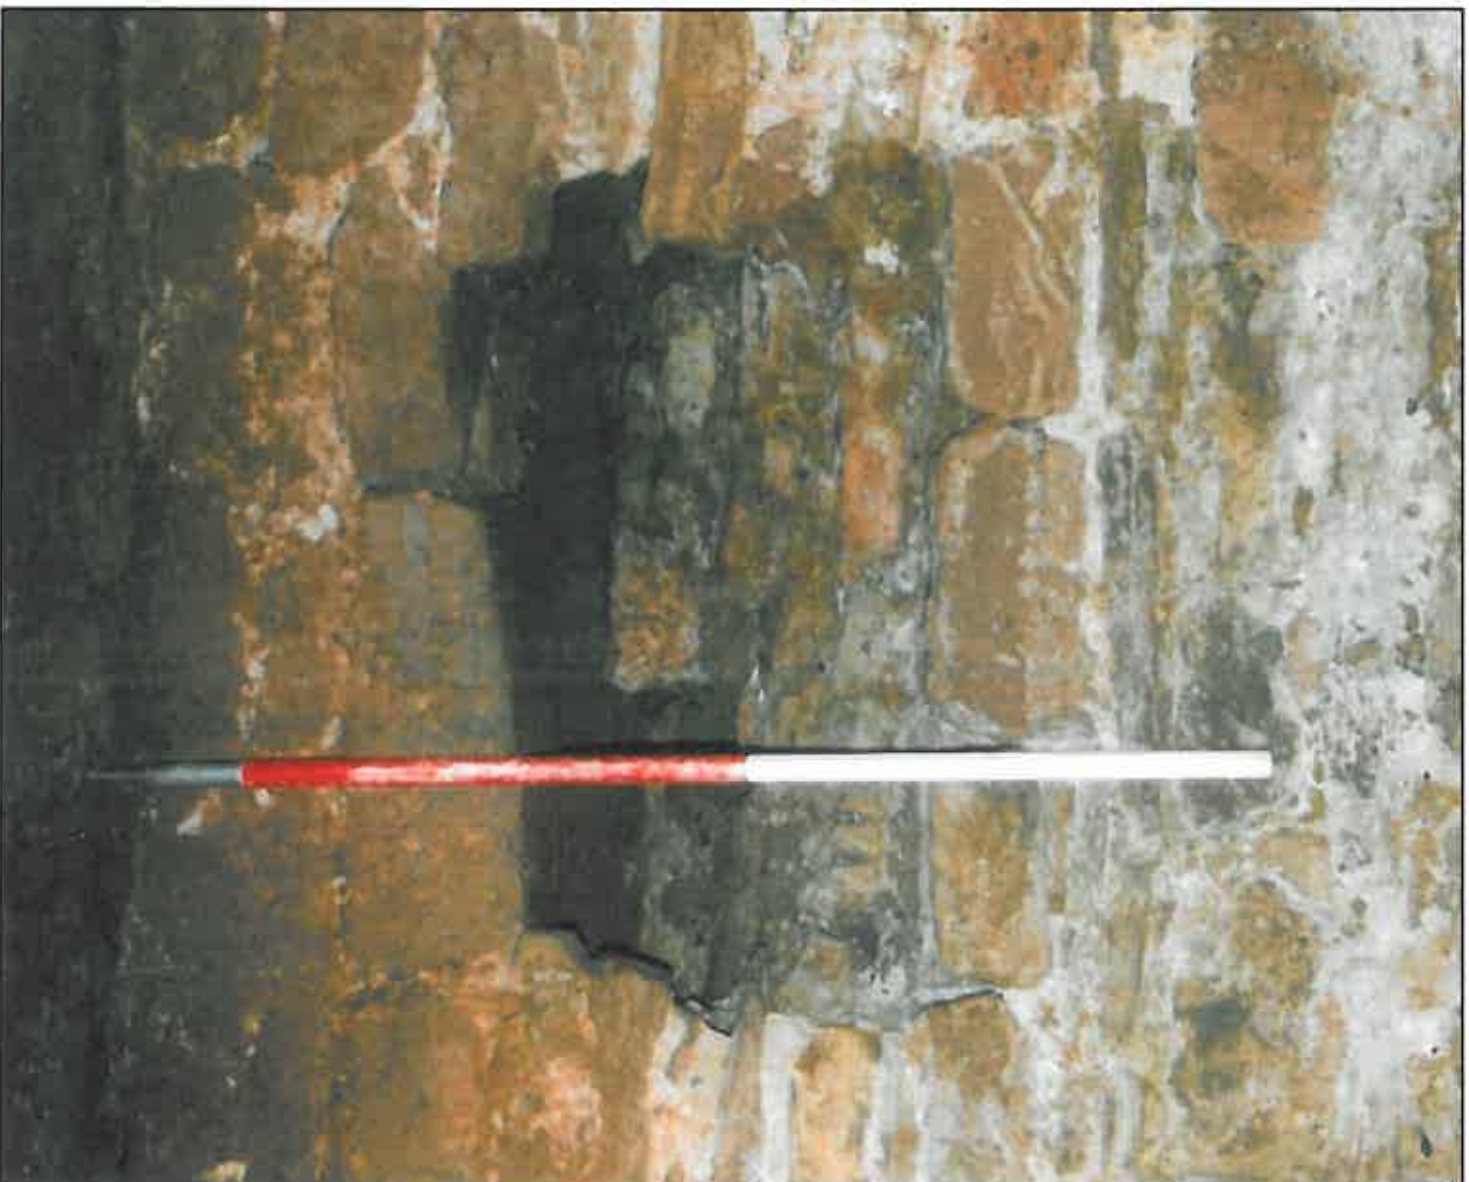
The small recess in the northwest wall (Plate 4) has an uncertain function. It could have been purpose built if this room was later used as storage or it may be the result of a collapse in the wall at some point.

Plate 4. Recess in the northwest wall

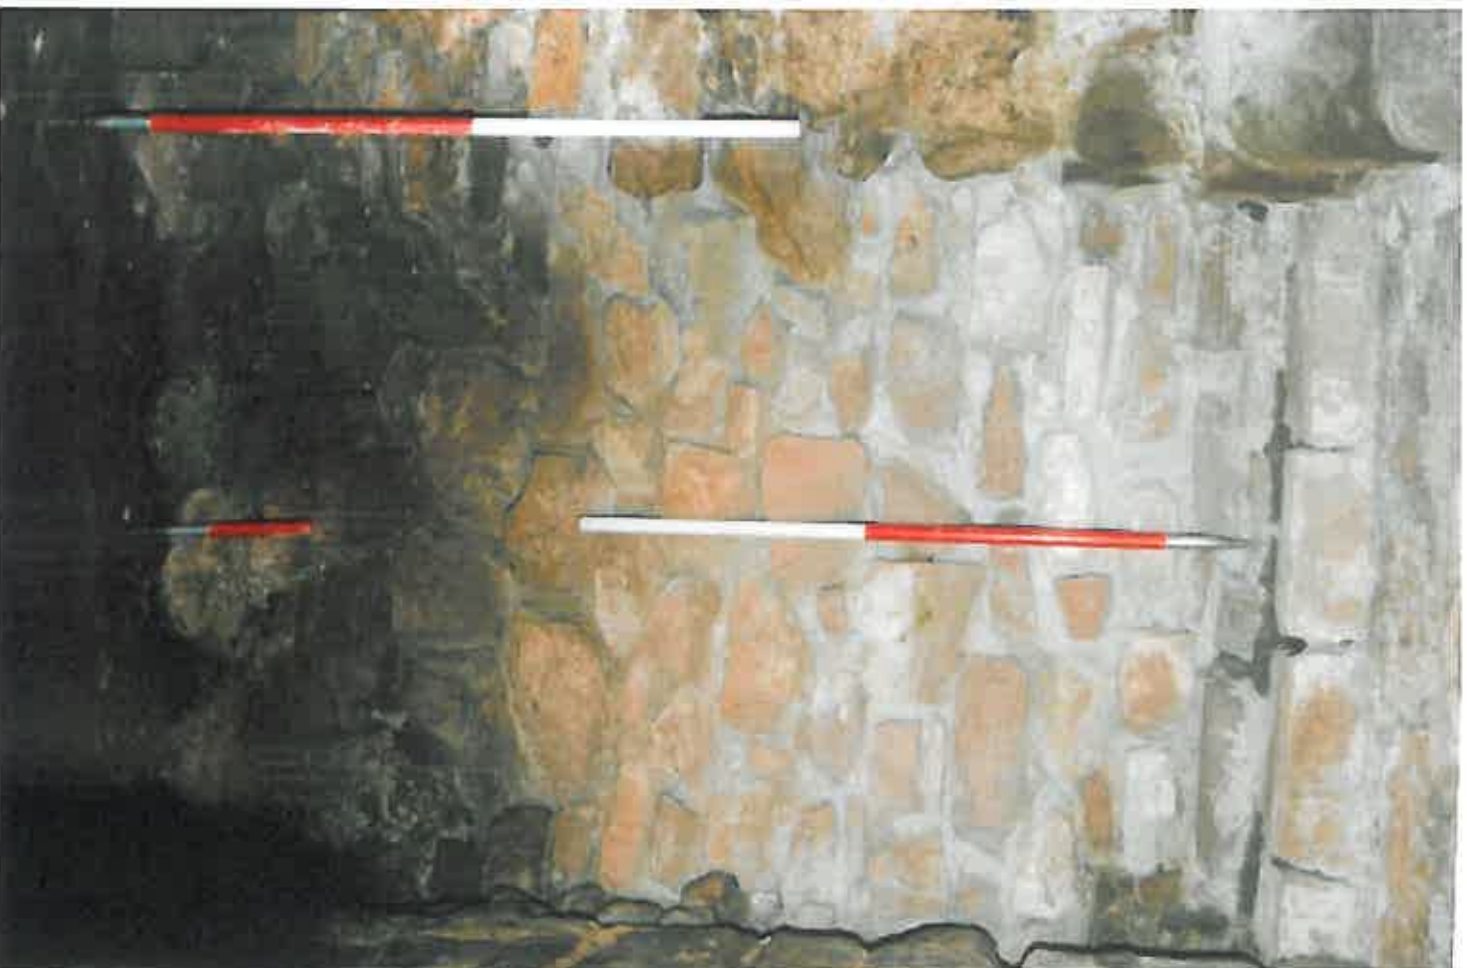
In the northwest wall of the dungeon at the northern end there was a rough opening (Plate 5), now blocked with core work set about 0.4m from the lost wall face. This was a passage that lead directly into the ground floor of the keep. From inside the keep the corresponding opening is now obscured by a modern wooden staircase and is set back from southeast wall. In the early 19th century this rough opening was described from inside the keep as:

Plate 5. The resealed opening on the northwest wall leading to the keep

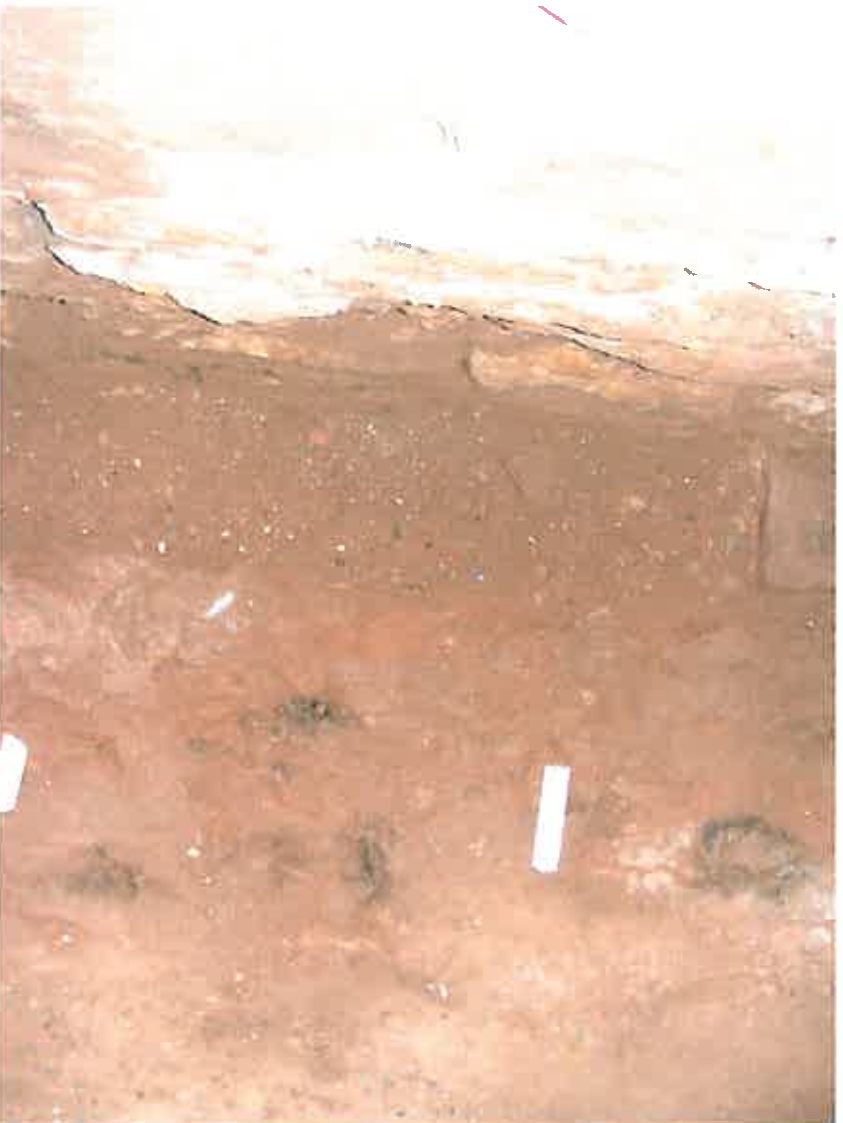
The modern gravel was removed from the dungeon floor to reveal a surface of Old Red Sandstone bedrock. The surface was very irregular with a gully running down the southeast wall (Plate 7). This gully contained a few square stones. It is quite possible that this gully may be a remnant of the footings trench for the southeast wall when the dungeon was constructed. The stones within may have been placed here in an attempt even out the floor surface. It seems feasible that the other stones uncovered near the entrance may have served the same purpose. It is unlikely that there would have been a laid stone floor in a building designed to be a dungeon when the bedrock would have served this purpose.

Plate 7. Gully which runs down the southeast wall. Possible remnant of a footings trench for the southeast wall of the dungeon

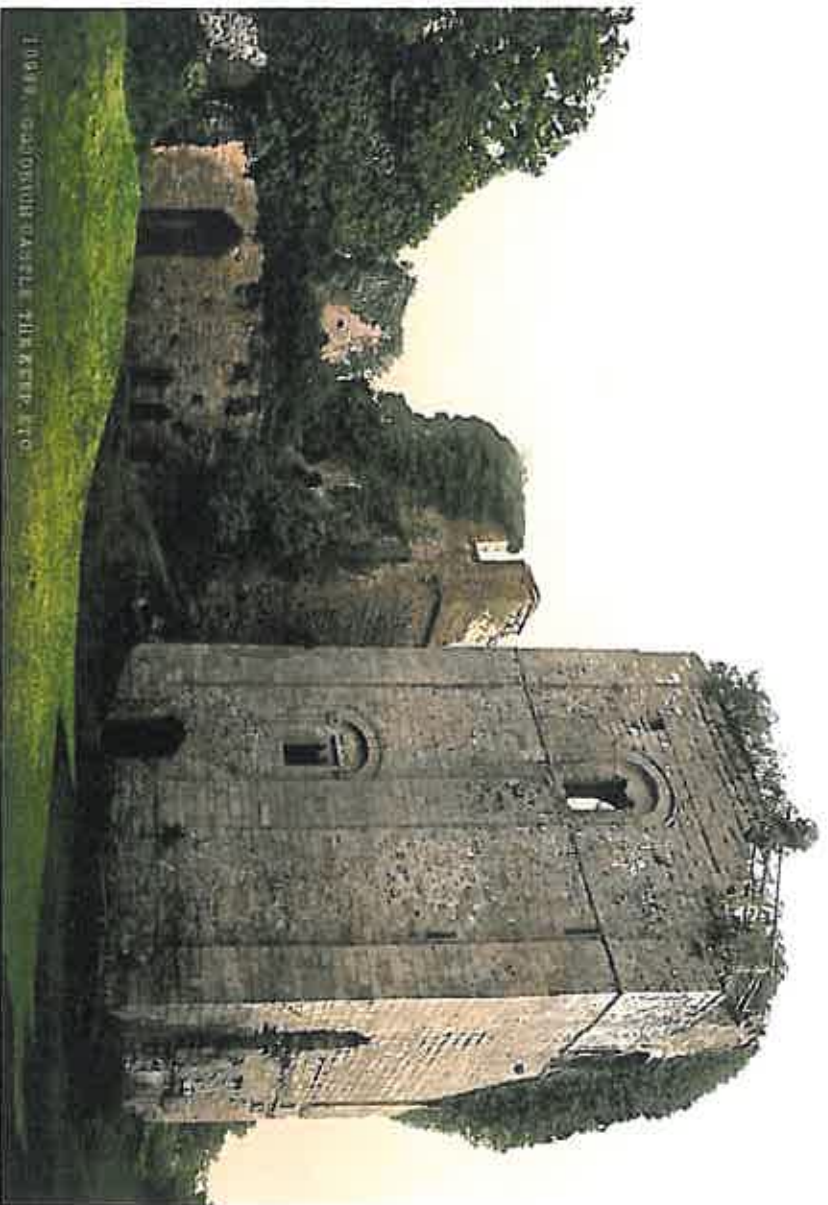
Plate 8. A photo from c. 1890-1900 showing the overgrown steps leading to the keep and no apparent entrance to the dungeon (Courtesy of the Library of Congress Prints and Photographs Division Washington, D.C. 20540 USA)

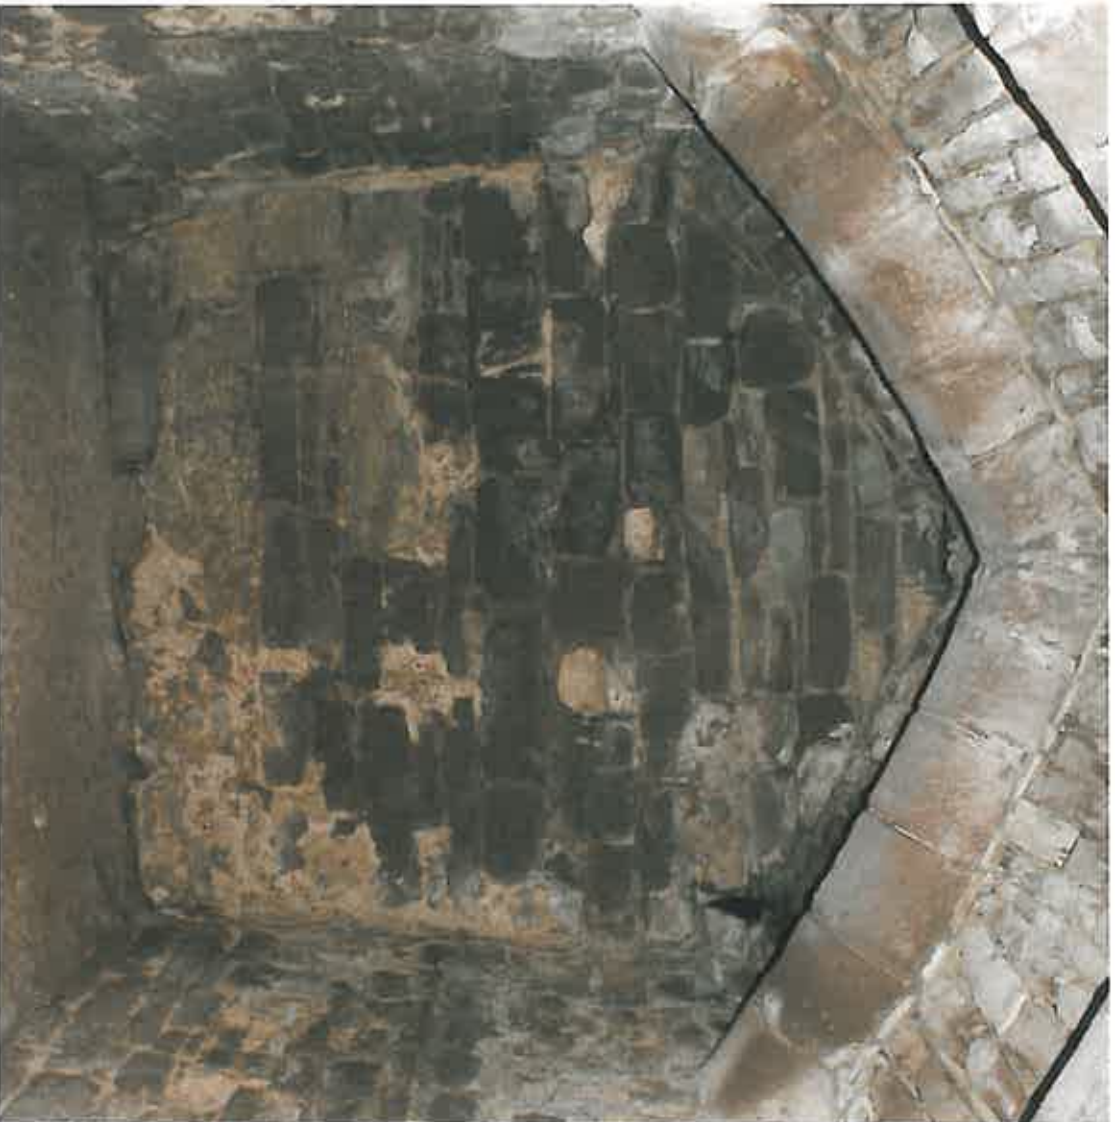
Plate 9. The rear wall of the dungeon with obvious signs of repair and maintenance
