# **Goodrich Castle Solar Arch Pier Capital and Remedial Work Herefordshire**

*Historical Conservation and Building Recording*

*Hereford Archaeology Series 805*

# **GOODRICH CASTLE SOLAR ARCH PIER CAPITAL AND REMEDIAL WORK**

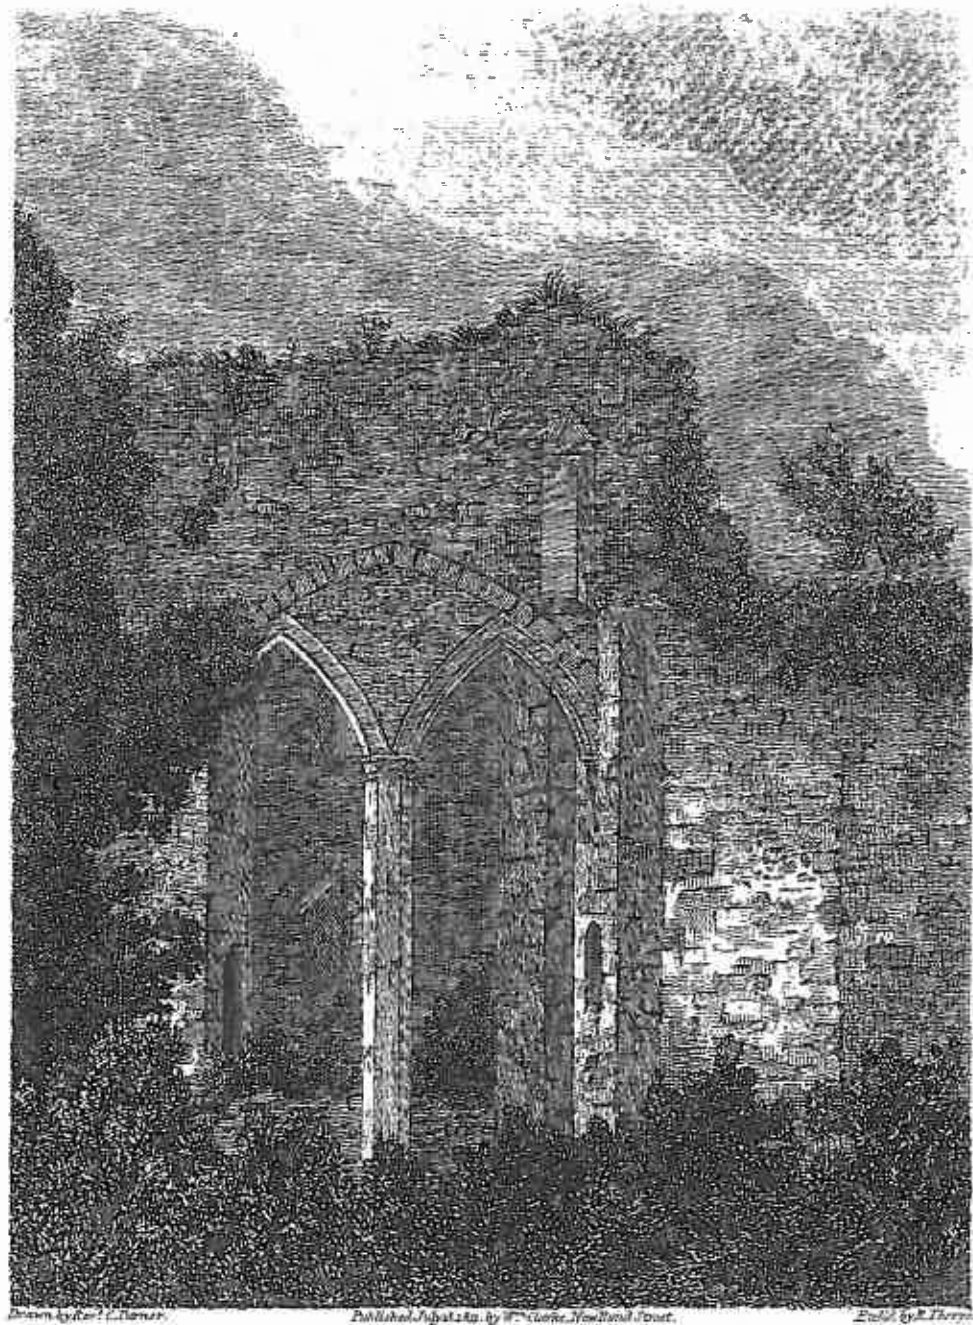
Figure 3. Rev. C Turner's sketch of the Solar Arch showing some detail on the capital

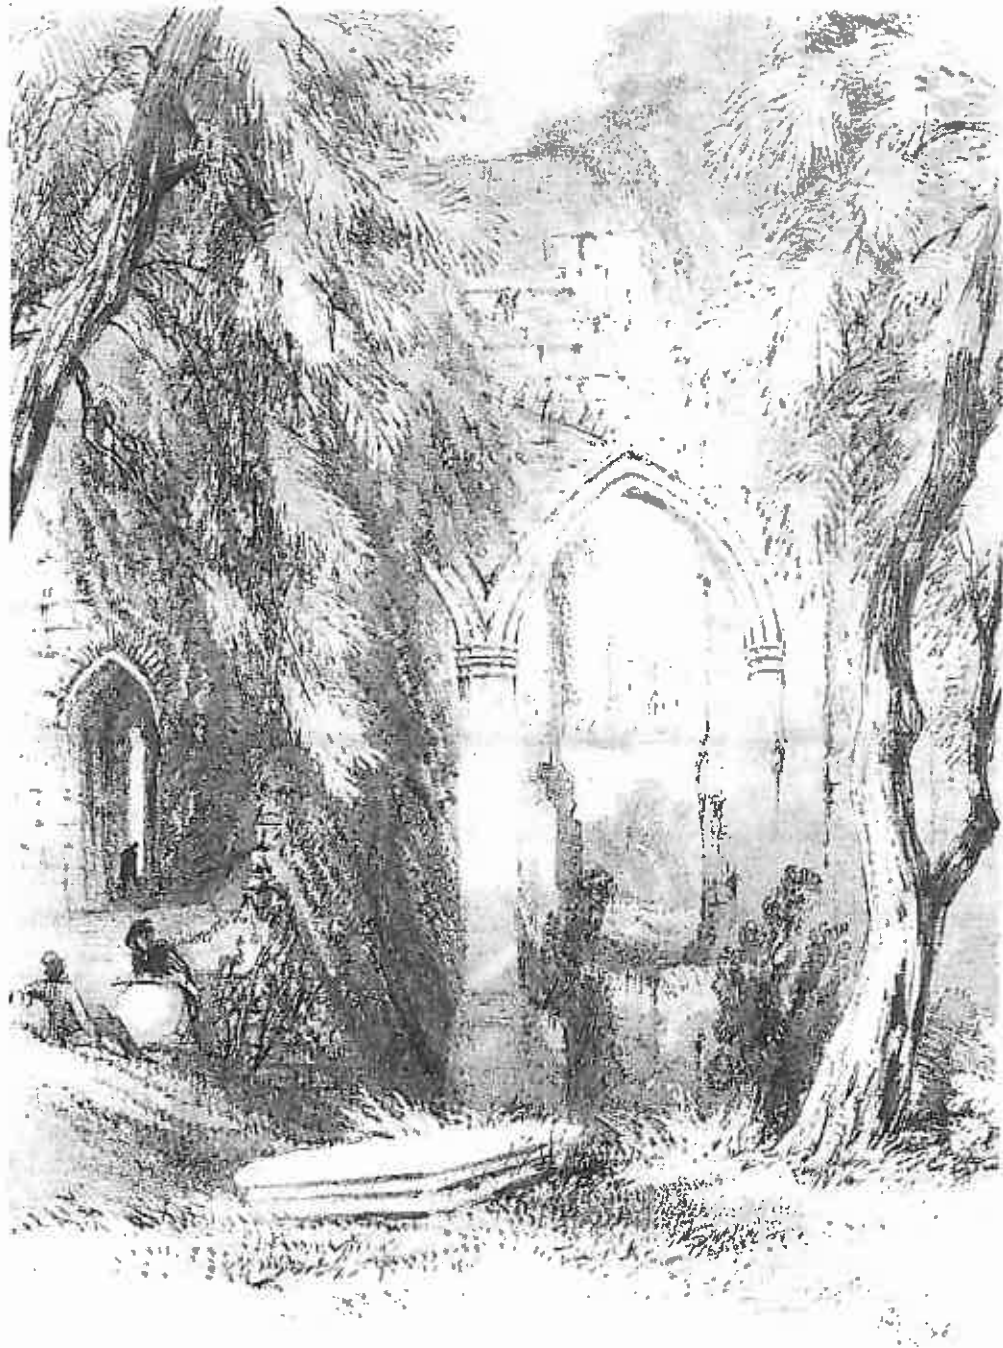
Figure 6. An engraving of 'Goodrich Castle and Court' in 1840(?) showing a four component moulded capital

Goodrich Castle appears to have caught the imagination of artists in the early 19<sup>th</sup> century as there are quite a few illustrations, sketches and engravings of the North Range from this period. A sketch by Rev. C. Turnor published in 1811 shows the Solar Arch and walls of the North Range but the detail of the capital is again lacking (Fig 3.). More artistic renderings of the Solar Arch and North Range prevail throughout this period, such as those published by Thomas McLean in 1822 (Fig 4) and by J.S Prout in 1832 (Fig 5). An engraving dating from circa 1840 is the one of the first to show the pier capital in any real detail. It clearly depicts the capital in good condition with four projecting components (Fig 6).

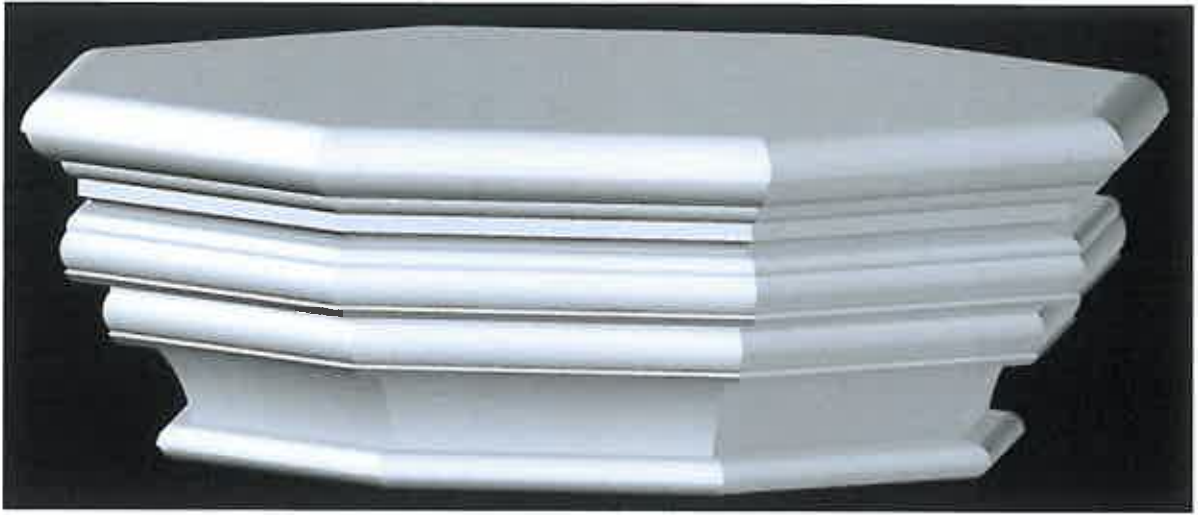
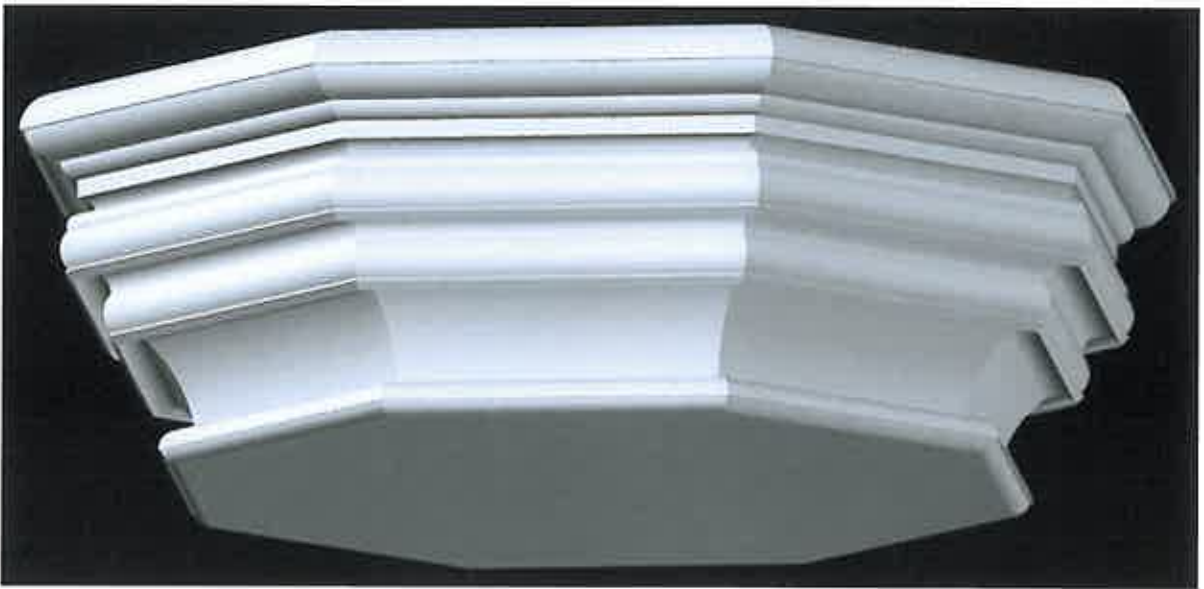
Figure 8. Goodrich Castle. Final design Solar Arch Pier Capital

Archaeological Investigations created a number of profile designs incorporating these proposals and after discussions with all involved parties a final design of the moulding was agreed upon (Fig 8). This design favoured using a scroll on the abacus and the necking, rather than the roll and fillet simply because this design is more resistant to erosion in the external environment. The upper and lower bell remained as Dr Morris suggested.

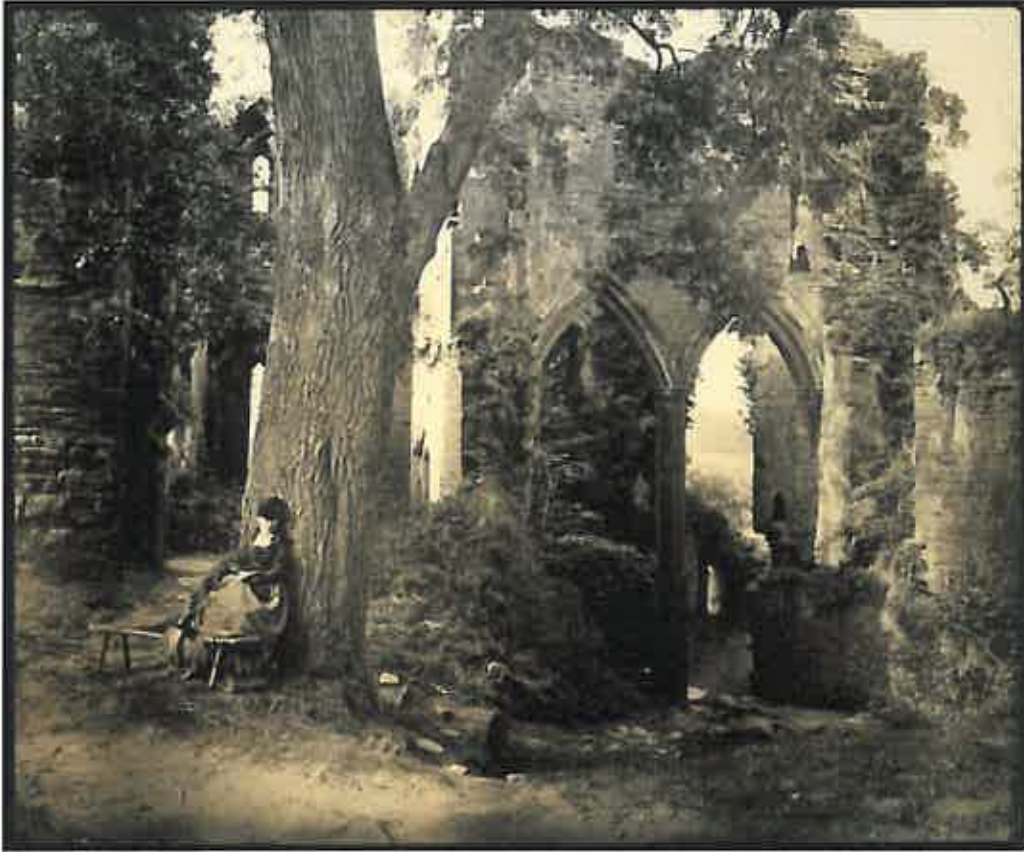
Plate 1. A photograph from c.1668 by Captian George Bankhart showing an overgrown North Range and Solar Arch in the Background.  
(Photograph courtesy of George Eastman House. Ex collection A E Marshall)

A photograph from 1868 (Plate 1) confirms that there were indeed four projecting components on the capital moulding. These components, looking from top to bottom on the capital are the abacus, bell upper, bell lower and necking. This picture clearly shows the effects of erosion on the capital as there are visible vertical face fractures on the bell upper and the bell lower (Plate 2). Erosion continued to be highly detrimental to the condition of the pier capital through to its replacement in December 2006.

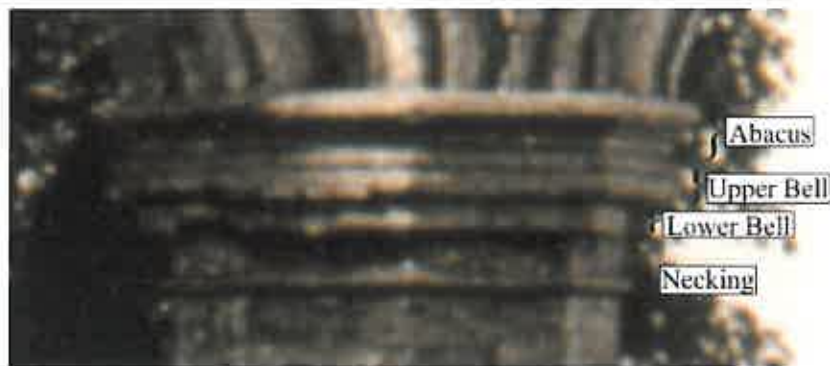
Plate 2. Enlargement of the capital from the c. 1868 photograph with added description of the four moulded components. The effects of erosion are clearly visible on the upper and lower Bell. (Photograph courtesy of George Eastman House. Ex collection A E Marshall)

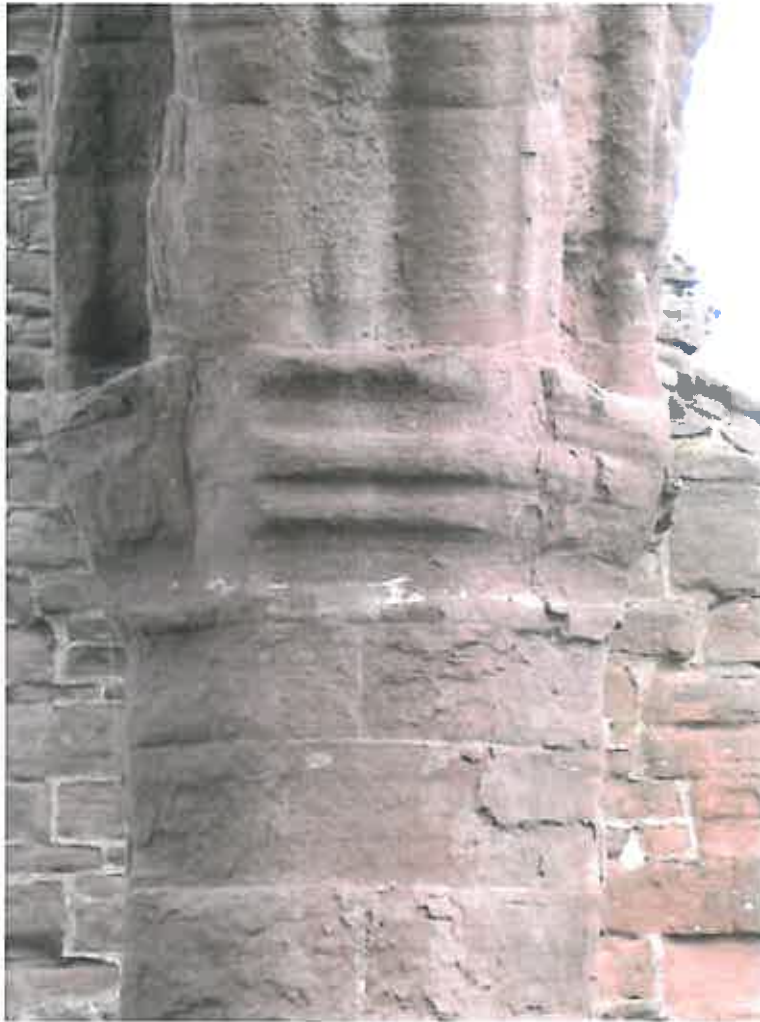
Plate 3. The effects of erosion on the pier capital

Although sandstone is a particularly durable stone and fairly resistant to weathering, the pier capital, with its complex design of projecting moulded components, was very severely eroded and it became impossible to distinguish the original features and details of this moulding (Plate 3). This provided a considerable challenge when determining the original profile of the capital. A vast number of illustrations and photographs, as well as the Royal Commissions Survey of Goodrich, 1930, were consulted in an attempt to best ascertain the original design of the capital thus allowing a more accurate reconstruction to be created.

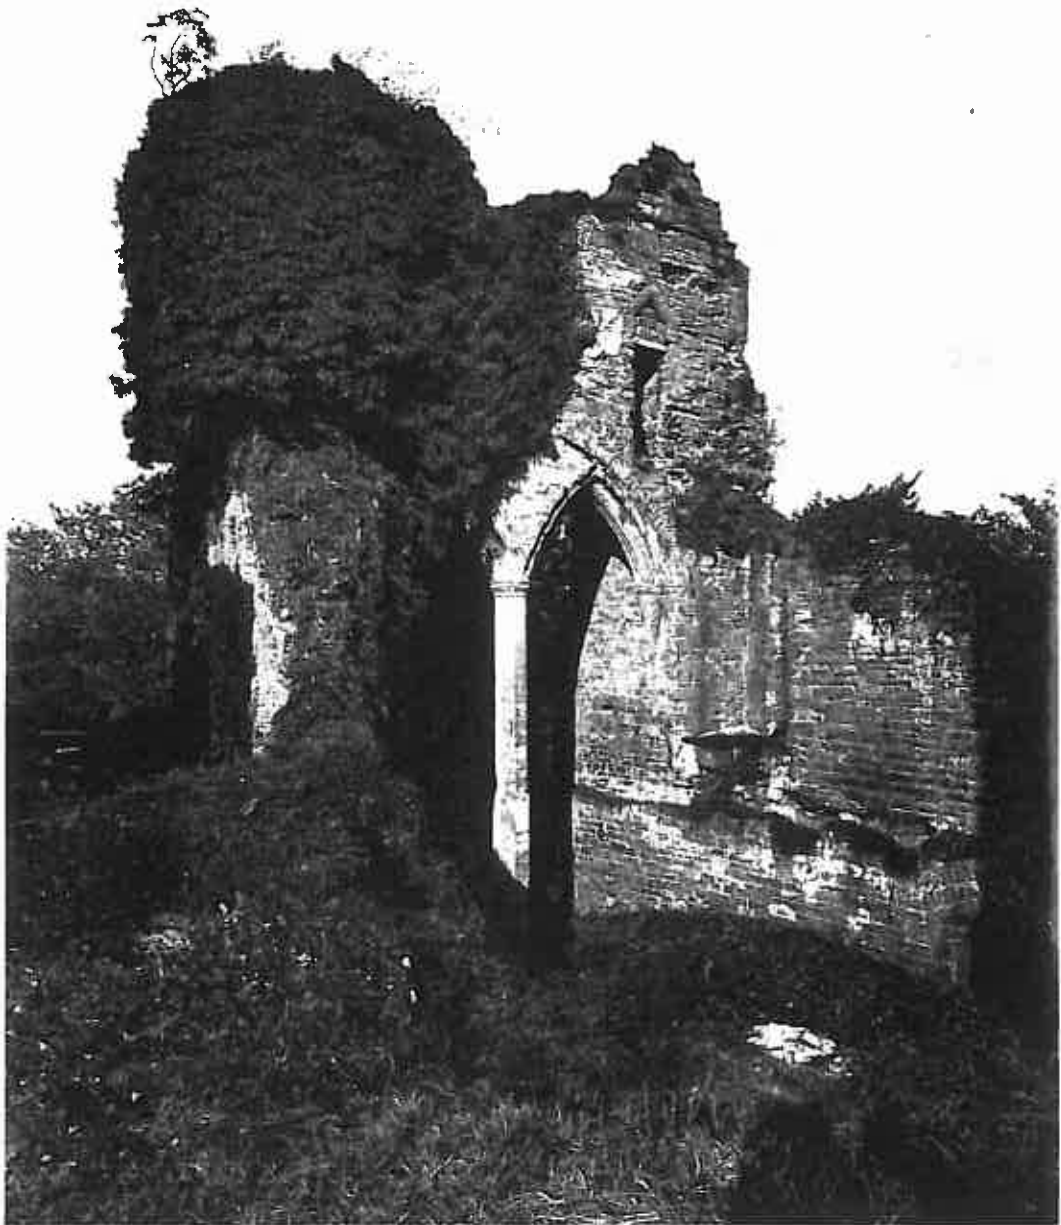
Plate 4. Photograph of a much overgrown North Range c.1925. (Photograph Courtesy of Ministry Of Works)

A number of photographs from the late 1920s and early 1930s showing the North Range and the Solar Arch were also studied in an attempt to elucidate the design features of the pier capital. One photograph obtained from the Ministry Of Works taken in 1925 (Plate 4) shows a very overgrown North Range. The general profile of the pier capital was visible but detailed features were not. Some of the photos by taken by B.C Clayton circa 1928, (Plates 5a and 5b), and for RCHME in 1930 (Plate 6) gave a clearer impression of the Capital's profile. When one of the photographs by Clayton was enlarged some more design detail was visible but the effects of erosion were again all too apparent (Plate 5c).

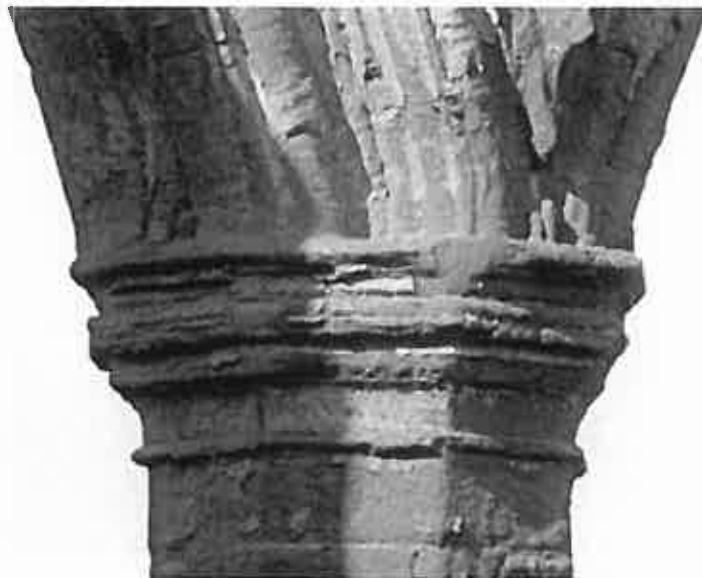
Plate 5c. Enlargement of capital from plate 5b

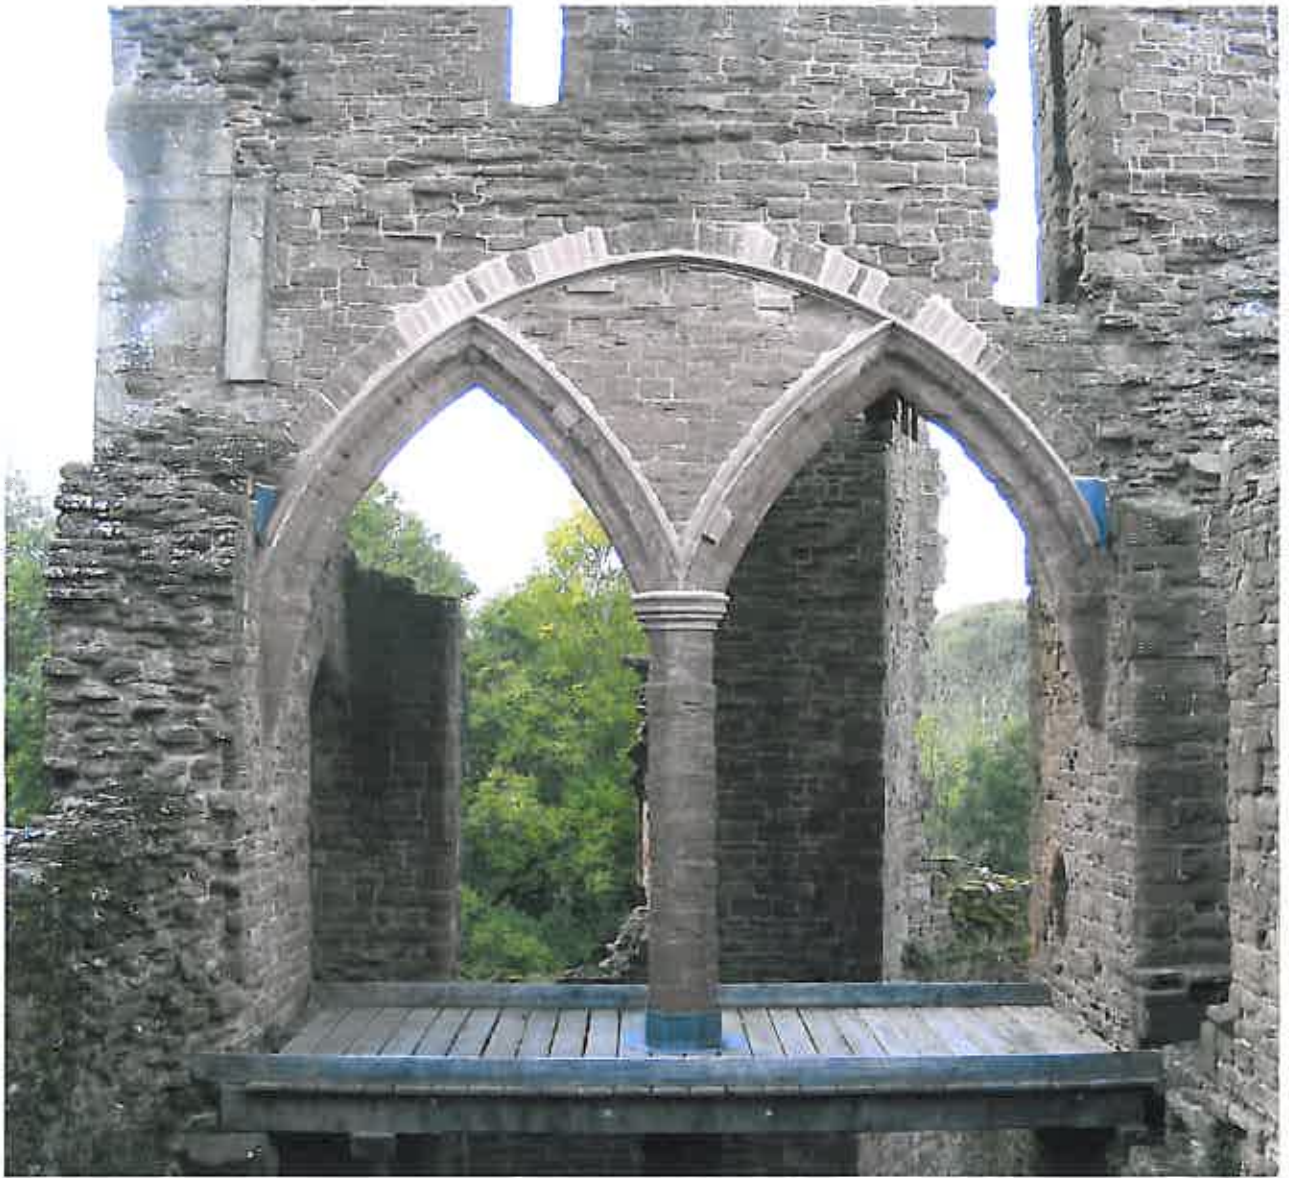
Plate 7. The Solar Arch after remedial works

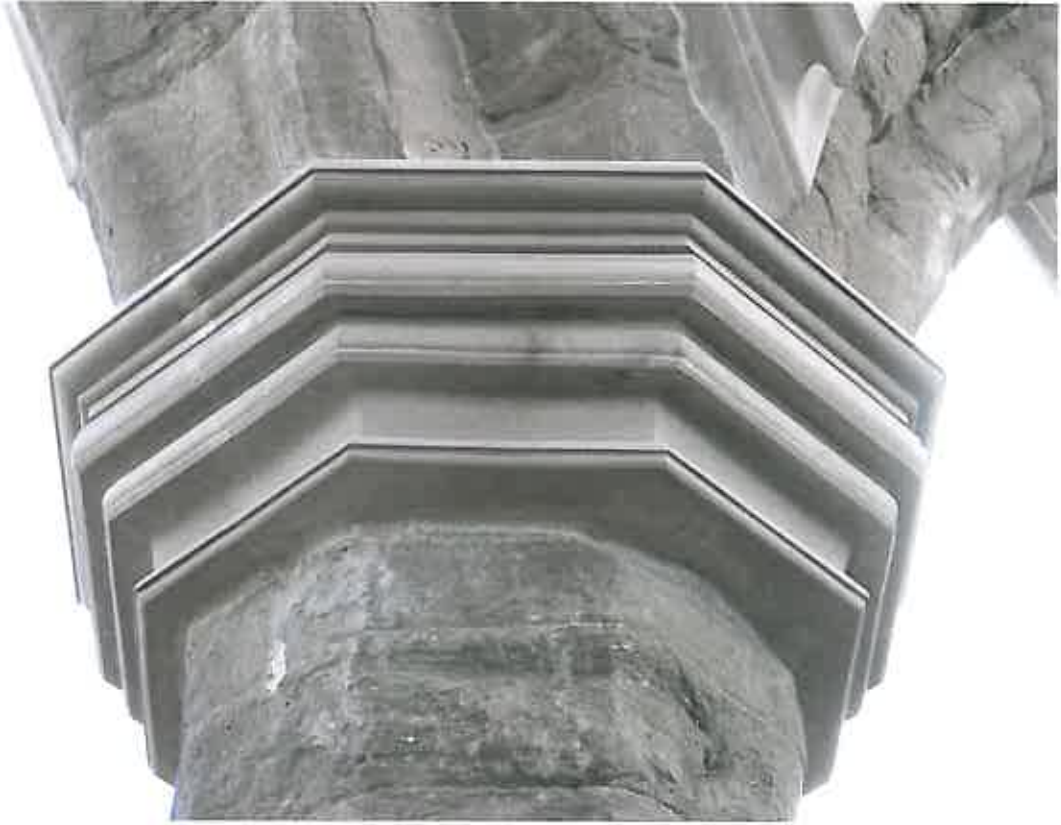
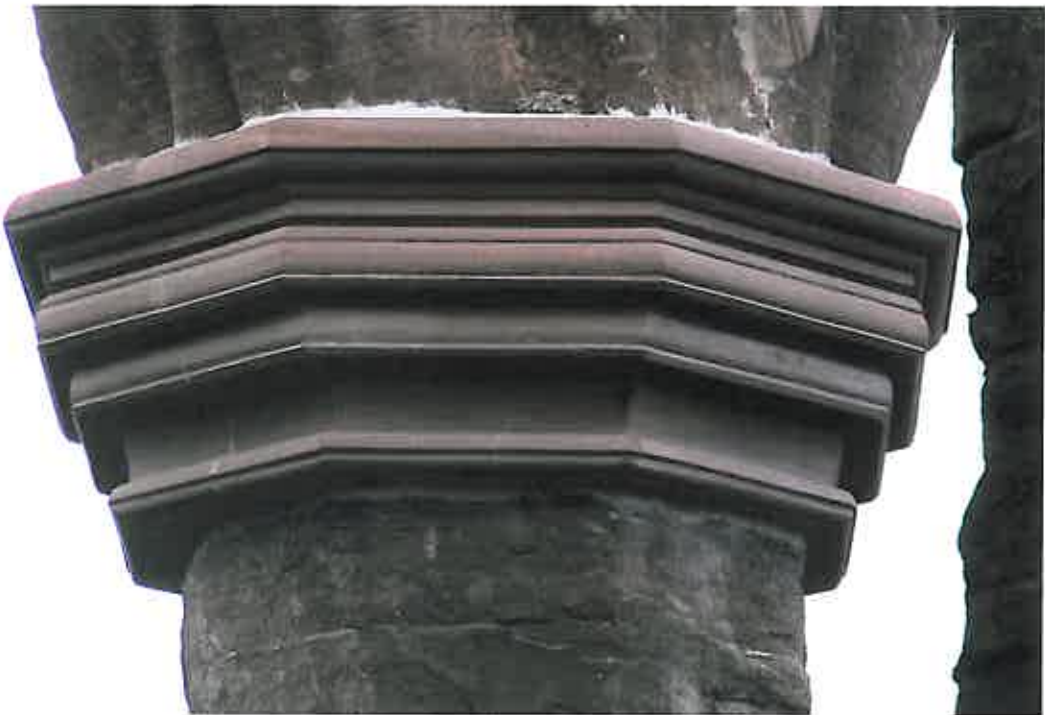
Plate 8. The new Solar Arch pier capital

The profiles created by Archaeological Investigations with advice from Dr R Morris were used in the reconstructions of the Solar Arch pier capital and the voussoirs. They are now a permanent fixture in the North Range of Goodrich Castle.
