**Land Off Canal Road  
(Blackfriars)  
Hereford**

**Archaeological evaluation and assessment of ground conditions**

**January 2008**

Hereford Archaeology Series 781

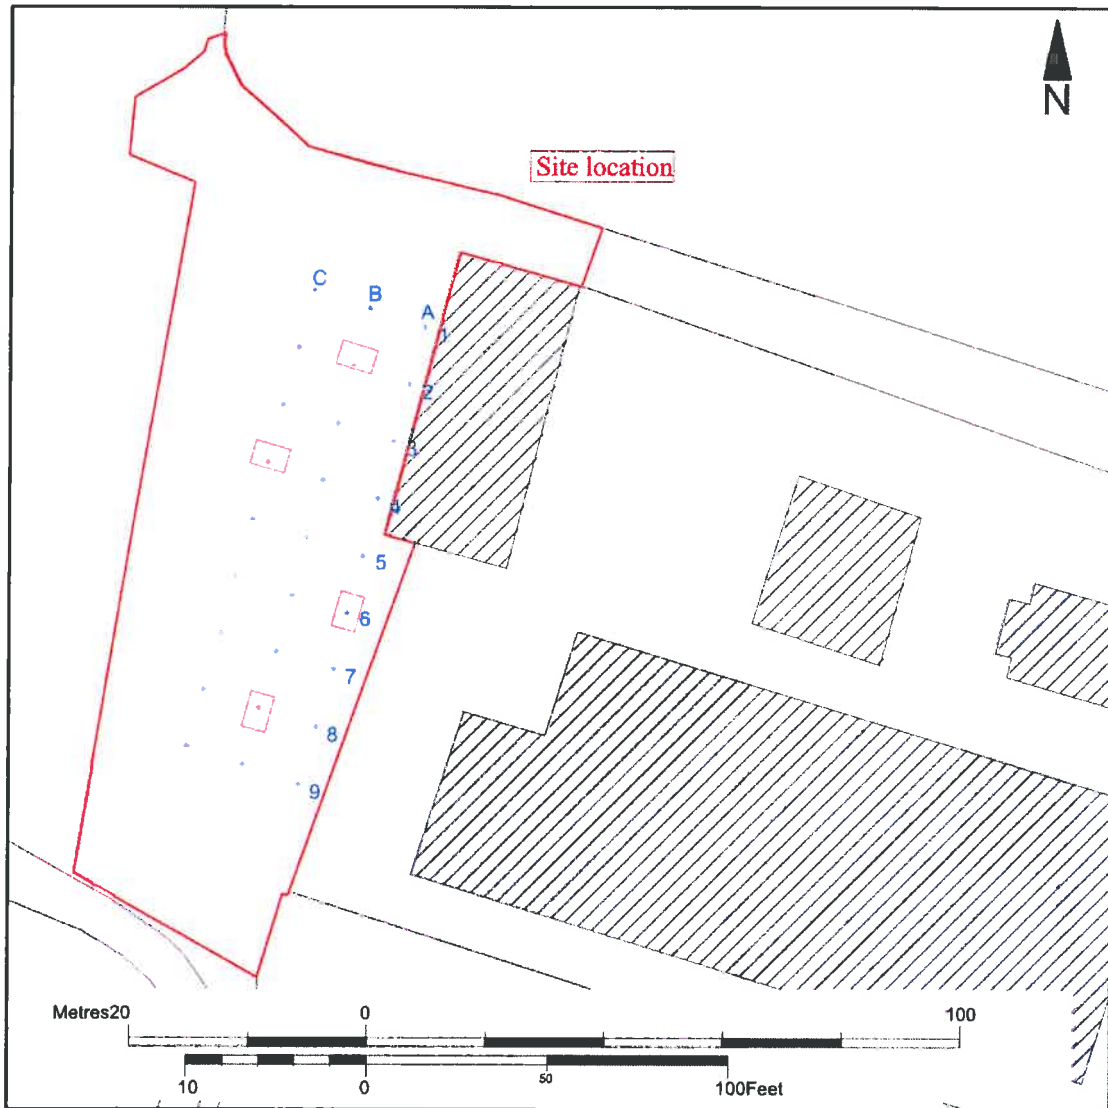
Figure 1

Plan showing the outline of the building and the bore hole sampling grid.

The borehole positions were aligned on a five metre grid over the footprint of the proposed residential development (27 boring locations were identified). Ten locations were selected by the geotechnical team as a representative sample to give a balanced interpretation across the site. At each location a core of deposits was taken. Natural glacial gravels were reached on each occasion and any further coring beyond this point was at the discretion of the geotechnical team. The completed cores were photographed using 35mm colour film. Borehole recording sheets were completed, noting the composition and depth of deposits. The cores were then removed from site for post-excavation analysis by Archaeological Investigations Ltd. The bore holes were refilled with Bentonite. Probe testing was also carried out on other borehole locations which were again selected by the geotechnical team. These procedures were overseen by an archaeologist.

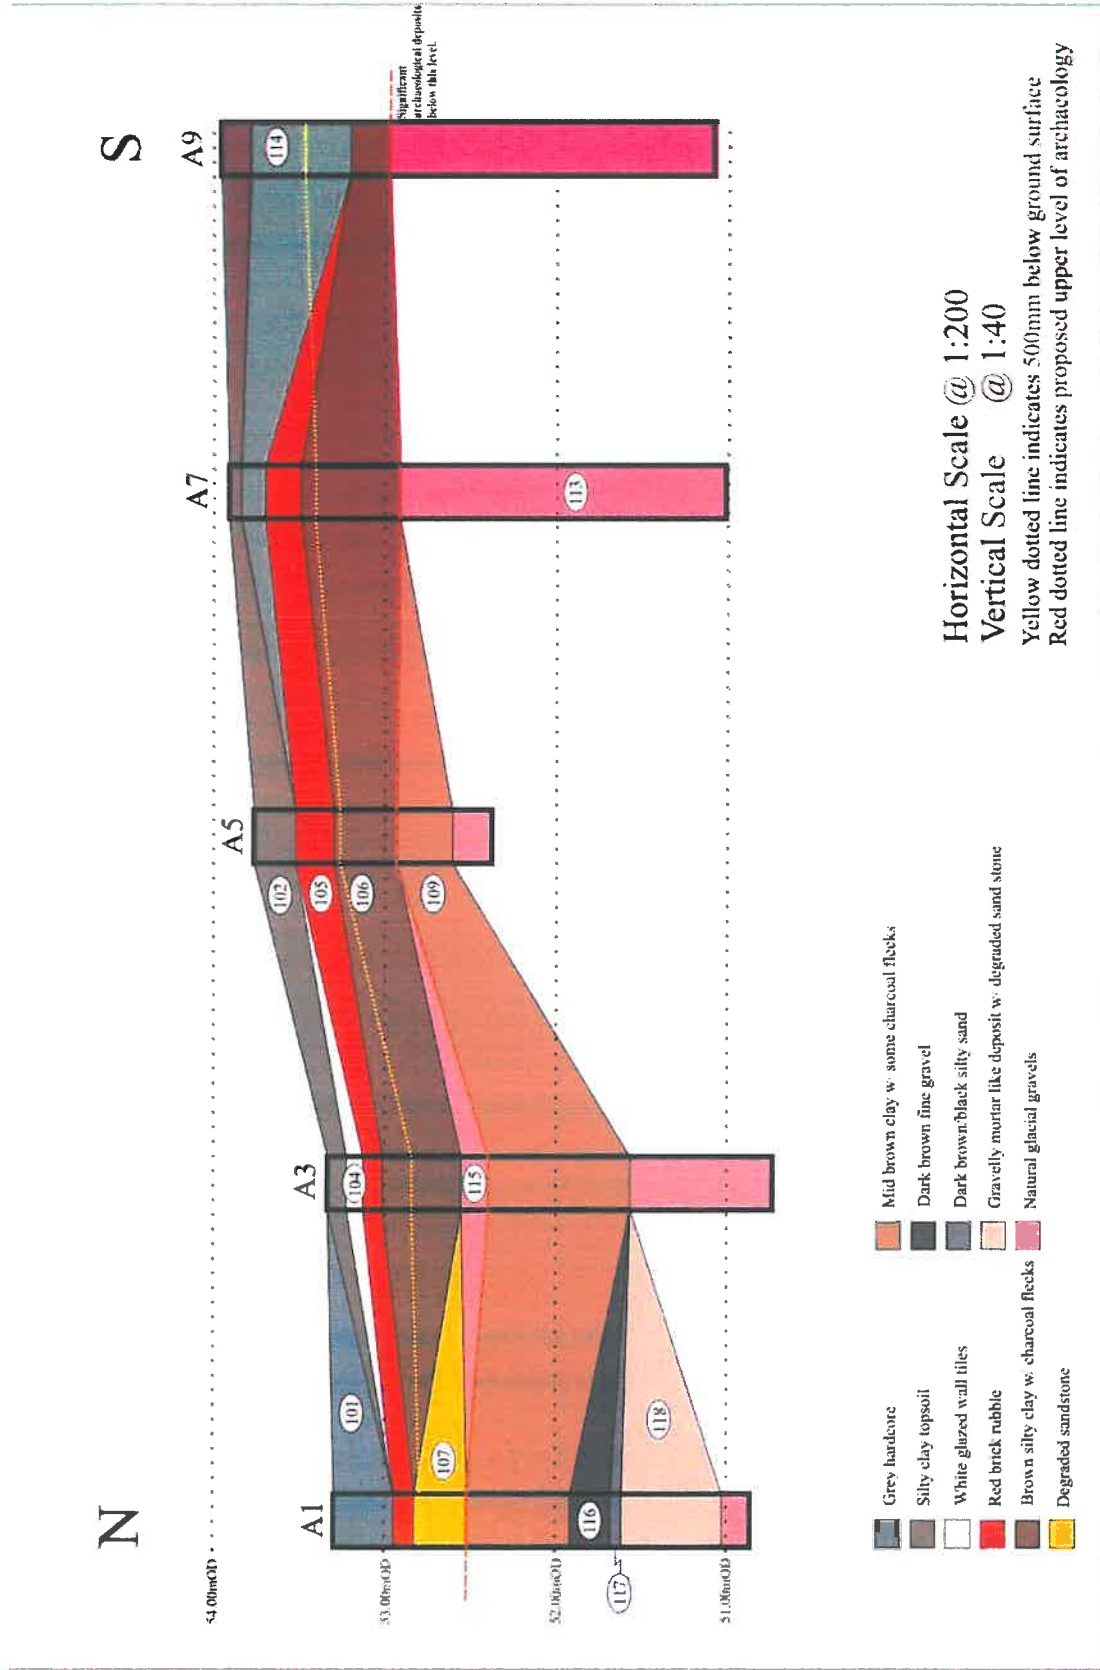
Sequence of deposits - Borehole row A  
(Postulated sequence indicated between boreholes)

### Boreholes (Fig. 2a, 2b)

The borehole cores revealed that the natural deposits on the site gradually sloped from 53.00mOSL in the south of the site to 51.00mOSL in the north.

The earliest deposits in the north of the site were variations in the natural gravels. A peat-like lens (112) was also present within the natural gravel in borehole C1.

Three distinct clay deposits were present overlying the gravels. The earliest (110) was the lightest in colour and contained fragments of degraded sandstone. It was present in only two of the boreholes. A mid brown clay deposit (109) overlay this and was present in seven of the ten boreholes.

Redeposited natural gravel (115) was found to be overlying the mid brown clay in borehole A3, and crushed sandstone (107) was found over the clay in the north of the site.

A deposit of dark brown/black silty clay (106) was present in nine of the ten boreholes. Above this was a modern layer of crushed red bricks and a layer of broken white wall tiles. A thin layer of topsoil disturbed by rubble dumps covered the site.

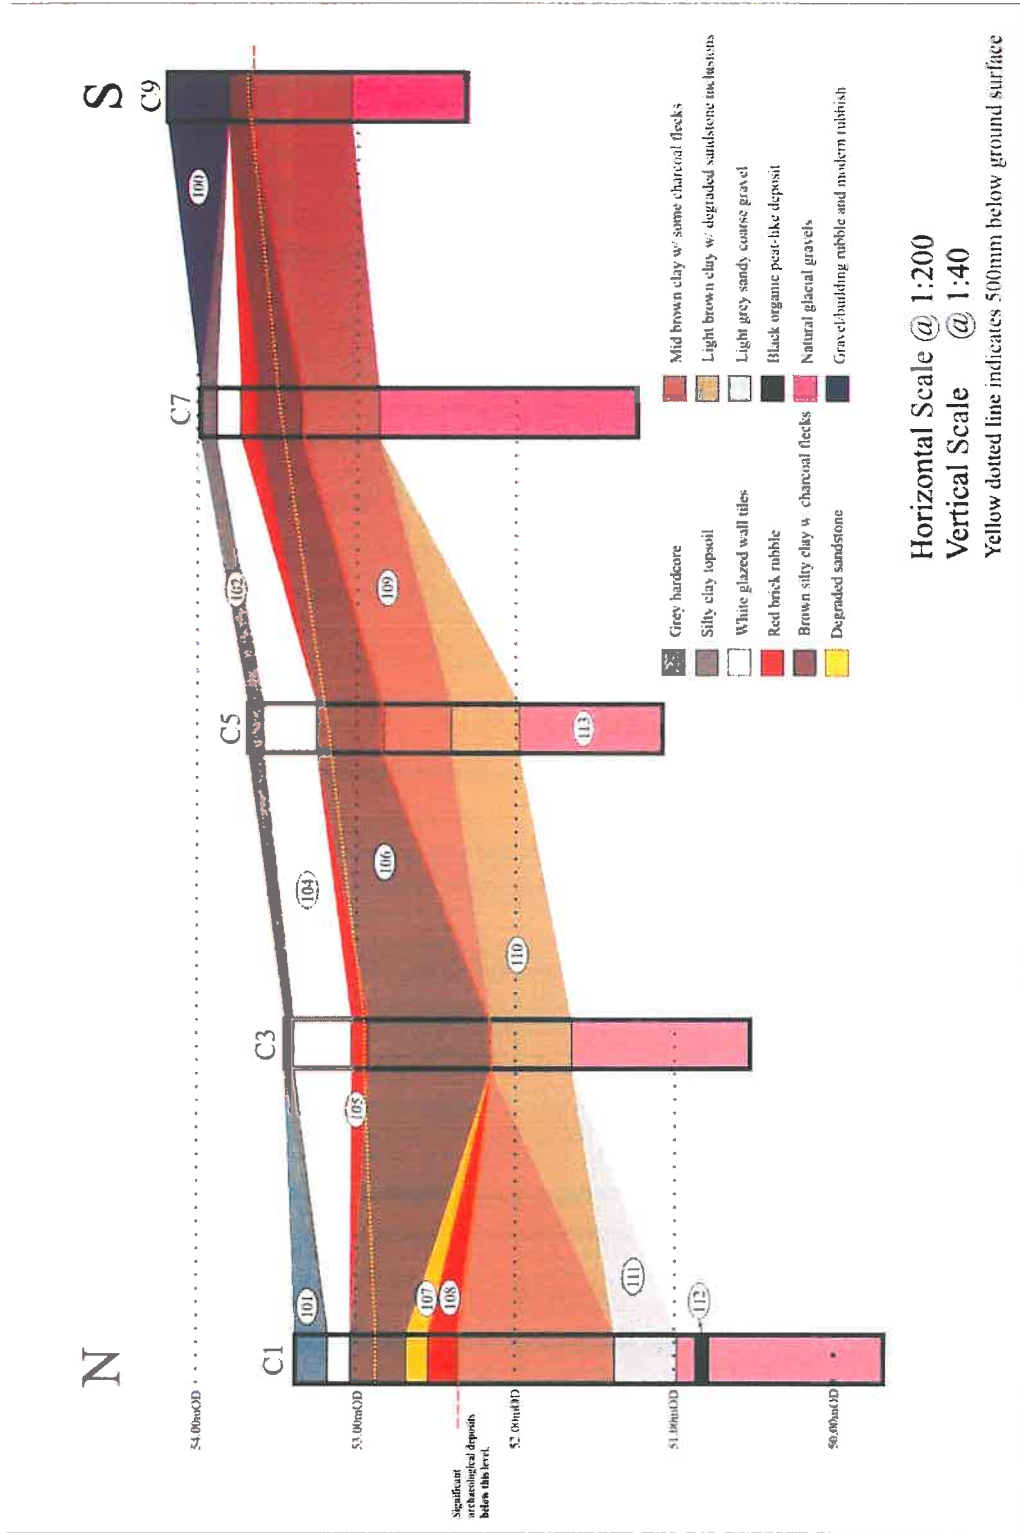
Figure 2b

Sequence of deposits - Borehole row C  
 (Postulated sequence indicated between boreholes)

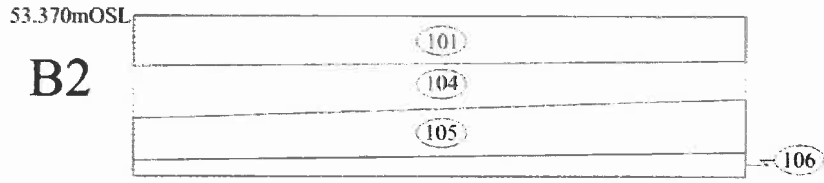
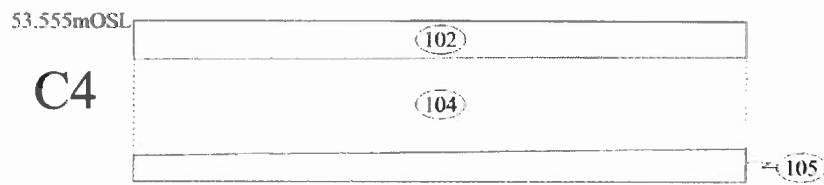
Figure 3

West facing section drawings of plate bearing test pits

Four borehole positions, B2, C4, A6 and B8, were also selected by the geotechnical team for the ground bearing pressure tests. This involved digging a trench, over the position of the holes to a maximum depth of 500mm. The first 400mm was excavated by machine and then a further 100mm by hand to accommodate the position of the plates. The excavation of each trench was monitored by an archaeologist, photographs taken and records made of the composition and depth of deposits. Each trench was then backfilled using the material removed from the trenches.

### **Plate bearing test pits (Fig. 3)**

No archaeological deposits were revealed during the excavation of the plate bearing test pits over A6, B2, B8 and C4. The sequence of deposits was the same as identified through the borehole cores.

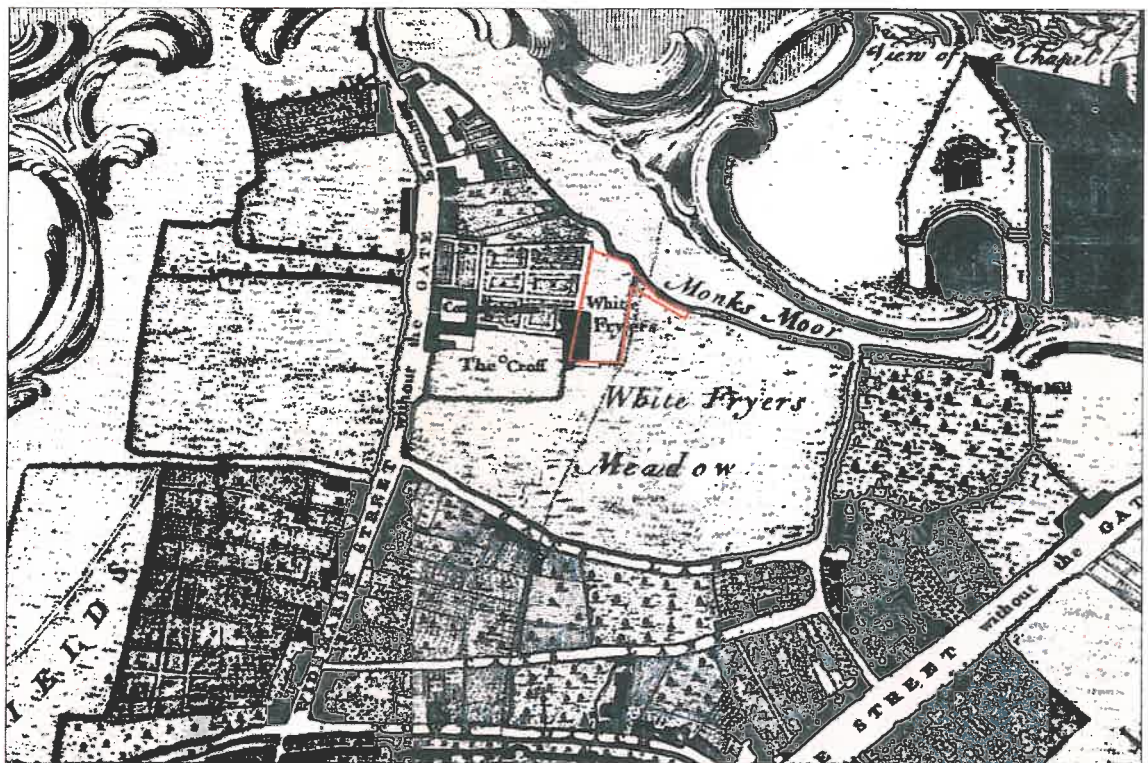
Figure 4b . Blackfriars (Erroneously labelled as White Fryers) on Taylor's map of Hereford, 1757

Taylor produced a detailed map of the city in 1757 (Fig 4b), over a century after the Civil War. The quadrangular Hospital is apparent in the lower part of the excerpt with, to the right, the northern part of the then ruined Coningsby house. Between the two, and to the north of the Hospital, the ground is given over to gardens. To the north again there appears to be several properties with frontages onto Widemarsh Street and gardens stretching back to the brook. The street frontages appear to widen as the depth of the property from road to stream decreases.
