CCTV Works, Witley Court Worcestershire (NGR SO 775 658)

Archaeological watching brief

Hereford Archaeology Series 797

An archaeological watching brief/evaluation

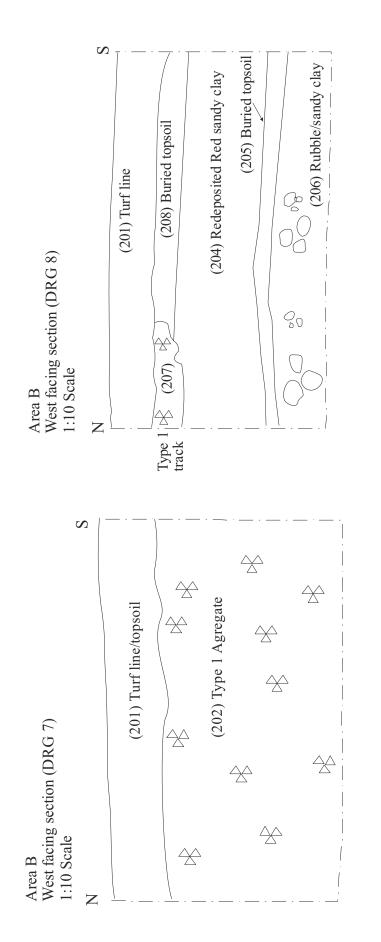
Figure 19 Sections in Area B

A cable run was excavated to a new column along the outside of the ha-ha on the east edge of the southern garden (see Figure 19). The trench was orientated northeast to southwest and was approximately 21.5m long, 0.37m wide and 0.60m deep.

The southern extent of the trench cut through the construction trench of steps leading to the pump room of the Poseidon fountain. To the north of the construction trench six contexts were recorded in section. Below the turf and topsoil the subsoil was cut by a possible path or track (207). The path or track was modern and probably orientated east west. It was constructed of Type 1 scalpings (crushed grey stones).

Below the subsoil was a re-deposit of clay that made-ground over a former horizon of topsoil (204). The older topsoil was probably imported to the site during one of the many landscape changes as it covered a mixed rubble and sandstone layer (206) that was not bottomed in the trench.

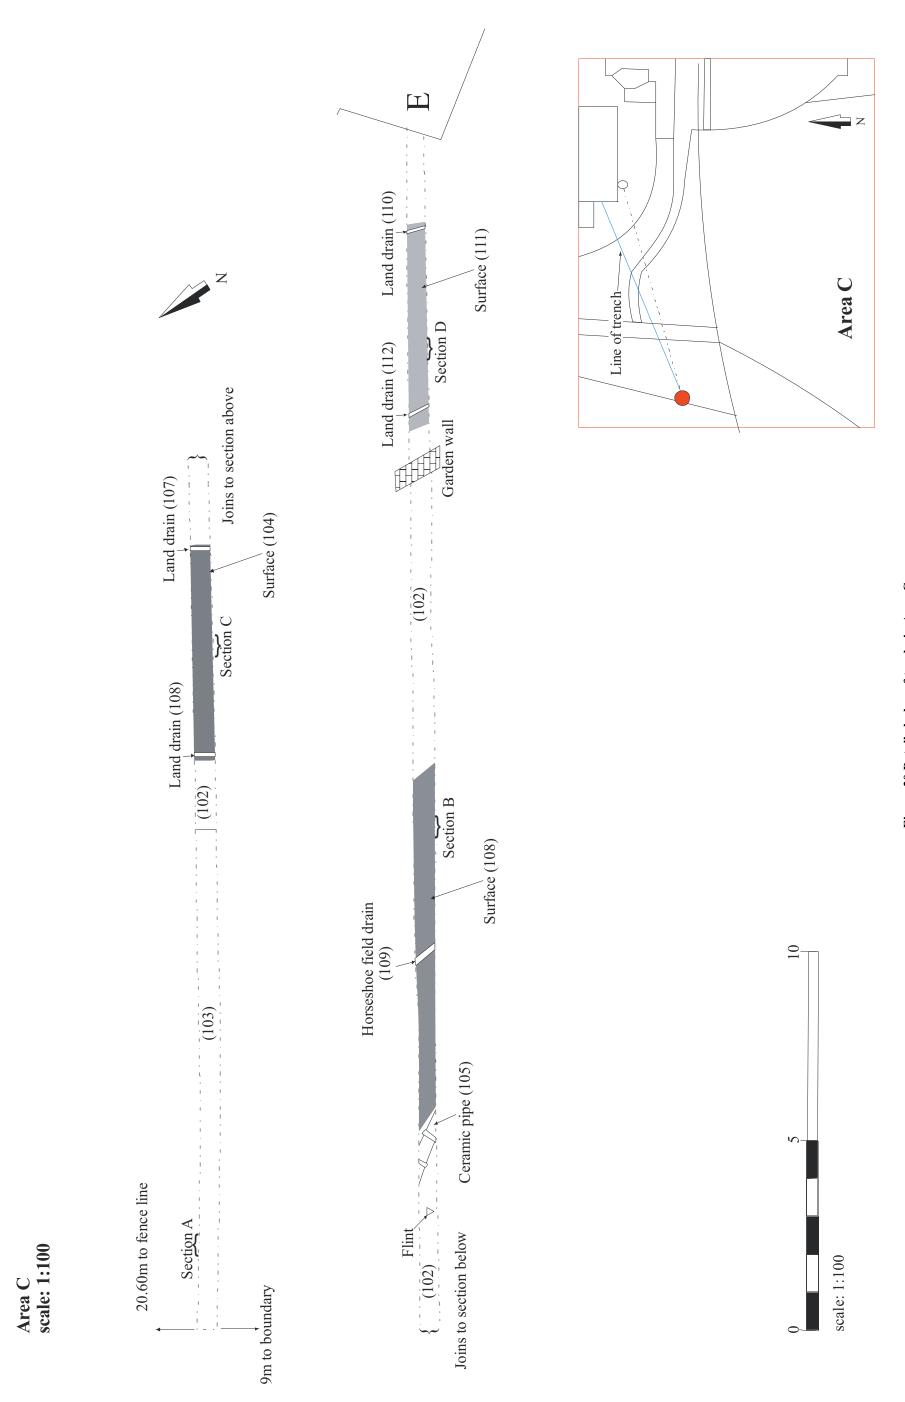
Figure 20 Detailed plan of tracks in Area C

To the south west of the stable block and below the topsoil was surface 111 (see Figure 21). The surface was made of large densely packed sandstone cobbles in a matrix of crushed broken brick and earth bedded on a thin skim of mortar. The entire width of the path was exposed in the trench and was 5.40m wide and cut into clean subsoil 102 to a depth of 0.30 - 0.35m. Below the surface were two land drains positioned one each side. The drains (110 and 112) were of red clay and would have drained excess water from the surface. The surface was substantial and probably severed as a large track or road leading to and from the stables. To the west of the surface was a north south garden wall (see Figure 20) that followed the same orientation as the surface.

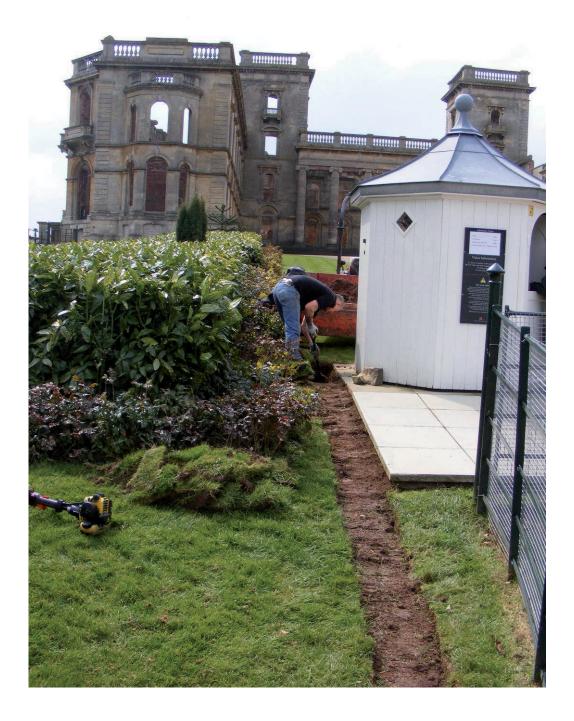
Plate 1 Area A facing south toward the main entrance to the court

A cable run was excavated linking the custodian's hut to a new column at the north end of the drive to the main entrance of the court. The trench ran north from the custodian's hut before turning east and north east across the drive to column A. The trench was approximately 32m long, 0.37m wide and excavated to a depth of 0.60m.

Two sections of the trench were examined in detail (see Figure 18). The main section was orientated northeast to southwest across the drive and cut through modern concrete and its associated make-up. Below the make-up of the concrete drive was rubble layer 312. The rubble was made up from mixed brick, mortar and sandstone and covered a possible earlier surface (314). This earlier surface was only partially exposed in northern part of the section but probably extended to the south. It was constructed of very compact water washed pebbles that were either laid or cut into a re-deposited silty sand soil (313). The northern extent of the surface was visible in section and was near vertical. There was no evidence for drains associated with the road but only the very top of it was exposed.

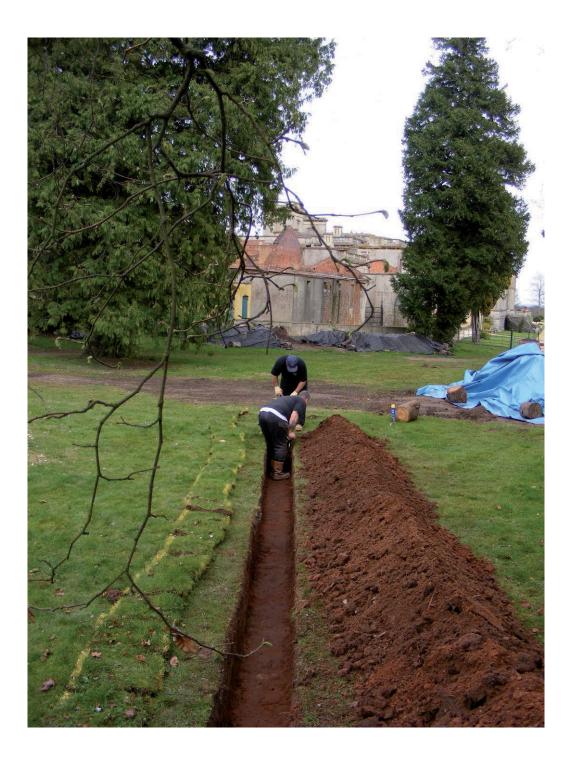
Plate 3 Area C facing north east toward the stable block

A cable run was excavated to a new column to the southwest corner of the stable range. The trench was orientated east west and approximately 56m long, 0.37m wide and excavated to a depth of 0.60m.

West of the garden wall the trench cut through 2 surfaces 108 and 104 and their associated foundation layers. The surfaces were off red gravel laid on a layer of mixed soot and coal waste and of compact gravel and stone. Below both surfaces was mixed brick, mortar and stone with pottery and glazed ceramic building material (CBM). Path 108 was 10m wide and 104 6m wide and both cut into subsoil 102 to a depth of 0.40m. An architectural stone fragment was recovered from within 108.
