# Land at Halesowen Street/Canal Road OLDBURY

*Archaeological evaluation.*

**January 2009**  
*Hereford Archaeology Series 813*

Land at  
Halesowen Street/Canal Road  
Oldbury,  
(NGR 39899 28950)

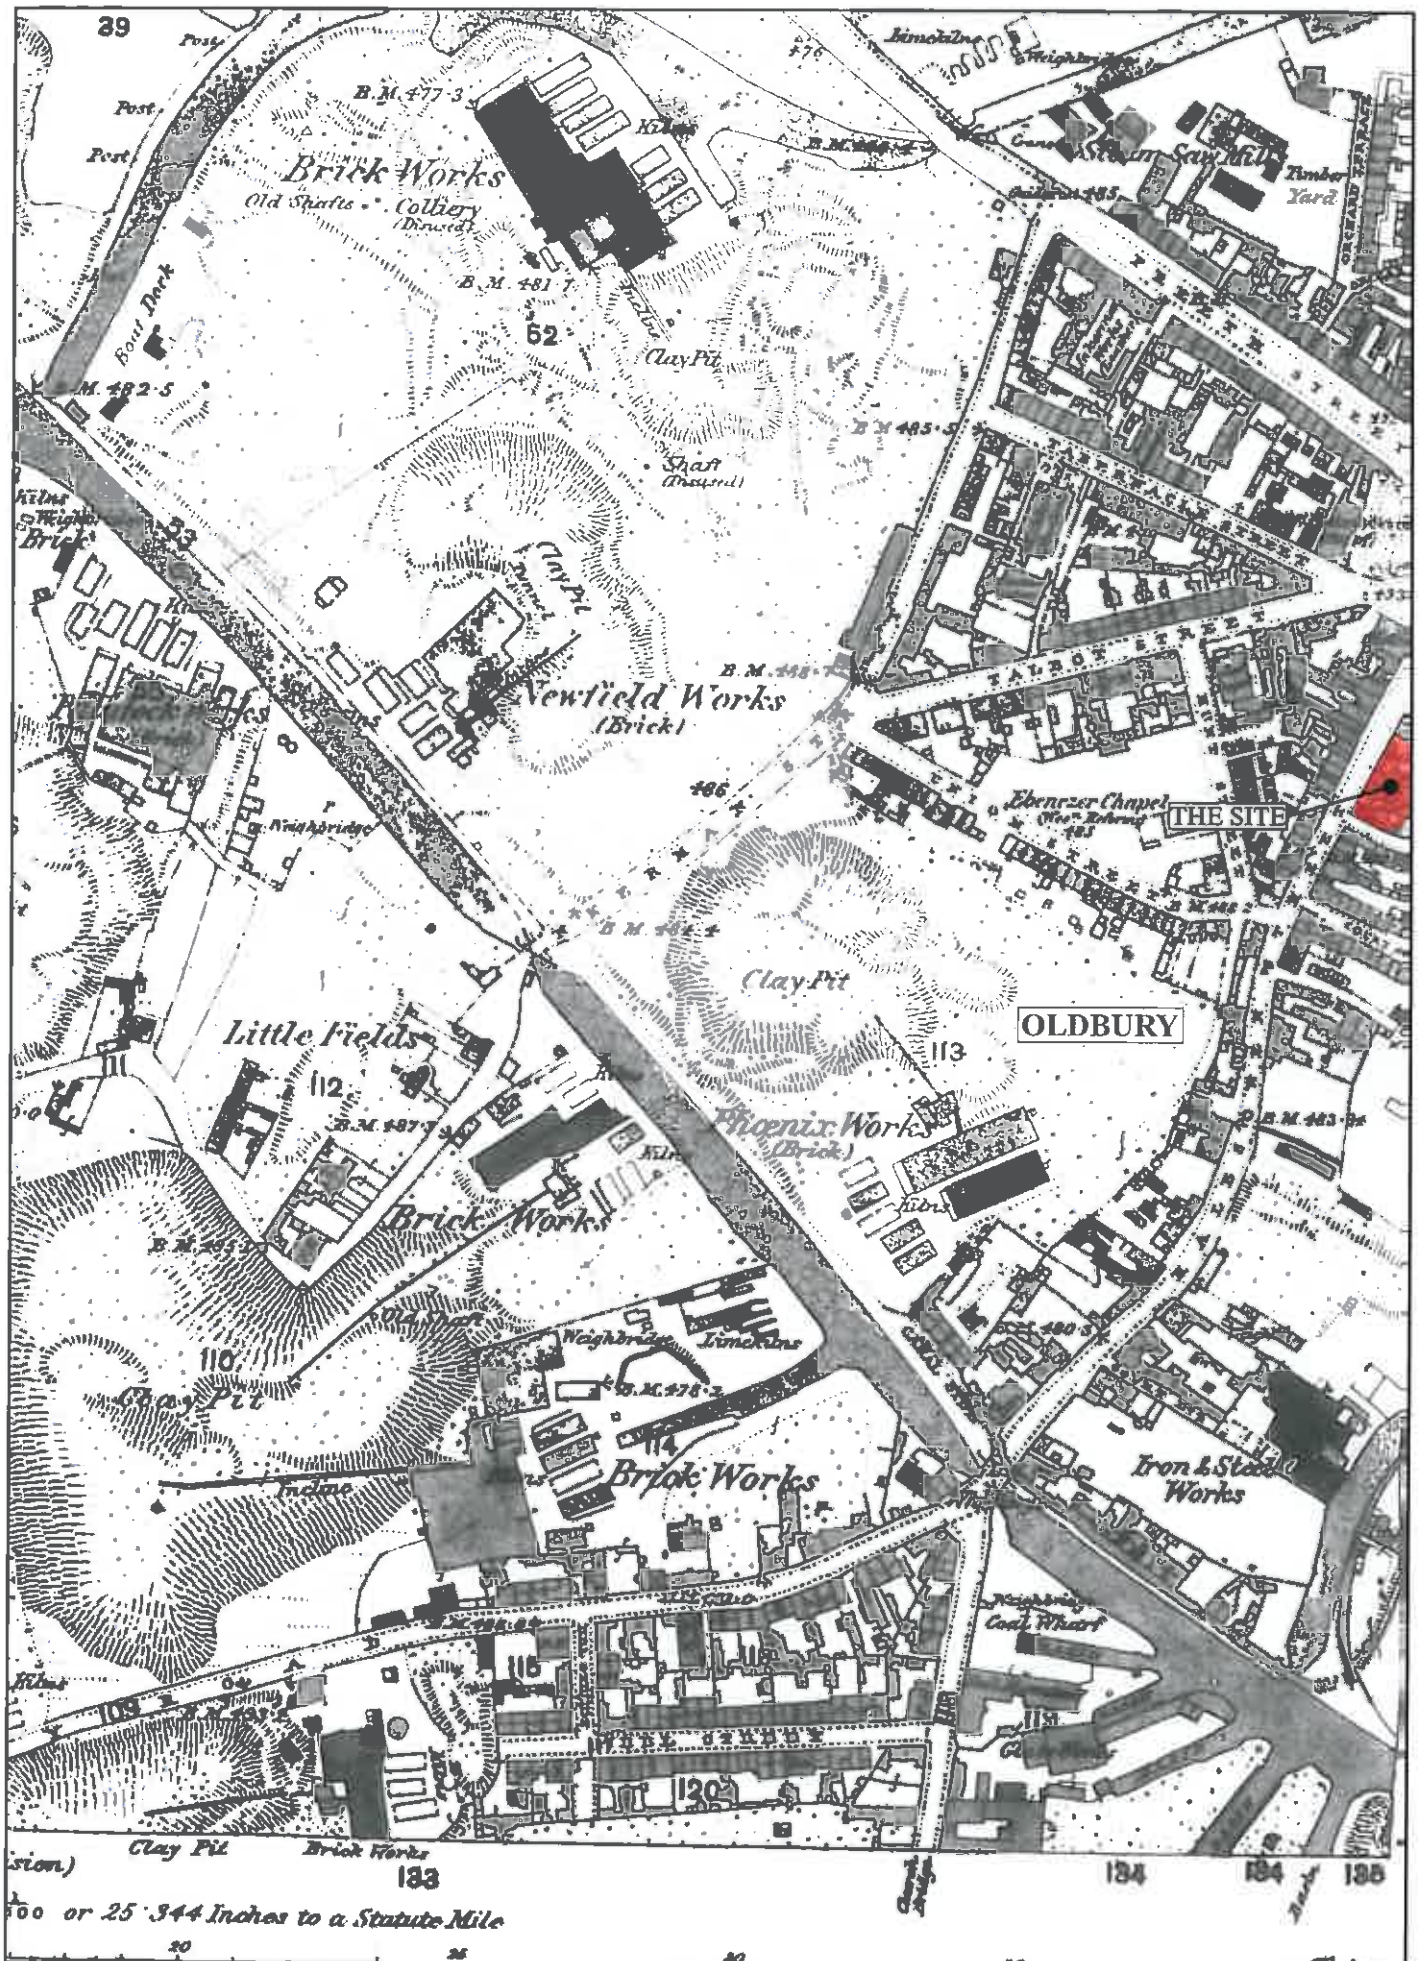
Location of the site in Oldbury as it was shown on the 1845 Tithe map, Figure 2.

A chapel, built in 1529, stood near to Halesowen Street (See Figure 2, the 1845 Tithe map). This was demolished in 1840 when Oldbury became a separate parish and was replaced by Christ Church in Church Square (see Figure 4, 1904 Ordnance Survey map). Part of the graveyard for the 16<sup>th</sup> century chapel was later taken up by road improvements.

The Tithe Map (1845, Figure 2) does not show Canal Street though a few buildings are present at the western end – on the site, at the junction of Canal Street and Halesowen Street. The history of Oldbury (1800-1875) (unpublished typescript Smethwick library) states that the cutting of the canal affected the development of the town, with land between Halesowen Street and Low Town being set out for building. The route of the canal meant that there was only one way into and out of Canal Street, as no bridge was built the canal cut off the route into Low Town. This meant that until the construction of Church Square – which had an opening into Canal Street there was only one way into and out of Canal Street, which gained the name ‘ by which it was best known for many years “Pudding Bag Street”’. The proper name of the street was restored to public usage once this route was built.

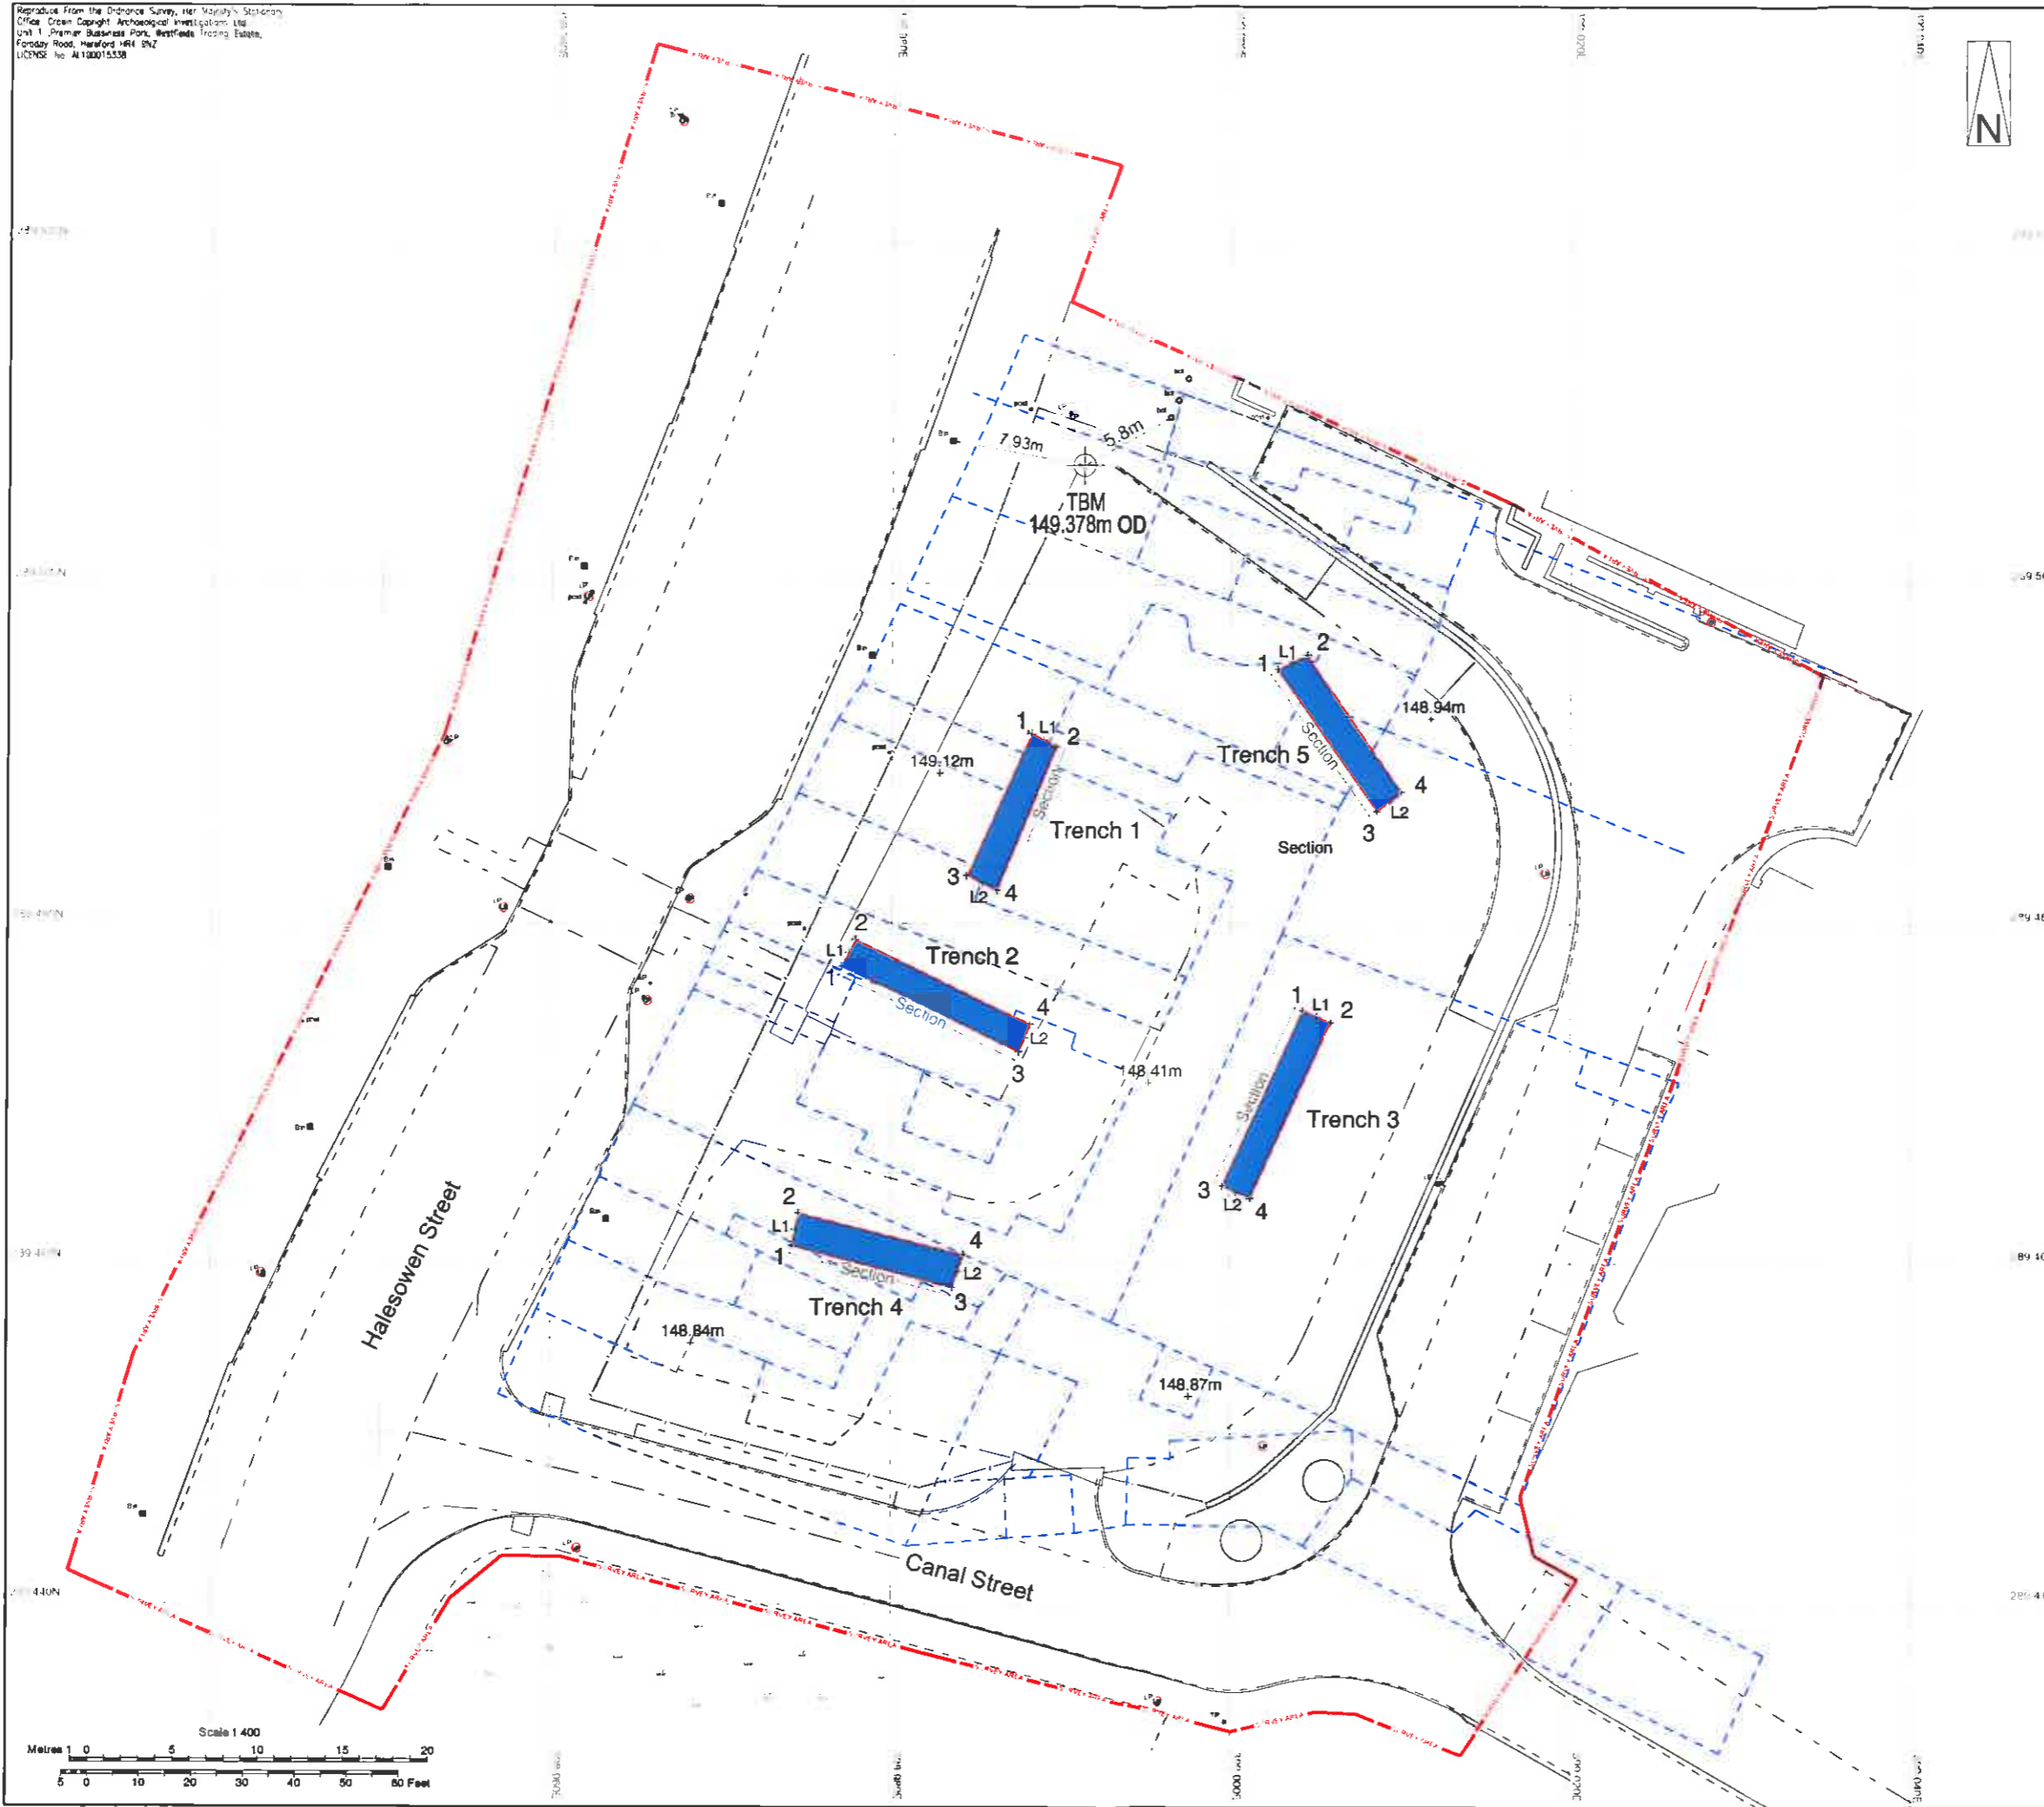
Figure 5

**Trench Location Plan.**

A total of five trenches were excavated as part of the evaluation on the site of the former bus station at Halesowen Street, Oldbury (Figure 5). The trenches were excavated using a "rubber duck" mechanical excavator with a toothless bucket measuring 1.60m wide, after the concrete surface had been cut, broken up and removed. The depth of trenches did not exceed 1.65m (2m deep in the case of Trench 1) and the concrete that had been removed from the trenches was piled ready for removal from the site.

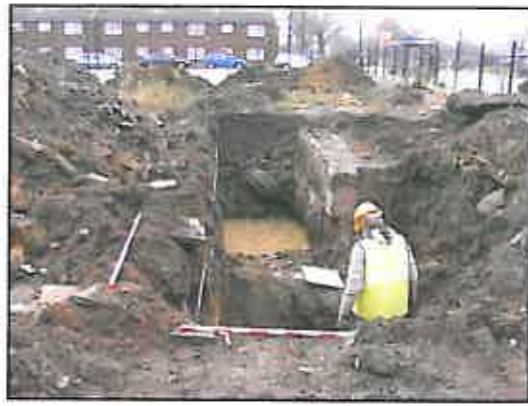
Plate 1, Trench 1, facing south, note the large concrete pile along the western edge of the trench.

The fill of the cellar had been cut by the concrete pile wall [105] (foundation for the bus station offices) and there was obvious disturbance to the buried remains of the terraced house that was a result of the piling. On the east side of the wall were remnants of buried topsoil mixed with the underlying natural clay (102) that contained modern finds, probably from garden soil from the terraced houses. Below this level (1.20-1.55m below present ground level) was natural yellow-brown clay, sand and washed gravel (103).

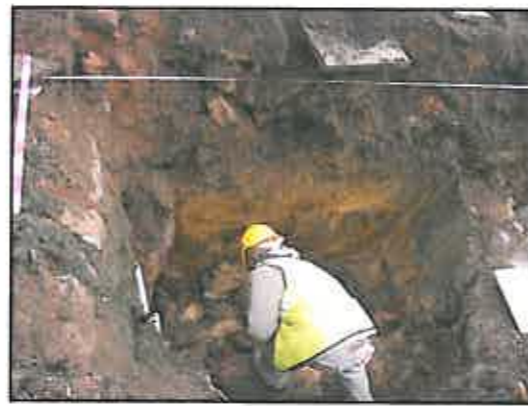
Plate 2, Trench 1, facing east, cleaning up rubble in the north end of the trench before cleaning the section for drawing.

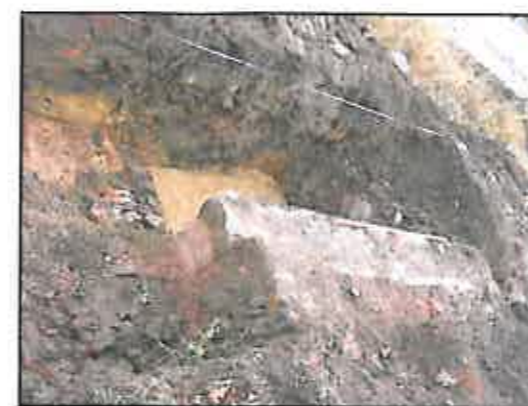
Plate 3, Trench 1, facing south-east, the concrete pile foundation is in the foreground, the area behind it is made ground overlying natural clay.

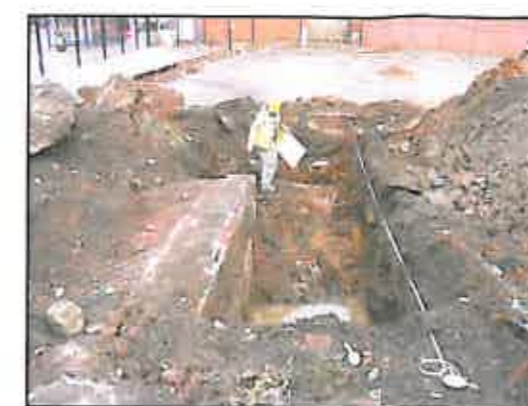
Plate 4, Trench 1 facing the north, the south end filled with water as soon as the trench was opened.

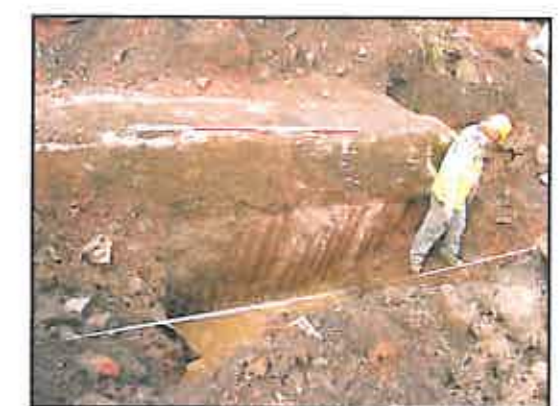
Plate 5, Trench 1, facing west. There are sheet pile impressions on this side of the concrete pile.

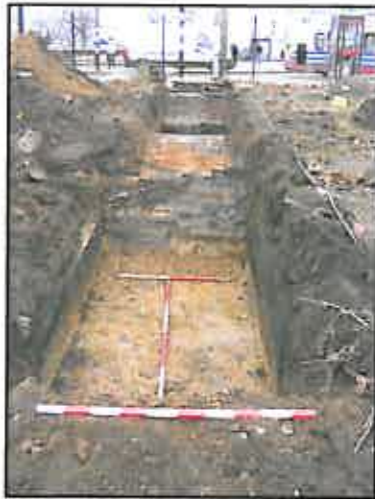
Plate 6, Trench 2, facing west from the eastern end of the trench.

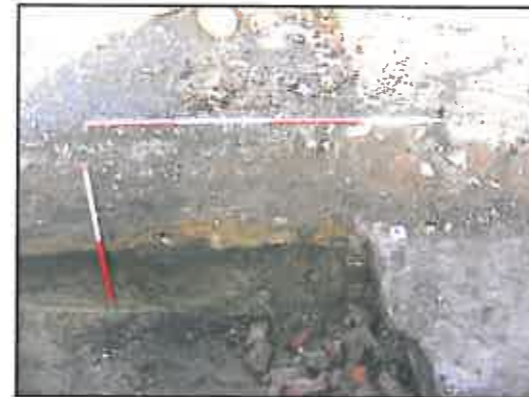
Plate 7, Trench 2, facing north, shows the remains of the (collapsed) wall [206], concrete [208] and adjacent stratified deposits.

The concrete pile wall that had been observed in Trench 1 [105] crossed Trench 2 in its western half [208]. Along the west edge of the concrete pile wall and on the same alignment was a brick wall bonded with pinkish-grey flecked mortar [206]. The wall lay within a cut [207] and had no foundation.

The wall predated the concrete structure and appeared to have been re-used as revetment for the pour of the concrete. A modern ceramic drain crossed the trench to the east of the concrete pile close to the surface and aligned northeast-southwest.

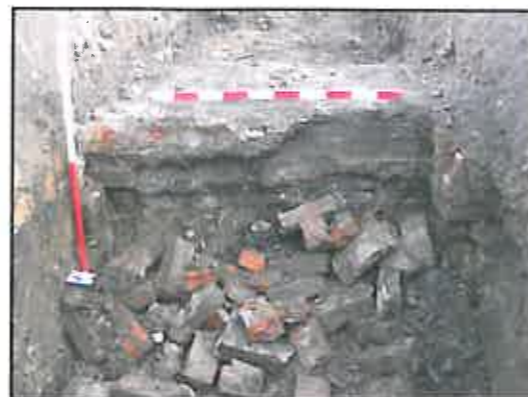
Plate 8, Trench 2 facing east, shows remains of the wall [206] and that the concrete pile [208] behind.

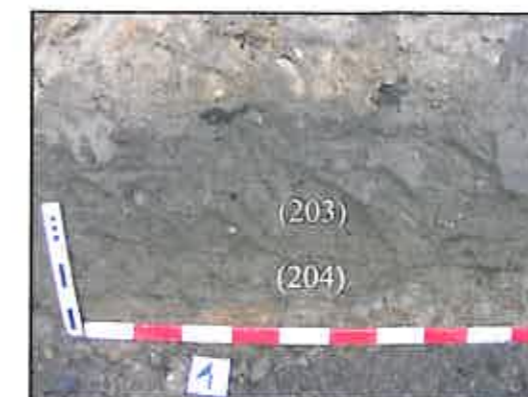
Plate 9, Trench 2, facing north, shows demolition/levelling layers overlying a layer of garden soil (203) which overlies a buried soil horizon (204).

Underlying these deposits was dark brown garden soil up to 0.40m deep (203), containing modern finds and a single piece of Medieval (Cistercian ware) pottery. The garden soil overlay a thin buried topsoil horizon (204), grey-brown in colour, silty clay textured and around 0.10m deep. The deposit contained a few pieces of modern pottery, glass and a piece of clay pipe, which may have been intrusive from the layer above, or may have been at the interface between the two deposits. A single piece of Post-Medieval roof tile was found within the deposit. The level of the natural clay layer in Trench 2 (205) rose towards the west side of the site.

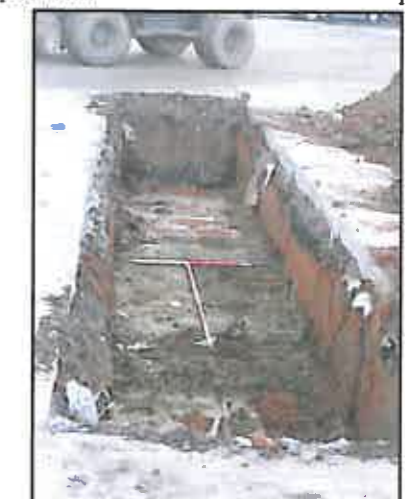
Plate 10, Trench 3, facing south, shows the red sand deposit below the modern concrete surface and overlying the natural clay below.

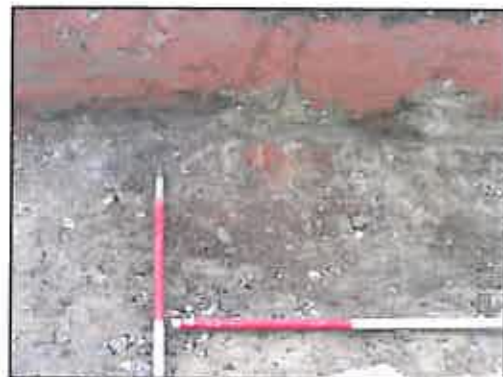
Plate 11, Trench 3, facing west, shows the red sand overlying traces of (303), the black waste and garden soil over the natural clay (304) below.

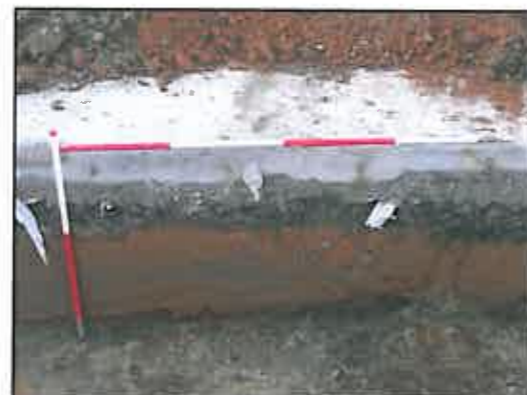
Plate 12, Trench 3, facing west, shows the thickness of the concrete surface, the scalpin sub base and the underlying red building sand used to fill and level the site before the bus station was built.

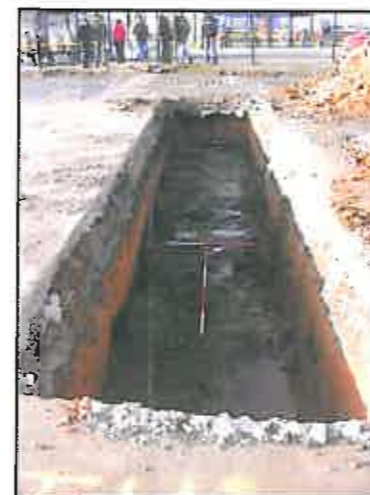
Plate 13, Trench 4, facing west, looking towards the bus stops on Halesowen Street.

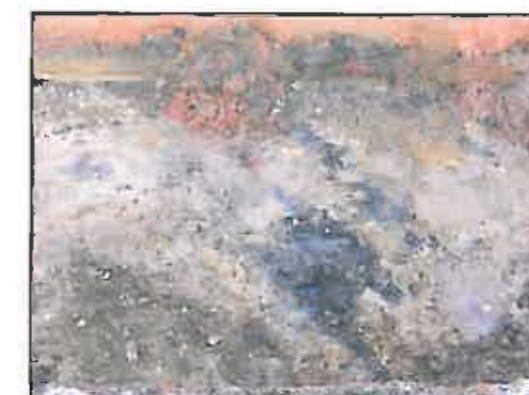
Plate 14, Trench 4, black marks cutting the natural yellow-brown clay, evidence that a machine with a toothed bucket was used to strip the site before the bus station was built.

The majority of the deposit had been machine stripped off using a toothed bucket, as was evident from the toothed bucket marks cutting into the underlying natural clay layer (contexts 304, 404 and 504) in all three trenches. The deposits appeared to have been mechanically stripped in preparation for the construction of the bus station.

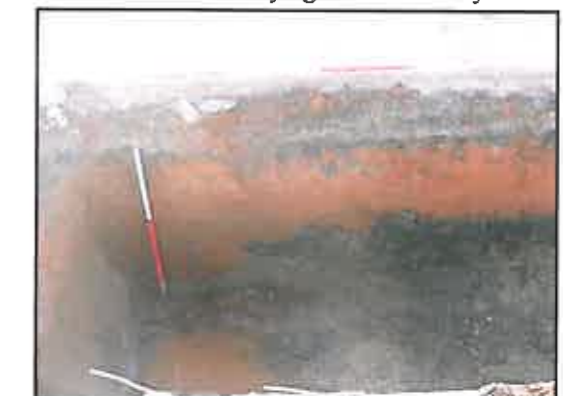
Plate 15, Trench 4, facing south, shows the red sand below the modern concrete surface and scalpin sub base. Black waste and garden soil visible in section.

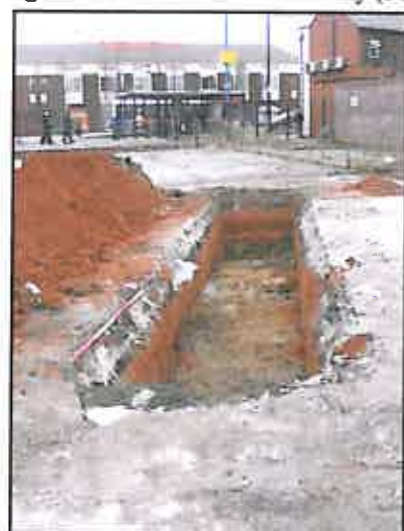
Plate 15, Trench 5, facing north-west towards Sainsburys and the bus stop.

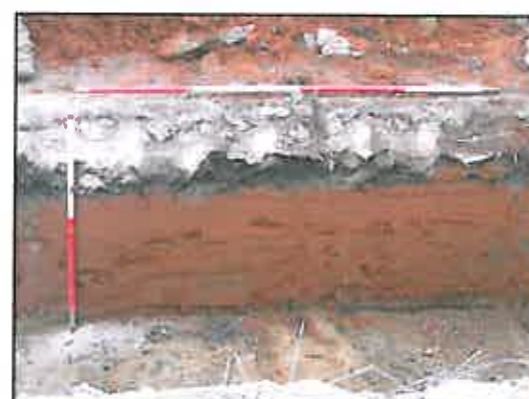
Plate 17, Trench 5, facing south, shows thickness of the concrete, the scalpin sub base and the underlying red sand that was directly overlying natural clay.

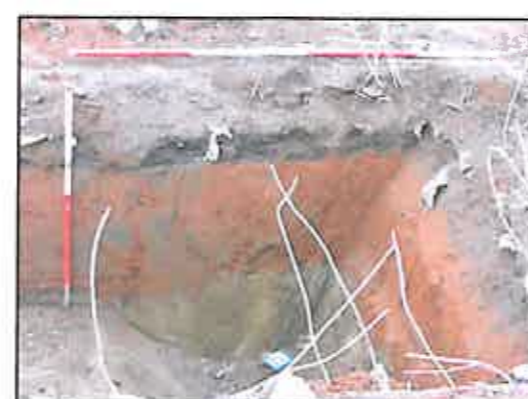
Plate 18, Trench 5, the north-west end facing south, shows the sondage into the natural clay layer.

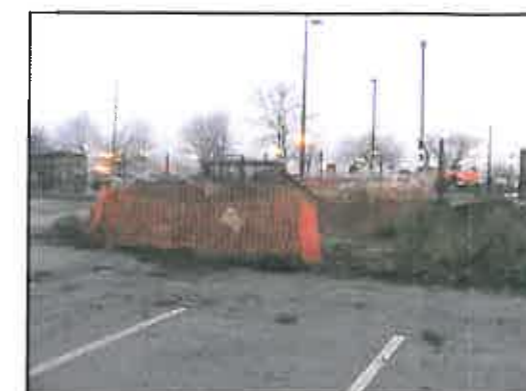
Plate 19, Trench 2, all the trenches were fenced off each evening until they were backfilled, which was done for the health and safety of the general public.

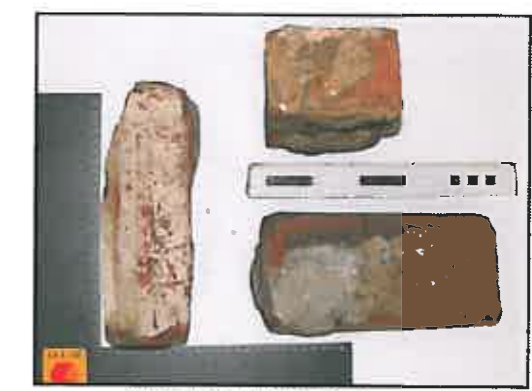
Plate 20, Sample of bricks from (bottom 2 bricks) context [104] (cellar wall in Trench 1), and (top 1) context [206] (wall in Trench 2). The bricks are of the same fabric and appear to be from the same moulds.

Bricks were sampled from contexts 206 and 104 - two examples from 104 and one from 206 (Plate 20). The bricks were substantially intact but all had suffered a degree of damage.
