# Thurnham Hall Thurnham, LANCASHIRE

*Archaeological survey of the roof.*

# Thurnham Hall Thurnham, Lancashire.

*Archaeological Survey of the roof.*

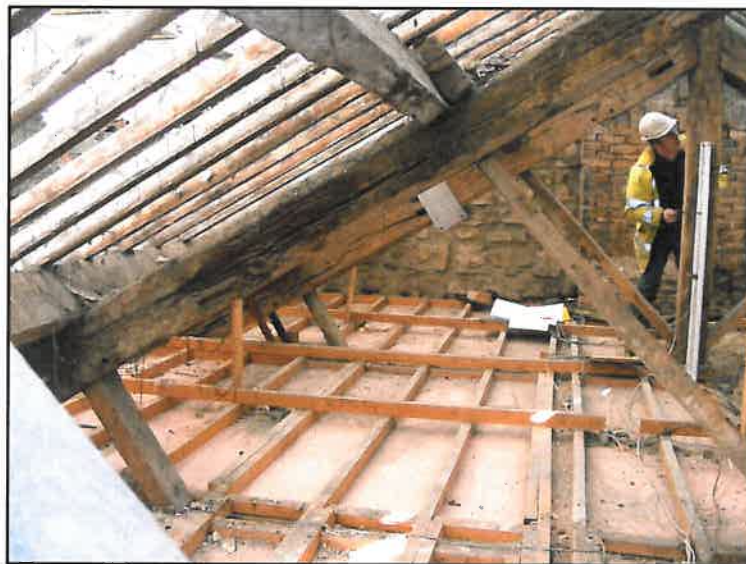
**Cover picture**      *Surveying in Roof 1 at Thurnham Hall, an archaeologist recording the details of Truss "B".*
