The Manor House, Medbourne: The Development of Leicestershire's Earliest Manor House

by *Nick Hill*

The development of this important manor house has been the subject of a recent programme of detailed recording and analysis, accompanied by dendrochronology. A complex sequence of building phases has been established, dating back to the earlier thirteenth century, with major rebuilding in the late thirteenth century and the sixteenth century. It is suggested that an aisled hall of c.1238, possibly timber-framed, was replaced in c.1288 with a stone-built hall and a cross wing containing service rooms below a solar. Parallels are drawn within the locality and wider national developments to establish the significance of the building. In national terms, it provides an excellent example of the transition from aisled hall to a base cruck or 'short principal' type of roof structure, with unusually precise dating of both phases. Regionally, it is argued that it is a representative example of an early 'great rebuilding' in this stone belt region, probably marking the transition from timber-framed construction to stone, and using the base cruck/short principal roof structure within stone wal

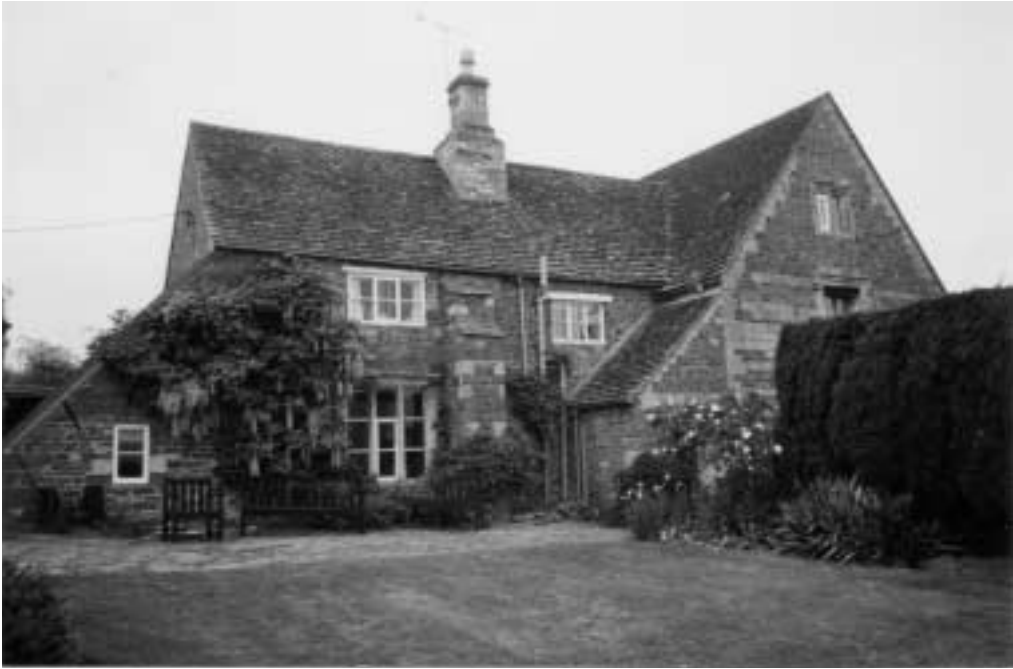
1. View of the west front

The existing house is built of stone and consists of a main block, the original hall, with a cross-wing at the south end (illus. 1-3). A striking feature is the fine set of three medieval stone doorways in the cross passage which lead into the former service end in the cross-wing (illus. 4). The hall has a central truss of base cruck/short principal type,

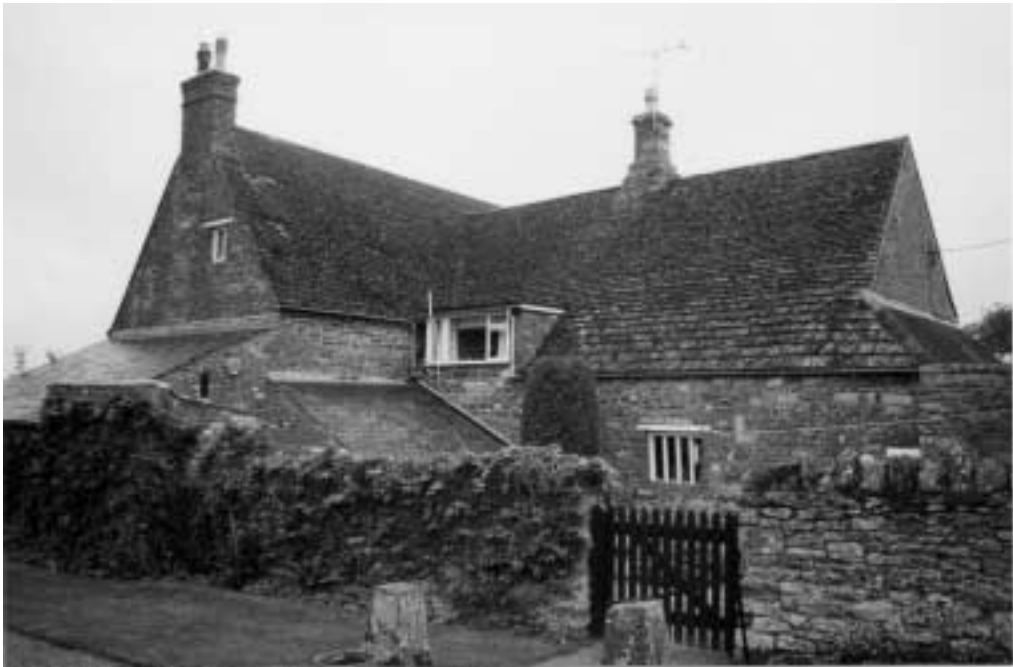
5. View of cross wing and hall from north-east

and is single-aisled, the former aisle to the west front having been removed, but the roof still sweeping low over the remaining aisle to the east (illus. 5). The roof structure over the hall has arcade plates which support notch-lapped common rafters of early type, together with a strange asymmetrically braced truss. To the north, the surviving lean-to block probably represents a reduced remnant of a further bay to the hall. A large chimney stack and first-floor structure were inserted into the open hall in the sixteenth century.

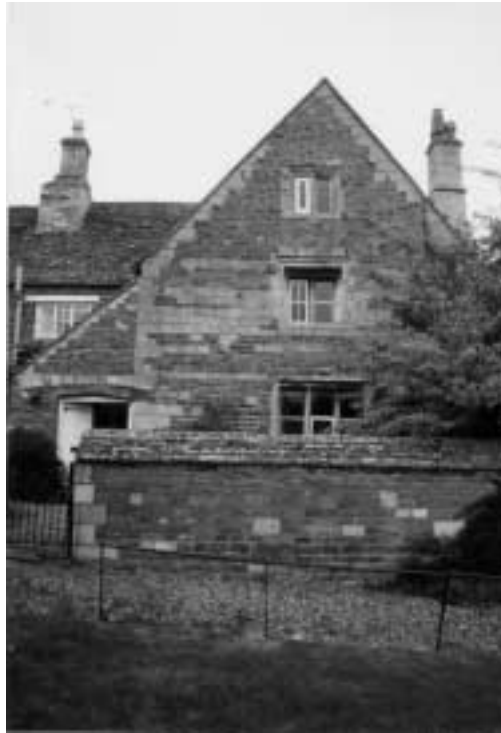
15. West gable of cross wing, with deeply moulded solar window

Both the arched roof timbers with nail-head ornament and the two-light pointed window in the east gable strongly suggest that this space formed an impressive solar, occupying the whole of the cross-wing first floor above the service rooms, and of late thirteenth-century date like the rebuilt hall block and the cross passage service doorways. The high quality moulded stone window of c.1500 (see below) in the west

gable at first floor level indicates that the use of this space as a fine solar probably continued through the fifteenth century. The current stone window here may well be a replacement of another thirteenth century window, similar to the one discovered in the east gable.
