A MEDIEVAL UNDERCROFT, TENEMENTS AND ASSOCIATED BUILDINGS AT 9 ST NICHOLAS PLACE AND RELATED SITES, LEICESTER

Roger Kipling

Examination of the results of recent archaeological excavations at 9 St Nicholas Place in Leicester, along with data from unpublished sites in the same locality, has yielded important information regarding the origins and development of burghal properties from the early medieval period onwards. It appears likely that these land divisions, with their probable late Anglo-Saxon origins, were initially laid out in an arrangement of substantial, regularly-sized plots prior to early sub-division during the medieval period, stemming from increasing pressure on urban space and driven by speculative commercial exploitation of street frontages along the principal commercial streets.

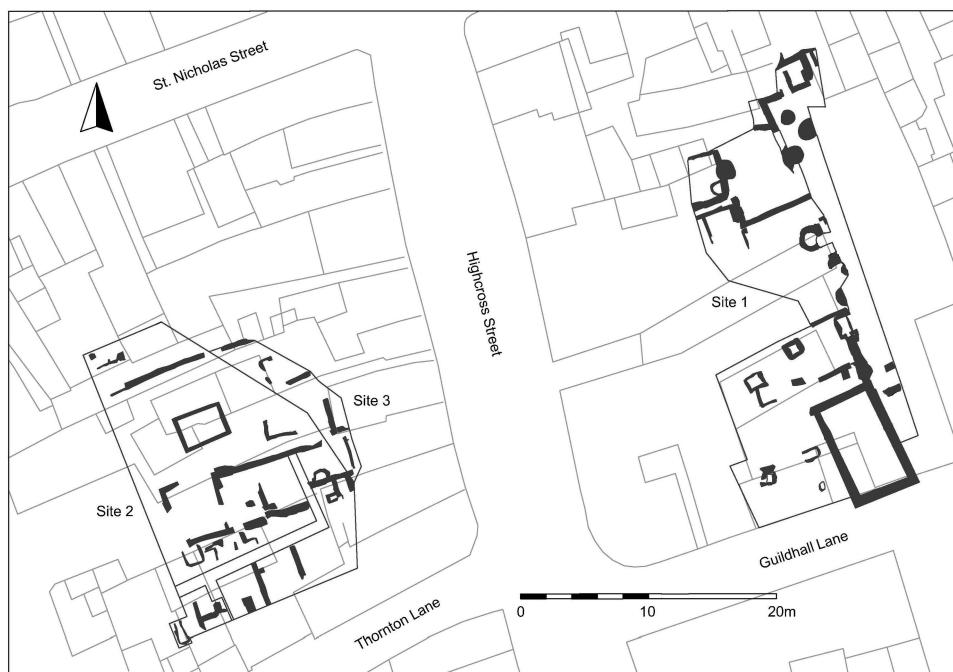
Fig. 1. Sites 1–3 overlaid over road plan, with street names as they were 1887–1955.

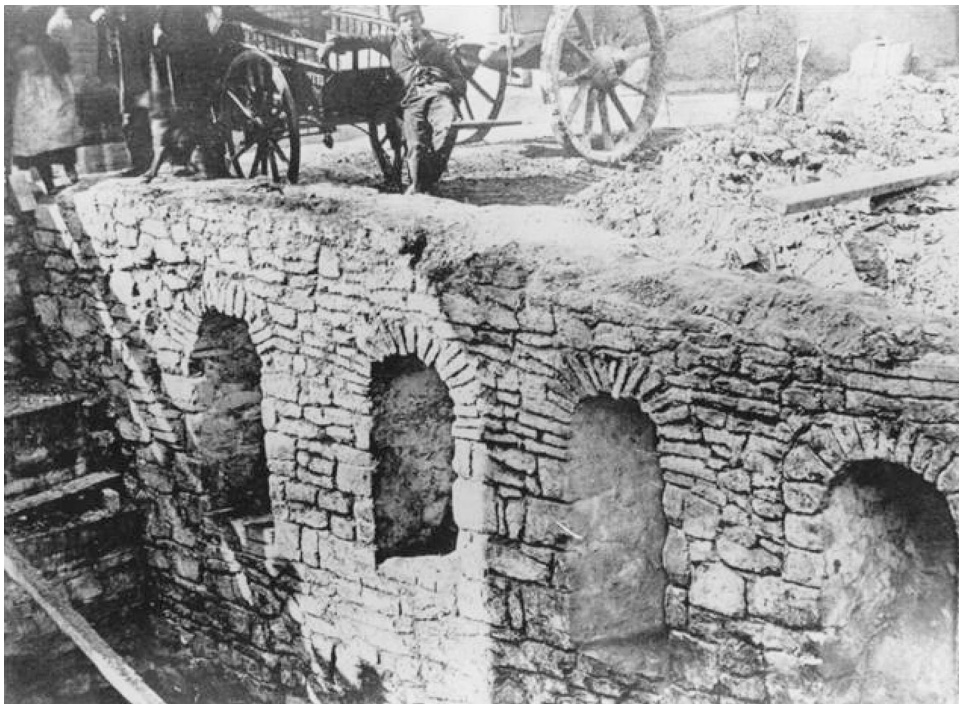
Fig. 8. The undercroft photographed in 1861.

The St Nicholas Place (Site 1) undercroft, first documented in 1844, lay for several hundred years beneath an Elizabethan timber-framed house until it was demolished in 1861. A contemporary photograph shows that the west wall of the

now-exposed undercroft, with its four round-headed windows, was largely intact prior to the redevelopment of the site. The construction of a brick-vaulted building over the structure resulted in considerable damage to its west wall. Following unsuccessful attempts in 1956 to schedule the cellar, its location was subsequently lost until its re-discovery by the Leicestershire Museums Survey Team in 1989. The recording of the fabric and a limited archaeological investigation of the interior was undertaken subsequently by Leicestershire Archaeological Unit in 1990, access being made via a small manhole (Hagar and Buckley 1990, 99). In 2003 the nineteenth-century buildings on the site were demolished and the brick vaults over the undercroft removed (Figs 9 and 10).

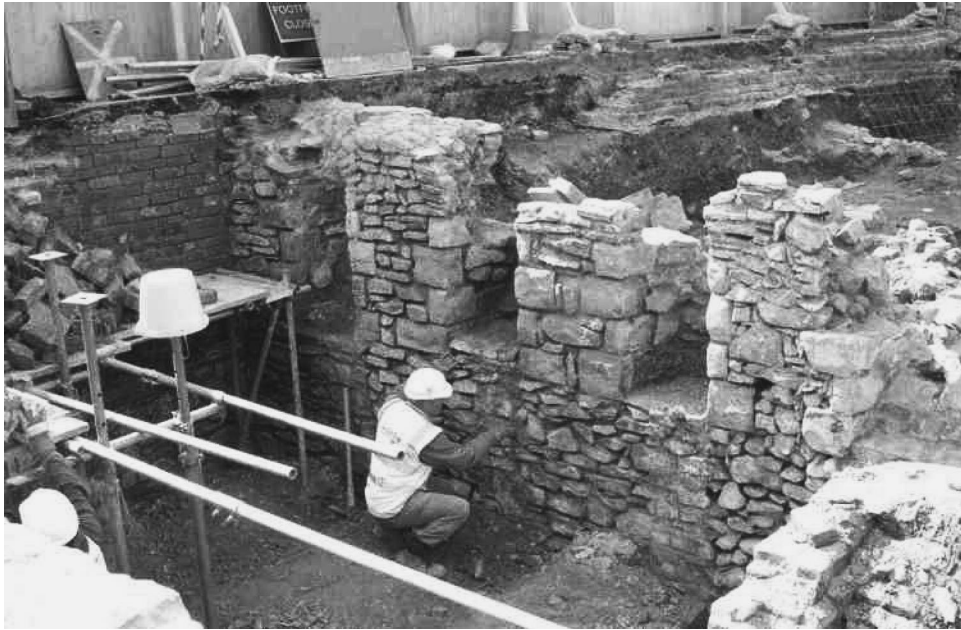
Fig. 9. The undercroft: western internal wall elevation.

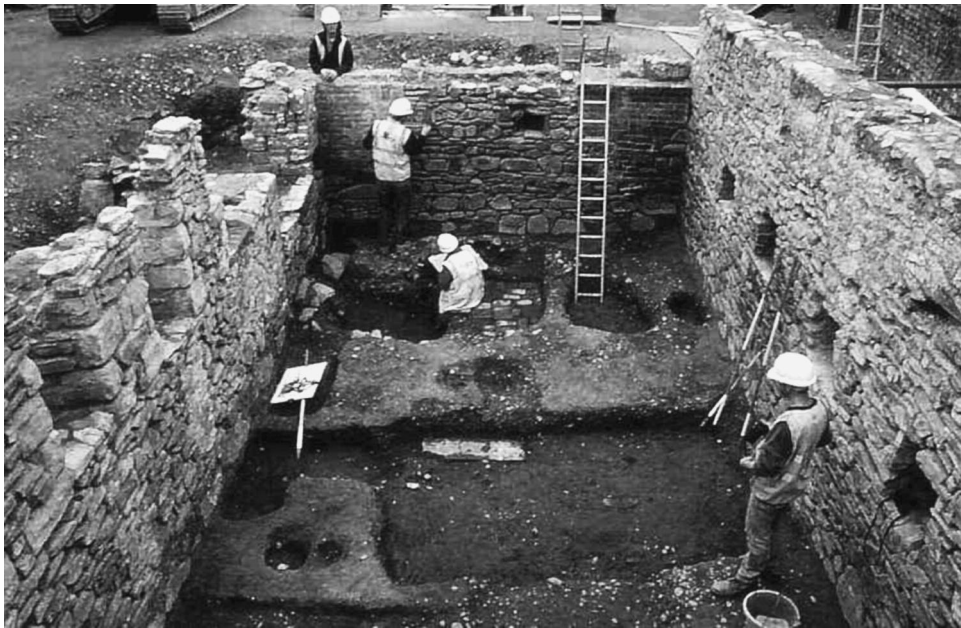
Fig. 10. The undercroft during excavation: view north.
