THE TWELFTH-CENTURY AISLED HALL OF LEICESTER CASTLE: A RE-ASSESSMENT

Nick Hill

A recent programme of research, accompanied by archaeological excavation and dendrochronology, has confirmed the Great Hall of Leicester Castle as the earliest known standing aisled hall in Britain, now tree-ring dated to 1137–62. It was built for Earl Robert II of Leicester, one of the greatest magnates of the period, probably in the 1150s when he was at the height of his powers. The form of the main twelfth-century roof structure, with timber arcades and a former clerestorey, was established in previous work of the 1980s. The current study has added detailed analysis of the external masonry walls, including the uncovering of two service doorways. Archaeological excavation established that the aisle posts were originally earth-fast. Drawing on earlier documentary study, a revised reconstruction of the original building form is proposed, relating the upper roof structure to the original masonry walls, aisles and floor level. Evidence indicates that a small service building was attached to the north gable, with a detached chamber block located to the south. The relationship of Leicester to other early a

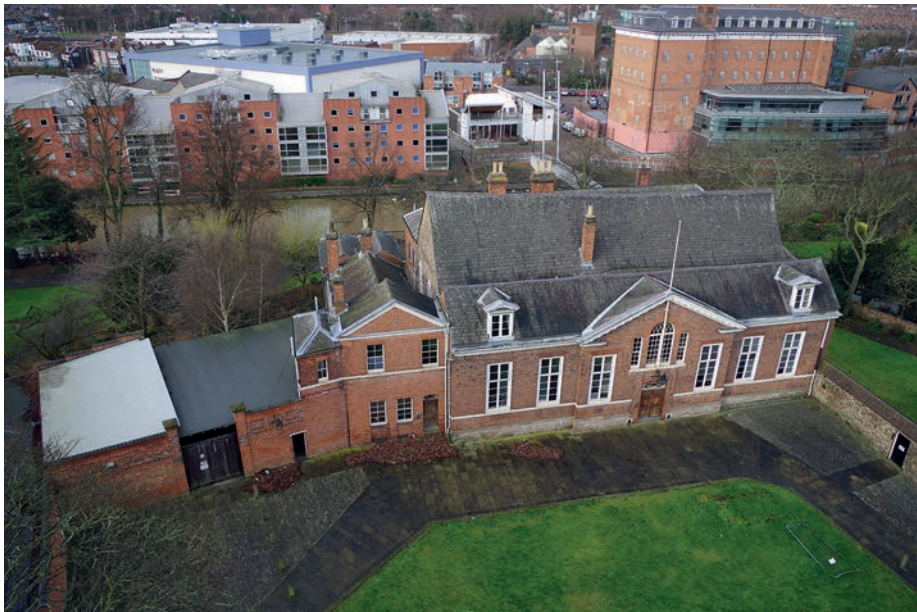
Fig. 2. Leicester Castle Hall from the east, with the new façade of c.1695. John of Gaunt's Cellar lies under the flat-roofed buildings to the left. *Image by N Finn.*

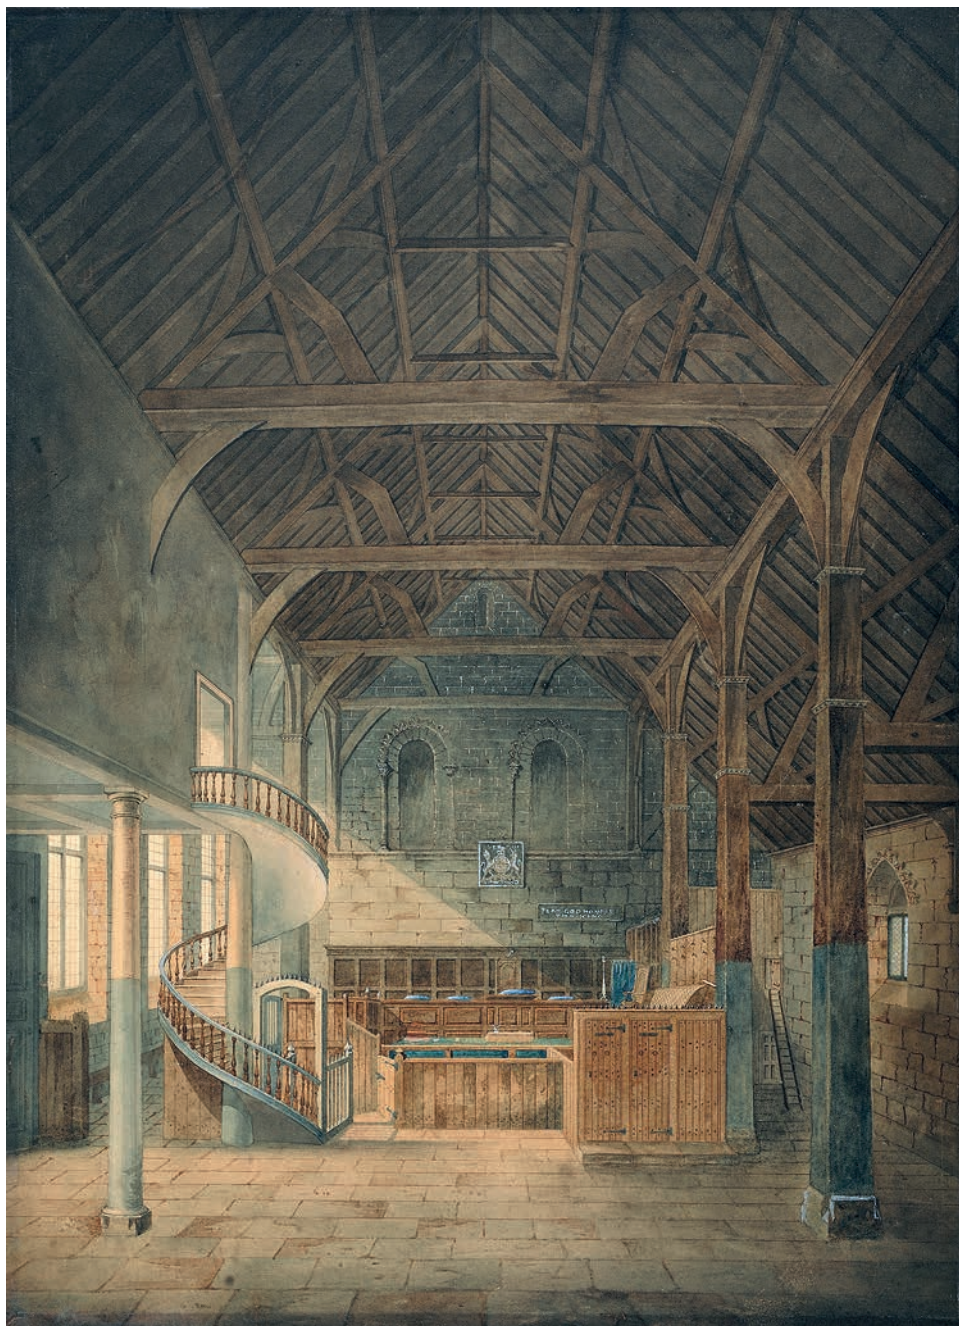
Fig. 3. Henry Goddard's drawing of 1821 of the Great Hall interior, looking south.
Drawing courtesy of A Goddard of Newton Harcourt, Leicestershire.

which included much cutting back²² of their west and east faces (see Figs 4 and 5). The 1821 Goddard drawings show aisle posts *c'* and *d'* as circular and without capitals, so these may have been replaced or altered at an earlier date, perhaps in *c.*1695.

The foot of post *f* on the west side was discovered in a nineteenth-century heating duct by Neil Finn in 1996.³¹ The base of the post sits on a padstone of Dane Hills sandstone, and has a number of mortices to the visible parts of the south, east and north faces (Figs 13 and 14). As interpreted in 1997, it was thought that this was the original padstone still *in situ*, and the pattern of mortices was associated with an early dais structure. The recent ULAS survey has indicated that the padstone is set above the level of the medieval floor, so cannot be *in situ*. The post base was re-examined closely by the author in 2017 as part of the current study. The padstone is built into the brickwork of 1821, so is probably a re-working of that date. The base of the post is clearly truncated, as it has a peg-hole angled downwards very close to the base at the south-east corner, presumably a secondary feature. The various mortices, the upper ones with *c.*15mm diameter peg-holes, appear of later date and secondary. They probably relate to previous phases of court fittings, which no doubt had raised benches, like the eighteenth-century fittings visible to the southern court on Goddard's drawing of 1821 (see Fig. 3). The most significant feature of the post

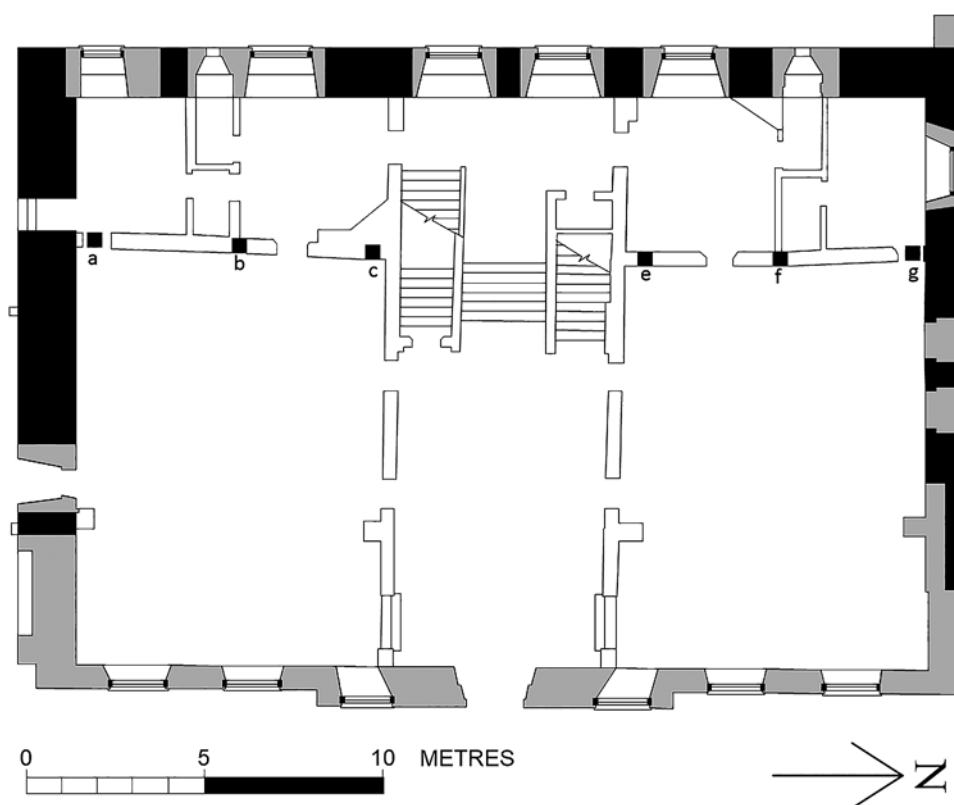
Fig. 4. Leicester Castle Hall: Ground-floor plan, with early walls shaded black.
Drawing N Hill and R Ovens, after N Klee.

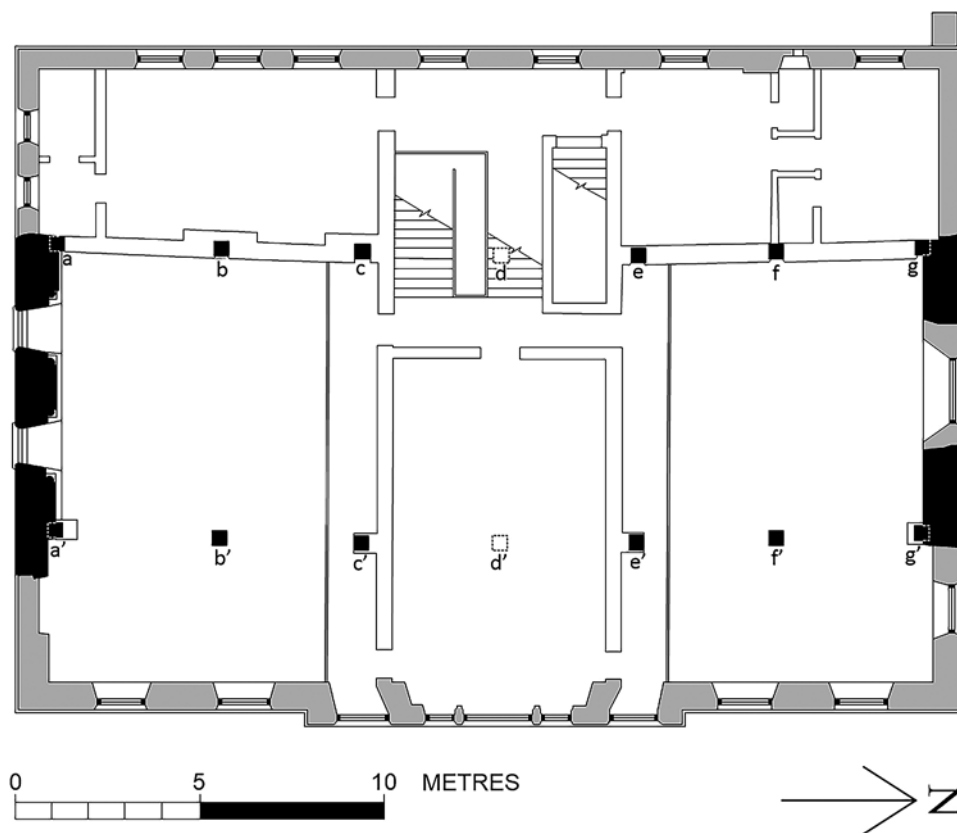
Fig. 5. Leicester Castle Hall: First-floor plan, with early walls shaded black.
Drawing N Hill and R Ovens, after E Born and W Horn.

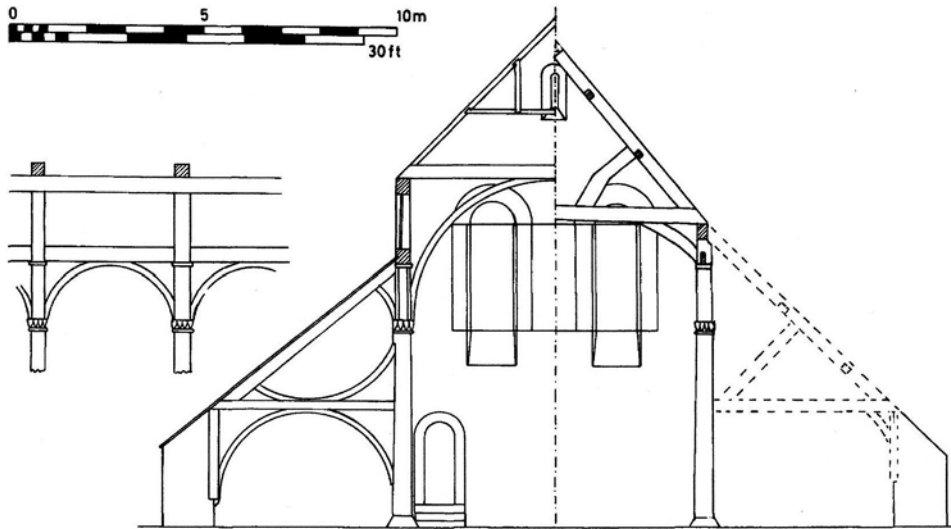
Fig. 6. Alcock's cross-section of 1987: the pre-1821 section to the right and reconstruction as original to the left, with longitudinal section of arcade.
Drawing N Alcock.

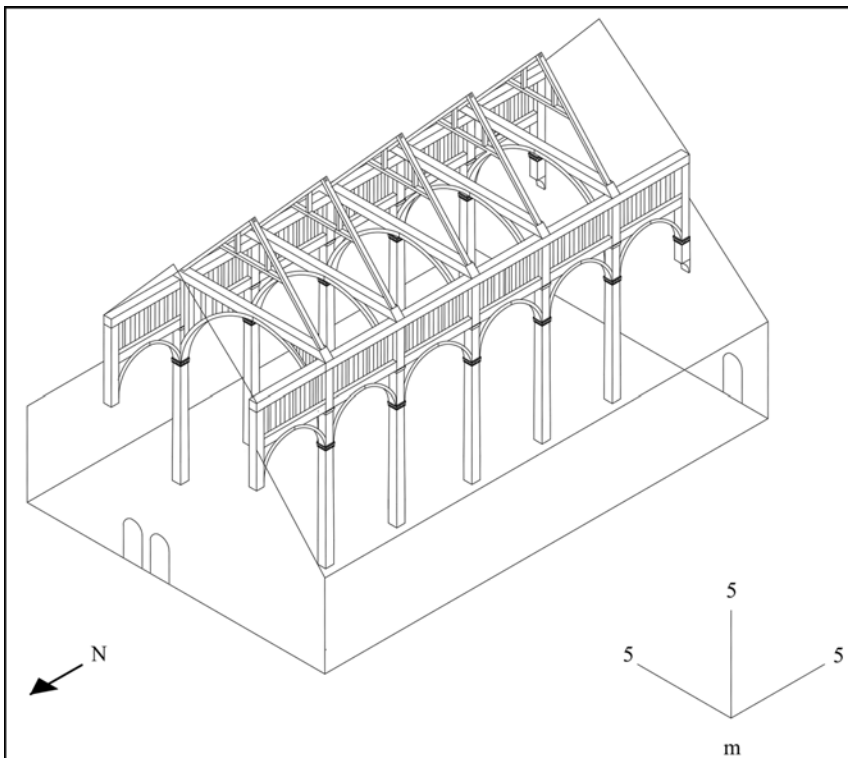
Fig. 7. Isometric reconstruction of the aisled hall with clerestory. *Drawing R Buckley.*

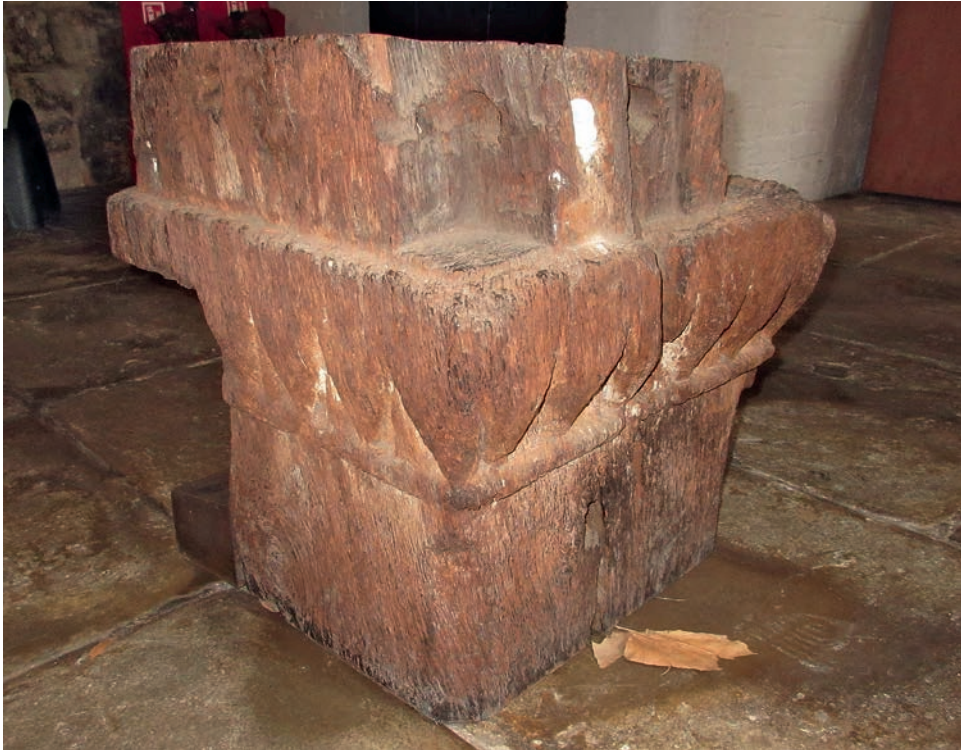
Fig. 8. The detached aisle post capital from the Castle Hall. *Image N Hill.*

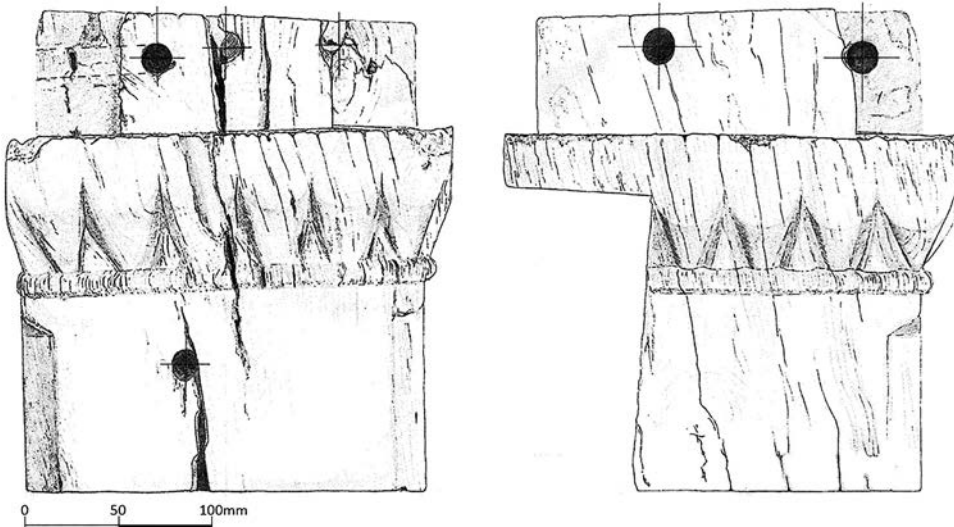
Fig. 9. The west and north faces of the detached capital, with face-pegging for curved nave and arcade braces, and notching for the gallery floor beam and joists. *Drawing N Klee (from ULAS archive).*

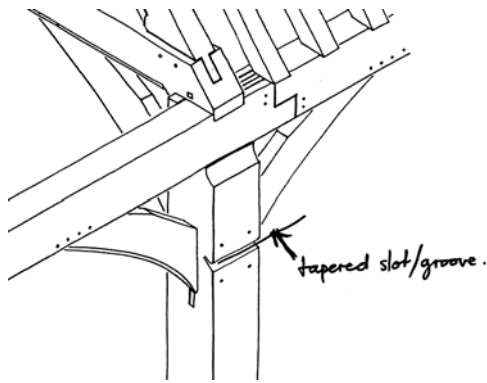
Fig. 10. The groove across the back of the posts, to receive the weathering of the aisle roof. Detail from N Klee drawing No 19 of June 1985, ULAS archive.

At higher level, the surviving posts retain further evidence for the clerestorey. The outer face of some of the eastern posts had downward-sloping grooves to receive a weathering for the aisle roof, as recorded by Klee (Fig. 10), no longer visible. A similar groove for the aisle roof weathering has been found on the clerestorey plate at Hereford Bishop's Palace.²⁶ The north and south sides of the posts also have square-cut grooves to take the plank infill of the clerestorey (Fig. 11). On posts b' and e', there are also sloping grooves of V-section, which Alcock thought were probably to receive timber wattling staves – representing a later repair to the clerestorey boarding.

For the aisles, a different configuration is shown from that of Alcock and Buckley. The groove in the back of the aisle posts, noted by Alcock and Buckley, and recorded by Klee (see Fig. 10), indicates the height at which the aisle roof abutted the main structure. The aisle roof has been drawn at an angle of 40°, resulting in an external wall height around 3m above internal floor level. The original roof covering was probably of timber shingles, as repaired in 1313-14, and replaced in 1377-78 with Swithland slates.⁵⁷ The traditional pitch for such roofs, especially Swithland, is at least 40°, and usually more, so it is unlikely that the aisle walls were any taller. The eaves detail as drawn shows the typical arrangement found in early stone buildings with common-rafter roofs. Such buildings had flat wall-tops to receive the roof timbers, usually with an inner and outer wall-plate. Vertical ashlar pieces of timber were used to connect the rafter to the sole piece and inner wall-plate. The upper part of the inside wall face was thus of timber, not stone (unlike the structure as rebuilt in *c.*1500). With the lower medieval floor level, there is space

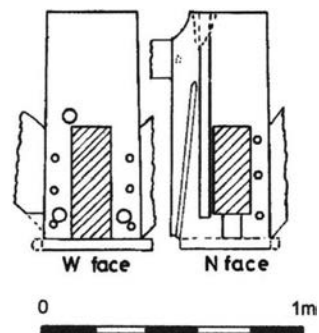
Fig. 11. Alcock's detail drawing of the surviving evidence on post *e'*. The north face shows the vertical slot for clerestory board infill. On the west face, the two large peg-holes at low level are thought to have been for the early mortice and tenon joint to the clerestory plate, though the purpose of the large peg-hole to the upper left is obscure.

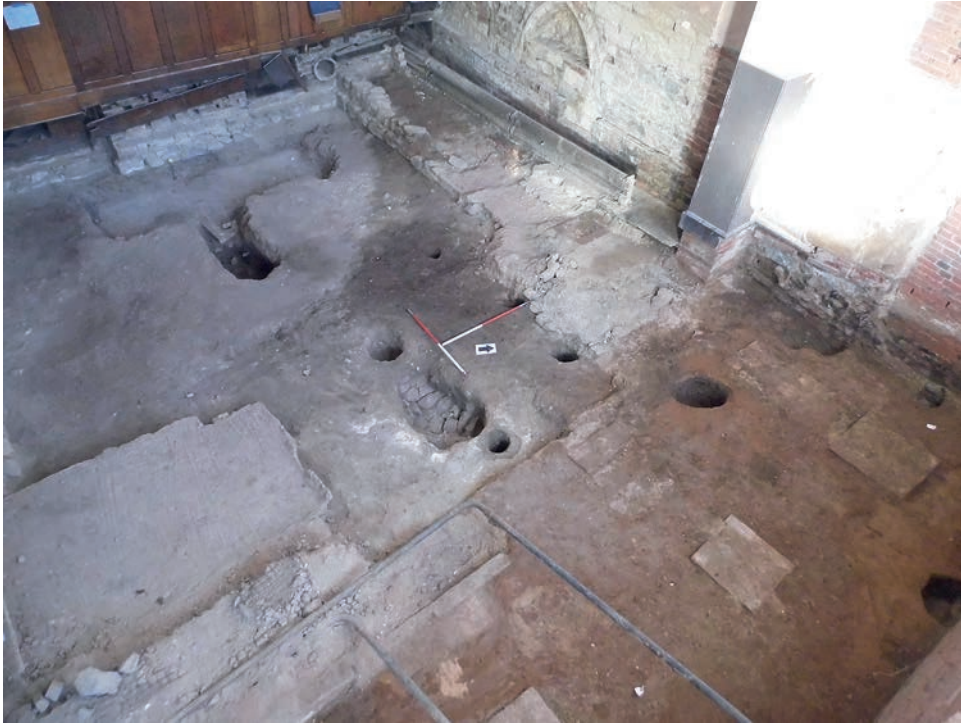
Fig. 12. The north courtroom as excavated in 2015–16. The post hole of former aisle post *f'* is the large pit in front of the measuring rods, backfilled with packed stones.

Further details of the timber structure can be added in three locations. Firstly, the excavation in 2016–17 in the north court (Fig. 12) revealed an original post hole for the missing eastern aisle post *f'*, indicating that the aisle posts were earth-fast.³⁰ The post hole was around 700–800mm wide and was excavated to a depth of 600mm, although it continued deeper. The upper level of the backfill retained the seating for a former rectangular padstone, clearly inserted when the foot of the earth-fast post was replaced. Pottery fragments associated with the padstone location suggested a date

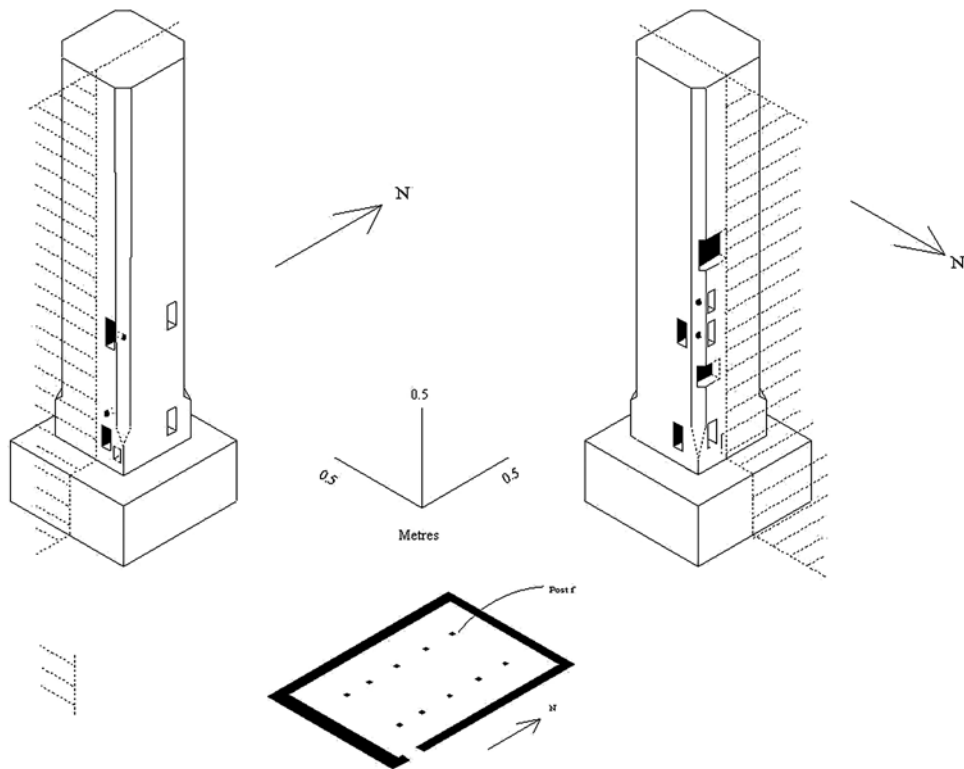
Fig. 13. Measured survey drawing of the foot of aisle post *f* to the Castle Hall. Much of the post is concealed by the inserted brick walling. *Drawing R Buckley.*

base is a slight horizontal step in the timber about 225mm above the padstone (not shown on Fig. 13; see Fig. 14), which runs across the east face and continues around onto the south face (the north face is concealed). Above this line, the face of the post is well-finished, with no obvious axe or saw marks. The lower part of the post is roughly finished, with axing marks. It is evident that the post originally had a projecting base, which has been cut back at a later date. Above this base, the corners of the post are eroded or roughly chamfered, so it is unclear if the corners were originally square or chamfered.

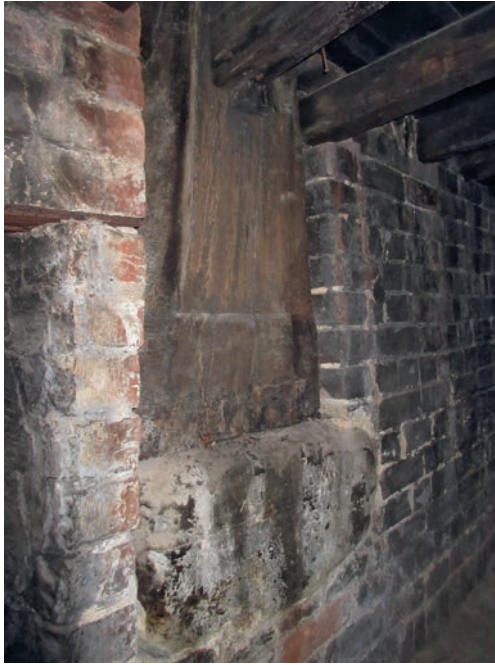
Fig. 14. Leicester Castle Hall; the foot of aisle post f, sitting on an inserted padstone, with horizontal step where the projecting base has been cut back. *Image N Hill.*

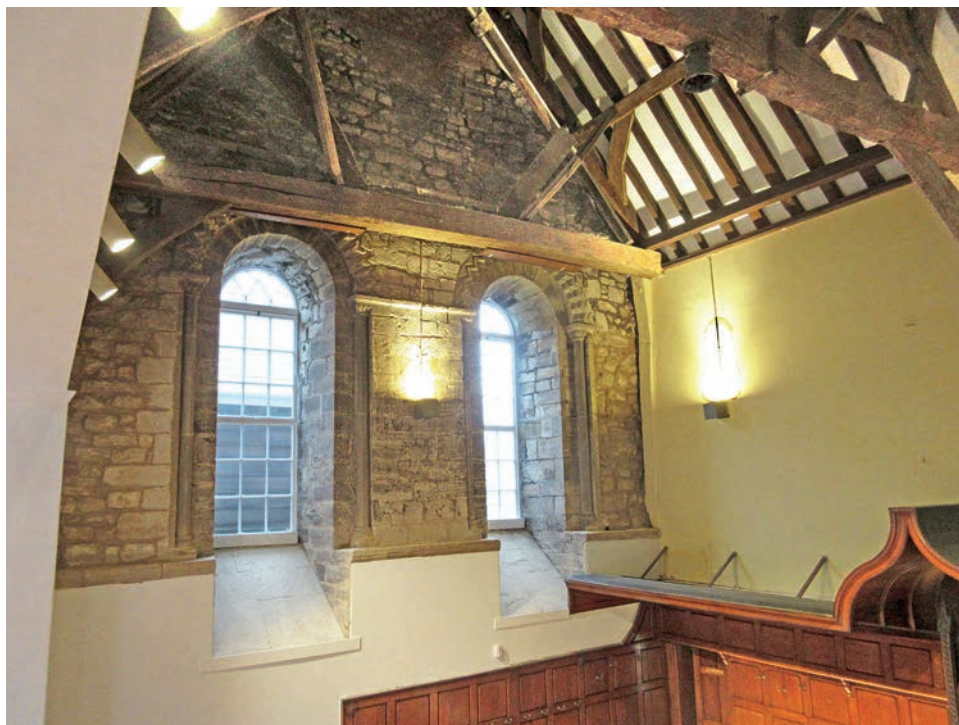
Fig. 15. The south gable, with fine Norman windows. *Image N Hill.*

The internal face of the south gable has the best surviving original masonry (Fig. 15). The two tall Norman windows have round arched heads surrounded by chevron

mouldings, with shafted jambs. Nichols includes a drawing of these ‘Two windows, or passages, stopt up, within-side of the Castle’ and a very similar drawing appears in Throsby’s history of Leicester of 1791.³⁵ The windows are shown still blocked up in the Goddard drawings of 1821, with additional detailed drawings of the shaft base, capital and chevron mouldings.³⁶ The windows were opened up and restored in 1821–58, but careful examination shows that much of the original twelfth-century masonry remains, with characteristic diagonal axing marks. As the early drawings show, the east window was better preserved than the west one, and it retains its original chevron mouldings, arch voussoirs and slightly splayed jambs, together with both shaft bases and scalloped capitals. The chevron ornament has two rows of roll-moulded lateral chevrons on the face, the chevrons pointing inwards in centripetal form with one chevron per voussoir.³⁷ The shafts themselves have been replaced, apart from one original shaft which survives to the west window, proving that its original form was, unusually, octagonal not circular. The whole arched head and chevron moulding of the west window have been renewed. The external face of the

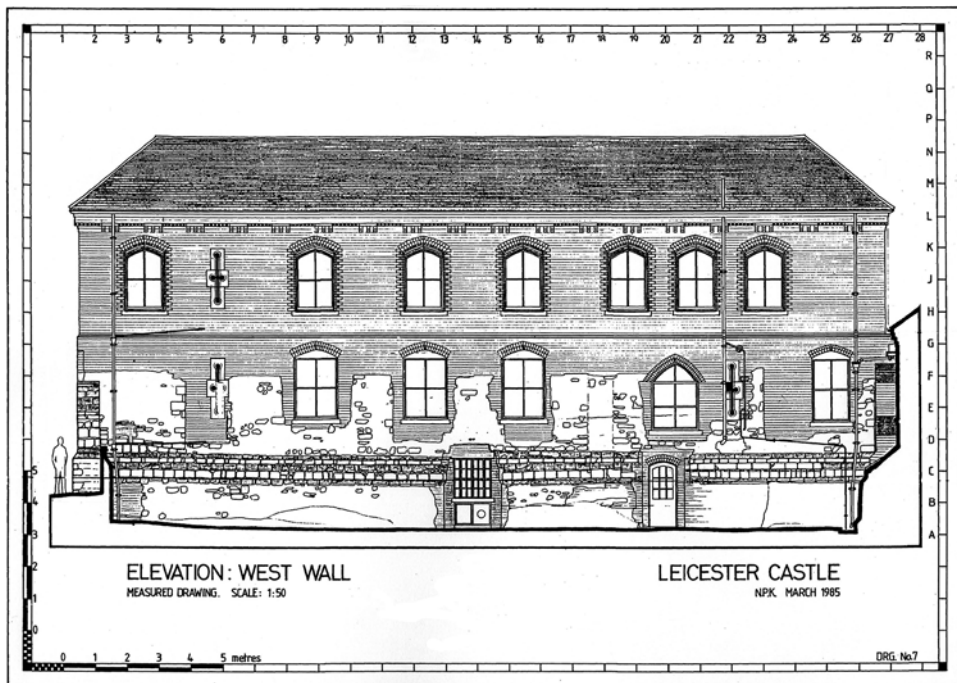
Fig. 16. West elevation survey drawing of 1985, with surviving twelfth-century plinth and nineteenth-century top storey. *Drawing N Klee.*

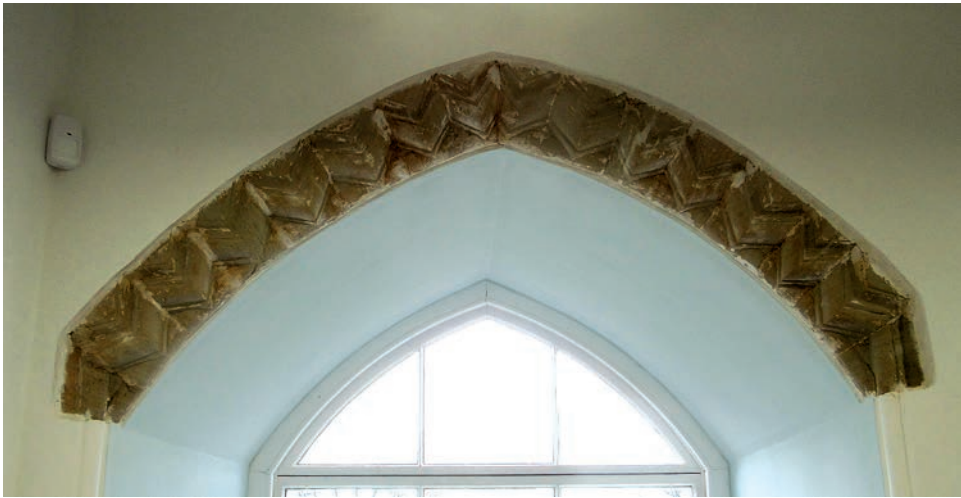
Fig. 17. Window to west elevation with pointed arch and chevron ornament.
Image N Hill.

The second window from the south end, lower-set and with a pointed brick arch above, is of particular interest. Although the exterior surround is now all of brick, the interior retains a masonry arch with chevron ornament, clearly original twelfth-century fabric, although probably re-set. The arch is pointed, not round-headed like the other early windows, forming a shallow two-centred arch, consisting of two uniform arcs, with a span on the internal face of 1,810mm (Fig. 17). It has a single row of roll-moulded chevrons, lateral on the face, pointing inwards in centripetal form – the same as the chevron of the south gable windows, but with a single row instead of two. There is one chevron per voussoir, with some irregularity in the voussoir width and chevron size. Where the voussoirs meet at the pointed head of

the arch, the chevron to either side is truncated, probably cut back when re-set.³⁹ At the springing of the arch, the roll moulding is continued down onto the vertical jamb, without the normal impost moulding. Below the arch, the jambs are covered up and the roll moulding continues, but in modern plasterwork. Given the irregularities, and a date which would be unusually early for a window with a pointed arch, it does seem most likely that the chevron arch has been re-set from elsewhere. The chevron arch is shown on the Goddard drawings of 1821 in its current location. Nichols and Throsby (1791) also include drawings of a chevron-arched window opening.⁴⁰ Additional details in Thompson, with drawings by Goddard, show that the moulded wall-plate of the c.1500 aisle roof was still in place directly above the window, indicating that the chevron-arched opening was in this position by the time of the c.1500 reconstruction of the roof.⁴¹

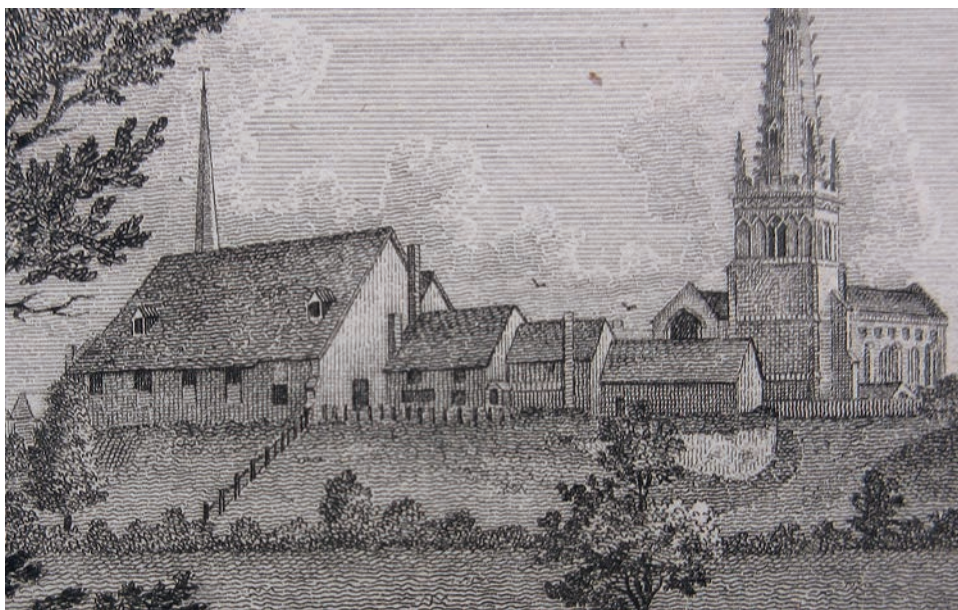
Fig. 18. Leicester Castle: Detail of a view of 1796 from the west, in Nichols' *History of Leicestershire*, Vol. I, Pt II, Pl. XXIV (opposite p.303).

however, is rather confusing. Throsby sketched a view of Leicester Castle from the west in 1789, but the detail seems suspect and parts of the building are obscured by trees.⁴² It shows a doorway with a pointed arch towards the south end of the west wall, and two windows with pointed arched heads and a central mullion, with intersecting ‘Y’ tracery in the head. A central mullion or tracery to the chevron-arched window seems most unlikely, as the detailed internal views of the window in both Throsby and Nichols show it with small glazing panes and no subdivision.⁴³ Nichols includes the same drawing, but also two others, noting that ‘some alterations have taken place’ since the time of the 1789 drawing.⁴⁴ Both these drawings show five windows in the west wall with flat heads, the southern one set at a lower level, and a range of three separately roofed blocks to the south (Fig. 18). A drawing by John Flower (or more probably his daughter Elizabeth) shows two windows towards the south end of the wall, but the rest is obscured by trees, and the date is probably after 1821.⁴⁵ Conflicting evidence comes from Thompson in 1859, who wrote that the west side had ‘six windows, corresponding to the six bays inside, between the columns. Outside, the openings seem to have had semi-circular heads – inside, they were pointed, and ornamented by the zig-

The south gable of the Great Hall currently contains two doorways (see Fig. 4), one in the west aisle and the other in the south-east corner of the nave. Any historic evidence around the doorway in the west aisle is concealed, but this doorway is indicated consistently on the two 1790s drawings in Nichols (see Fig. 18), and the early nineteenth-century Flower drawing.⁶⁴ A door in the end gable of an aisle is the normal location for a door leading from the upper end of an early hall towards the principal chamber, as seen, for example, at the castle halls of Oakham (1180s) and Winchester (1222–35), and the bishop's hall at Auckland Castle, County Durham (c.1190).⁶⁵ The doorway in the south-east corner of the nave is in Norman style, but entirely Victorian, inserted when the southern block was added in 1858.⁶⁶ The rest of the south wall is covered by plaster, so no historic evidence is now visible. However, a local architect and archaeologist, T. H. Fosbrooke, recorded further evidence relating to the south wall of the nave in the 1920s: 'On the south wall, now hidden by the woodwork of the jury box etc, are two doorways and remains of others which led to the kitchen, pantry and buttery, but they have been so mutilated by modern alteration as to be little more than mere suggestions.'⁶⁷ Fosbrooke also produced a sketch in 1917 showing his conception of the original appearance of the interior of the hall, which included a pair of round-headed doorways in the centre of the south gable.⁶⁸ Without any other details, and if the remaining evidence was indeed 'mere suggestions', it is difficult to conclude that these were original twelfth-century doorways. Given the extensive development of ancillary buildings at both the high and low ends of the hall in the following centuries (see below), the variety of doorways noted by Fosbrooke could be later insertions.

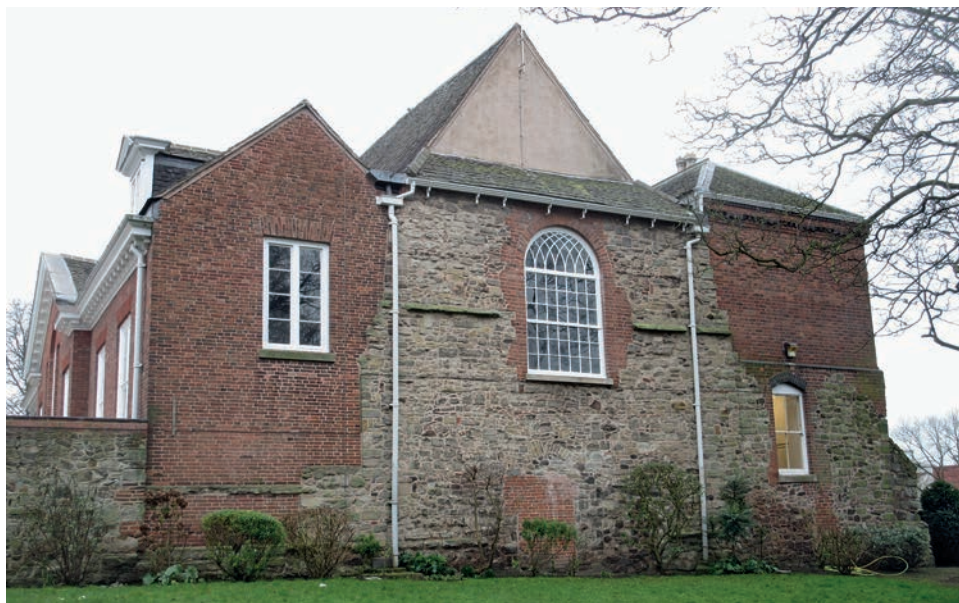
Fig. 19. The north gable. Note the projecting stone weathering to either side of the large window, indicating that an original building abutted against this wall. *Image N Hill.*

Of the original masonry, it remains to examine the north gable wall. The exterior face of this wall faces into the private garden of Castle House (Fig. 19). It has a number of early masonry features that have received little previous comment, as it is less readily accessible, although Nick Klee produced a measured survey drawing in the 1980s (Fig. 20). Inside, the building works of 2016–17 enabled previously hidden features to be seen, including two blocked medieval doorways.⁴⁹ The eastern part of the wall was largely rebuilt in brickwork in *c.*1695, and the upper gable has been replaced, with parts of the western side also re-worked in brick. Nonetheless, a large area of the earlier walling remains.

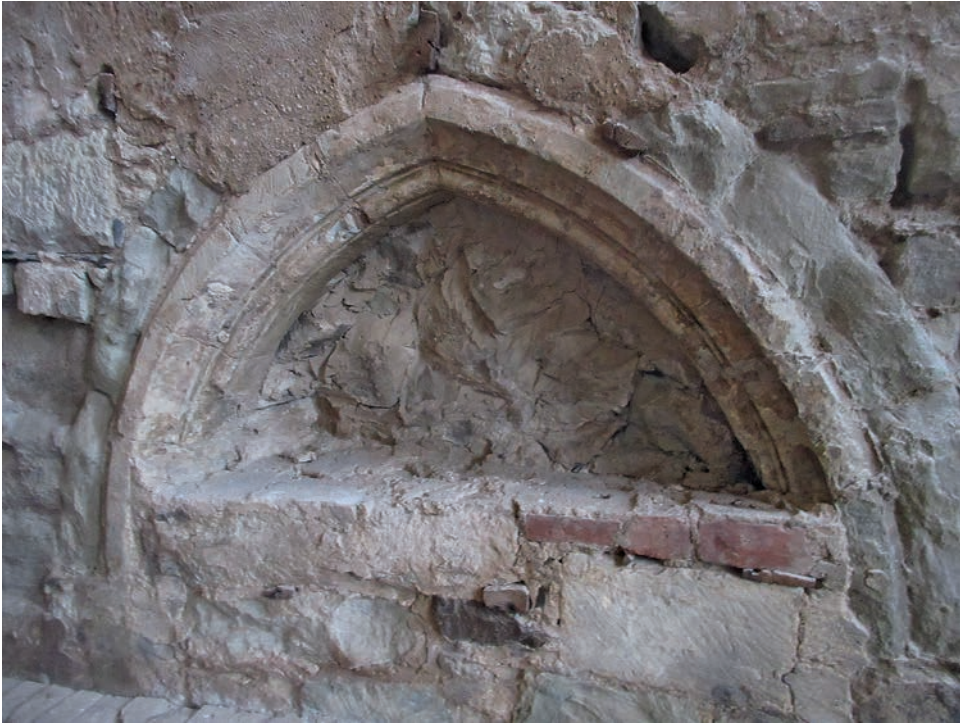
Fig. 21. One of the blocked doorways in the north gable, as uncovered in 2016.
Image N Hill.

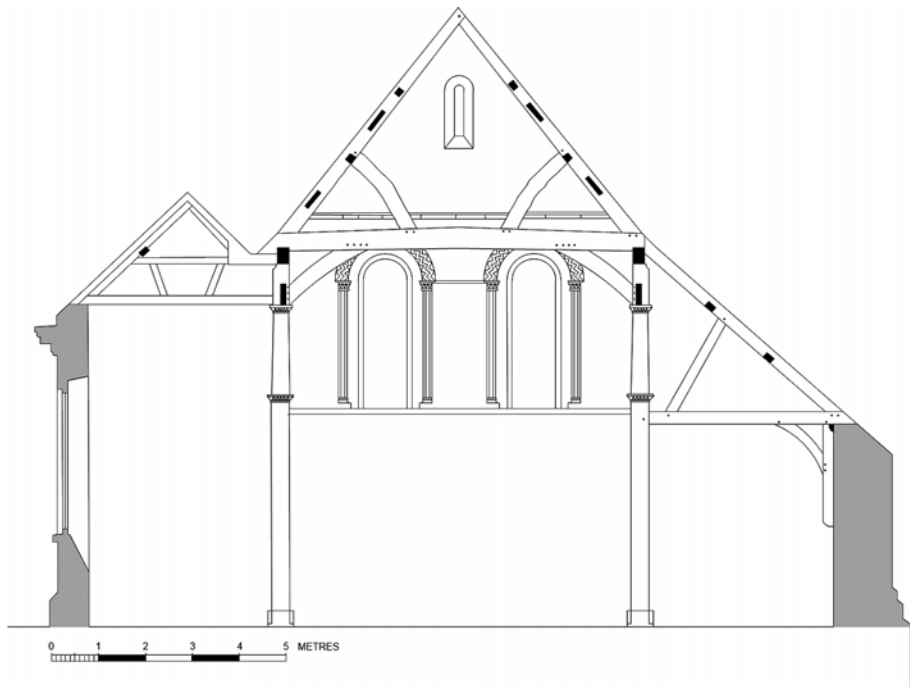
Fig. 22. Cross-section with the nave and west aisle roofs reconstructed as in *c.*1500, before the alterations of 1821. The east aisle was rebuilt in *c.*1695.
Drawing N Hill and R Ovens.

A reconstruction of the original cross-section of the hall has been produced, drawing largely on Alcock and Buckley's version of 1987 but with some revision, in particular for the aisles. The starting point is a reconstruction of the cross-section, as it was after the replacement of the roof in *c.*1500 and the reconstruction of the east aisle in *c.*1695, but before the alterations of 1821 (Fig. 22). The central nave section, still existing, is based on the Horn survey of the 1960s. The aisle post and aisle are based on Klee's survey information of 1985–86 and site measurement, together with the evidence of the Goddard drawings of 1821. The height of the west aisle can be accurately estimated, as the chevron-arched window head, re-set in *c.*1500, still survives, and it had the moulded aisle wall-plate a short distance above it. The aisle roof of *c.*1500 had half-trusses with each tie-beam supported by a wall-post on

a corbel, with an arch-brace. It had two sets of tenoned purlins, and the common rafters sat directly on the moulded wall-plate. Horn's survey shows the nave roof pitch at 51°, and the aisle roof as reconstructed has a pitch of 41°. The nineteenth-century Flower drawing shows a similar easing of the roof pitch over the aisle.⁵³

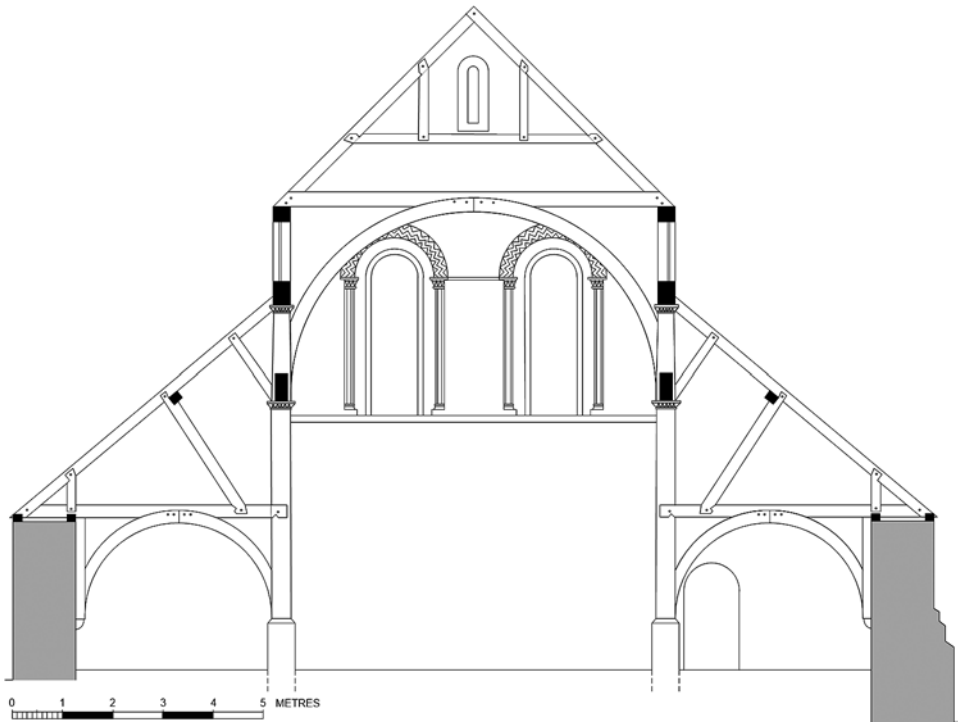
Fig. 23. Cross-section reconstructed as originally in the mid-twelfth century.
Drawing N Hill and R Ovens.

below the aisle tie for a set of semi-circular timber arch-braces, similar to the lost braces at Hereford Bishop's Palace.

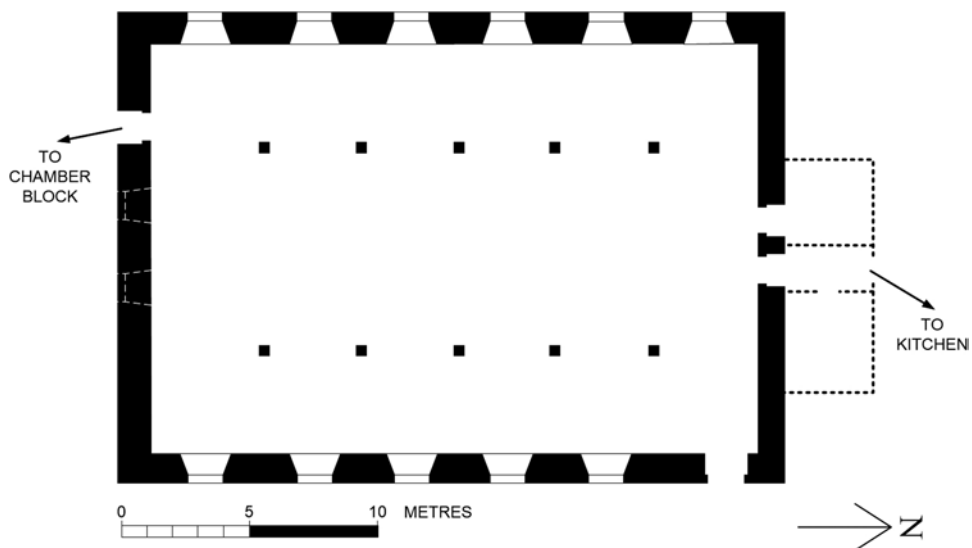
Fig. 24. Ground-floor plan reconstructed as original. *Drawing N Hill and R Ovens.*

The original plan is therefore reconstructed with the service end to the north (Fig. 24). A lean-to projection, housing the buttery and pantry, is shown attached to the north gable, its roof fitting underneath the stone weathering noted above (Fig. 25). Evidence for a similar lean-to attachment housing services has recently been assembled for the late twelfth-century Oakham Castle hall.⁹² The projecting stones noted on the north gable suggest that the service building might have had external walls of stone, but as the excavation conducted here did not identify any evidence for foundations, the wall material has been left open.⁹³ The original services building at Oakham is thought to have had timber walls, and excavation has shown that the stone-built hall of Clarendon Palace (Wiltshire) had an original attached timber building for the services.⁹⁴ The ground slopes away to the north, which might explain why, in the 1523 survey, the floors of the buttery and pantry

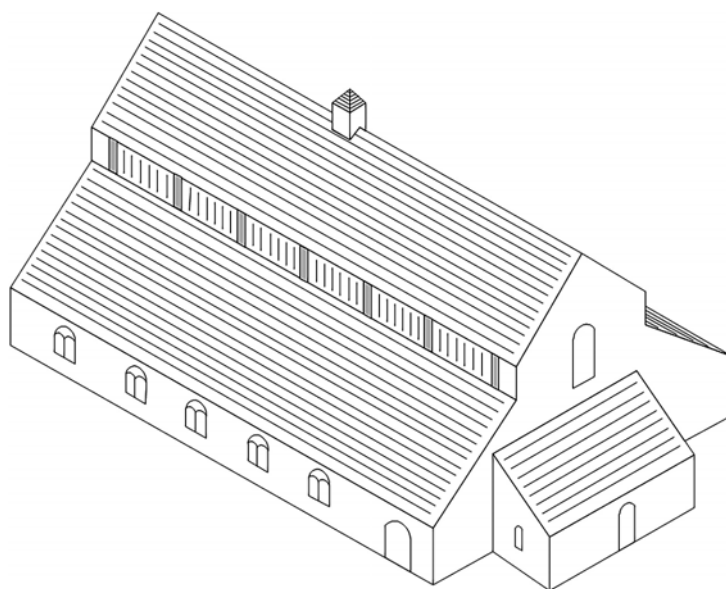
Fig. 25. Reconstruction view of the exterior as original, with lean-to service building attached to the north gable. *Drawing N Hill and R Ovens.*

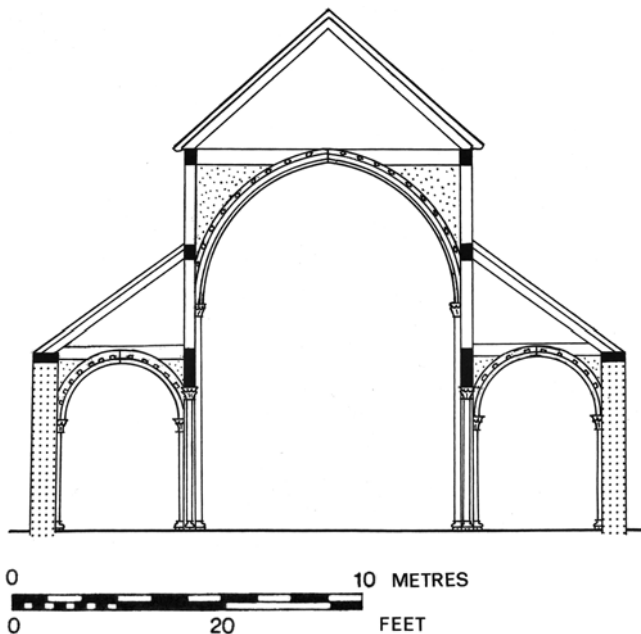
Fig. 26. Hereford Bishop's Palace: cross-section reconstructed as original.
Drawing J Blair 1987.

As noted by Alcock and Buckley, the hall at Leicester bears particular comparison with that at Hereford (Fig. 26), especially the timber structure. Both buildings had not only timber posts and longitudinal round-arched arcades, but also great timber arches spanning across the central nave. These transverse arches have to reach to a considerable height, as the original design of both buildings has been deduced to include a clerestory – the only two examples of such a feature yet found in aisled halls. The carpentry details are also similar in both buildings, with the arcade plates tenoned into the posts, but the great arched braces lapped and face-pegged, a rather insecure detail in comparison with the tenoned braces of slightly later work. At Hereford, the spandrels above the arcade braces were originally infilled with plastered panels, a treatment no doubt also applied to the nave and aisle arches. The visual effect was to create a solid arch, which may well have been the case at Leicester for the arcade arches, although (as noted above) it seems only the northern nave arch spandrels were infilled. Only one other example of an aisled hall with semi-circular lapped braces has been found, at Burmington Manor (Fig. 27), tree-ring dated to 1194/95. The round-arched arcade braces of one bay survive here, together with clear evidence for the nave braces, although this smaller hall had no clerestory.¹³⁰

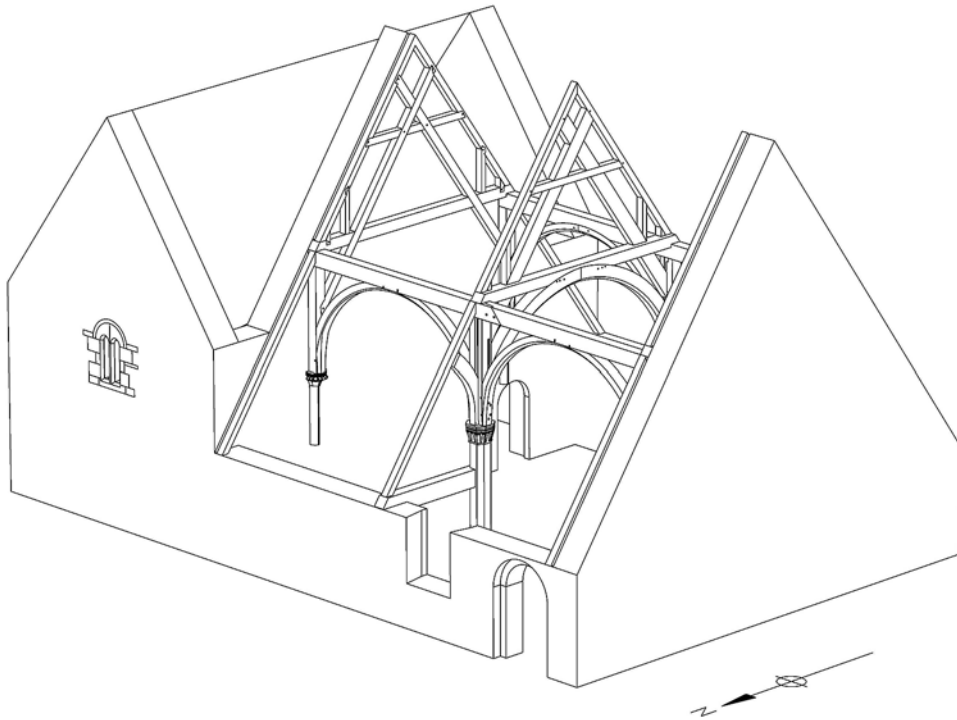
Fig. 27. Burmington Manor, Warwickshire: reconstruction of the original hall of 1194/95, with longitudinal and transverse braces. *Drawing J Walker.*

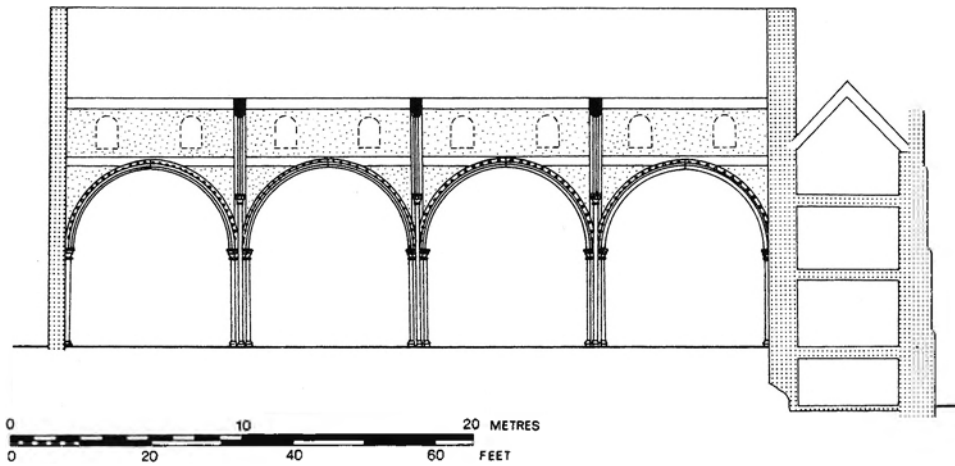
Fig. 28. Hereford Bishop's Palace: long section reconstructed as original.
Drawing J Blair 1987.

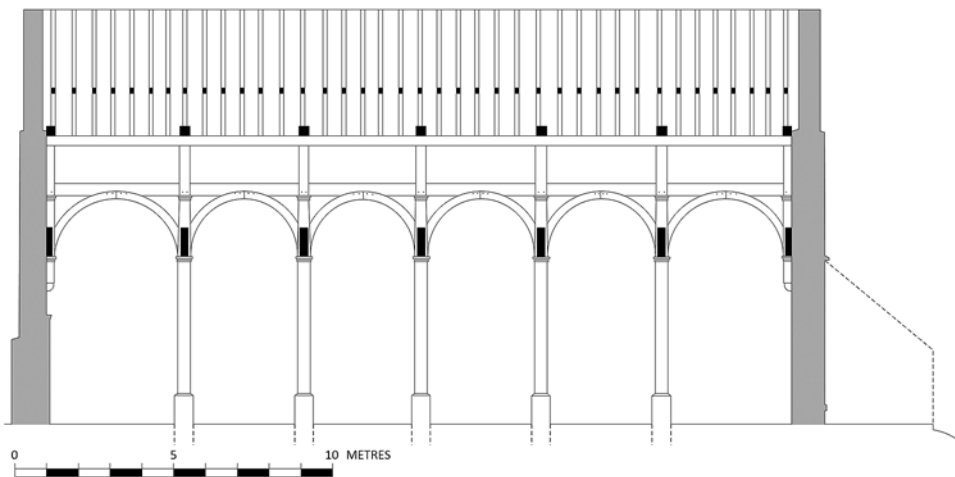
Fig. 29. Leicester Castle Hall: long section reconstructed as original.
Drawing N Hill and R Ovens.
