A MEDIEVAL HUNTING LODGE AT BRADGATE PARK, LEICESTERSHIRE

Richard Thomas, Jennifer Browning, James Harvey and Peter Liddle

This paper presents the results from the first two seasons of the Bradgate Park Fieldschool (2015–16), which focused on a moated site located inside the boundary of the medieval deer park. Survey and excavation confirmed the presence of a timber-framed building offset to the west within the centre of a levelled platform. The material culture supports a date of construction in the mid-thirteenth century, but the building was abandoned by the end of the fourteenth century or early in the fifteenth century, and apparently collapsed *in situ*. The building had a three-bay hall of base cruck construction, with a service bay and a chamber. A general paucity of artefacts recovered during the excavation suggests that the site was occupied temporarily or for only a short period of time. Taken together, the evidence suggests that the structure was a periodically occupied hunting lodge, although it may have served a secondary function as a park-keeper's residence.

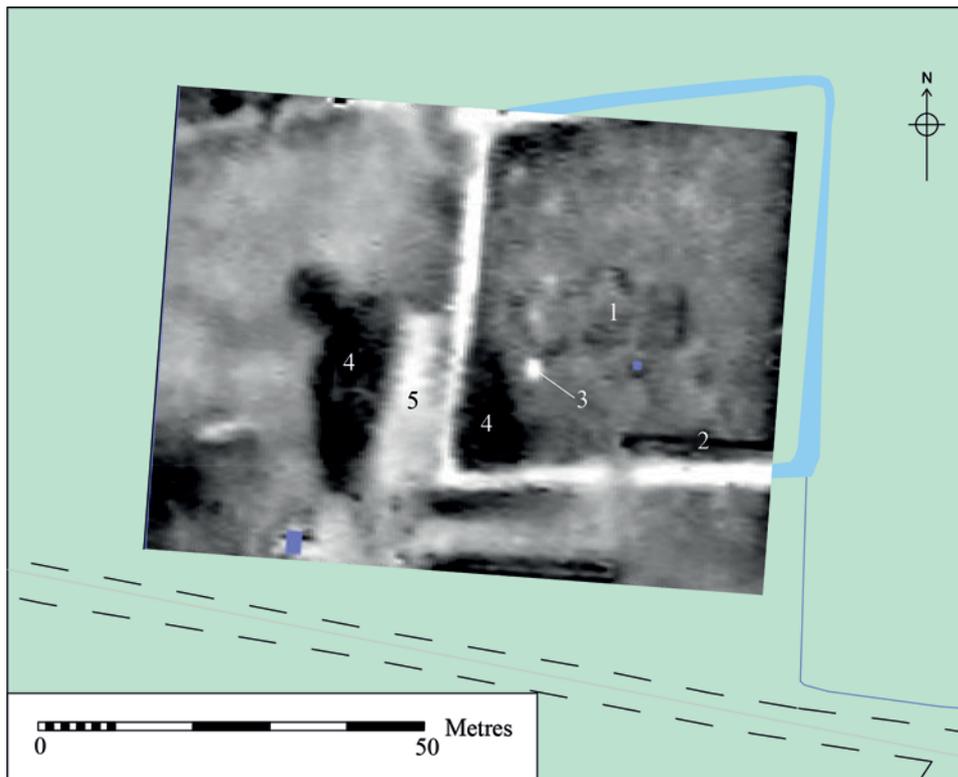
The resistance survey revealed an east–west rectangular building with stone footings within the centre of the platform, offset towards the western boundary Fig. 2 (1). Rectangular projections to the north and west of the building were suggestive of external chimneystacks. A high-resistance linear feature was apparent in the south-east and southern borders of the platform, corresponding to the location of an internal bank Fig. 2 (2), while a low resistance circular feature was located just outside the south-west corner of the building Fig. 2 (3). The high-resistance anomaly straddling the moat to the west Fig. 2 (4) corresponds to upcast of gravels from the construction of a small pond (apparent as a low-resistance feature) Fig. 2 (5), a familiar addition to moated sites (Wilson 1985, 51). The remainder of the interior of the platform appeared bereft of archaeological features, with no evidence for ancillary structures.

Fig. 2. Soil resistance survey of the moated platform (plotted range from 16 ohms (white) to 46 ohms (black)).

Prior to excavation, a soil resistance survey, using a Geoscan RM85 resistivity meter with a multiplexed twin probe array, giving a sampling interval of 0.5m and a traverse interval of 1m between readings, was undertaken to encompass the entirety of the moated platform (Fig. 2).

A sub-circular feature to the south-west of the building was evident in the resistance survey (Fig. 2). It measured 2.3 × 2.8m and was 0.35m deep (Fig. 18) and had irregular sloping sides and a flat base. It cut through disuse deposits relating to the building, and therefore post-dated this activity. The fill consisted of mid-brownish grey sandy clay, with frequent large stones, some heat-affected with mortar adhering. Analysis showed these were partially burnt limestone fragments. A small sample of slaked lime (water that has been added to quicklime) was also present, suggesting

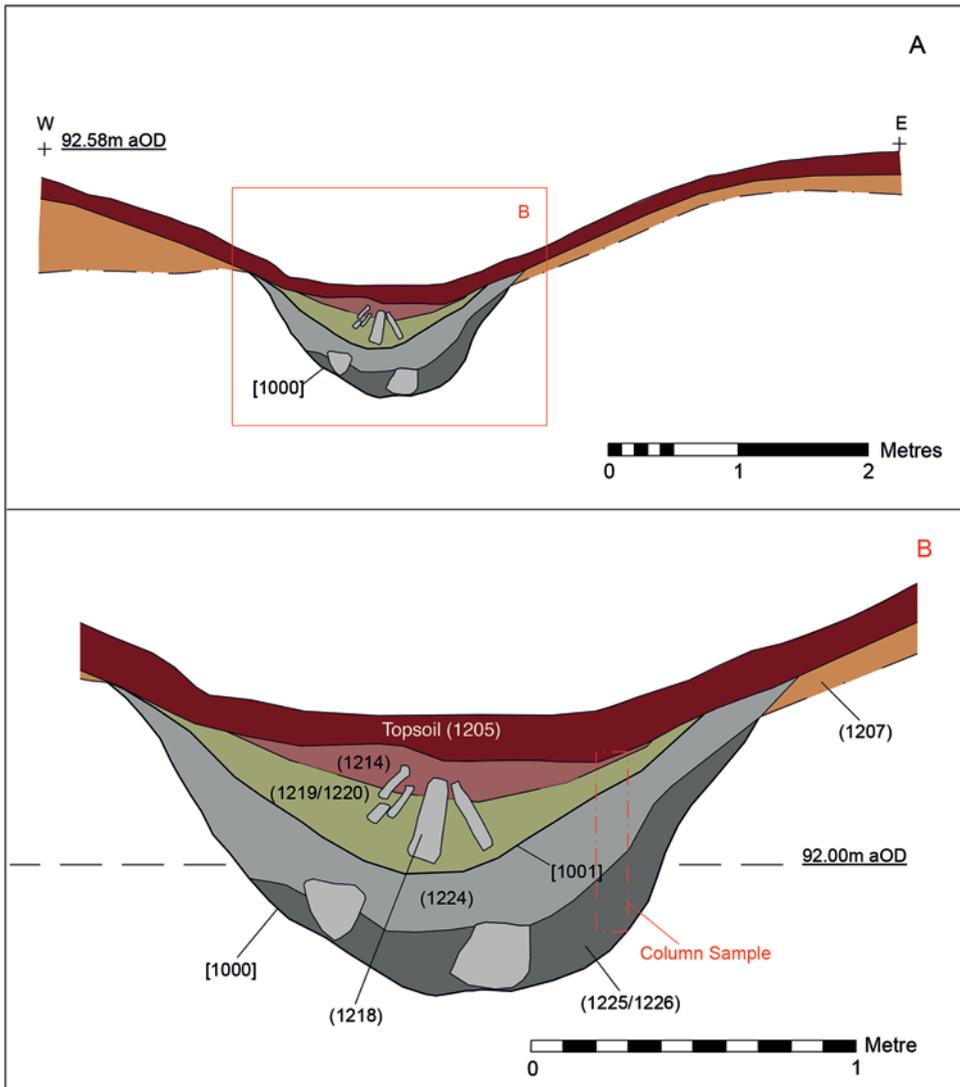
Trench 1 was positioned on the north-west corner of the platform (Fig. 3), extending from the top of the platform through the moat. The existing earthwork measured 5m wide and 1m deep, but excavation of the ditch revealed a further metre of waterlogged sediment down to the base (Fig. 4). Primary silting (1225/1226) was present to a depth of 0.2m and consisted of dark grey silty clay, containing

Fig. 4. Excavated section through moat (Trench 1).

large stones and pebbles that likely tumbled into the open ditch. A secondary fill (1224), dark grey silty clay and 0.18m thick, contained small well-sorted stones, natural flint and two fragments of (residual) Roman combed shelly ware pottery (first/second century). The moat was re-cut later through the subsoil/bank material and a narrow drain formed of irregular slate fragments was inserted to improve water flow around the moat. This cut was filled with mid-yellowish grey silty clay (1219/1220), 0.22m thick, overlain by a second layer of silting (1214), consisting of mid-brownish grey clayey silt (0.14m thick). A layer (1222) along the western edge of the bank overlying (1215) may represent up-cast from the re-cut. A humic layer

A monolith sample was taken through the moat sediments to assess the preservation of pollen for environmental reconstruction (Fig. 4). While pollen grains were poorly preserved, there was sufficient evidence to indicate that the moat contained a permanent body of shallow water with rotting organic matter, including detritus from grazing herbivores.

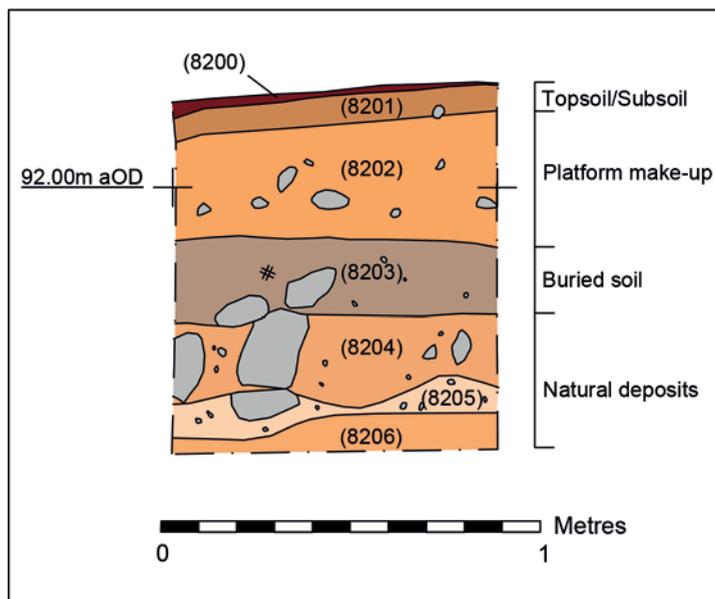
A sondage excavated within the north-east corner of Trench 8 showed the stratigraphic sequence on the platform (Fig. 5). The platform make-up/levelling was a thin deposit (0.1–0.35m thick), which overlaid a buried soil (0.18–0.23m thick). A similar soil was identified in other trenches across the moated site. It consisted of variations upon light–mid greyish-brown sandy or clayey silt *c.*0.25m thick, containing frequent charcoal flecks; also seen in the pollen and micromorphological samples. The soil produced a single sherd of pottery dating from the twelfth or early to mid-thirteenth centuries. The deposit capped a series of natural sandy clays and clayey silts with abundant gravel and iron panning. In Trench 8 the soil sealed a sequence of deposits [(8204), (8205), (8206)] forming part of the natural gravel terrace sequence, pre-dating the construction of the platform. Micromorphology of these deposits elsewhere on the site (Trench 7) identified a clear boundary between the buried soil and the later platform make-up, with no indication of trampling or stabilisation prior to the deposition of materials for the floor.

Fig. 5. Section of sondage excavated through the platform and underlying deposits.

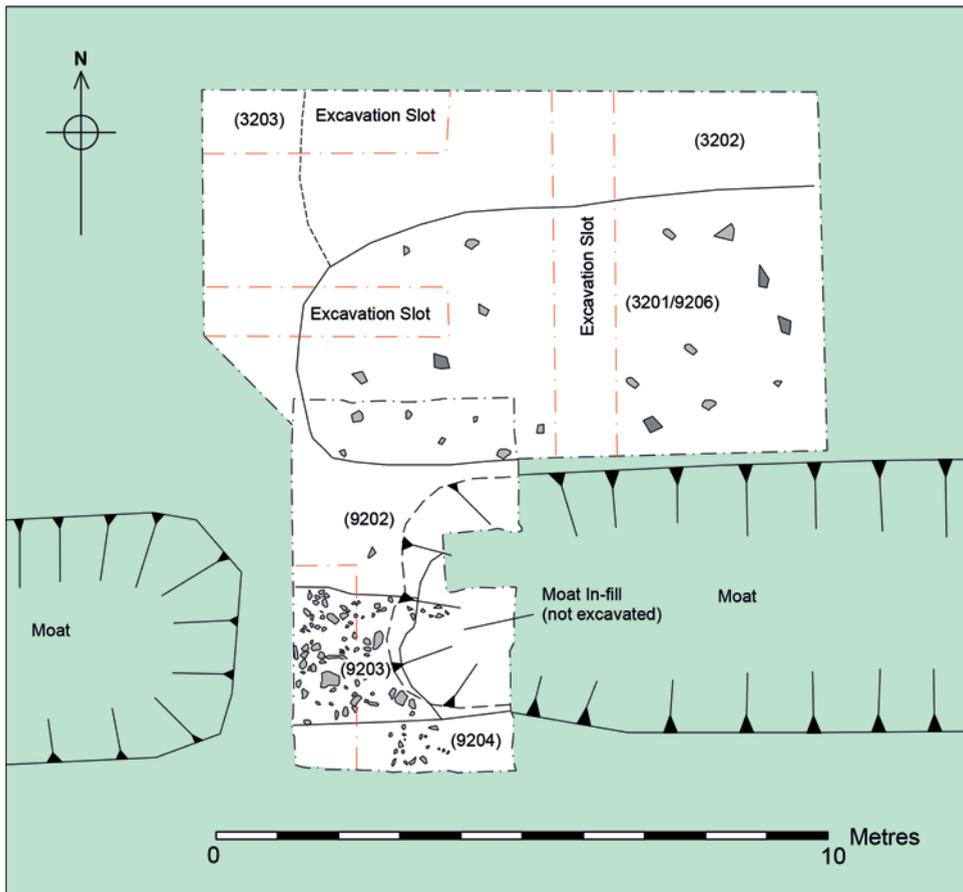
Trench 9, an extension to Trench 3, explored whether the current causeway entrance to the platform was contemporary with the moat or the result of later backfilling (Fig. 3). Removal of the topsoil revealed the southern extent of (3201=9206) at the northern end of the trench. It produced a single sherd of pottery dating to the mid-thirteenth century. To the south, a series of sandy silt and clayey silt subsoils [(9202, 9204)] were exposed beneath the topsoil. A section excavated through these deposits against the western side of the trench revealed a stone-lined drain [9000], partially constructed out of re-used roof slates. It was orientated east-west, presumably to facilitate the drainage of water through the causeway, and is likely to be contemporary with an overlying stone layer (9203) that would have provided consolidation (Fig. 6). This feature probably links with the drain recorded within the moat in Trench 1, indicating that these deposits post-date the occupation of the building.

A series of boreholes excavated to establish the presence/absence of moat deposits beneath the causeway located natural silts, sands and gravels and sands beneath the topsoil and subsoil, suggesting that the causeway was an original feature of the moated site.

Fig. 6. Plan of Trenches 3 and 9.

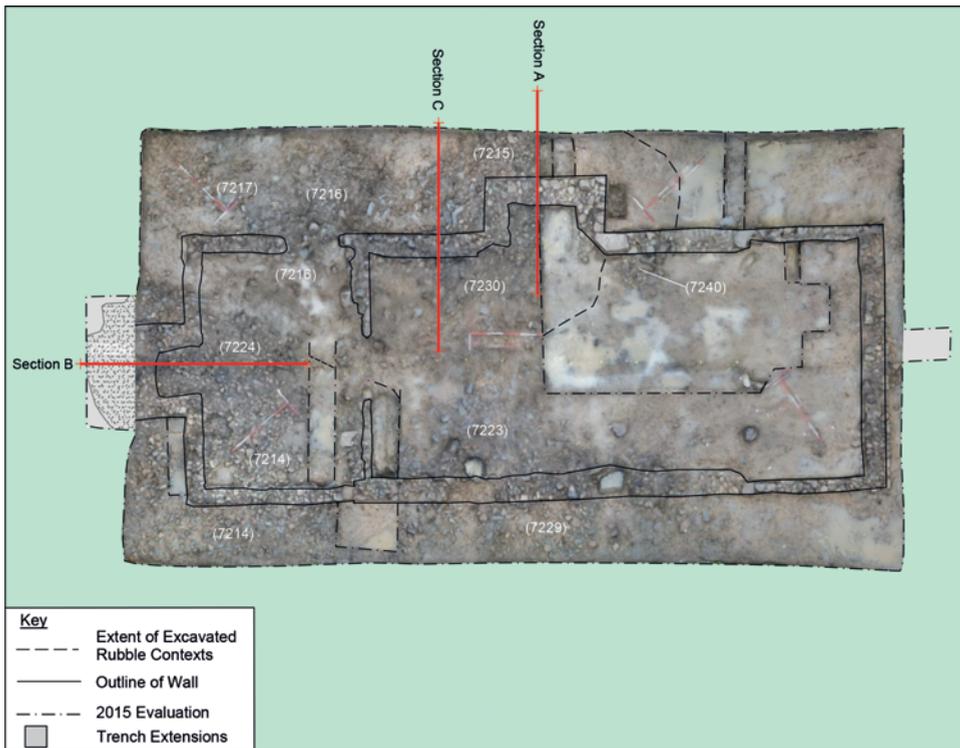
The underlying rubble spreads (0.1–0.2m thick) were located within and outside the building. These were concentrated around the northern and western fireplaces, as observed during the resistance survey (Fig. 2) and over the south-west and north-west parts of the building (Fig. 7). Pottery from these deposits dated from the fourteenth to fifteenth centuries. Inconsistencies in rubble composition, such

Fig. 7. Plan of rubble spreads; the position of illustrated sections (Fig. 10) is also noted.

as a predominance of slates in some deposits and an absence in others, suggested that there were several episodes of deposition, possibly related to different collapse events. The upper layers contained a greater quantity of roof slates and a high proportion was present in the rubble around the south wall. The absence of slates in the eastern half of the building suggests that the roof in this area was oriented in a different direction, likely a lean-to. This was supported by the presence of slates in a small eastward extension to Trench 7, indicating the roof slid off beyond the eastern edge of the trench (Fig. 7). The greater abundance of stone rubble in the western and south-western parts of the building suggest that the upstanding structures were higher in these areas of the building.

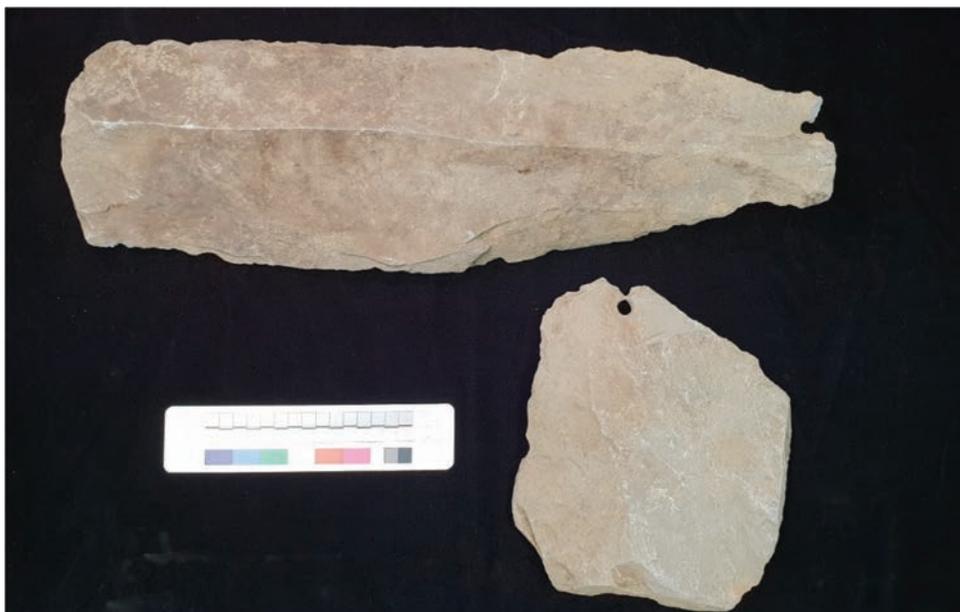
The colour of the slates is consistent with an origin from the quarries at Groby, c.5km to the south-west (Ramsey 2007), while the presence of diamond-shaped roof tiles indicates that some pre-dressed Roman slates from the quarry may have been exploited (Fig. 8; David Ramsey pers. comm.). These layers also produced green-glazed ceramic ridge tiles from the Chilvers Coton kilns, Nuneaton, some of which were decorated with looped and spiked crests (Fig. 9). A linear deposit of up-turned, fragmented ridge tiles, along the southern border of Trench 7, indicates that they slid off the roof as it collapsed.

Fig. 8. Comparison of a medieval (top) and a possible re-used Roman roof tile (bottom).

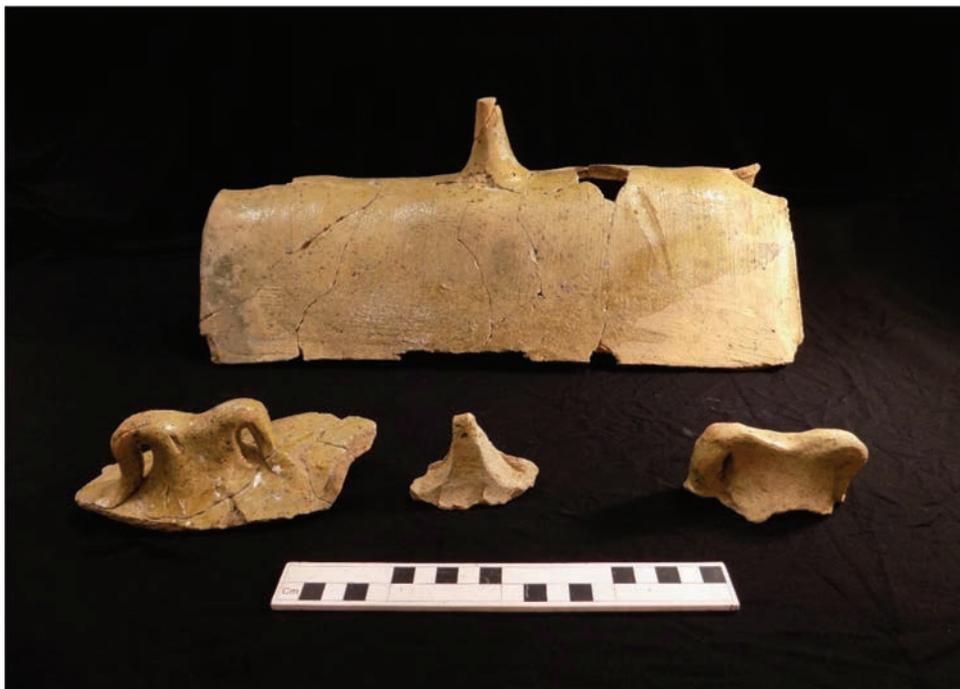
Fig. 9. An almost complete ridge tile and fragments of open and closed looped crests and part of a cockscomb crest, all in medieval sandy ware 1, dating from the later thirteenth or fourteenth centuries.

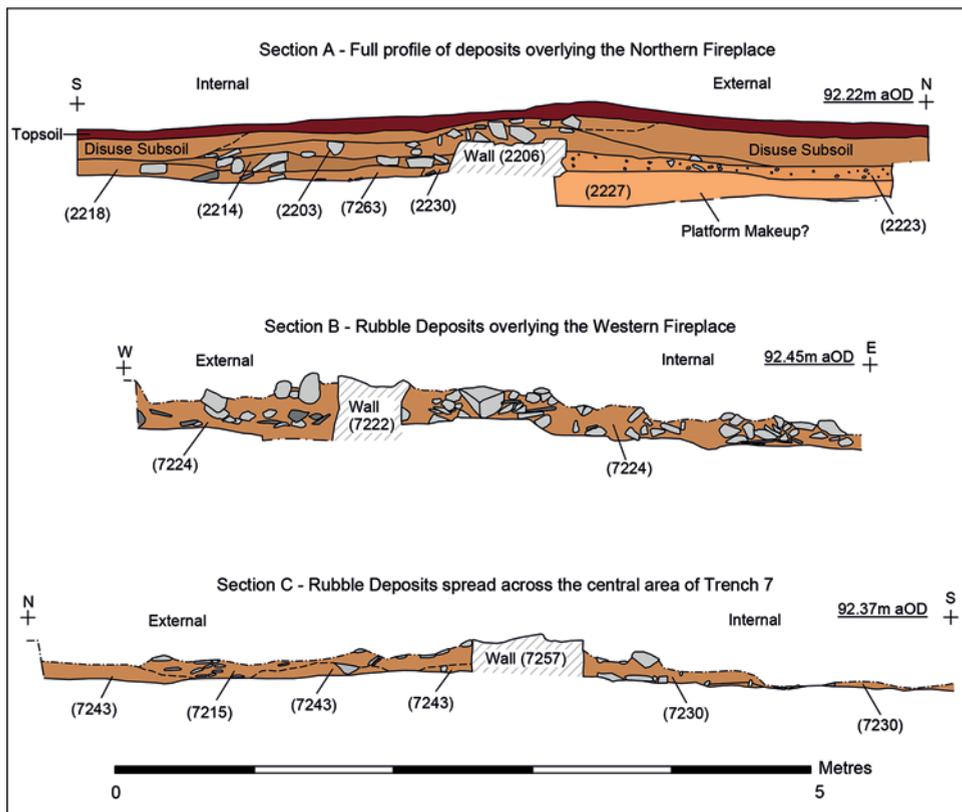
Lower deposits, such as (7231) on the interior of the northern fireplace, mostly comprised larger diorite rubble. Similarly (7229), below (7214) exterior of the south wall, contained few slates but consisted mainly of diorite fragments in a silty matrix, indicating that it derived from the collapse of the walls rather than the roof. This suggests that the roof was supported on timbers and the stone infill collapsed first. The quantity of diorite rubble implies dwarf rather than full-height walls, while the concentrations over the northern and western fireplaces reflects the greater height of the masonry of the external chimneystacks. Dumps of rubble in the interior of the central part of the building (7223/7230) were less dense than those on the exterior, but contained a mix of stone, slate, iron nails and unidentified ferrous objects (Fig. 10, Section C).

Fig. 10. Selected sections illustrating deposits overlying the building. Section locations are indicated in Fig. 7.

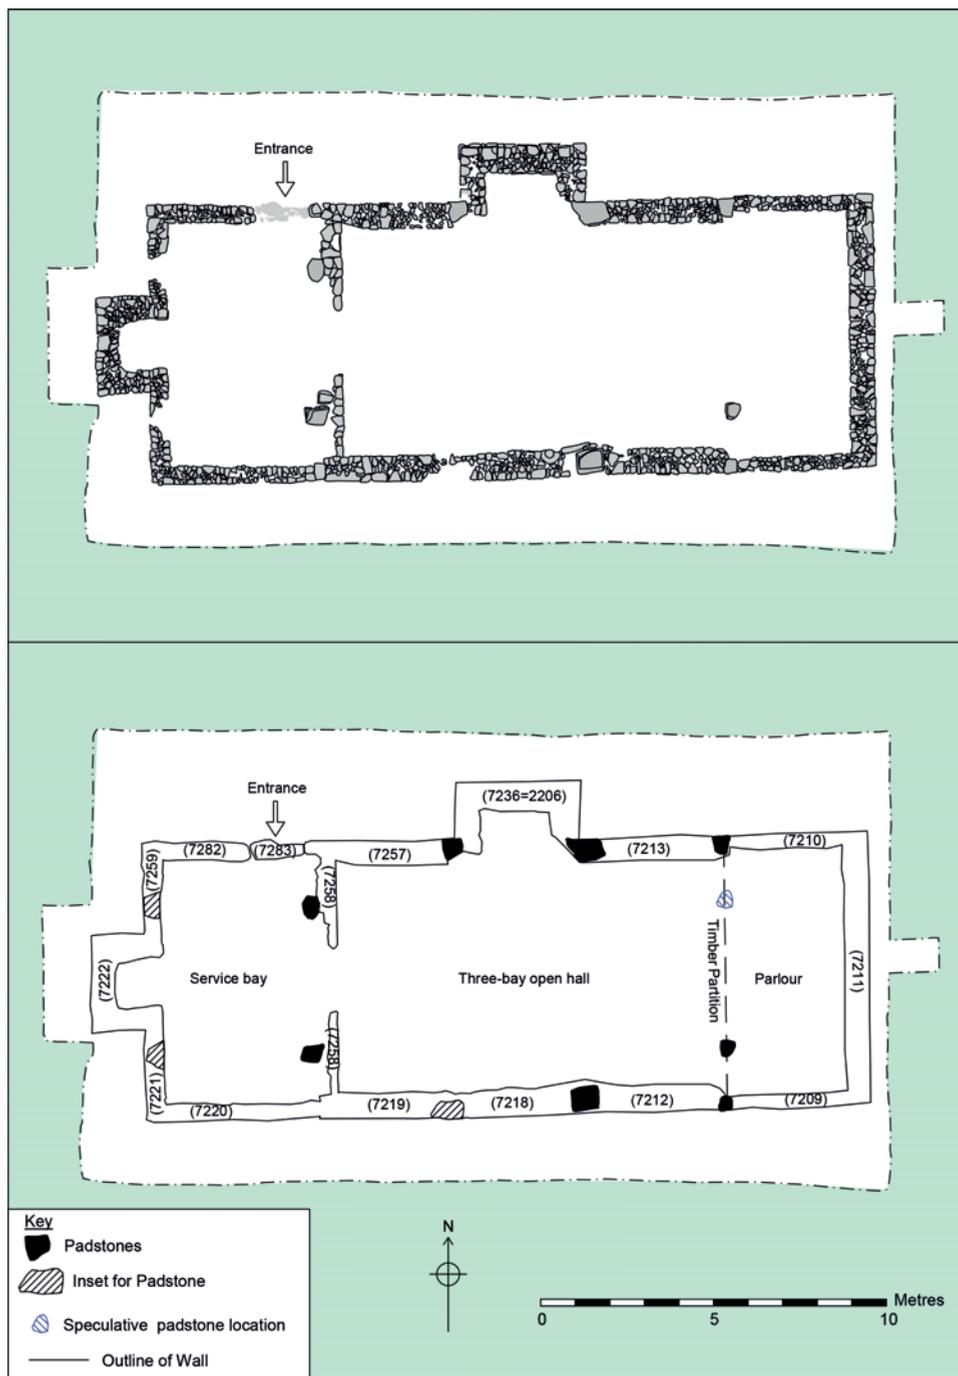
The removal of the rubble revealed a low stone wall defining a building *c.*21m × 8m, orientated east-west and offset westwards from the centre of the platform. Three opposing pairs of large flat-topped diorite blocks were positioned along the line of the north and south walls. They were spaced at regular intervals, creating five bays measuring between 3.85–4.15m wide. The central pair of padstones were significantly larger than the others, with dimensions of 1.0 × 0.5m (Fig. 11),

Fig. 11. Plan of the structural remains of the timber-framed building (top: structural remains; bottom: schematic plan).

particularly when compared to the pair to the east that measured only 0.4–0.5m. There was a padstone on the northern wall, west of the dominant pair, but its opposite number on the southern wall had been knocked out of place into the interior of the building.

No further padstones were identified on the north and south walls; however, a pair were present along the line of a north–south partition wall (7258). Each was inset from the north and south walls by *c.* 1.6–1.7m, with a 3.7m gap between them, and probably supported the posts of a truss, separating the hall and service bay. Although no padstones remained on the western wall, two rubble-filled gaps inset from the north and south walls, on either side of the western fireplace, suggested that the stones had been removed. These gaps line up with the *in situ* padstones on the partition wall (7258), creating a bay 4.5m wide. Another partition was hinted at in the eastern side of the building in line with the easternmost pair of padstones within the walls, although only one of the inset padstones was present (Fig. 11).

The remnants of the wall defined the perimeter of the building, but do not appear to be a continuous build (Fig. 11). The walls were constructed directly on top of the platform with no evidence of a foundation trench; they were presumably constructed after the erection of the timber frame and butted up against the posts, infilling the lower part of the building. Some parts of the wall were constructed in one event: the eastern wall (7211) was keyed into the southern and northern walls (Fig. 15, Section D), (7209) and (7210); the walls of the western bay (7221), (7259) and (7257) were also keyed in at the corners. By contrast, the end bay walls butt up to the central walls of the building (7219). The relationship between the western fireplace (7222) and the west wall (Fig. 13, Section E), (7221) and (7259), was unclear, but the northern fireplace wall (7236) was not keyed in to the north wall, suggesting that it belonged to a later phase. The partition wall (7258) butts up against the north and south wall.

The wall was constructed predominantly from irregular, locally sourced diorite blocks, with occasional quartz, river cobbles and slate. The coursing was random, but the wall had a fair face and showed some evidence for a rubble core. The number of courses varied between two and four, although this was sometimes difficult to ascertain because of the irregularity of the coursing. The largest stones were positioned on the outside edge, with slightly smaller stones on the inner edge and even smaller stones, river cobbles and slates forming the rubble core and infill. There were no convincing traces of a bonding material, suggesting that the walls were drystone or bonded with a material that has since degraded (e.g. clay). Bracken roots had penetrated the stones, potentially replacing whatever bonding material had been there.

The wall was not uniformly thick: the north (7210) and south (7209) walls of the eastern bay measured 0.4m, with facing stones and a very narrow rubble core; however, the eastern end wall (7211) was 0.7m wide, with a wider, looser rubble core. The western end bay also had thinner north and south walls, and a thicker west wall. The fireplaces were the most substantial part of the structure; the northern fireplace (7236) was 0.8m wide and stood up to 0.8m tall, while the western fireplace (7222) was 0.7m wide and 0.4m tall. The northern wall (7257) changed in width from 0.75m immediately west of the northern fireplace, curving

to 0.56m close to the junction with the partition wall (7258). The ‘partition’ on the east side of the western bay appeared to have a different construction: the eastern side was faced but there were no *in situ* facing stones on the west, producing an unfinished edge.

A 1.6m wide gap in the wall on the north side of the building, immediately west of the partition wall, is the most likely candidate for the entrance (Fig. 11). Several flattish stones were laid within it, possibly forming a threshold (7283), although these were not laid neatly and do not tessellate (Fig. 12). The wall on either side of the gap is not well-finished, suggesting that, if this was the entrance, it must originally have contained a wooden doorframe.

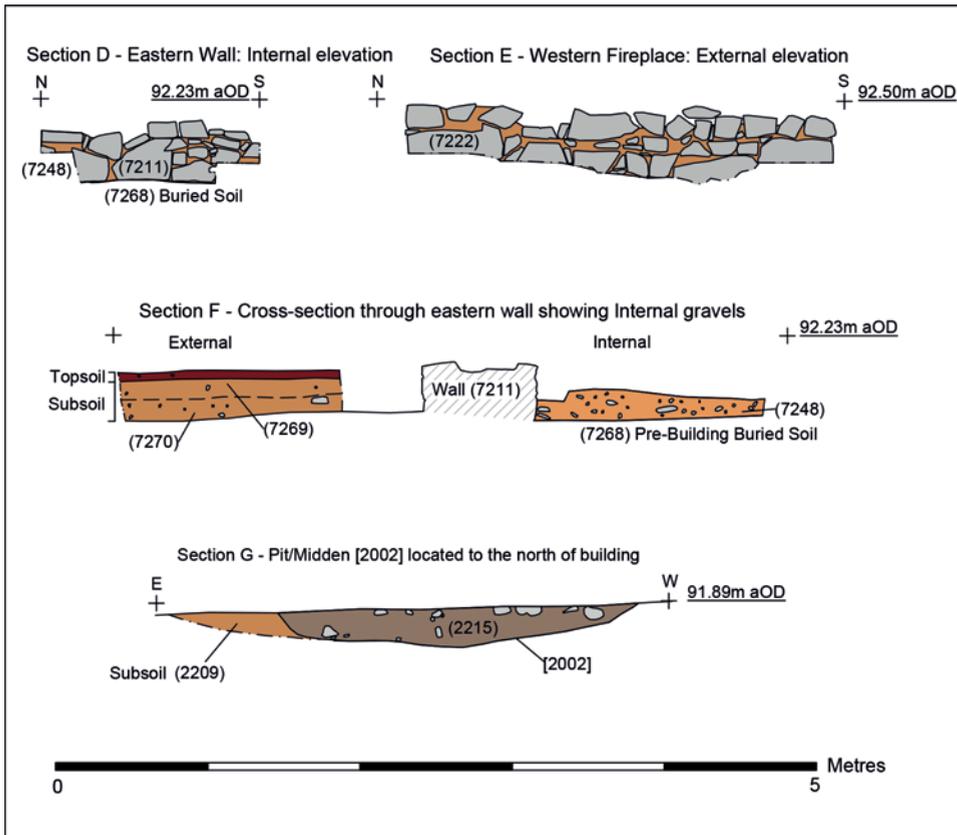
Fig. 13. Selected sections of deposits associated with the building. Section locations are indicated in Fig. 14.

abandonment of the building. The interior gravel surface was insufficiently level to have functioned as a floor; rather, it may have been a consolidation layer that underlay a solid floor surface, such as planking. This interpretation is supported by micromorphological analysis and the paucity of material culture in the buildings interior, indicating that artefacts had been prevented from becoming incorporated into the sediments. The pottery recovered from these deposits dated broadly from the mid-thirteenth to fourteenth century. A similar deposit was present on the exterior of the building, surviving best next to the northern fireplace (2223=7225; Fig. 10, Section A; Fig. 14).

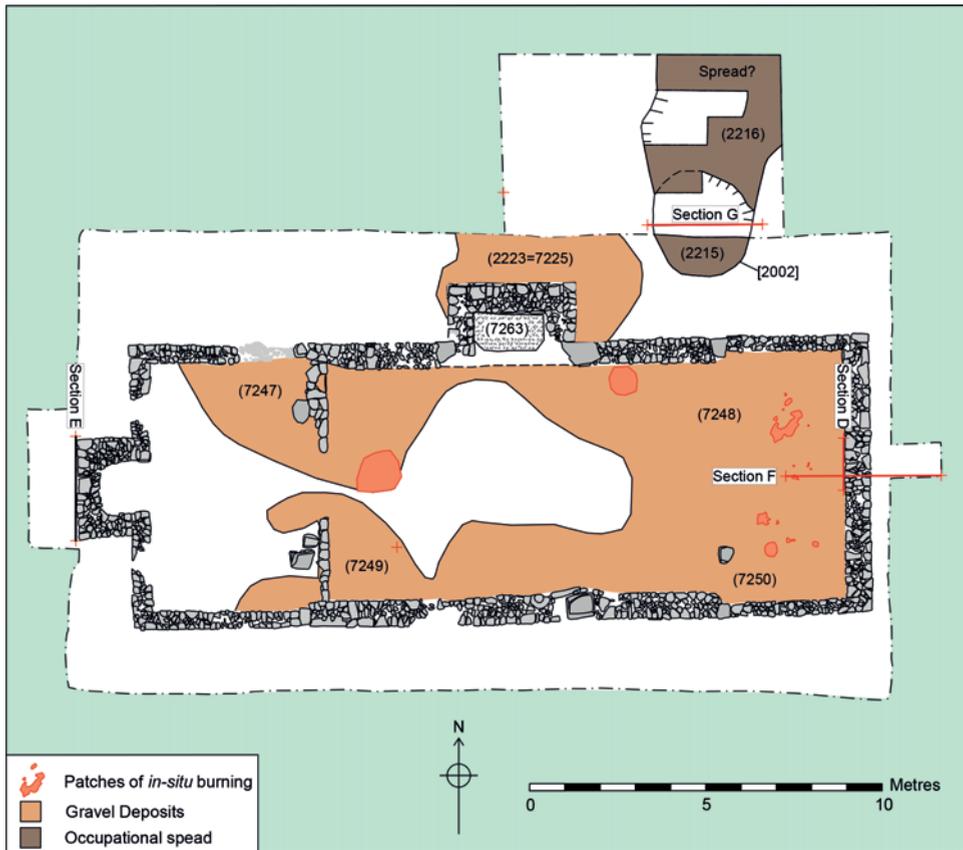
Fig. 14. Plan of gravel spreads and burnt areas within the building; the position of illustrated sections (Fig. 13) is also noted.

Areas of scorching were identified within the gravel spreads in several locations across the interior of the building and their dispersed locations suggest they resulted

from single event fires lit within the abandoned building (Fig. 14) – rather than being associated with a pre-fireplace building phase. These deposits produced low numbers of wood charcoal fragments.

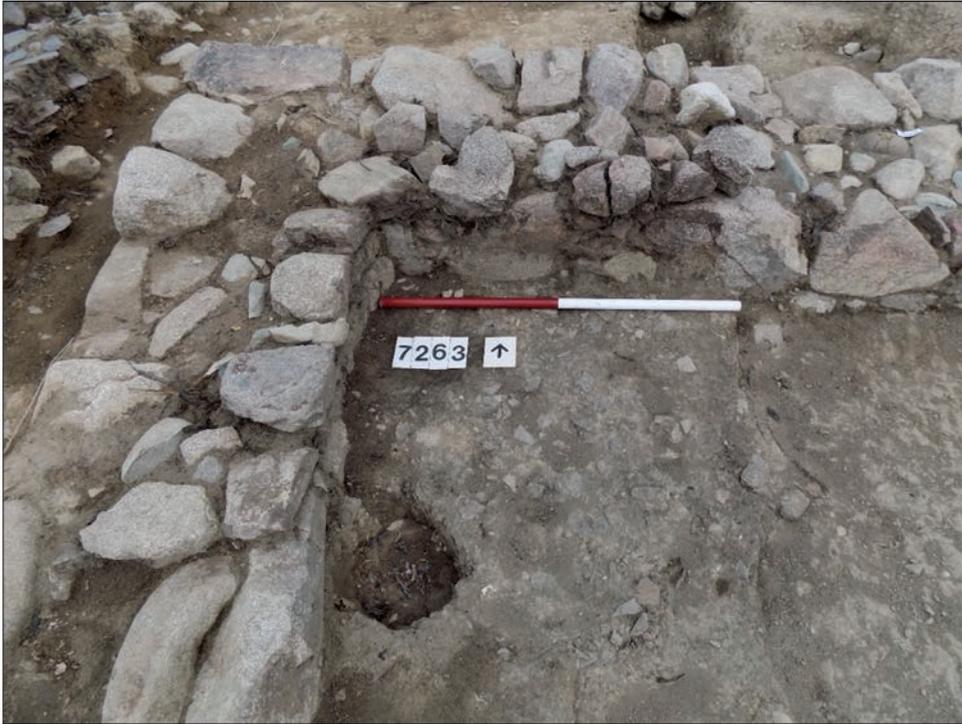
The northern fireplace was a substantial structure, with interior dimensions of 2.1 × 1.2m and overlain by layers of rubble. The upper layer (2203=7215=7230) consisted predominantly of diorite fragments from the collapsed stack, and roof slates with a small proportion of rolled cobbles and an iron nail. A lower rubble layer (7231=2214), present on the inside of the fireplace, contained fewer slates in relation to diorite fragments, which were generally larger than the components of the layer above.

The internal face of the wall showed signs of heat damage and a sequence of silts containing charcoal was identified within the fireplace, but the relationships between them was ambiguous. A silty deposit (7232/7261=2219) was identified close to the inner face of the fireplace, containing occasional fragments of slate, charcoal, iron nails, small stones, plant remains (peas and cereal grains) and mid-thirteenth–fourteenth-century pottery. The presence of slate and iron roof nails in a related context (2218) implies that it formed after abandonment. A thin (0.03m) layer of diorite chippings (7263) was encountered below this level, which may represent the remnants of a hearth or floor surface (Fig. 15). This deposit was not identified on the eastern side of the hearth excavated in 2015; instead, a sequence of thin layers of uncertain relationship were identified [(2230), (2233) and (2234)], all of which overlay the top of the platform material or buried soil (Fig. 10, Section A). This complexity probably reflects the fact that the hearth was regularly cleaned out, as indicated by micromorphological examination. The available evidence strongly suggests that this fireplace served the hall.

Fig. 15. Possible surface recorded within the northern fireplace, looking north.

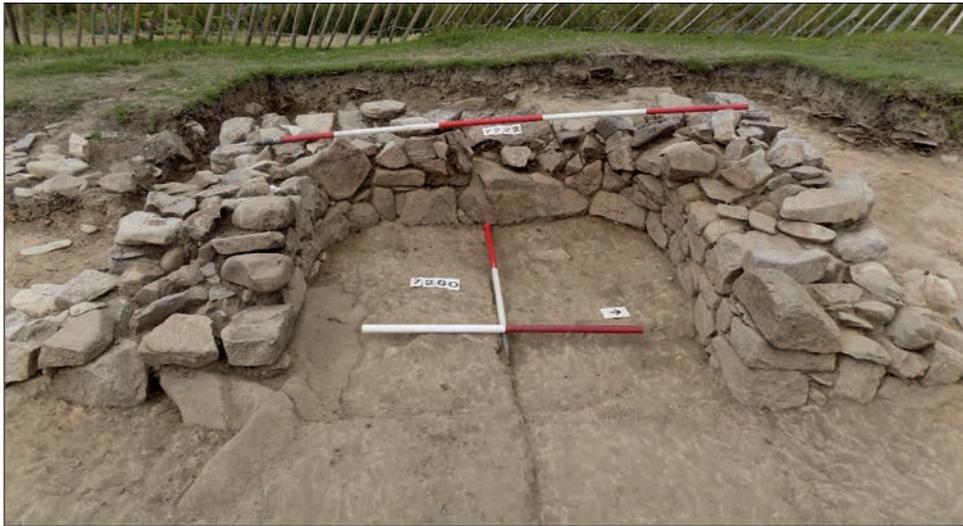
Excavation confirmed that the projection on the western wall of the building, observed in the resistance survey (Fig. 2), was another fireplace. This was smaller than the fireplace in the north wall, with an internal size of $1.5 \times 1.5\text{m}$. The interior faces of the stones were reddened and heat-cracked, and were progressively curved in profile (Fig. 16). These characteristics suggest that the feature was a service/kitchen fireplace, perhaps with a boiler (Brears 2008, 121), indicating that the western bay formed the service area. The fact that the heat damage did not extend to the floor level suggests the fire was raised on a metal hearth. The fireplace wall (7222) was covered by slate and diorite rubble (7224), below which was a deposit (7266=7245) containing a small quantity of rubble and iron nails that appeared to represent disuse silting following abandonment. Two thin layers [(7229) and (7280)] underlay this deposit; the latter could conceivably be the remnant of a floor surface, but might also be a slightly mixed interface onto the top of the buried soil (7281). Micromorphological analysis of the sediments within the service/kitchen fireplace provided evidence of wood burning. Weathered, rounded, sand-sized pottery fragments suggest that this site was used long-term, allowing artefacts to become part of the overall sediment. High humus content in the fine fraction also indicates that other activities involving organics (cooking, plant processing) occurred here, possibly on a regular basis.

Fig. 16. The western fireplace with possible floor layer exposed, looking west.

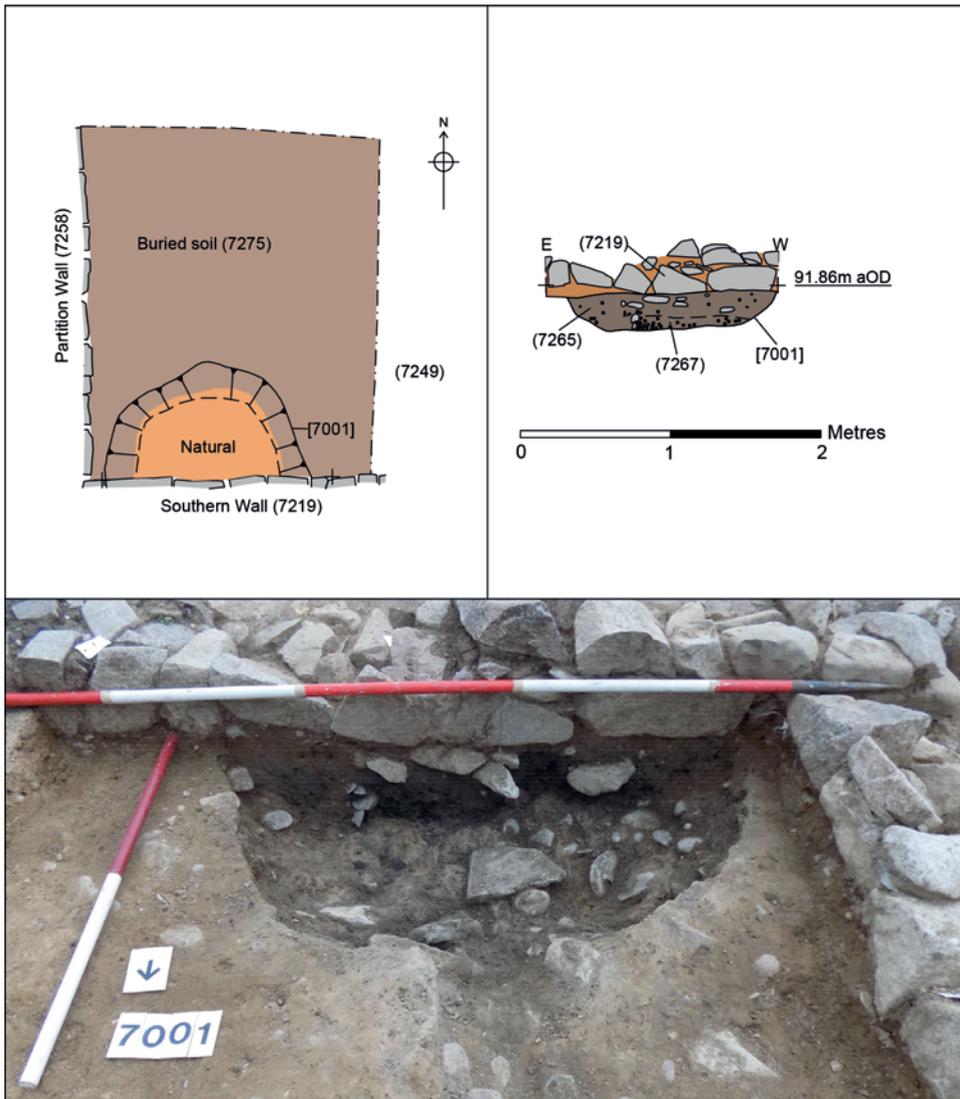
A sub-oval pit with a flat base [7001/4001] was found below the intersection of the south wall (7219) and partition wall (7258). The southern edge was concealed beneath the wall (Fig. 17). The feature measured 1.4m on its east–west axis, with a minimum width and depth of 0.76m and 0.25m respectively. The upper fill (7265/4221) was a sandy silt containing diorite fragments, pebbles and occasional charcoal flecks. The lower fill (7267) contained abundant charcoal that appeared to be predominantly a dump of hearth material almost exclusively made up of Oak (*Quercus* sp.), which was heavily bioturbated. Radiocarbon dating of a rare hazel (*Corylus avellana*) charcoal fragment returned a date of 793–971 cal AD at 95.4% probability (SUERC-79469), indicating that the pit pre-dates both the building and the platform. The fact that the pit was seen directly below levels relating to the building suggests either that it had been exposed by reduction of the ground level during the levelling process or that the area was not heavily cultivated between the backfilling of the pit and the erection of the building.

Fig. 17. Pit [7001/4001] located below wall (7219).

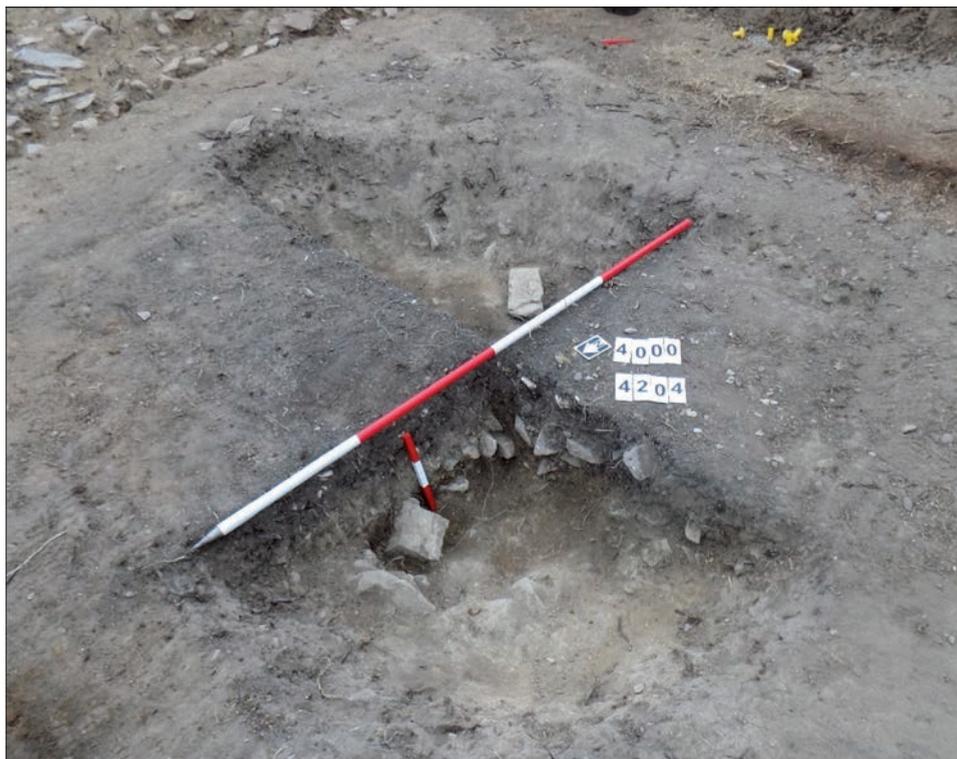
Fig. 18. Pit [4000], looking south-east.

that the pit was filled with debris from the production of lime for mortar. However, the lack of *in situ* burning precludes the pit itself being the site of production. Other finds from the feature included roof slate, mortar and (residual) Roman greyware pottery.

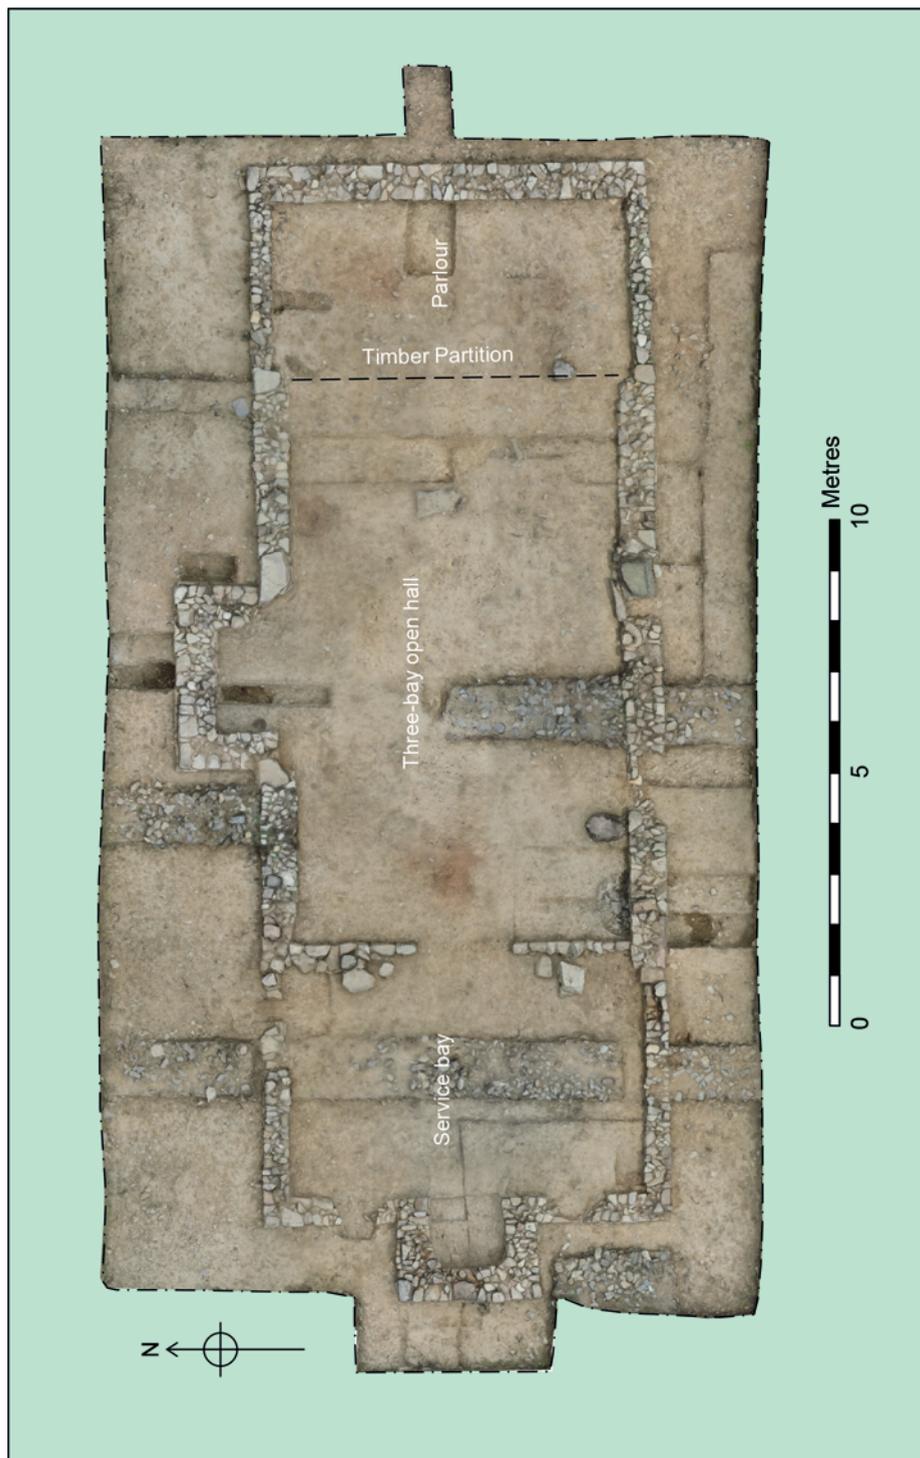
The building (Fig. 19) was timber-framed with padstones dividing the structure into five bays and low stone walls that provided a base for timber or earth-built walls and protected the timbers from the damp ground (Gardiner 2014, 20). The roof comprised locally sourced slate tiles surmounted by decorated green-glazed ridge tiles, fired in the Chilvers Coton kilns, Nuneaton. Based on the excavated remains, the building appears to have consisted of a central hall of three bays, defined by four trusses. The position of the padstones suggests that the trusses at either end of the hall were of aisled form with the two centre trusses being of base cruck construction. There was an aisled service bay to the west of the hall and an inner room or parlour in a lean-to bay east of the hall.

The westernmost part of the building was occupied by a service bay marked out by a partition, containing a service/kitchen fireplace with an external stone chimneystack. The greater concentration of stone rubble in the western and south-western area of the site provides evidence that the service end chimneystack was set against the outer face of a gabled wall. The partition between the service bay and the hall may have been infilled between the aisled posts and outer walls and open in the middle, in the form of a spere truss. Access to the building was through the northern side of this bay; there was no evidence for a cross passage with opposing entrances.

Fig. 19. Orthophotograph of Trench 7, generated from a 3D photogrammetry model.
The full model can be accessed at <https://skfb.ly/R7TF>.

A central three-bay hall, c.8m long, was defined by larger padstones and thicker walls signifying the importance of this space. A later fireplace with an external stone chimneystack was inserted into the northern wall: the lower concentration of stone rubble adjacent to this structure is consistent with a chimneystack set against the outside of the lower side wall. Unfortunately, there was no clear evidence for an earlier central hearth. The inclusion of a fireplace with an external chimneystack is a further marker of the status of the building; while chimneystacks were appearing in high-status buildings with increased regularity in the thirteenth century, the technology does not seem to have become common until the fifteenth century (Dresbeck 1971). Indeed, a ground-floor wall fireplace in a hall is exceptional prior to 1450.

A second partition was identified in the east side of the building and was presumably closed, except for a doorway giving access to a private chamber beyond. The floor of the building is difficult to characterise, although the micromorphological evidence and the paucity of finds suggest an impermeable surface such as a plank floor, underlain by a gravel surface; an exterior gravel surface was also visible to north of the building. The platform was remarkable for the absence of features/deposits, although there was a hint at a possible midden deposit in Trench 8.

The presence of padstones and an internal span of 6.5m would put it at the top end for a normal cruck span, or a post and frame structure of fourteenth century date (Alcock and Miles 2014, 32); however, such a span would be well within the limits of a base cruck. The presence of a spere provides additional supporting evidence (Nick Hill pers. comm.). Thus, a timber post (blade) would have risen from each padstone at ground level and formed the main upright of the wall, until it was truncated by a transverse beam that supported the roof timbers.
