Military Road and 11a Military Road, Heddon-on-the-Wall, Northumberland

Archaeological Watching Brief

for Northern Gas Networks

v.1.2
08/07/2021

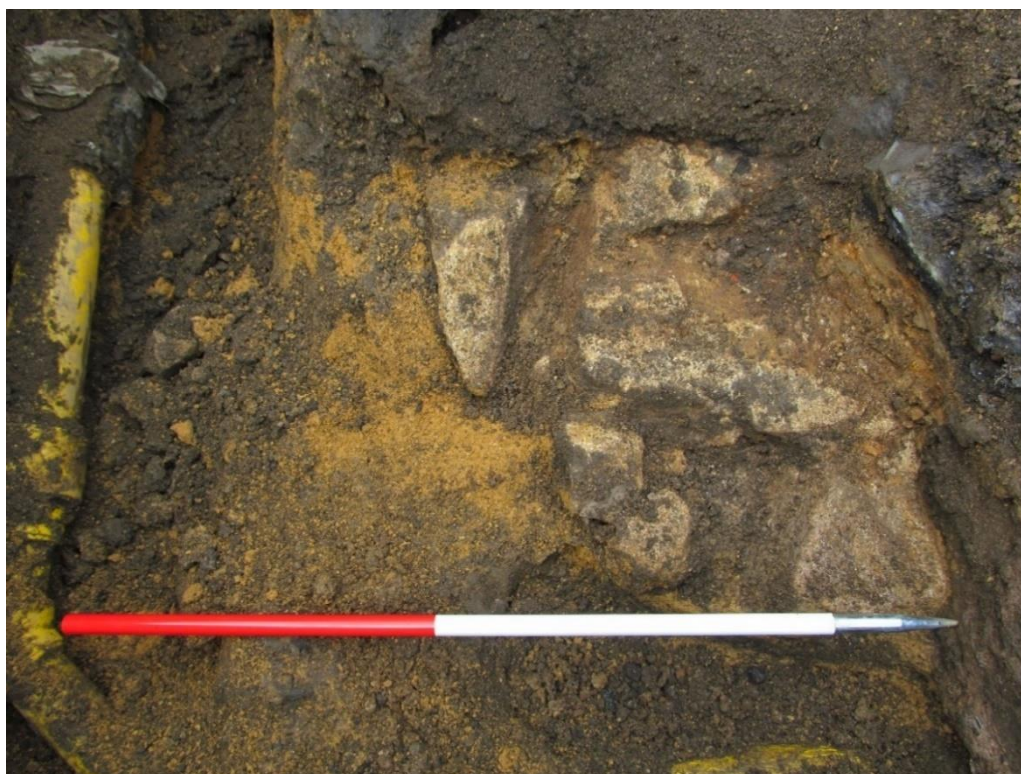
Trench 1 contained context (105), surviving core material of Hadrian's Wall (Figures 5 - 8). This was encountered at around 0.6m below modern ground surface at a height of 125.66m – 125.70m AOD. The maximum dimensions of the exposed Wall core were 0.6m x 0.6m x 0.2m. It was centred on NGR NZ 13153, 67057.

Figure 5: Context (105) in plan. Gas main [103] can be seen in the left of the frame. Looking west. 1 x 1m scale.

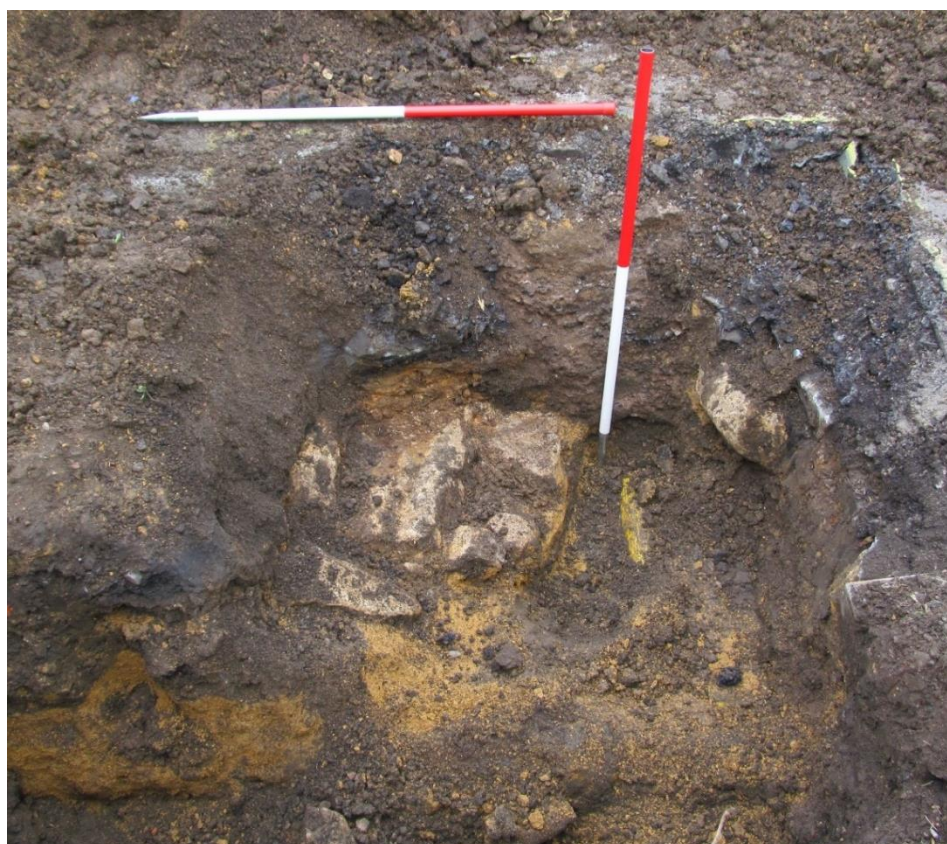
Figure 6: Context (105) in plan, looking north. 2 x 1m scale

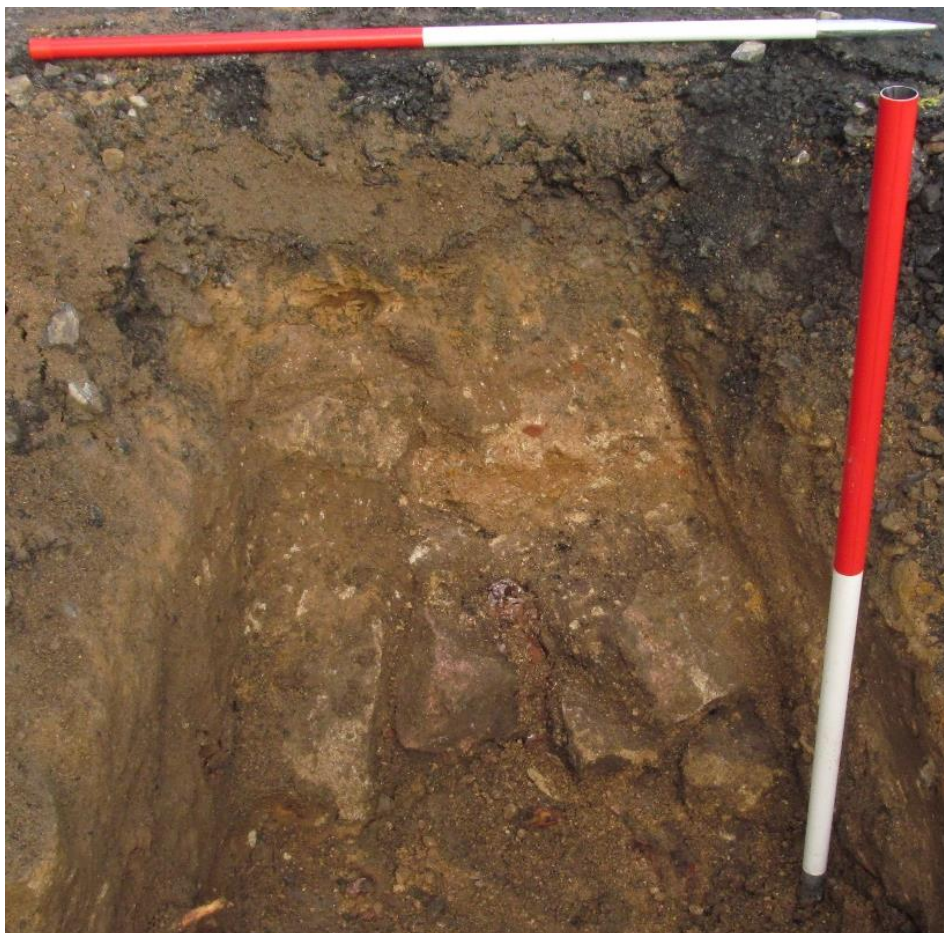
Wall remains (205) were constructed of large sub-angular stone blocks in a compacted yellowish orange sandy clay packing. A small deposit of probable compacted whiteish pink limestone mortar overlay the stones was seen in section only (Figure 9).

Figure 9: East-facing section of Trench 2, showing context (205) and possible overlying mortar in the right of the section and the cut of [203] in the left of the section. Looking west. 2 x 1m scale

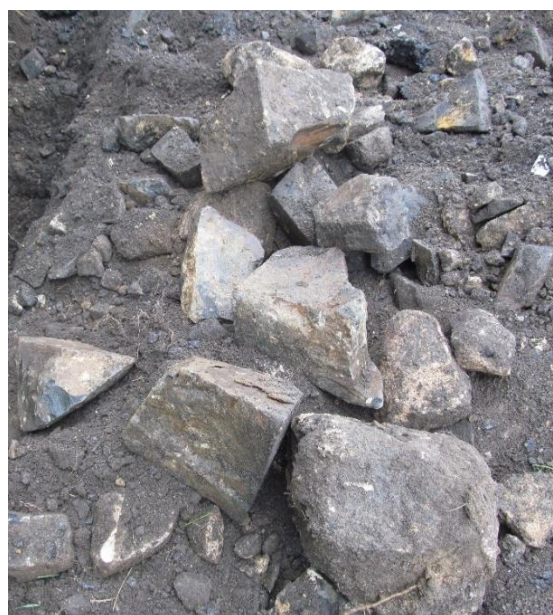
Figure 11: Representative fragments of whinstone found in (304)

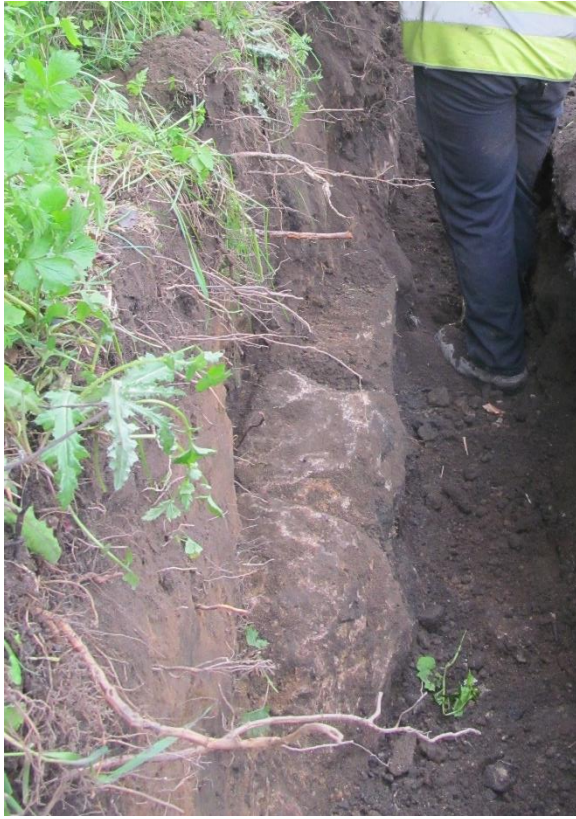
Context (305) consisted of a line of faced stones, measuring on average 0.3m x 0.2m x 0.3m and incorporating at least three surviving courses; the lowest course contained eight or nine stones, the middle course totalling seven stones, and the upper course containing a single stone. These stones exhibited some wear on their faces, suggesting either that they were used as kerbstones for the 18th century road, or formed part of the Broad Wall

Figure 12: Context (305) as exposed, looking west.

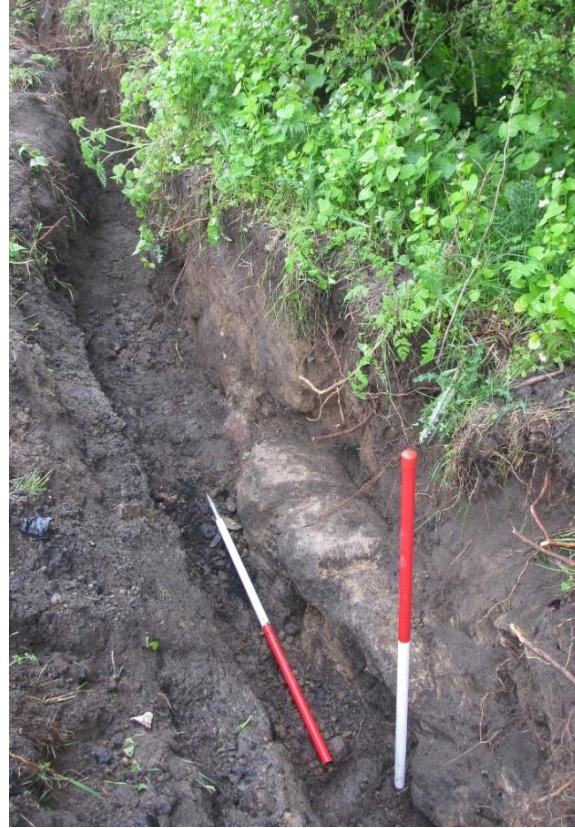
Figure 13: Context (305) once cleaned, looking east-south-east. 2 x 1m scale

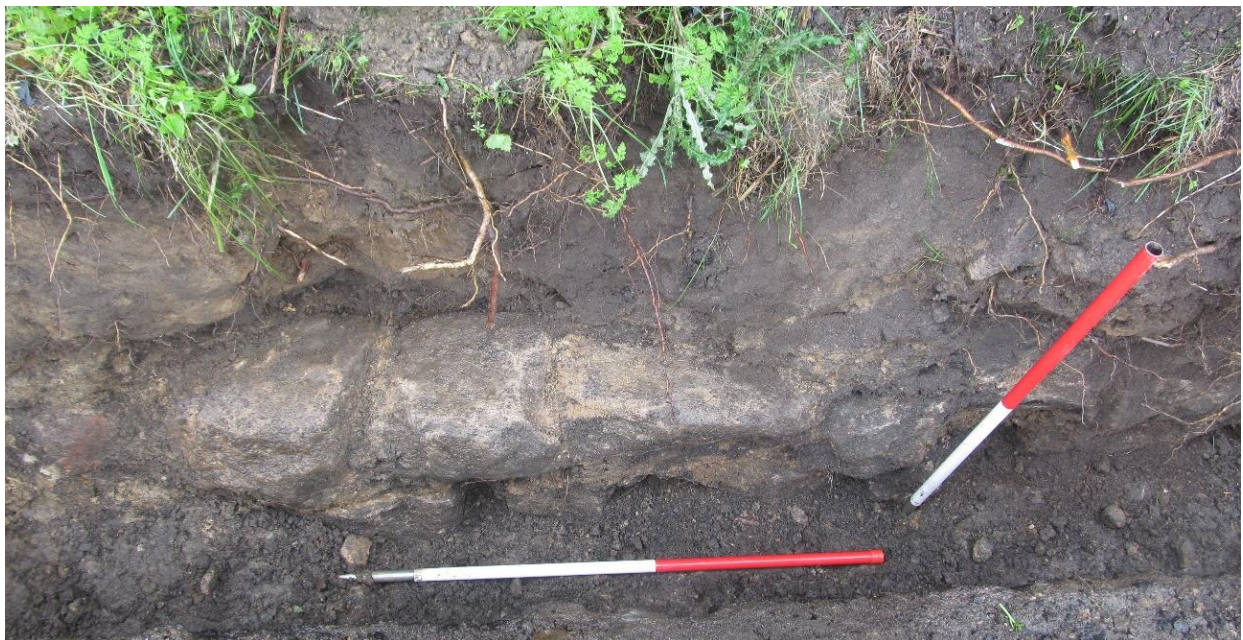
As noted above, a small section of in situ Hadrian's Wall, (305) and (306), was encountered in the north-facing section of the trench, running along the southern side of Trench 3 (Figures 2 and 12 - 16). In total, this section of Wall measured 6m in length, protruding into the trench by between 0.25m and 0.3m. It was seen at a height of 25.90m AOD and reached an exposed maximum depth of 0.5m. Context (305), facing stones, was centred on NGR NZ 12999.62, 67095.74, and context (306), Wall core, was centred on NGR NZ 12996.37, 67096.46. The coordinates of their section and planning points are given in Figure 18.

Figure 14: North-facing section of contexts (305 and (306)), looking south. 2 x 1m scale

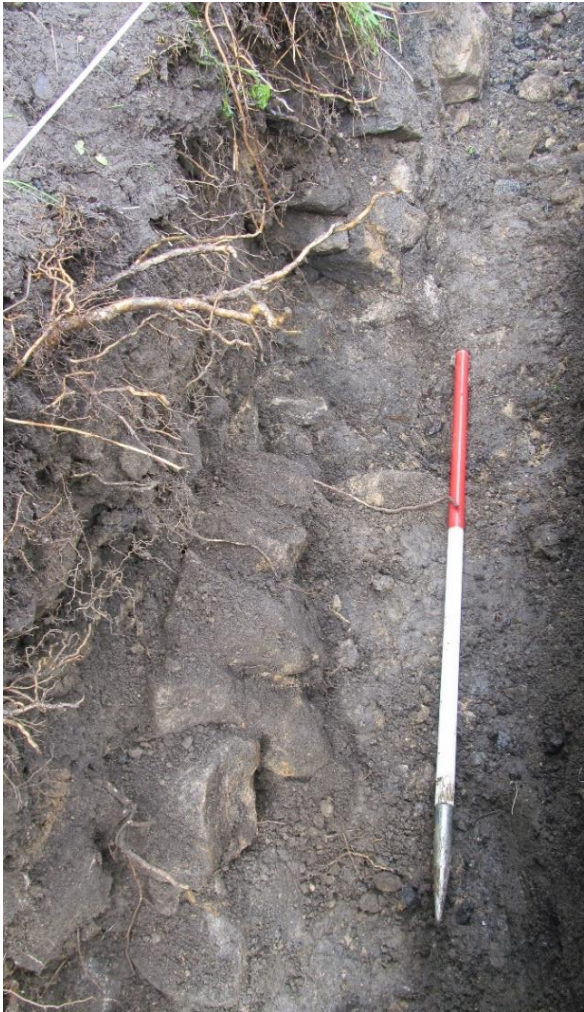
Figure 16: Context (306), looking west. 1 x 1m scale

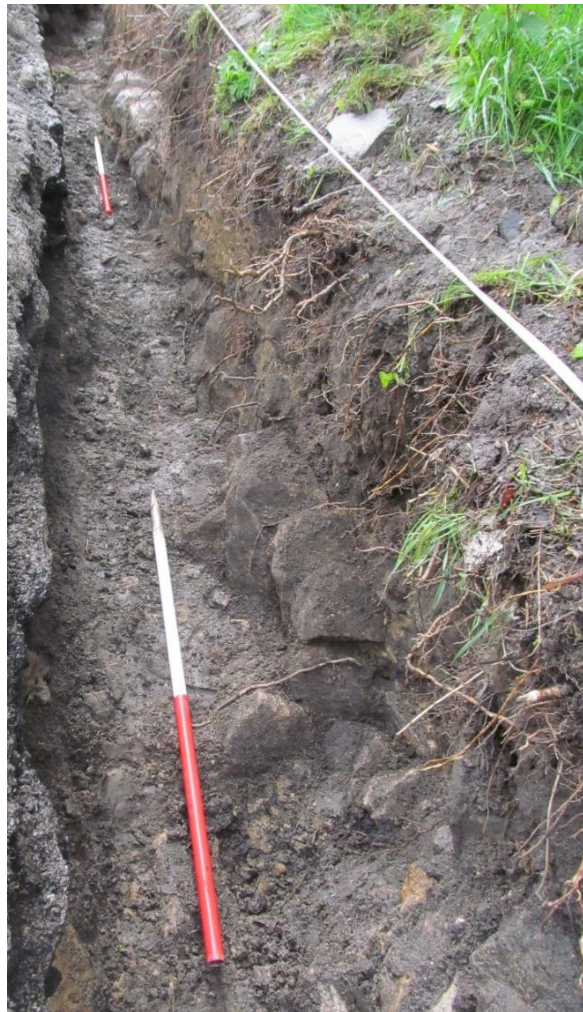
Figure 15: Contexts (306) (foreground) and (305) (background), looking east. 2 x 1m scale

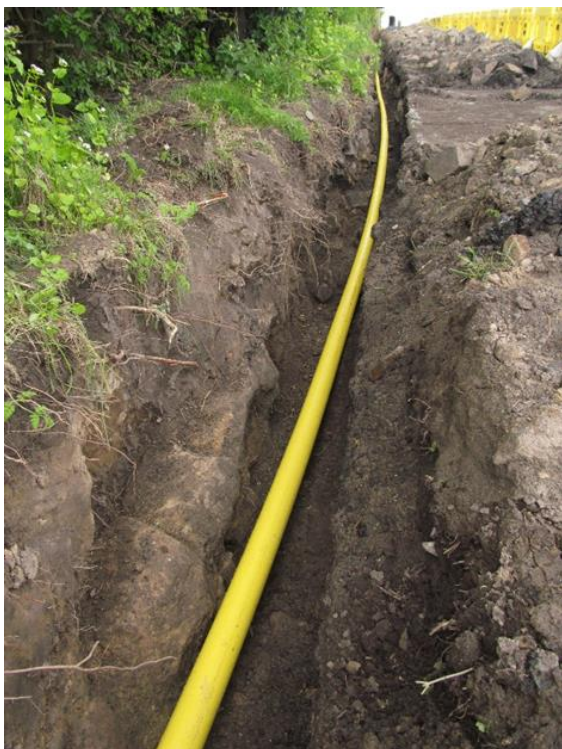
Figure 17 (left): Replacement gas pipe in Trench 3, demonstrating that it does not disturb the remains of the Wall. Looking west

Due to *in situ* remains of Hadrian's Wall being present, the planned excavation methodology for the new gas main was adapted, in consultation with Historic England, on the first day of groundworks to avoid harm to the monument. Rather than the pipe being laid between pilot trenches, as planned, it was laid along the same route as the old gas main which was to be replaced. Excavations did not further disturb the Wall.

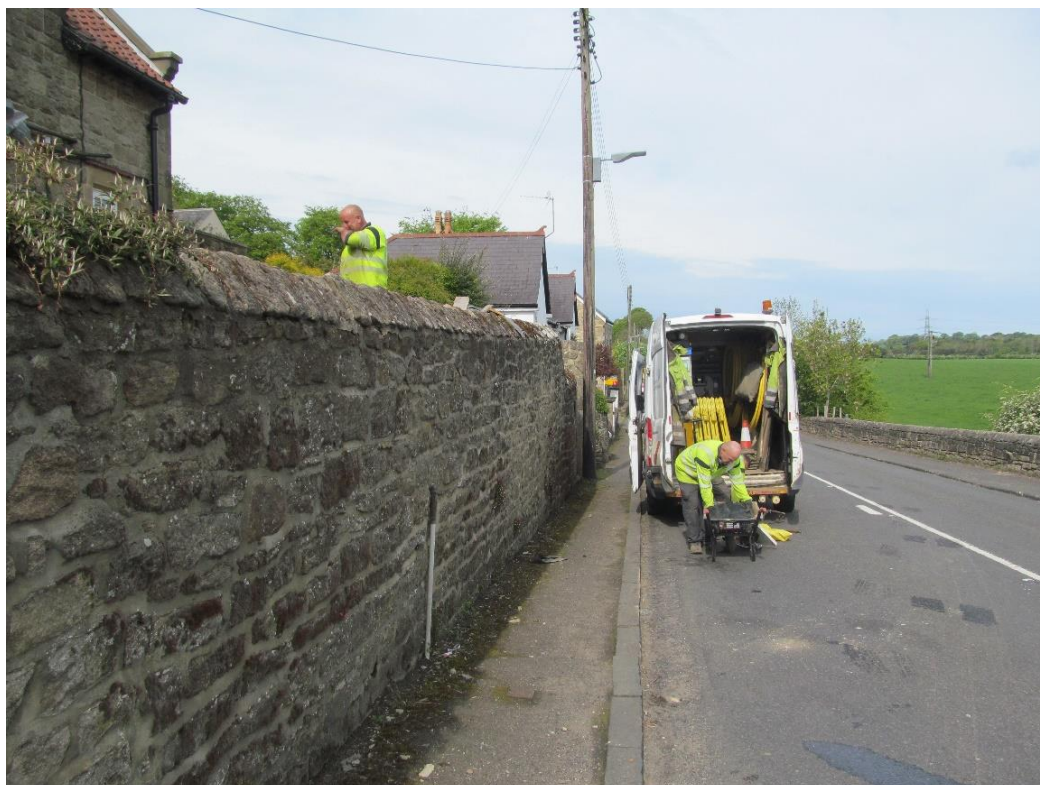
Beneath these three contexts lay a thick deposit made ground formed of quite compact, mid-orangish brown coarse sandy clay, (404), which contained fairly frequent medium rounded stones. This was overlain by a thin ashy layer of material (403), formed of loose, dark greyish black silty ash. Context (403) had an average thickness of 60mm, but context (404) continued past the base of the pipe trench; therefore, its full depth is not known. These two made ground deposits must relate to the raising of the ground level at 11a Military Road by at least a metre above that of Military Road, presumably as part of the construction of the property (Figure 25).

Figure 25: Differentiation in height between the garden of 11a Military Road (left of frame) and Military Road (right of frame), looking west
