P21-063

53 Military Road, Heddon-on-the-Wall, Northumberland

Archaeological Watching Brief

for Northern Gas Networks

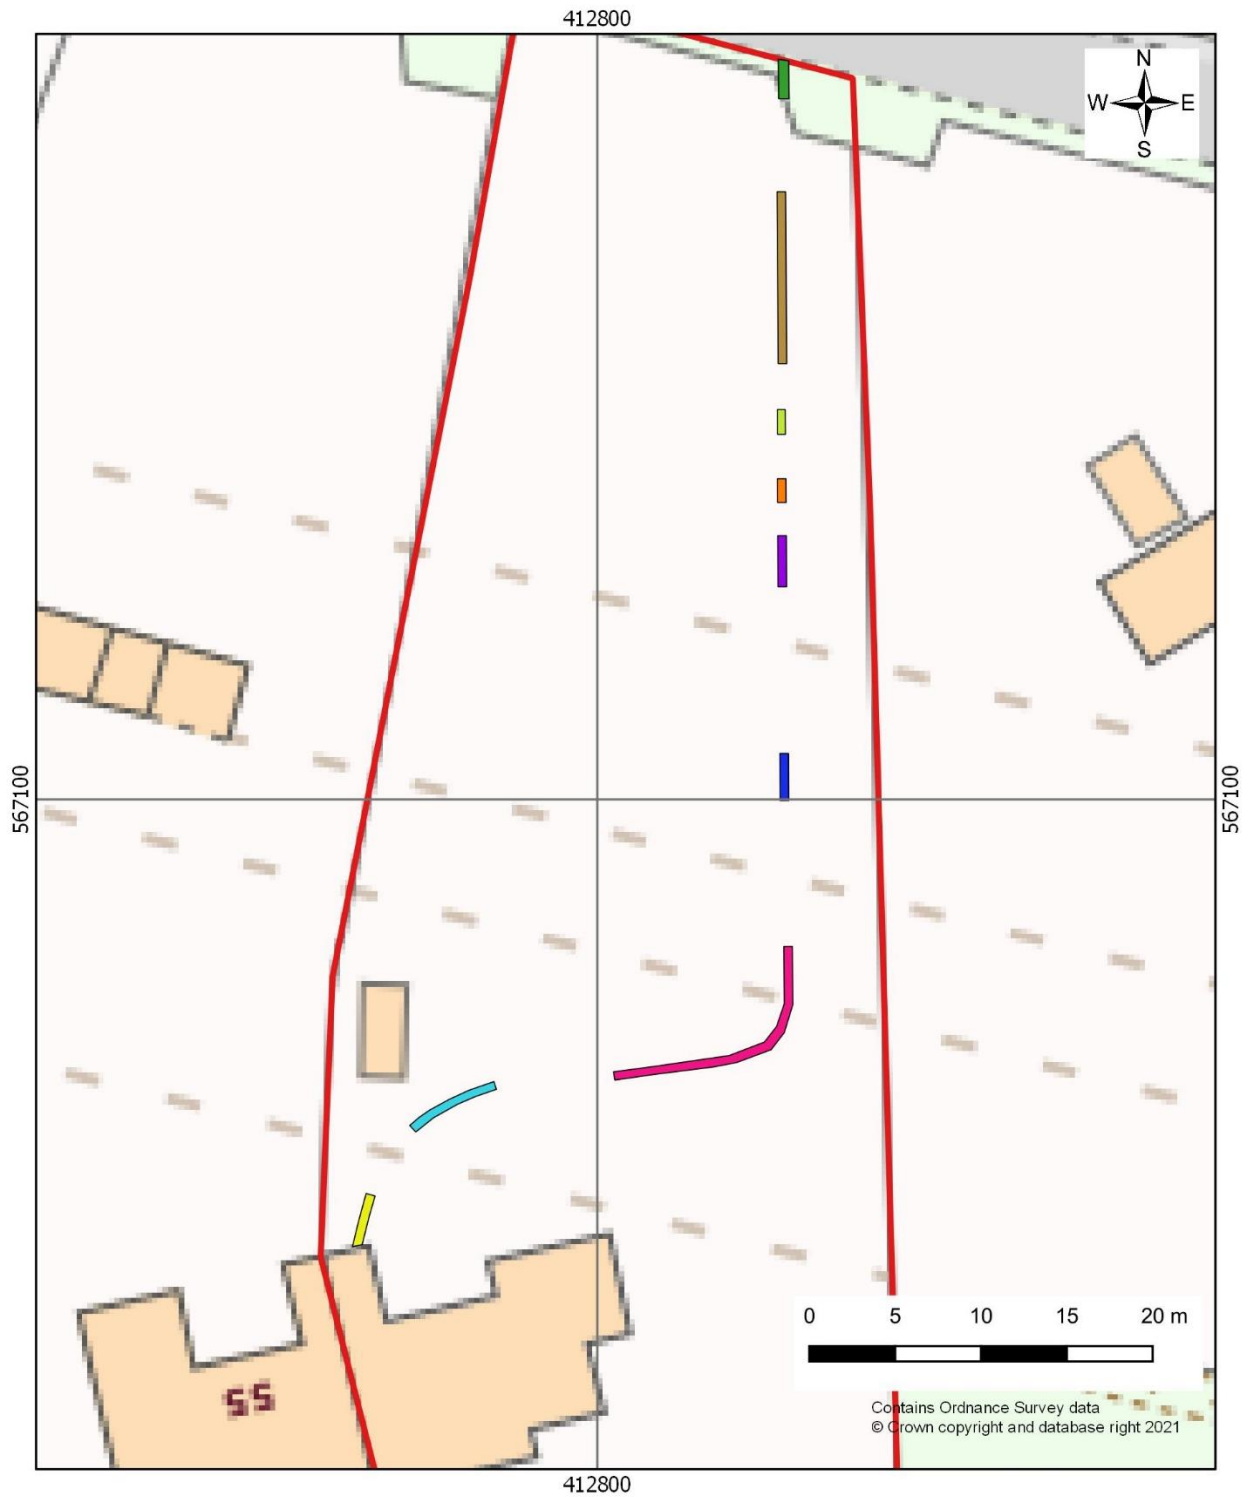
Figure 2: Trench locations

Excavation of the new gas pipe was carried out using a combination of hand and machine digging, with a total of 9 small pilot trenches excavated along its length (Figure 2). A pneumatic mole was used to join each of these pilot trenches so that the new pipe could be inserted between them.

The pilot trenches varied from 1.3m to 15m in length but were all of 0.5m width. Apart from Trench 9, which reached a maximum depth of 1m, the trenches were dug to a depth of 0.7m – 0.8m.

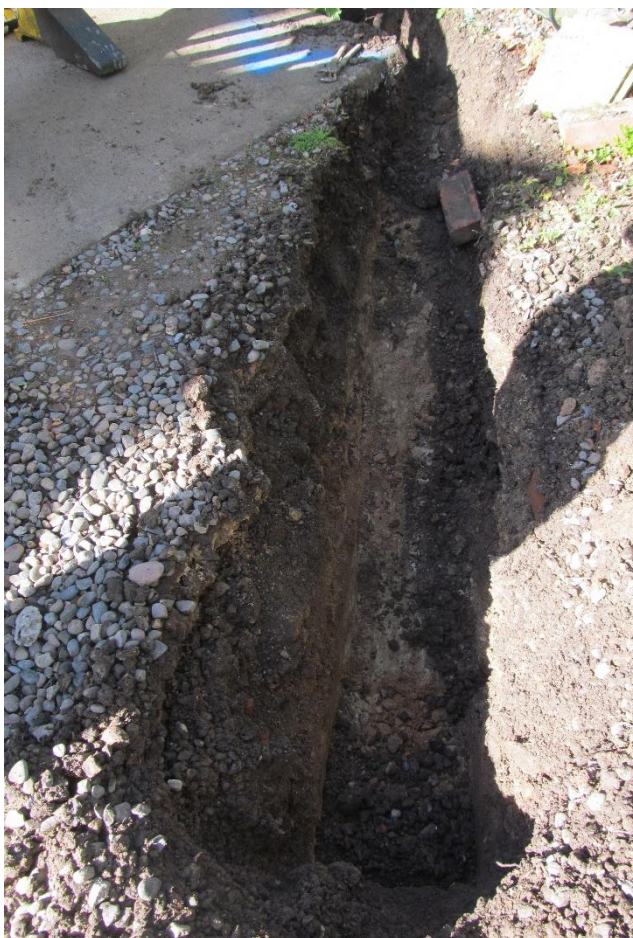
Trenches 1 and 2 contained modern service trenches, which underlay (001) and cut into (002) (Figures 5 and 6). Trench 9 contained the modern cobble driveway deposits (008) and (009), which overlay the earlier driveway of (002). It also contained two phases of footpath for Military Road, the earlier phase, (011), truncated by modern gas main [012] running east – west along the road. Trench 9's section suggested that the driveway deposits abutted the footpath deposits, although their installation may have been contemporary (Figure 19).

Figure 5: Trench 1, looking south-west. Unscaled.

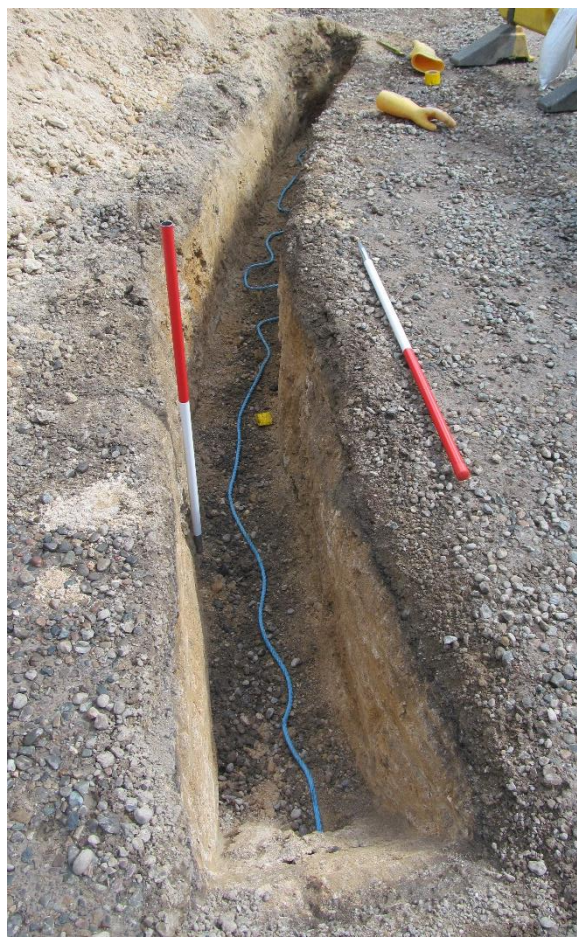
Figure 6: Trench 2, looking east. 2 x 2m scale

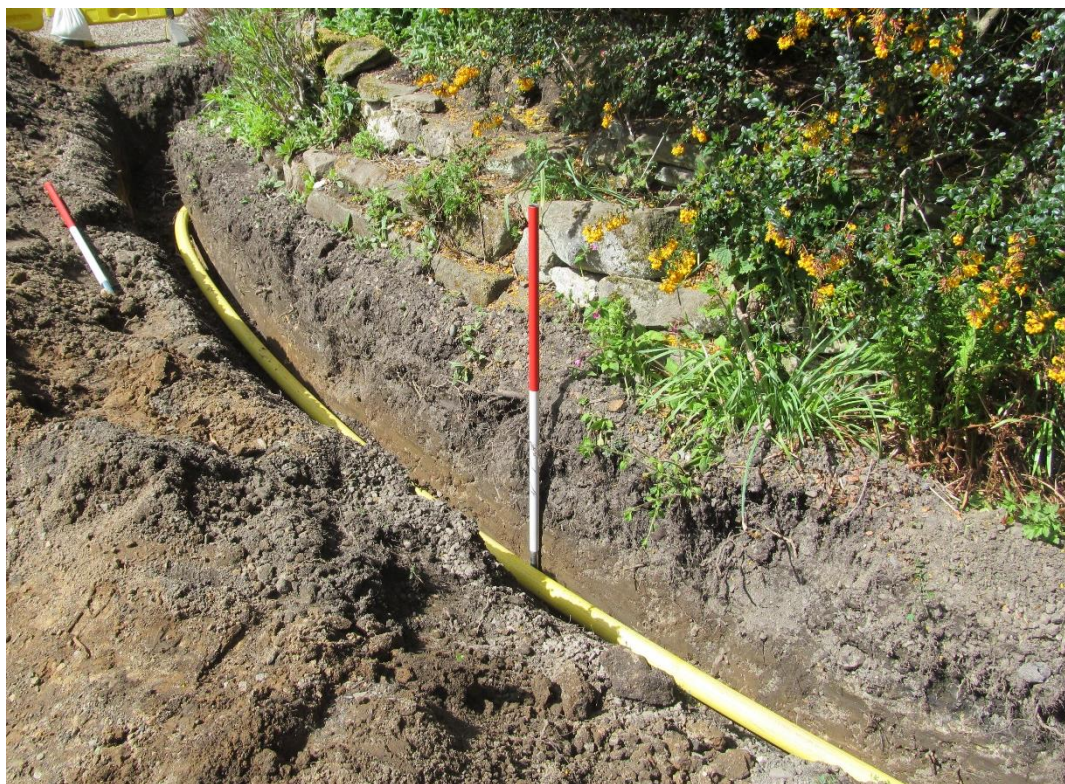
Context (001) was underlain by context (002), the earlier gravel drive, present in all trenches apart from Trench 1 (Figures 6 – 10 and 14 – 17). It comprised small – medium-sized cobbles in a very dark greyish silty matrix and is likely to be the original driveway associated with the construction of the property. Natural deposit (003), a friable medium-fine grained yellowish white sandstone and yellowish orange clay, was seen in all trenches but Trench 4 (Figures 5 – 8 and 14 – 17).

Figure 7: Trench 3, western half, looking west-south-west. 2 x 1m scale

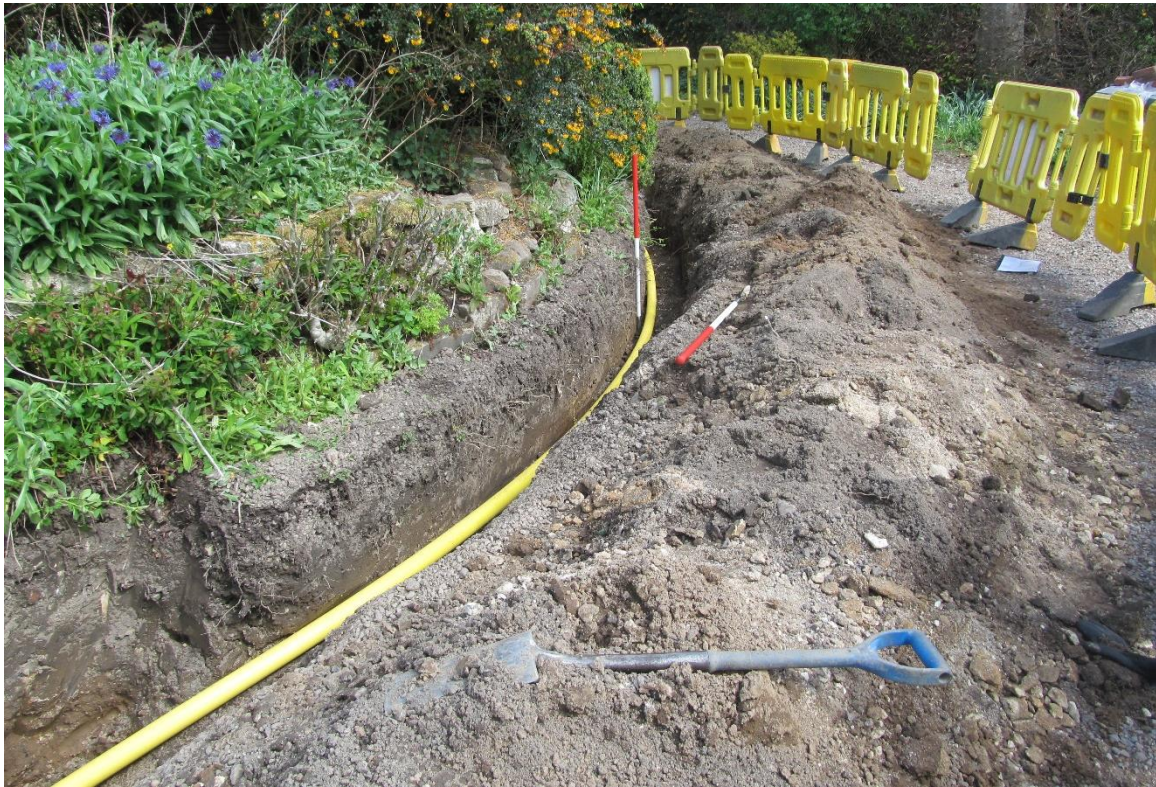
Figure 8: Trench 3, looking north-east. 2 x 1m scale

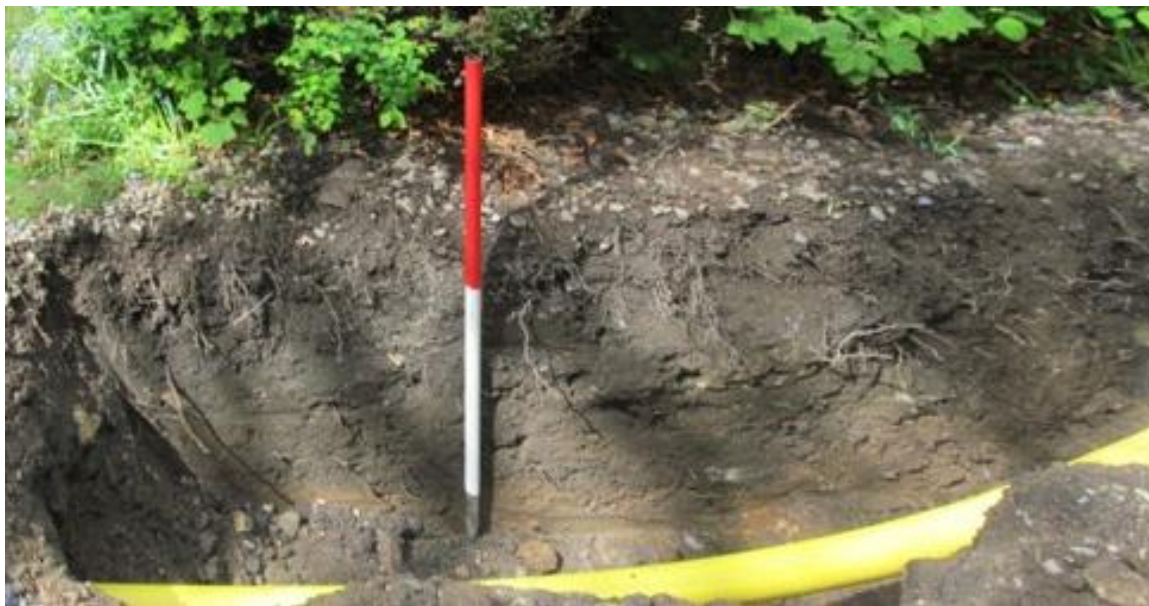
The only two deposits of a probable archaeological nature were (004) and (007), both seen in Trench 4 (Figures 9 and 19). (004), overlying (007), was a compact mid-greyish brown sandy silt with no tip lines or inclusions, suggesting a natural silting

depositional process. (007) was a very compact light orangish yellow coarse sandy clay, seen at the very base of Trench 4 and interpreted as redeposited natural. No cut relating to these deposits was seen in section or plan. The deposits encountered are considered to be fills within the vallum ditch, the cut of which is likely to be deeper and wider than the boundaries of Trench 4.

Figure 9: East-facing section of Trench 4, showing probable vallum deposits. 1 x 1m scale

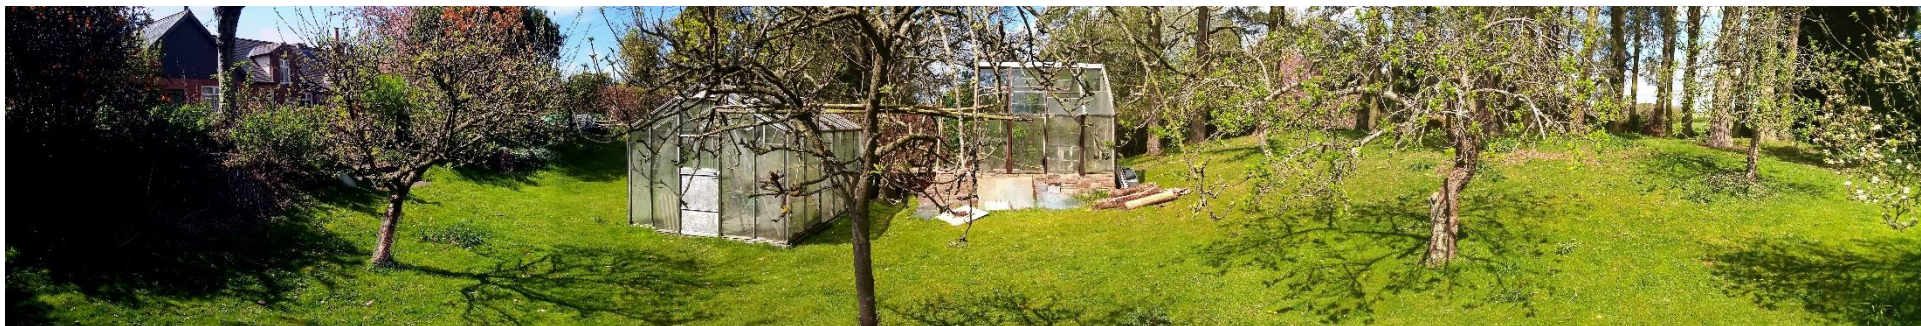
Figures 11 – 13 show that the banks and ditch of Hadrian's Wall's vallum survive in very good condition in the garden of 53 Military Road, to the immediate west of the excavated trenches. Trench 4 was clearly located in the base of the vallum ditch (see Figure 13 in particular), and therefore contexts (004) and (007) are thought to be vallum ditch fill deposits.

Figure 10: View over garden of 53 Military Road, showing greenhouses sat within the vallum ditch and the vallum banks rising to their left and right. Looking south-south-west to north-west

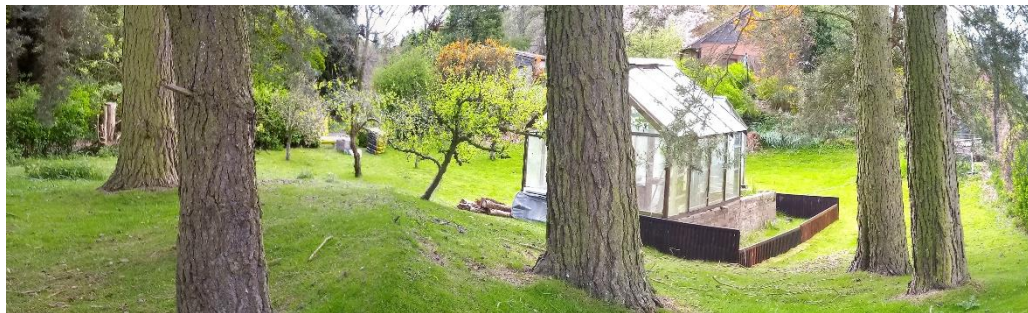
Figure 11: View over greenhouses sat within the vallum ditch, with 53 Military Road in the background. Looking south-east

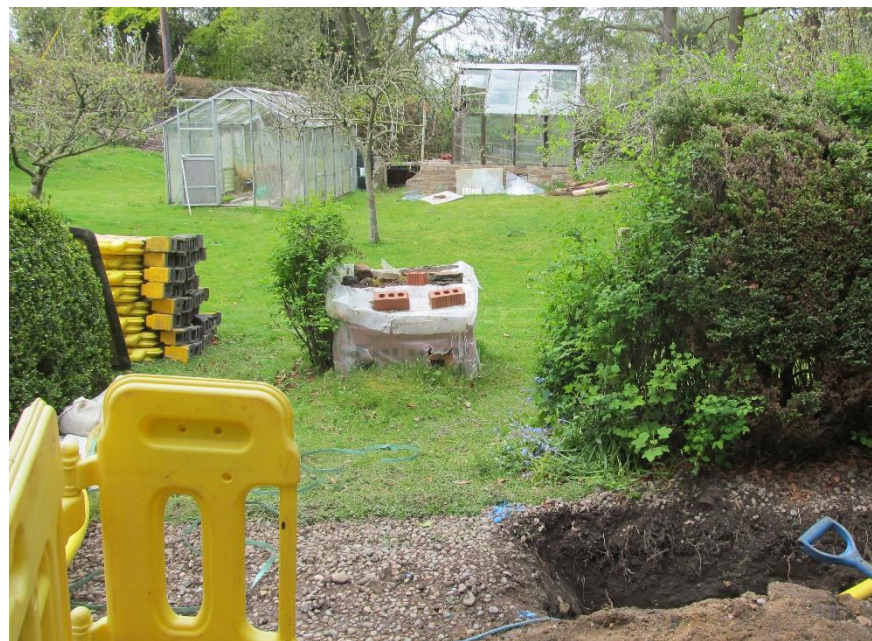
Figure 12: View over Trench 4's southern end, showing greenhouses in the centre background and the rise of the vallum bank to their left

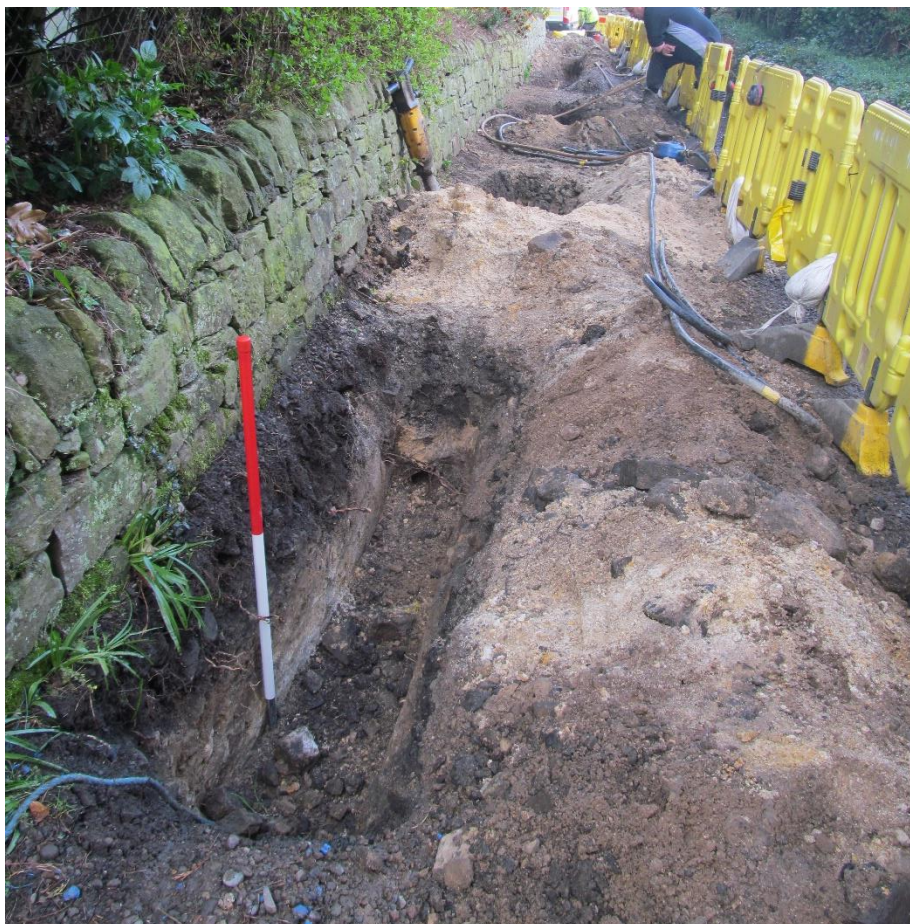
Figure 13: Trenches 5 (foreground) to 8 (background), looking north. 1 x 1m scale

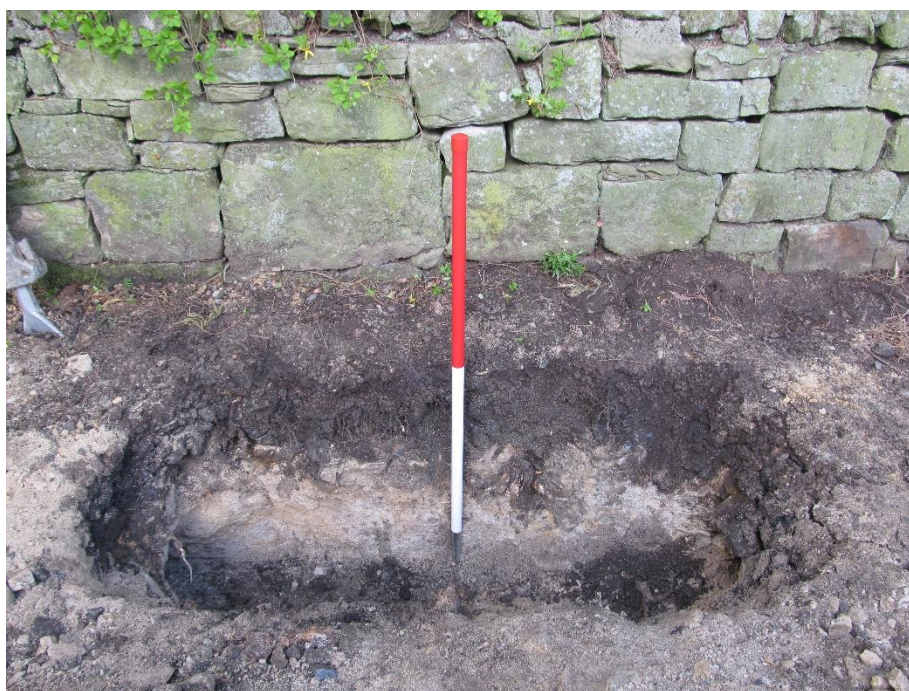
Figure 14: East-facing section of Trench 6, representative of Trenches 5 – 8.

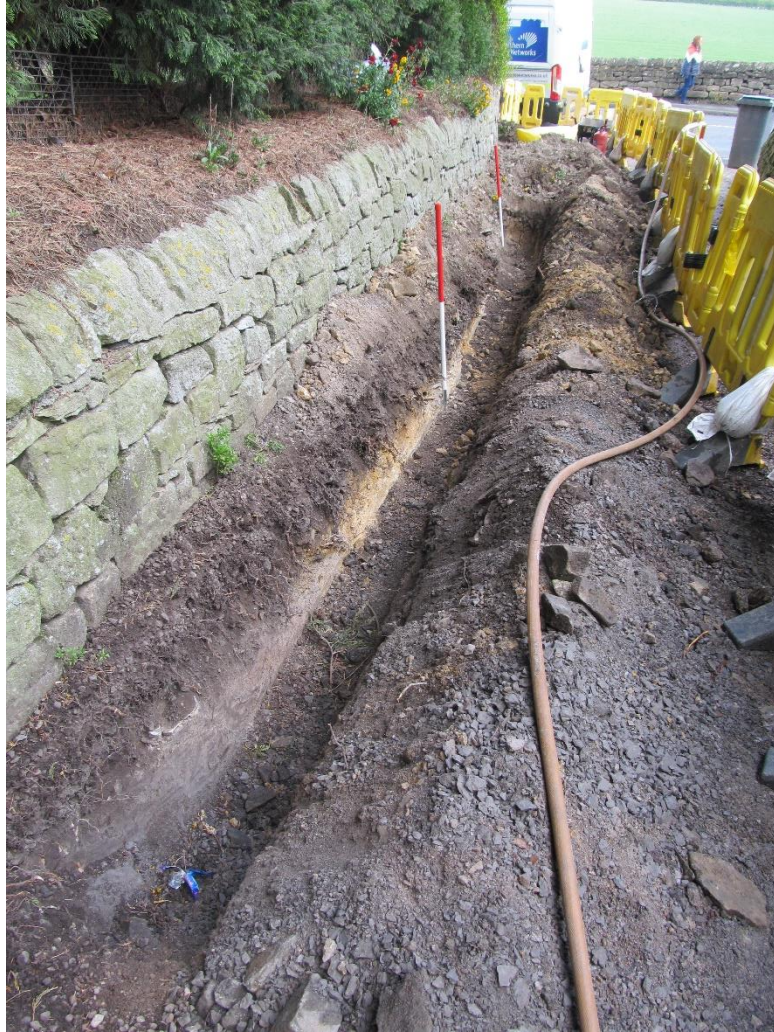
Figure 15: Trench 8, looking north. 2 x 1m scale

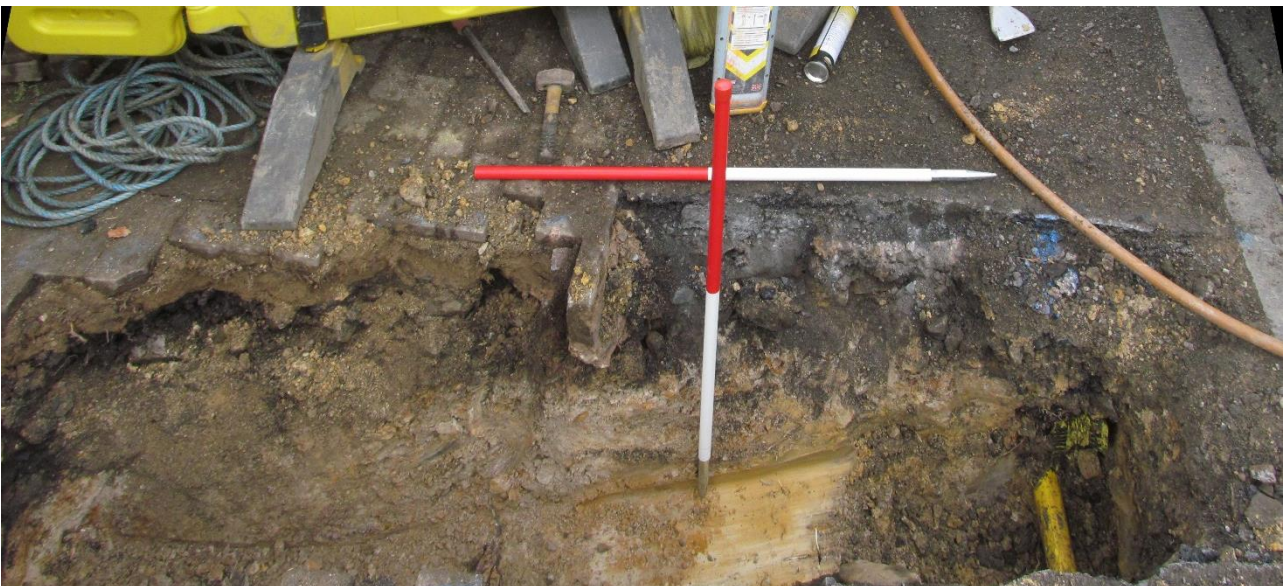
Figure 16: East-facing section of Trench 9, showing earlier iterations of 53 Military Road's driveway and the footpath along Military Road. The two are demarcated by the protruding brick to the left of the vertical scale

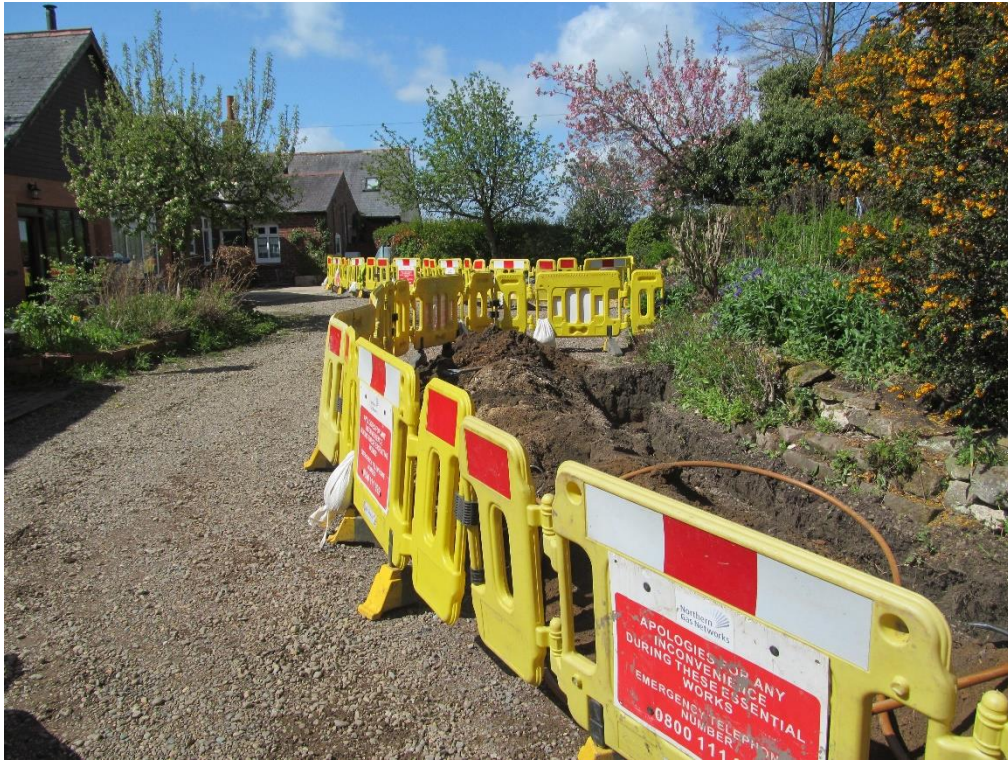
Figure 17: View of southern end of the PDA once excavated, looking south-west

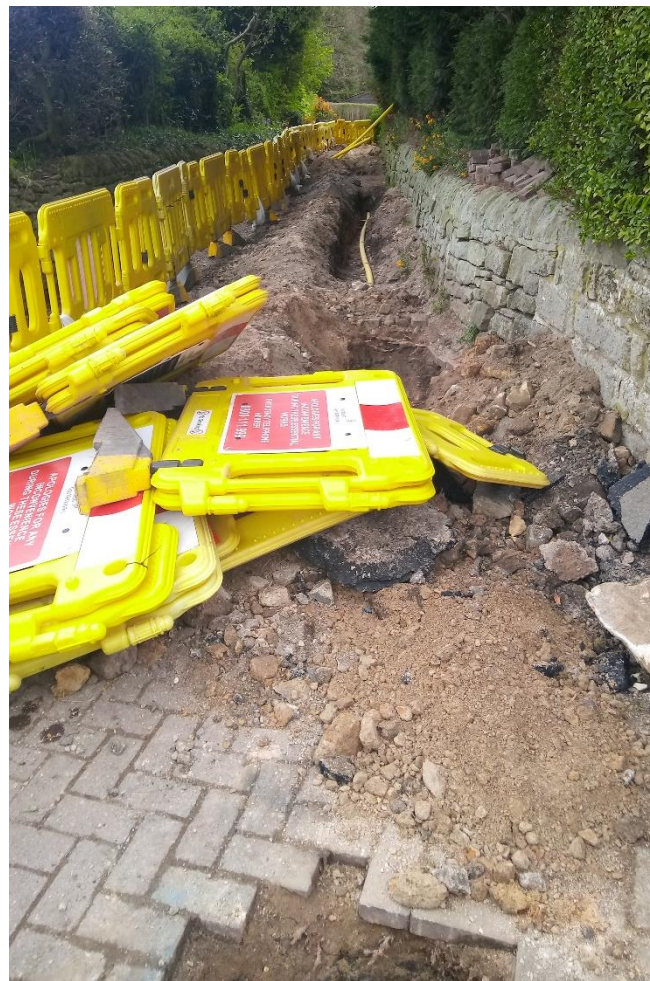
Figure 18: View of northern end of the PDA once excavated, looking south

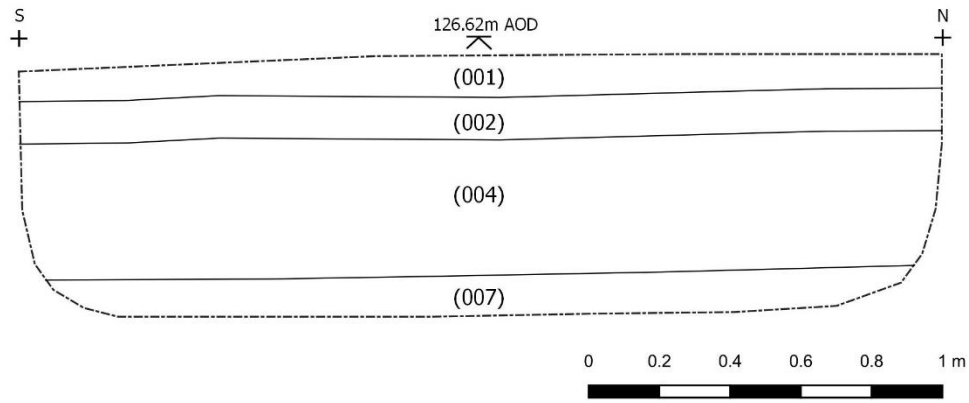
Figure 19: Drawn section of Trench 4, showing vallum deposits

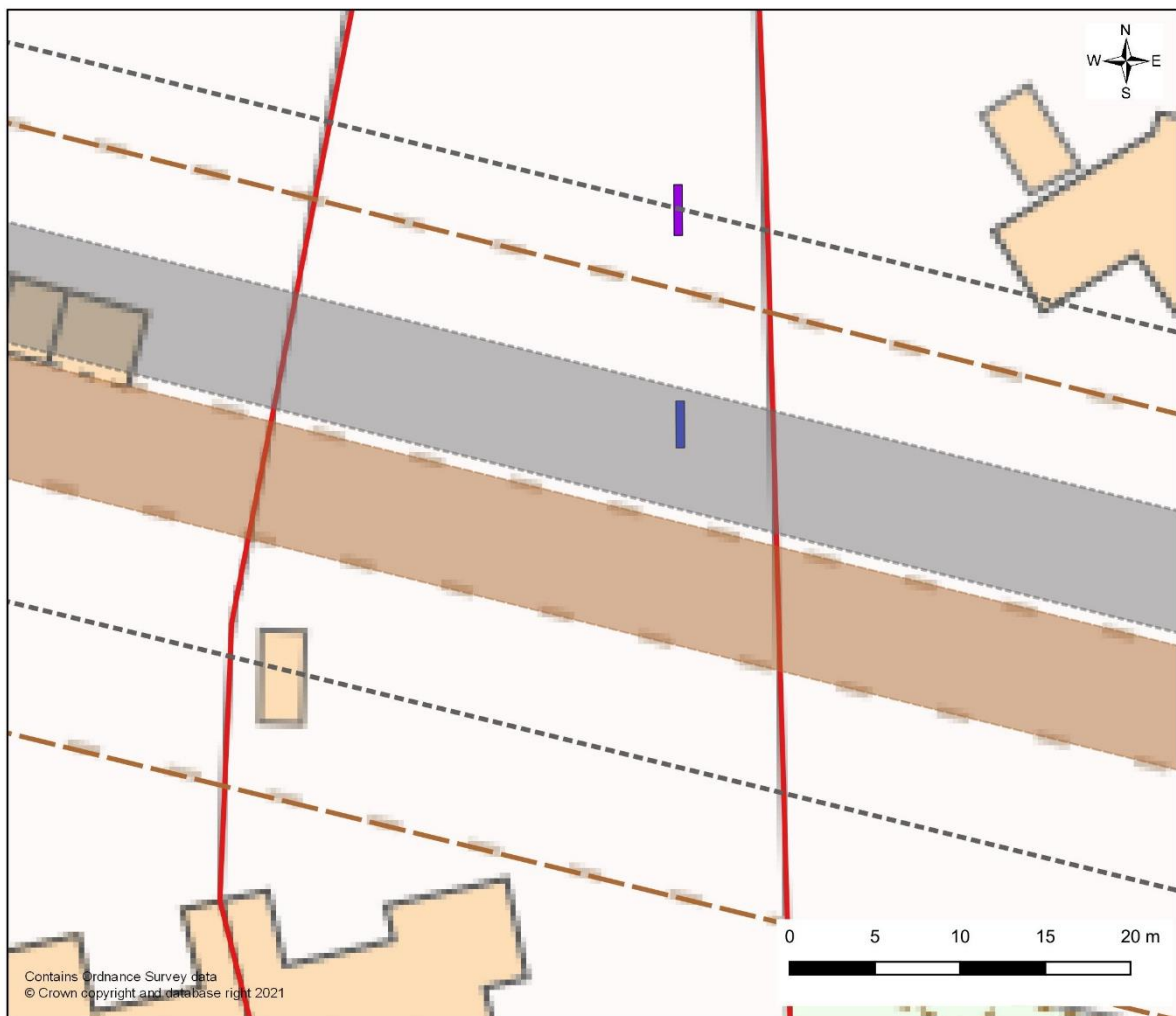
The deposits of Trench 4 and the elevated level of Trench 5, to Trench 4's north, indicate that the OS data for the position of the vallum ditch and banks is incorrect; these actually lie approximately 7m to the north of their recorded locations (see Figure 20).

Figure 20: Line of vallum banks and ditch, as shown on OS mapping and after fieldwork
