Ambrey Archaeology

Level 2 Historic
Building
Recording of
Furnace Farm
Barns, Shelsley
Walsh,
Worcestershire
WSM 77222

Date 14th May 2021

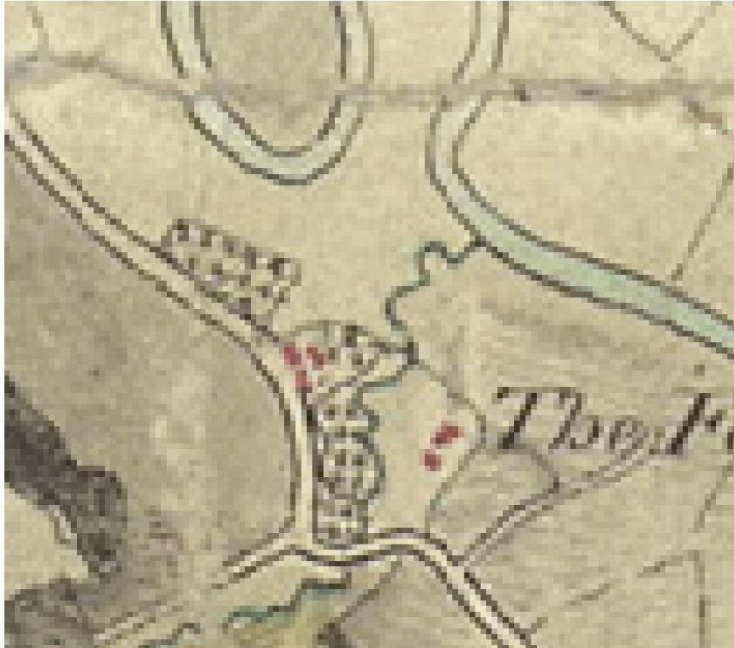
Figure 4: 1813 Ordnance Survey Drawing

Three buildings are shown in the vicinity of the site on the OS Drawing of 1813 (Figure 4).

The road layout and the layout of the buildings shown on the 1803 map, 1813 map and the 1839 tithe map had changed by 1884. The location and plan of Furnace Farmhouse on these maps appears to differ from the depiction on later maps, but timber frame elements of the farmhouse itself are likely to have been extant by 1839, as timber was largely replaced as a building material by brick and old red sandstone by the mid to late 18th century in the Teme Valley (HE 2020).

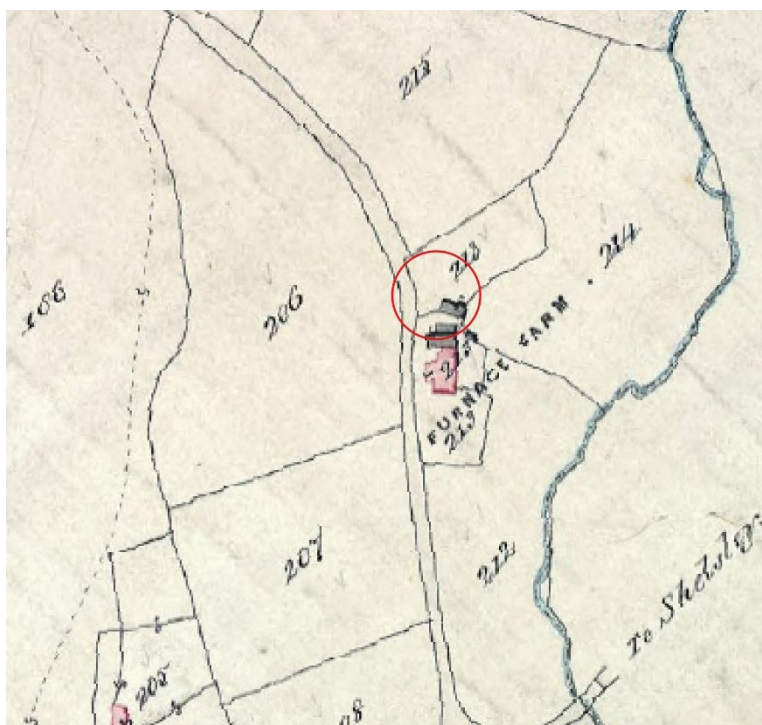
Figure 5: 1839 tithe map of the parish of Stanford on Teme (approximate location)

A network of trackways associated with quarries and limekilns are shown on the 1839 tithe map to the west of the site, in the woodlands on the hill (WSM69260) with a limekiln about 500m to the west of the site (WSM57315).

On the 1839 tithe map (Figure 5) some of the fields across the road have been amalgamated and are referred to as orchards and the layout of the buildings may also have changed with a building possibly being added in the centre.

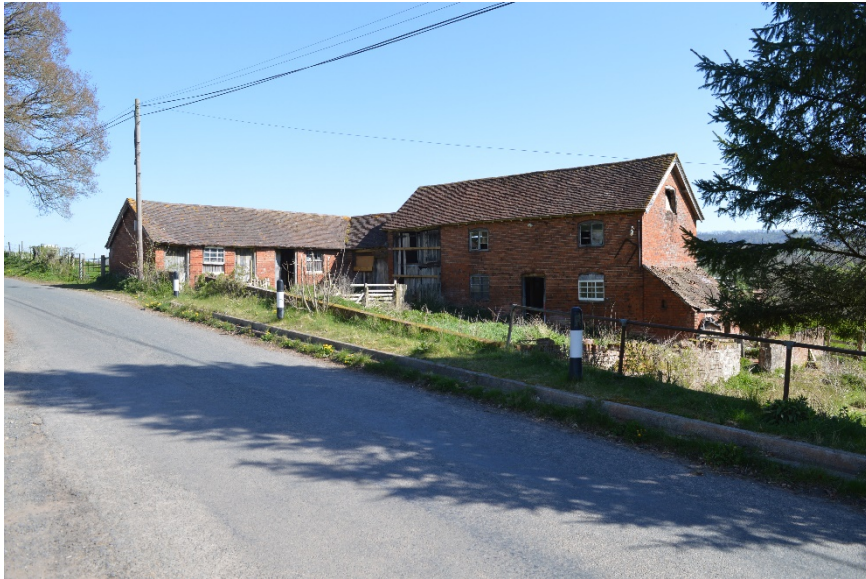
Plate 1: View north-east to Furnace Farm Barns from road

The Furnace Farm barns comprise brick buildings roofed with ceramic tiles, named in this report as Barn A, Barn B and Barn C (Figures 8 and 9, Plates 1 - 4).

Barn C joins Barns A and C (Plate 1).

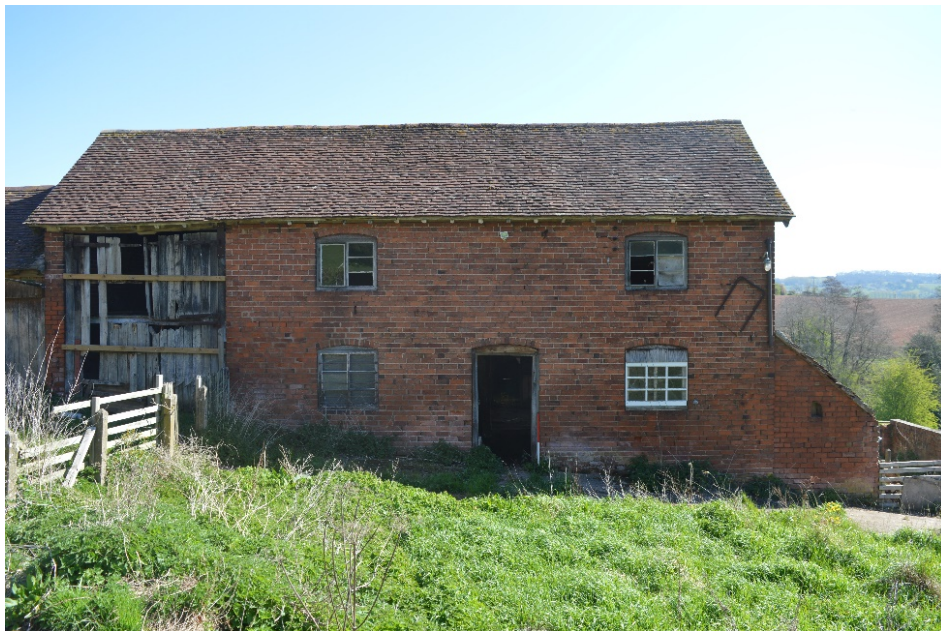
Plate 5: Western elevation of Barn A (1m scale)

The west-facing elevation of Barn A (Plate 5) contains four windows, two on the ground floor and two on the first floor with a door centred between them. The windows and door have segmental arches each of a of single row of brick headers.

The arrangement of windows and door in the front elevation gives the impression of a domestic building and would be symmetrical within the building were it not for the full height opposing doors on the left-hand side of the elevation.

The ground floor window frames contain reused wooden casement windows of varying styles and the upper storey windows are casements with metal frames which have been inserted into wooden frames.

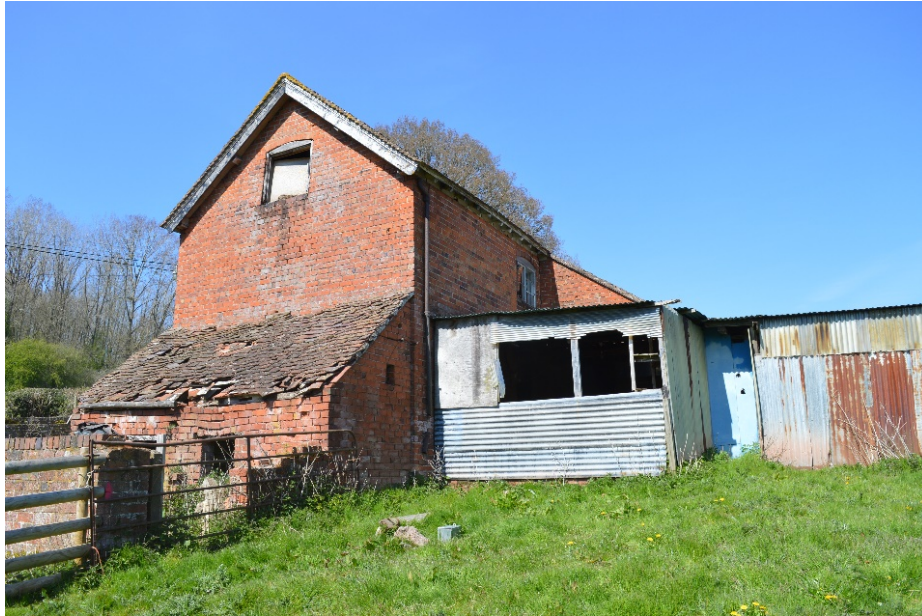
Plate 6: Southern gable from south east showing pig sty. Extension to rear also partially visible behind corrugated iron sheds

A single storey lean-to built to the south-south-eastern gable of the larger barn probably functioned as a pigsty (Plate 6). This building was not closely investigated as it was considered unsafe to enter.

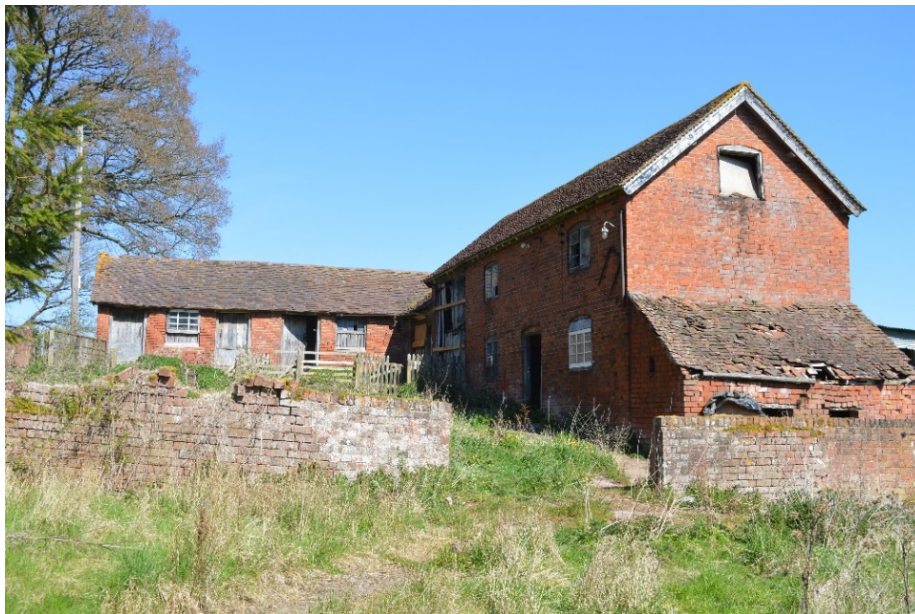
Plate 7: South-south-east facing elevation of Barn B

Barn B (Plate 7) is a single storey building at a right angle with a gable facing the road. There are three doorways and two windows in the southern elevation none of which have arches over. The doorways are filled with wooden plank doors one of which is a stable-type door.

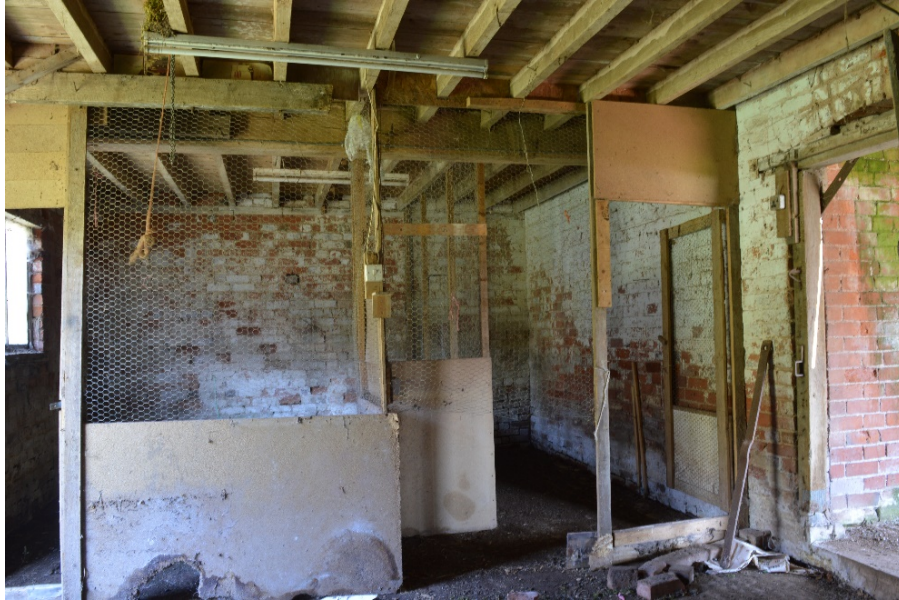
Plate 8: Ground floor interior of Barn A

The ground floor interior of Barn A has been used recently possibly for housing birds (Plate 8). There are cages or enclosures walled with chicken wire in the northern half of room No 1. The floor is partially earthen with cobbles and some bricks close to the rear door.

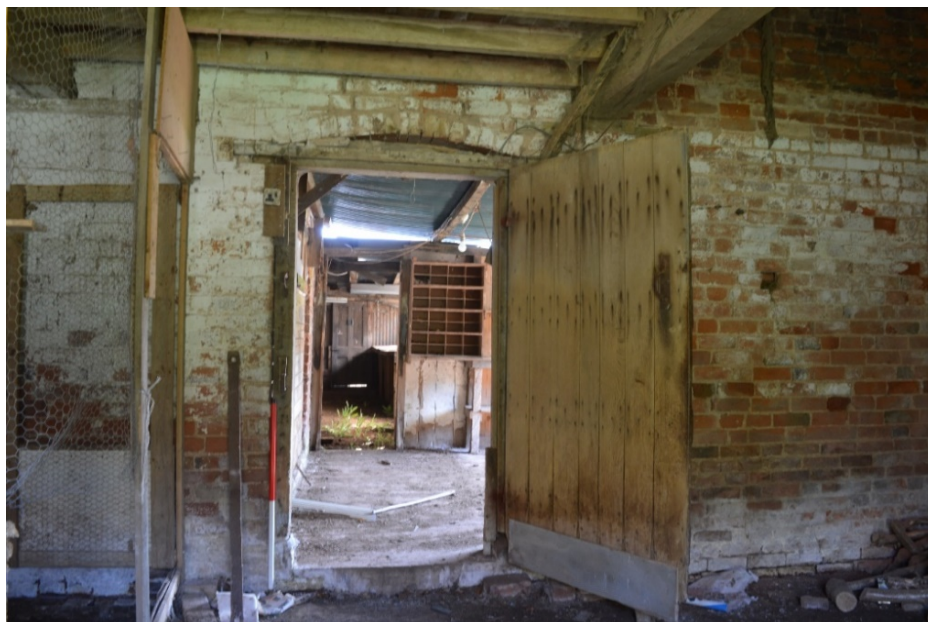
Plate 9: Rear door in Barn A

The doorway to the rear has a segmental arch with a wooden lintel inserted beneath (Plate 9). It is filled with a wooden plank door with what may be blacksmith forged ironwork (similar to that in other doors in the buildings, see plate 19).

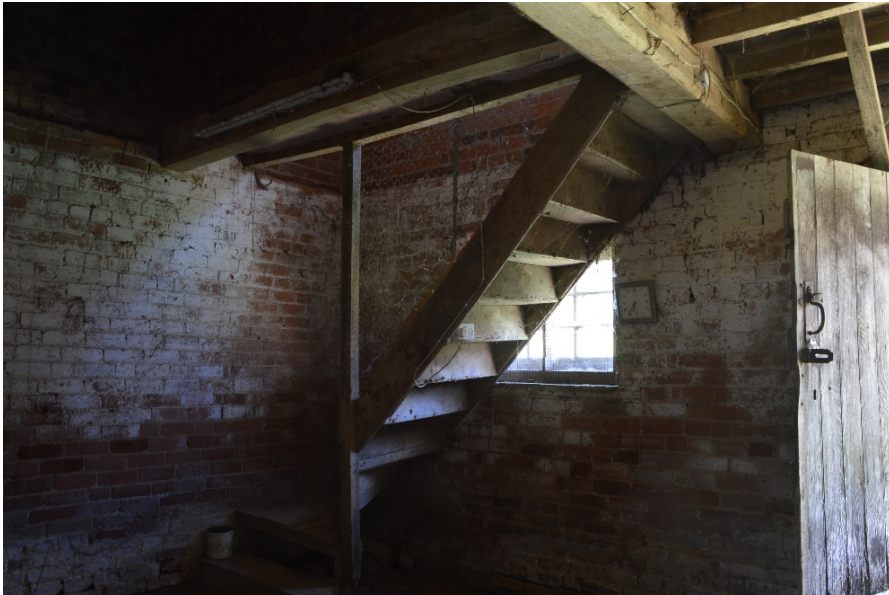
Plate 10: Wooden stairway in south-west corner Barn A

A modern wooden stairway in the south western corner accesses the first floor.

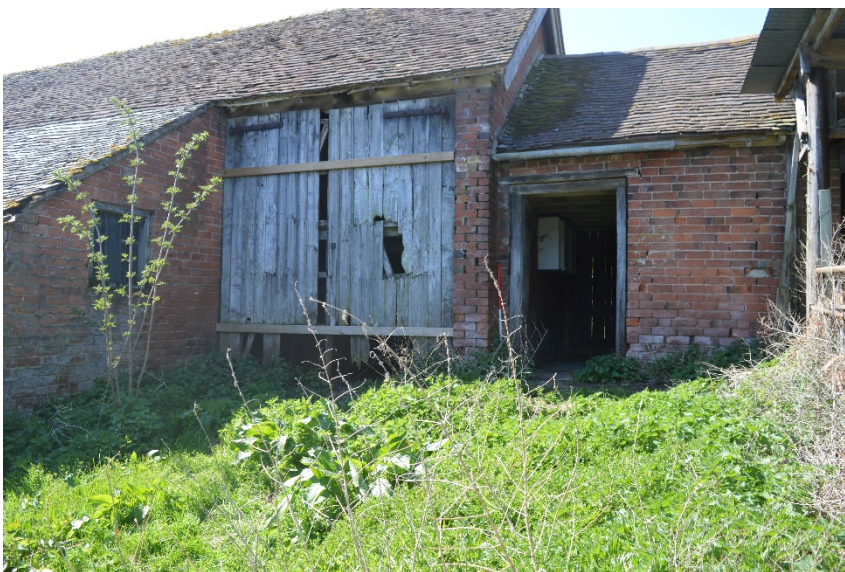
Plate 11: Lean-to with cat slide roof from north-east

The brick-built shed at the rear of Barn A (Plates 11 and 12) has a catslide roof held up by a truss (Plate 12), with a tie beam of a curved length of wood used in a vernacular style similar to woodwork on the first floor.

The brickwork of the southern wall of the lean-to is not tied in with that of the main building suggesting that the building may be later. A large doorway with a wooden lintel has been partially narrowed with wooden planks.

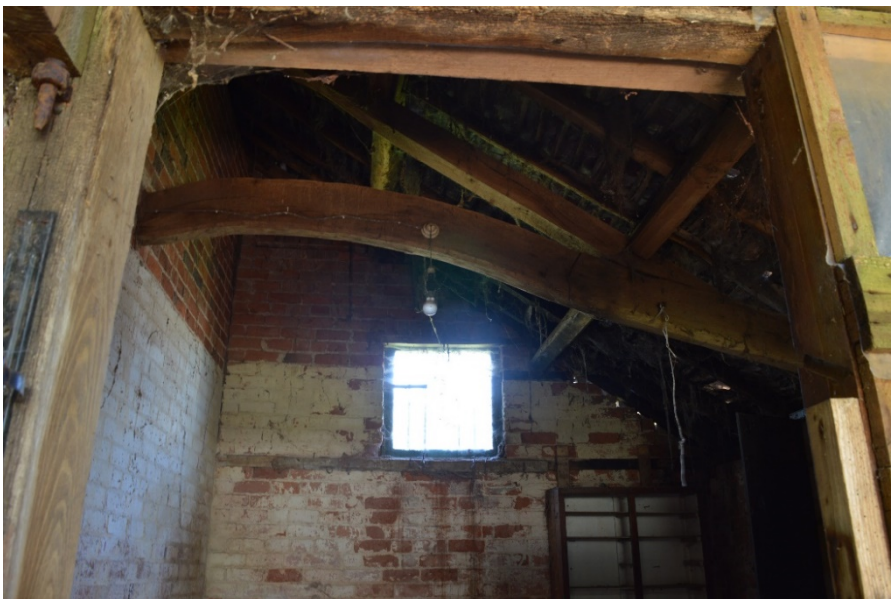
Plate 13: Curved beam in lean-to shed to rear

The outshot to the rear is supported by a truss incorporating a large vernacular curved beam strikingly similar to one used upstairs. However, the brickwork in this building is not tied into that of the main barn to the west, suggesting that it was a later addition (Phase 3), and that the cat slide roof was added when the extension was constructed.

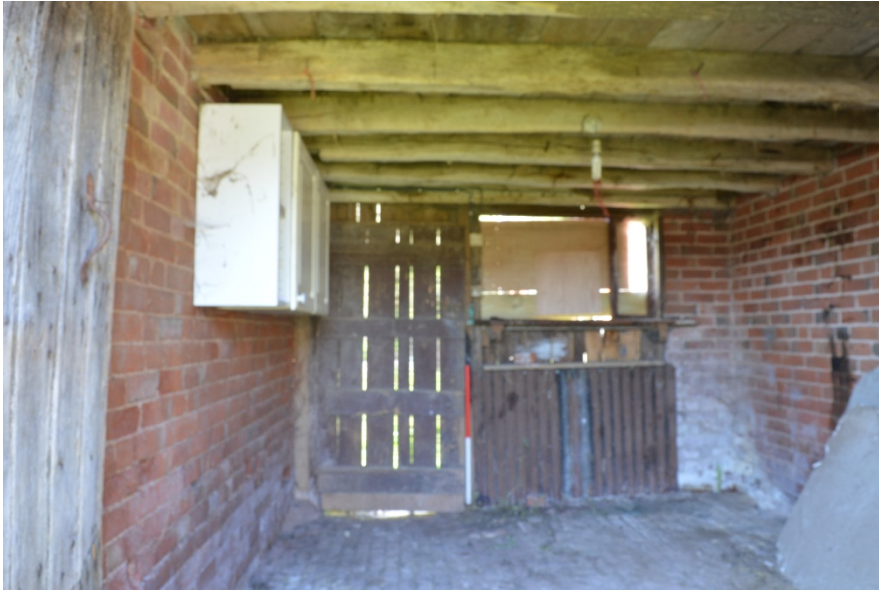
Plate 14: Barn C, ground floor, from

Barn C has a plain interior with a brick floor (Plate 14). The doorway to the front elevation was originally wide suggesting perhaps that this functioned as a cart shed. The ceiling joists are rough-hewn.

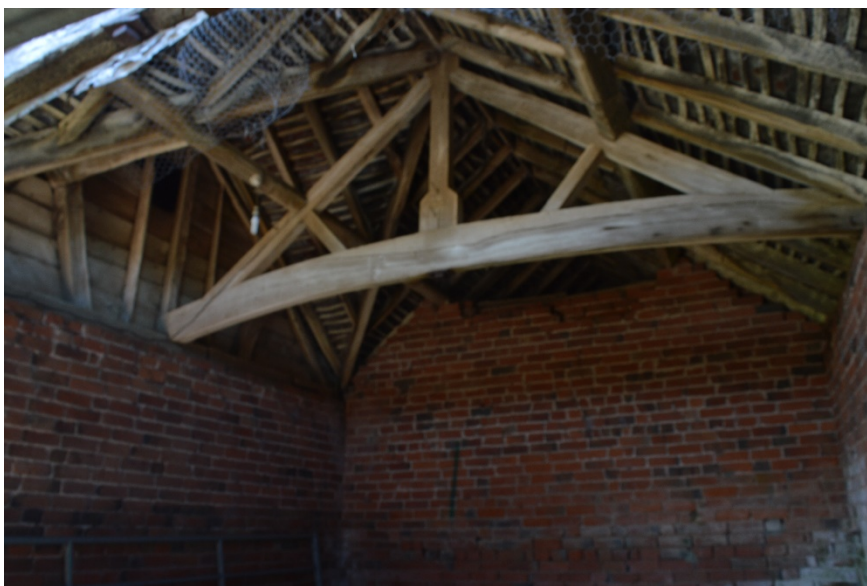
Plate 15: Shelter shed to rear

The shed to the north-east in Barn B is open to the rear and may have functioned as a shelter (Plate 15). Until recently it has housed sheep.

A machined kingpost truss holds up the roof in the shelter shed.

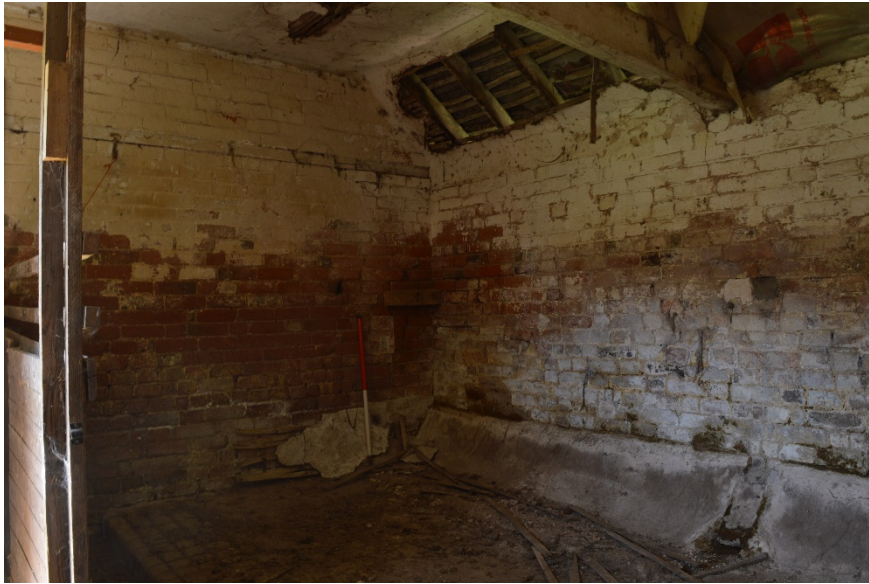
*Plate 16:
Central shed in
Barn B*

The western part of Barn B is divided into two sheds. The most western of these is accessed by two doors to the front, and by a door in the east wall which links to the eastern shed. Both have brick floors on two different levels and the concrete base of a probable animal feeder runs along the north wall of the east shed and the remnants of a wooden partition remain here as well (Plate 16). The roof trusses in both sheds are also machined, and an inserted ceiling obscures some of the roof truss (Plates 17 and 18). These may have originally been used for stabling or housing stock. A stable door in the eastern of the two sheds displays ironwork which may have been locally forged rather than mass produced (Plates 19 and 20).

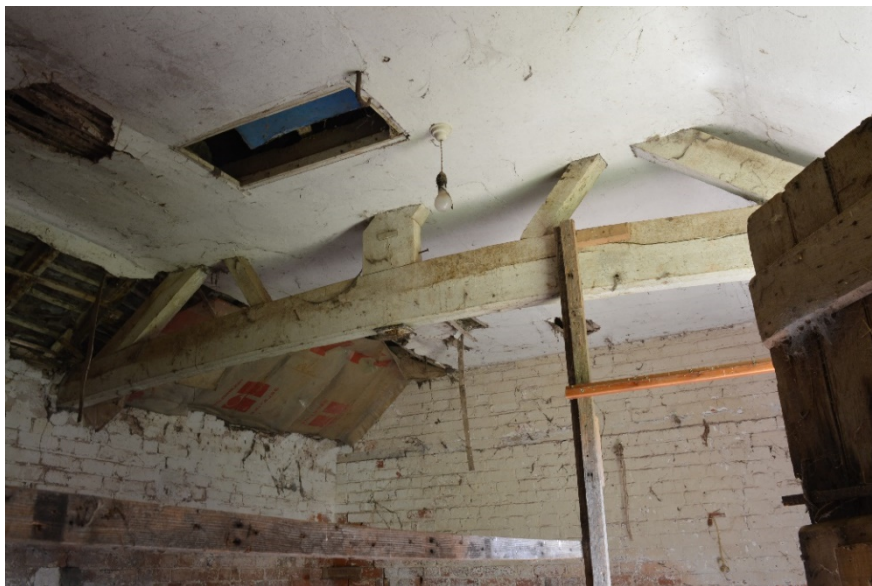
Plate 17: King post truss partially obscured by an inserted ceiling, Barn B

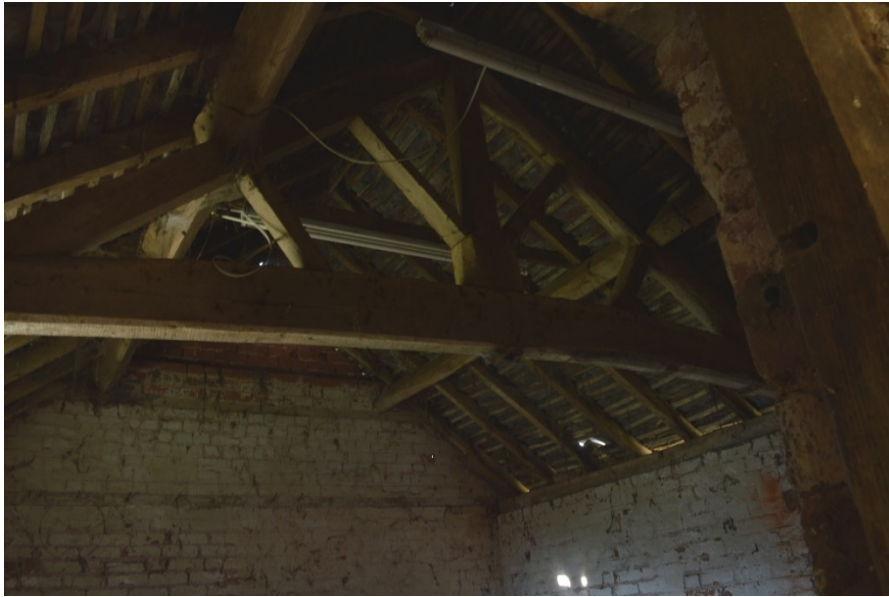
Plate 18: King post truss in the western shed in Barn B

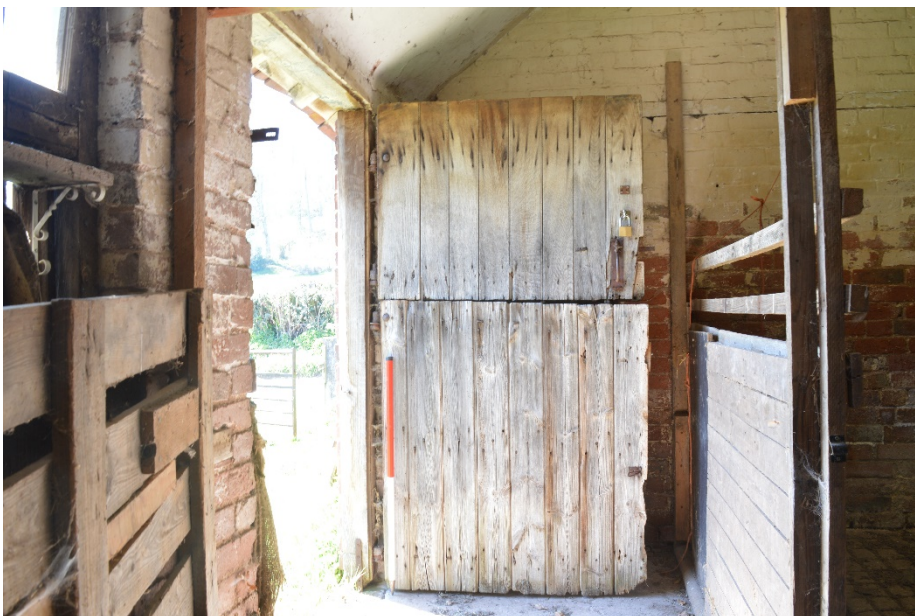
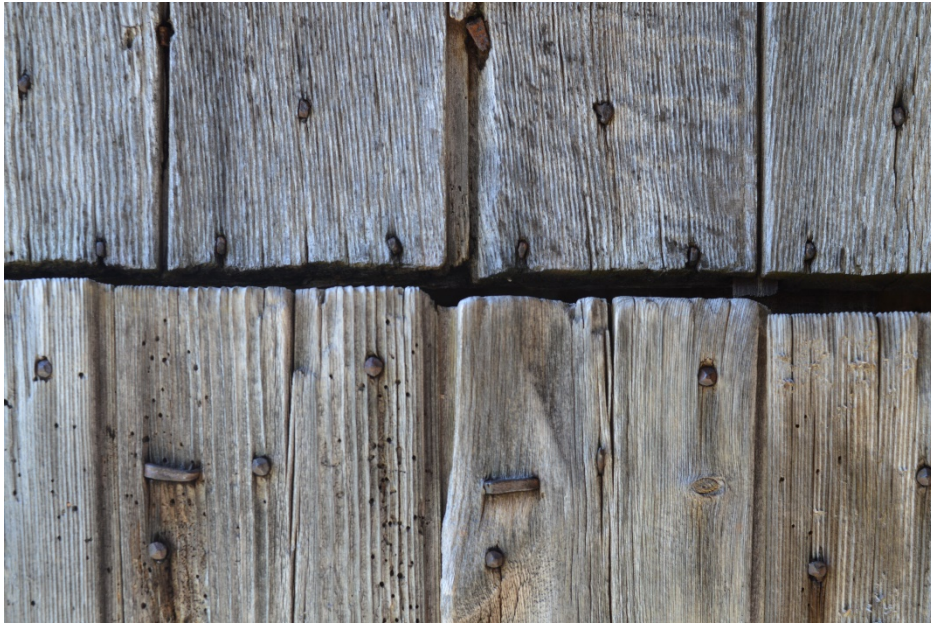
Plate 19: Stable door in Barn B

Plate 20: Iron nails on stable door in Barn B

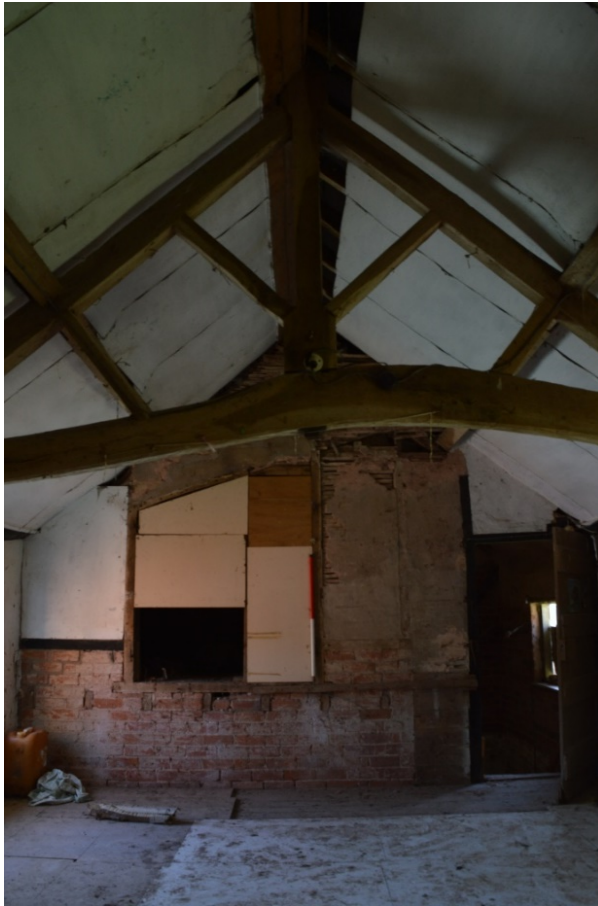
The roof is supported by a king post truss with additional struts supporting the main rafters beneath the purlins (Plate 21). The tie beam is carved from a long, curved piece of wood, similar to the beam in the ground floor rear extension.

Plate 21: First floor, Barn A. Vernacular king post truss with inserted room or storage space in background

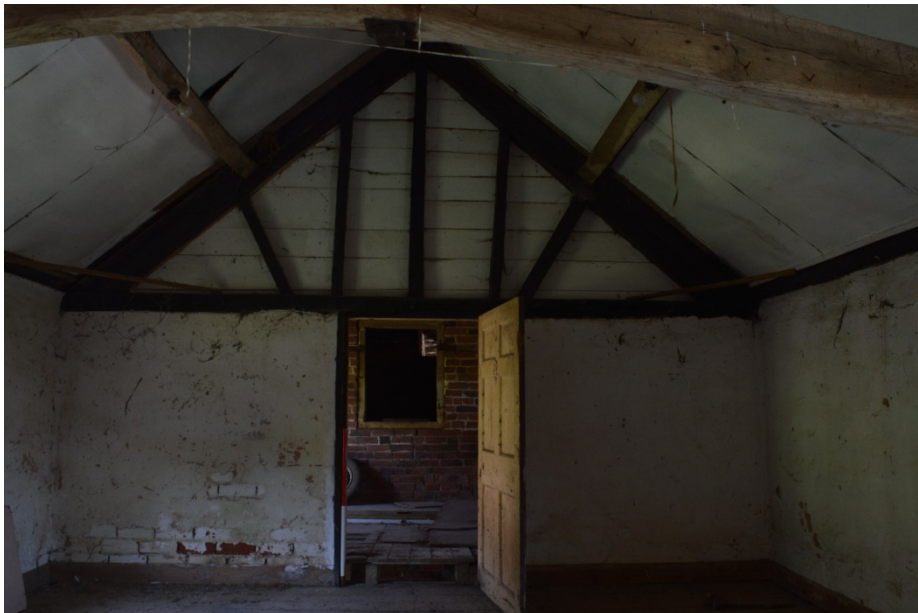
The roof truss in the north gable towards the threshing bay is of a different structure to the king post truss, and may be reused (Plate 22). In addition to three central struts, two diagonal struts which connect the tie-beam to the principal rafters are slightly offset from the purlins. A wall of horizontal boards completes the height of the gable from the brick wall to the apex of the truss.

Plate 22: First floor, Barn A. Truss in gable overlooking threshing barn

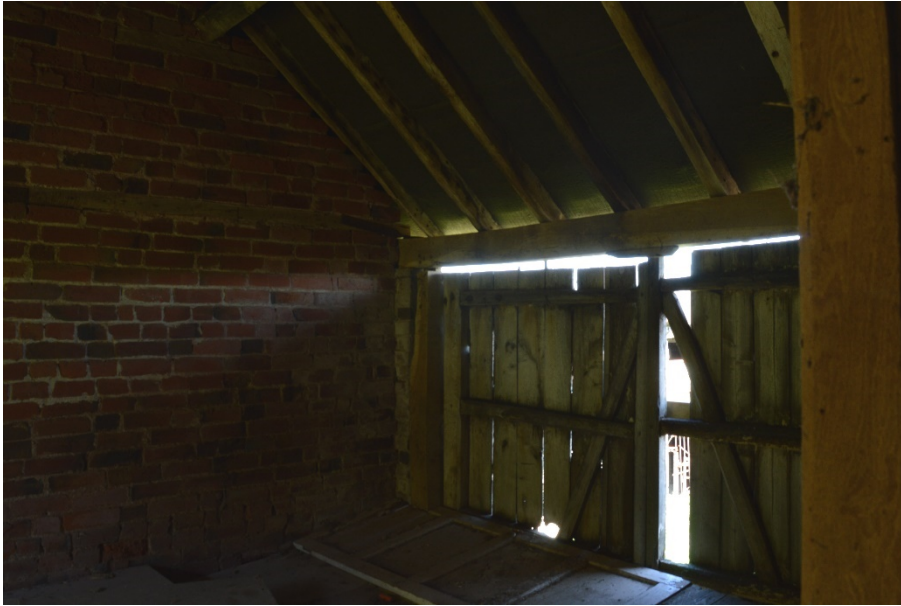
Plate 23: Inserted floor in threshing barn, Barn A.

An inserted floor at first floor level in the threshing barn, is boarded out with old doors and ply and was not considered safe to walk on (Plate 23). Roughly shaped beams act as lintels over both opposing doorways, and at about this height a narrow wooden lintel runs along the width of the

gable to the north, which forms the southern wall of the loft of Barn C. The bonding on the brickwork of this gable is generally more random than elsewhere in the building.

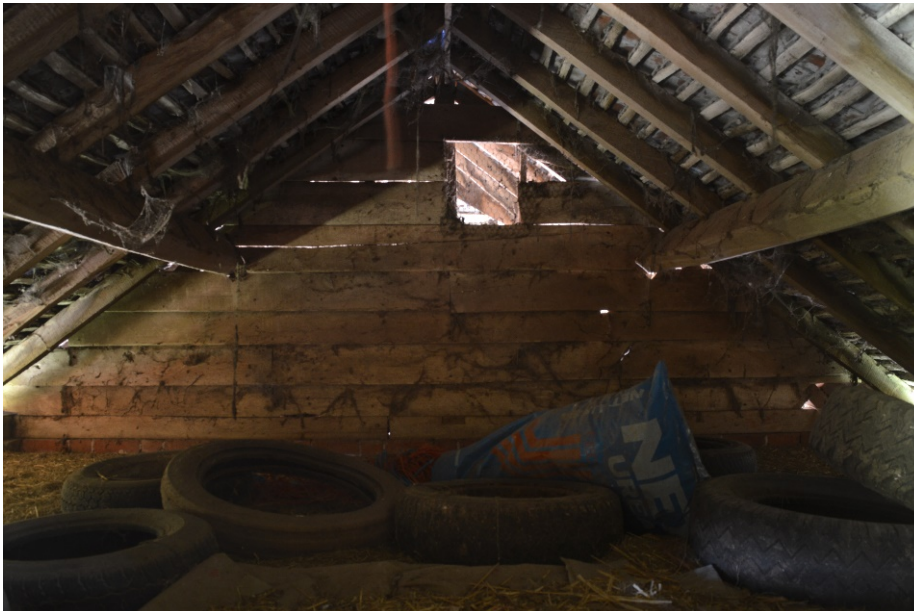
Plate 24: Loft, Barn C.

The loft in Barn C was not considered safe to enter but a photograph was taken through a small door or window in the southern brick gable (Plate 24). Roofing batons are visible through the common rafters. Currently used for storage of old tyres, its original function may have been for storage of hay or animal feed. The apex of the northern gable of this shed is a wall of wooden planks with an offset window within it. This sits on a brick wall of similar construction to the majority of the walls in the barn complex.
