# Ambrey Archaeology

Watching Brief  
on the removal  
of a retaining wall  
at

St Gregory's Churchyard,  
Castlemorton, Malvern

WSM73297

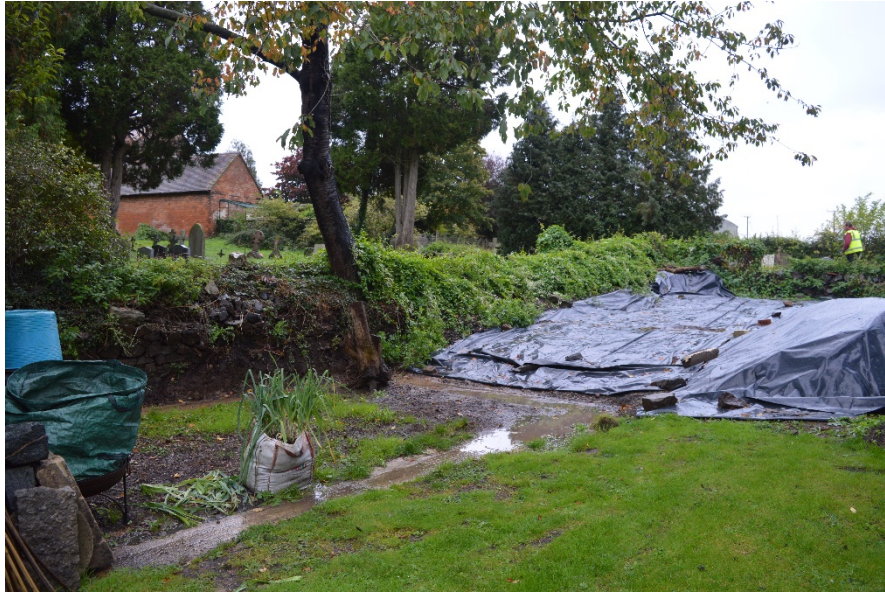
The wall before demolition was topped by a layer of collapsed stone and in the north-east of the site, a mixture of stone and rubbish. It was covered with a layer of scrub and vegetation including trees and shrubs (Plates 1 and 2).

*Plate 1 Site before excavation, from south-west*

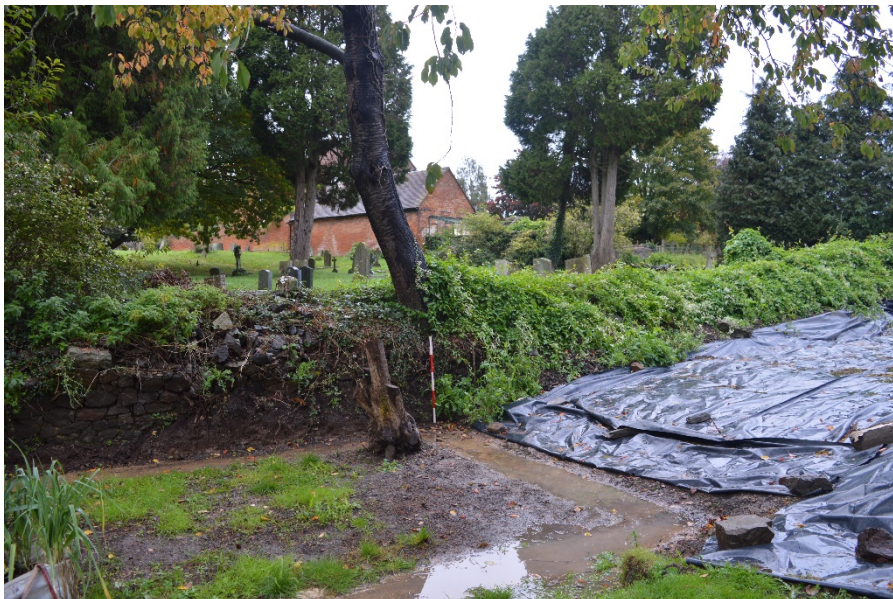
*Plate 2 Wall before excavation, from south-west*

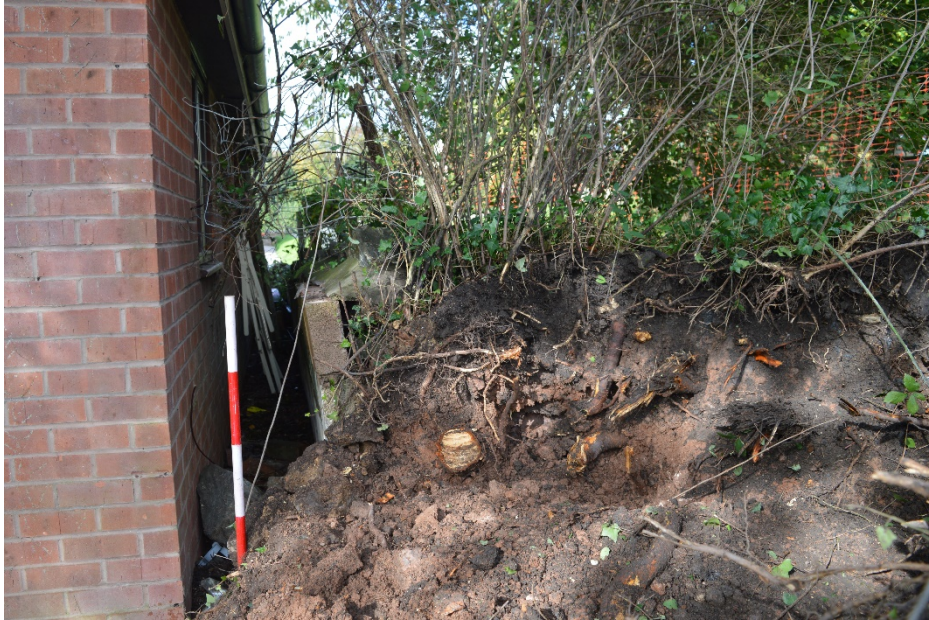
Following removal of scrub and vegetation, a layer of collapse and rubble along the line of the revetment wall was removed. This was mixed in the eastern corner with modern waste - glass and china fragments, as well as brick and metal finds, all of mid-late 20<sup>th</sup> century date. Some indeterminate bone fragments were recovered both in the 20<sup>th</sup> century waste and in looser areas of subsoil around tree and shrub roots, these were reburied on site (Plate 3).

*Plate 3 Western extent of demolition and excavation, by modern garden shed*

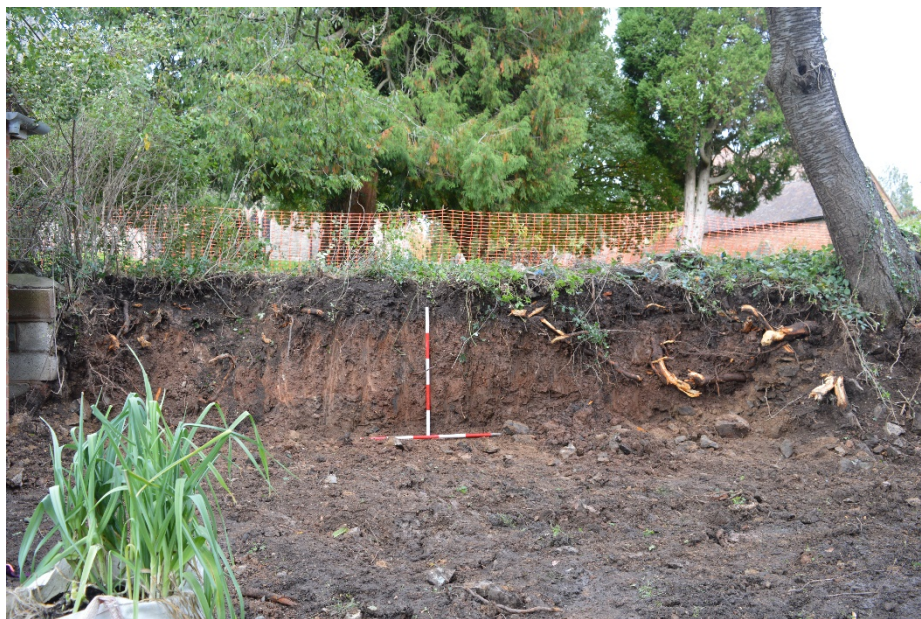
The wall was cut into the natural substrate, a compact, grey silty clay which was overlain by a reddish silty clay deposit, much disturbed by rooting (Plates 4-7).

*Plate 4 South-west facing section following removal of revetment wall*

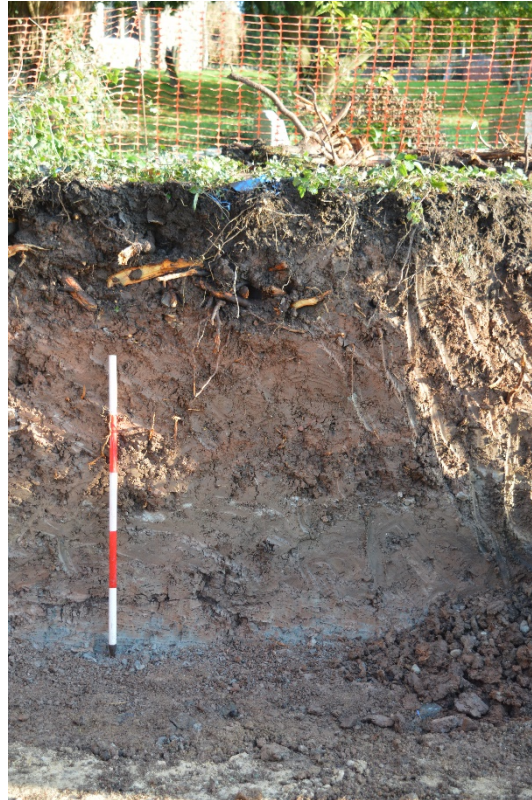
*Plate 5 South-facing section following  
removal of revetment wall*

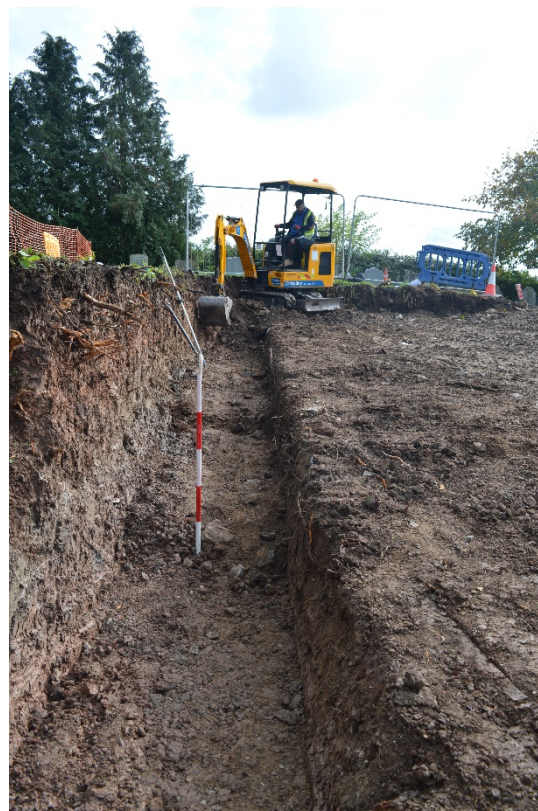
*Plate 6 foundation trench for  
replacement wall, from north-west*

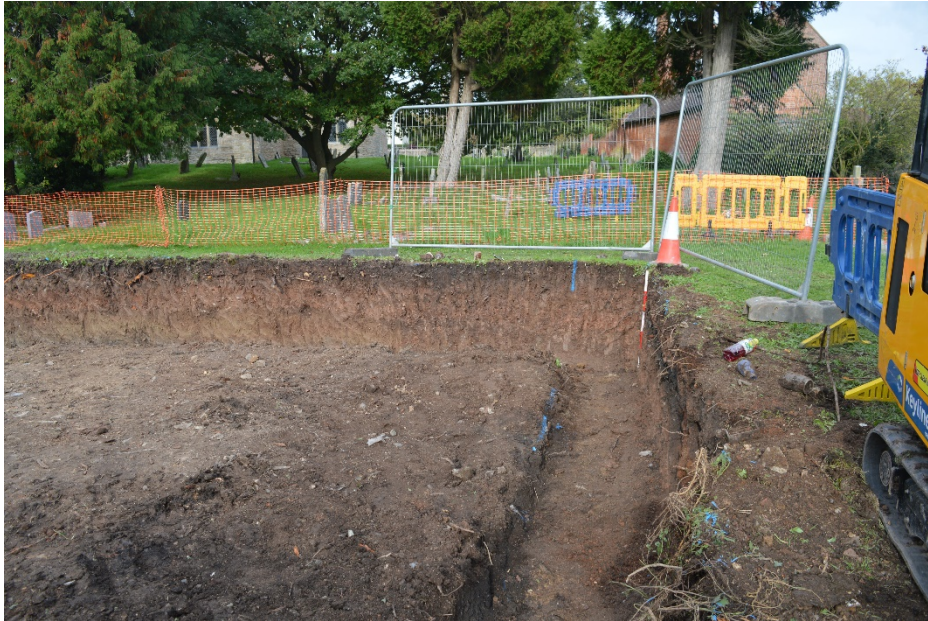
*Plate 7 Site fully excavated from south*

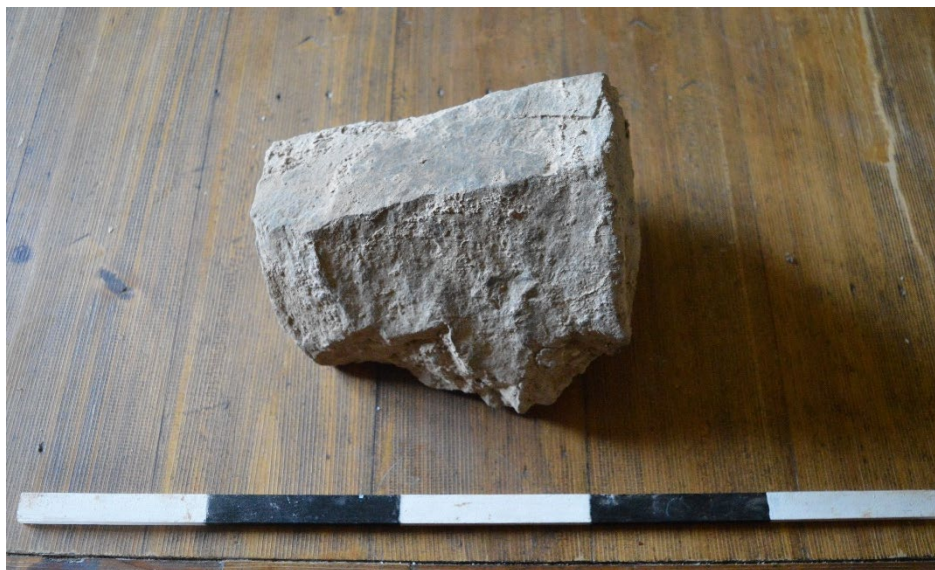
A single possible architectural fragment was found reused at the base of the excavations of the boundary wall. The fragment appears to have been partially shaped (Plate 8) and may have been rejected or unfinished.

*Plate 8 Possible shaped architectural fragment*
