Ambrey Archaeology

Archaeological
Building Recording
(Level 3) at Stable to
the rear of Sidney
House, Worcester
Road, Great Malvern
WSM78247

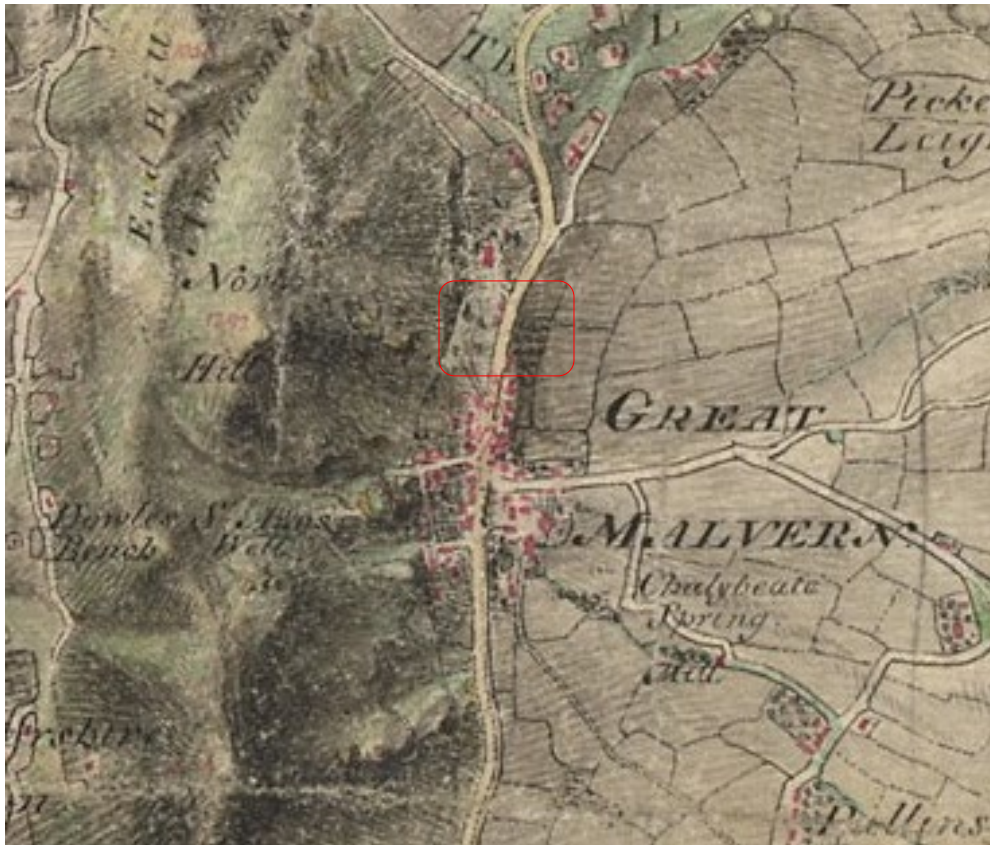
Figure 2: OS Drawing, 1814, with approximate site location outlined in red

The 1812 Ordnance Survey Drawing (Fig 2) shows a cluster of buildings around the junction to the south of the site but with the beginnings of linear development moving northwards on the Worcester Road depicted. Many of the new buildings were built as lodging houses or small hotels.

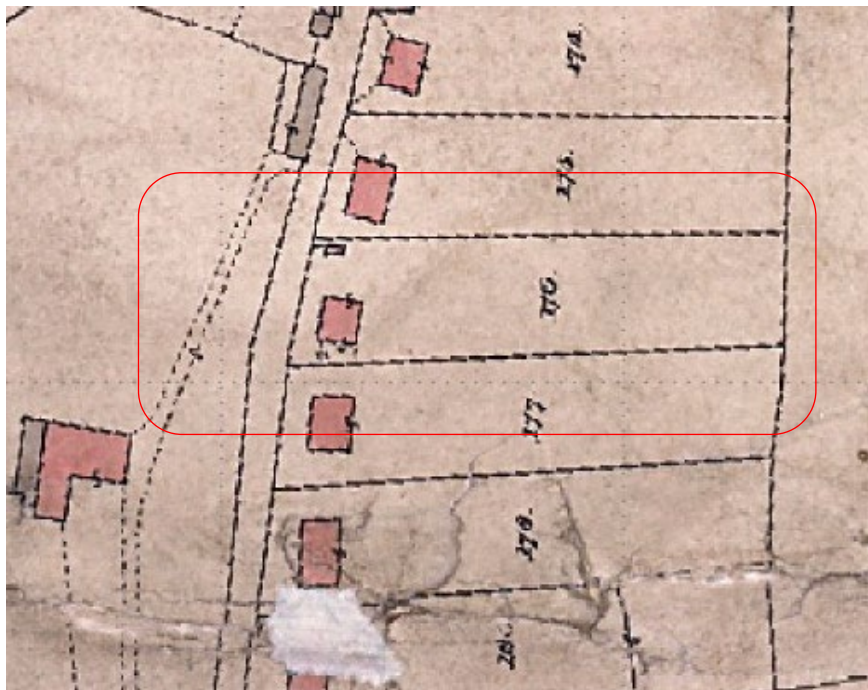
Figure 4: 1841 tithe map of Great Malvern, with site location outlined in red

On the tithe map of 1841 (Fig 4) the plan of the house appears to be more schematic, with no link shown between the carriage house and the main house. The building to the rear of the range fronting onto Worcester Road is not shown. The plot (no. 176) is identified as 'House & Garden', owned by Sarah Key and occupied by Joseph Matthews and others. A roughly square building is depicted in the location of Sidney House in the south-west of a long rectangular plot to the east of the Worcester Road. In the north-west of the plot, the carriage house (Brooks & Pevsner 2007, 470), a smaller rectangular building, is shown, oriented east-west. In the 1841 census, Sarah 'Kay', age 60, is registered in the parish of Great Malvern. An Elizabeth Brook is next in the listing, both are of

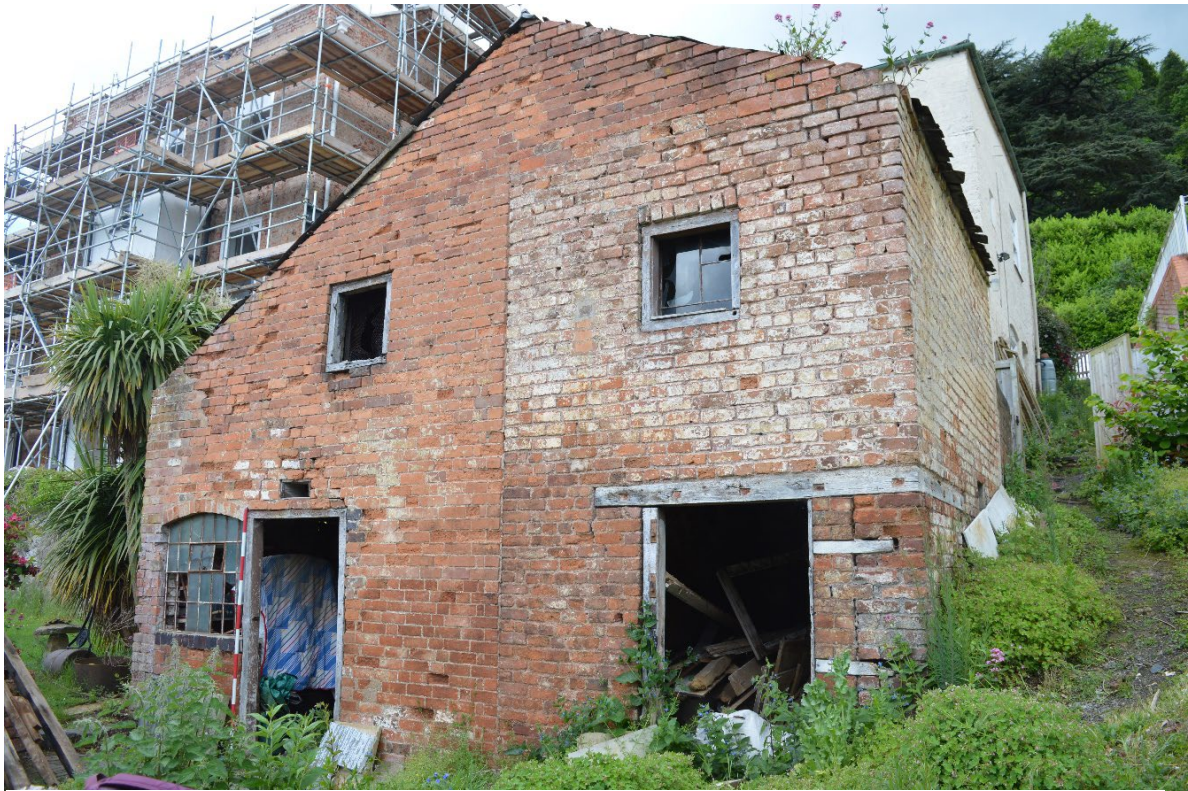
The former stable is a brick building, with a slate roof in poor condition (Plate 3). The ridgeline of the roof is covered with lead. The building is built into a steep eastward slope. The slope is steep enough that although the building is of two storeys, each floor can be accessed from ground level, the eastern-facing doors open into the ground floor of the building, while the first floor is accessed from the west.

Plate 3: Oblique view south-west of recorded building

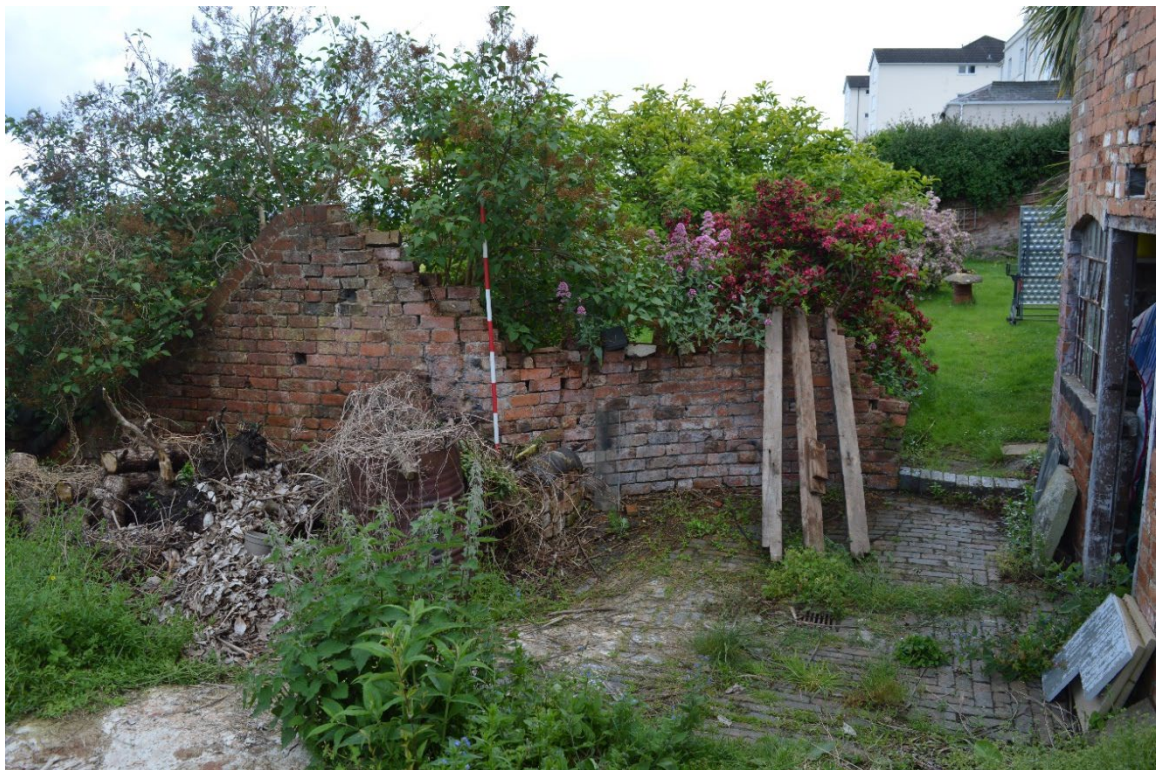
Part of another building depicted on the Ordnance Survey maps immediately to the south of the stable survives at the site as well as a curving garden wall which connects the buildings (Plate 4).

Plate 4: View west of surviving wall of former building and curved garden wall

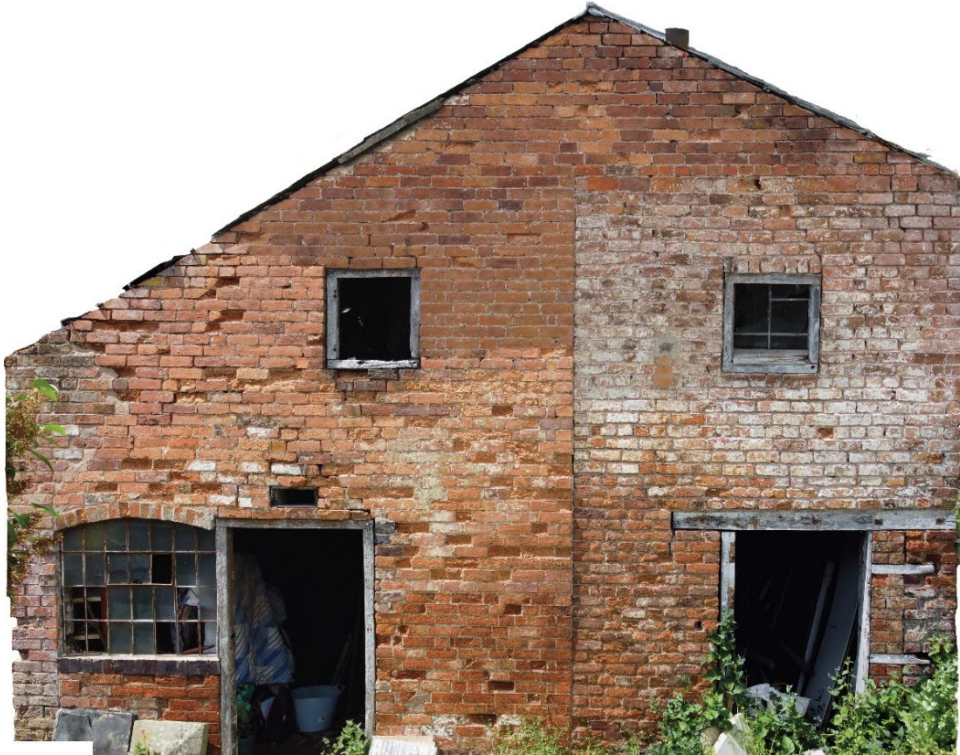
The brickwork on the southern part of the eastern elevation is in poorer condition across most of the face, with many of the bricks loose and/or heavily weathered.

Plate 5: Montage of aerial views west of building

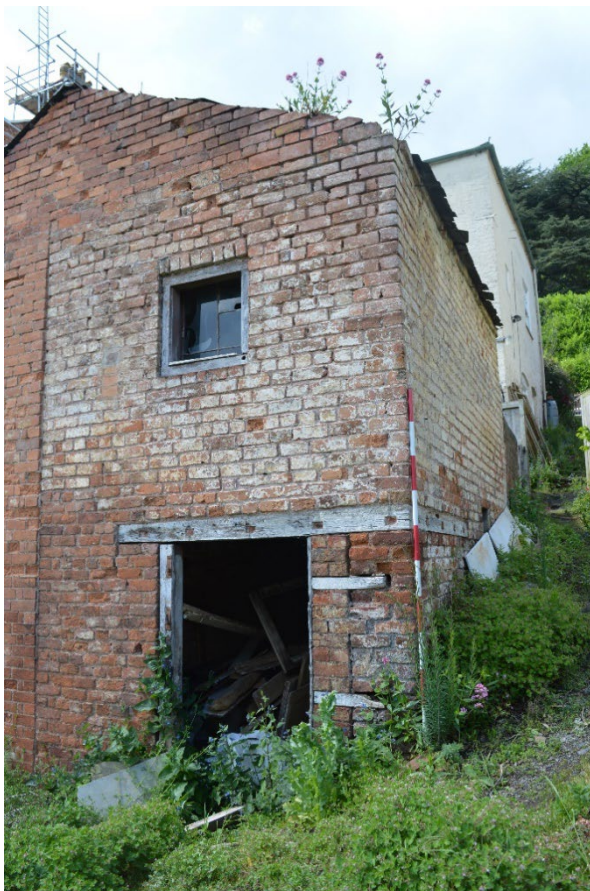
The door to the ground floor shed has a wooden lintel, and two wooden joints are interspersed with the brickwork to the north of the door (Plate 6).

Five rectangular indentations are set into the lintel at regular intervals in this lintel, (there are similar indentations on a lintel in the northern elevation) and the remnants of bricks in these indentations suggest that broken bricks or snapped headers had at one time been affixed. It is possible that the indentations are redundant mortices on reused timbers and the brick fragments were incorporated into the features to provide decoration.

Plate 6: View south-west of north-eastern corner of building

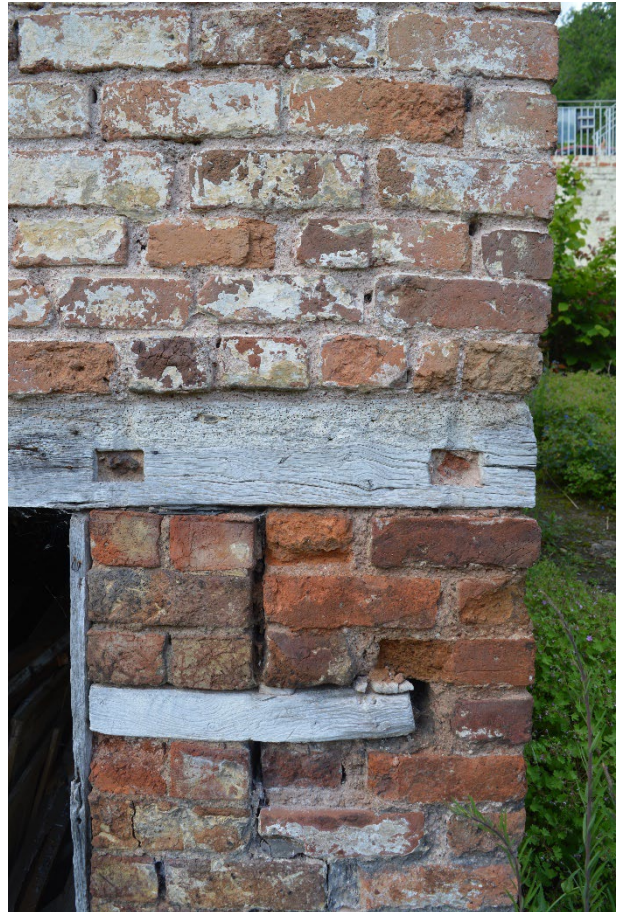
The brickwork is in poor condition in this location and it appears in places that another joint may be visible between the corner of the wall and the door (Plate 7).

Plate 7: Detail of woodwork in east elevation in north-eastern corner of building

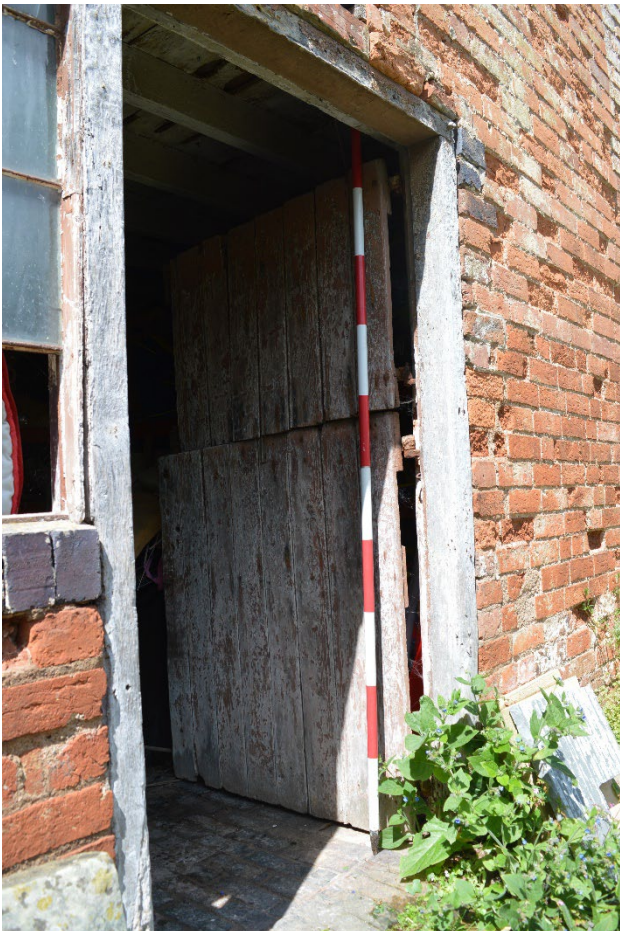
On the ground floor a door and window opening are located close together in the elevation. The door opening with no arch, the doorway is framed by a wooden frame. Within this opening is a wooden-plank stable door (Plate 8). The window opening with a segmental arch of headers is immediately beside the doorway occupied by a metal window of 28 glass panes with metal glazing bars and rounded head (Plate 9).

Plate 8: Boarded door to stable (1)

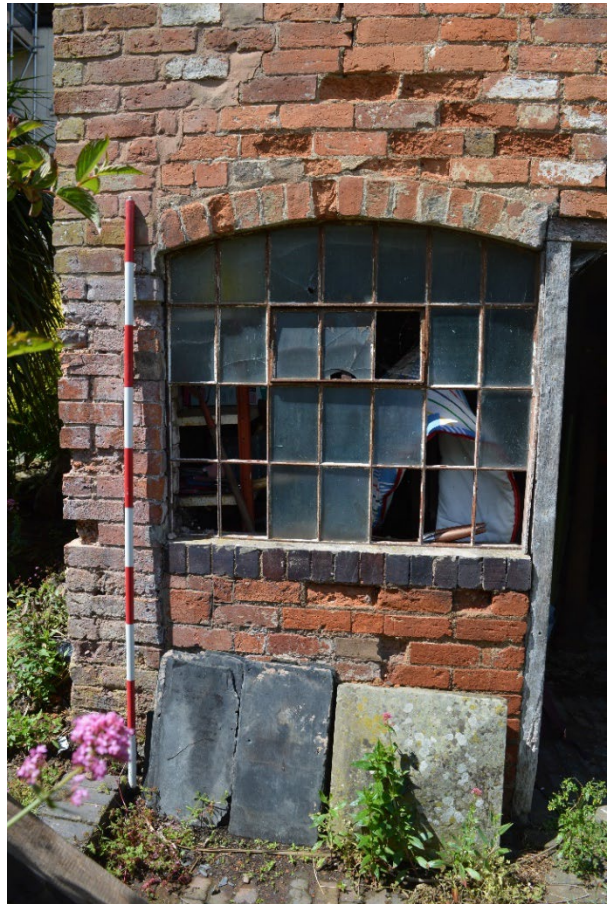
*Plate 9: Metal
window in east
elevation*

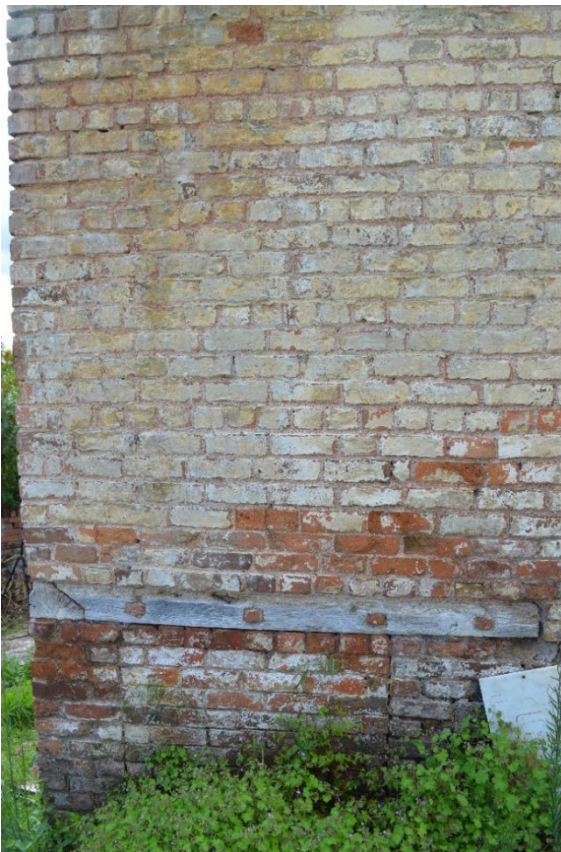
A wooden lintel over the doorway joins the lintel described in the east elevation at the corner (Plates 10 & 11). A similar arrangement of brick header fragments used as decoration have been used on this lintel. Perhaps due to a more sheltered aspect, the fragments have survived better on this face. Beneath the lintel, the bricked-up doorway has a flat arch of brick headers. The ground has risen significantly and is embanked against this face of the building and the doorway is now partially below ground level on the exterior.

Plate 10: Wooden
lintel in north
elevation

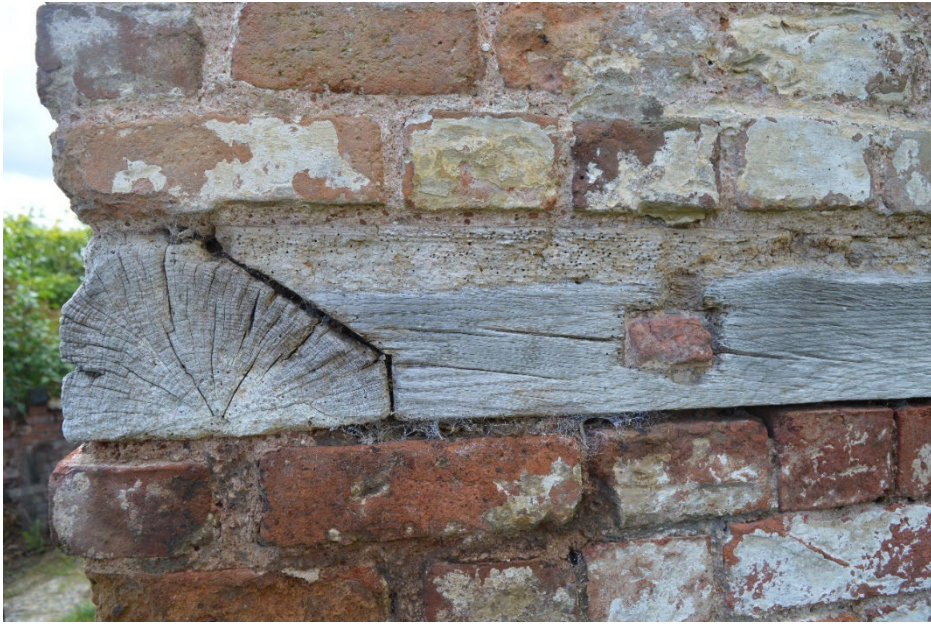
Plate 11: Joint between lintels on east and north elevations

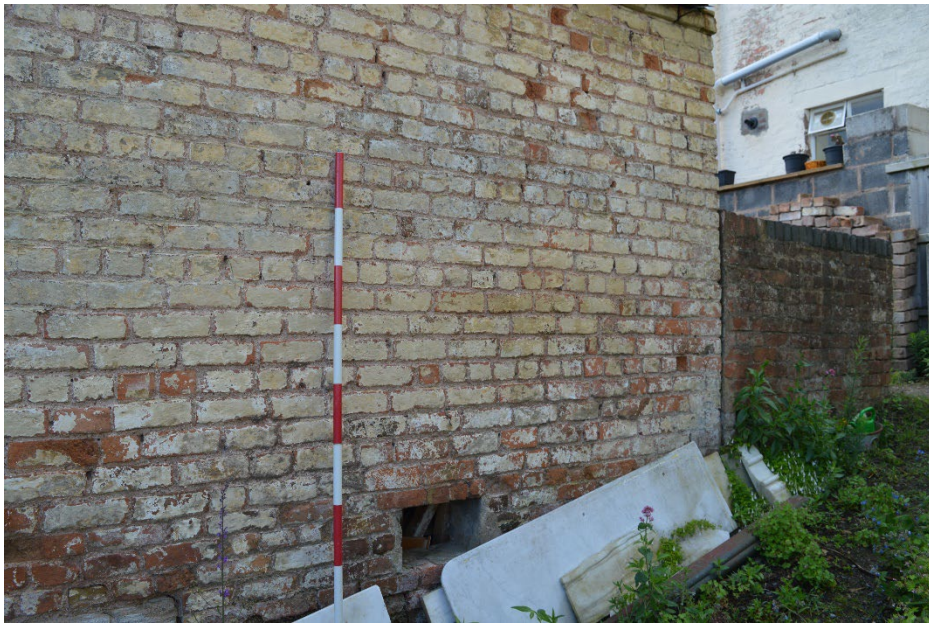
A rectangular opening almost at current ground level to the exterior of the building (Plate 12) may be a former window as it measures above head-height in the interior (see Plate15).

Plate 12: Possible window opening in north elevation

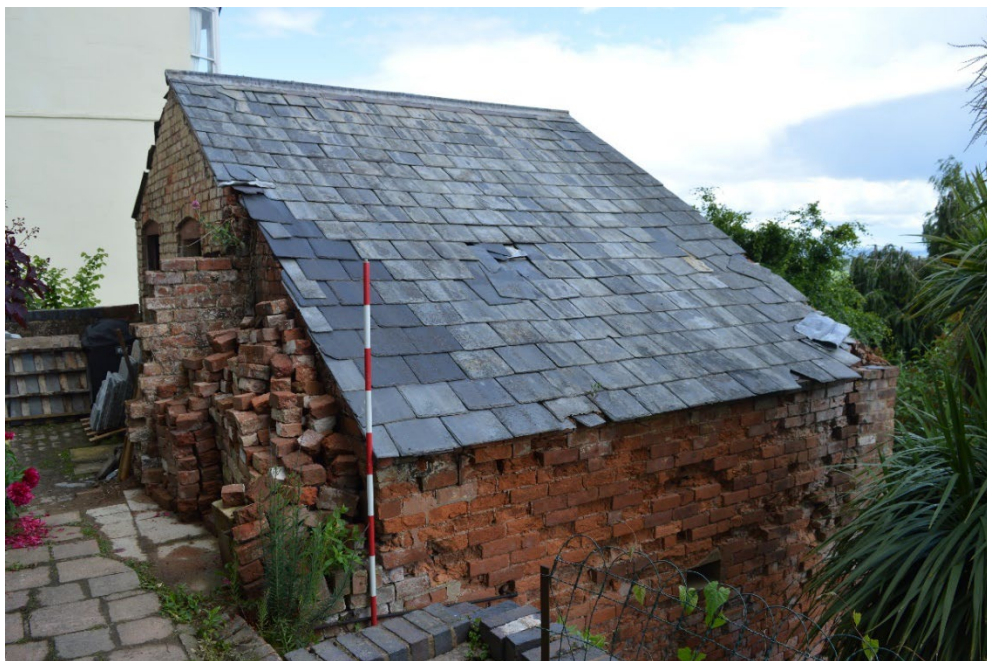
The brickwork on this elevation is in very poor condition. No features were noted in the brickwork of this face.

Plate 14: Oblique view north-east of south elevation

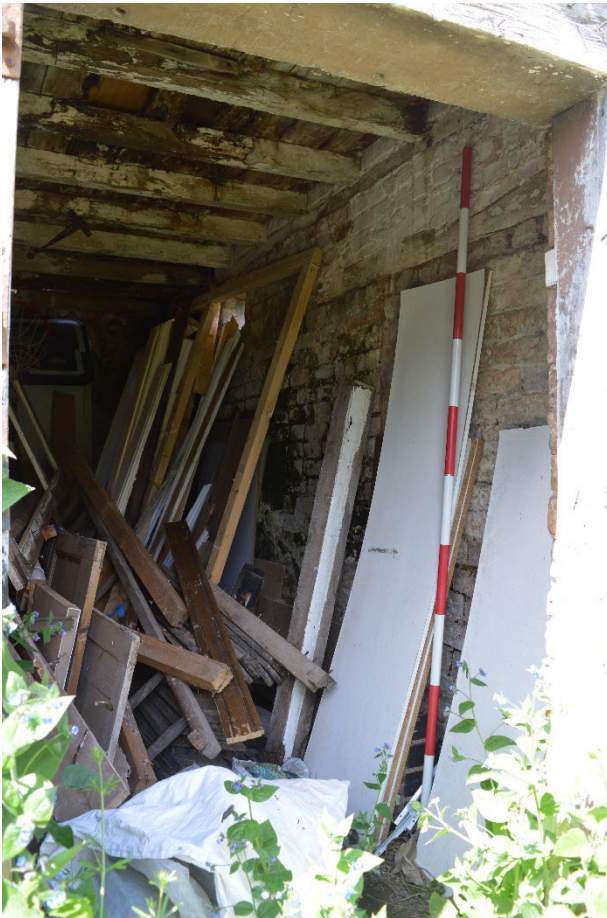
Room No. 1, accessed from the east, is being used for storage and was photographed from the doorway (see Plate 16) on the lower level. It was possible to make out the window opening above head height close to the rear corner on the north wall. The brickwork of a blocked-up doorway was also evident from the interior. The similarity in the lintels suggest that the doorways are contemporary.

Plate 16: View west to Interior of Room 1. Note the possible window opening in north wall to rear

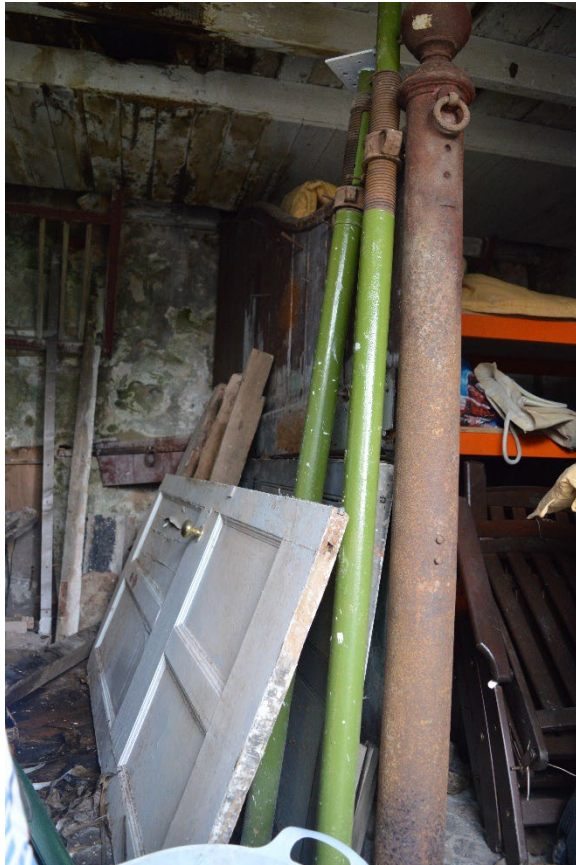
Room No. 2 has been used as a stable, with surviving partitions and wooden mangers fixed to the wall, suggesting that this would have provided stabling for two horses in loose boxes, one to the left and one to the right (Plate 17). The stable partition is decorative as well as functional; composed of joined vertical wooden planks in a curving profile with the top covered by metal. The terminus of the partition as it faces the door is provided by an iron post capped with a decorative metal ball. A tether ring is fitted to the post, and one is visible also in the rear of the loose box on the left.

The ceiling to the stable may be a later insertion, as it appears to be low relative to the partitions. There is no evidence of pitching holes for hay from a loft above the mangers which further suggests either that the ceiling has been replaced, or that hay for the horses was stored elsewhere.

Plate 17: View west to interior of stable

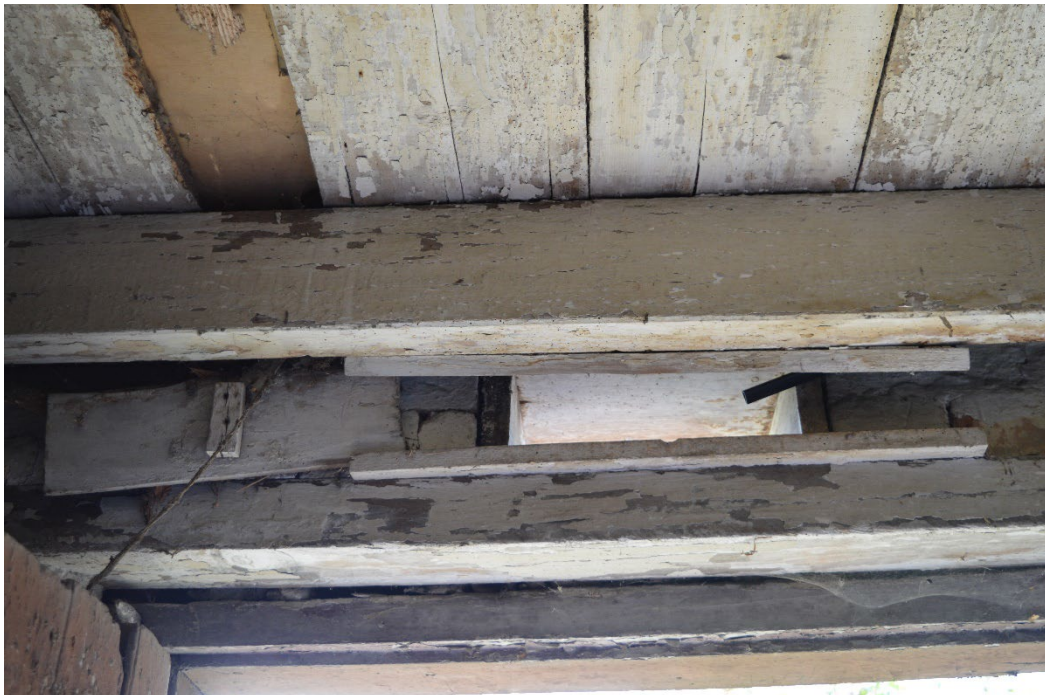
A woodwork shutter over the doorway probably provided ventilation (Plate 18).

Plate 18: Possible ventilation hatch over door in stable

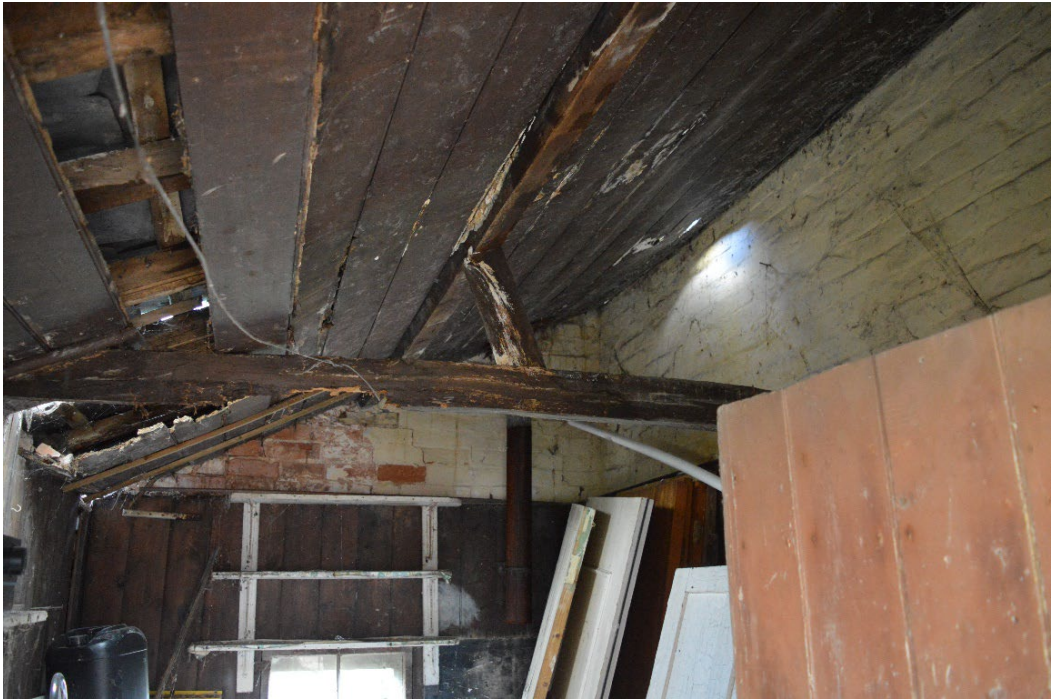
Room No. 3 on the First Floor (Fig 9) is being used for storage and was photographed from the doorway (Plate 19). Wooden wall panelling above the window in the east wall was noted. The timber in the roof truss appears to be machined softwood.

Plate 19: View east in Room 3, First Floor

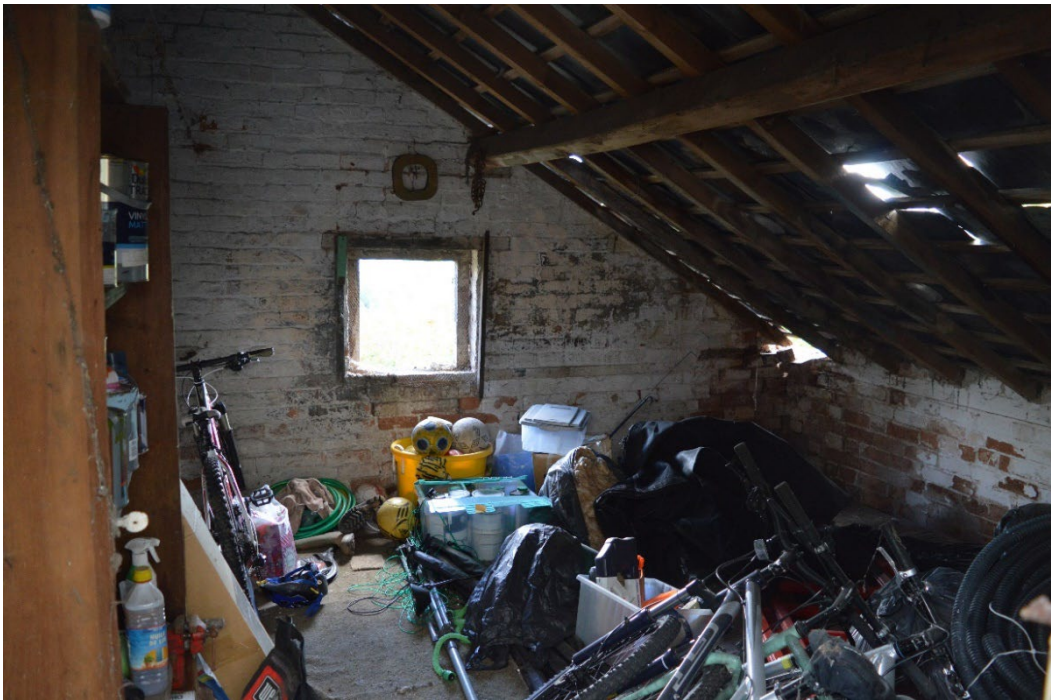
Plate 20: View east in Room 4, first floor

Room No. 4 is being used for storage and was photographed from the doorway (Plate 20).
