# Ambrey Archaeology

Archaeological  
Evaluation at 49  
Winchcombe Road,  
Sedgeberrow,  
Worcestershire

WSM 78345

Date: 28 September 2022; Rev 1

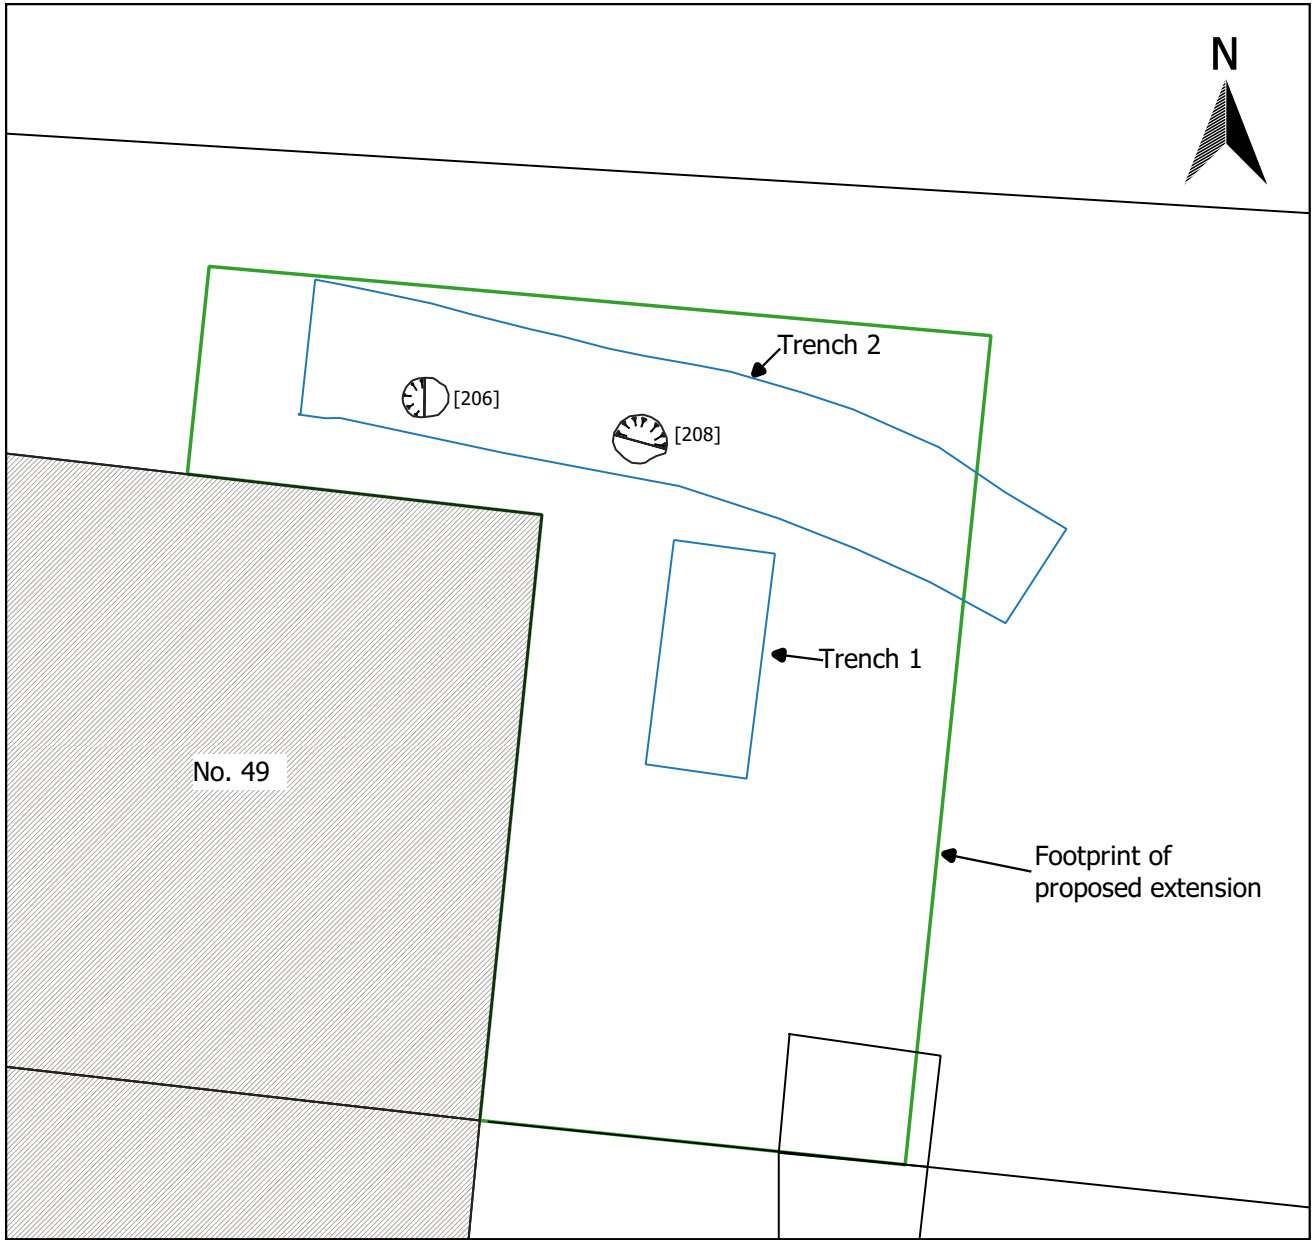
Figure 3: Trench locations

The field survey was undertaken on 20<sup>th</sup> September 2022. Two trenches were laid out on the site in positions designed to test the archaeological potential of the footprint of the proposed extension (Figure 3). Due to the constraints of the site and the discovery of a sewer, when the patio slabs were removed prior to fieldwork, it was necessary to change alter the intended locations of the trenches as set out in the WSI.

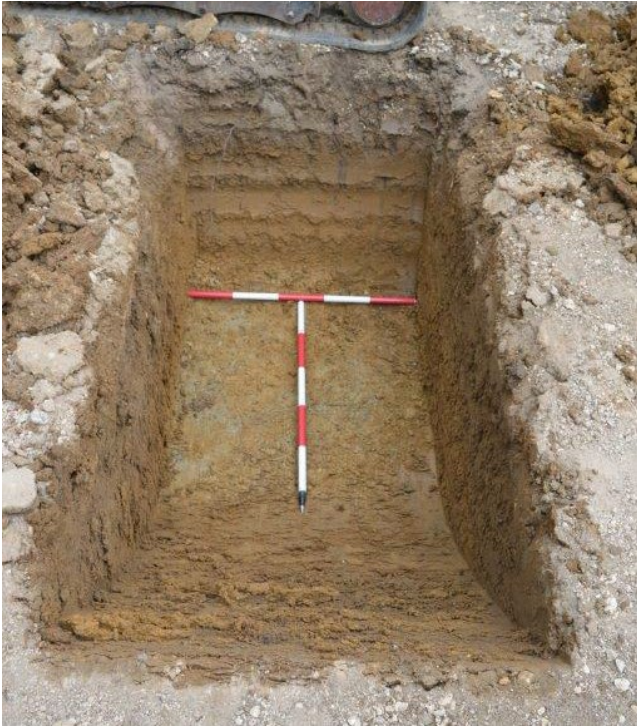
Context (100), the uppermost layer in Trench 1, was a loose light brown sandy clay with frequent angular stones with brick, slate, glass and charcoal. This had formed the base layer for a patio which had been located in this area.

*Plate 1: Trench 1 facing north (1m scales)*

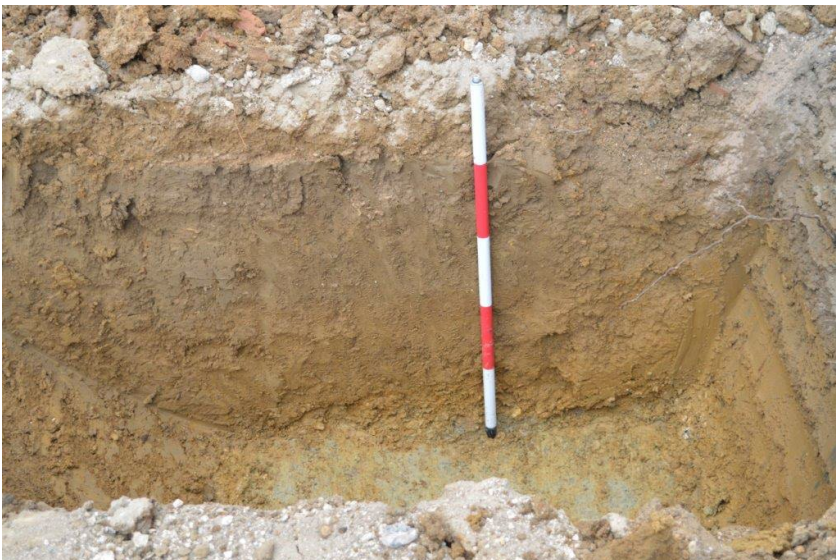
Underlying this were two layers interpreted as subsoil derived from alluvial deposition (Plate 2). The uppermost (101) was a mid-brown silty clay with occasional rounded stones and natural flint. Below this was a firm noticeably more yellow silty clay with occasional manganese flecks and rounded cobbles (102).

*Plate 2: East facing section of Trench 1 showing two layers of alluvium (1m scale)*

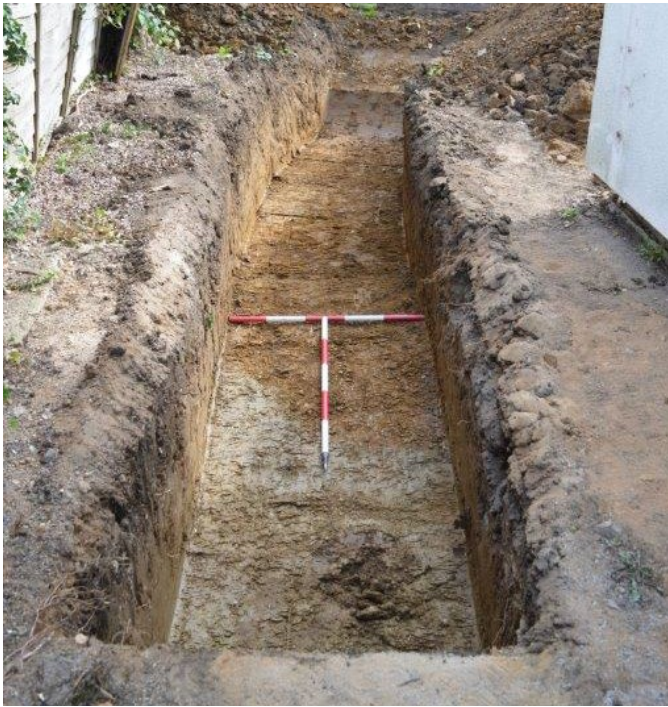
Context (200), the uppermost layer in Trench 2, was a loose, dark brown sandy silt with frequent brick, glass, ash and small rounded pebbles, surviving to a depth of 0.3m. This is thought to be a layer of made ground, possibly imported to raise the level at the side of the house following construction. Below this (201), surviving to a depth of (0.3-0.65m), was the same as (101) and (202) (0.65-0.7m) was the same as 102. A layer at the base of the eastern end of the trench (203) was the

same brashy limestone gravel as (103), though to the west (204) was a blue grey clay similar to the patches in (103) but more widespread. Investigation by hand revealed that these two deposits were intermingled in an irregular fashion and both are interpreted as river derived.

*Plate 3: Trench 2 facing east (2m scales) with natural layer (203) in foreground and (204) further to the east*

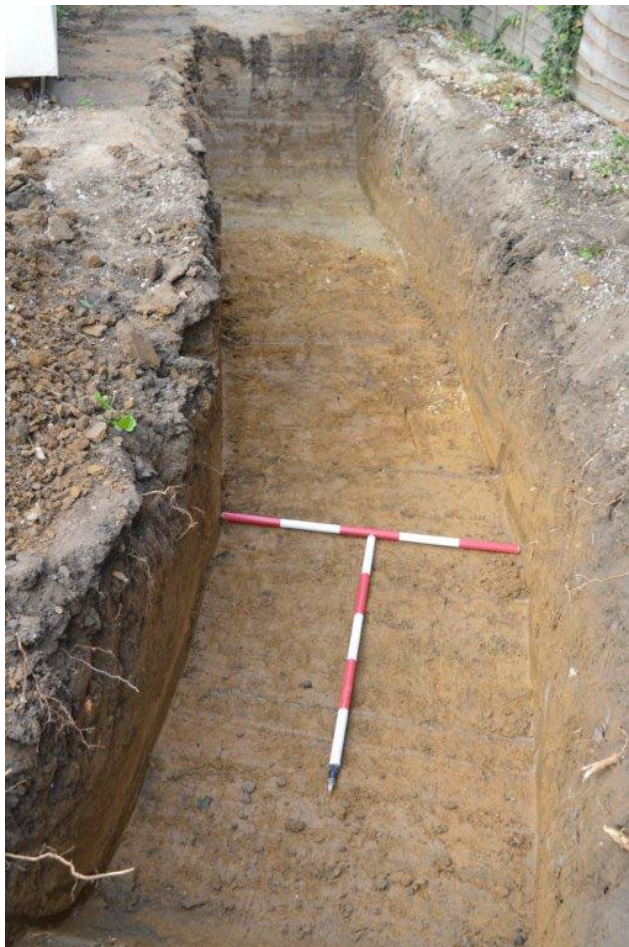
*Plate 4: Trench 2 facing west (2m scales)*

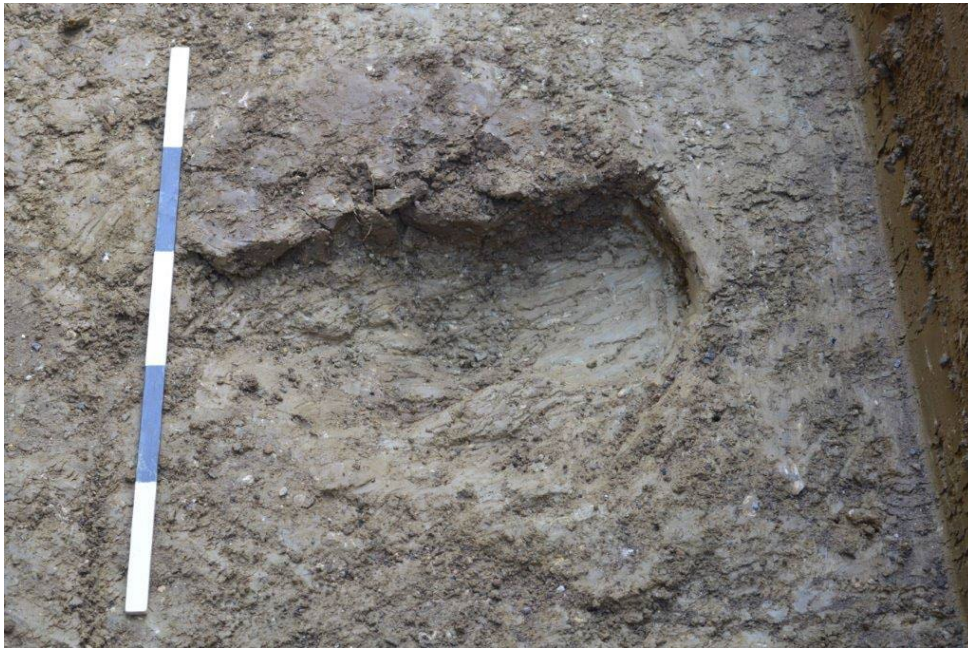
Two sub round postholes were cut into the alluvial layers and the underlying gravel. Posthole [206] (Plate 5) at the western end of the trench was 0.4m in diameter with a maximum depth of 0.14m from the top of the blue clay. It had a sharp break of slope at the top to vertical side to the north and gentle side to the south and an irregular base. It was filled by (205) a firm mid brown silty clay with occasional charcoal flecks, ceramic building material, fragments of limestone and a broken piece of brick. At its base this feature cut (204) the blue grey clay present at the eastern end of the trench.

*Plate 5: Post hole cut [206] filled by (205) facing east (0.5m scale)*

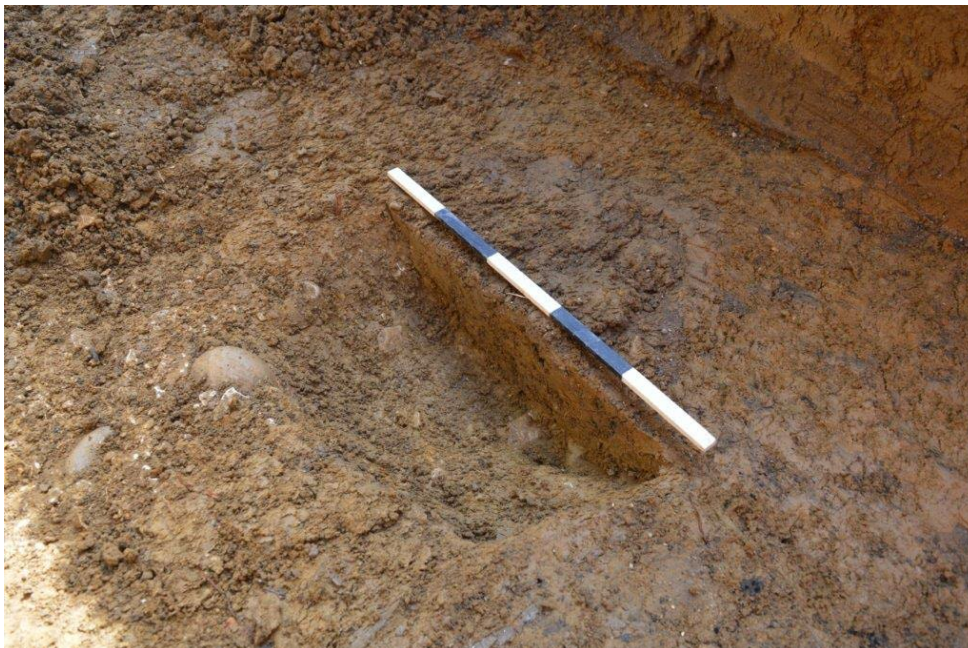
Some 2m to the east, posthole [208] (Plate 6) was 0.45m in diameter with a maximum depth of 0.16m from the top of the gravel. The sides were approximately 45° with a bowl-shaped, slightly irregular base. It was filled by (207), a firm, mid-brown silty clay with occasional charcoal flecks and ceramic building material. Although no dating evidence was retrieved from this deposit, it is thought, due to its location and similar size to have formed part of the same structure as [206].

*Plate 6: Post hole cut [208] filled by (207) facing south-east (0.5m scale)*
