Ambrey Archaeology Ltd

Archaeological Watching Brief at No 2 Willow Cottage, Upton-upon- Severn, Worcestershire

Project ref. AMB108

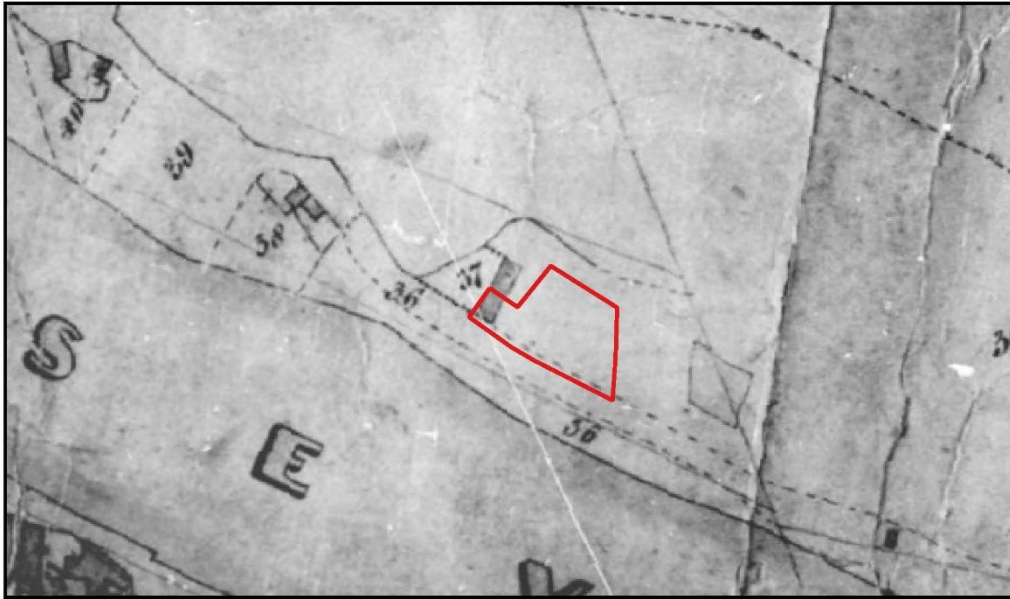
Figure 3. Extract of 1840 tithe map of Upton on Severn

On the 1840 Tithe Map of the parish of Upton on Severn (Figure 3), a building is shown in the location of Rose Cottage which extends to the south of its current footprint. It is labelled as Plot 37, a cottage and garden owned by Thomas Heach and occupied by George Parsons. The land to the east (Plot 36) which encompasses the remainder of the site is also owned by Thomas Heach and is described as an allotment in Royal Meadow, set to pasture.

At the time of the 1840 tithe map there was no indication of industrial activity at the site. A building, the northern part of which survives as Rose Cottage was recorded simply as a cottage and garden and the surrounding area is pasture. However, by the Ordnance Survey of 1884, this building and another rectangular building with a long axis approximately NW-SE were marked as a brickworks. The size of the adjacent flooded quarry pit would suggest that this activity had been carried out for some decades by this time. Such a site would be suitable for brick production during this period as a ready source of alluvial clay (recorded in the trenches as 104 and 205) could be processed into bricks and readily transported on the river to growing settlements such as Worcester, Gloucester, Stourport or Bewdley.

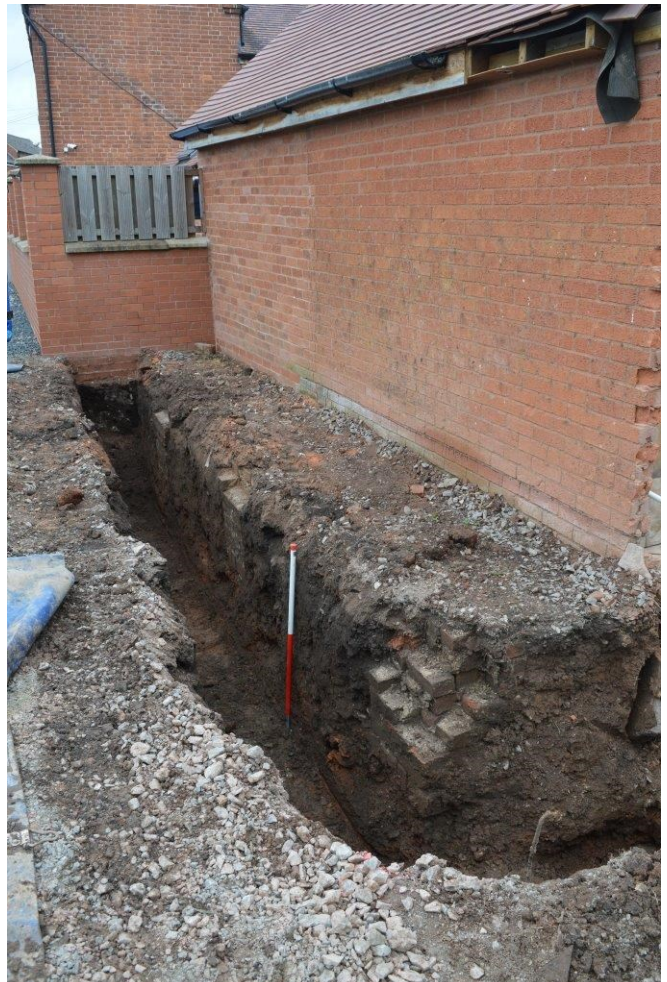
Plate 6. Trench 1, view north-west, scale 1m

The bases of the three walls were set onto layer (103) a firm, brick red silty clay with frequent brick fragments, charcoal, ash, cinders and lenses of clay (Plate 6). This is interpreted as waste material from the functioning of the brickworks and survived to a depth of 0.3m, beneath which a compact, light buff clay was interpreted as a natural alluvial deposit (104).

It is thought that the concrete surface uncovered in the south-eastern section of Trench 1 represents the internal floor surface of the building. This would suggest that the foundations of the building were relatively shallow and set on a layer of material (103) which was already the product of brick making in the vicinity. The function of the building is not clear, but it may have been for activities such as moulding the bricks.

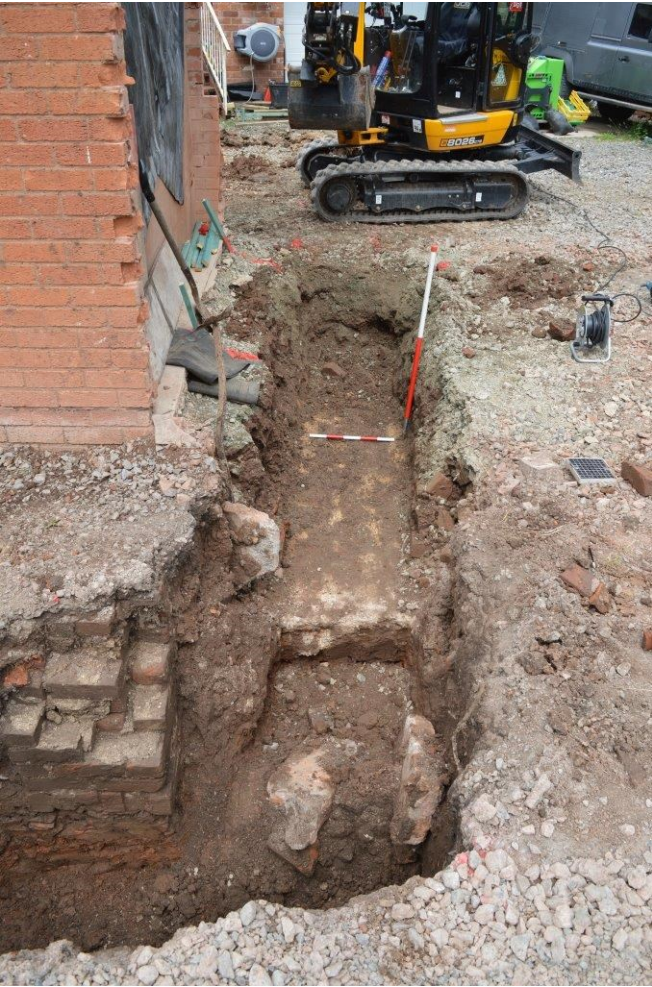
Plate 7. South-eastern section of Trench 1, view north-east, scales 1m and 0.5m

In the south-eastern arm of the foundations, a hard, buff yellow layer of concrete (108) was present at a depth of 0.4m (Plate 7). This feature is interpreted as a possible former floor surface of a building which had been laid over a base of loose, broken tiles.

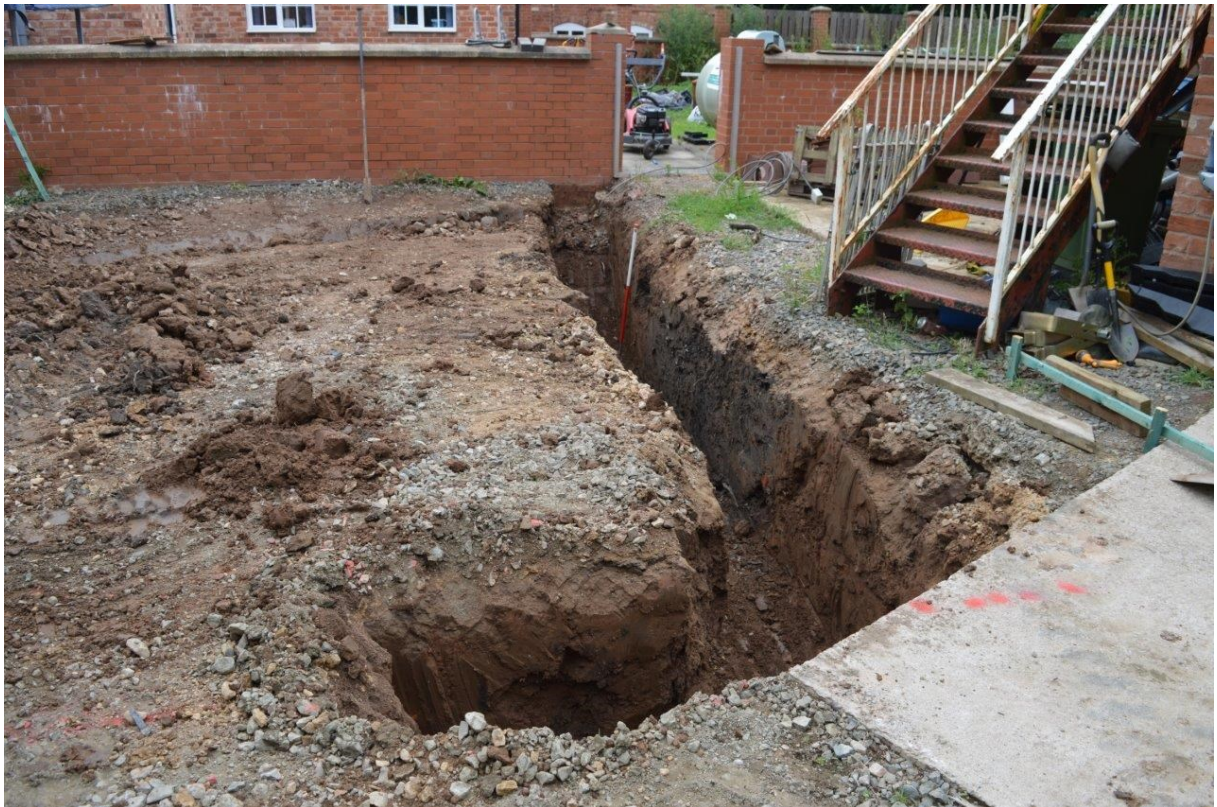
Plate 8. Trench 2 fully excavated, cut [204] to right of ranging rod, view north, scale 1m

In the central part of the north-western section of the foundation trench, a large, shallow, U-shaped cut [204] was filled by a firm, blueish grey sandy silt with frequent rooting and occasional brick and tile (Plate 8). This feature is interpreted as a tree bowl and is in the location of a large ash tree, which

according to the owners, once grew in this location. The tree is visible on Google Earth images until 2013.
