Ambrey Archaeology Ltd

Archaeological Building Recording (Level 1) of Mousehall Farm Cottage, Clent, Worcestershire WSM 80820

Version 2

Date: 17th June 2024

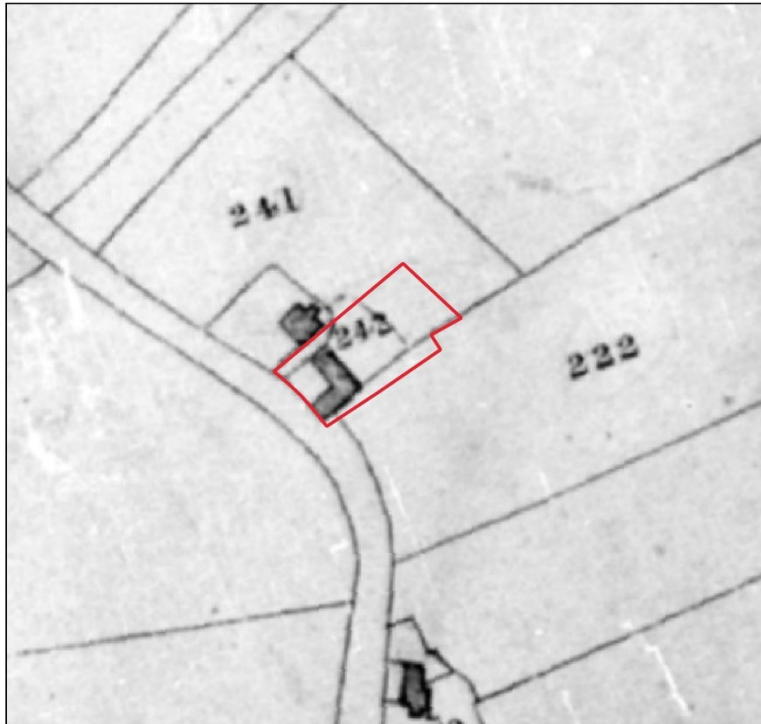
Figure 2: Extract of 1838 tithe map of the parish of Clent

The building is depicted on the 1838 tithe map of the Parish of Clent (Fig. 2) as plot nos 141 and 142 'Mouses Hole'; 'House garden & Farm Buildings,' but it is not clear who owned and occupied the farm.

The farm buildings are shown as an L-shaped range separated from the farmhouse to the north-west by a track.

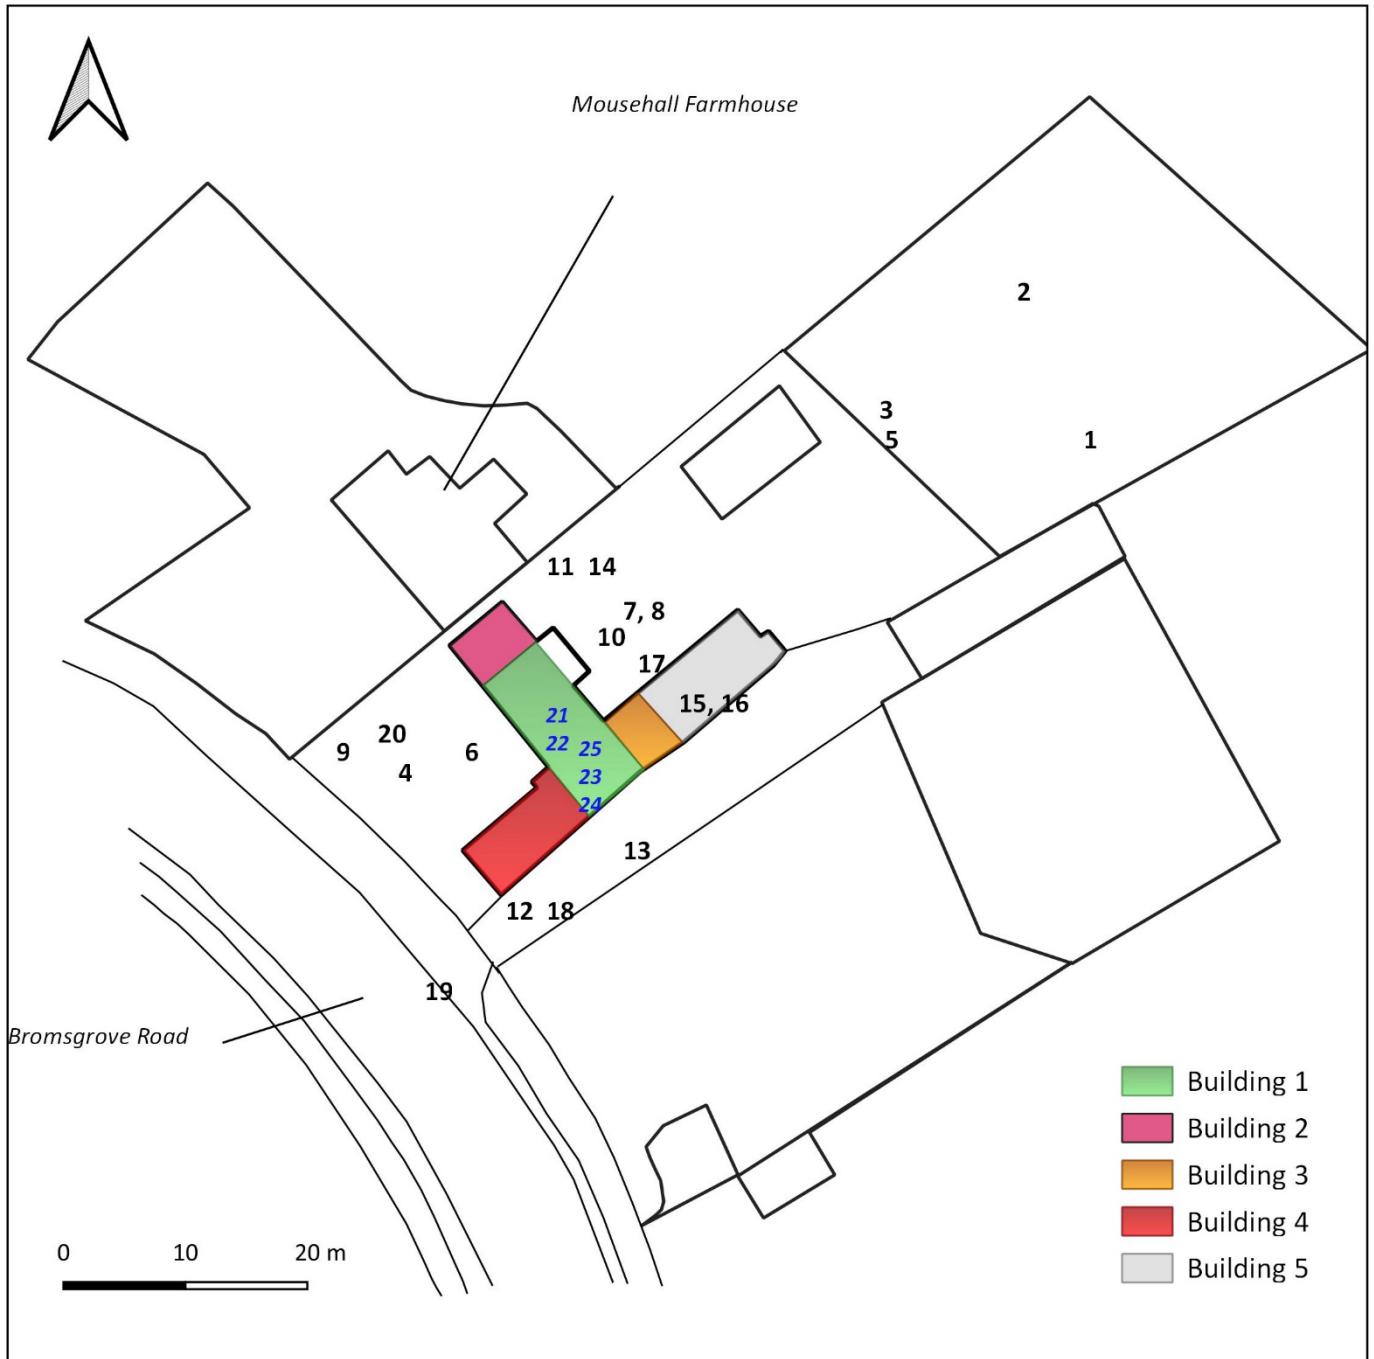
Figure 4. Plan of Buildings with photo locations marked. (Photos taken on First Floor level numbered in blue)

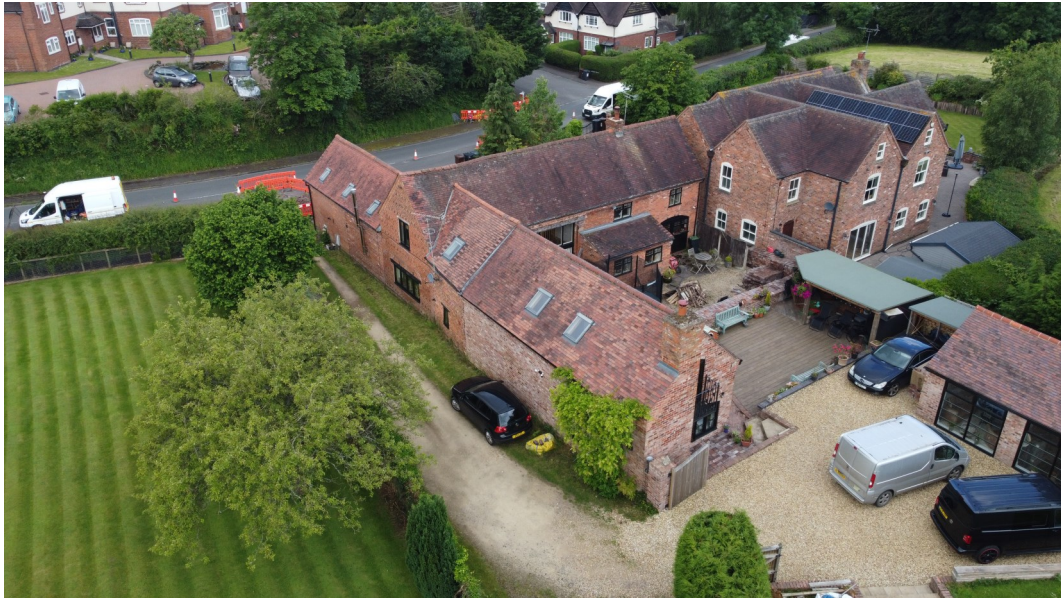
The buildings surveyed comprise brick-built former barns with tiled gable roofs, located immediately to the south-east of Mousehall Farm (Plate 1). The buildings were much altered during a phase of restoration around 2000-2005.

Plate 1. Low level aerial view west of the former farmstead

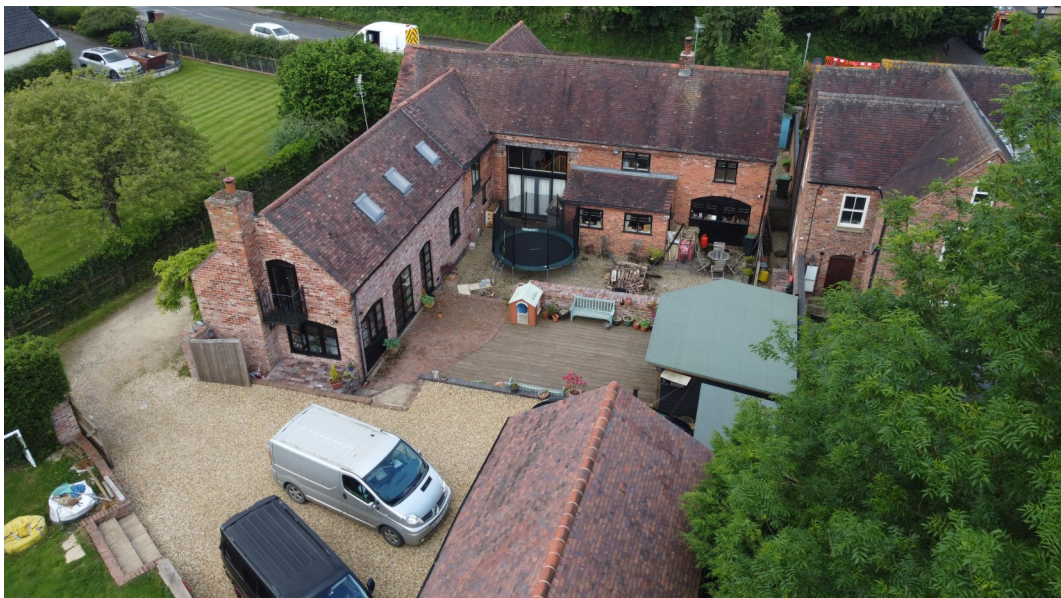
The main range (Plate 2), which is oriented north-west by south-east, comprises a three bay threshing barn Building 1, abutting a probable former cart shed or carriage house (Building 2). This range is abutted by two buildings; later extensions, both of which, as well as the largest barn itself, are shown on 19th century mapping.

Plate 2. Low level aerial view south of the former farmstead

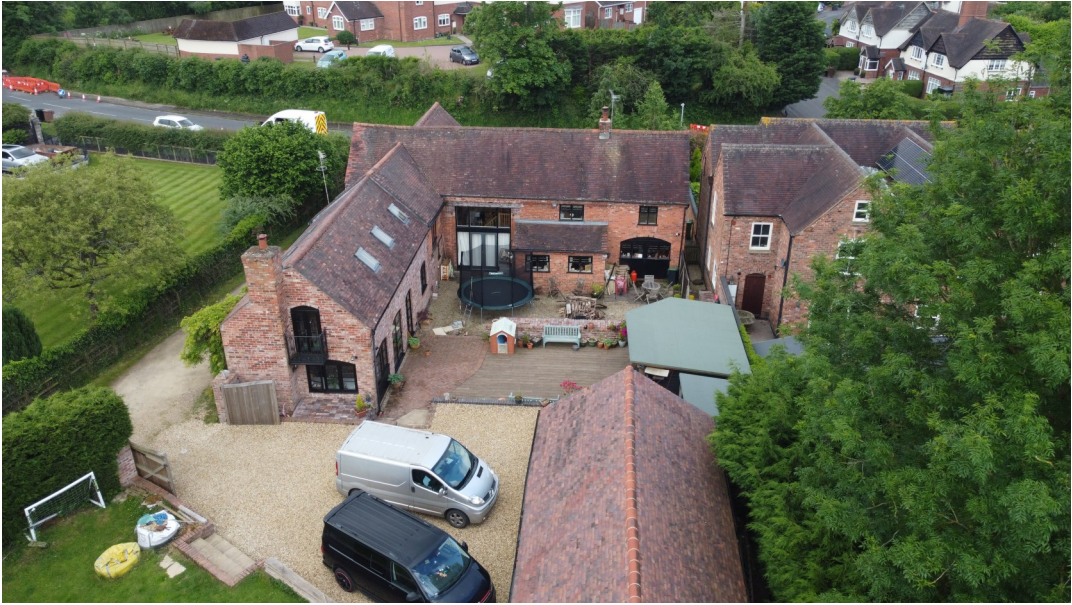
Building 1 is a three-bay former barn with two opposing full-height openings for threshing doors in the central bay (Plate 3). On the front elevation there is a decorative dog tooth brick course below the eaves (Plate 4), interrupted above the threshing door opening with a lintel probably inserted at the same time as the uPVC windows.

Plate 3. Low level aerial view south-west of the former farmstead

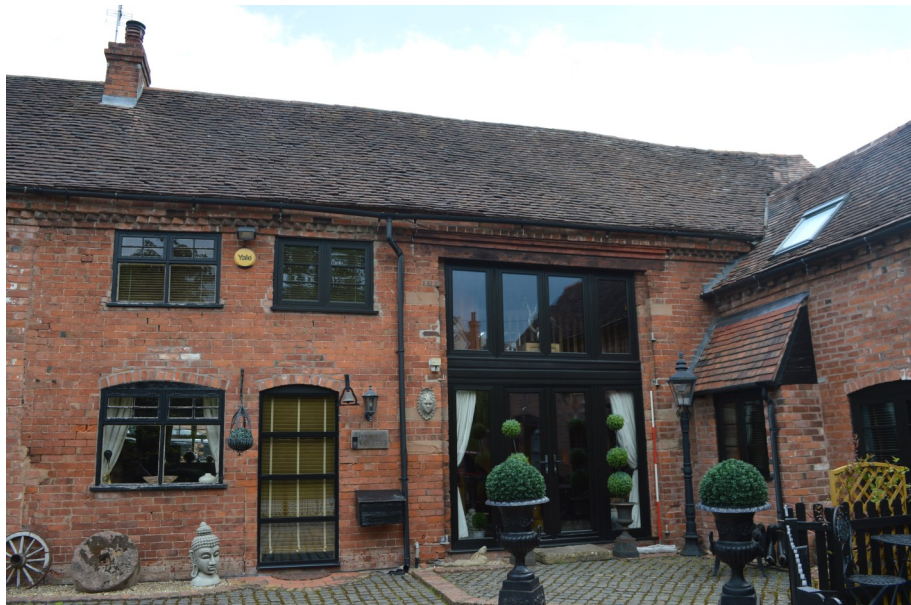
Plate 4. View north-east towards threshing doorway in Building 1

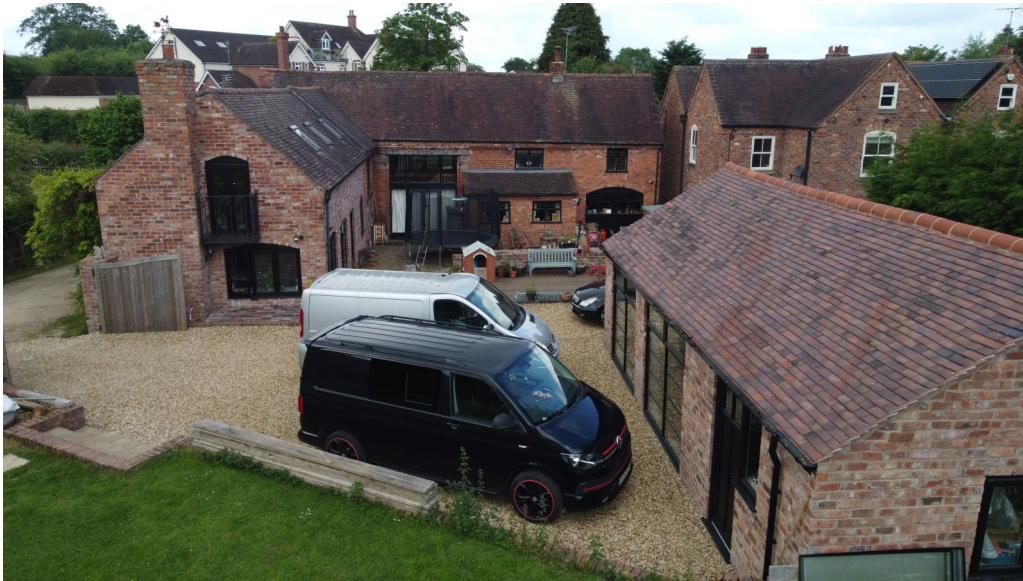
The former threshing door openings (Plates 5 and 6) are set into recessed brickwork with decorative ashlar blocks set into the jambs at intervals (Plates 7 and 8). The openings are fully glazed with French doors in the glazing in both elevations.

Plate 5. Low level view west of former farmyard

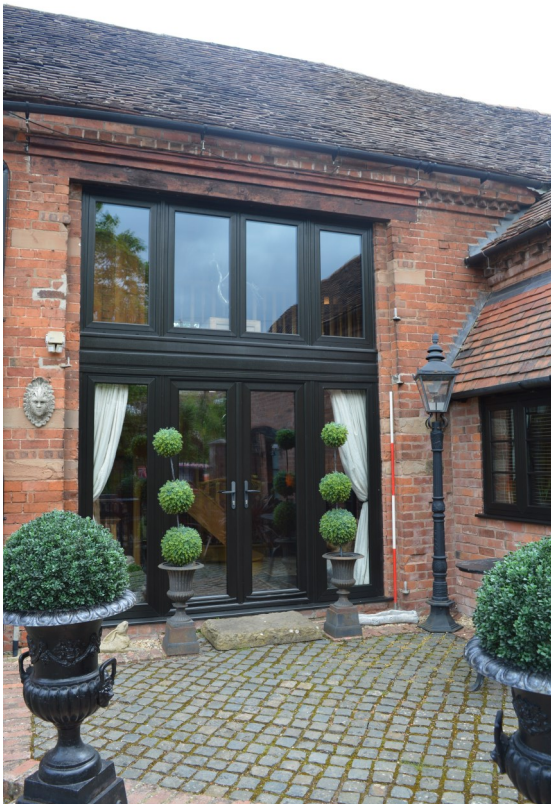
Plate 6. Threshing doors on the front elevation in Building 1

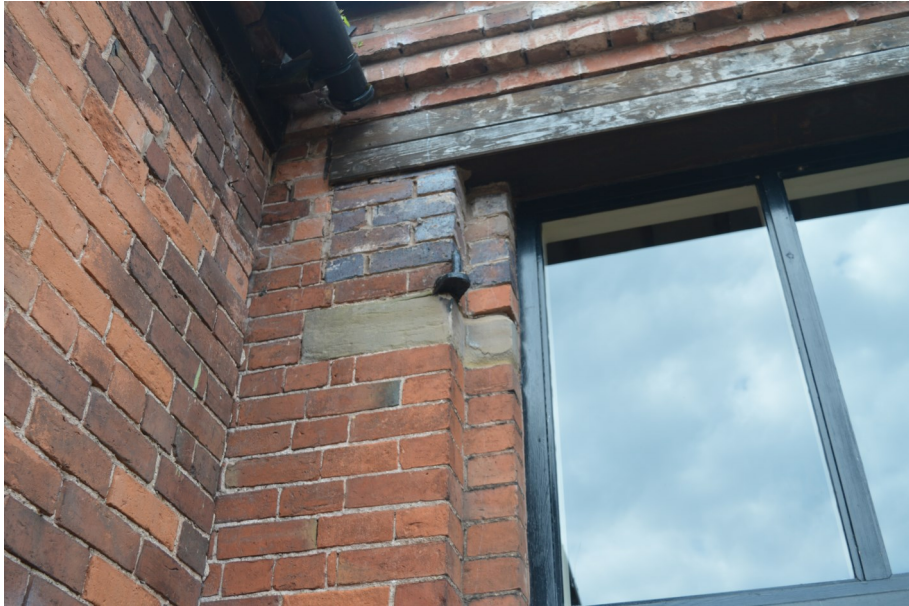
Plate 7. Detail of stone work in doorjamb in rear of Building 1

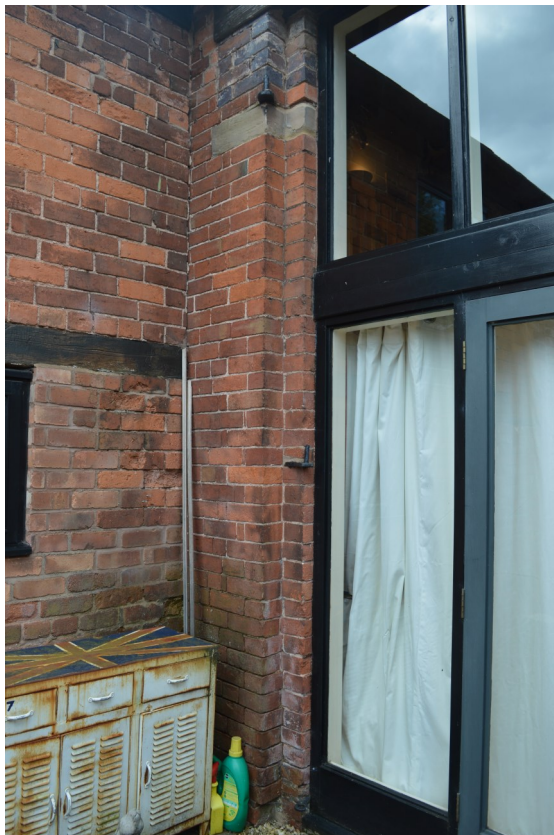
Plate 8. View south of doorjamb in rear of Building 1

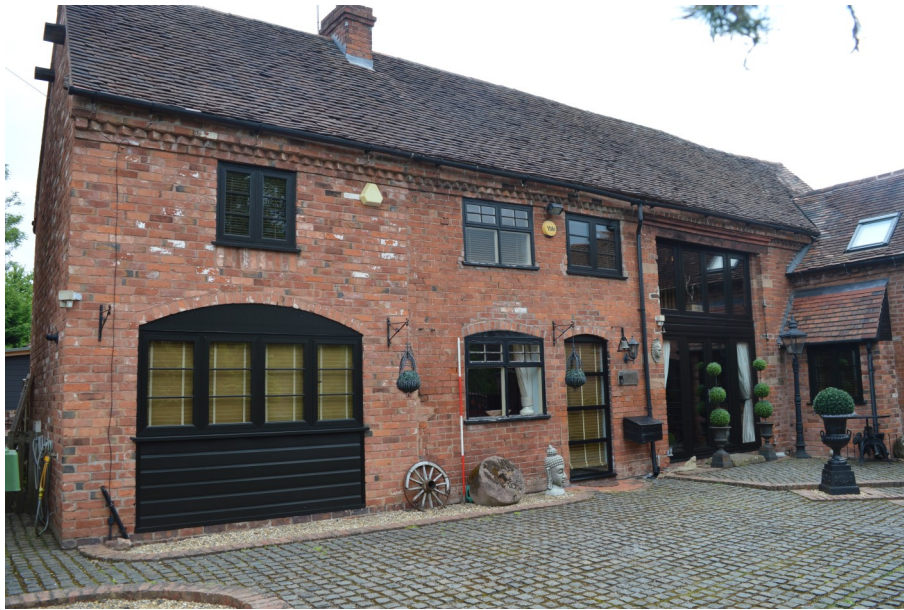
There is a door and window, both with segmental brick arches on the ground floor level in the front elevation with two casement windows over this in first floor level (Plate 9).

This building is constructed of bricks of a different hue to those in Building 1 and the brickwork in both buildings is not tied in (Plate 14 and see Plate 9). Dog tooth brickwork continues beneath the eaves in this building. On the front and rear elevations, double-doorways filled with four light windows beneath segmental arches are located on the ground floor with casement windows located centrally above this. The window on the first floor is located directly beneath the course of decorative brickwork on the front elevation and that on the rear elevation is directly beneath the lowest protruding brick course. Below the window sills on each elevation there is a row of vertical bricks.

Plate 9. Front elevation of Buildings 1 and 2

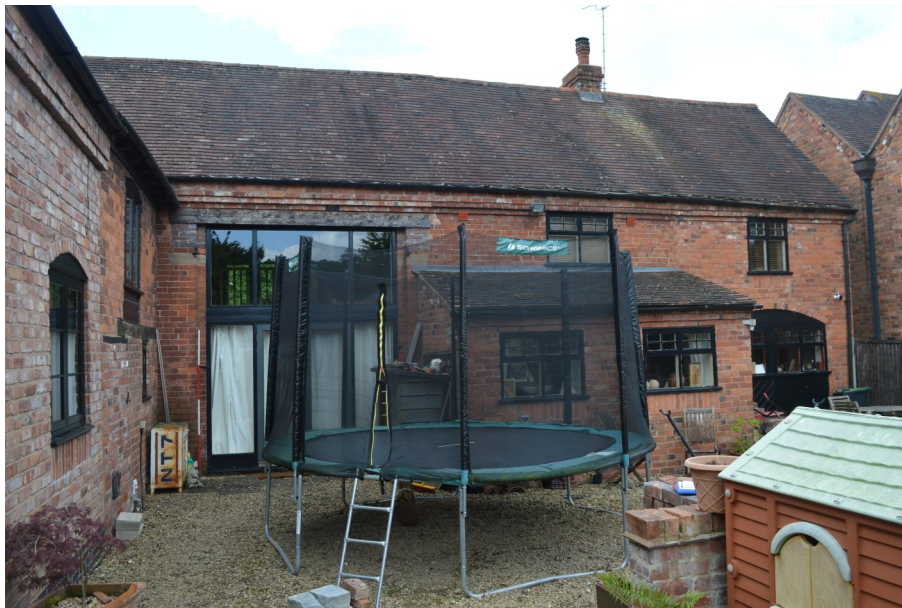
On the rear elevation a small lean-to extension with a shed roof contains two top-opening casement windows with wooden frames, both with upright bricks beneath their sills (Plates 10 and 11).

Plate 10. Rear elevation of Buildings 1 and 2

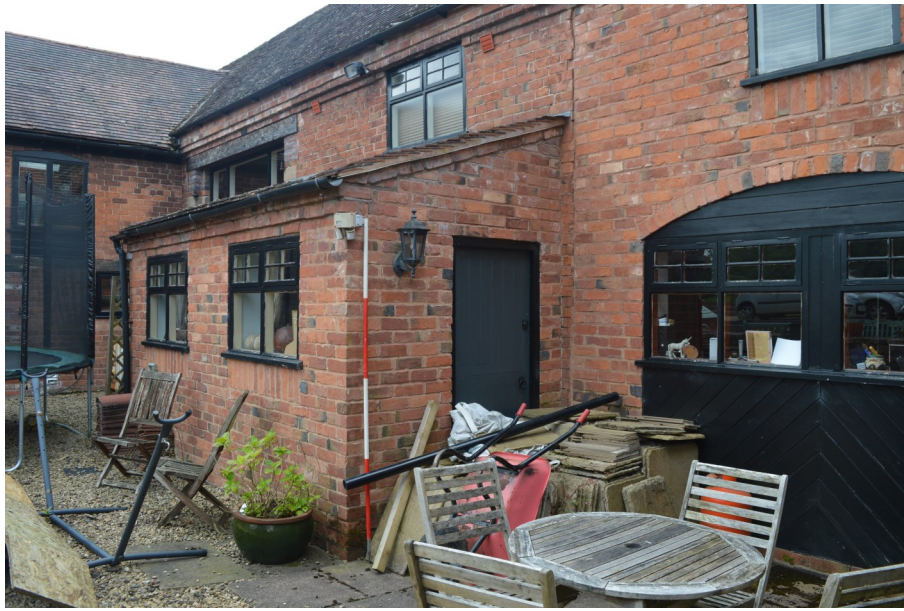
Plate 11. Lean-to to rear of Building 1

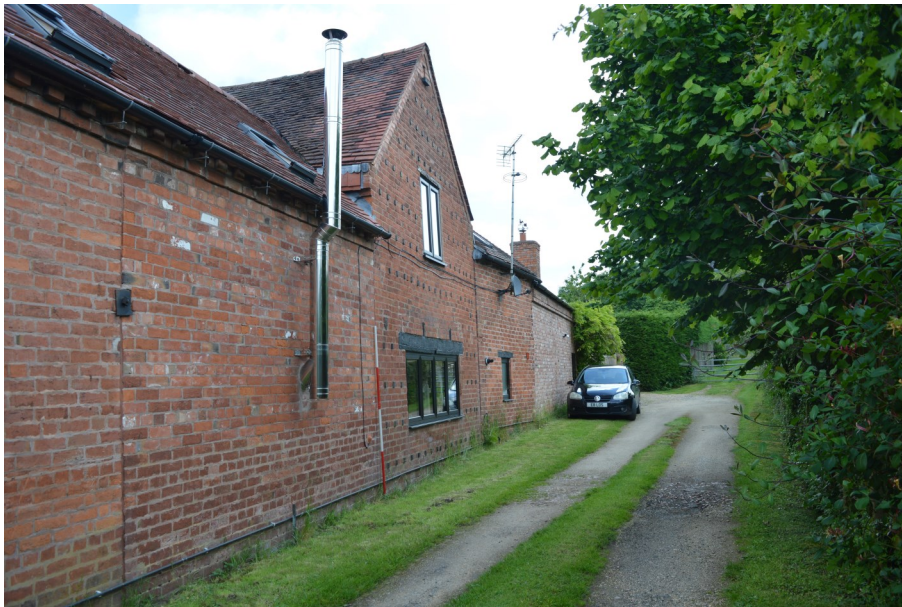
The gable (Plate 12) is built in stretcher bond with decorative dark blue brick stubs arranged regularly every sixth course below the apex from twelve courses down. At mid-level in the gable, there are gaps in this decorative brickwork suggesting that these areas had been repaired.

Two blue bricks protrude from a small, bricked-up rectangular aperture in the apex— probably a former owl hole.

This building displays significant rebuilding or refurbishment with a distinct variation in the brick hues of different phases in the south-east elevation (see Plate 12). This elevation is mostly devoid of architectural elements apart from a pair of ashlar blocks at the base by the gas mains (Plate 18). There is brick dentilling below the eaves on the south-east and north-west elevations and the southern corner of the building is of curved brickwork (Plate 19).

Plate 12. View north-east along track to south-east of buildings, with the Gable of Building 1 in centre of photograph

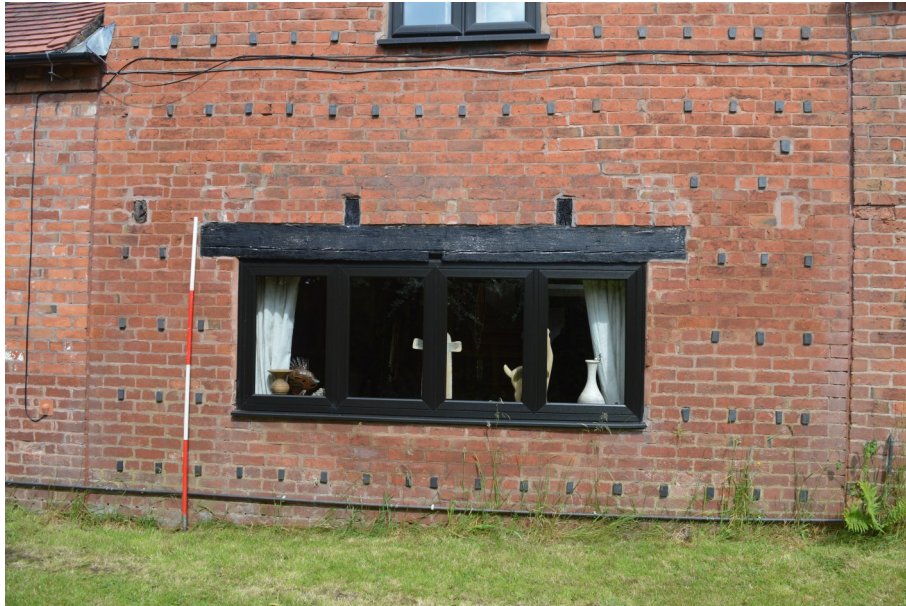
A four- light uPVC window is located centrally within the ground floor of the gable, beneath a substantial lintel of reused timber (Plate 13). There is a long, two light casement window located at first floor level.

Plate 13. Ground floor window in south-east gable of Building 1

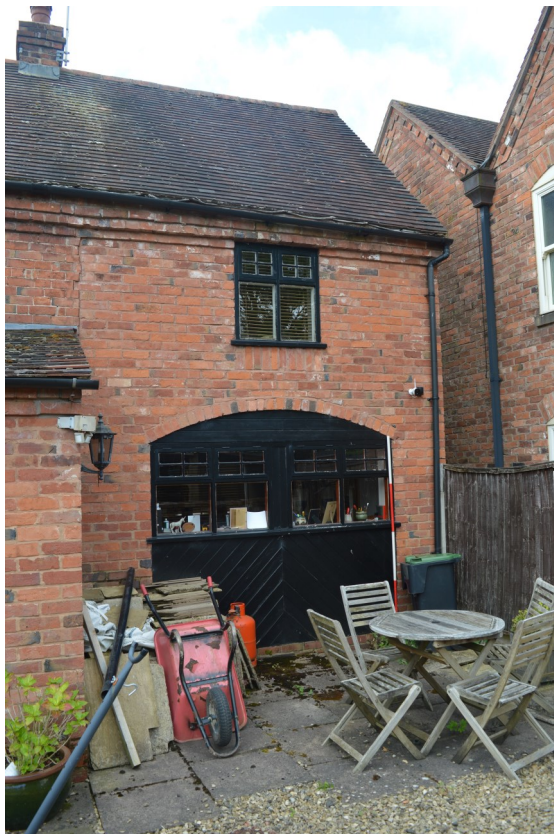
Plate 14. View west of Building 2

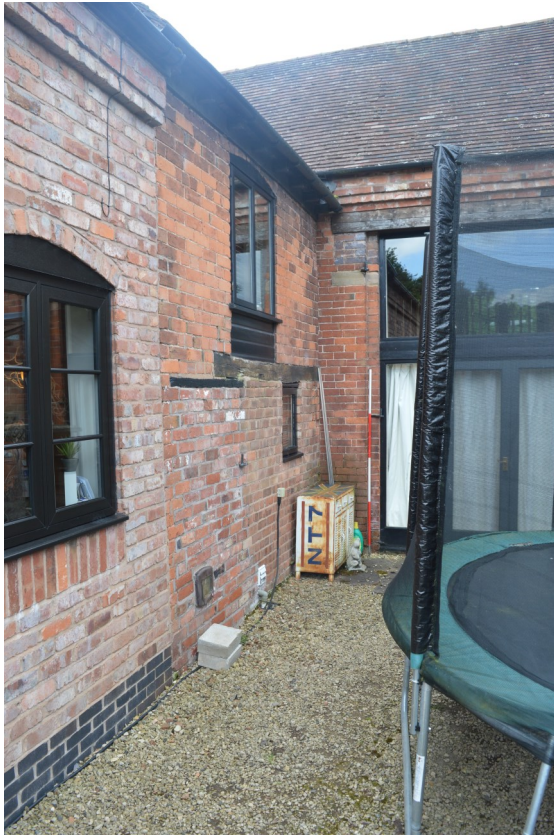
The building has a single light window with a timber lintel in the south-east elevation and a window each on the ground and first floor in the north-west elevation, both off centre. A large timber lintel in the north-west elevation may be a bonded timber or indicate a former opening. Similarly a less substantial timber just beneath this may represent a blocked opening or be a bonded timber (Plate 17).

Plate 17. Oblique view of north-west elevation of Building 3

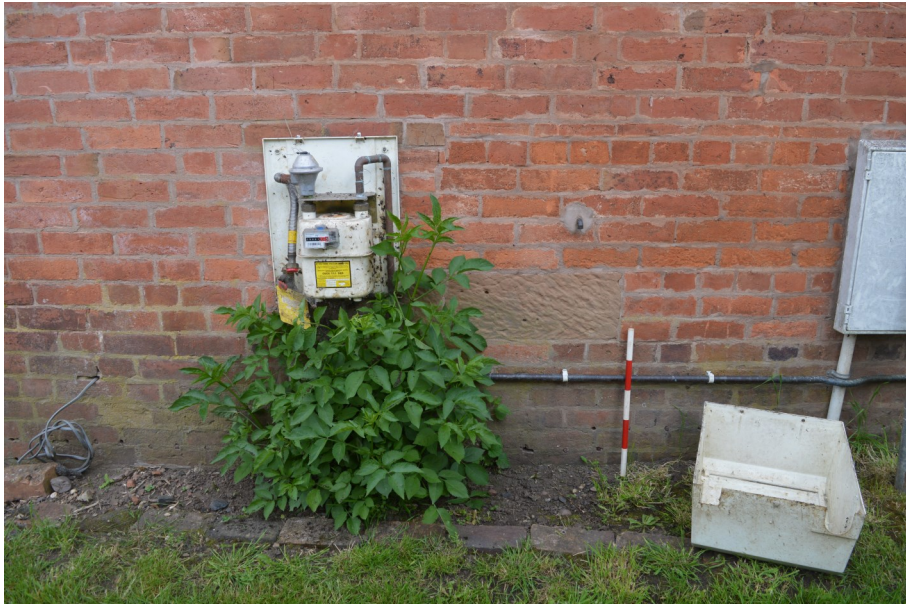
Plate 18. Reused ashlar blocks in Building 4, view north-west

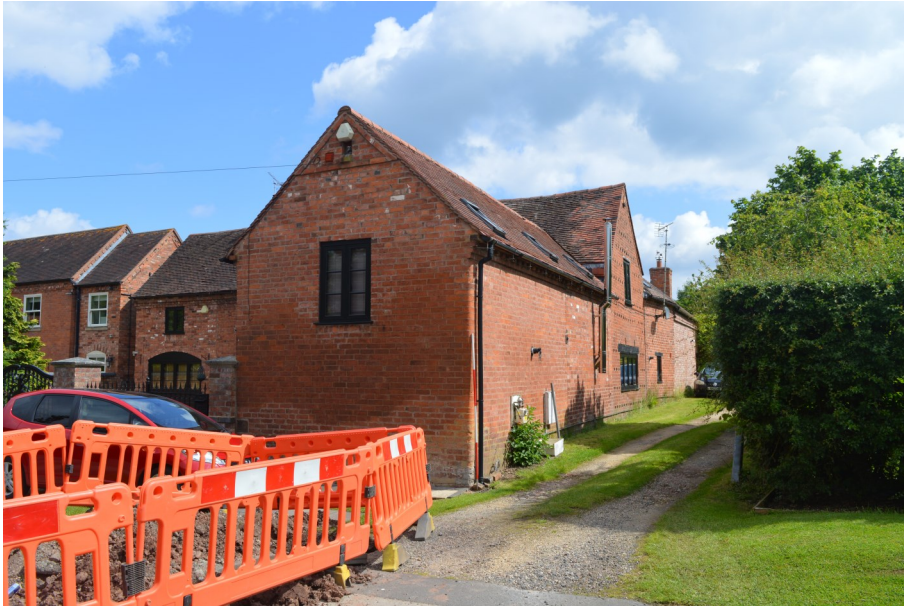
Plate 19. Oblique view of south-west gable, Building 4

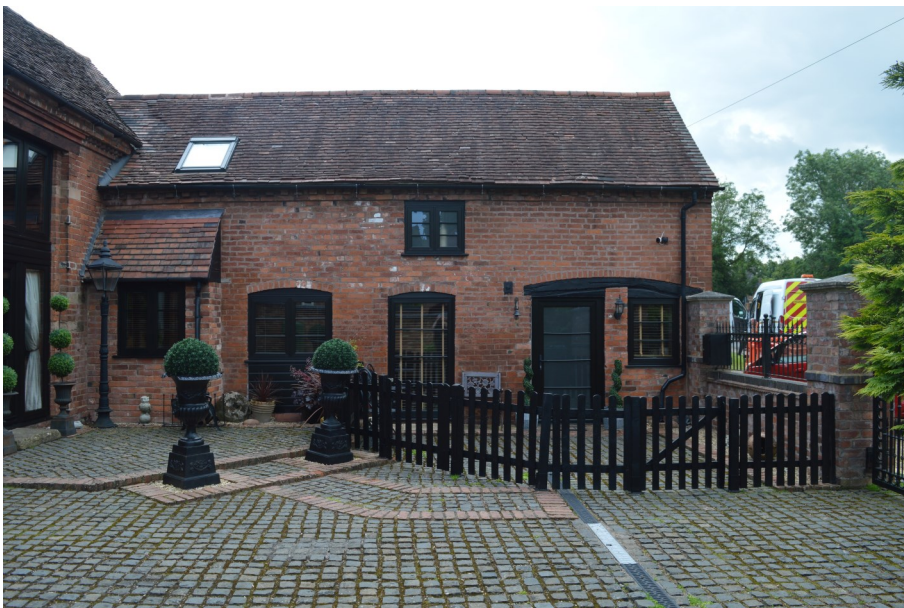
A substantial curved timber lintel beneath a segmental arch in the south-western bay indicates a former double doorway, now filled with a door and window (Plate 20). Two further doorways to the north of this have segmental arches and a small lean-to extension with a shed roof contains a single casement window. On the first floor, a casement window directly beneath the brickwork below the eaves has no arch or differential brickwork beneath the sill. There is a single window in the first floor in the south-west gable. There is a blocked owl hole in the apex.

Plate 20. South-east elevation of Building 4

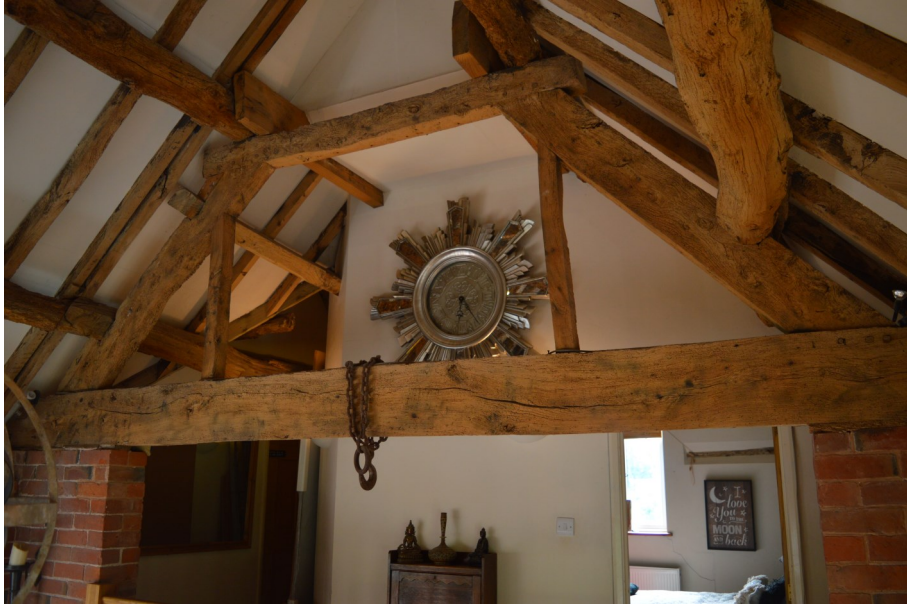
The trusses comprise substantial tie beams with principal rafters supporting trenched purlins morticed into a straining piece supporting upper purlins (Plate 21). The principal rafters are propped with insubstantial queen posts. The truss to the south-west is infilled with brick (Plate 22). Several of

the original timbers are elm and show evidence of having had beetle infestation. Many timbers have therefore been replaced or strengthened with modern machined timbers.

Plate 21. Roof truss, view north-west

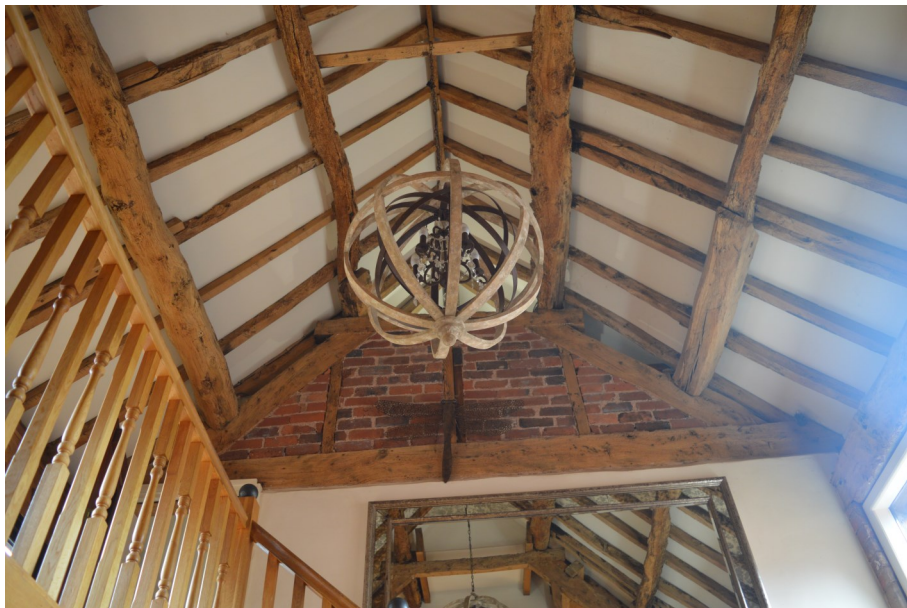
Plate 22. Roof truss, infilled with brick, view south-east

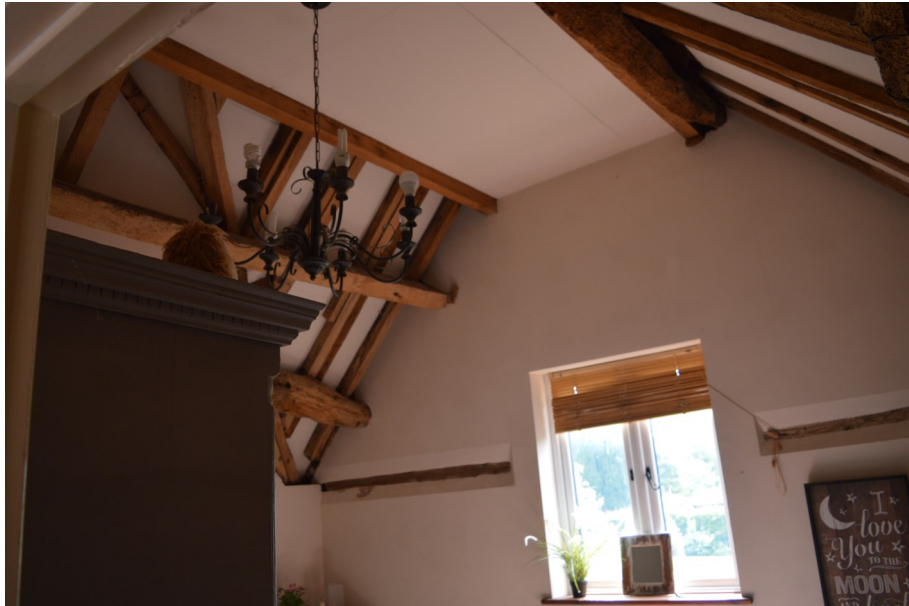
In Bedroom 1, some timbers have been left exposed and there is evidence of an internal bonded timber in the wall on either side of the window (Plate 23). Some of the roof timbers in the area of the junction of Buildings 1 and 3 survive in this area (Plates 24 and 25).

Plate 23. View south-east in bedroom, first floor, Building 1

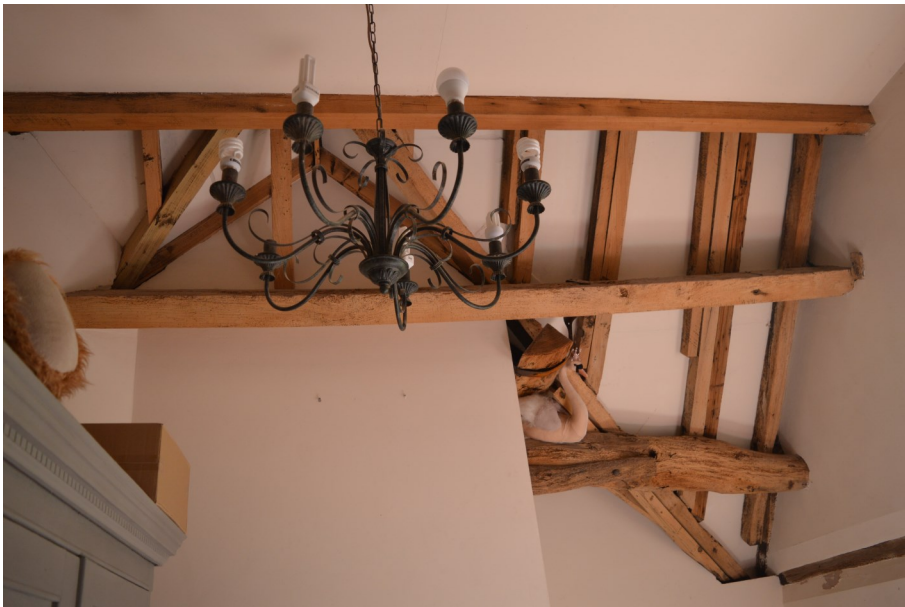
Plate 24. View north-east in bedroom, first floor, Building 1

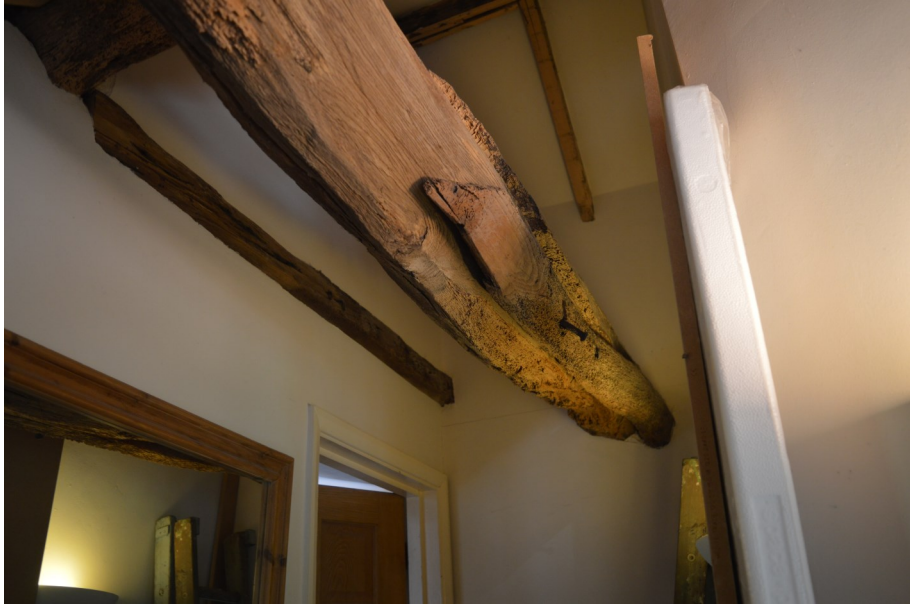
Plate 25. Exposed timbers in landing
