Ambrey Archaeology Ltd

Historic Building Survey of Building recording (Level 3) and monitoring at Nos 58a and 58b High Street, Evesham, Worcestershire

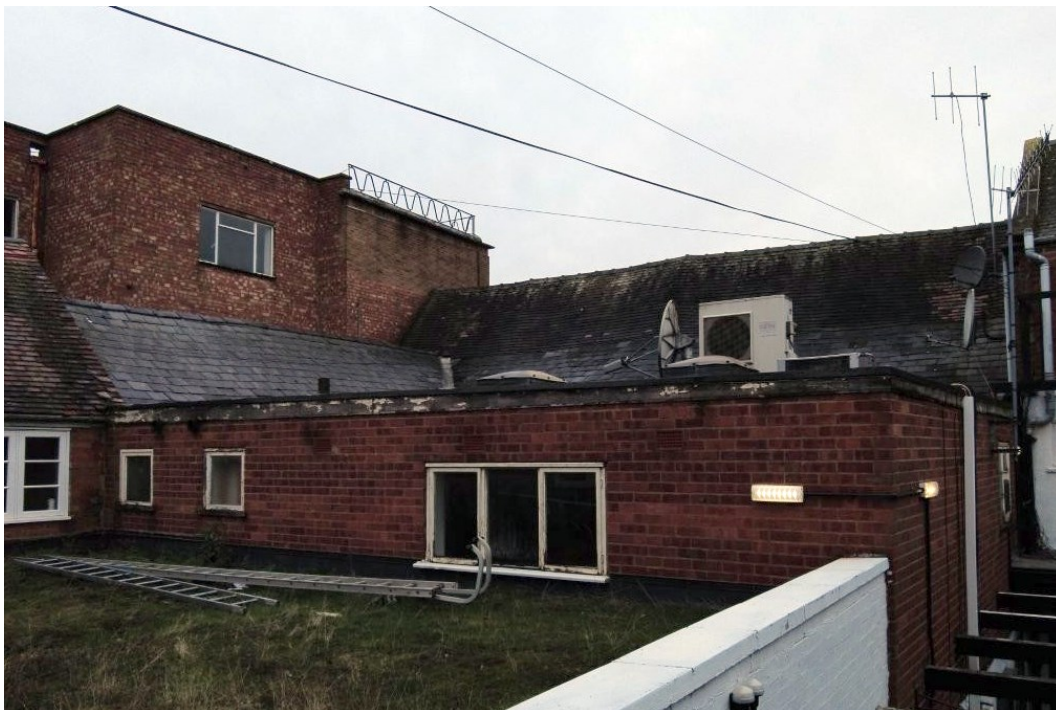
Plate 2. Rear view of building, view south-west. Ridge line of Phase 1 section of building to rear of air conditioning unit, Phase 2 extension with slate lower and to left, Phase 3 flat roofed extension in foreground.

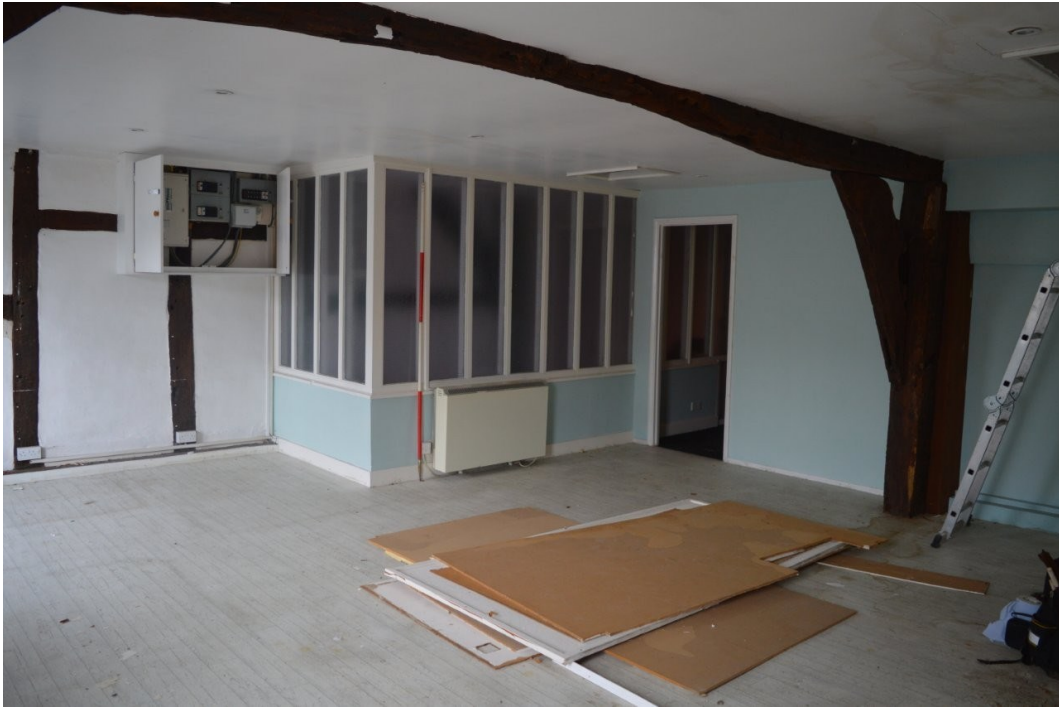
Plate 3. Room 1, view north-east, scale 2m
