## Archaeological Monitoring and Recording (watching brief) at Land off Mill Street, Cannock, Staffordshire

Ambrey Archaeology reference: AMB291

Date: 24<sup>th</sup> March 2025

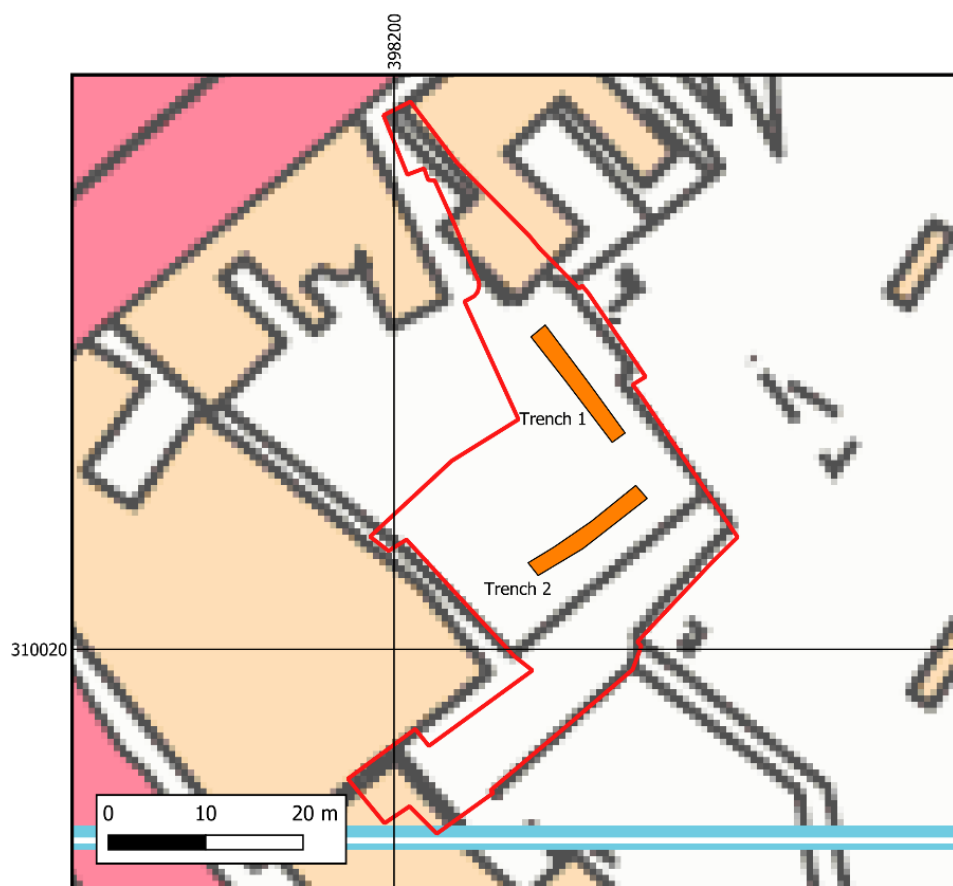
Figure 3. Locations of evaluation trenches

Evaluation of the site was carried out in January 2025 by Ambrey Archaeology Ltd. Two trenches were excavated, one in the location of the proposed buildings and another in an area for access to the north. Five features were recorded in the northern trench. Four comprised shallow pits or postholes aligned north-west by south-east in a row. The features were similar in plan and fill suggesting they were contemporary with each other. Pottery recovered from two of the features was domestic in nature; one was part of a pipkin, used for cooking over a fire and the other was probably from a fine jug and they dated from the late 12th to early 14th century.

The alignment of the pits or postholes and a difference in the depth of topsoil from one side of the trench to the other suggest that they could represent the boundary of a burgage plot which would have run perpendicular to Mill Street with differing cultivation depths on either side of the fence.

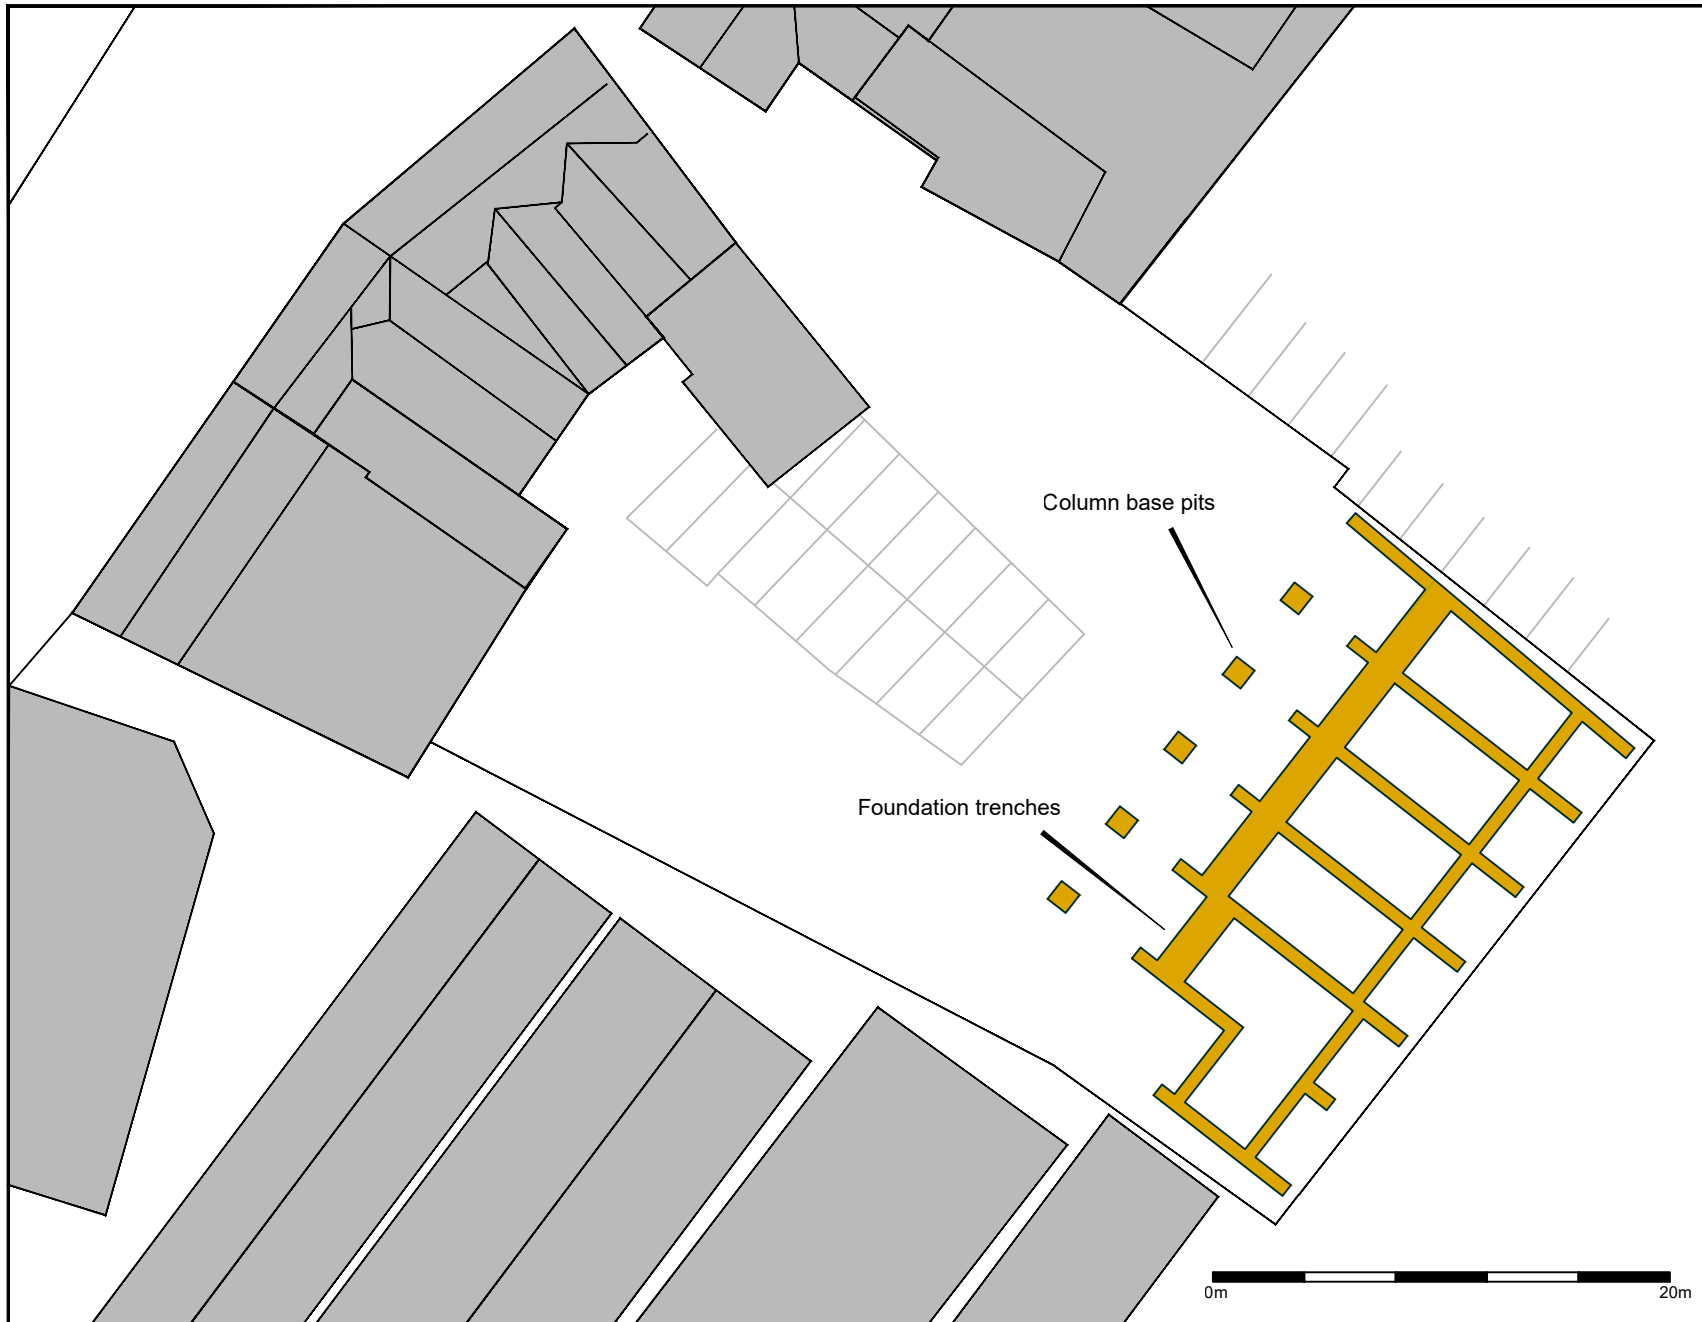
Figure 4. Location of excavations

A plan showing the location of the excavated foundations is presented in Figure 4 and a plan of the Figure 5 foundations with context information is presented in Figure 5.

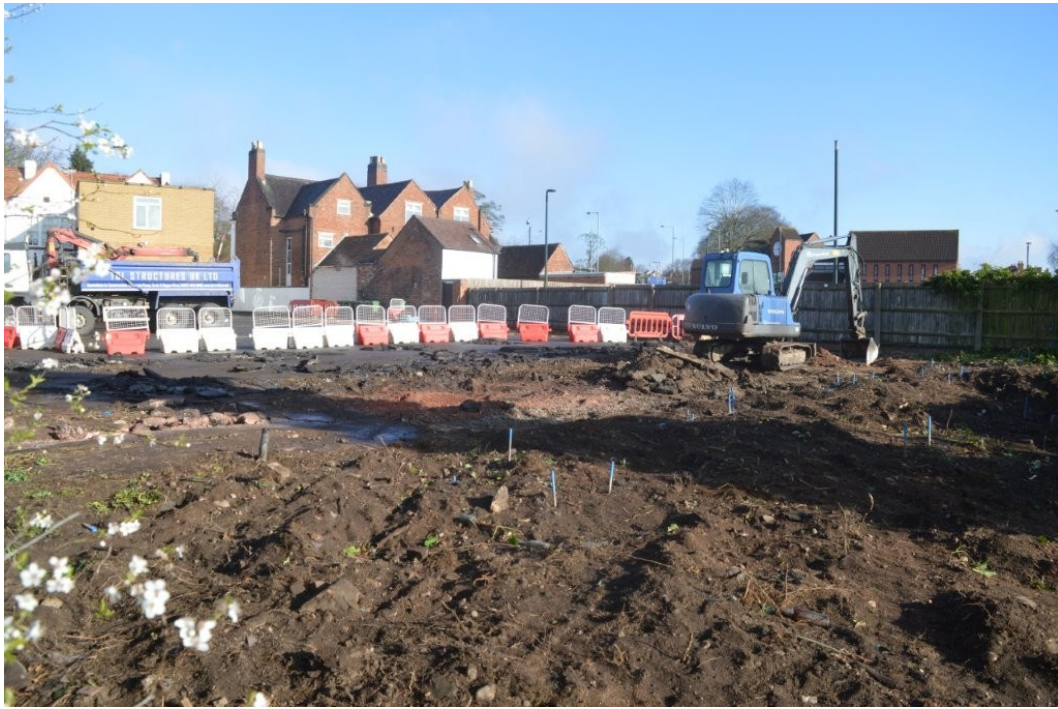
*Plate 1. View north across site prior to excavations*

Prior to archaeological monitoring the tarmac layer was broken and scrub vegetation removed from the southern section of the site (Plate 1). Excavation of the foundation trenches was undertaken using two mechanical excavators fitted with toothless buckets and under archaeological supervision (Plate 2) although one excavator was generally employed with storage and removal of topsoil.

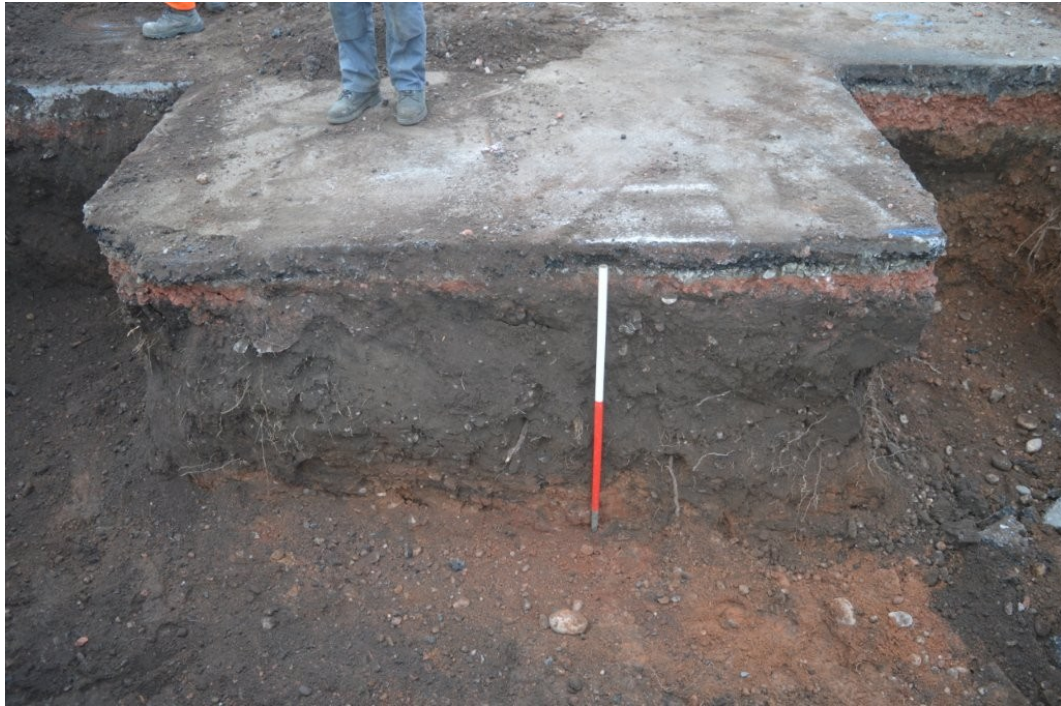
*Plate 3. Section in north-western arm of foundation trenches, view north-west, scale 1m*

In the northern half of the area of foundations, the upper layer was the tarmac surface of the car park (1001) which rested on a compact grey sand and gravel imported roadstone base (1002) to a general depth of 0.2m. Beneath this was a loose, orange-red sand and gravel (1003) interpreted as material imported to level the surface prior to laying of the car park surface (Plate 3).

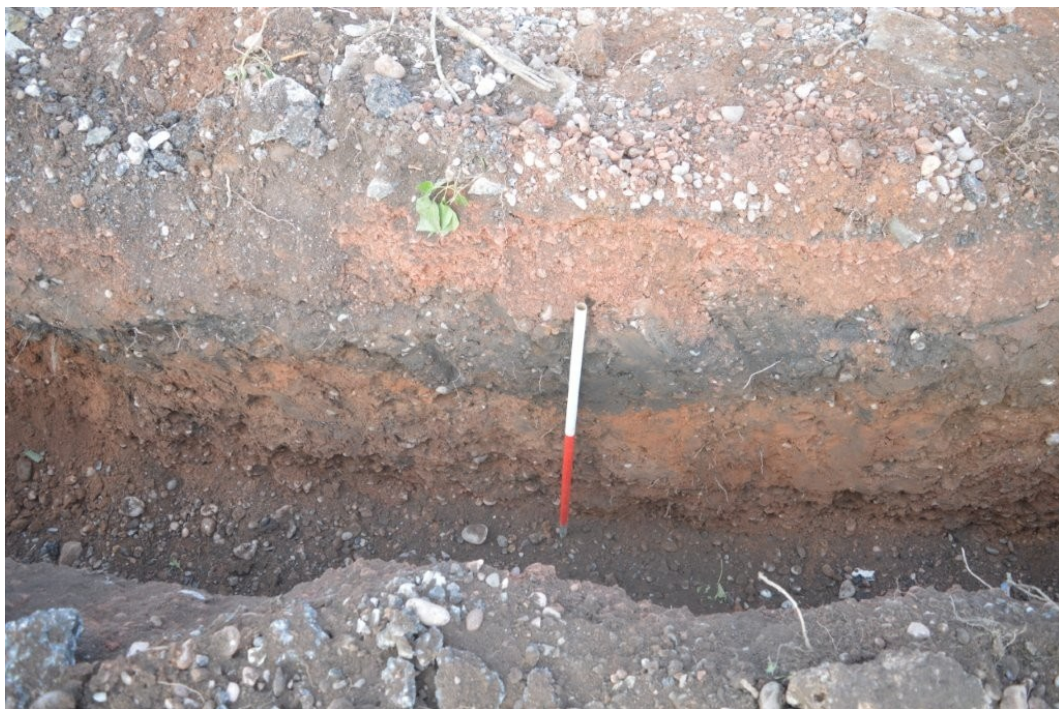
*Plate 8. Section in central part of foundation trenches showing thicker layer of subsoil (1006), view north-east, scale 1m*

In general, the topsoil was present to a depth of 0.75m and in the central part of the site it overlies (1005) a moderately compact, orange sand, with frequent cobbles, small pebbles and charcoal flecking. As in the evaluation (context 205) this was interpreted as a subsoil or interface layer with the natural substrate. This was deeper (up to 0.3m) in the central part of the excavations (Plate 8). In the evaluation a fragment of pipe stem was recovered from this layer. In the south-eastern arm of the foundations, a high voltage electric cable was present, and a plastic foul pipe ran the length of the north-eastern arm (Plate 9).

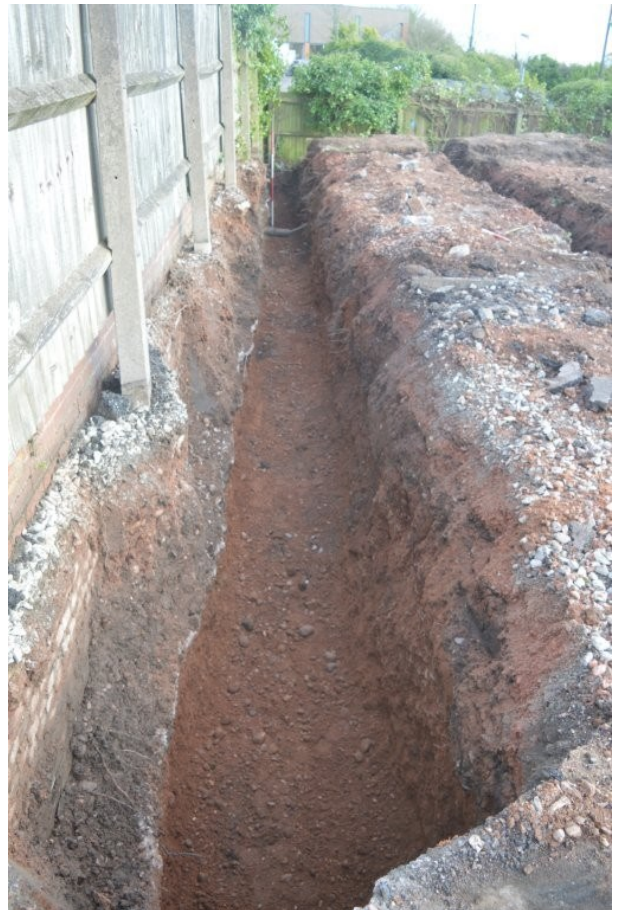
*Plate 10. North-eastern arm of foundations, view south-east, scale 2m*

In the south of the site, the topsoil directly overlies the natural substrate, generally at a depth of one metre. This was a firm, mid-brown to orange sand and gravel, with frequent pebbles and lenses of bright orange or red sand interpreted as the Devensian till mapped in this area by the BGS. The

foundations exceeded the depth of this layer, particularly in the north-eastern arm (Plate 10) which provided a good cross section of the layer.

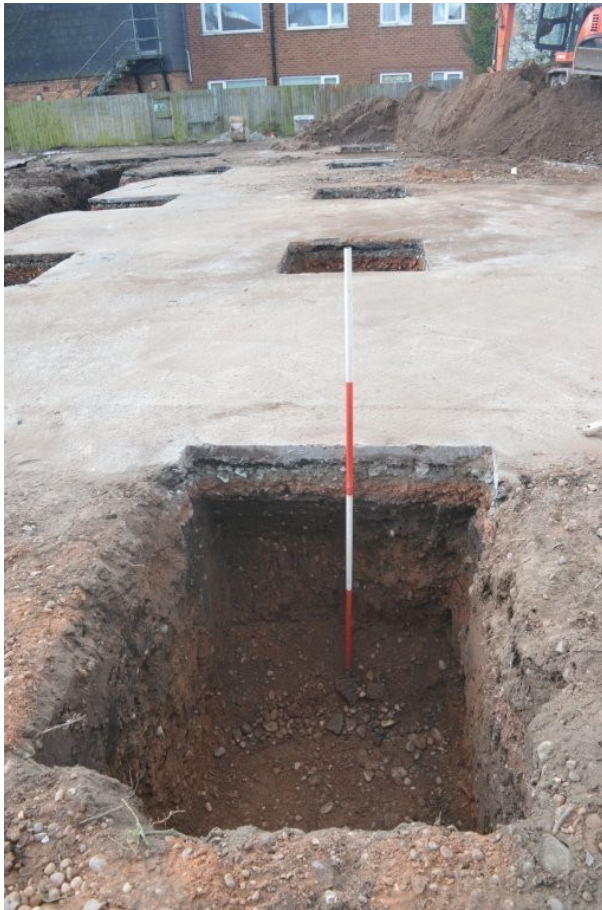
*Plate 11. Line of foundation pits at north-east edge of site, view south-west, scale 2m*

A similar sequence to the rest of the site was recorded in a series of pits which will form the bases to columns on the north-east edge of the excavations (Plate 11).

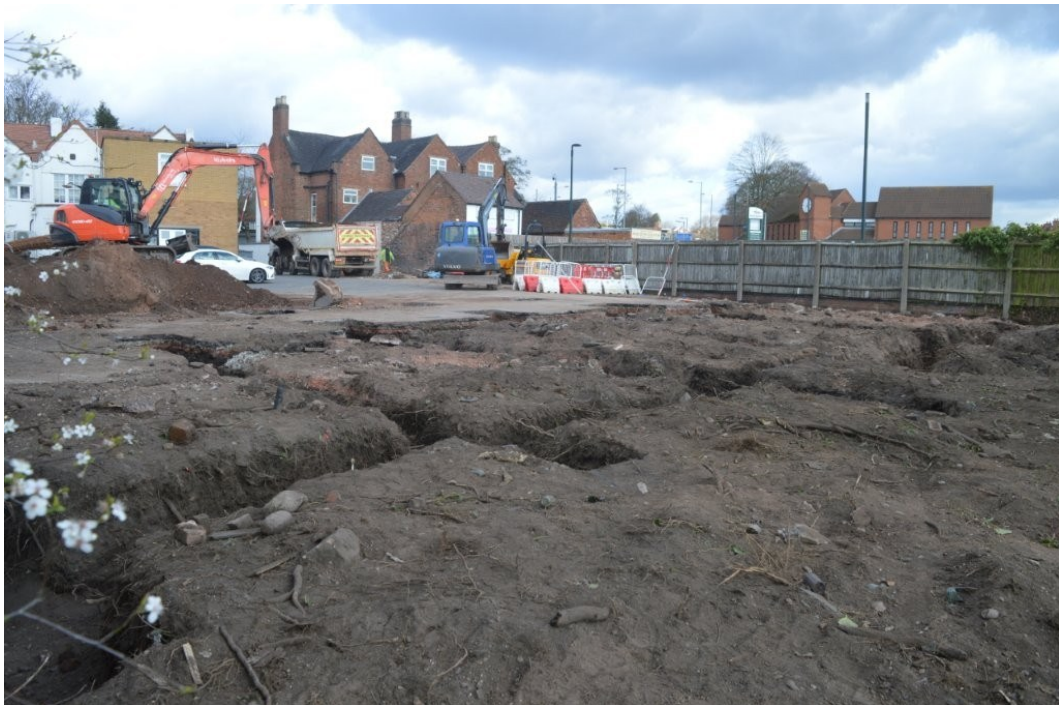
*Plate 12. The site with foundation trenches completed, view north*

Plate 12 shows the foundations fully excavated.

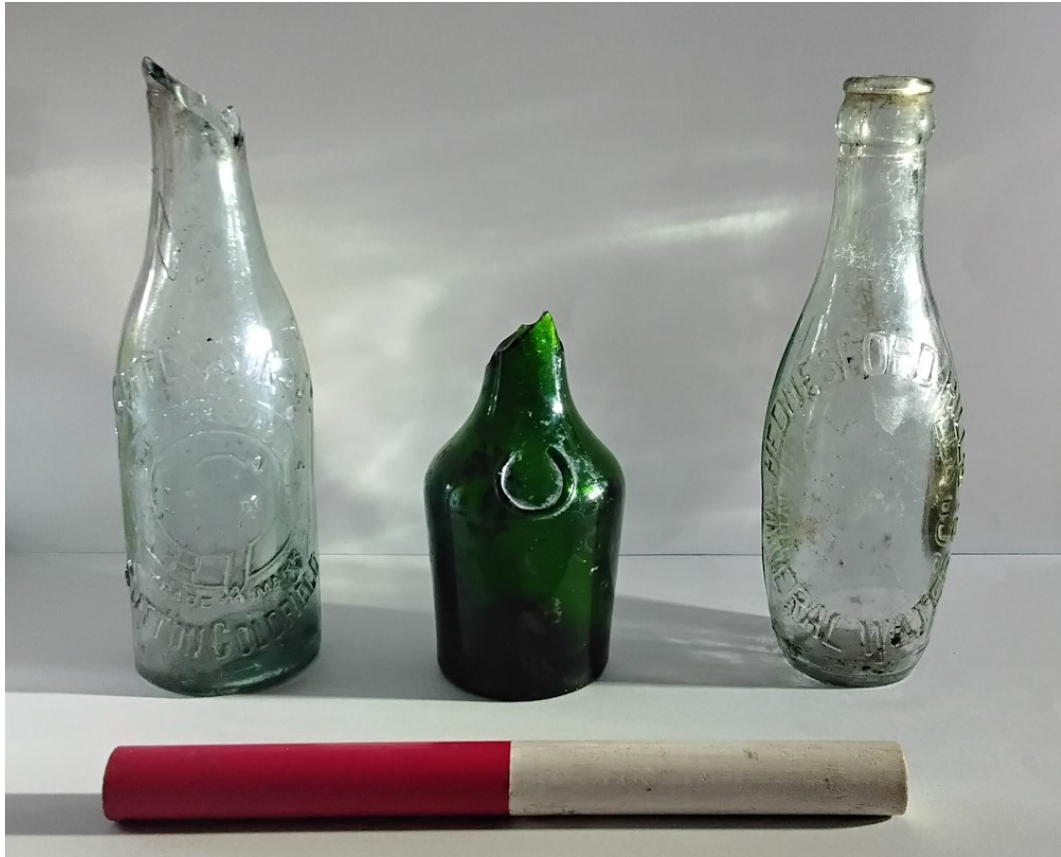
*Plate 13. Bottles recovered from Context 1004, scale 0.2m*

Three bottles were recovered from topsoil (1004) and are shown in Plate 13. These are as follows:-

1. Half bottle of Benedictine Liqueur, invented in 1863
2. Hednesford Hills Mineral Water – early 20<sup>th</sup> century
3. Goffe and Sons Mineral Water of Sutton Coldfield – established 1837

It is not considered that these should be retained for museum accession.
