# Ambrey Archaeology Ltd

## Historic Building Recording of Stables Barn, Valley Farm, Elmley Lovett, Droitwich Spa

Project AMB295

WSM81756 (Event No)

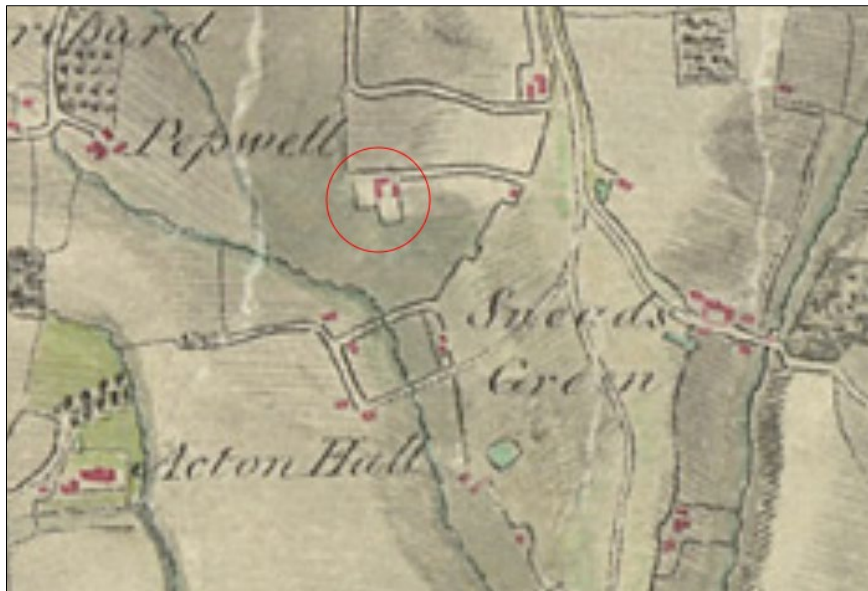
Figure 3. Extract of Ordnance Survey Drawing 214 Kidderminster with location of Valley Farm circled

On the 1812 Ordnance Survey drawing of Kidderminster (OS214, Figure 2) a U-shaped set of buildings are shown in the location of Valley Farm, but the map does not have sufficient detail to draw many conclusions from this arrangement. However it shows that a farm is likely to have stood in this location.

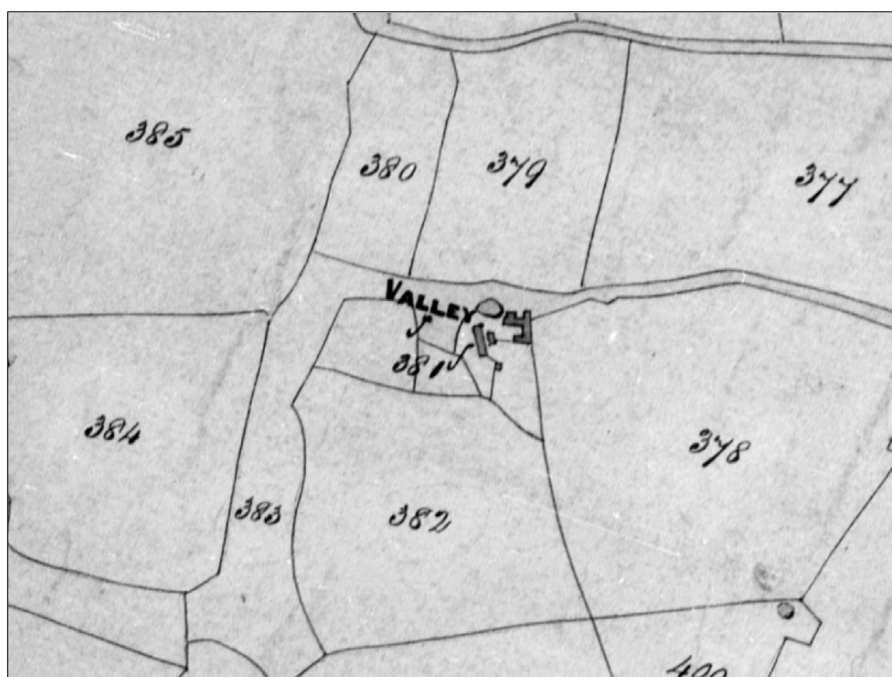
Figure 4. Extract of 1840 tithe map of the parish of Elmley Lovett

More detail is shown on the 1840 tithe map of the parish of Elmley Lovett (Figure 4) on which four buildings are shown. One to the east, possibly a farmhouse, forms an approximate U shape with several projecting wings. To the west is a long, rectangular building while between these is a smaller building, possibly also rectangular. The tithe apportionment for 'Valley' (parcel 381) is described as *house, Garden and Orchard* owned by Brook Forester esq and occupied by James Davenport.

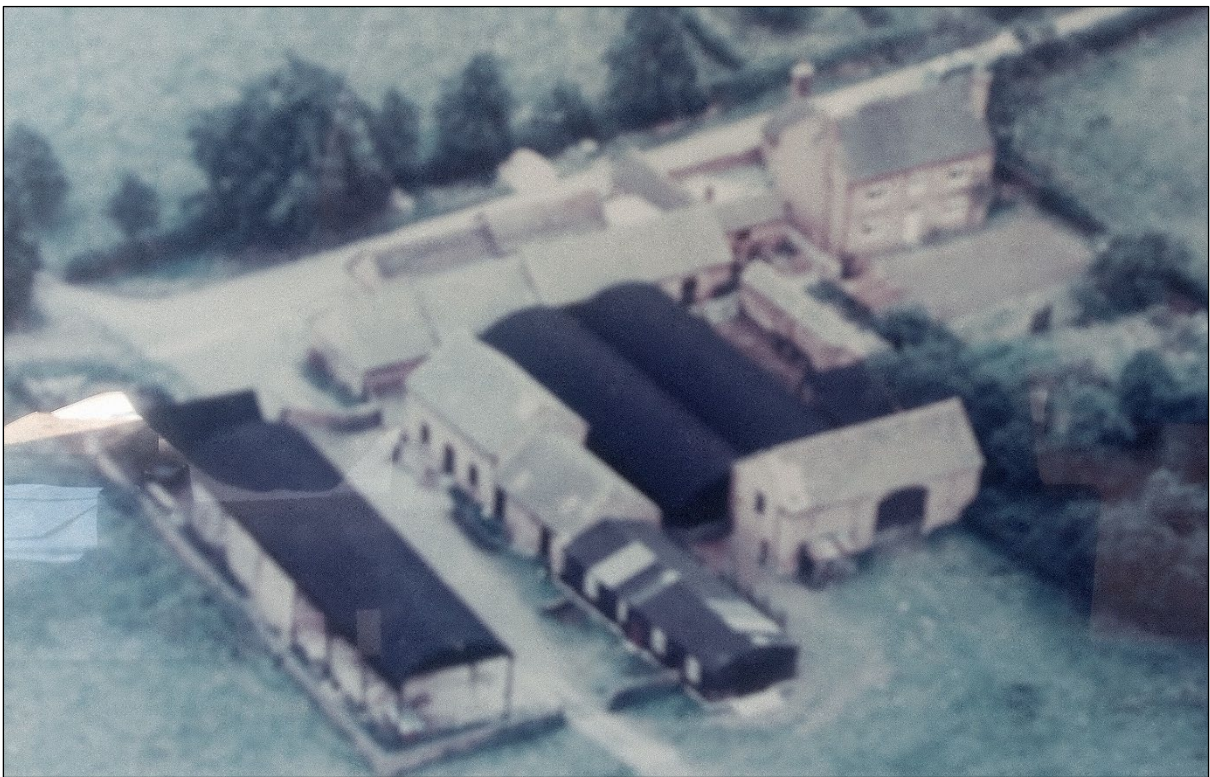
*Figure 7. Extract of 1960s aerial photograph of Valley Farm taken from the south-west*

An aerial photograph supplied by the owner which was taken in the 1960s (Figure 6) shows Dutch barn type buildings occupying the courtyard, an arrangement also shown on Ordnance Survey maps of this period.

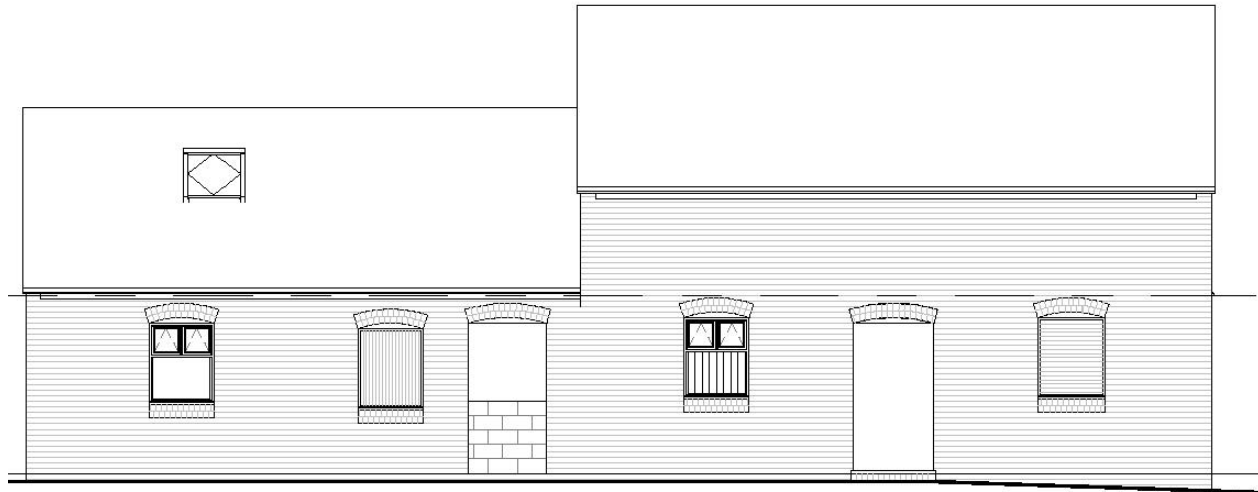
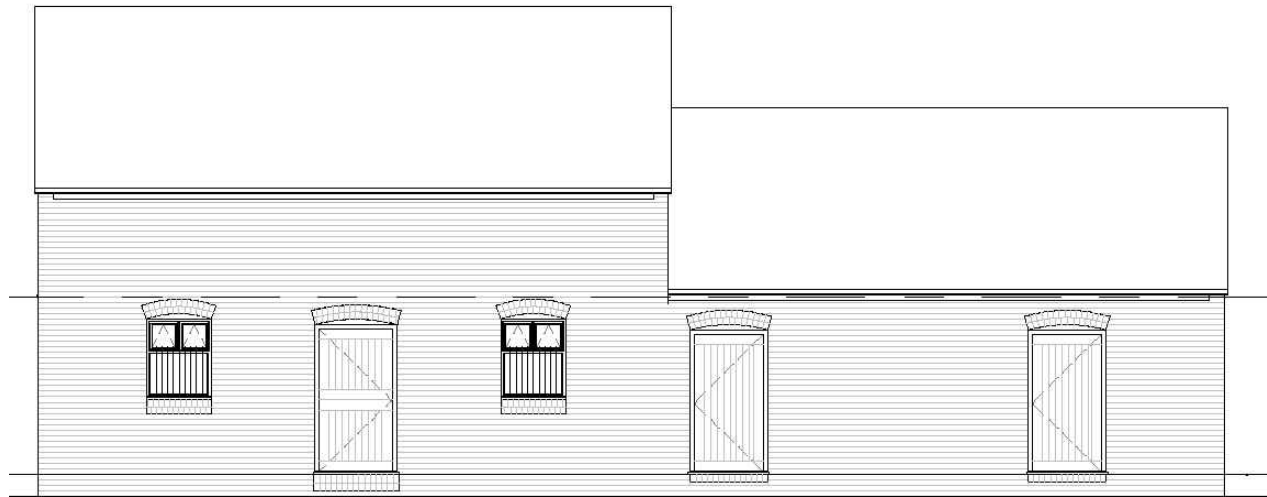
*Figure 10. Stables barn elevations  
reproduced from Greenspace Architects Ltd Drawing no 22/01 - A1002*

East elevation

South elevation

West elevation

North elevation

*A plan showing external photograph directions is presented as Figure 8 and internal floorplans and photograph directions are shown on Figure 9. Elevations, reproduced from Greenspace Architects Ltd's drawing 22-01/A1002 are presented in Figure 10.*

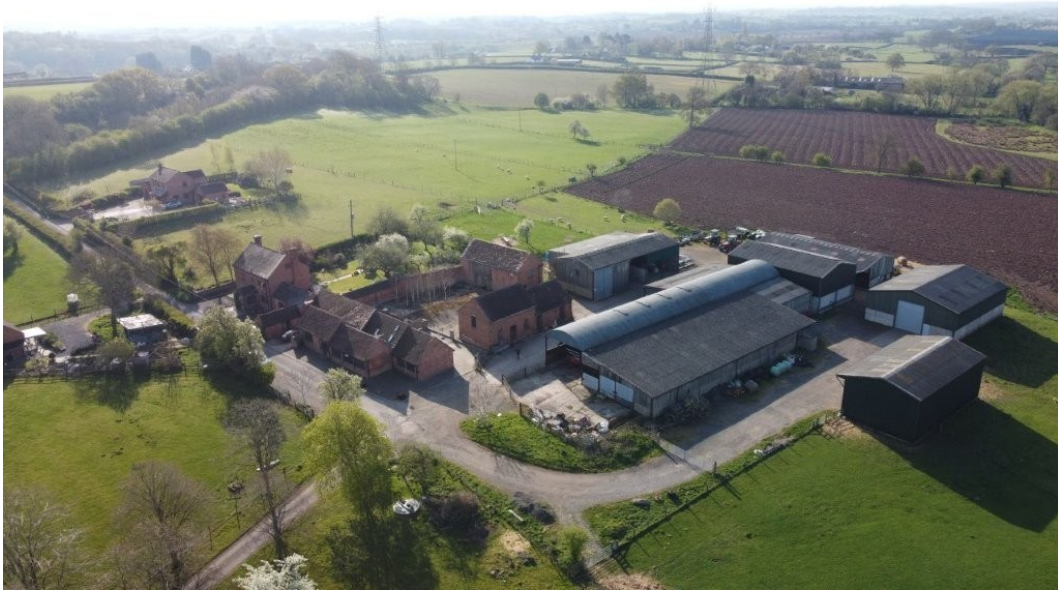
*Plate 1. Low level aerial view south-east of Valley Farm*

Valley Farm is located about 1km south-west of the village of Elmley Lovett and 5km south-east of Stourport (NGR 385676, 268566, Figure 1). It is located in gently undulating landscape comprising a mix of arable and pastoral fields with intermittent woodland at a height of approximately 47m AOD (Plates 1 and 2). The Oxford, Worcester and Wolverhampton Railway runs 130m to the east of the farm. A small stream, a tributary of the Hadley Brook, flows roughly southward to the west of the farm.

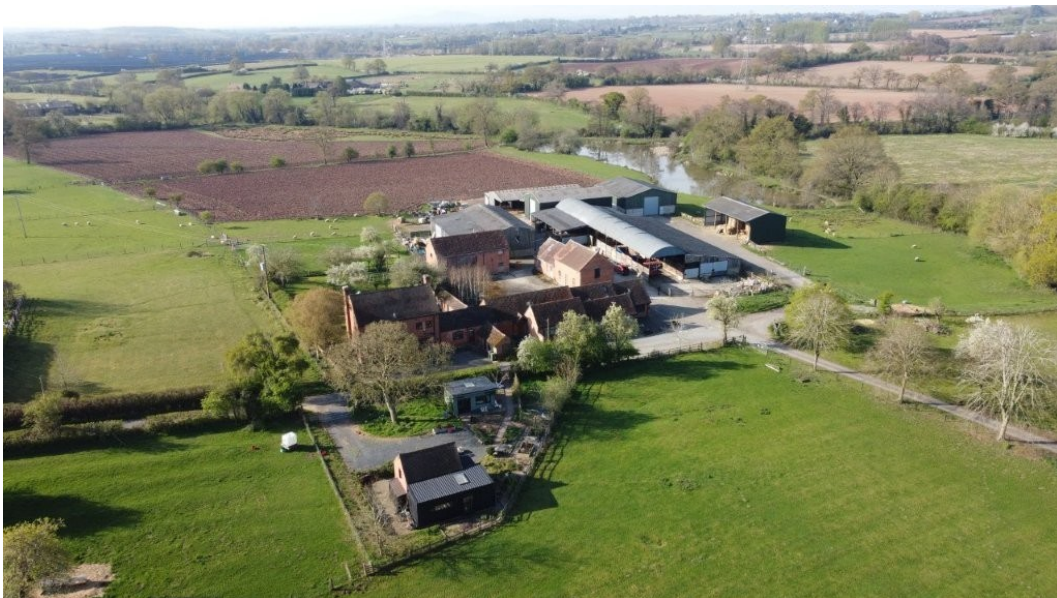
*Plate 2. Low level aerial view south-west of Valley Farm*

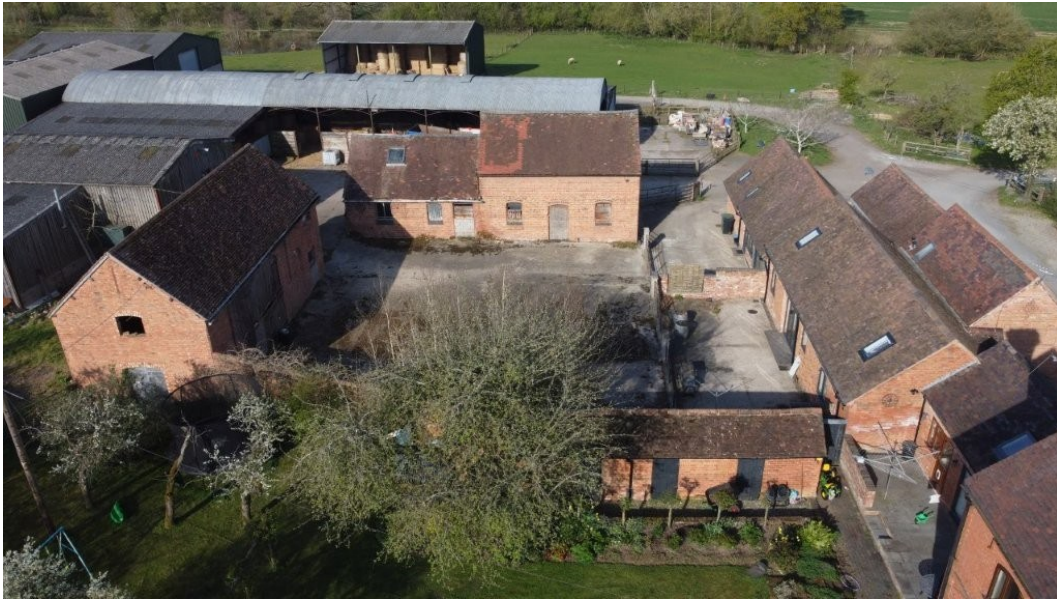
*Plate 3. Low level aerial view of the courtyard farm arrangement with Stables Barn facing, Mill Barn to left (south) and converted single storey buildings to the right (north)*

Stables Barn forms the west side of the square, concreted courtyard to the west of the farmhouse (Plate 3). To the north are single storey former agricultural buildings now converted into residences. An unconverted threshing barn runs along the south of the courtyard while to the east a wall divides the courtyard from the garden to the rear of the farmhouse, behind which are former pigsties.

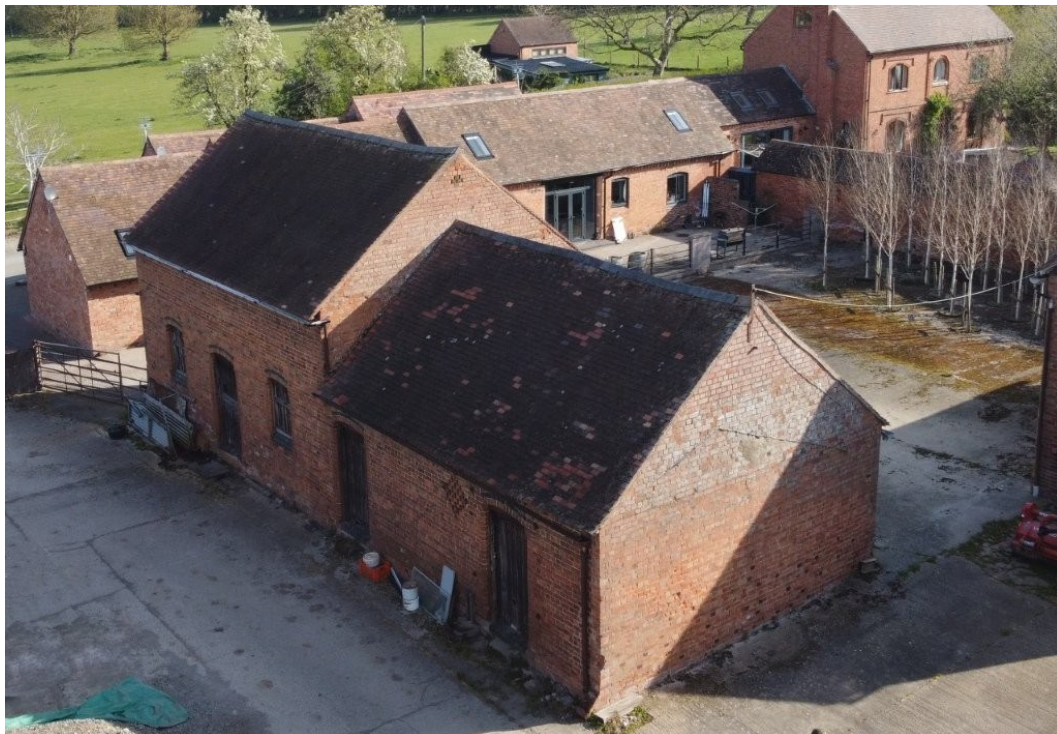
*Plate 4. Low level aerial view north-east of Stables Barn*

Stables Barn is a rectangular building (16.7m x 6.2m) which stands on the west side of the courtyard with its long axis orientated north-south. It is in two sections, that to the north being a two storey building while to the south it is of one storey (Plates 4 and 5). Both have simple gable roofs of plain ceramic tiles although the ridges are at different heights. The bricks are laid in English bond with lime mortar, repaired in places with cement based mortar. The bricks measure 9 ½" x 4 ½" x 3" and are mid red although blue bricks are used in specific locations as described below. At ground level there is a slight plinth formed by a row of bricks set slightly forward. There are there are small low brick buttresses against the corners of the building on the west side (Plate 6).

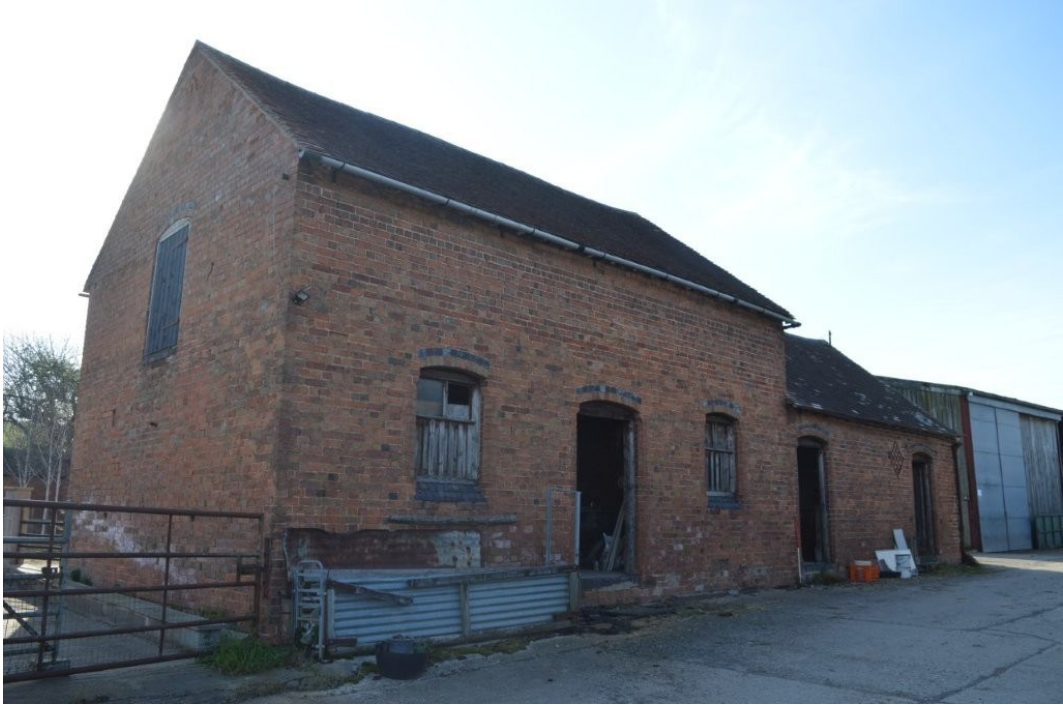
*Plate 5. North and west elevations of Stables Barn, view south-east, scale 1m*

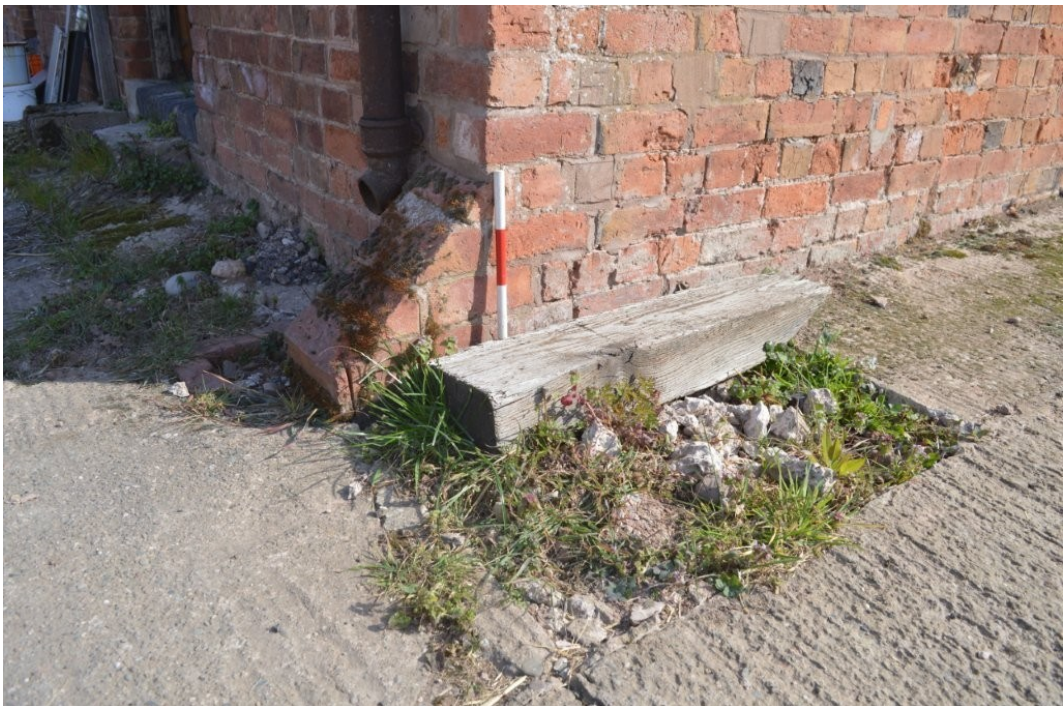
*Plate 6. Low buttress at south-west corner of Stables Barn, view north-east, scale 0.3m*

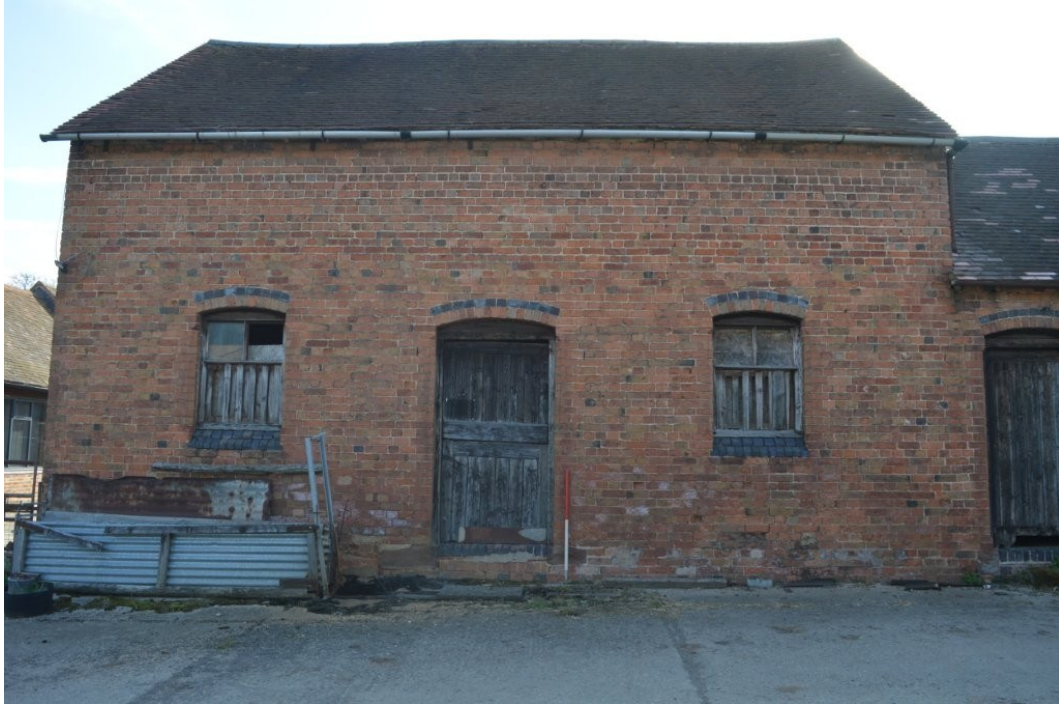
*Plate 7. West facing elevation of northern section of Stables Barn, view east, scale 1m*

The **west elevation** of the two storey section of the building (Plate 7) has a central door flanked by a window on each side. These are under segmental brick arches comprising two rows of headers, the upper of which is of blue bricks. Both door and window jambs are formed of cant bricks, those at the door resting on squared red sandstone blocks (Plate 8).

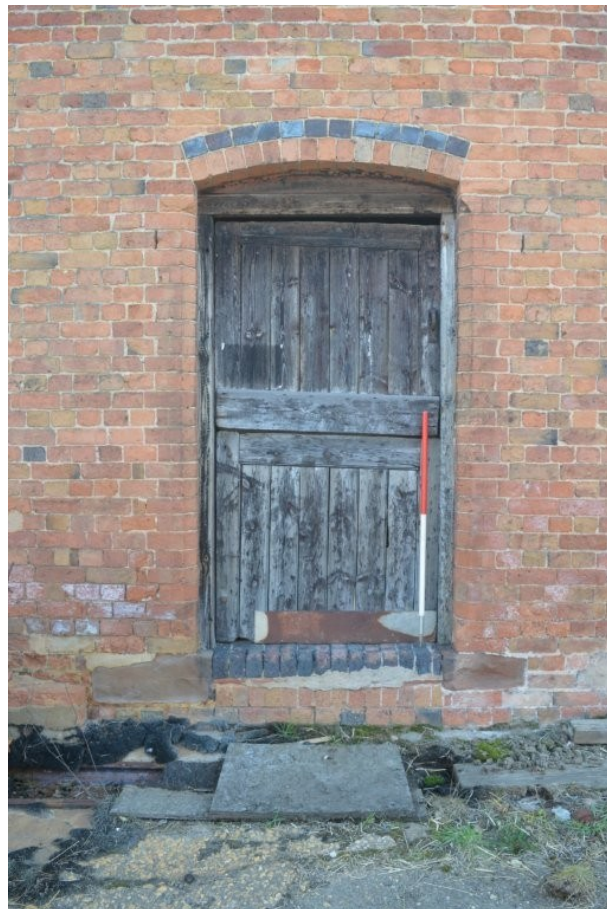
*Plate 8. Doorway in northern section of Stables Barn, view east, scale 1m*

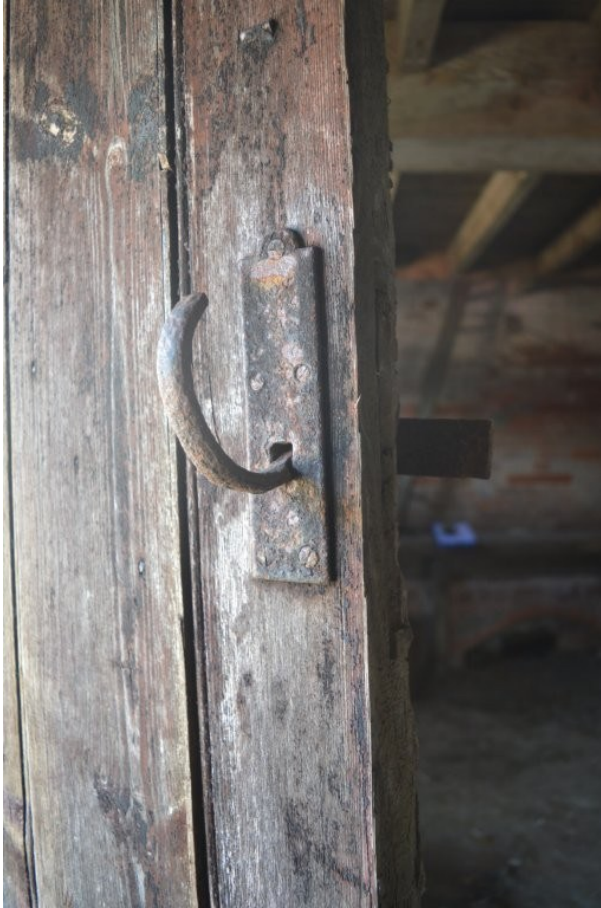
*Plate 9. Detail of door latch, in northern section of Stables Barn*

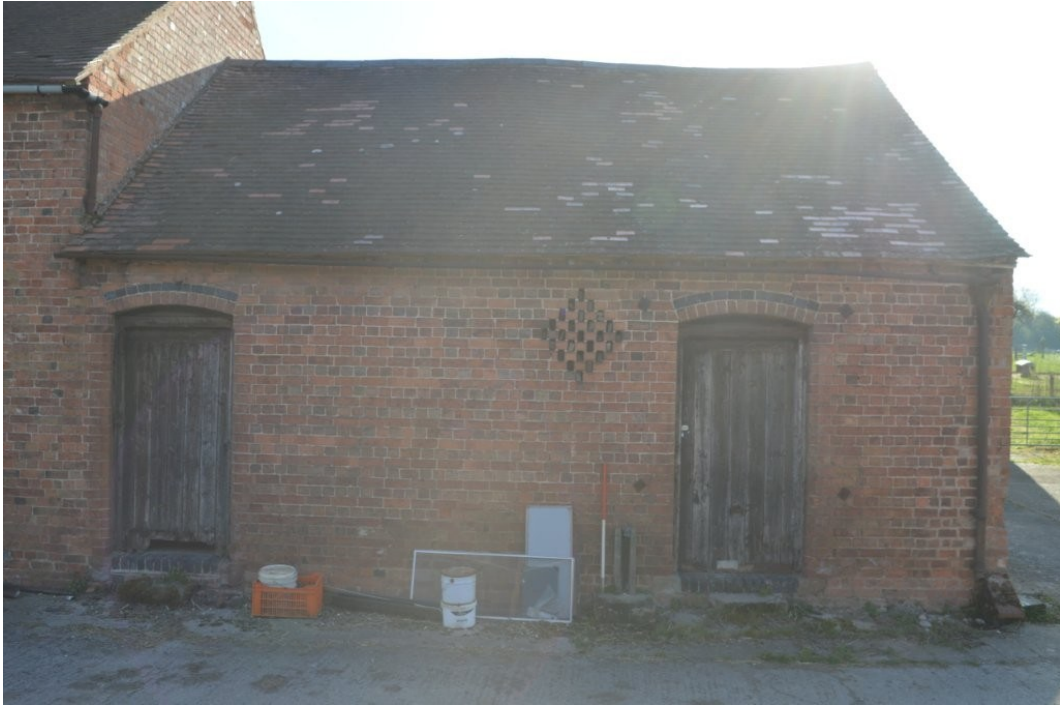
*Plate 11. Western elevation of single storey section of Stables Barn, view east, scale 1m*

There are two doorways in the single storey section of the building (Plate 11) the brick details of which are the same as that described above. The doors are of plain ledged and braced type, though both have the distinctive latch.

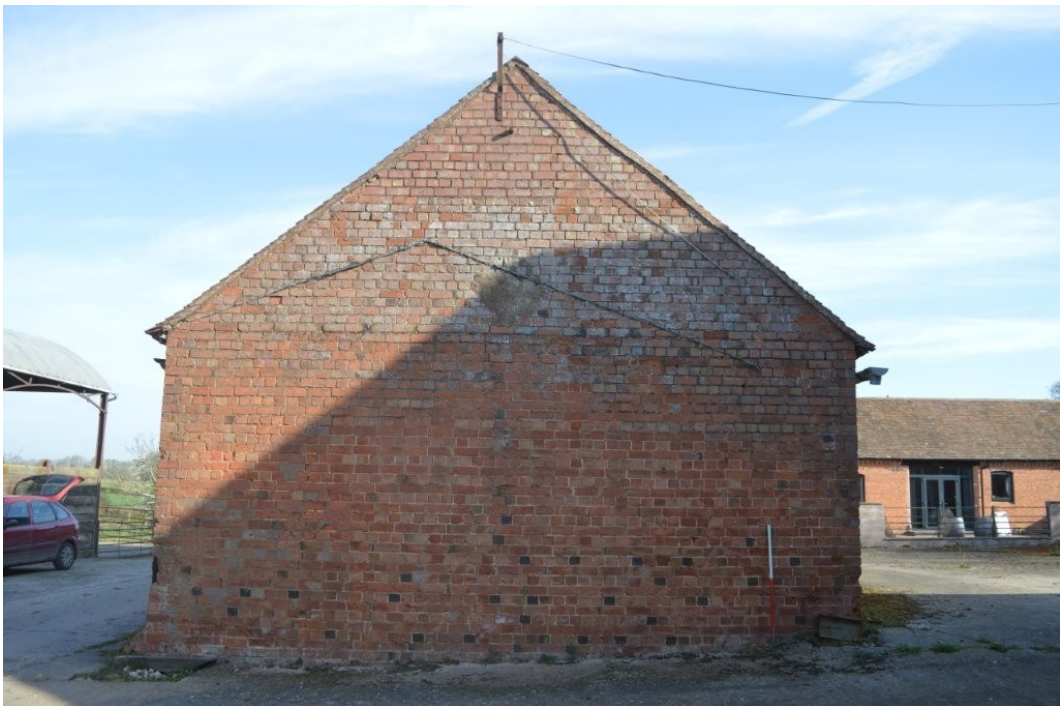
*Plate 12. Southern gable of Stables Barn, view north, scale 1m*

The **south elevation** of the single storey building (Plate 12) is a plain gable, the only feature being the scar of the former building attached to this side of the building (Figure 6) with a shallow gable roof, offset slightly to the west. The ground level here rises westward so this end of the building is slightly shorter on the east side.

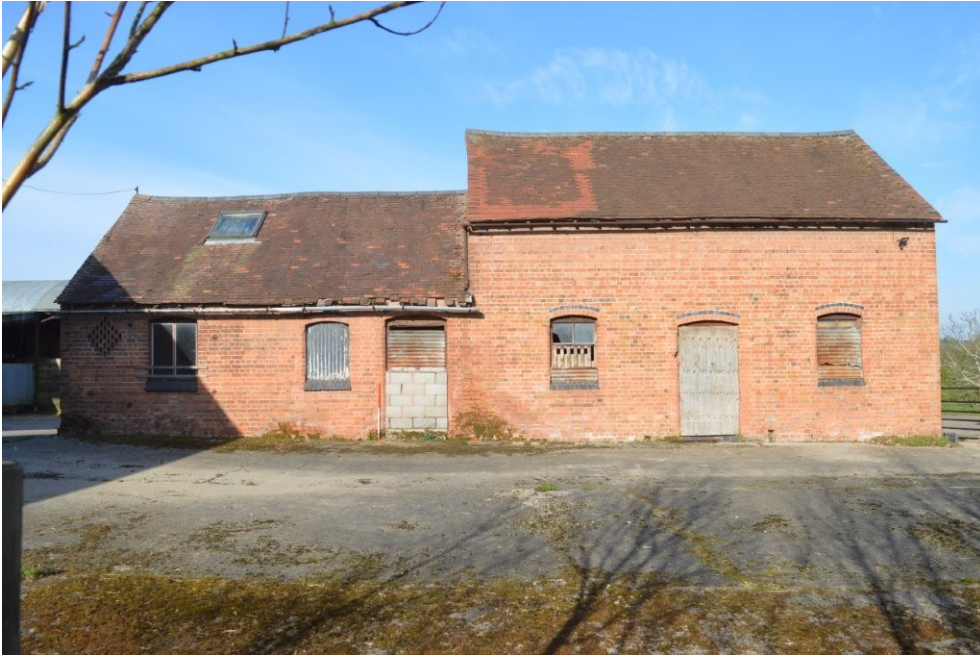
*Plate 13. Eastern elevation of Stables Barn, view west, scale 1m*

The **east elevation** of the two storey section of the building, which overlooks the courtyard (Plate 13) mirrors the west elevation except that the ground level here is higher and there is no step to the

doorways. The central door has been covered with plyboard and the northern window with corrugated metal sheeting.

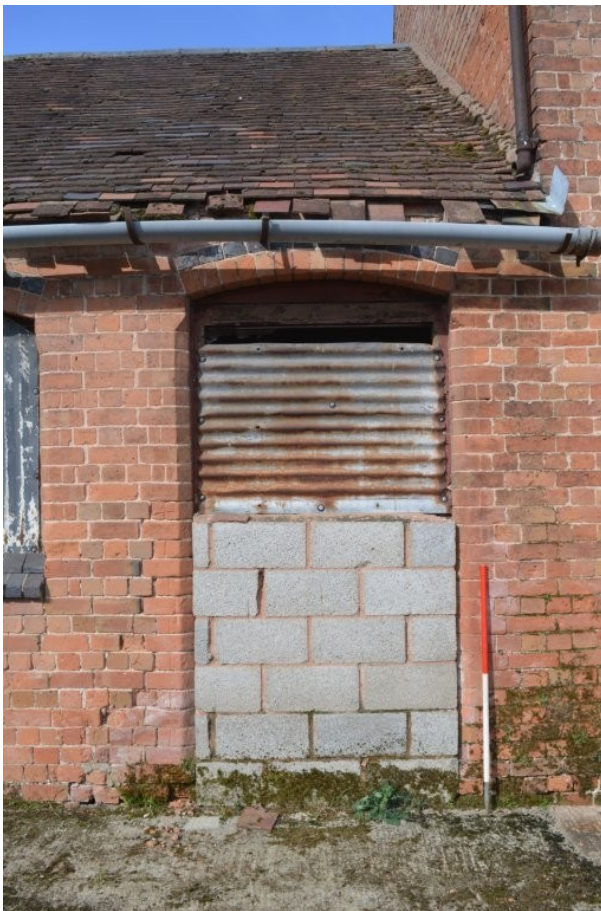
*Plate 14. Partially blocked doorway in eastern elevation of Stables Barn, view west, scale 1m*

On this side there is only one door in the single storey section at the northern end, although the lower half of this has been blocked with breeze blocks while the upper section has a cover of corrugated metal sheeting (Plate 14). One adjacent window is similarly blocked while another to the south comprises two fixed panes in a wooden frame. There is a lozenge shaped ventilation panel at the southern end of the building.

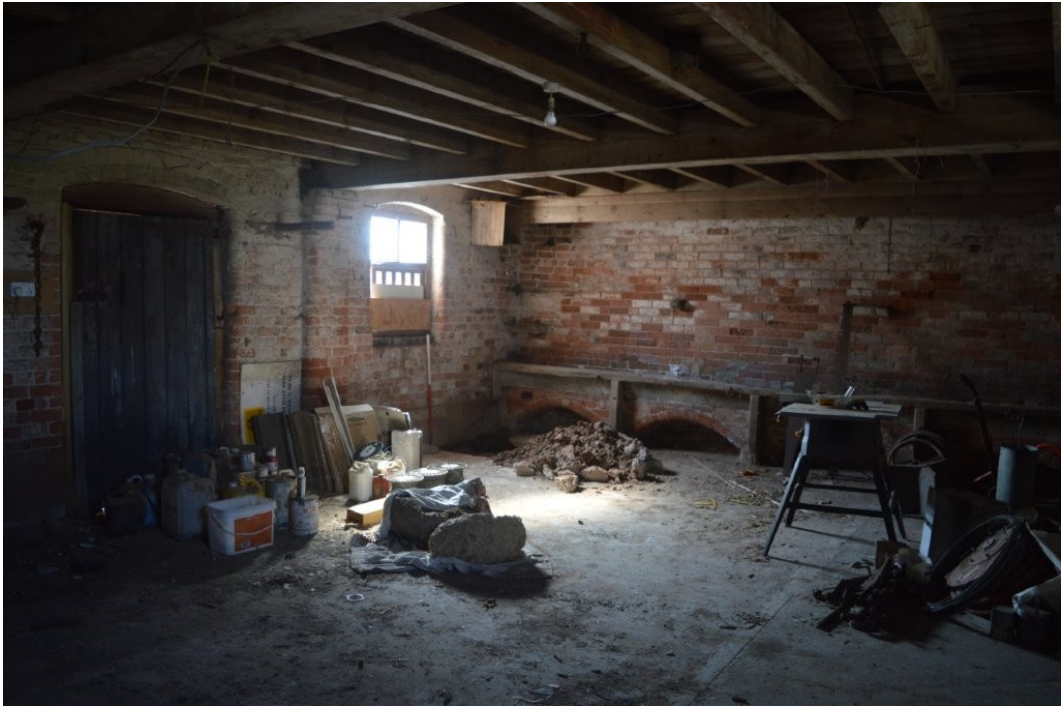
*Plate 17. Stables on the ground floor of two storey section, view south-east, scale 1m*

The ground floor space of the two storey section of the building is a single space with bare brick walls, formerly limewashed (Plates 16 and 17). The floor is of concrete and a recently dug test pit in one corner of the room shows that this does not cover an earlier surface.

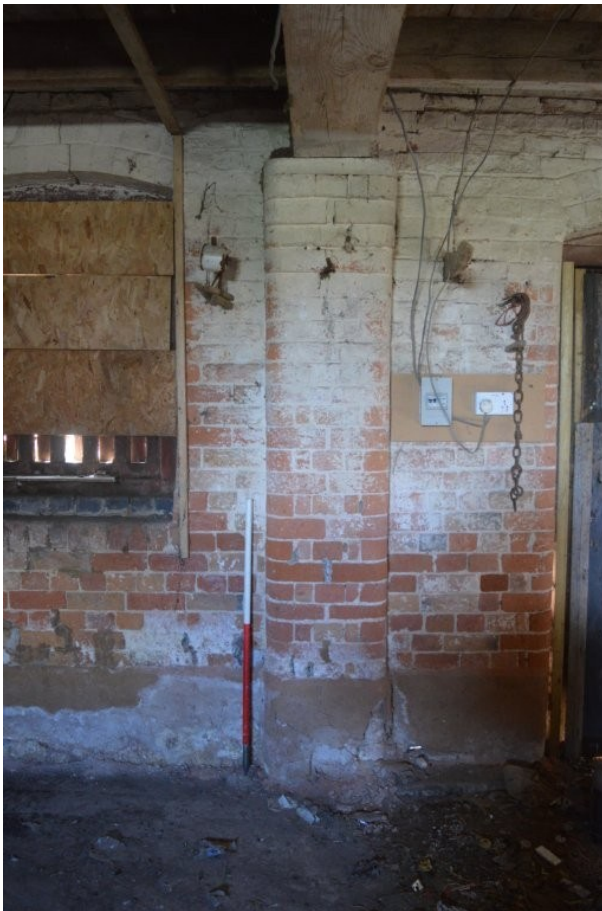
*Plate 18. Brick pilaster supporting transverse beam in stables, view east, scale 1m*

The exposed joists of the floor above are carried on two substantial transverse beams, partially set into the wall and also resting on moulded brick pilasters in which the upper four rows are set progressively forward to form a wider space on which there is a wooden pad (Plate 18). The beams are squared with no chamfer and there are clear circular saw marks (Plate 19).

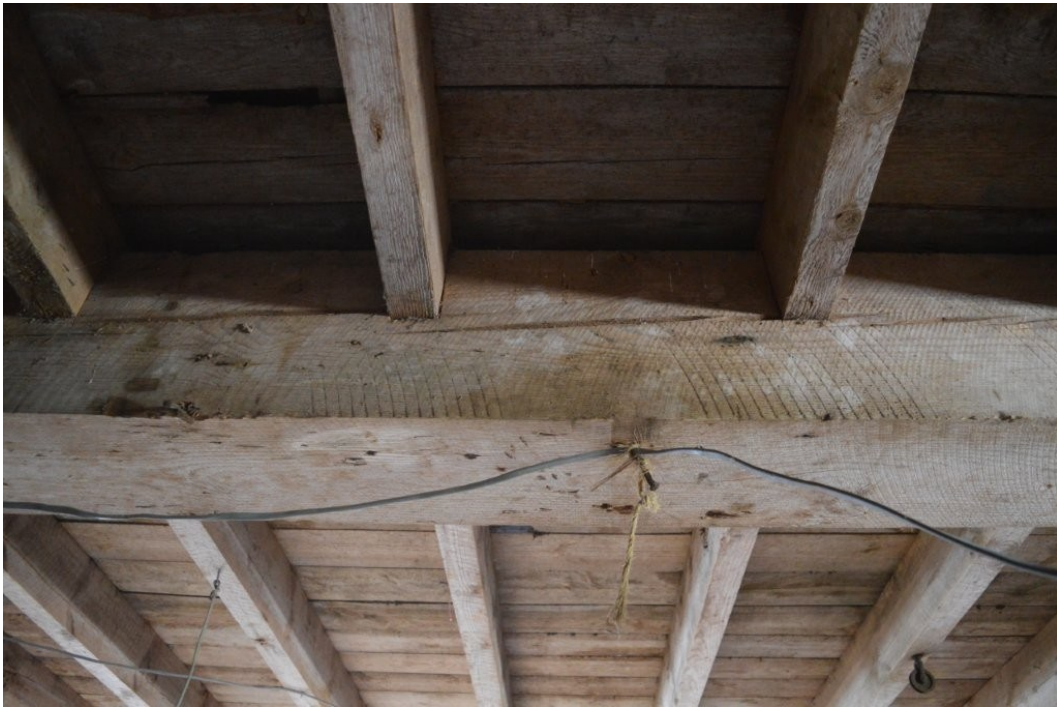
*Plate 19. Circular saw marks on transverse beam above stables, view south*

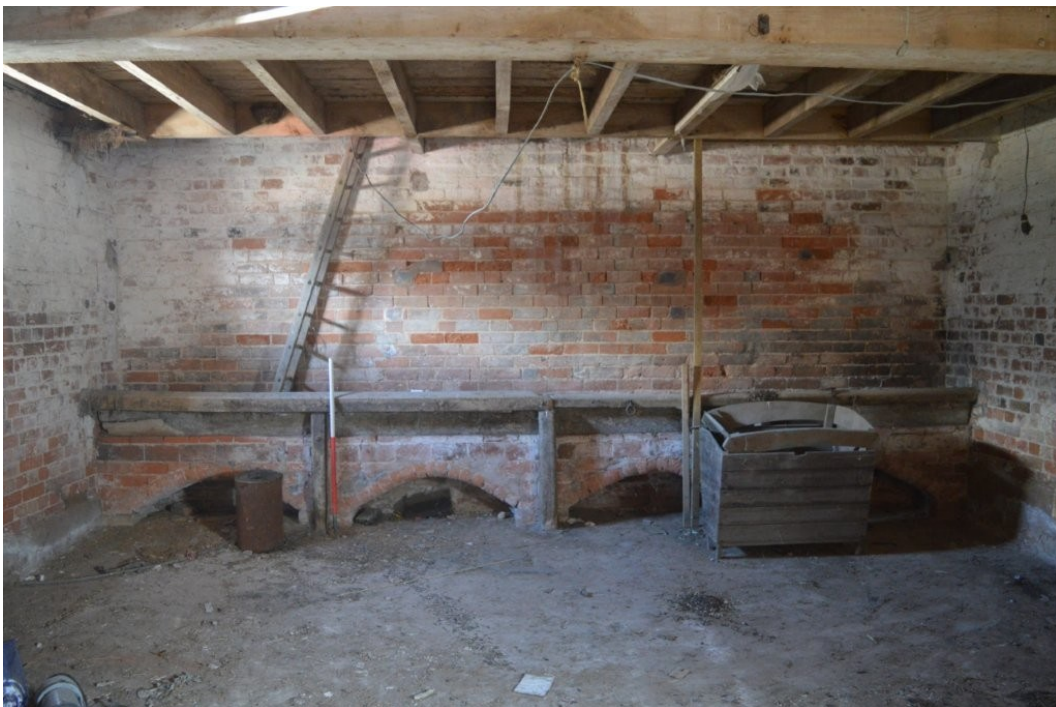
*Plate 20. Feeding trough at northern end of stables, scale 1m*

At the northern and southern ends of the building are wooden feeding troughs, each supported on four shallow arches of moulded brick (Plates 20 and 21). The horizontal front member of the trough is set into the wall on either side and supported by a post between each arch and has tether rings attached.

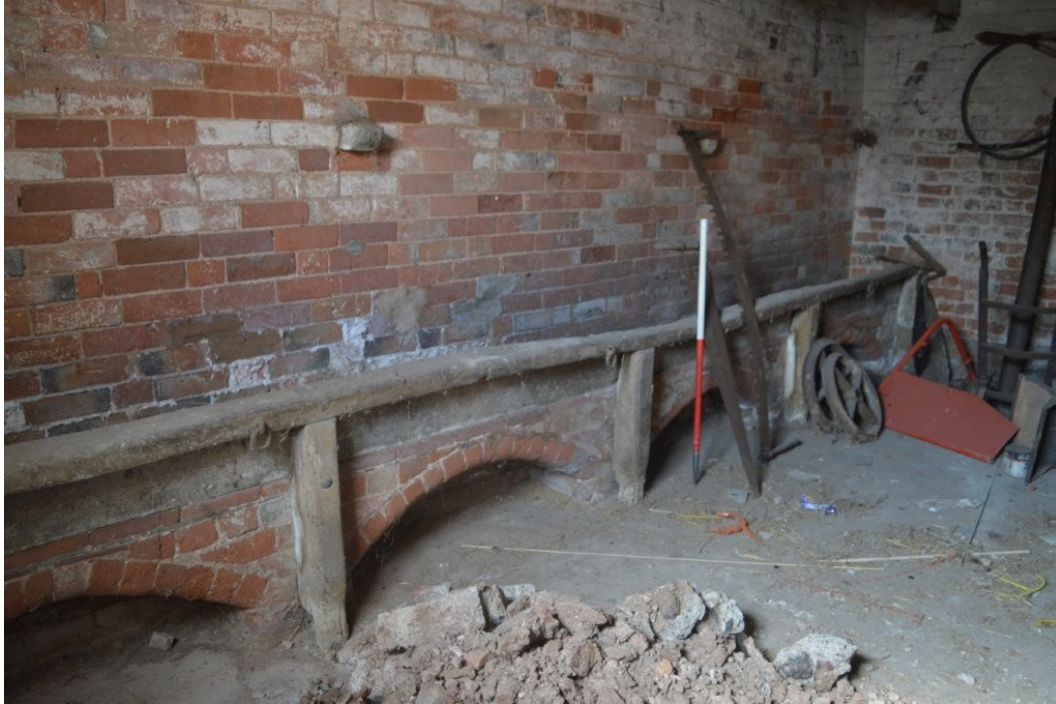
*Plate 21. Feeding trough at southern end of building, view south-west, scale 1m*

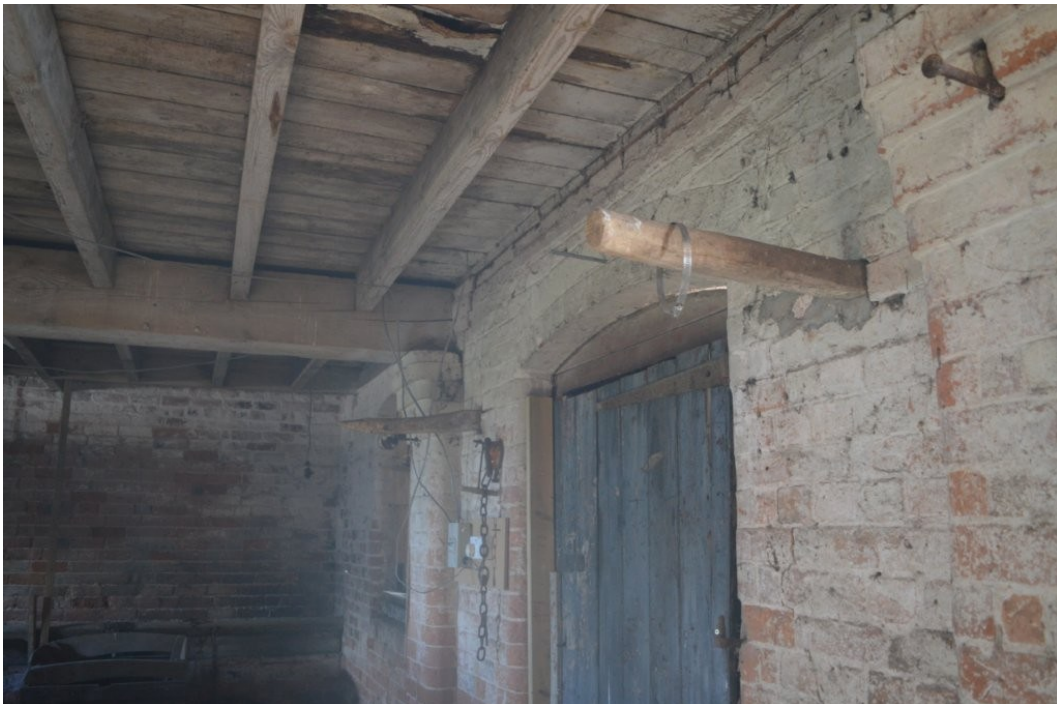
*Plate 22. Tack pegs either side of eastern door in stables*

Either side of the doorway in the western wall are wooden pegs for holding tack (Plate 22).

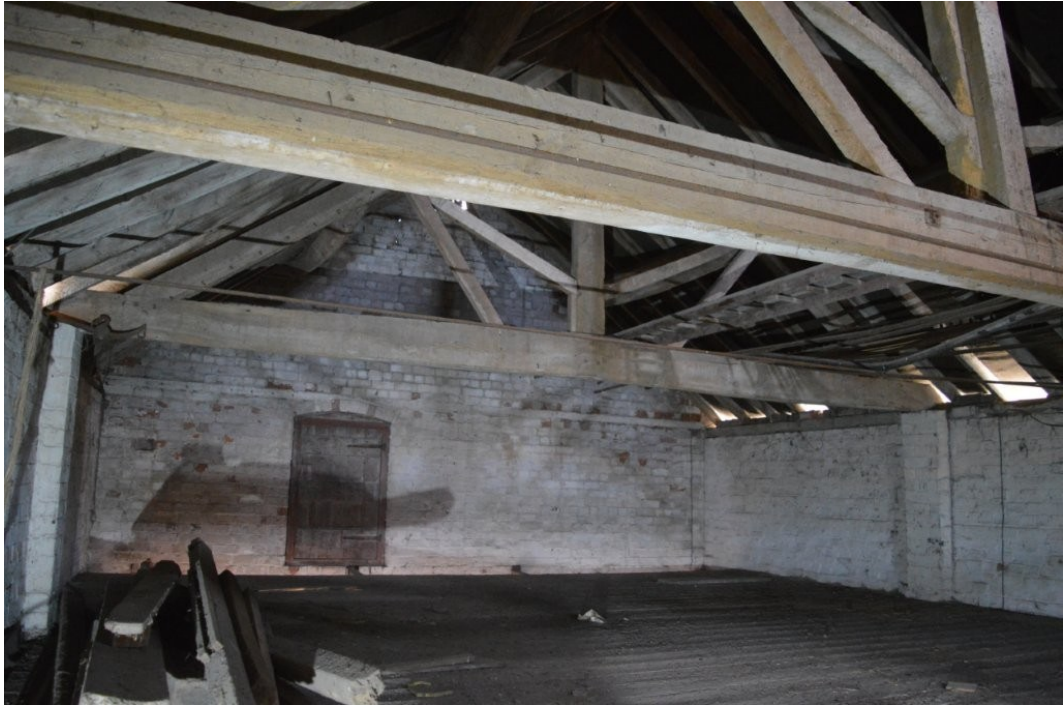
*Plate 23. The hay loft, view south-west*

The hay loft above, accessed by a ladder through the hay drop, is also a single space open to the rafters (Plate 23). This area was only partially entered due to the slightly dilapidated state of the floorboards.

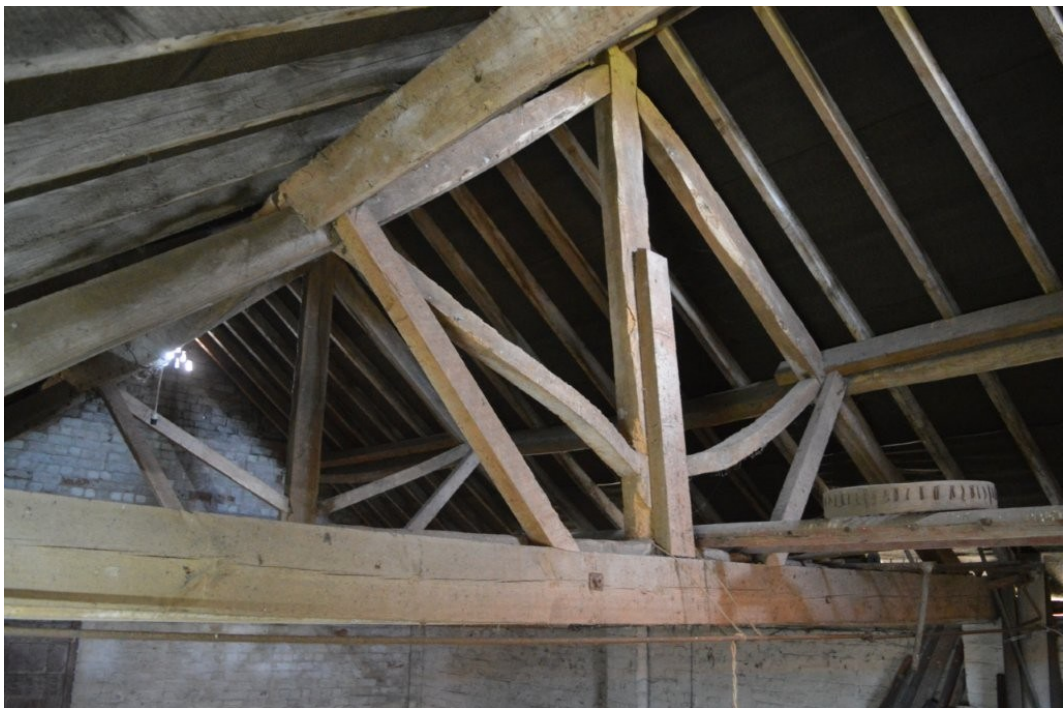
*Plate 24. Roof trusses in hay loft, view south-west*

Two internal trusses define three bays. These are of king post form with raking struts to the principal rafters although these are strengthened by an additional strut at a steeper angle which joins the principal rafters at the same position (Plate 24). It is likely that these are later additions. The purlins are trenched and these also appear to have been strengthened in sections by additional sections above (Plate 25). There is felt beneath the slates, indicating that this section of the building has been re-roofed relatively recently and was perhaps strengthened at this point.

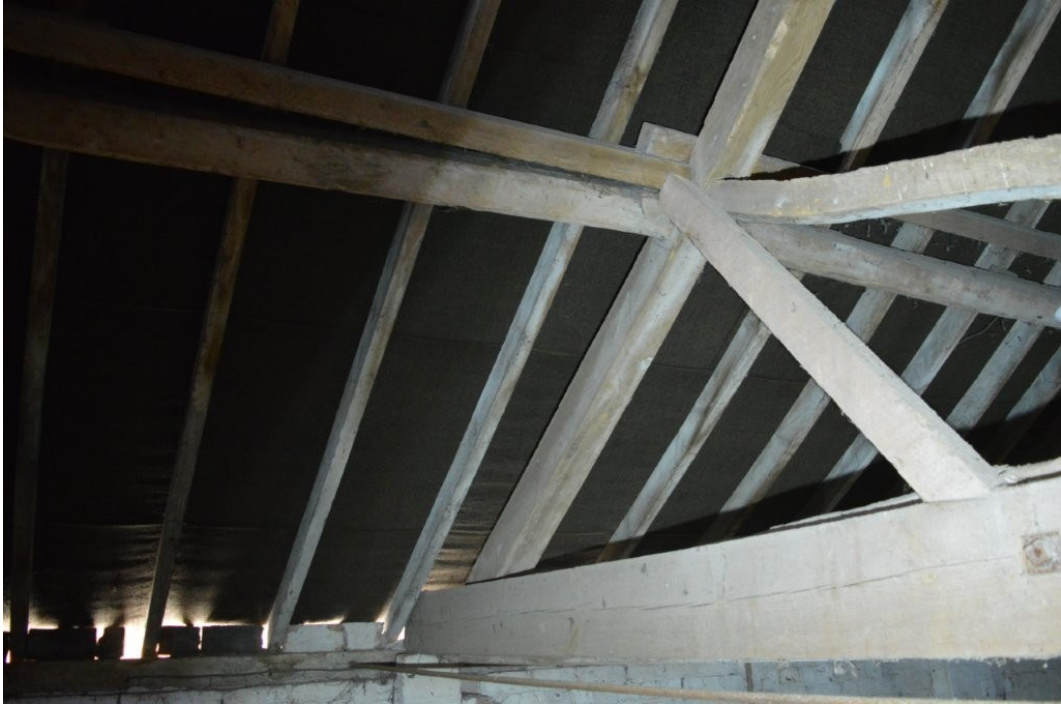
*Plate 25. View south-east showing strengthened purlin in east pitch of hay loft roof*

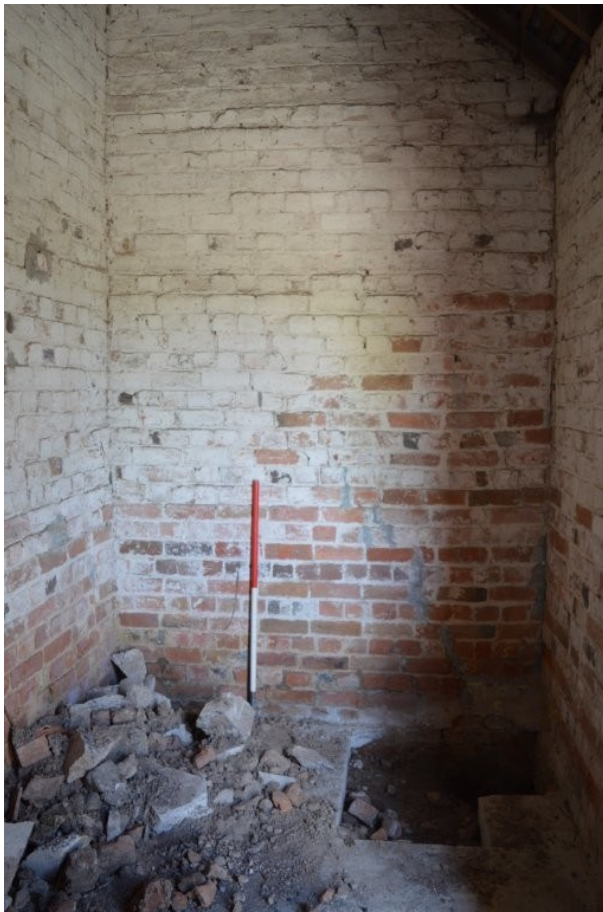
*Plate 26. West section of central area, view south, scale 1m*

The single storey part of the building is divided into two main spaces. The northern (central) of these comprises a single bay divided unevenly into east and west sections by a wall into which a later doorway beneath a steel lintel has been formed. The western part of this bay is a small, bare space

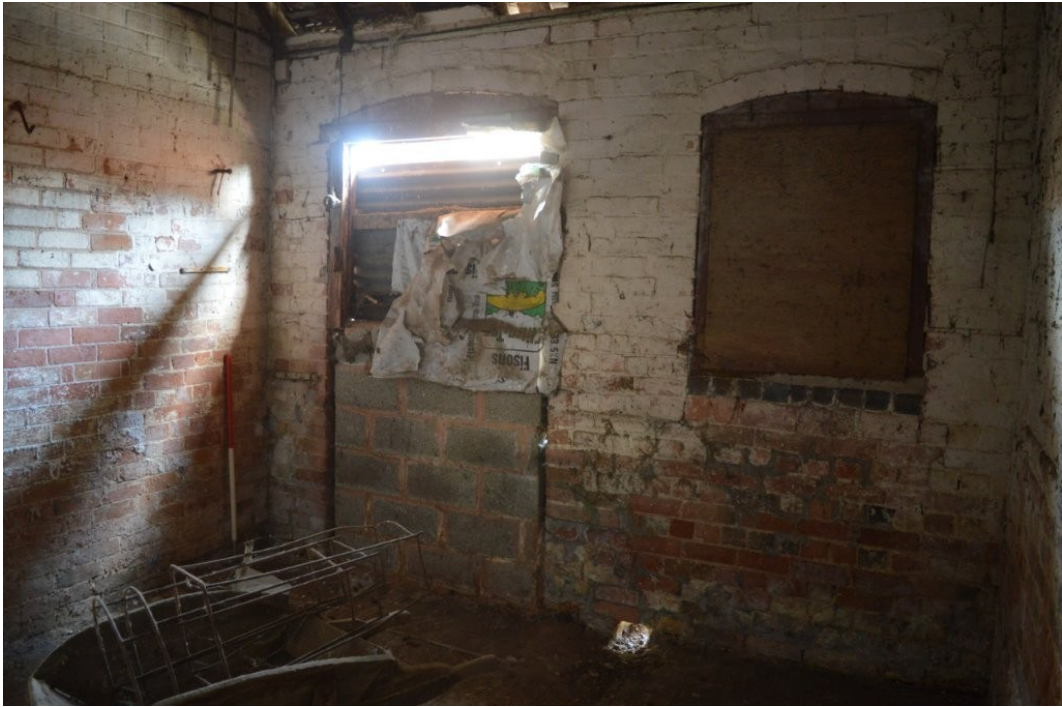
*Plate 27. East side of central section, view north-east, scale 1m*

with white painted walls and a concrete floor (Plate 26). The eastern part of this end of the building (Plate 27) has a brick floor with gullies leading to a floor level aperture in the east wall (Plate 28). The remains of a lath and plaster ceiling are attached to the rafters and the off centre door from the hay loft is in the north wall (Plate 29). It is thought that this room was probably a loose box with a door (now partially blocked) leading onto the courtyard and an easy means of dropping hay from the adjacent loft.
