# Ambrey Archaeology Ltd

## Historic Building Recording of Stables Barn, Valley Farm, Elmley Lovett, Droitwich Spa

Project AMB295

WSM81756 (Event No)

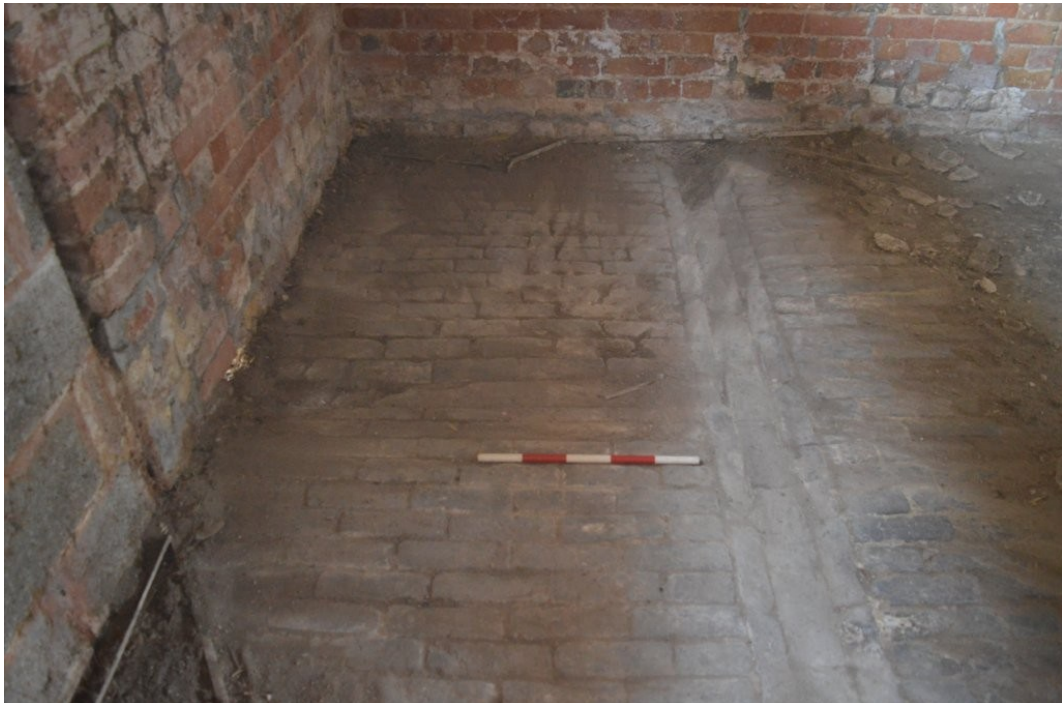
*Plate 28. brick floor in eastern side of central section, view south, scale 0.5m*

with white painted walls and a concrete floor (Plate 26). The eastern part of this end of the building (Plate 27) has a brick floor with gullies leading to a floor level aperture in the east wall (Plate 28). The remains of a lath and plaster ceiling are attached to the rafters and the off centre door from the hay loft is in the north wall (Plate 29). It is thought that this room was probably a loose box with a door (now partially blocked) leading onto the courtyard and an easy means of dropping hay from the adjacent loft.

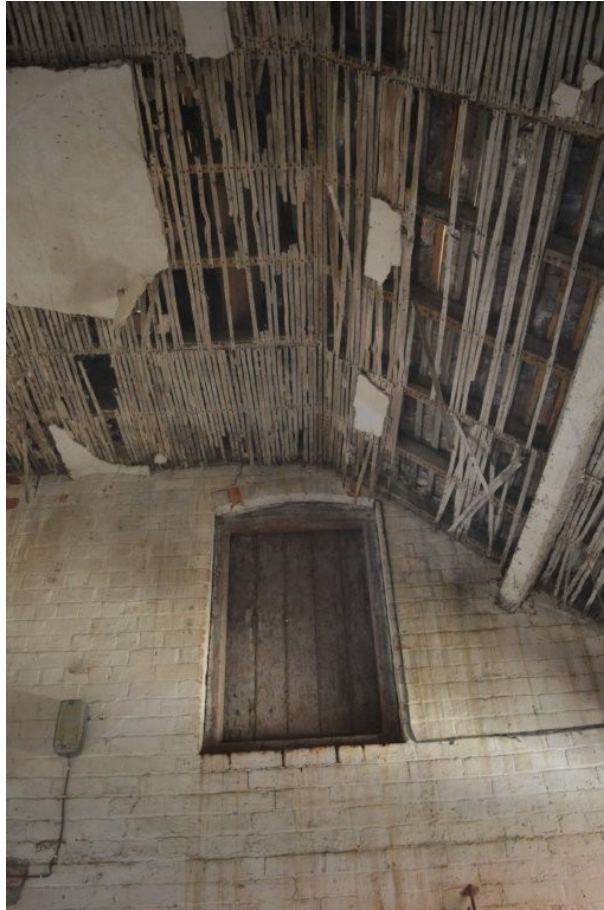
*Plate 30. View west-south-west in southern room of building, scale 1m*

The southern part of the building was, in recent years, converted into an artist's studio (Plates 30 and 31). It has a concrete floor, the wall is lined with painted chipboard and there is an inserted ceiling.

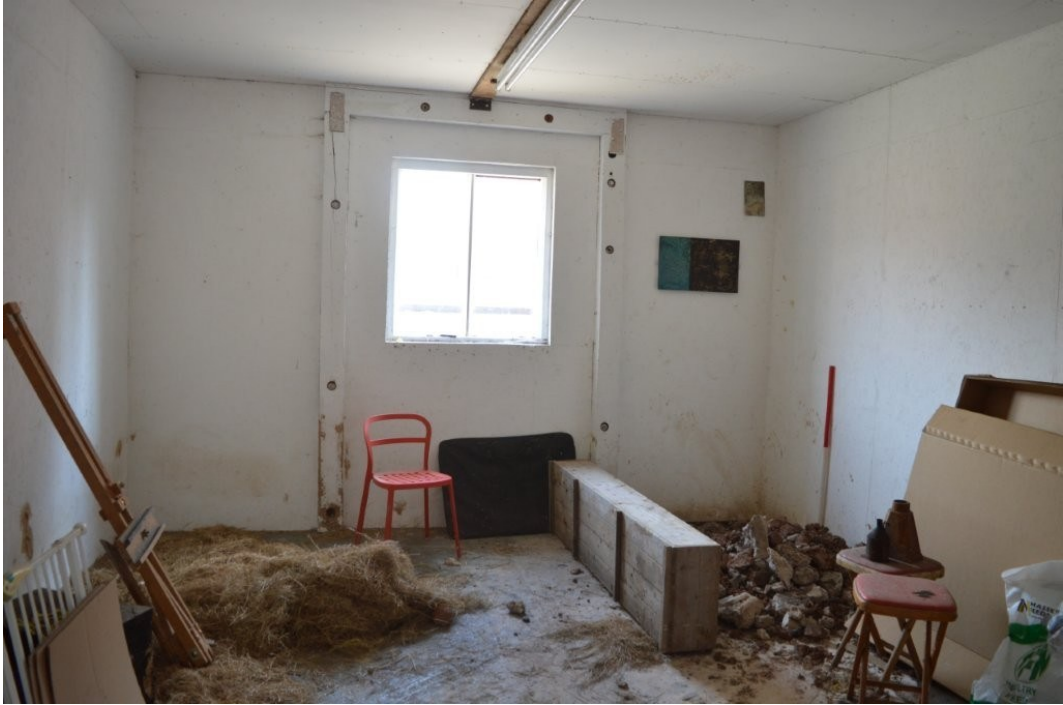
*Plate 31. View north east in southern room of building, scale 1m*

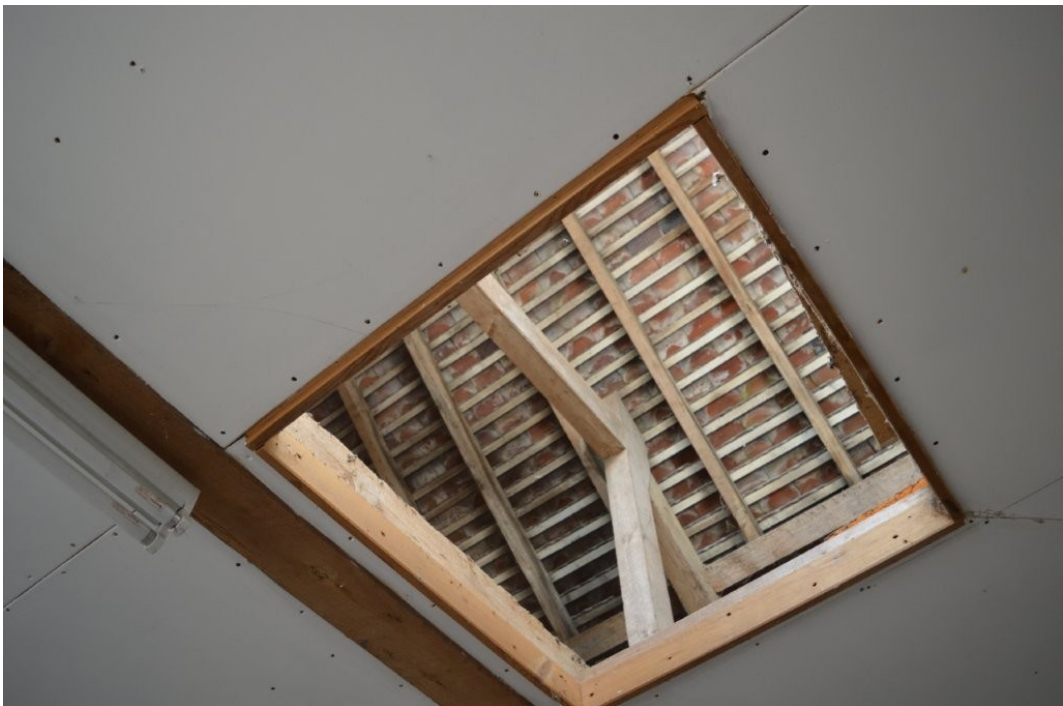
*Plate 32. View into attic space above southern room*

The roof space above this section of the building was not accessible, but a central truss, creating a two bay space was visible through a hatch. The truss is of queen post form in which the principal rafter does not extend above the straining post. There is a single trenched purlin central to the principal rafter.
