# Ambrey Archaeology Ltd

## Archaeological Monitoring and Recording (watching brief) at Upton House Farm, Elmley Lovett, Droitwich

Event No: WSM81019

Date: 22<sup>nd</sup> April 2025

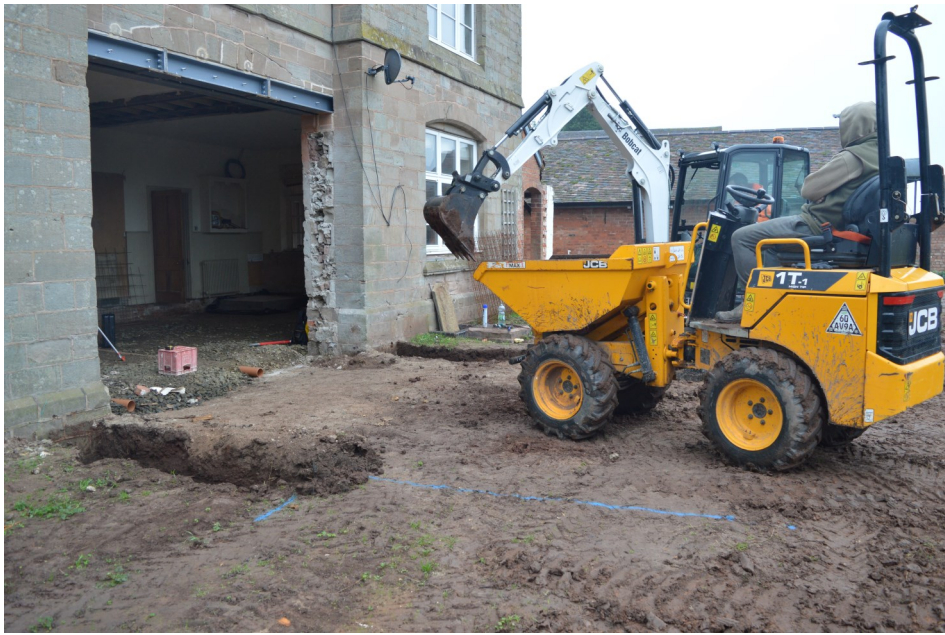
**Trench 1** (Fig. 5) was located to the SSW of the house and comprised 3 arms, the north-south oriented wings measuring 3m, joined by an E-W wing of 5m. Prior to the excavations the site had been cleared (Plate 1) leaving the top layer of made ground (101); a moderately loose mid-brown sandy silt containing roots and infrequent pebbles and some broken pipe work. The foundation plinth of the house (Plate 2) was evident in the east and west arms (108) and in the western arm a gas pipe (109) was recorded close to the surface within (101).

*Plate 1. View north-east mid way through excavation of Trench 1*

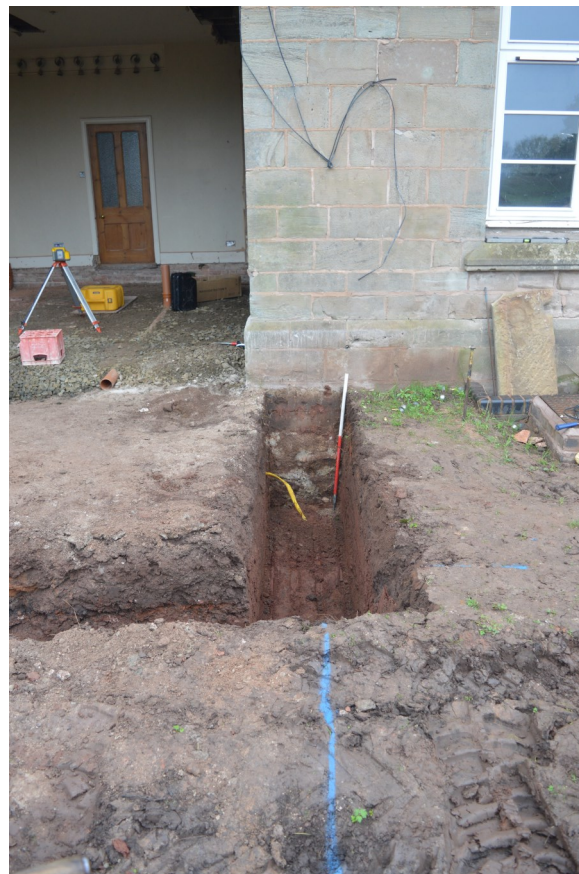
*Plate 2. View NNE of eastern arm of Trench 1, scale 1m*

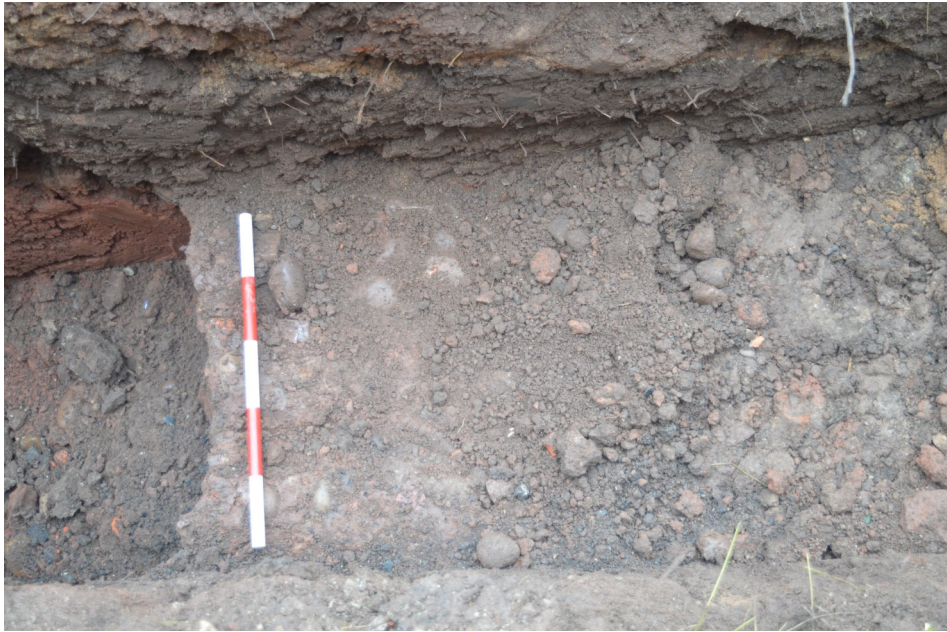
In the east-west arm of the trench, beneath a buried tarmac surface (106) at 0.57m bgl, a surface comprising cobbles and cbm and modern pottery (105, Plate 3) overlay the natural substrate.

In two locations, surfaces and structural features were recorded which may be related to earlier buildings which stood at the site. To the rear of the house in Trench 1, partial remains of a cobbled surface were recorded at about 0.80m below ground level. This may have been a farm surface associated with either Upton House in its current form or with the earlier building which stood on the site. No dateable finds were recovered from this context.

*Plate 3. View SSW of (105), cobbled layer, Trench 1, scale 0.50m*

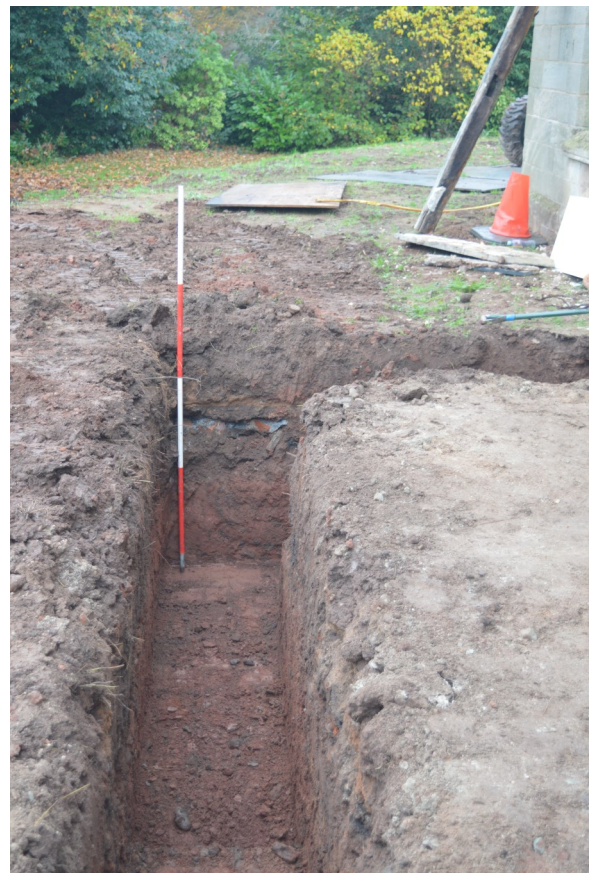
Overlying the natural substrate in the south-western corner of the trench was the remains of a brick surface set in asphalt (107, Plate 4).

*Plate 4. View WNW along southern arm of Trench 1, scale 2m*

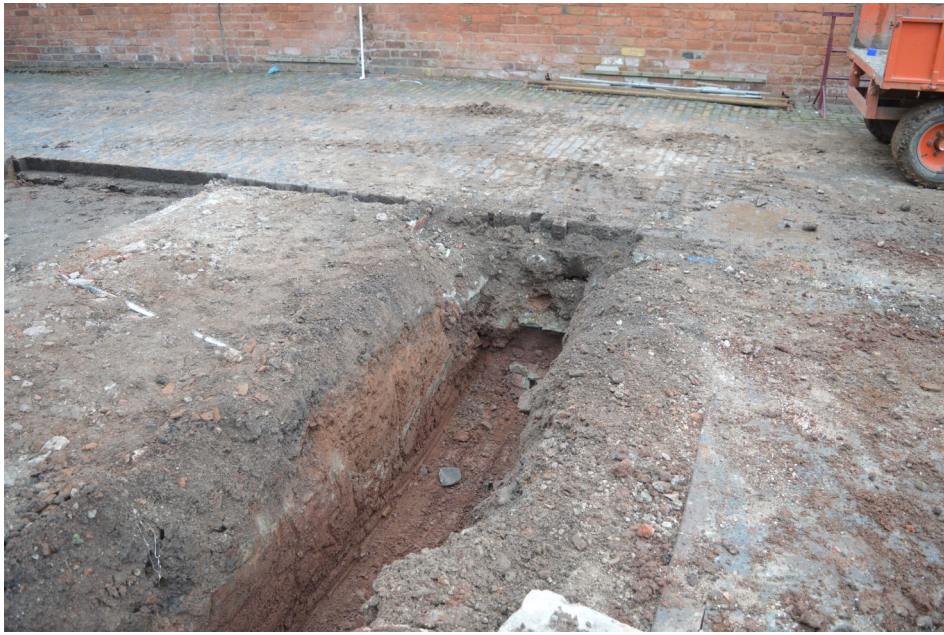
**Trench 2** (Fig. 6), located to the SE of the SE corner of the house, comprised four arms, 2m N-S, 5m E-W, an eastern N-S arm of 4m and a northern arm of 3m. Prior to groundworks taking place a surface of Shropshire Blue brick was removed by the contractors. Some bricks remained in the eastern part of the trench (211) with a modern water pipe (209) running beneath them along the eastern edge of the trench (Plate 5).

*Plate 5. View ENE of southern arm of Trench 2*

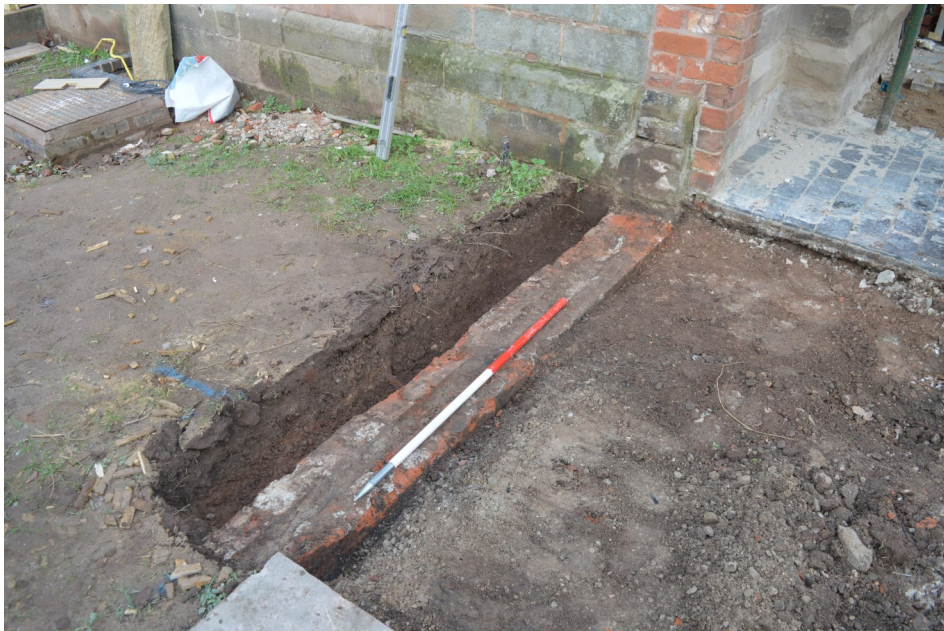
Elsewhere the top layer of the trench was similar to that in Trench 1; a layer of made ground comprising a loose silty clay with cbm (201). Immediately beneath this, two brick courses of a former garden wall (202) were encountered in the western arm of the trench (Plate 6). The brick courses were laid on a thin layer of concrete. The wall comprised two rows of bonded brick, oriented NE-SW, with a central cavity with a concrete filling. It mostly lay directly on the natural substrate (204), but at the northern end of the trench where it met the SE corner of the house, part of the house foundation (217) was revealed; comprising a dressed sandstone rubble over a brick and rubble plinth 0.60m deep.

*Plate 6. View NNW of wall (202), scale 1m*

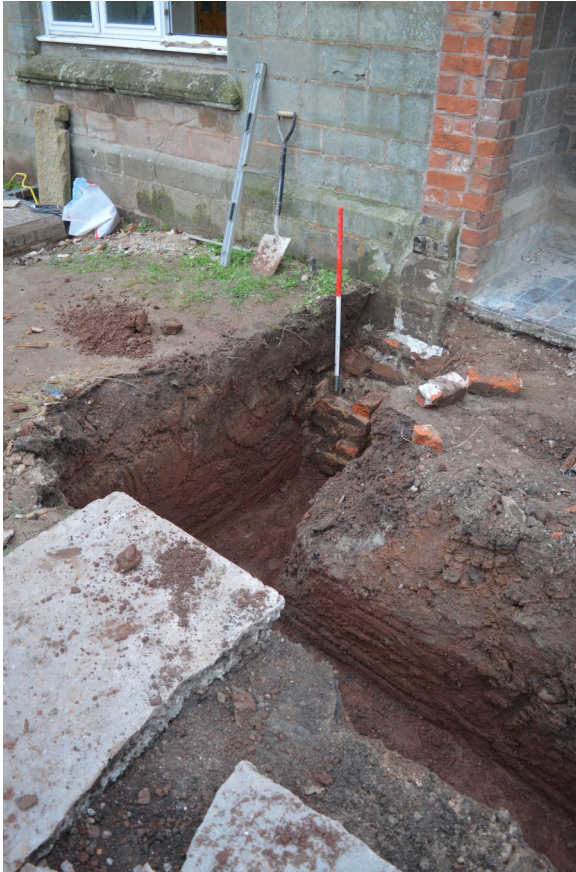
The courses of bricks forming part of the foundation which extended into the trench at this point were retained in situ (Plate 7). Further to the south, a land drain (208) ran under (202). A layer of made ground to the west of the wall comprised a purplish brown clay mixed with soft dark brown silty clay (203), containing moderate charcoal flecking and small stones, with modern ceramic, cbm and glass. In the E-W arm of the trench, to the east of wall (202), another layer of made ground (205) comprised mixed loose ashy sandy clay with frequent cbm and mortar (Plate 8). A ceramic drain

*Plate 7. View NNW of part of house foundation (217), scale 1m*

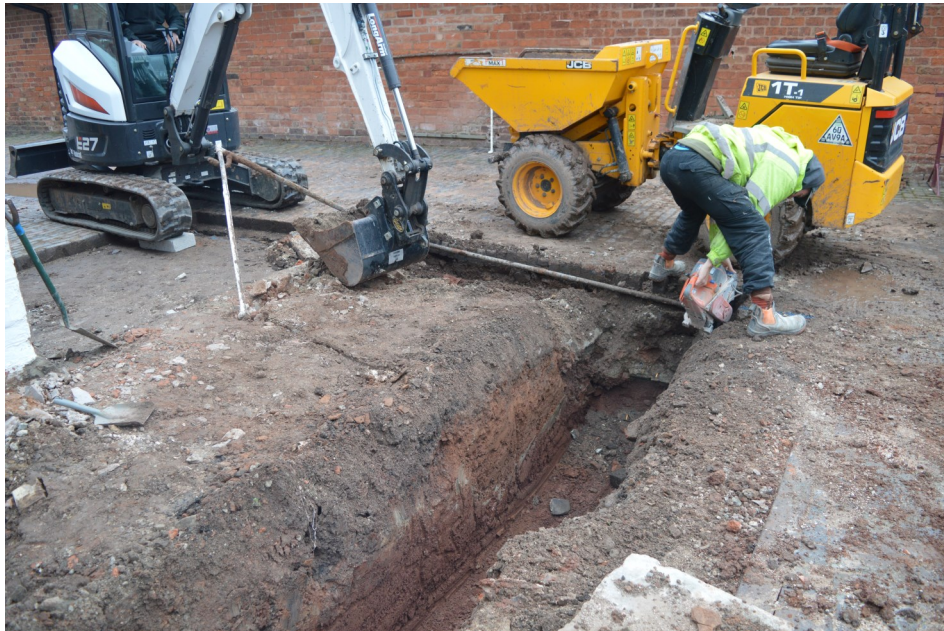
*Plate 8. View NE of the southern arm of Trench 2*

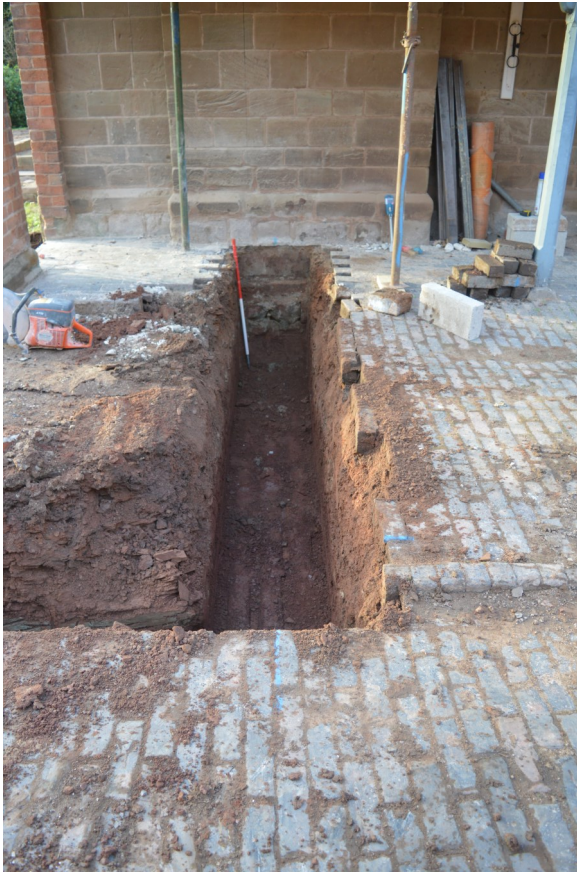
(206) was recorded in this layer. The brick foundations of the eastern wall of a recently demolished shed (207) were encountered in the eastern arm of the trench, similar to garden wall foundations (202). A line of foundation stones for the covered walkway was uncovered (210) and a plinth for the standing wall comprising coursed rubble and brick (216, Plate 9). Plate 10 shows the trench fully excavated.

*Plate 9. View ENE along northern arm of Trench 2, scale 1m*

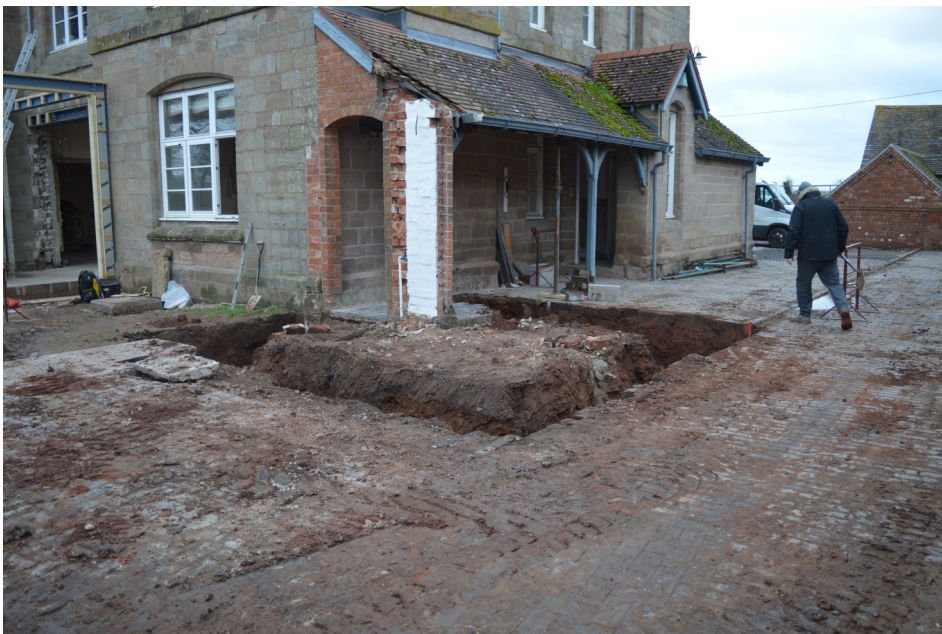
*Plate 10. View NW of Trench 2*

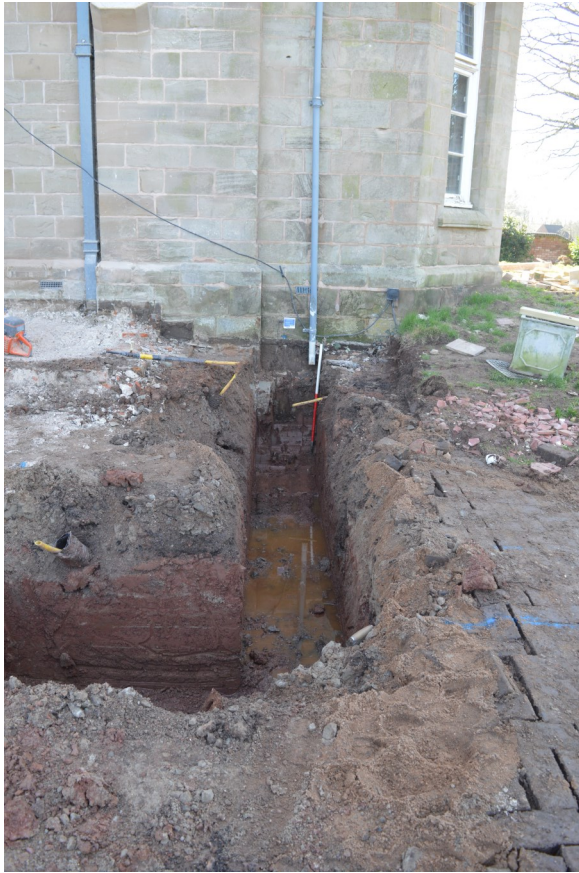
Made ground was recorded in Trench 3 comprising a soft grey sand with frequent charcoal (301) (Plate 11). The area was heavily disturbed by services – a gas pipe in the west of the trench close to the house (302) two drainage inspection chambers one (304) of concrete on breeze blocks in the west of the trench and one brick built chamber in the central trench (309), both measuring about 1m<sup>2</sup> with plastic drain pipes leading to and from them (303) and (310). Further foul pipes/drainage pipes were recorded in the trench (312) and (313) (Plate 12).

*Plate 11. View SSW  
along the western arm of  
Trench 3, scale 1m*

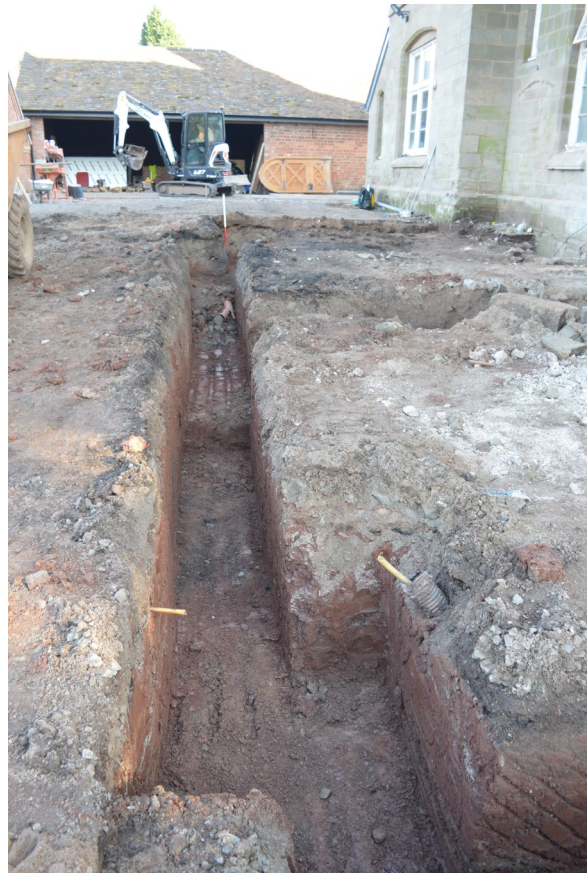
*Plate 12. View ESE along north-  
ern boundary of Trench 3, scale  
1m*

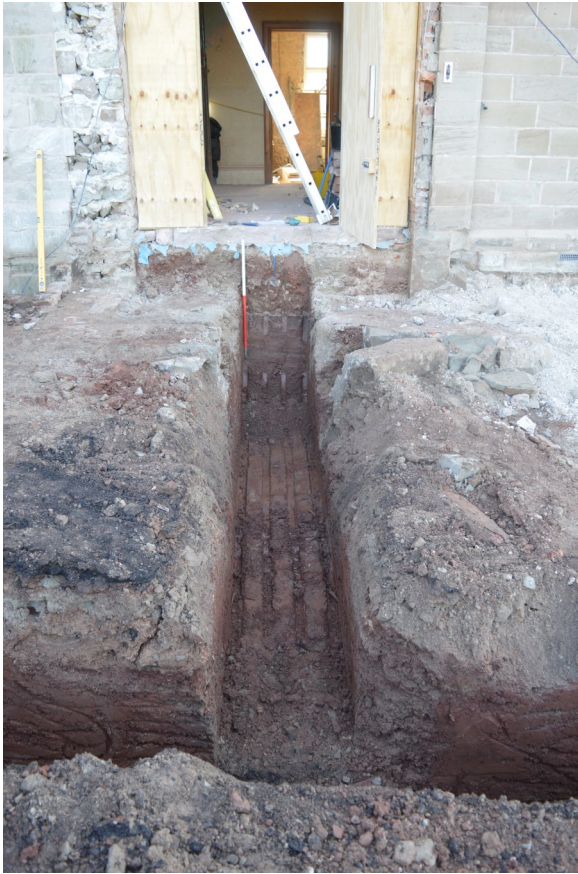
In addition the footing of the removed porch was recorded (308) comprising a line of sandstone rubble, 0.50m wide (Plate 13).

*Plate 13. View SSW along central arm of Trench 3, scale 1m*

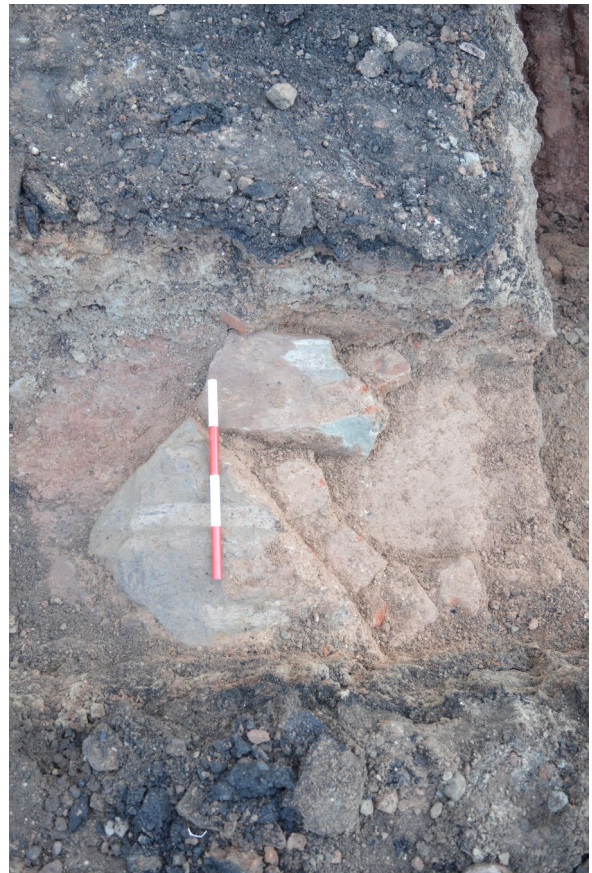
The possible foundation or demolition layer from a former garden wall was recorded (311); comprising a sandstone boulder and smaller stones and cbm in a mortar-rich matrix, 1 layer of stones maximum 0.70m wide (Plate 14).

The remains of a masonry structure, of rubble and brick, were recorded to the north of the house in Trench 3. A single course of stones overlay bricks which were not bonded with any regularity and the feature may have been the remains of a demolished structure deposited in this location as a revetment or to build up the ground. If it is the remains of a wall foundation the wall is likely to have been a garden feature.

*Plate 14. View WNW of 9311) possible garden wall foundation, scale 0.40m*

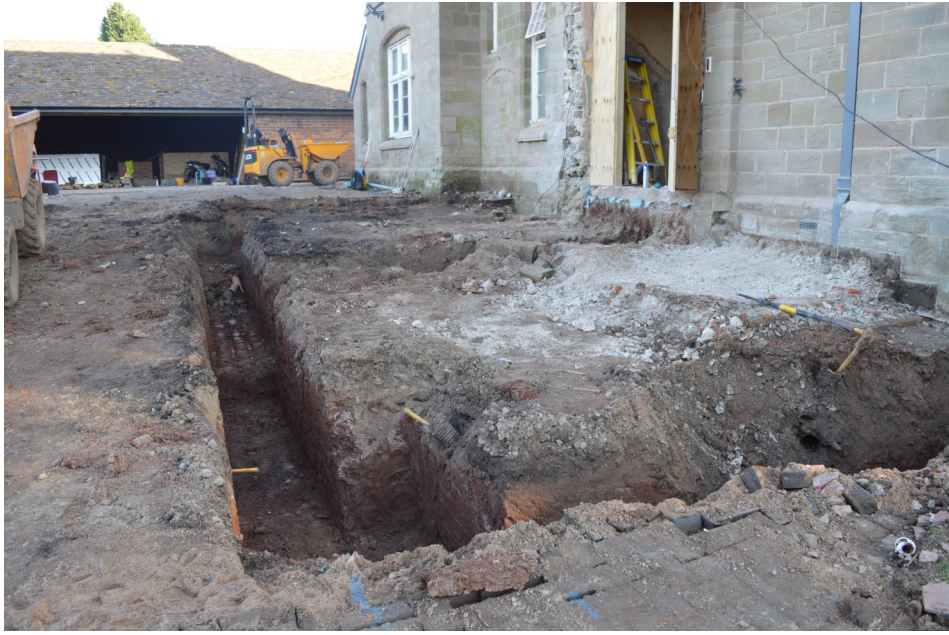
The natural substrate was recorded from a depth of 0.20m (305). Plate 15 shows the trench fully excavated.

*Plate 15. View SW of Trench 3*
