Ambrey Archaeology Ltd

Historic building recording of Ford Cottage, Stourport road, Charlton, Hartlebury

Project AMB289

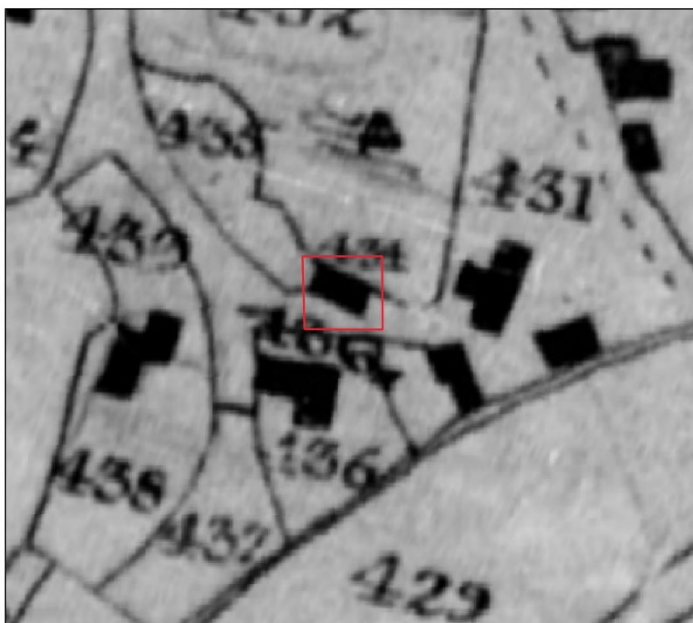
Fig 4. Extract of 1838 tithe map of the parish of Hartlebury

On the 1838 tithe map (Fig 4) of the parish of Hartlebury, a building is shown in the location of Ford Cottage as a simple rectangle numbered 434. In the apportionment which accompanies the map and identified as 'A Cottage' owned by George Hallen Esq and occupied by John Broom who had a garden close by. The small plot numbered 435 which adjoins the cottage to the north-west is a garden owned and occupied by George Harris. The line of the bank is visible immediately to the rear of the cottage to the east.

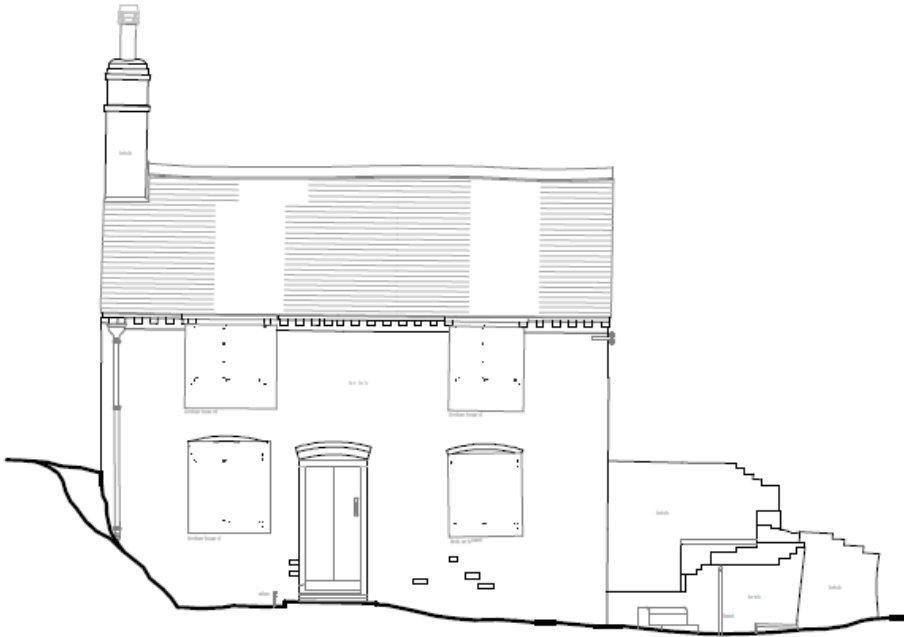
Figure 9. South-west elevation

On the ground floor a central doorway has a segmental arch of brick headers on sides with flat headers over (Plate 3). The doorway is filled with a boarded door which is ledged to the interior. The windows are boarded up with plyboard with parts of the brick arches visible. On the left hand side flat headers are visible and on the right hand side the upright headers are visible with flat headers over.

There are two windows to the first floor, both also covered with plyboard.

There is brick dentilling beneath the eaves. The first floor windows are both directly beneath the eaves with no arch, and both interrupt the dentilling (Plate 4).

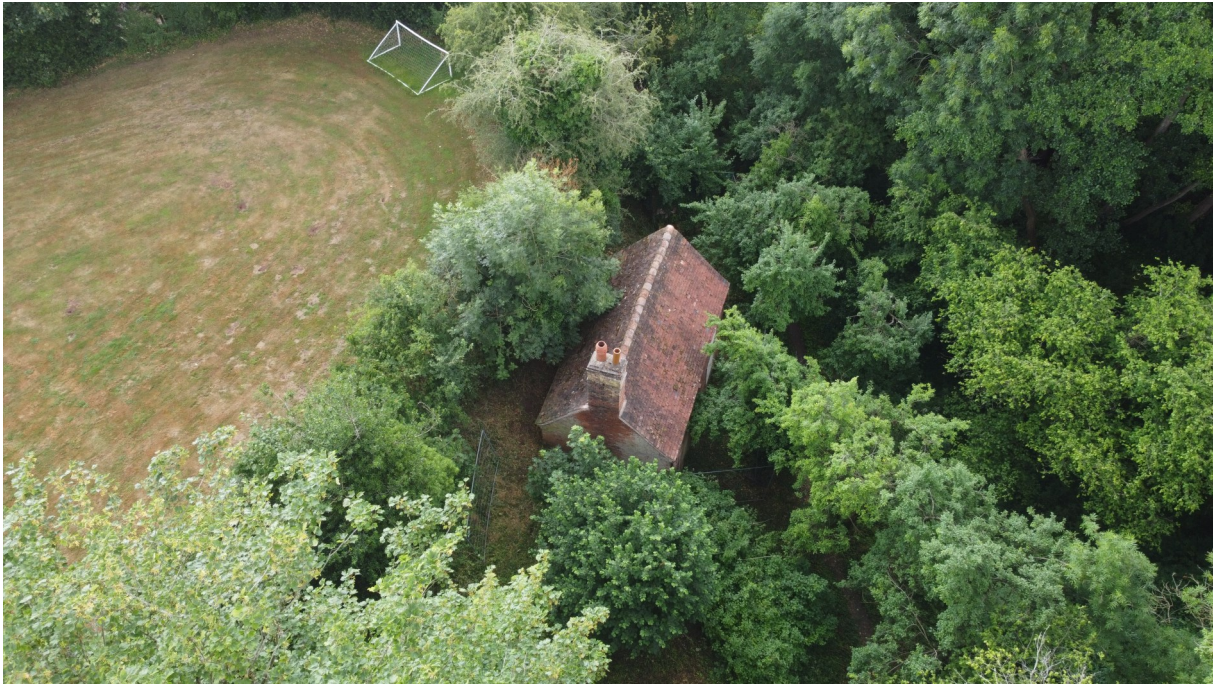
Plate 1. Low level aerial photograph of Ford Cottage, view east

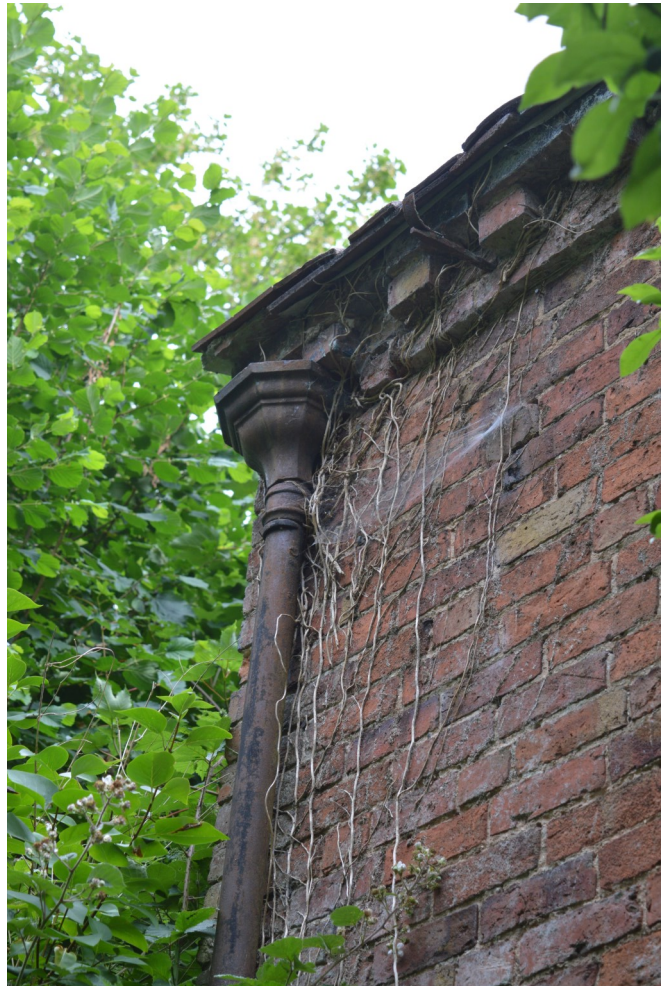
Plate 5. View west of cast iron rain-water goods

The rainwater goods are cast iron with a hopper head collecting rainwater directly from the roof in the left-hand corner of the elevation (Plate 5).

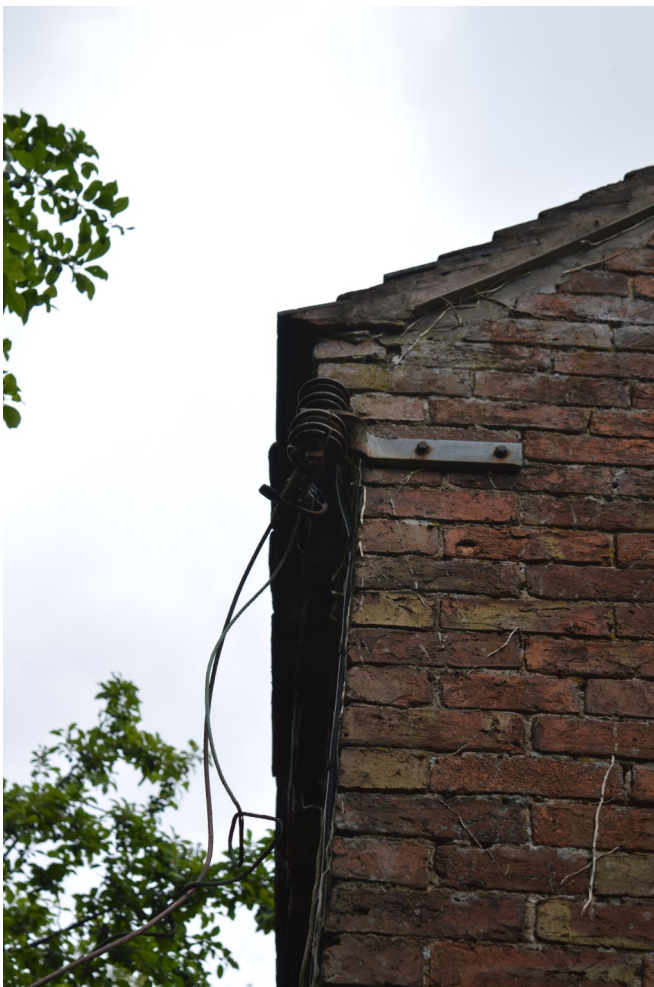
Plate 6. Ceramic insulator on corner of front elevation

Parts of former electrical fittings survive on the right-hand corner of the elevation, including a ceramic insulator (Plate 6).

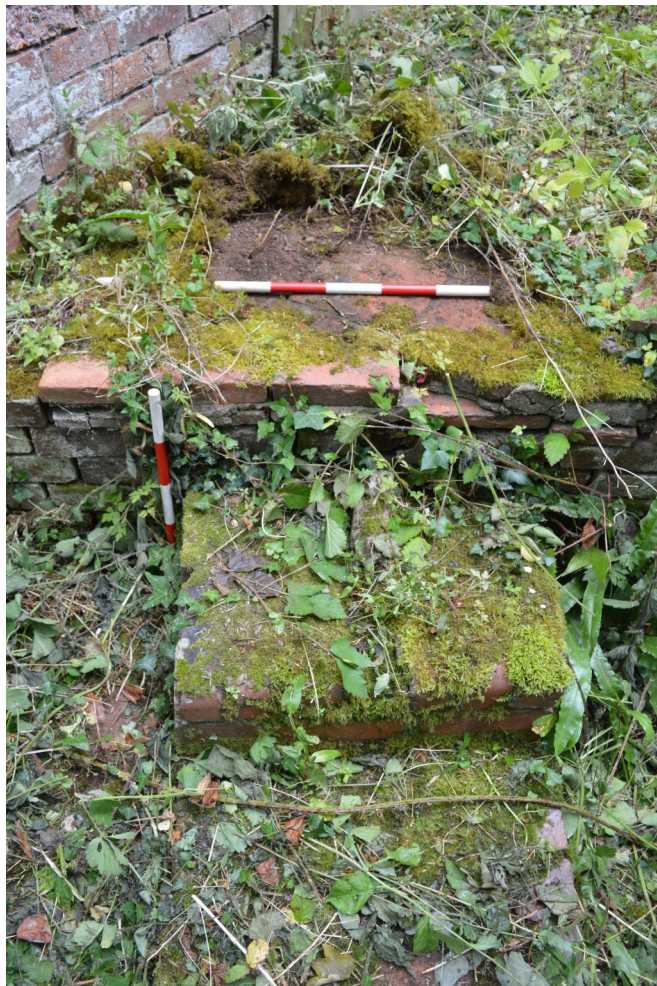
Plate 9. Steps to former outshot, scales 0.40 and 0.50m

Steps lead up to the former building, comprising roughly coursed bricks, to a floor surface higher than that of the main building (about 0.40m high), covered with quarry tiles (Plate 9).

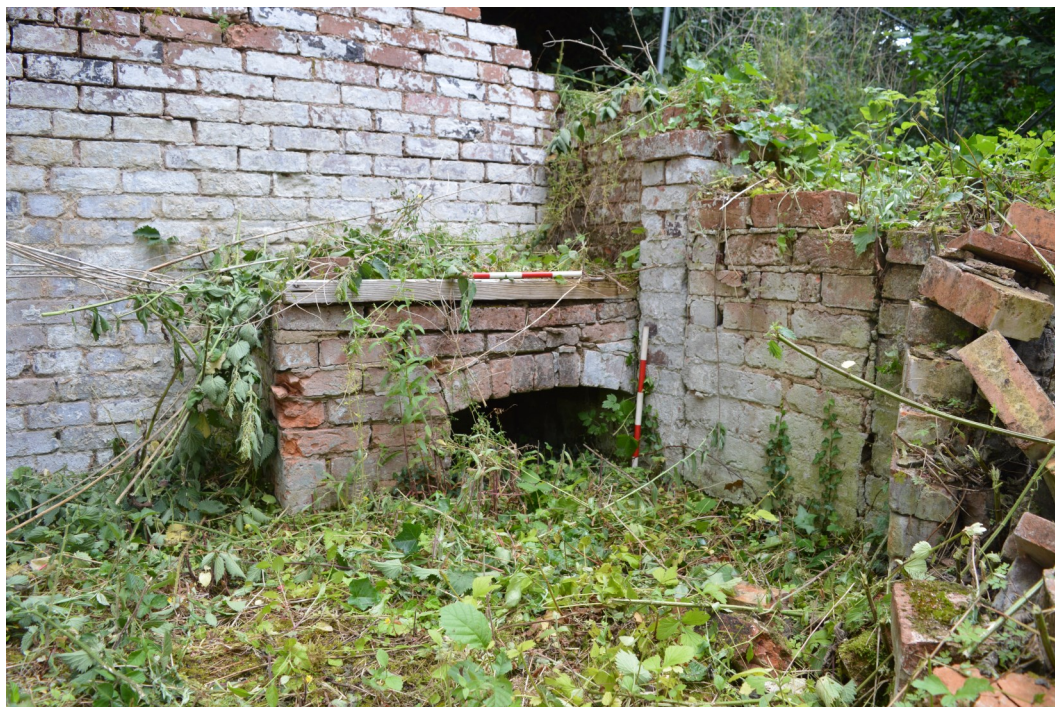
Plate 10. View north east to possible oven and blocked-up entrance/former structure, scale 0.50m

There is a low structure, probably an oven, with an arch in the rear of the building in the north-eastern corner (Plate 10 and see Plate 8). The structure is about seven brick courses high, and 5 to 6 courses long. The arch is a segmental arch of brick headers on the side, 2.5 bricks deep. The top of the structure is partly edged with timber and covered with quarry tiles, now grown over with nettles and moss. There is a blocked aperture in the south-east wall leading to a possible chimney. This appears to be a later feature than the possible oven described above as it partly obscures its arch.

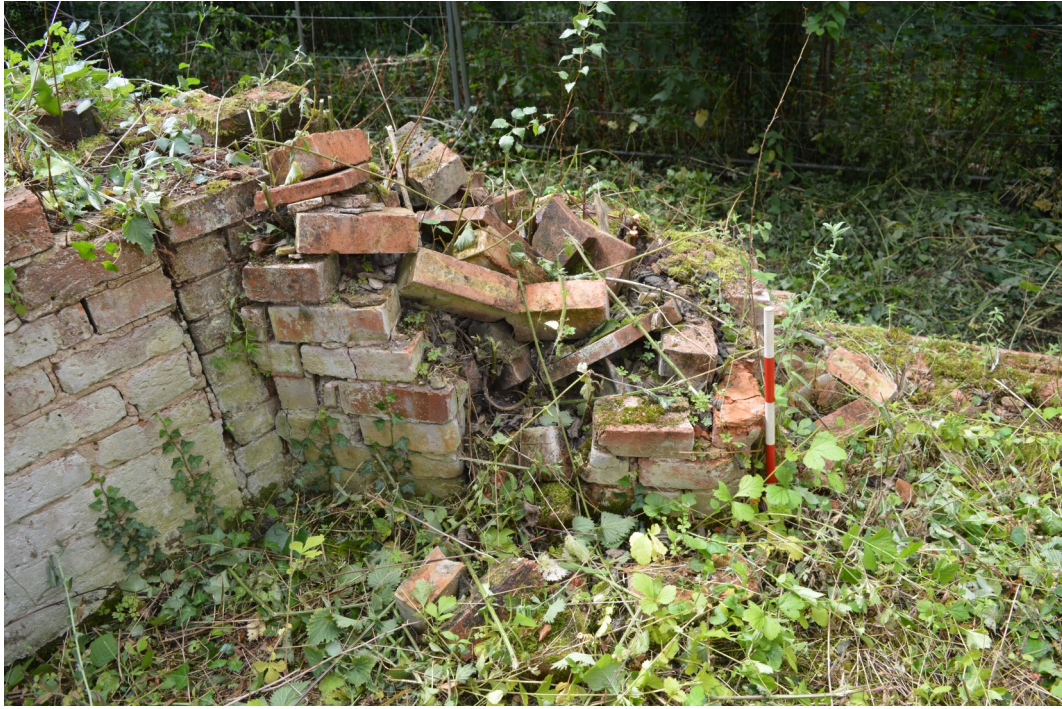
Plate 11. View south-east to possible former fire place, scale 0.40m

A collapsed brick structure in the south-eastern corner of this building appears also to have had a central aperture, probably for a fireplace (Plate 11)

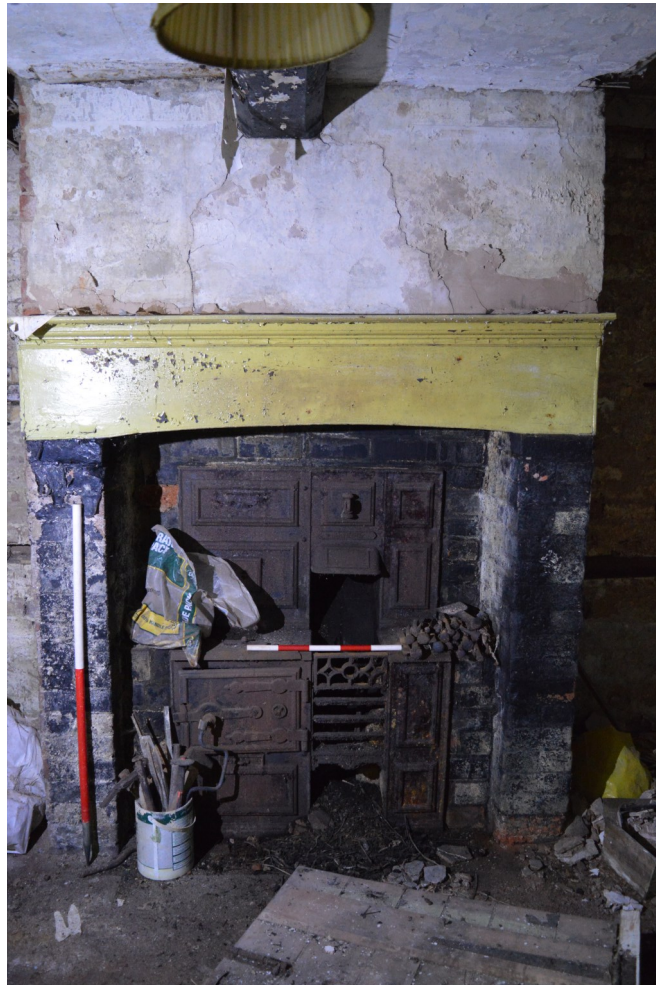
Plate 15. Cast iron range in north-west of Room A, Scales 1m and 0.50m

There is a cast iron fireplace with ovens and grates central in chimney in a brick squarish fireplace with a carved and moulded wooden mantel (Plates 15 & 16). A plate on the stove indicates that it was made or sold by L Watkins, Kidderminster.

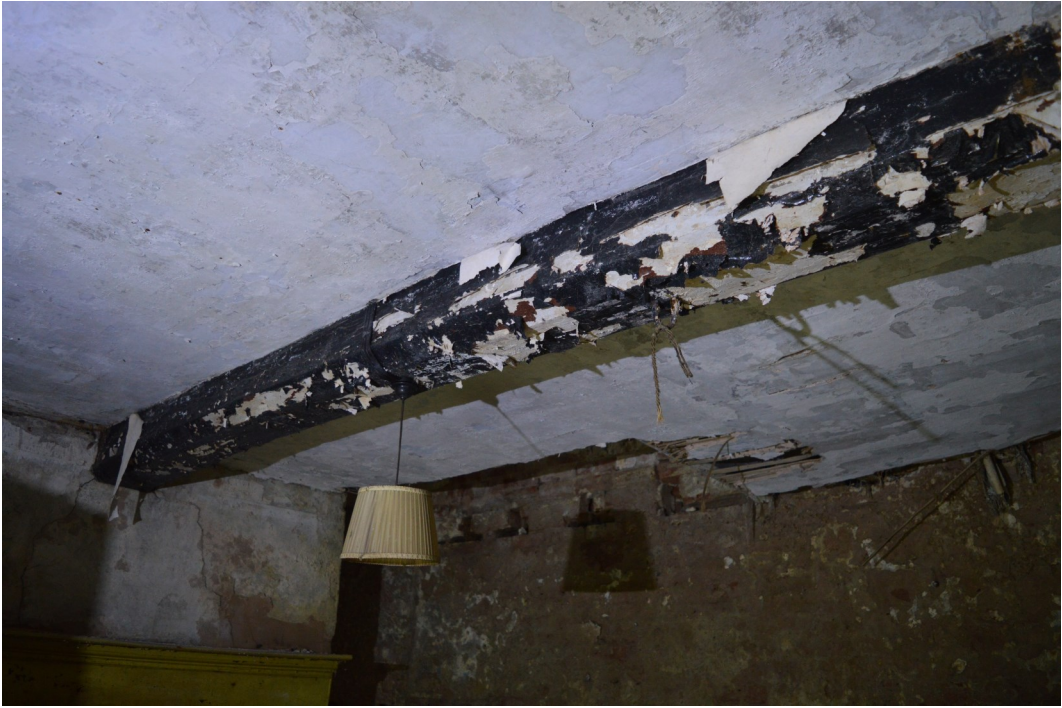
Plate 17. View north of chamfered beam in Room A

A transverse beam crosses the ceiling, heavily covered in peeling paint (Plate 17). It is chamfered with stops at the east end (Plate 18) and enters the chimney breast at the west end. There is a hook in the soffit at the SE end.

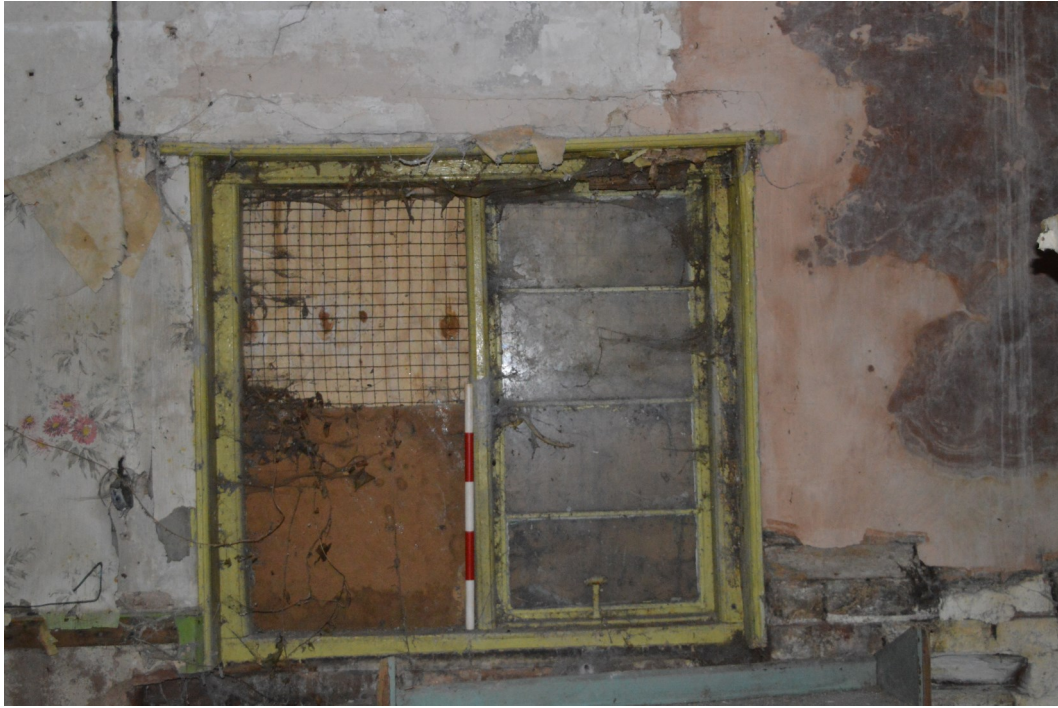
Plate 19. View south-west of Crittall style window, Room A, scale 0.50m

A window in the south-eastern wall has timber surrounds which match those of the mantel above the fireplace in decoration (Plate 19). It is filled with a two light casement window, missing glass in the left hand light. The right hand light is a side-opening light in Crittal style metal frames.

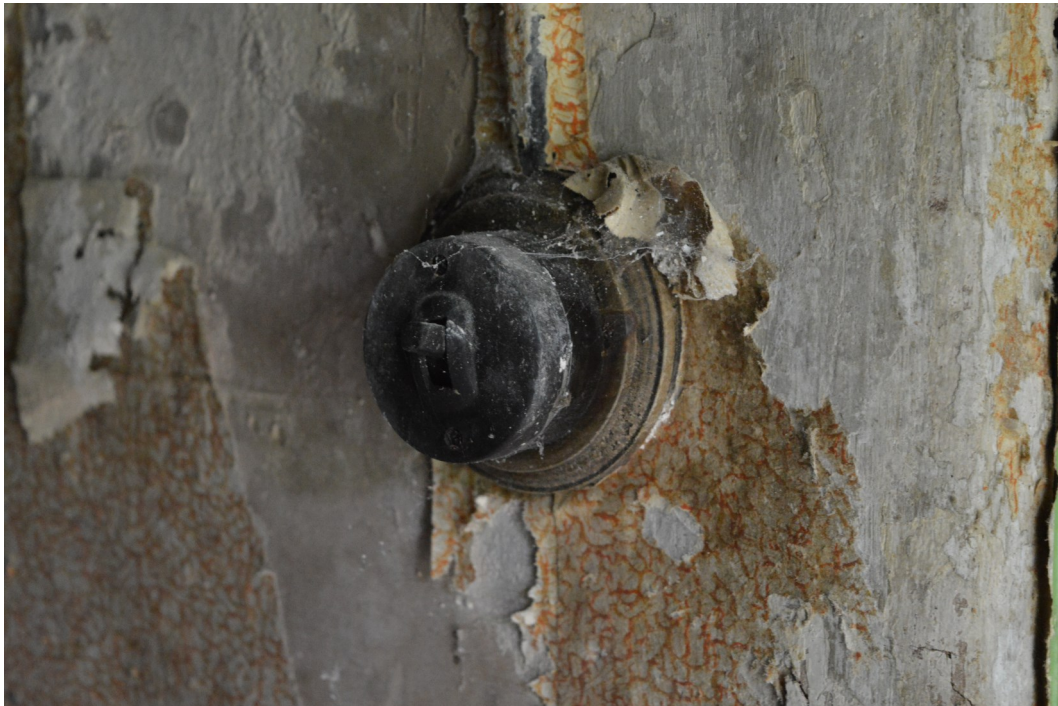
Plate 20. Plastic and Bakelite electrical fitting, Room A

A rectangular gap in the ceiling to the north of the fireplace may indicate the location of a former staircase. A light switch on the SE wall by a door to Room B is of Bakelite and plastic (Plate 20).

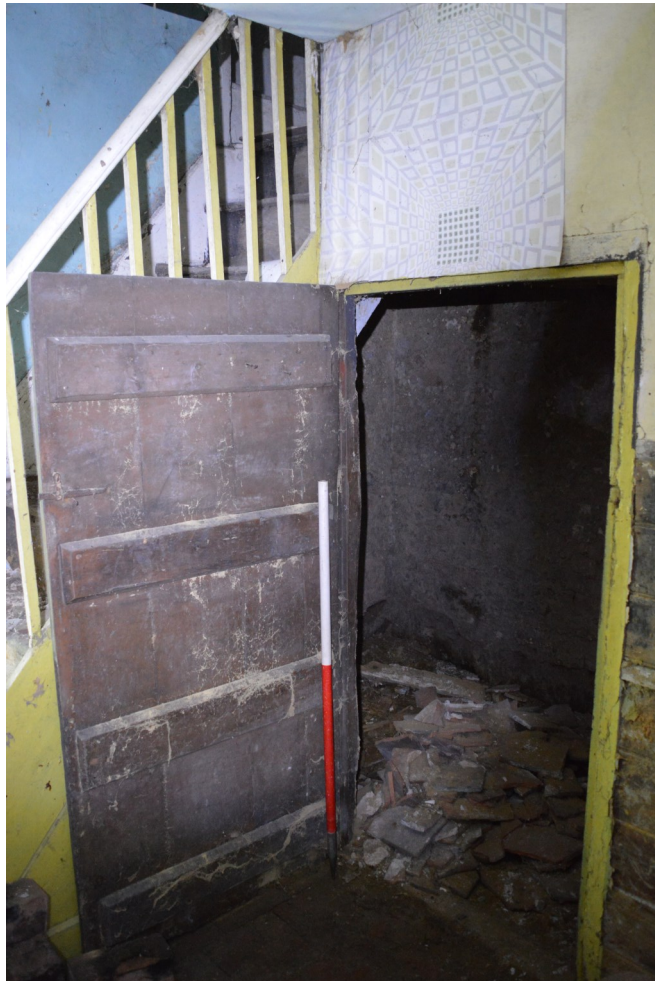
Plate 22. View north into cupboard/pantry, scale 1m

In the northern wall, a door leads to a smaller room, the southern wall of which is a partition made of vertical boards, which was probably a pantry (Plate 22). A large shelf on a bracket was fixed to the north wall in this room.

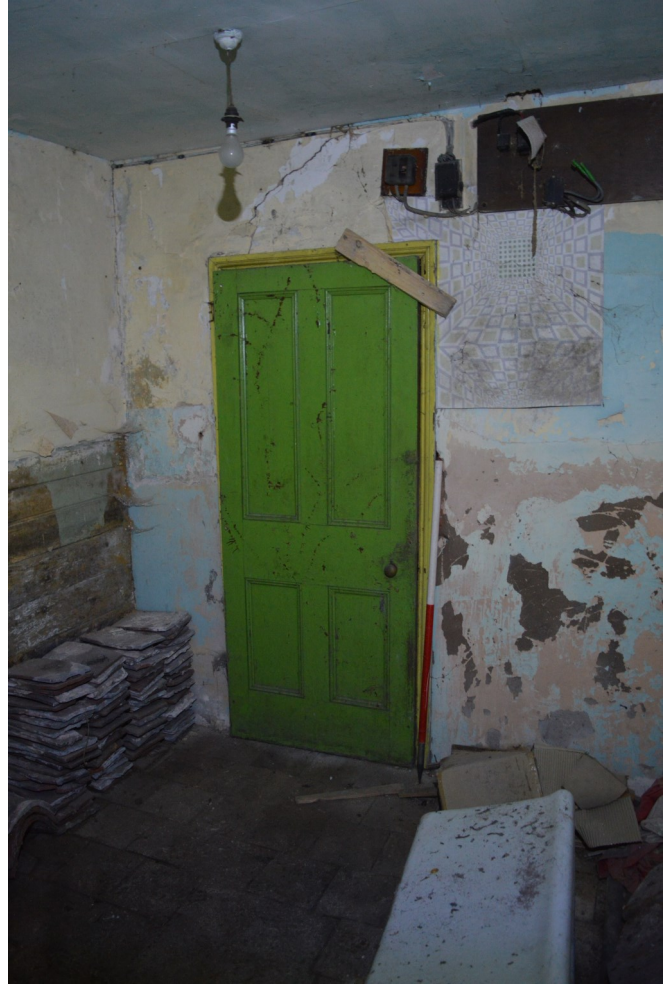
Plate 23. View east to door at south-east end of cottage, scale 1m

A four panelled door to the south-eastern end of the house is nailed shut from inside using a bracket (Plate 23). The remnants of former electrics are fixed to the wall to above the door to the right.

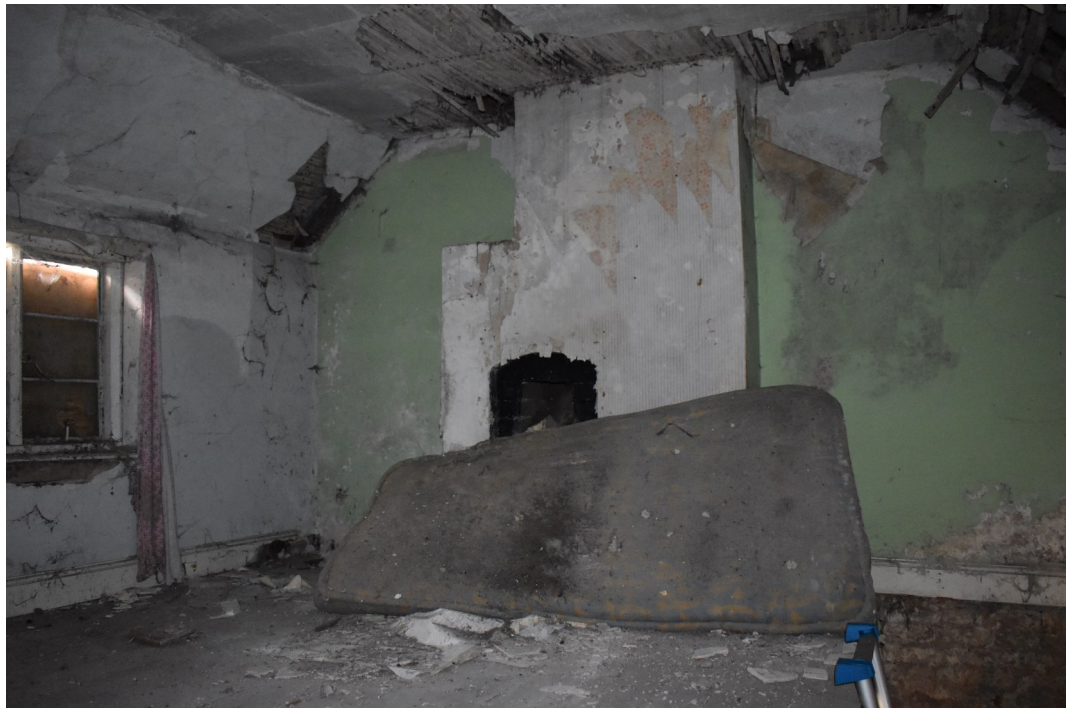
Plate 24. View west in Room C

In [Room C](#) (Plate 24), a former fireplace is located off centre in the chimney breast. The window in the front wall is a 'Crittall style' metal framed casement, as on the ground floor (Plate 25). The two first floor rooms are connected by a door in the rear of the rooms. There is a step up from Room C to Room D (Plate 26)

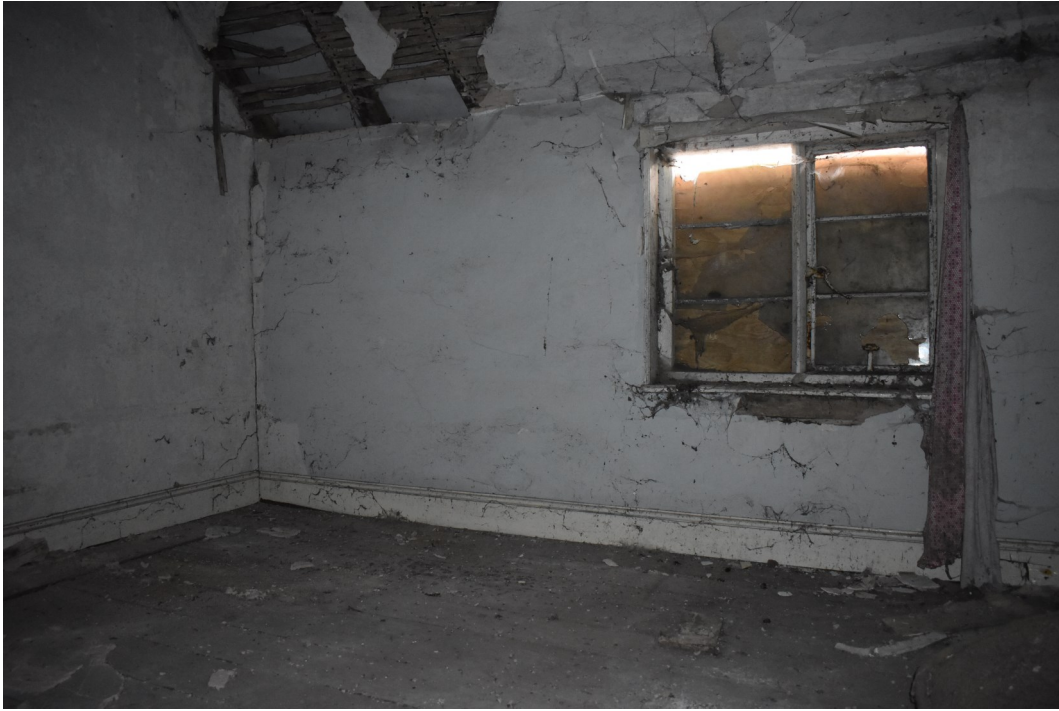
Plate 25. View south in Room C

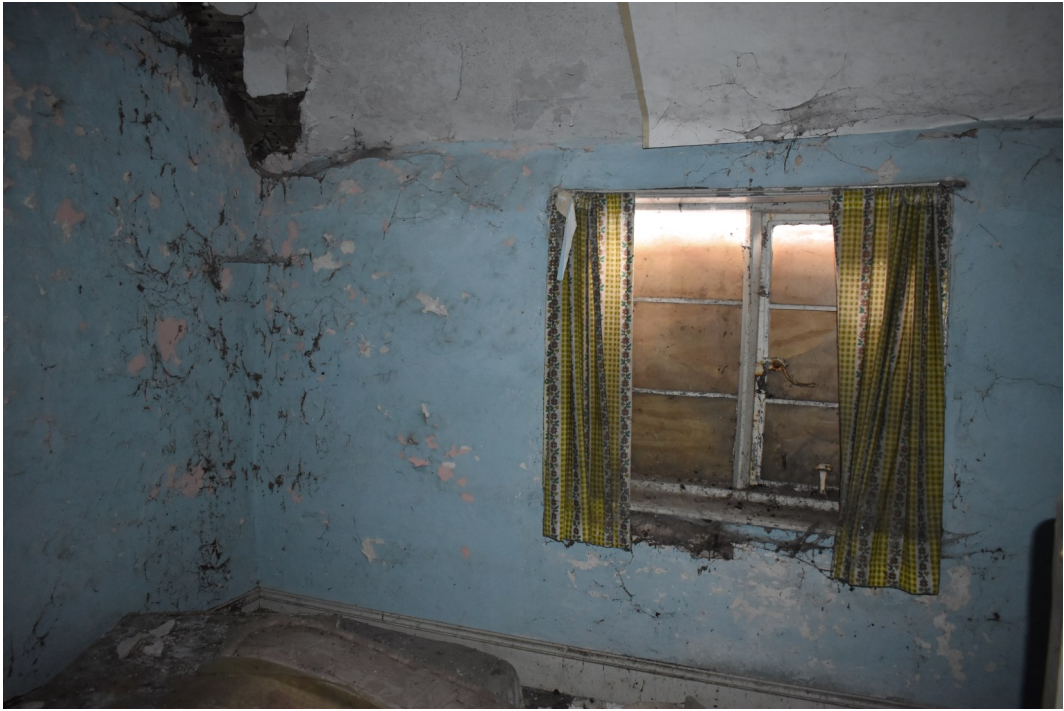
Plate 27. View south in Room D

The window in the front wall of [Room D](#) is of the same construction as elsewhere in the building (Plate 27).
