# Ambrey Archaeology Ltd

## Historic building recording and archaeological monitoring and recording at 41 High St, Feckenham, Worcestershire

Project AMB287

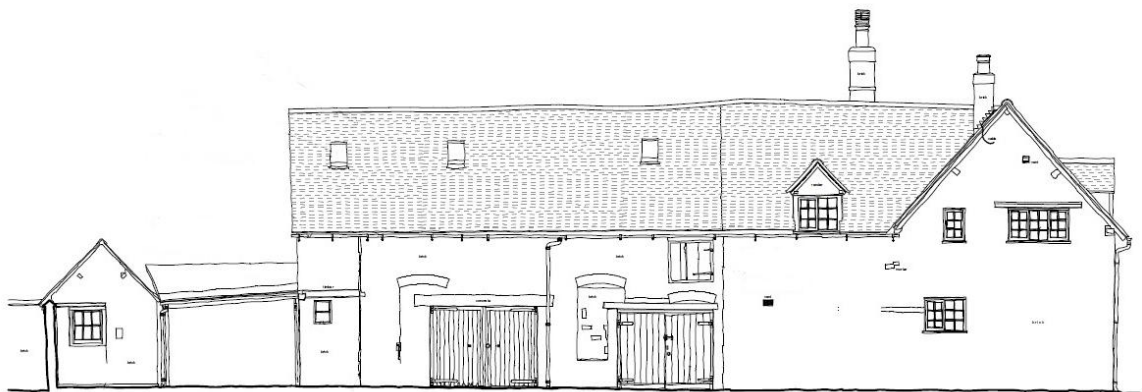
Figure 9. South elevation

The south elevation is built mostly in stretcher bond but above the level of segmental arches over former doorways and windows the brickwork appears to be English Garden Wall bond. There is a clear break in the brickwork between the stable building and that to the east.

There are two double doorways in this elevation. The first is towards the eastern end of the elevation on the ground floor, and is filled with doors which are boarded and ledged with iron fittings beneath a timber lintel, a later insertion likely to have been a reused post (Plate 4). The doorway is close to the joint with the building connected with No 43 and is clearly a smaller doorway and window which have been altered and truncated to create a double doorway.

Above the lintel, on the right hand side, is a segmental arch, of brick stretchers and headers, over a former, smaller opening. To the left of the large doorway is a partially blocked up window also with a segmental arch, similar to that on the right but higher up in the elevation. The left-hand jamb of the doorway is a later insertion, and the lintel and the doorjamb also truncate the former bricked-up window.

Above the arch, a square hatch is filled with a small, boarded door, rustic in style, comprising boards of varying sizes and with mismatched door furniture. The hatch opening is under a simple flat arch of brick headers (Plate 5). The brickwork above the double doorway lintel and to the left of the hatch has been recently re-pointed. The brickwork above the hatch, under the eaves, has been mended or repaired and is different to that on either side.

To the west, the second double doorway appears more modern, is ledged and braced with different, more uniform, door furniture (Plate 6). This has a concrete lintel and the doorway and lintel truncate a doorway on the left which has a segmental arch on the same line as that of the blocked up window to the left of the eastern double doorway. This second blocked up doorway has been bricked up flush with the rest of the wall.

An extra half bay has been added to the west of the main building (Plate 7). There has been no keying in of the brickwork, and there is a thick line of mortar joining the two. A single bonded timber keys the western part to the east. This contains empty stave/peg holes and is cut to fit one which runs along the west elevation. A small fixed wooden window with two panes is located just below the horizontal timber.

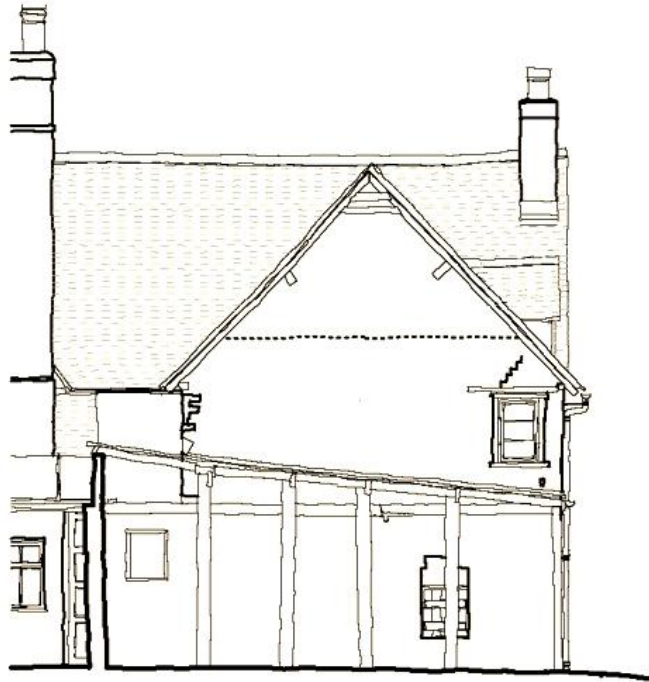
*Figure 10. West elevation*

This elevation is partly obscured by the lean-to described above.

A reused Baltic timber has been employed as a bonded timber or wall plate which horizontally runs across the elevation at about 2m height. The brick work below this contains mass produced bricks, regular in shape and a darker reddish brown in colour. Eight courses above the level of the eaves, bricks are pinker and glossier.

In the right hand part of wall, a small square opening contains a boarded wooden door which would open out, but is blocked by a post which holds up the roof of the lean-to (Plate 10). A window in the northern corner has a wooden frame but no glass (Plate 11).

Above this, the first floor wall stops short towards the western corner and is narrower than the ground floor (Plate 12).

A window in the corner just below the gap mentioned above has a wooden frame but no glass.

Above lean-to roof towards the right hand edge of the elevation is a single-light, metal framed, side opening casement, with three panes.

There has been replacement brickwork towards the apex of this gable.

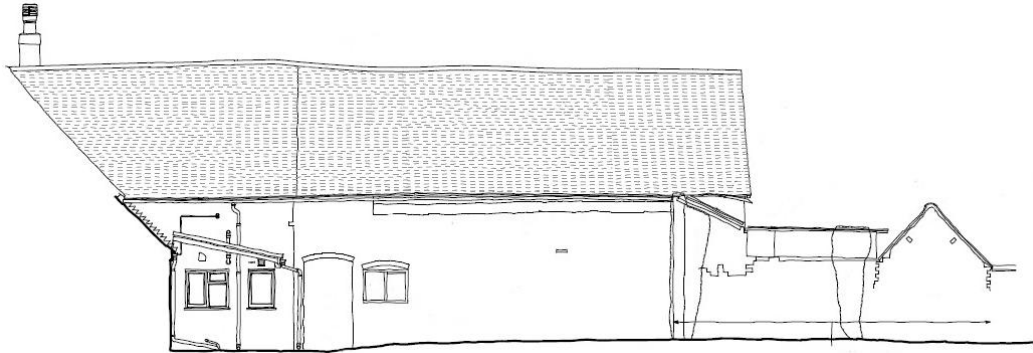
Figure 11. North elevation

The northern elevation was not accessed during the survey as it is in the grounds of another property. However, an elevation was prepared by Nick Joyce Architects and is presented in Fig. 11 below.

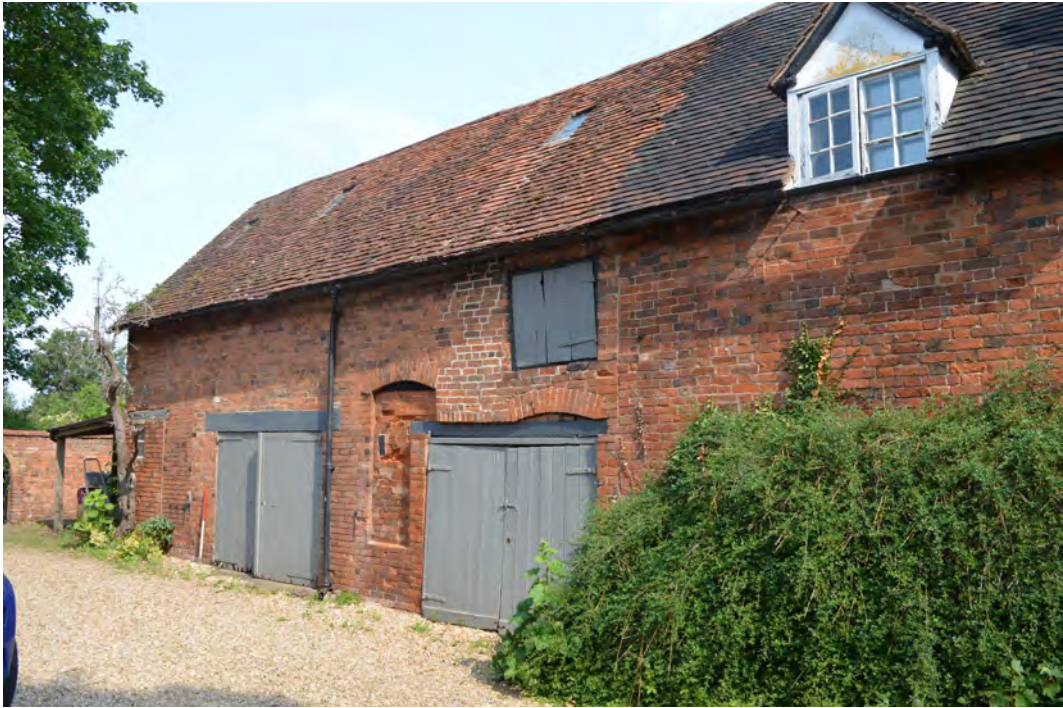
The former stable to Feckenham House is a range of brick buildings in a yard to the north of No. 41 High Street (Feckenham House) (Plate 1). The buildings are of two storeys in height comprising a ground floor plus attic. They are constructed of brick with a tiled roof into which skylights have been added. The buildings abut a brick building to the east which is joined to No. 43, overlooking the High Street (Plate 2).

*Plate 1. View north-west of former stables, scale 1m*

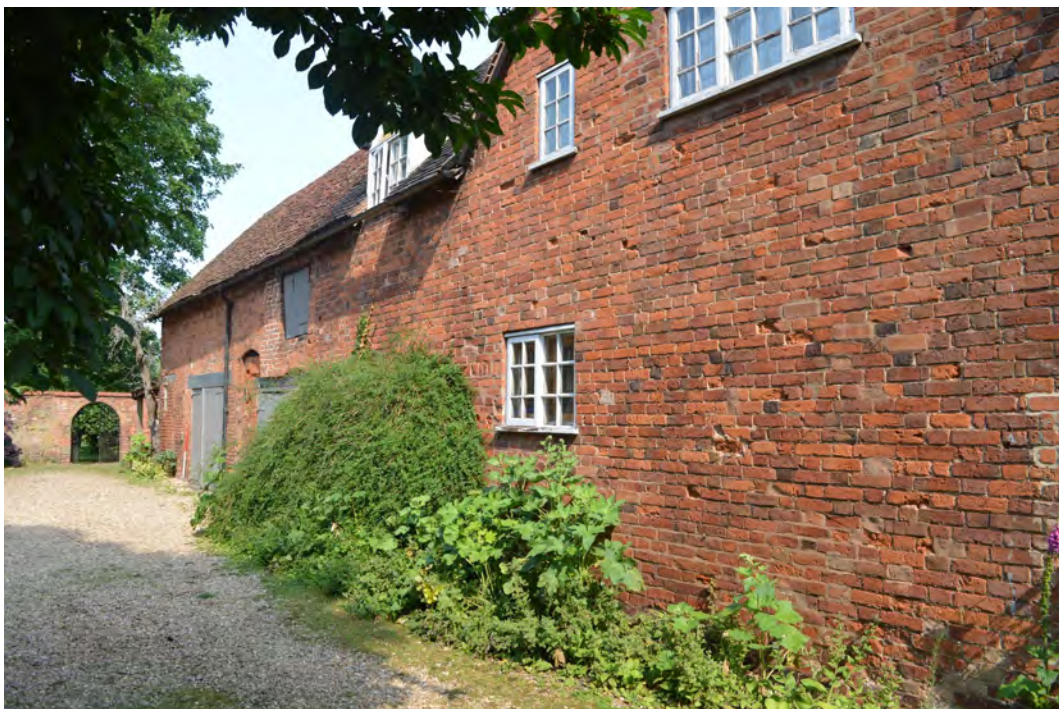
*Plate 2. View north-north-west of former stable, with No. 43 High Street, Feckenham on the right hand side of the photograph*

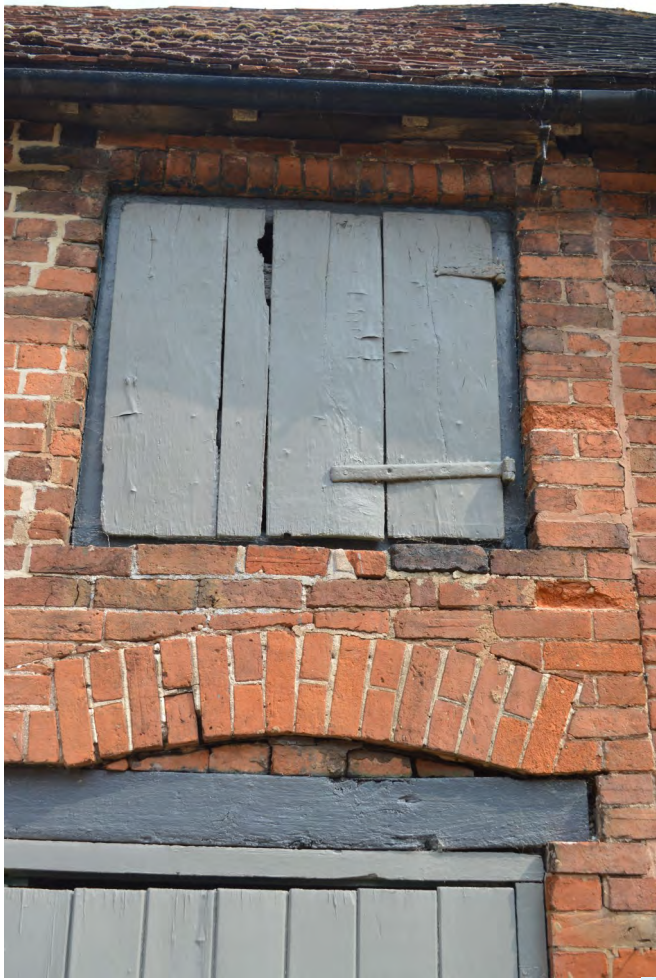
*Plate 5. Segmental arch of former opening, view north*

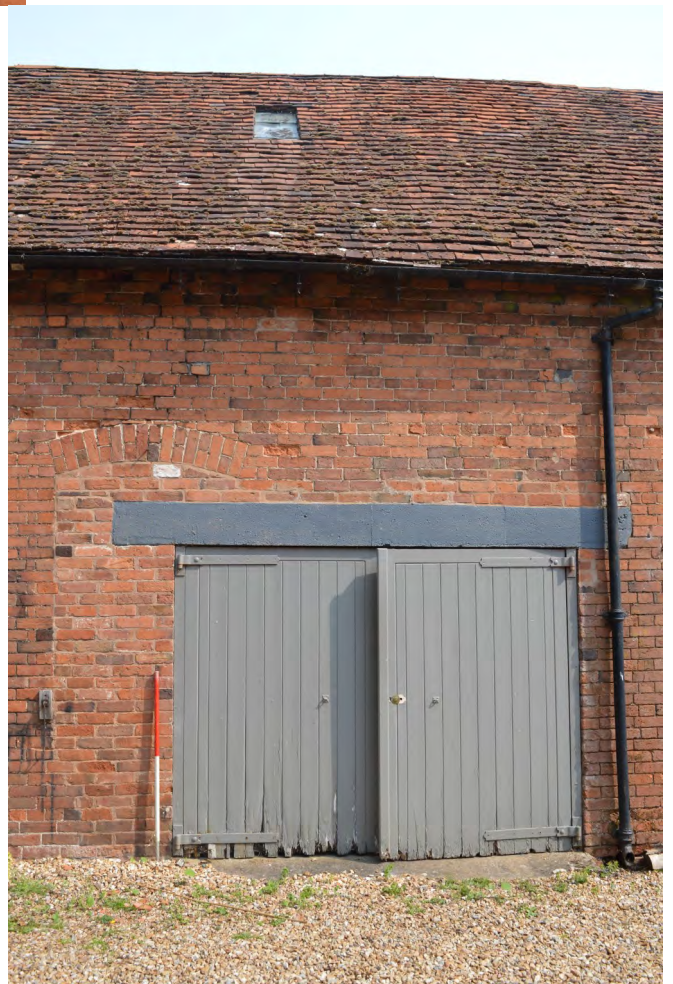
*Plate 6. Western set of double doors*

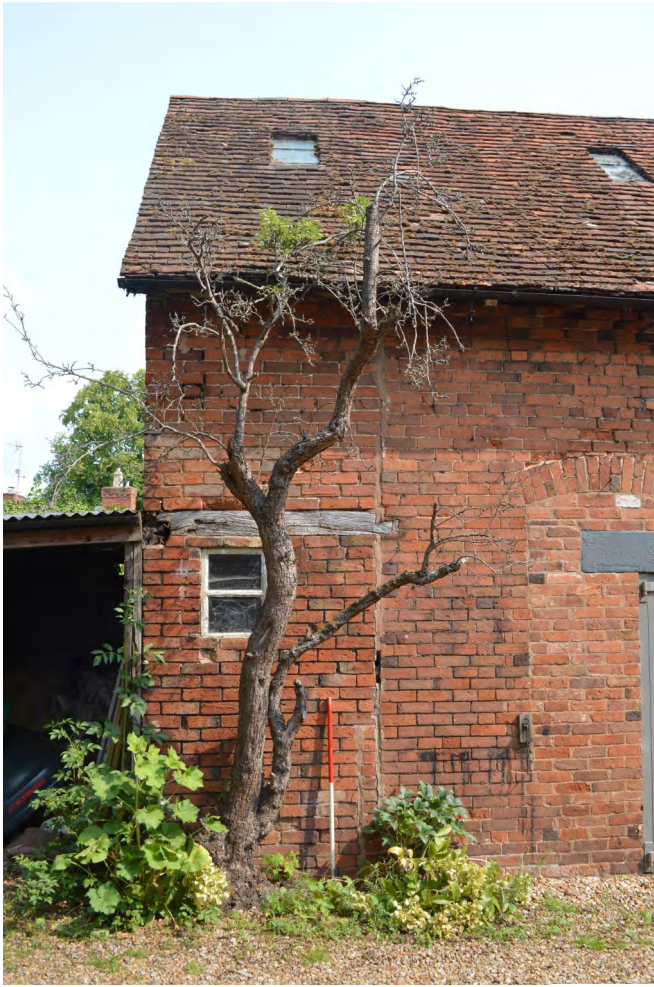
*Plate 7. View north to added half bay*

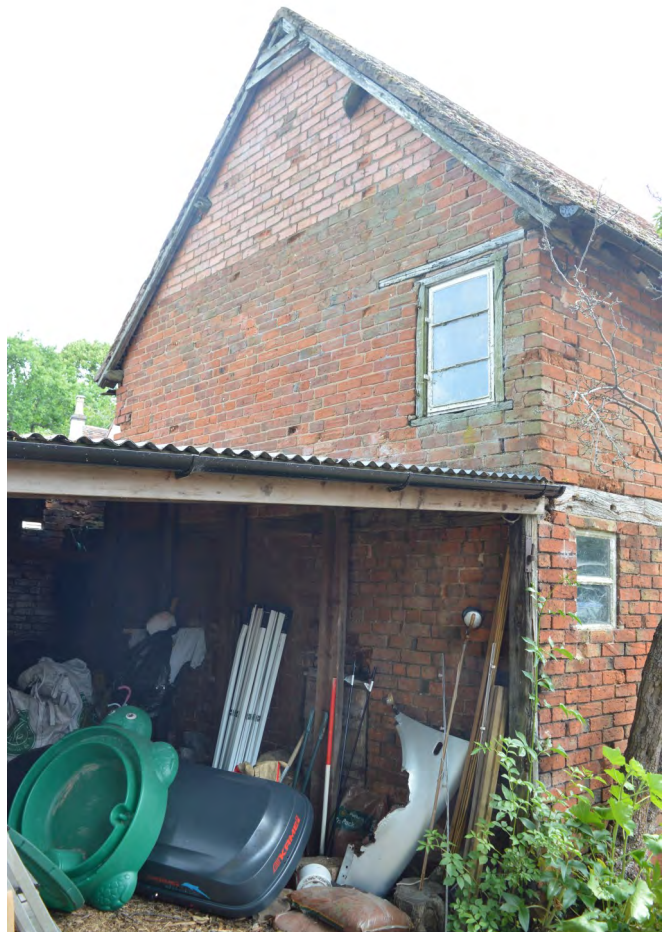
To the west, posts hold up a galvanised sheet metal roof which slopes to the west and covers an open area (Plate 8). A wall to the rear of this lean-to, forms the boundary to the property to the north and may have been a garden wall. It is in poor condition in places.

*Plate 8. View north-east of western gable and lean-to*

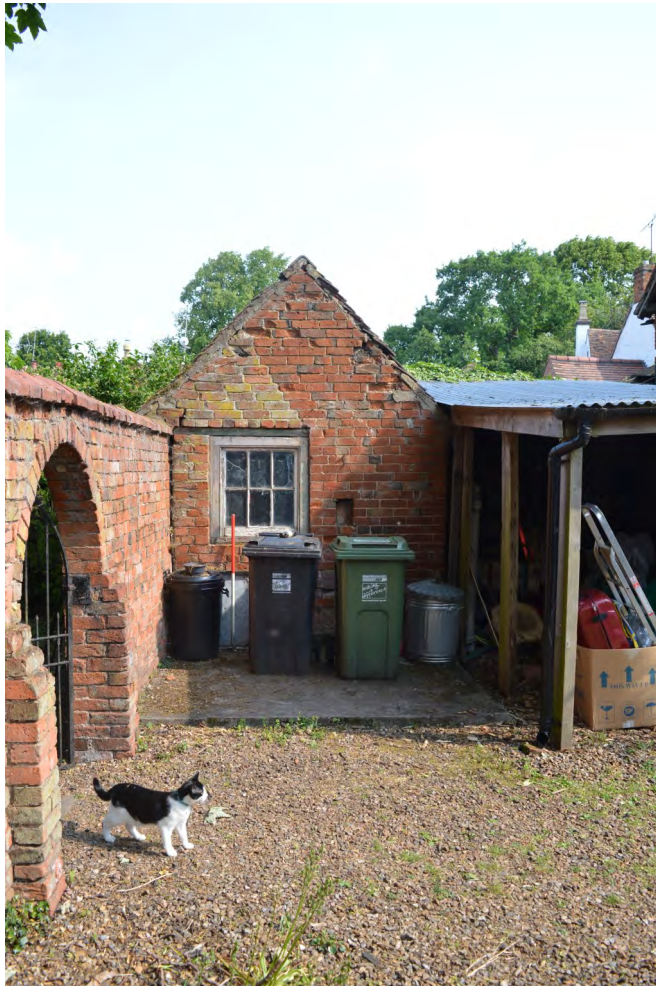
To the west of this the gable of a single storey brick building is set back and occupies about half of the footprint (N-S) of the rest of the buildings (Plate 9). There is a fixed wooden window of six panes (3/3) offset within this gable. The building post-dates the garden wall which runs north-south along the W of it.

*Plate 9. Brick building to west of lean-to, view north*

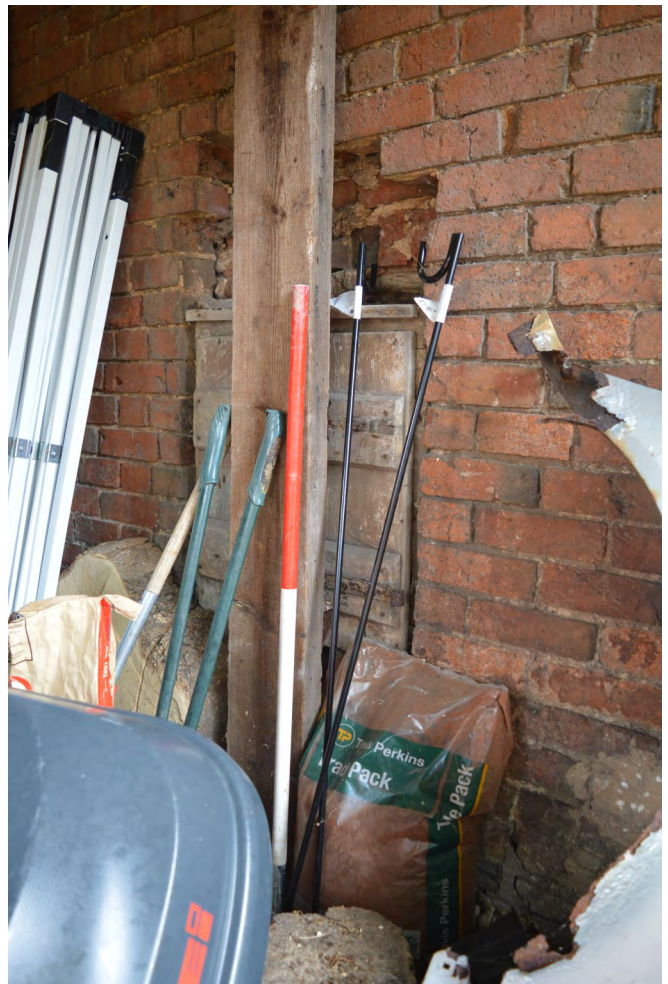
*Plate 10. Small hatch in western gable, view north-east*

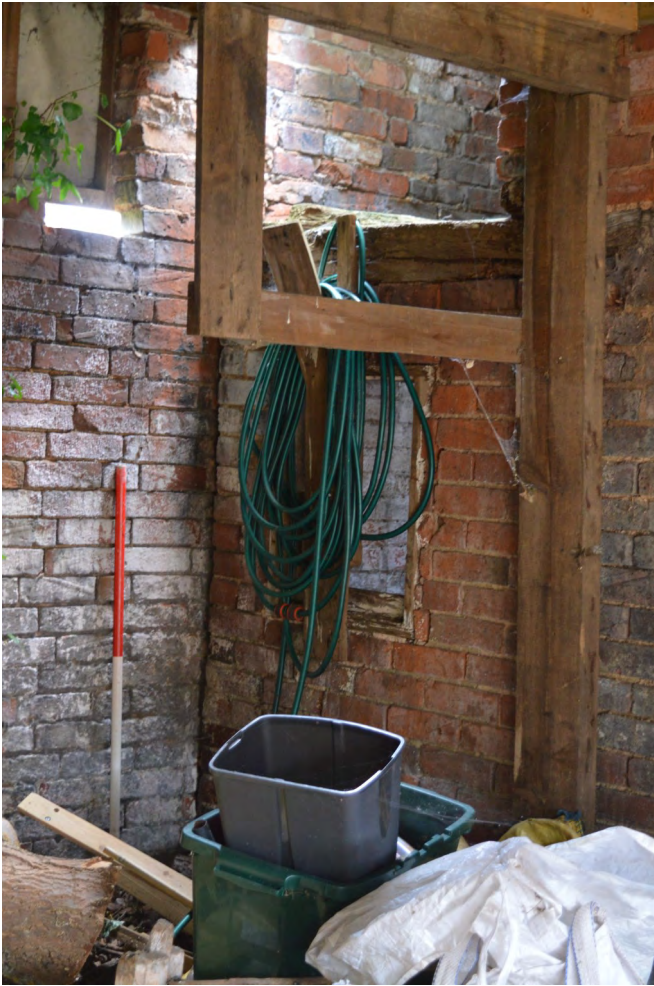
*Plate 11. North-western corner of the added half bay, narrower at first floor level than ground floor level, view north-east*

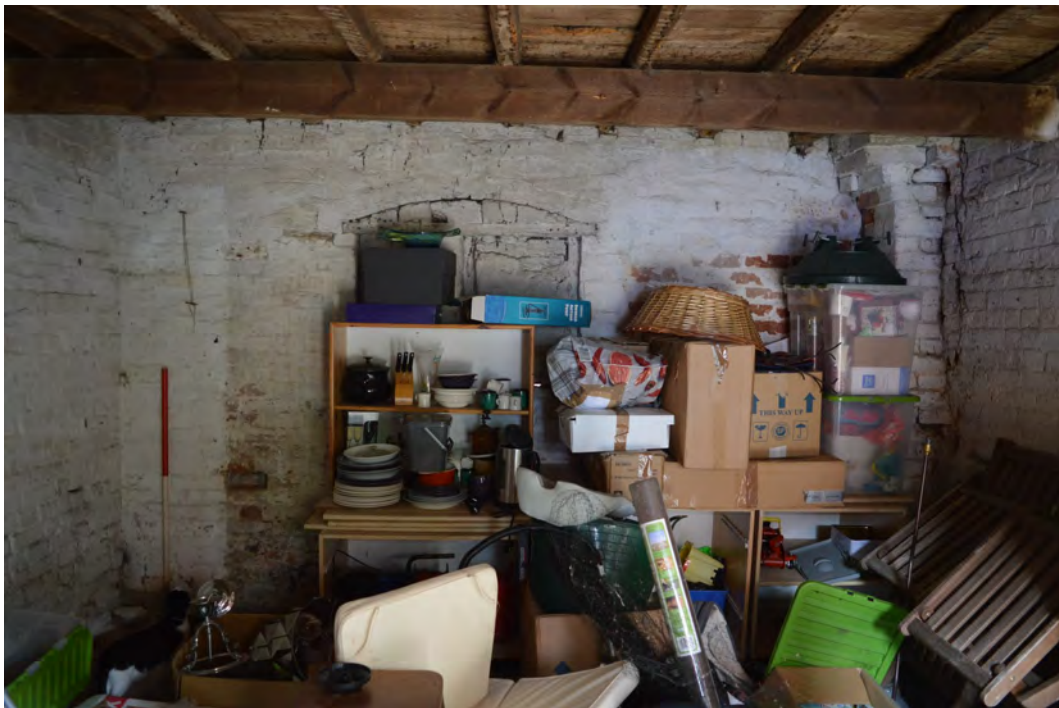
**Room 1** in the east of the building is currently used for storage (Plate 14). The floor is of cobbles, covered with concrete in places and the walls are all of painted brick.

*Plate 14. View north inside Room 1*

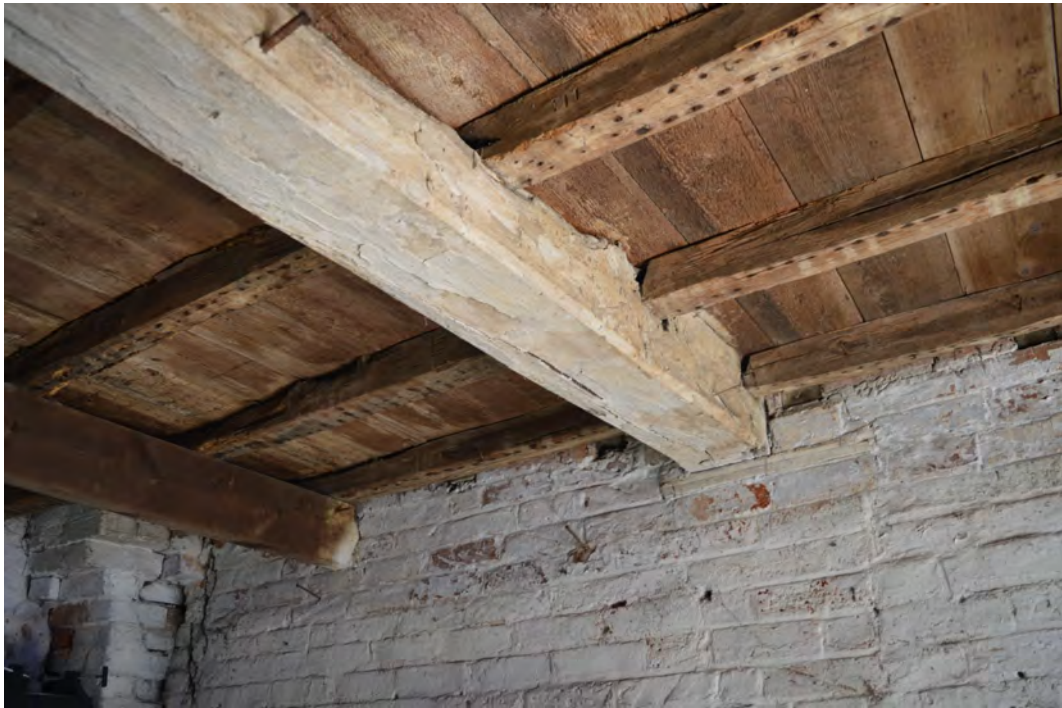
Several transverse beams carry the joists for the floor above. The central one is oak and has a slight chamfer with stops at each end (Plate 15). Other transverse beams are of softwood. The joists are also of softwood and there is evidence in multiple nails of a removed ceiling. There is evidence of pit sawing on the soffit of the oak beam (Plate 16) and two incised carpenter's marks (II + III) on the southern side as well as blacksmith's nails (Plate 17).

*Plate 15. Beam in Room 1, view north-east*

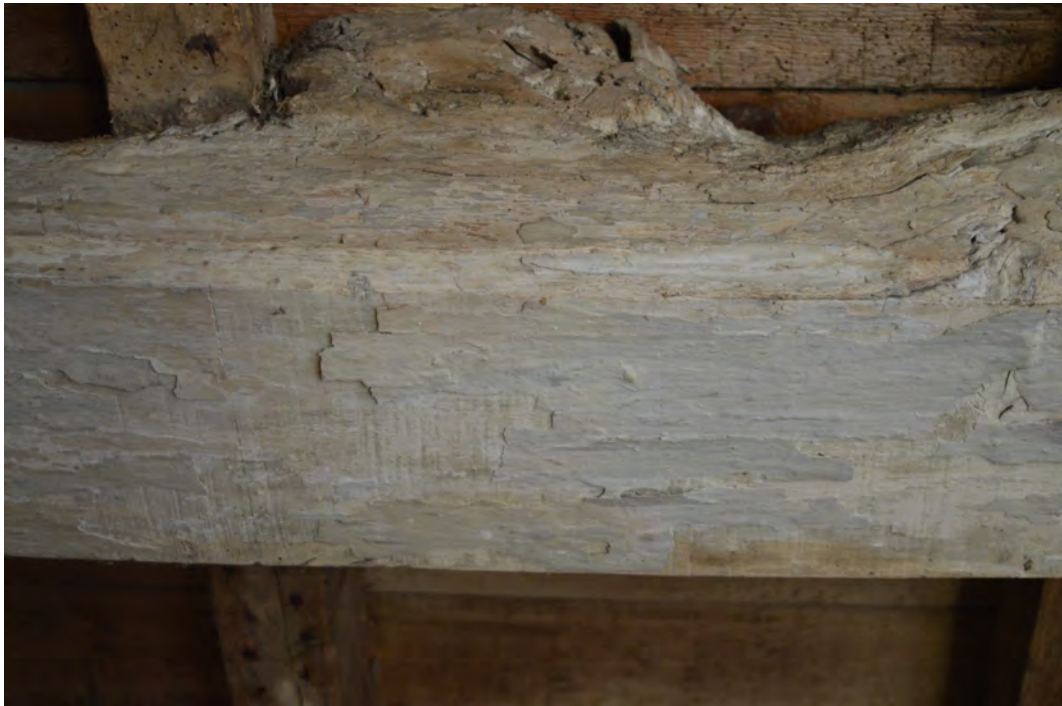
*Plate 16. Pit saw marks on beam in Room 1*

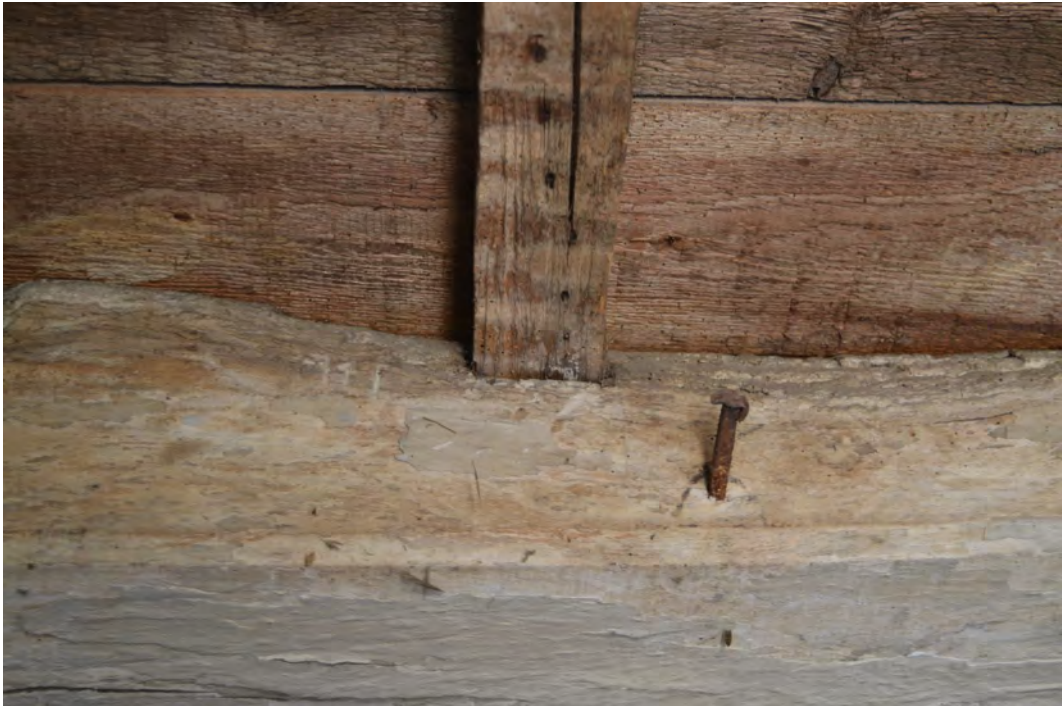
*Plate 17. Carpenter's marks and blacksmith's nail, Room 1*

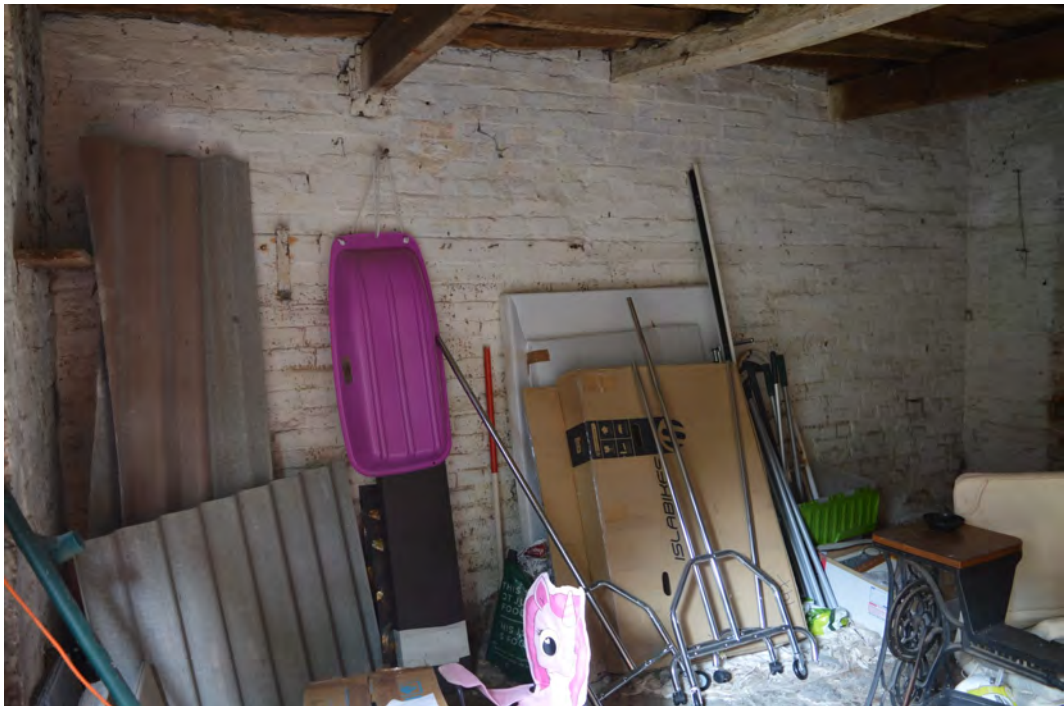
A bonded timber runs along the western wall of the room, about 1.2m high (Plate 18).

*Plate 18. View north-west in Room 1*

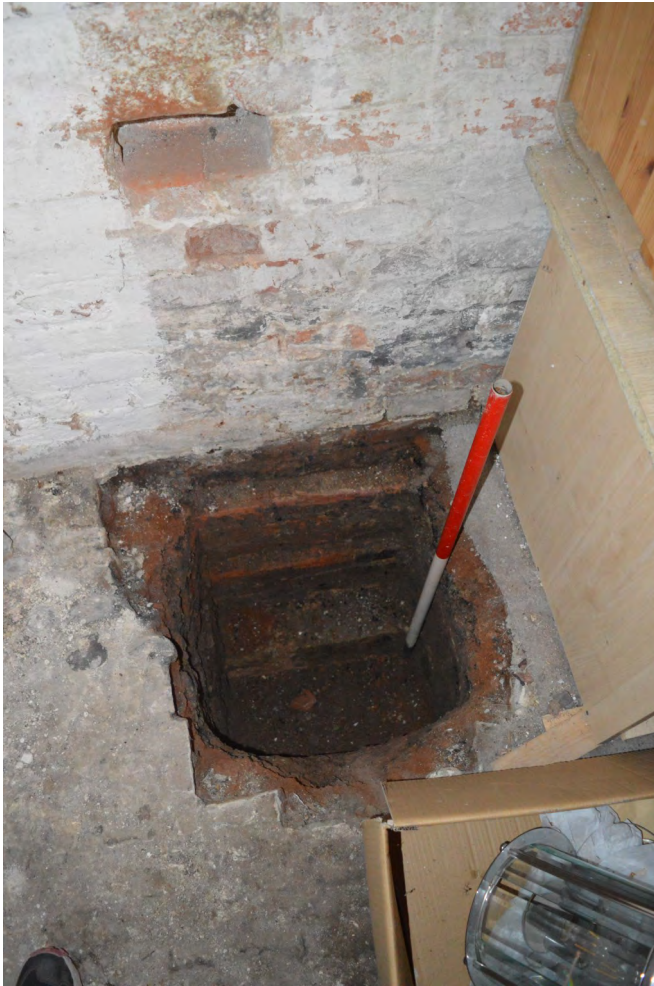
The brick foundation of the building was exposed in a test pit along the northern wall (Plate 19).

*Plate 19. Trial pit in northern part of Room 1, showing brick foundation*

The exposure of the foundations in trial pits inside the building suggest that the current building may have replaced an earlier structure on the same site.

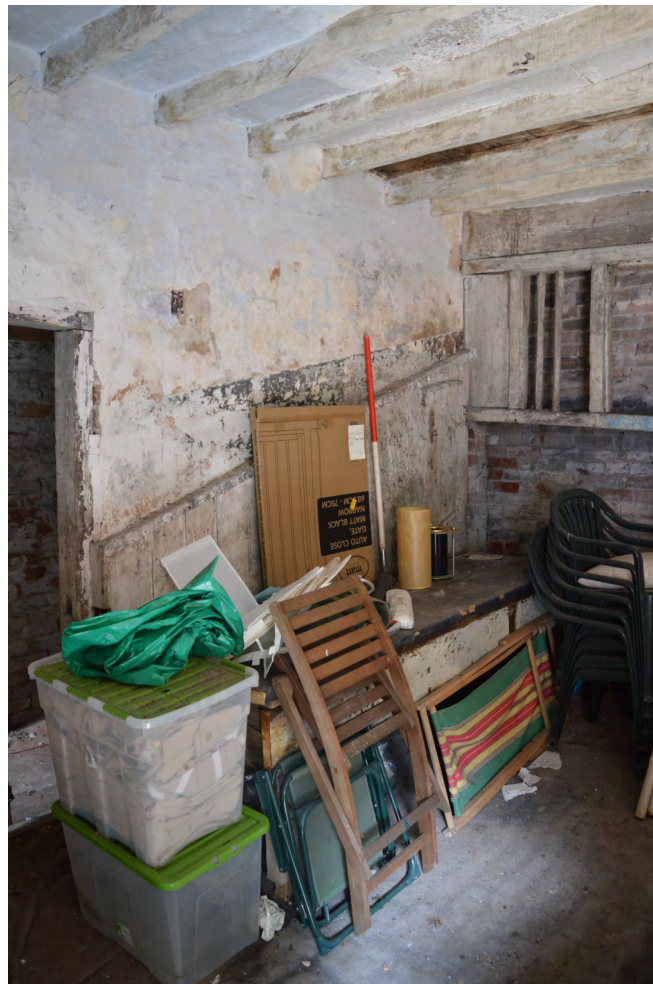
The western wall of a loose box of tongue and groove wooden boards projects southwards from the manger along the western wall of the room (Plate 22). The top of the loose box wall is capped with lead, and it rises towards the manger. The wall beyond this has been plastered and painted with the remains of a greenish paint above the loose box wall roughly following the line of the feature. A door in this wall to the south of the loose box wall leads to the smaller room beyond which is the half bay. The doorjambs are softwood re-used timbers. The underside of a boxed-in, straight stairwell leading from the smaller room to the first floor occupies the south-western corner of the room.

*Plate 22. Remnants of manger and side of loose box in Room 2, view north-west*

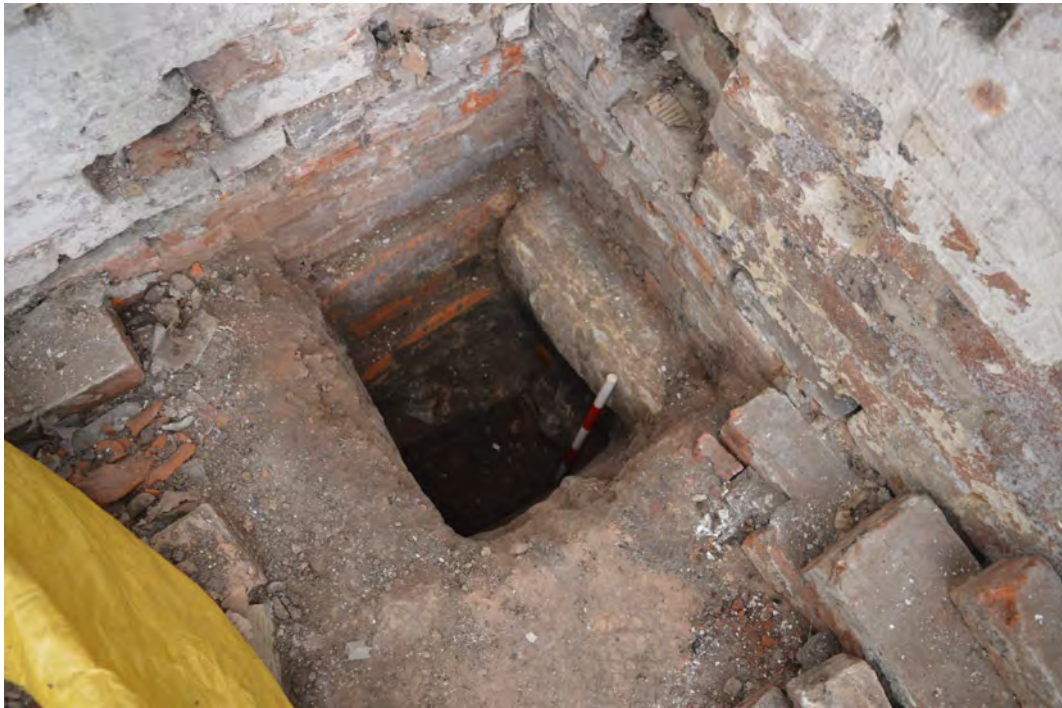
In the north-eastern corner of the room a trial pit (Plate 25) excavated previously has exposed the brick foundations of the building, in this case with a rubble limestone (at about 0.1 -0.27m below ground level) as well as brick. Beneath the upper level of brick and stone foundations a lower layer of stone foundations were noted (at about 0.50- 0.77m below ground level).

*Plate 25. View north-east in Room 2 showing foundations exposed in Trial Pit, scale 0.50m*

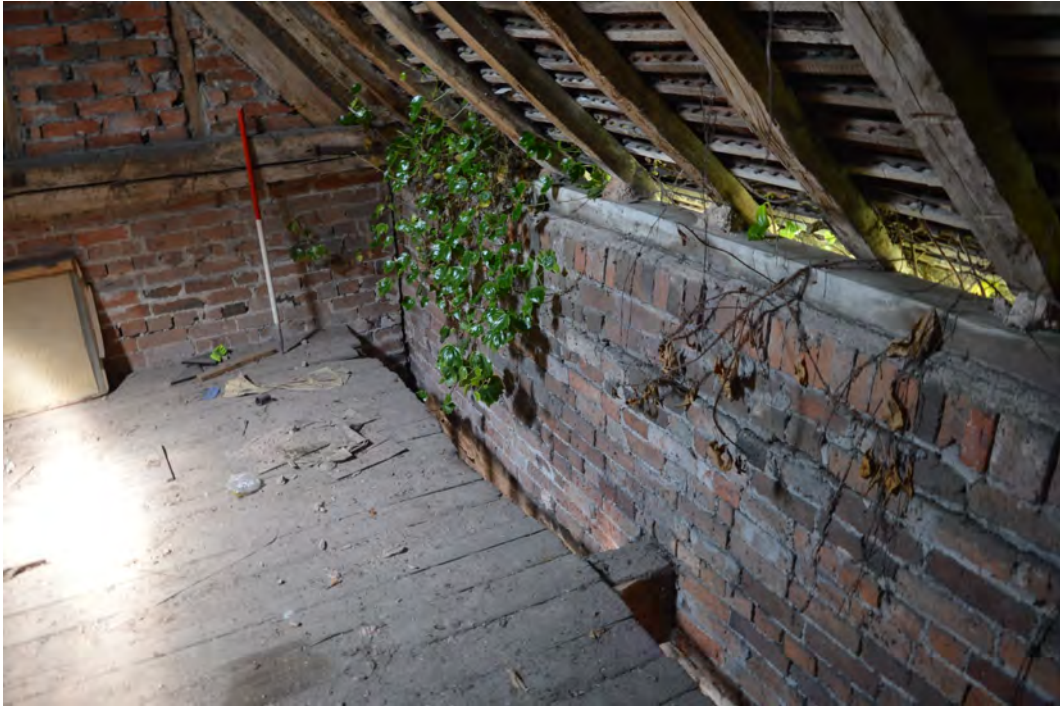
*Plate 31. View north-west in Room 3, showing hay drop*

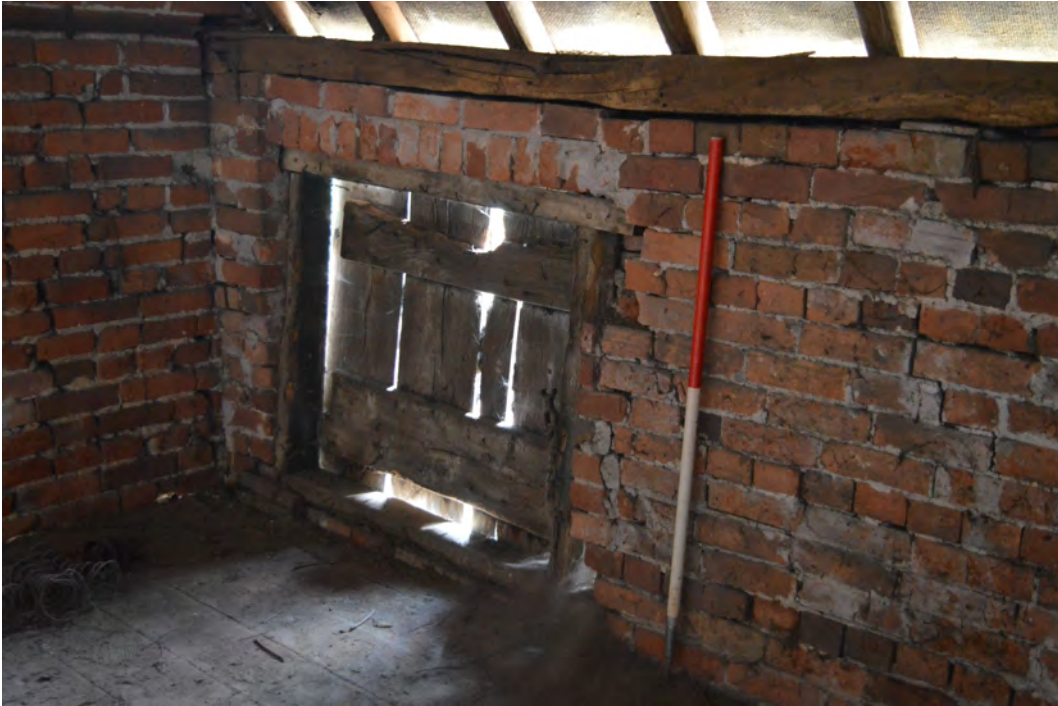
The hatch door to the exterior in the south-east of the room is probably the opening through which hay was forked from outside (Plate 33). In the north-western corner, there is a hatch in the floorboards to the room below (Plate 34).

*Plate 33. View south-east in Room 5*

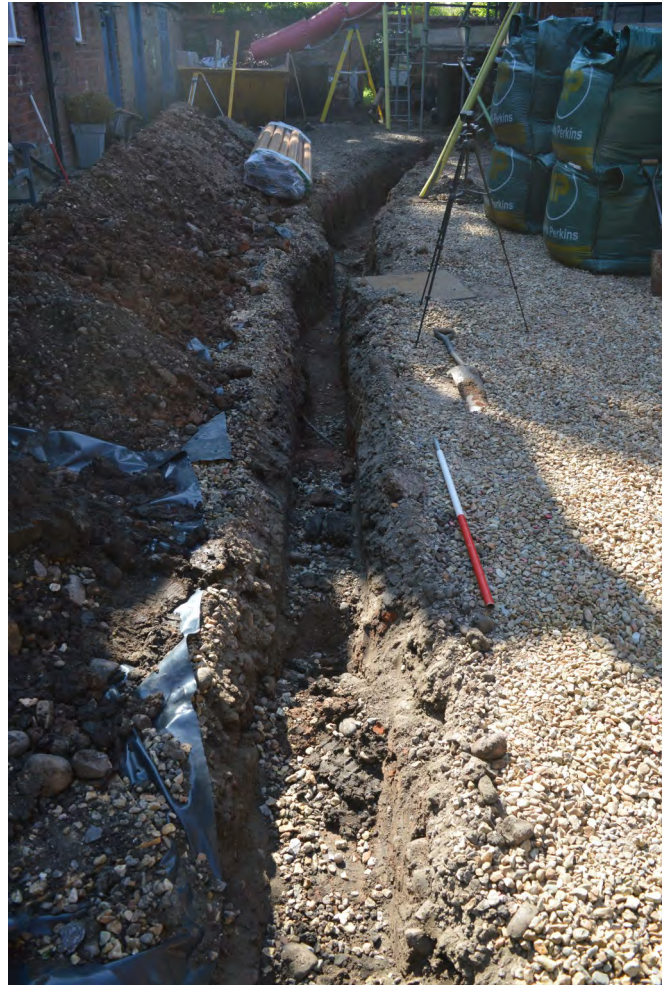
Within the service trench, the upper layer (101) comprised a loose grey gravel, the surface of the driveway or yard in this area (Plate 35). This overlay (105) a loose grey sand acting as a base for this layer. This in turn directly overlay the natural substrate (106) which comprised a hard reddish brown clay with frequent cobbles.

*Plate 35. View west in service trench*
