# Ambrey Archaeology Ltd

## Archaeological evaluation of land at Eastington Hall, Longdon Heath, Upton upon Severn, Worcester WSM81999

Date: 9<sup>th</sup> October 2025

Planning ref. M/24/01784/HP

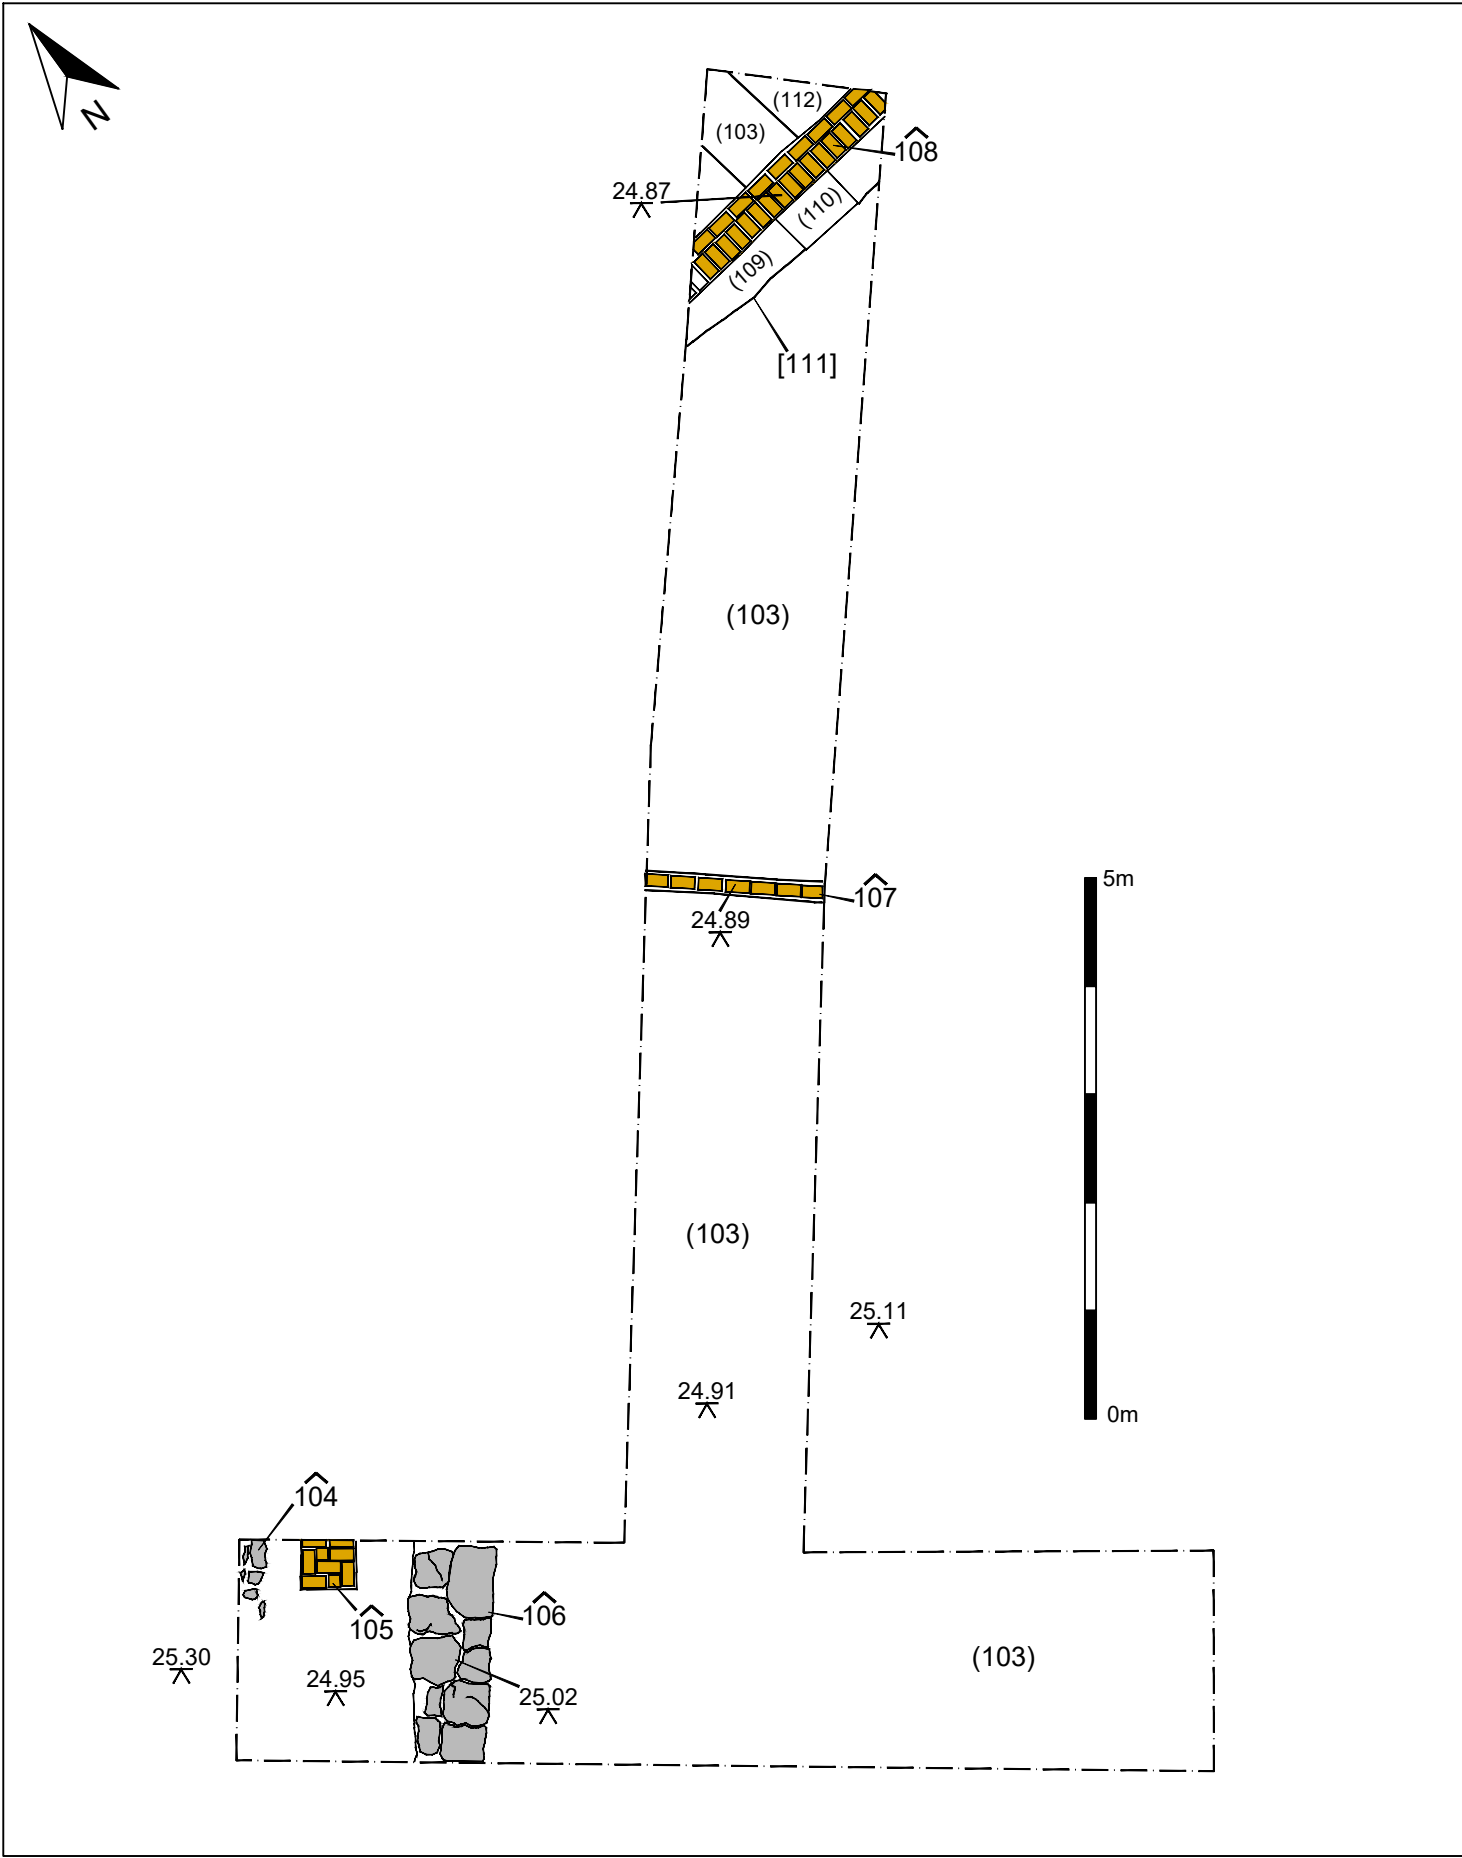
Figure 6. Plan of Trench 1

**Trench 1** (Plates 1-3, Figure 6) was T shaped and situated in the location of the proposed 'shelter shed'. The longer arm was 13.5m long and orientated NE-SW meeting the centre of the shorter arm which was 8.8m long and orientated NW-SE.

Several structural features were present in this trench. At the north-western end of the shorter arm {104} was a small line of unbonded blue lias stones, 0.24m wide and 0.8m long which may have been the foundation of a small wall or the edge of a demolition layer (Plate 4). Some 200mm to the south-east of this was a square structure formed of eight bricks laid flat {105} and set into the natural substrate. This also appeared to continue into the north-eastern baulk of the trench and may have represent part of a former surface or a post pad.

Figures 8 and 9 demonstrate that the north-western wall of the building abutting the barn aligns with stone foundation {106} which crossed the southern part of Trench 1, and it is clear from the geophysical report that it continues both to the north-east and south-west (Linear feature I in the SUMO report). No south-eastern wall was present, presumably because the building was open fronted. There are some squarish anomalies shown on the geophysical survey labelled as structural remnants of uncertain origin which might represent the post pads of pillars.

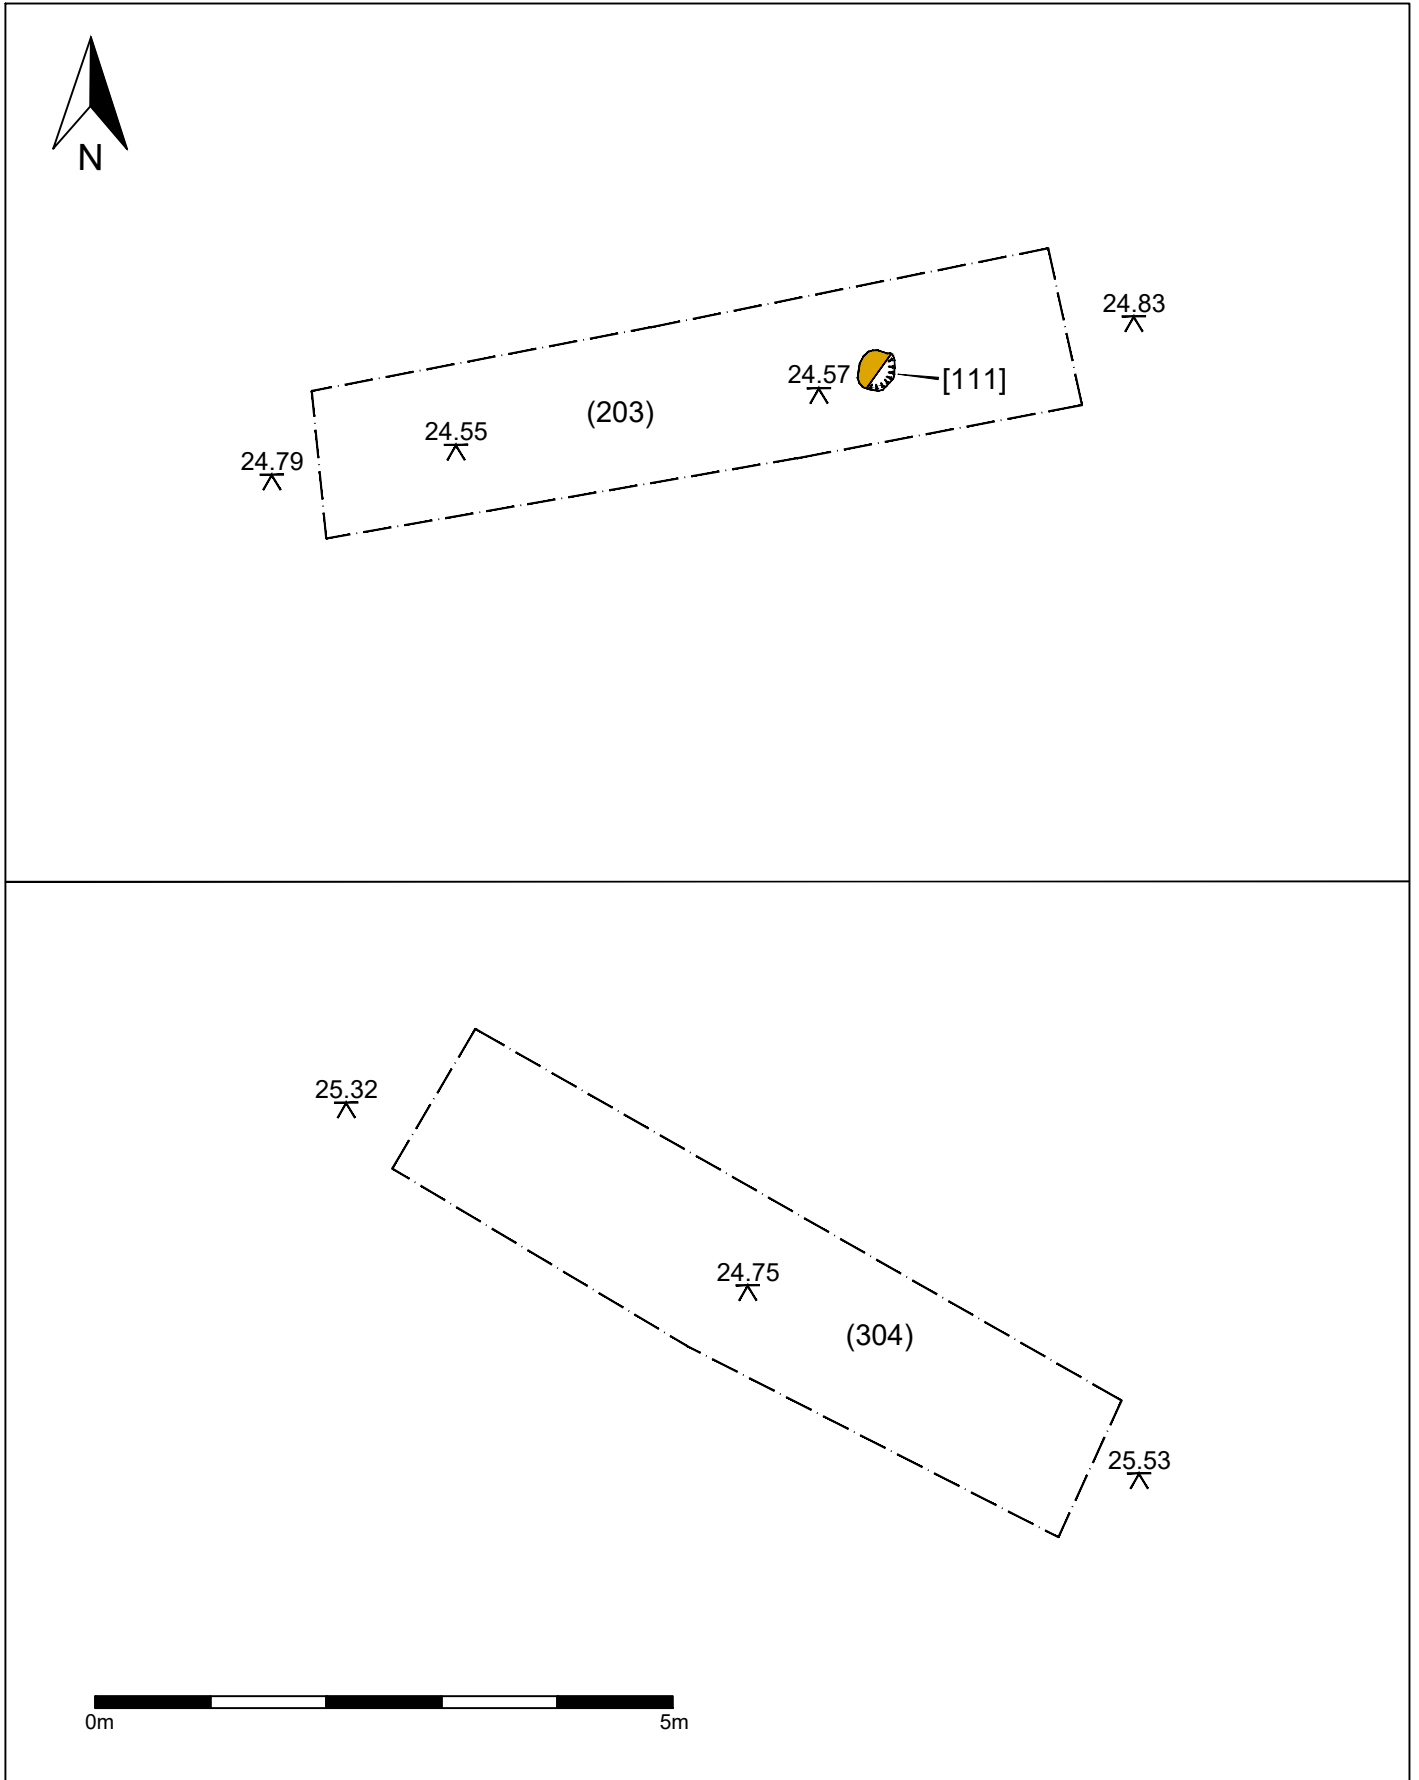
Figure 7. Plan of Trenches 2 and 3

**Trench 2** (Plate 10, Figure 7) was 6.4m long and 1.6m wide, orientated approximately east-west and situated in a patch of grass to the west of Trench 1 in the location of the proposed 'threshing barn' which will house the swimming pool. Topsoil here was a mid-brown clay silt with frequent charcoal flecks present to a depth of 0.13m. This overlay a subsoil comprising compact reddish-brown sandy clay with blue patches, charcoal flecking, brick fragments and frequent angular stones which in turn overly the natural substrate at a depth of 0.3m.

**Trench 3** (Plate 12, Figure 7) was situated 30m to the south-west of Trench 1 in the location of the proposed 'cart shed' and 'machinery shed'. It was 6.7m long and orientated WNW-ESE. The topsoil

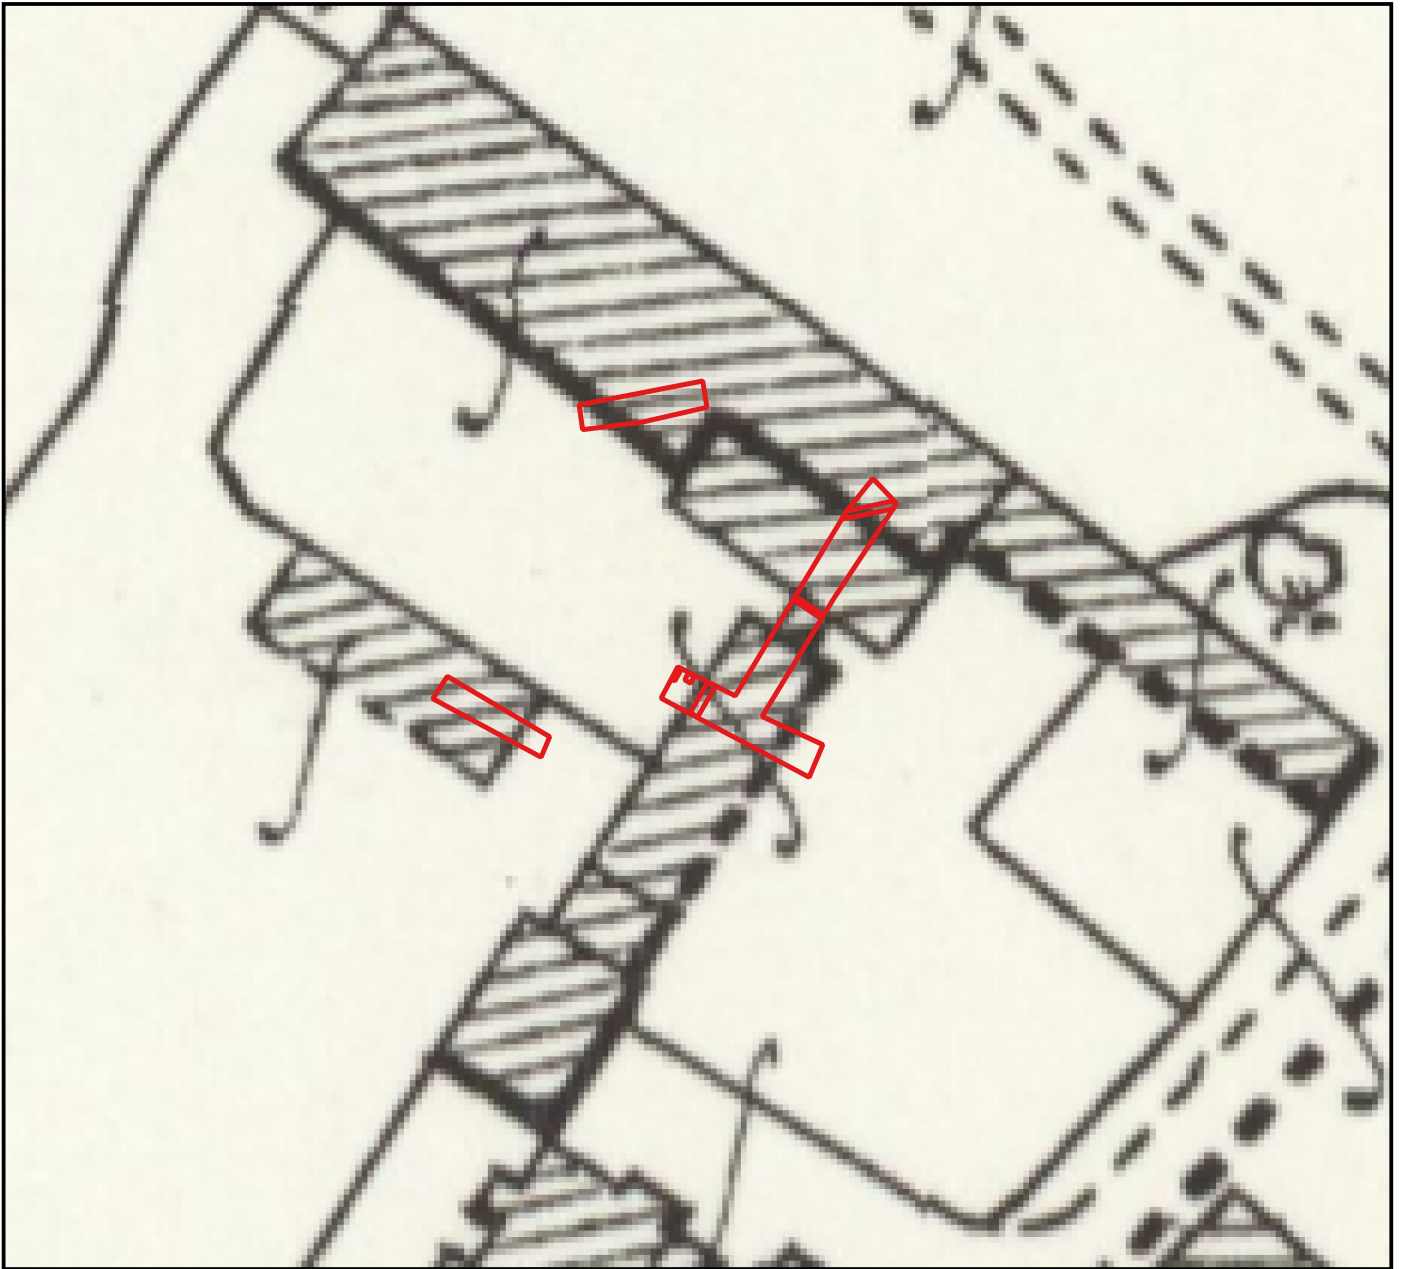
Figure 8. Trench locations laid over 1904 25 inch Ordnance Survey map

The 25 inch edition Ordnance Survey map of 1904 (Figure 8) depicts the walls of the buildings fronting the farmyard with dotted lines indicating that these were open fronted, probably shelter sheds or cart sheds. A photograph of circa 1910 reproduced as Plate 14 shows an open fronted building abutting the barn with a relatively steep gable roof which appears to be tiled, the ridge line of which is approximately at the height of the gables of the barn.

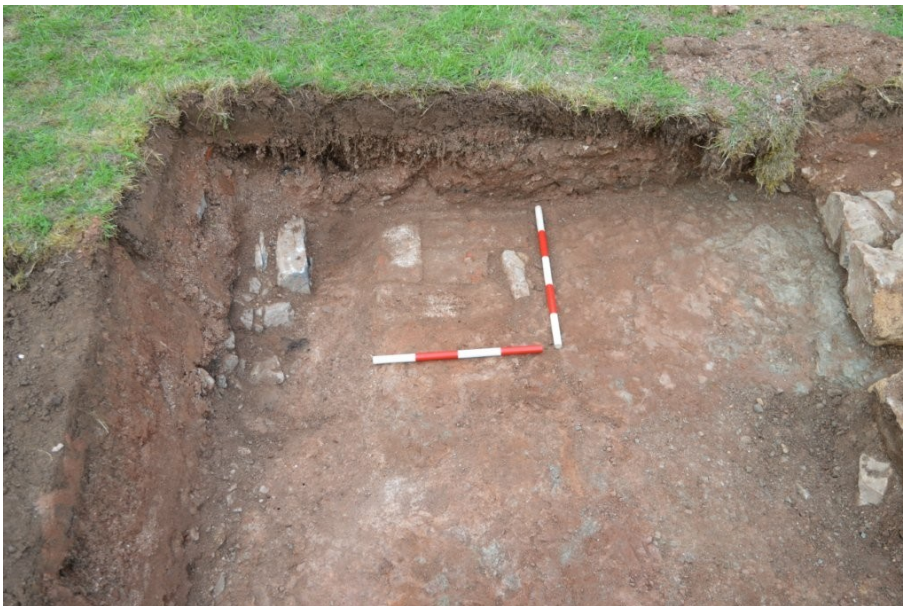
*Plate 4. Structures {104} and {105} in north western end of shorter arm of Trench 1, scales 0.4m and 0.5m*

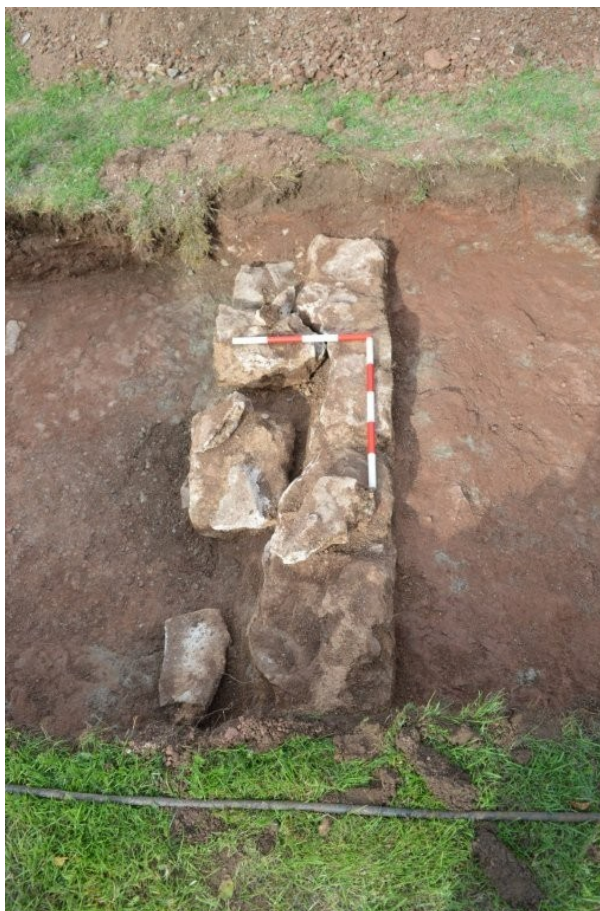
A further 0.9m to the south-east were two rows of mortared unshaped stones {106} interspersed with irregular lumps of concrete (Plate 5). This crossed the trench on a SW-NE alignment, was up to 0.5m wide and present in the trench for a length of 1.7m. The orientation of this structure was similar to that of the hall, barn and former buildings which stood in this location and it aligns with the north-west wall of the farm building shown in this location on Ordnance Survey maps until the 1940s.

*Plate 5. Wall foundation {106}, view north-east, scales 0.4m and 0.5m*

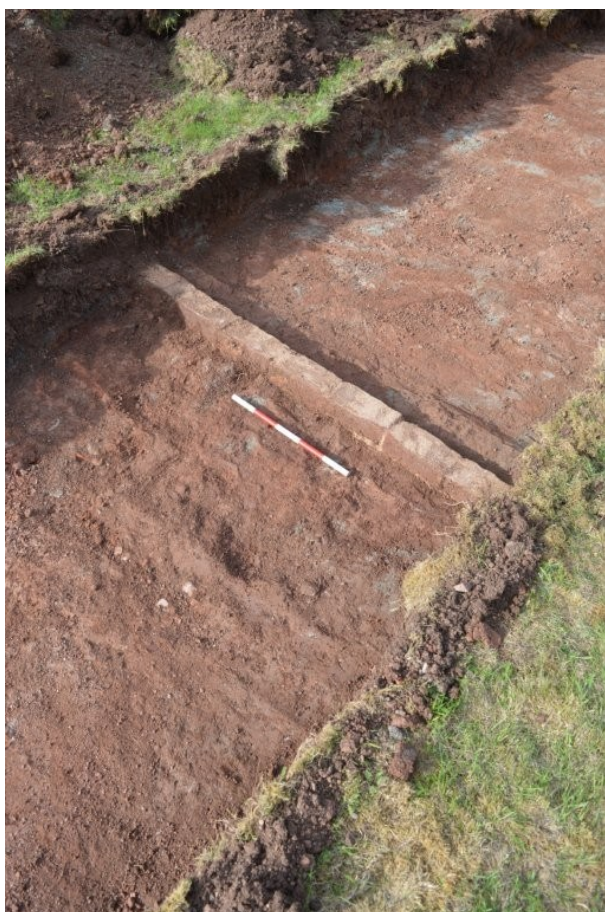
In the central part of the longer arm of the trench, structure {107} comprised a single row of bricks laid flat end to end (header bond) bonded with lime mortar (Plate 6). The bricks were 230mm x 110m x 80mm (9" x 4" x 3") and unfroged.

*Plate 6. Foundation {107}, view north, scale 0.5m*

Brick footing {107} aligns with the southern edge of the northern building which was separated by a passage from the building to the south in 1904 but had been joined by 1928.

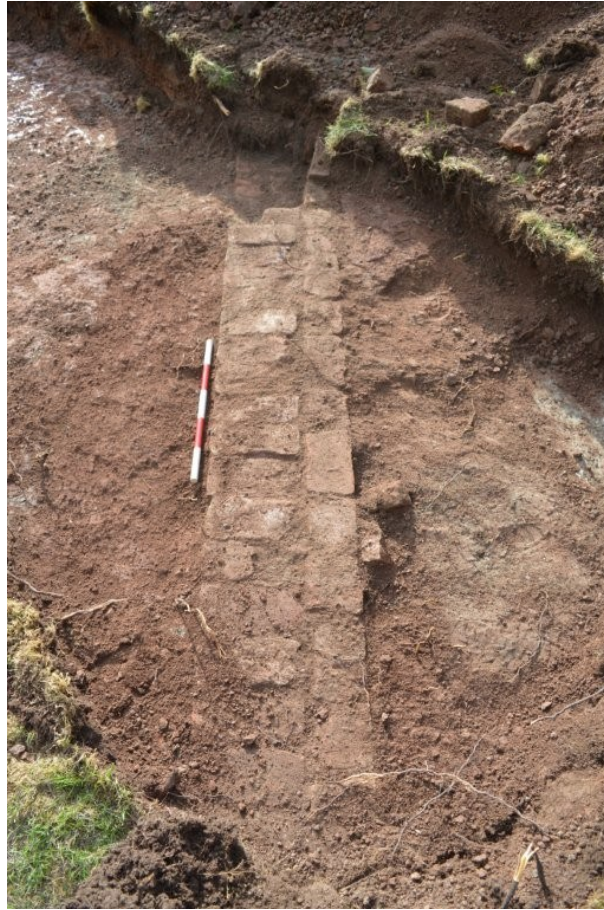
At the north-eastern end of the trench, a wider brick foundation {108} crossed the trench (Plate 7). This was orientated approximately east-west and was therefore at a 45 degree angle to the other structures within the trench and the buildings which formerly stood here. It comprising two rows of bricks, one laid in stretchers and the other headers. The bricks are 230mm x 110m x 80mm (9" x 4" x 3") and unfroged, bonded with lime mortar.

*Plate 7. Brick structure {108},  
view west, scale 0.5m*

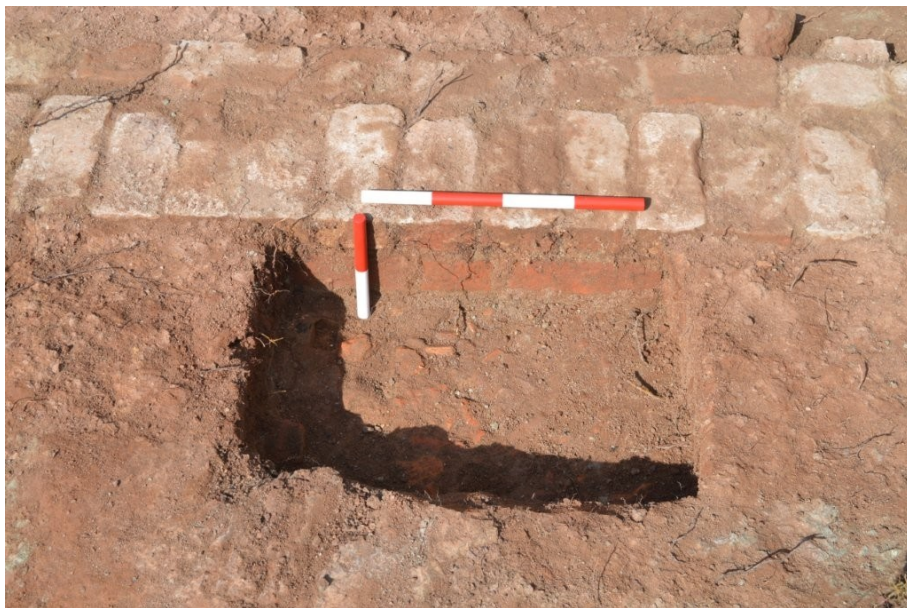
On the south side of this structure, a section was excavated through a steep sided, flat-bottomed cut [111] which was 0.4m wide and 0.2m deep (Plate 8). The upper fill (109) was a firm reddish brown sandy clay with frequent cbm and charcoal flecking which lay over a rough surface formed of brick and tile fragments set into a matrix of concrete (110). Within the concrete was a square slot which appeared to have formerly housed a post. This feature was interpreted as a drain running adjacent to the wall.

*Plate 8. Cut [111] with layer (110) exposed at the base, view north, scales 0.2m  
and 0.4m*

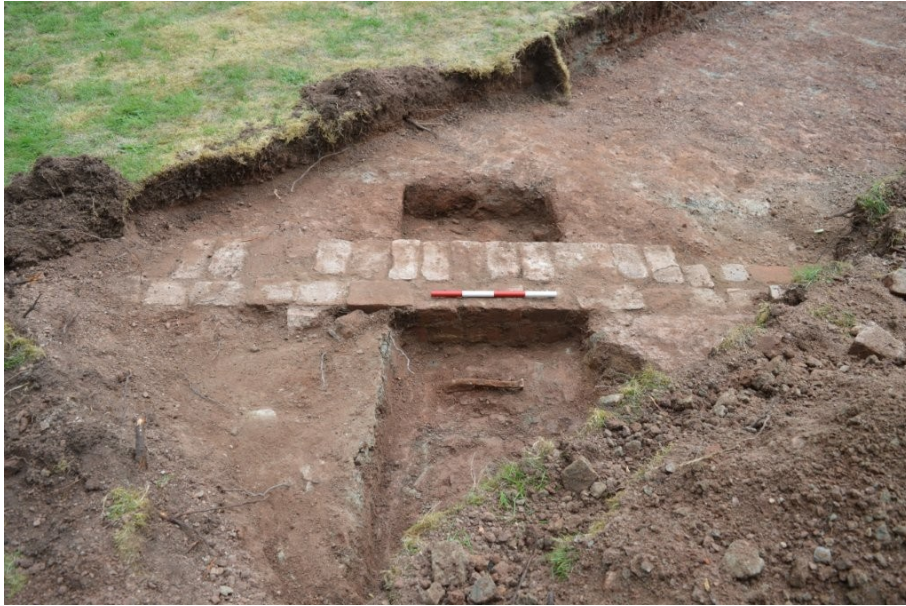
On the north side of the wall a section was also excavated through a layer (112) comprising a firm reddish-brown sandy clay with frequent cbm, mortar and charcoal flecks (Plate 9). This is interpreted as a layer of made ground deposited against the wall to raise the level on this side. A large iron peg had been driven into the natural substrate below this layer.

*Plate 9. Brick structure {108} with section excavated through layer (112), scale 0.4m*

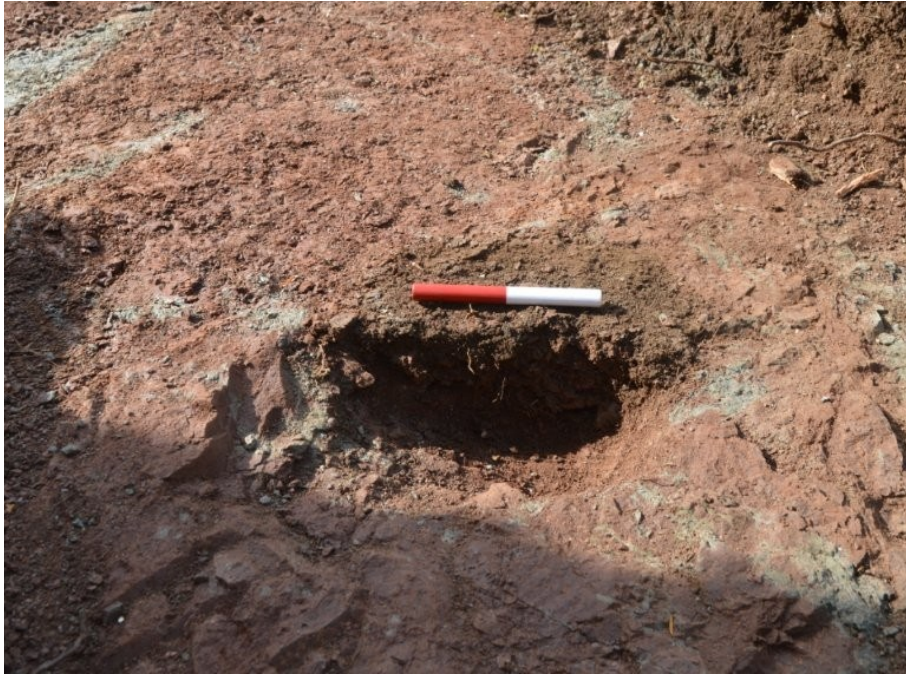
A single feature was recorded in this trench; a small sub circular pit [205] with a diameter of 0.38m and depth of 0.14m (Plate 11). It was irregular in profile with moderately sloping sides and an irregular base. It was filled with a loose, mid-brown clay silt with frequent angular stones (204) and is interpreted as a garden feature, possibly dug to plant a shrub.

*Plate 11. Pit [111] view north-west, scale 0.2m*

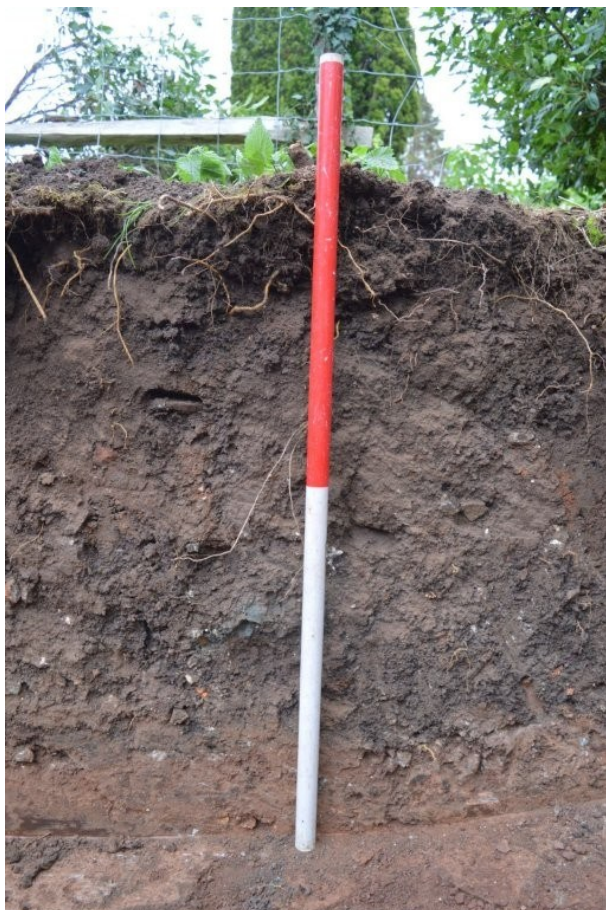
(301) was a loose dark grey-brown clay silt with frequent lumps of charcoal and cbm present to a depth of 0.3m. This overlay a deep, mixed layer of grey-brown silty clay, brick fragments and tile with frequent angular stones (302), interpreted as a made ground with demolition material (Plate 13). This in turn overlay a compact, reddish brown silty clay with frequent cbm (303) interpreted as subsoil. The natural substrate (304) was revealed at a depth of 0.8m.

*Plate 13. South-west facing baulk of Trench 3*

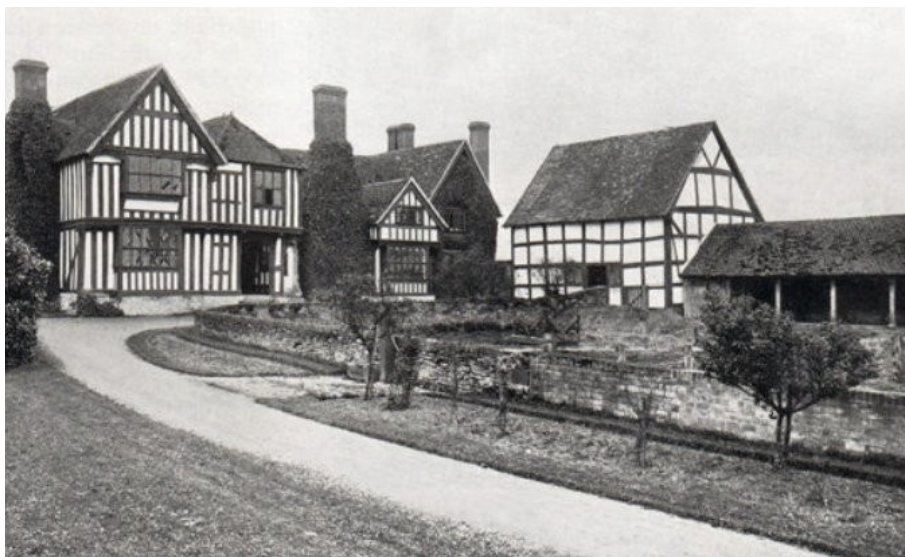
*Plate 14. C. 1910 Photograph of Eastington Hall showing open fronted shed, demolished in the 1940s.*
