# Ambrey Archaeology Ltd

## Archaeological building recording and monitoring at 123 Pensax, Abberley, Worcester

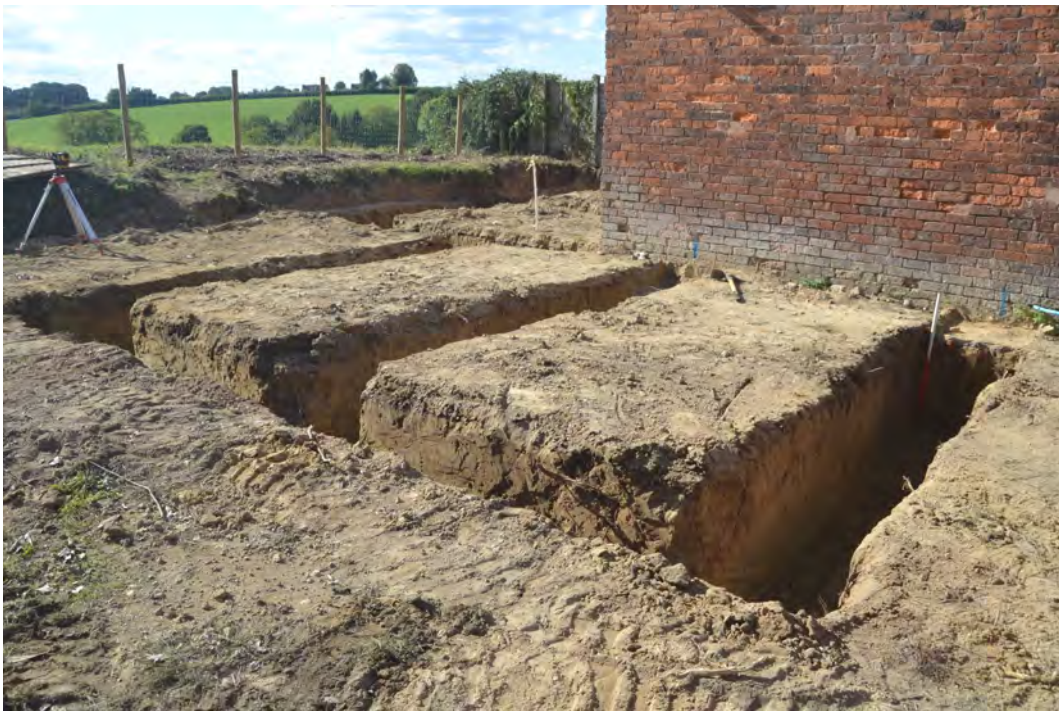
*Plate 46. View west of foundations fully excavated*
