Excavations at the Tower of London, 1976/7

GEOFFREY PARNELL

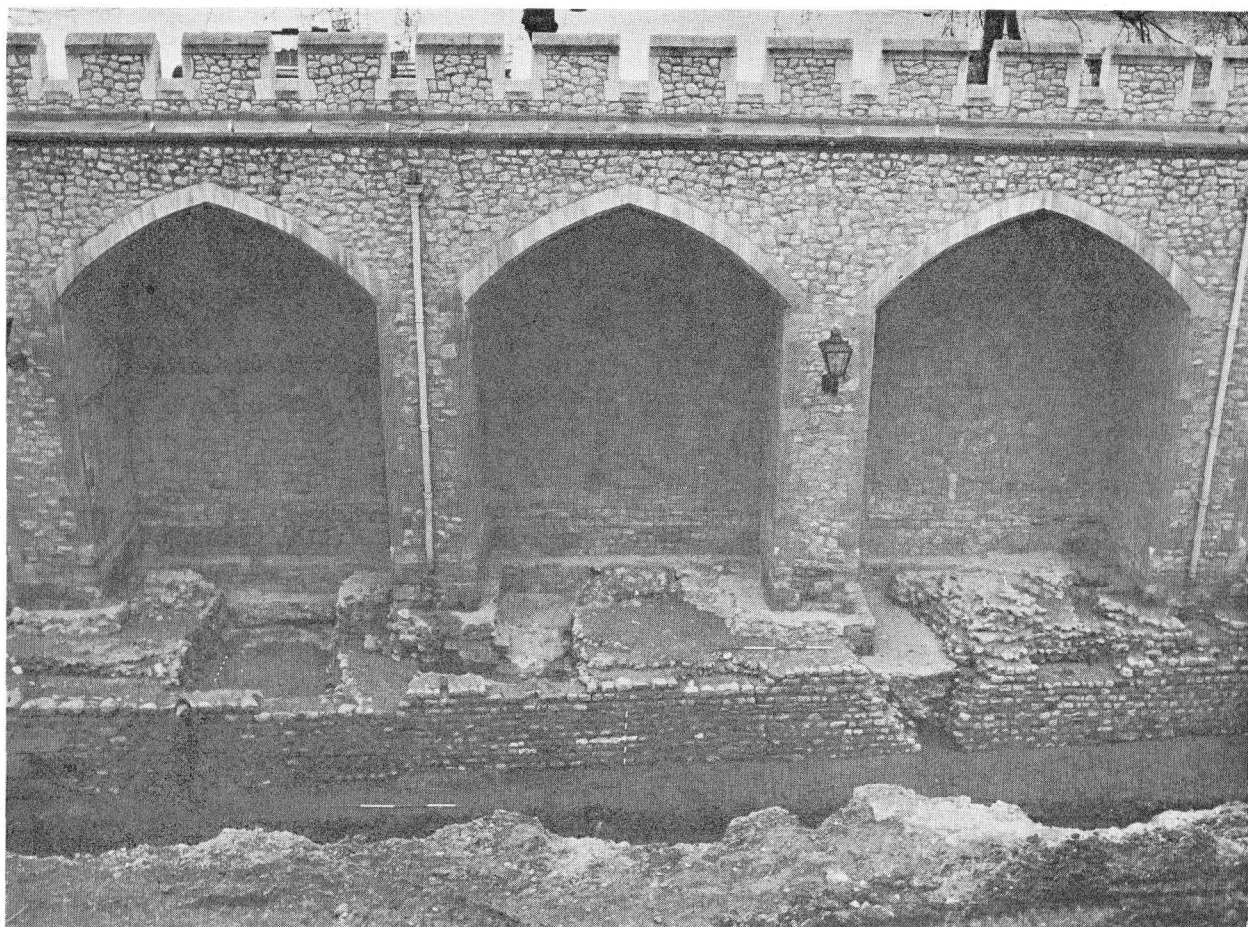
Fig. 1: General view looking south.

No further notable activity was recorded until the building of a massive riverside wall in the fourth century. A total length of 21m was exposed, providing valuable information about this late addition to London's defences.

The core of the wall was standing to a maximum height of 2.15m, the face 1.90m, the width of the wall, established at two separate points, was 3.20m.

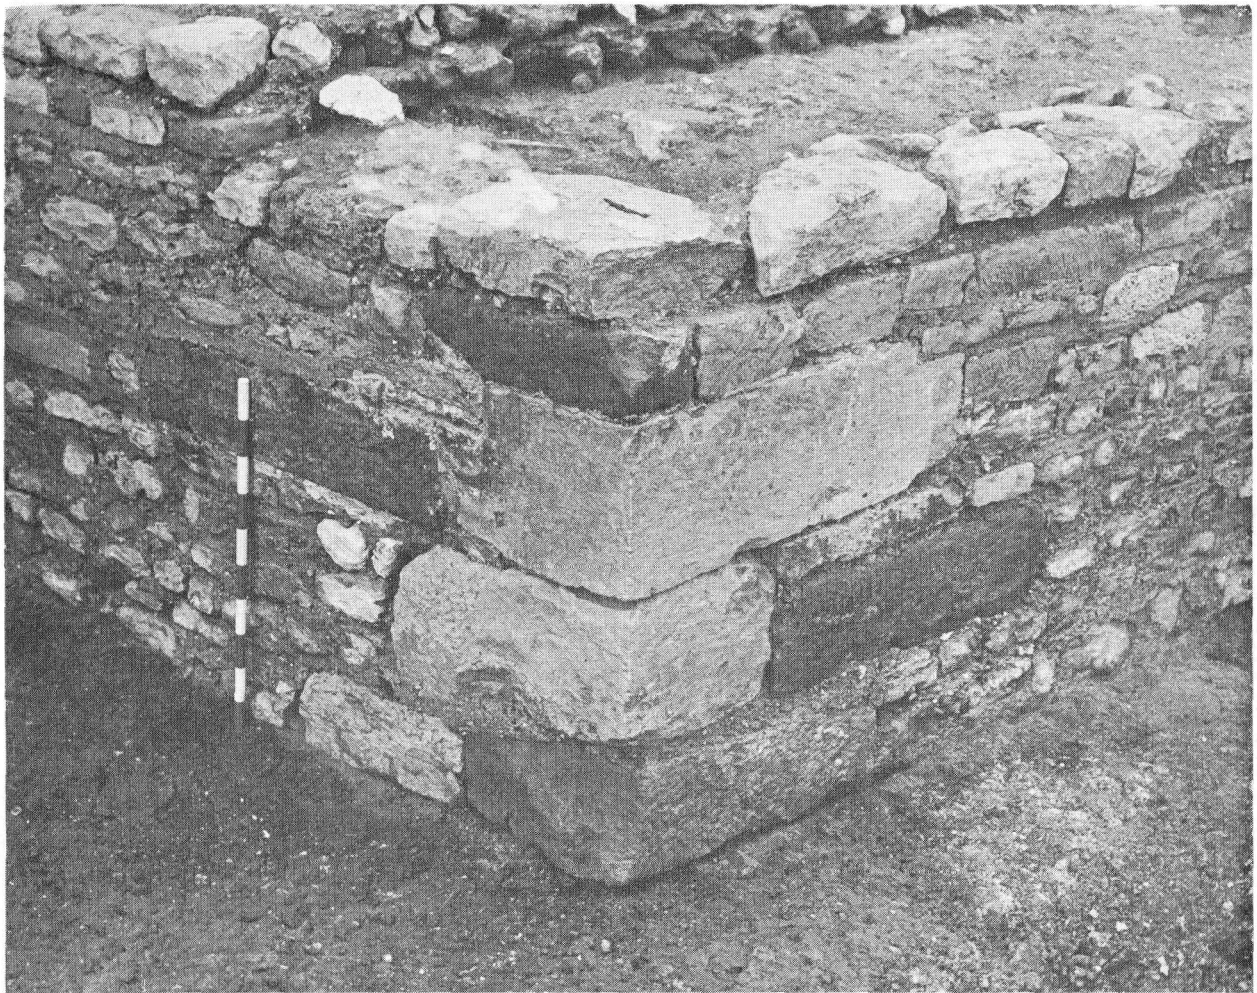
Fig. 2: corner showing re-used architectural stone.

Within a short distance of the present Lanthorn Tower, the wall turned south at 100°, several large pieces of architectural stone being re-used to form the corner. A fourth-century scarping of the earlier city bank, revealed adjacent to the Lanthorn Tower, is likely to be associated with the southward extension of the wall and combined with later documentary evidence, would suggest a return just south of the present curtain wall. It is probable that this southward extension of the wall formed part of a promontory linked to the landward defences and guarding the river approach to the city.
