## GPO Newgate Street, 1975-9; the Roman levels

STEVE ROSKAMS

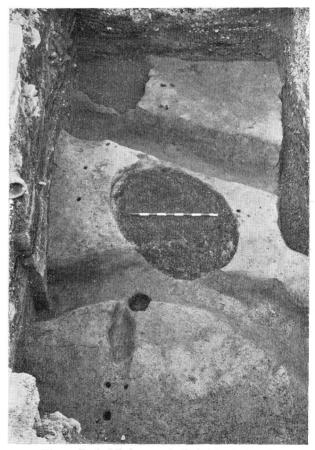
Fig. 1: Period I, fragment of circular hut and associated boundary ditch.

The first sign of building activity, found in the south and of pre-Boudiccan date, was a fragment of a circular hut cut directly into the natural brickearth (Fig. 1). No associated floors survived, but a probable boundary ditch to the north is contemporary. The latter's alignment is not that of the subsequent structures on the site, which run perpendicular to the Roman forerunner of Newgate Street. Hence, both ditch and hut may ante-date the setting out of that thoroughfare. Material derived from their backfill is of pre-Flavian date. The rest of the area was given over to the piecemeal, small-scale quarrying of brickearth.

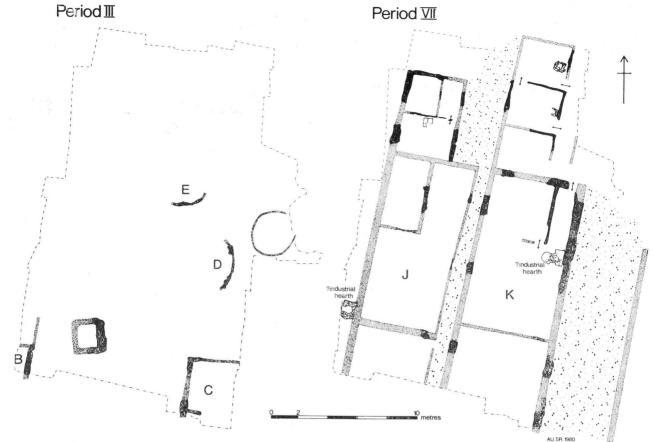
Fig. 2: Period III structures.

During period III (Fig. 2) parts of two rectangular buildings were found in the extreme south. They would have fronted on to the street and were timberframed, with sill beams set into the ground and probably a daub superstructure. Further north, fragments of several circular huts were found of wattle and daub construction. All of these buildings were destroyed by fire (Fig. 4). Their apparent contemporaneity of construction shows the co-existence of rectangular buildings employing stronger framing, near the street and, further north, structures "less

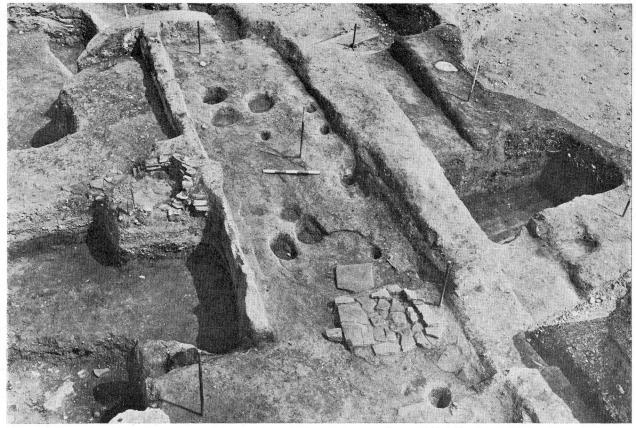
Fig. 8: Period VII. Brickearth sills and hearths in central part of Building K, looking north-east.

ises with selling taking place at the frontage. Just behind this were large rooms, some of which contained sturdy hearths, implying an industrial function, maybe producing the goods sold at the frontage. At the rear were smaller rooms, containing less substantial, but well-preserved hearths (Figs. 6-8), this time merely for heating. The rooms could have been used for production as well, or for domestic living. No material survived within them to give a direct indication of function. Further living quarters probably existed on a second storey near the street. In later phases the western building was modified and extended in the north, becoming split off from the eastern one at the end of its life. The latter was substantially unaltered until both structures were destroyed in the Hadrianic fire. The resulting destruction debris spread across the whole site. It incorporated partially articulated fallen walls of dried and fired bricks (Fig. 9), collapsed from internal and external frameworks.
