Excavations at Watling Court

Part 1: Roman

DOMINIC PERRING

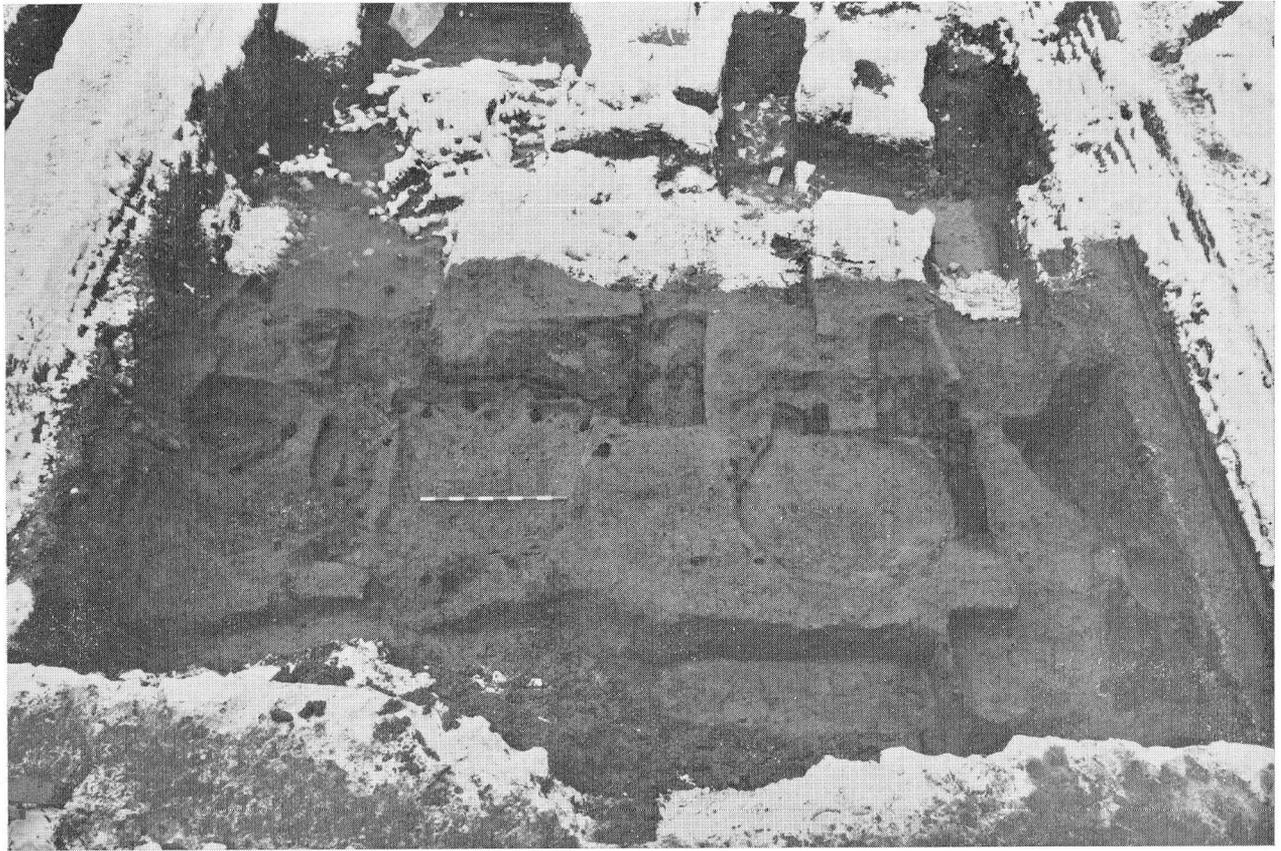
Fig. 1: Traces of the timber floor of Structure 2. The scale is in 0.10m (4in) units.
(Photo: Trevor Hurst)

These rectangular buildings (Fig. 1) may have been timber framed, but the walls were so slightly founded that their positions could only be determined from the extent of the floor surfaces. The destruction debris included many fragments of air-dried or poorly fired bricks which may have been used as infilling for the walls. The buildings were destroyed by fire so early within the structural sequence as first to suggest its equation with the documented razing of the city by Boudica in

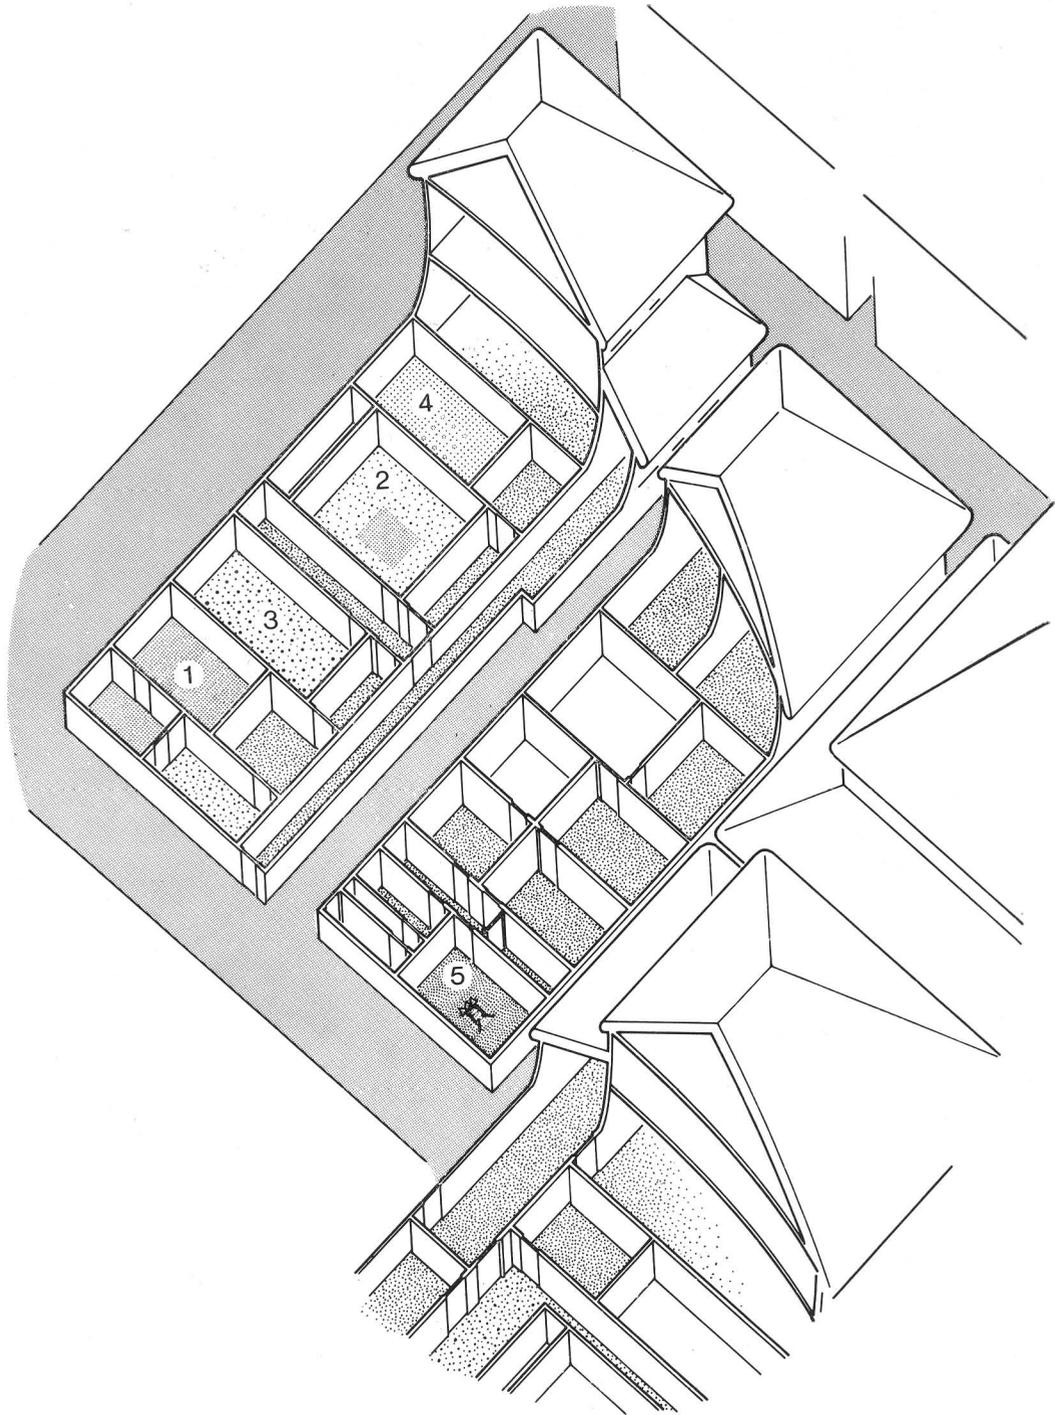
Fig. 2: Conjectured extent of the Period IV buildings seen from the north-east. Structure 6, in the middle, was *c* 29m (30 yards) long. Rooms number 1 to 5 are referred to in the text.

By the end of the first century the site had, however, been fully developed; to the extent that no space remained open except for service alleyways. Three buildings (Period IV, Structures 4, 6 and 8, Fig. 2) were excavated in detail, and parts of several others observed; all were apparently domestic in function. They were all destroyed by a major fire of the 120's AD, almost certainly the 'Hadrianic fire'⁴; the debris from which buried the lower part of the buildings, which were conse-

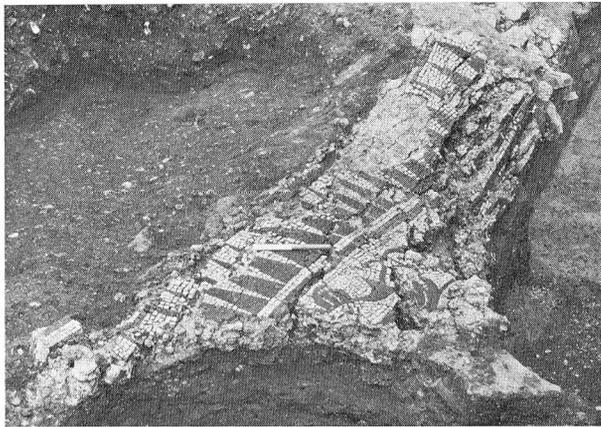
Fig. 3: First century mosaic floor in Room 1 of Structure 4, viewed from the south-west. The scale is in 0.10m (4in) units.
(Photo: Jon Bailey)

In the southernmost building (Structure 4) the load-bearing walls had been built on a dwarf wall of ragstone in mortar bonding. Several of the rooms had been appointed with red and white plastered walls, and a number of high quality floors had been laid. A mosaic floor (Fig. 3) in the east end of the building (Room 1 on Fig. 2) was made from small squared black and white tesserae set into a mortar base. The design consisted of a strip of alternating black and white triangles above a floral border of leaves, scrolls, and tendrils. Black and white geometrical designs of this type were most popular during the early Roman period in Britain; more brightly coloured mosaics were rare until the later Roman period. Other floors in the building were of *opus signinum*, a mixture of tile fragments in sandy mortar which had been ground down and polished to a smooth surface. A quarter-round moulded skirting of *opus signinum* was also laid in two of the rooms. In three rooms (Rooms 2, 3 and 4 on Fig. 2) mosaic designs had been set into the *opus signinum*: this was technically complex operation as the tesserae would have been laid before the *opus signinum* had set, and floors of this type are rare (Fig. 4).

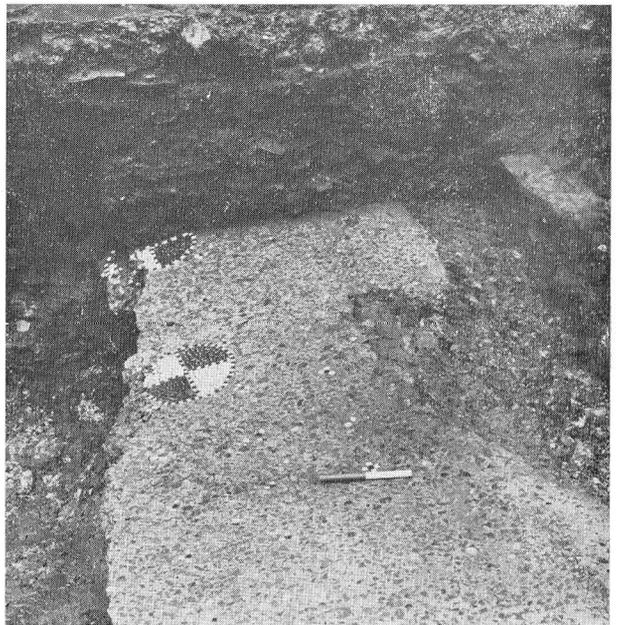
Fig. 4: Mosaic roundels set into the *opus signinum* floor of Room 4 of Structure 4, viewed from the north. The scale is in 0.10m (4in) units.

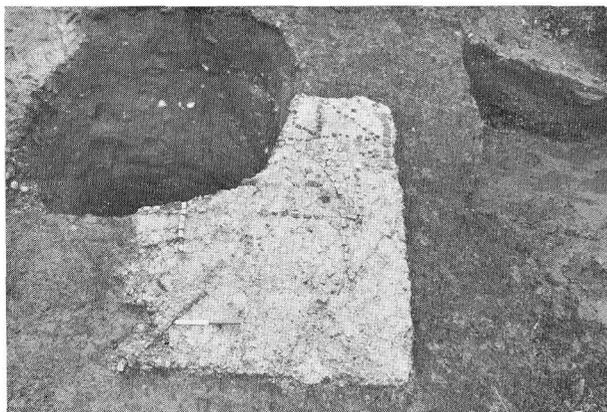
Fig. 5: Tessellated design in Room 5 of Structure 6 as revealed after the removal of the mortar floor, viewed from the north. The scale is in 0.10m (4in) units.

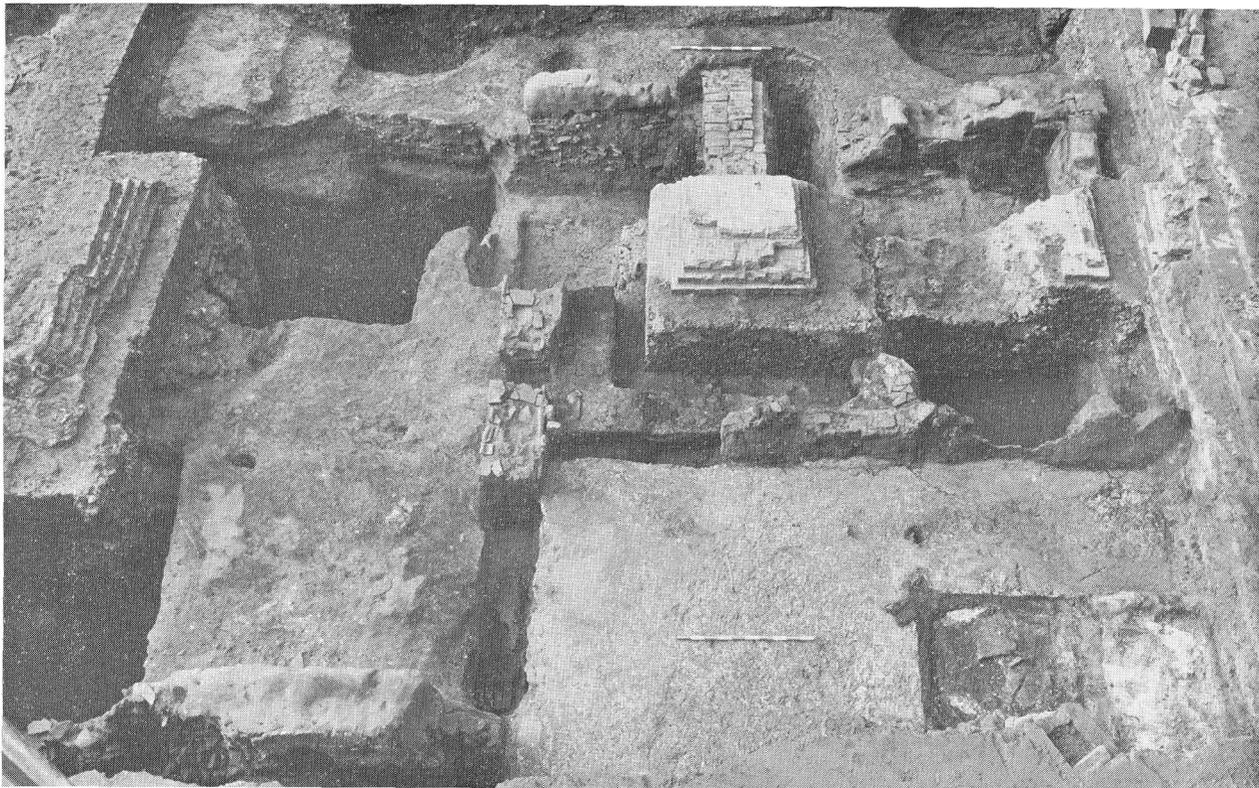
Fig. 6: Structure 8 viewed from the east; the concrete and brick foundations are modern. The scale is in 0.10m (4in) units. (Photo: Trevor Hurst)

The northern building (Structure 8) was generally similar to the southern, although its load-bearing walls were differently constructed. In these the walls were built of brickearth bonded tile beneath puddled brickearth (Fig 6). These walls survived, in places, to a height in excess of 1m (3ft 3in) and no trace of a superimposed timber structure survived the post-destruction clearance. It is possible that these walls were built entirely of tile and brickearth to first floor level. The destruction debris within this building survived well (Fig. 7). A thin band of charcoal had been formed when the timber elements (doors, furniture, etc) were burnt away, and some of the plaster from the walls had also fallen away before the ceiling and roof collapsed. The ceiling plaster lay in a jumble on the floor. Some sheets of plaster had fallen directly to lie face down, but most of it had fallen in an arc to end face up. This plaster could be distinguished from the wall plaster by the impressions of the ceilings lathes into which the plaster had been pressed (lathes had not been used in the construction

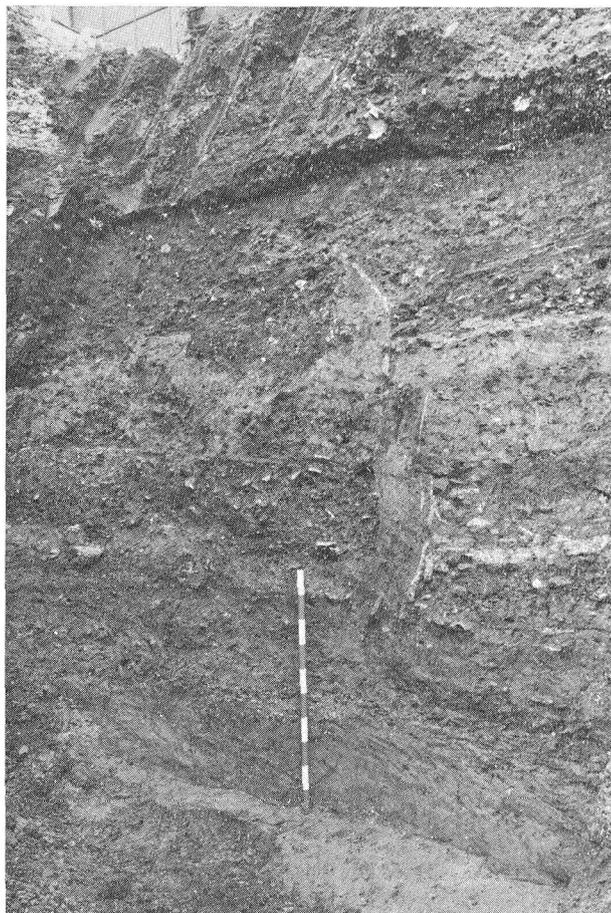
Fig. 8: Section through Roman deposits with natural brick earth at the base and 'dark earth' at the top. Slightly higher than and to the left of the scale (which is in 0.10m - 4in - units) can be seen a sequence of three plaster faced brickearth walls, perpetuating a Flavian wall line. The topmost wall had slumped in the mid-second century fire, and poor quality post-fire surfaces can be seen to its right. (Photo: Jon Bailey)
