Excavations at Watling Court

Part 2: Late Roman to Modern

DOM PERRING

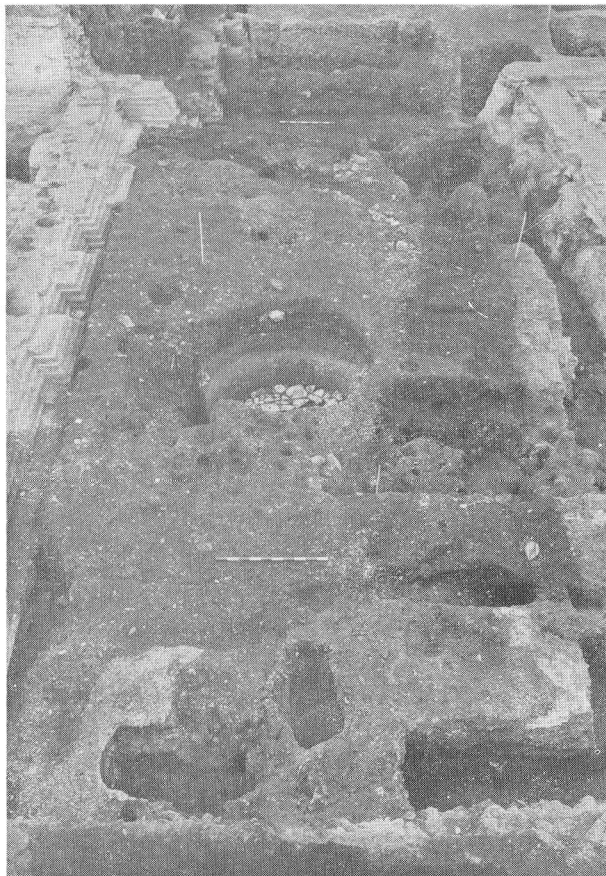
Fig. 3: The 'larger' sunken featured building (d on Fig. 2) before excavation, visible as the darker area between the Victorian wall foundations. The scale is in 0.10m units.

The 'third' building survived over a larger area than the other examples (Figs. 2 and 3) and three

of its walls survived; the position of the fourth could be located, with a fair degree of certainty, beneath a Victorian wall line. The entire cut area measured 14.7m by 6m (48ft x 20ft) with an effective floor area between the walls of 13.3m by 4.7m (44ft x 15ft). The end walls of the building were of slightly different construction from those outlined above; the uprights were not set into a timber ground beam and there was no trace of an inner plank lining. As the end walls would not have taken a significant part of the roof load, this difference does not affect the structural details proposed above. Inside this building a sequence of floor surfaces was comparatively well preserved. Dumps of smithing waste formed a solid platform for the flooring, although impressions of timbers beneath the waste suggest the possibility of an earlier, largely destroyed, timber floor. The nature of the floor set over the waste platform was not established but its successor was well preserved. This floor consisted of timber joists and planking. The joists were longitudinally split and trimmed but otherwise uncarpentered timbers,

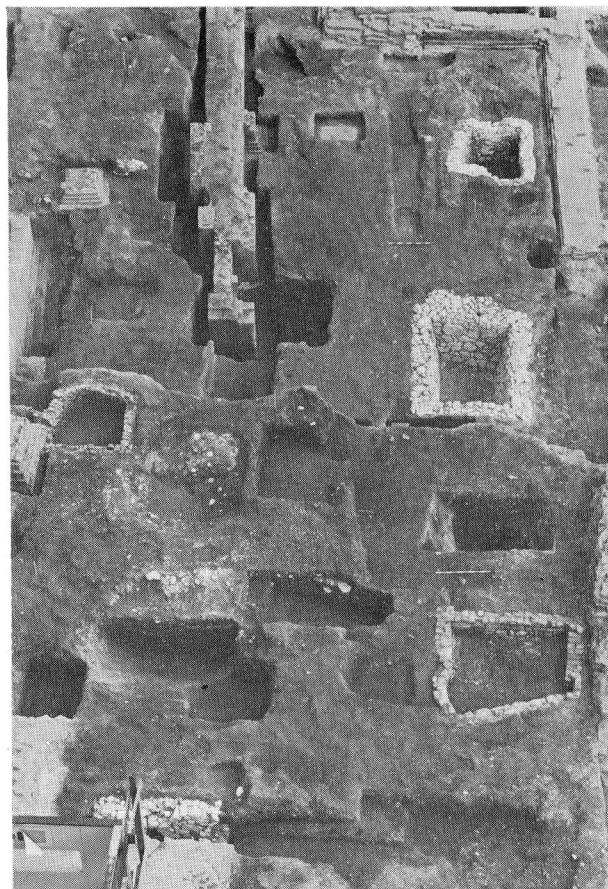
Fig. 7: Medieval and post-medieval rubbish pits and cess pits alongside Salters Court, the line of which is clearly indicated by the chalk and brick lined cess pits. The scale is in 0.10m units.

The properties, and cess pits, clearly backed on to an alleyway, the line of which had been perpetuated to modern times by Salters Court. The earlier sunken or cellared buildings were also positioned
