The Infirmary of Bermondsey Priory

DAVID BEARD

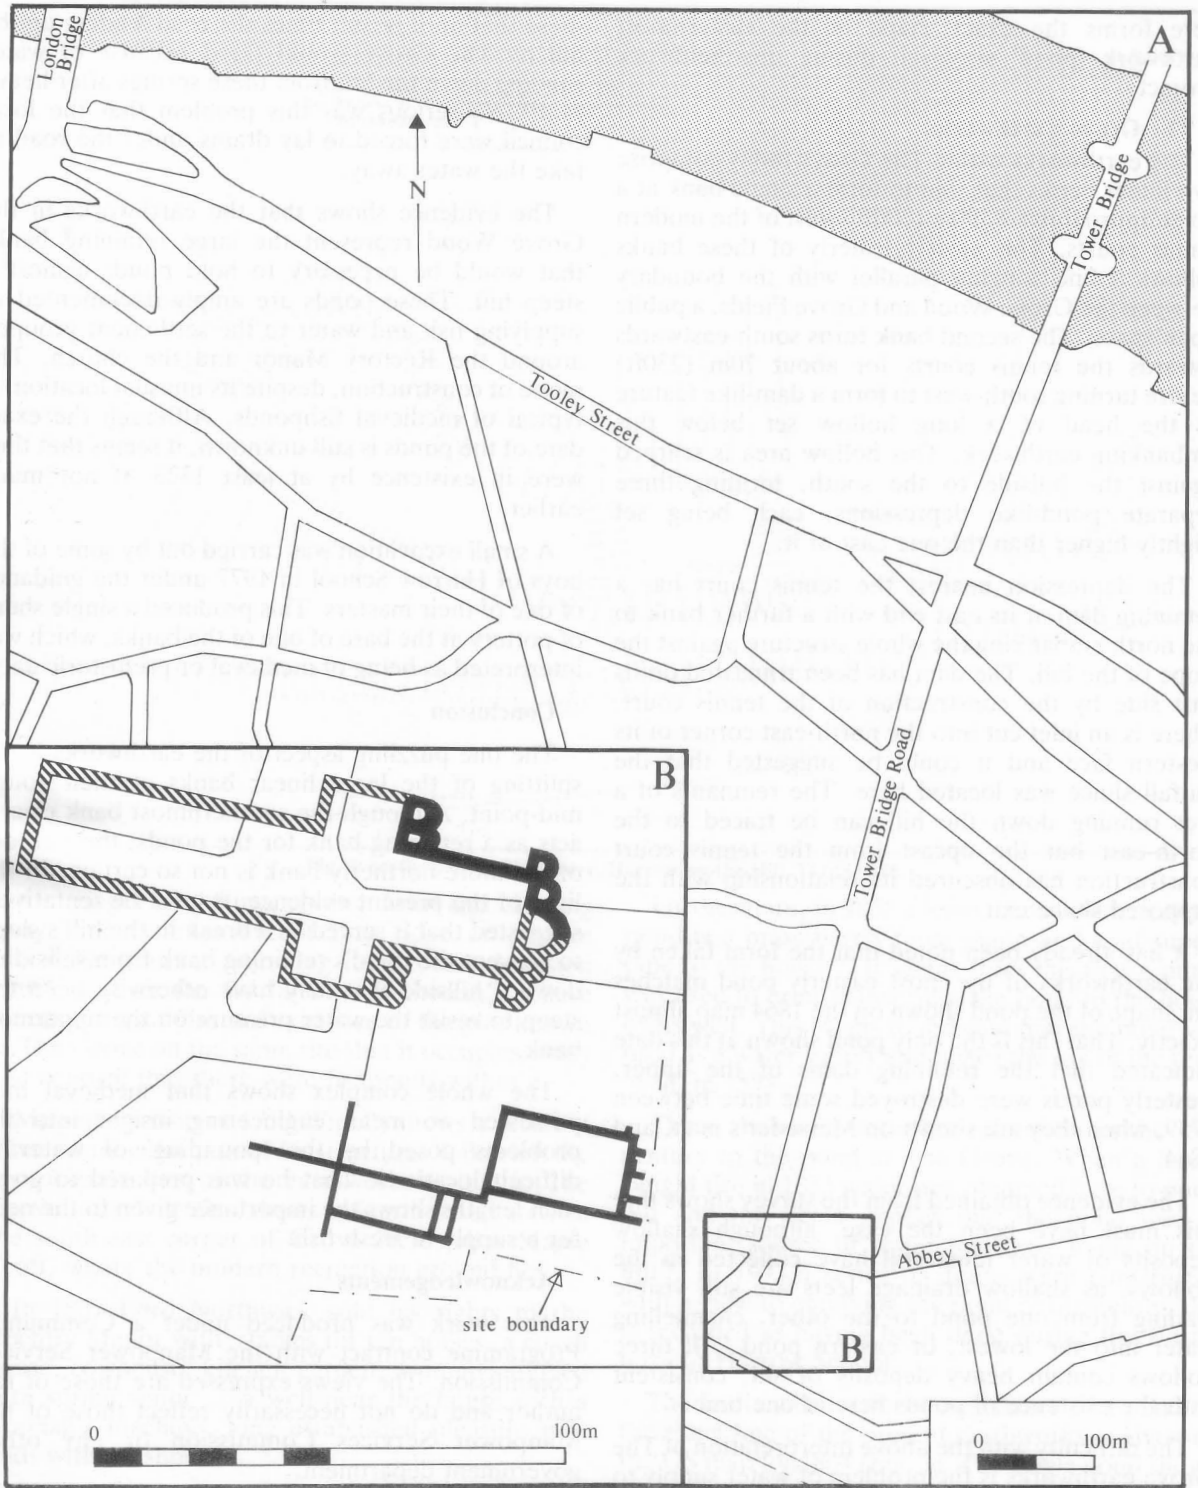
Fig. 1: (A) location map of site showing (B) Phase Three of infirmary hall and other buildings, and approximate location of church.

IN SPRING 1984 the Department of Greater London Archaeology of the Museum of London began excavations on a large redevelopment site at Long Walk, S.E.1. (Fig. 1). The site belongs to Southwark Council, who intend to use it for housing. It lies to the south of the church of the Cluniac priory of Bermondsey, the position of which is now shown

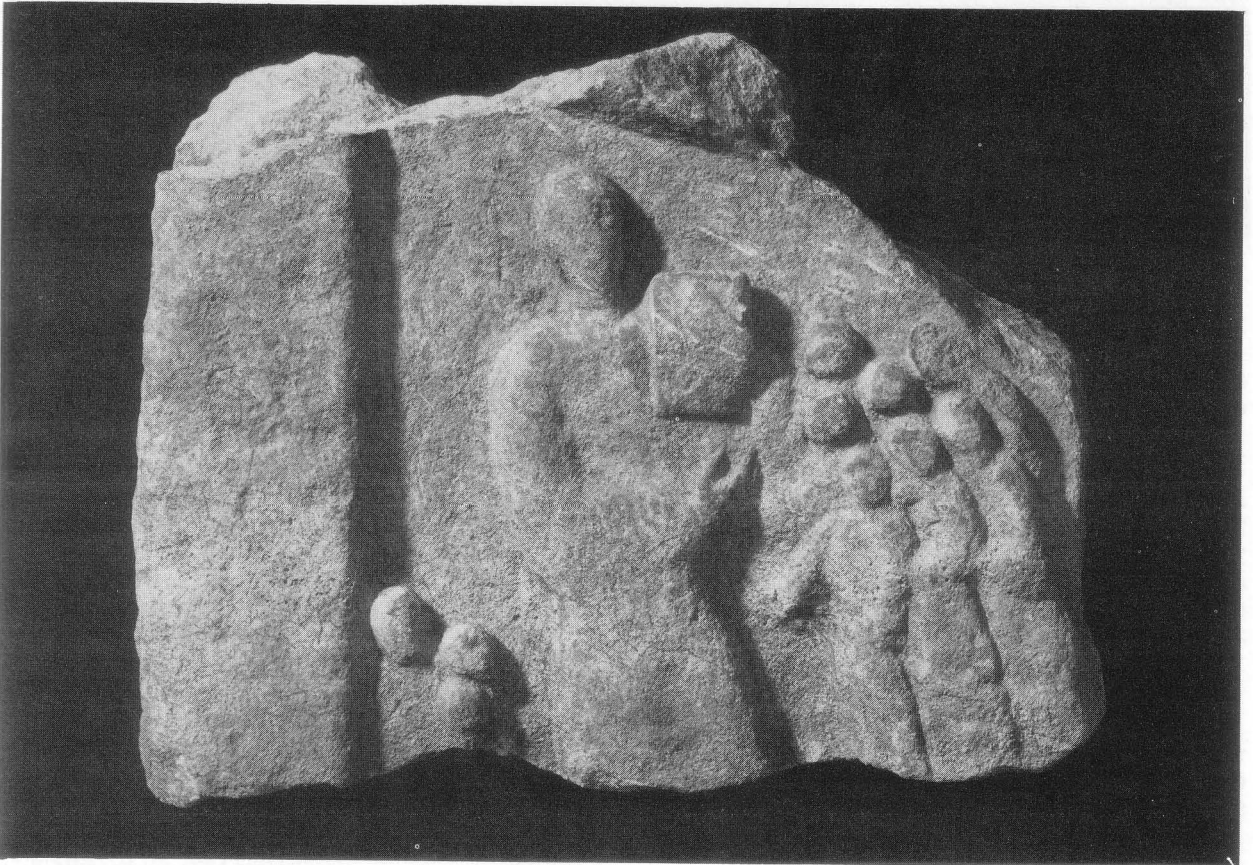
Fig. 5: fragment of sculpture, probably 11th century.

From a feature cut by the north wall of the eastern extension came a fragment of sculpture (Fig. 5). The fragment is *c* 0.36m × 0.27m (14in × 10½in) and carved in oolitic limestone. The sculpture is very

worn and shows a large central figure holding a book, a standing group of figures to the right and three lower (kneeling?) figures to the left. The left side of the fragment is bounded by a wide raised bar and part of a curving bar remains above the figures. The sculpture is probably 11th century in date⁵, and the scene may represent the raising of Lazarus⁶. The presence of this fragment in 12th century construction levels may indicate renovation of an ecclesiastical building elsewhere on site at this time.

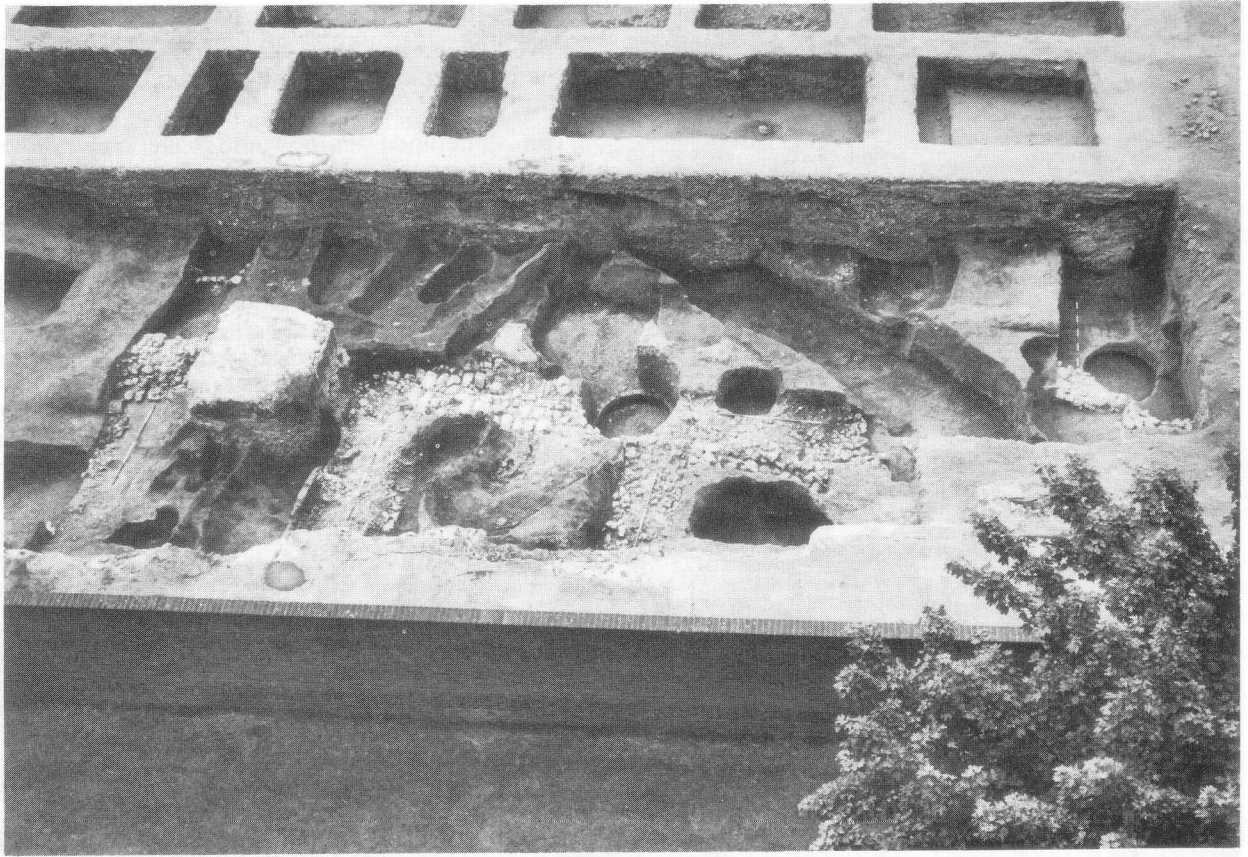
Fig. 6: east end of Phase Three infirmary wall.

16m (92ft × 52ft 6in), with four small rooms to its east (Fig. 6). The plan of this building is very similar to the infirmary hall at the priory of St. Pancras, Lewes⁷.

The foundations for the new hall had an average width of c 1.3m (4ft 3in). At the east end of the hall they had been nearly completely robbed in the post-medieval period, and in some cases survived only as robber trenches. Where the foundations did survive they consisted of chalk blocks bonded with clay. The foundation of the west wall of phase two was retained for the foundation of the west wall of the new building, and in part was considerably reinforced with well-mortared ragstone rubble. In the south-west corner of the hall was a stone-lined cesspit which may be a secondary construction.
